*Prepared for the County of Santa Barbara on August 26, 2021*

# UNION OIL BUILDING Facility Assessment Report

# STRUCTURAL – ASCI 41-17 TIER I AND LIMITED TIER 2 EVALUATION

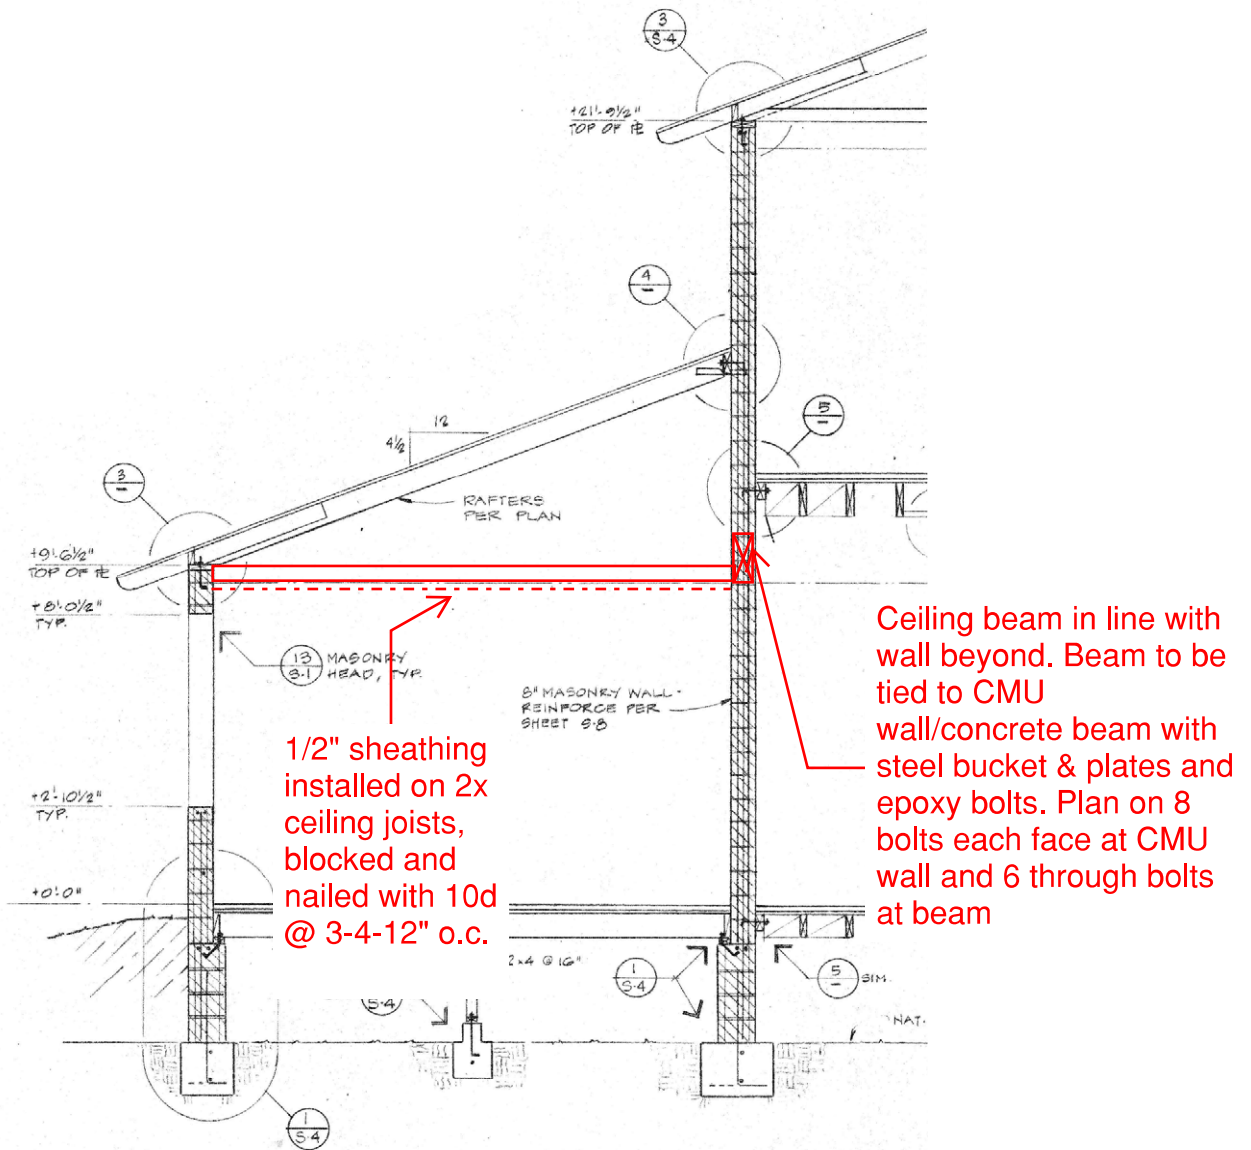
Deficiency 4.4 & 4.3 - Soft and Weak Story

Similar condition to the weak story above, the rear of the building has too large or a stiffness change between the upper and lower levels. In addition to the length of the available shear wall being 30% less, the downstairs walls are taller by 2'-4". This increased height will make the walls more flexible downstairs and have a higher deflection. The higher the deflection, the lower the stiffness.

At the rear of the building, there are three options to address this deficiency:

- A. Infill (2) 4'-0" windows in the downstairs main wall line.
- B. Add a minimum length of 6'-8" of 8" reinforced masonry shear wall downstairs, in line with the shear wall above. New wall requires connection to the floor diaphragm and a new foundation support.
- C. Construct a horizontal diaphragm to connect the main rear wall to the single-story walls that are offset.

Like the weak story deficiency, there are three options to address this deficiency:

- A. Infill (1) 4'-0" window in the downstairs main wall line.
- B. Add a minimum length of 11'-8" of 8" reinforced masonry shear wall downstairs, in line with the shear wall above. New wall requires connection to the floor diaphragm and a new foundation support.
- C. Construct a horizontal diaphragm to connect the main rear wall to the single-story walls that are offset and fill in a single downstairs window anywhere on the combined wall line.
