Watershed Conditions Due to the Thomas Fire

A Report from
U.S. Forest Service, CAL FIRE
and CA Geological Survey

*Presented to the Santa
Barbara County Board of
Supervisors*

May 1, 2018

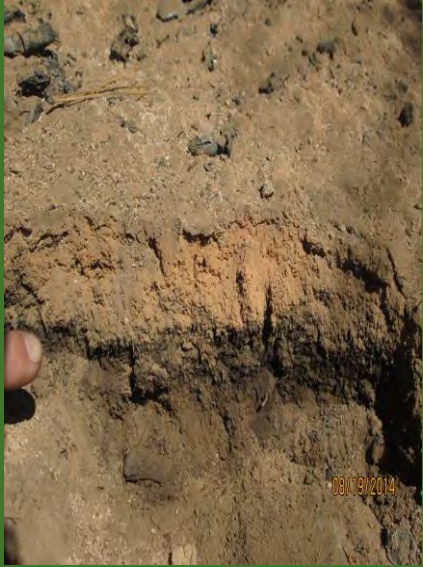
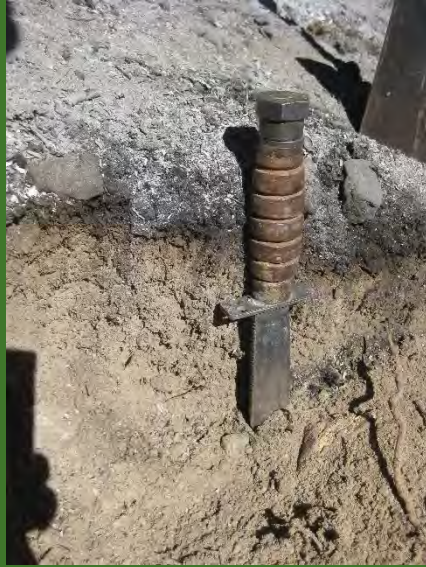
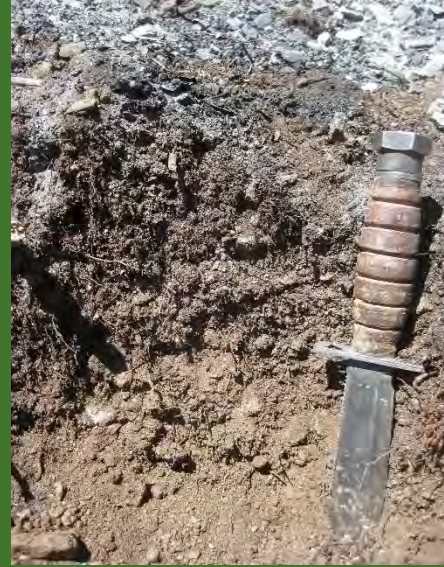
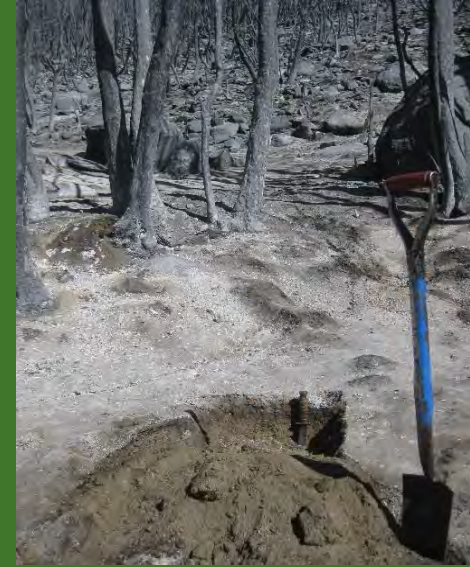
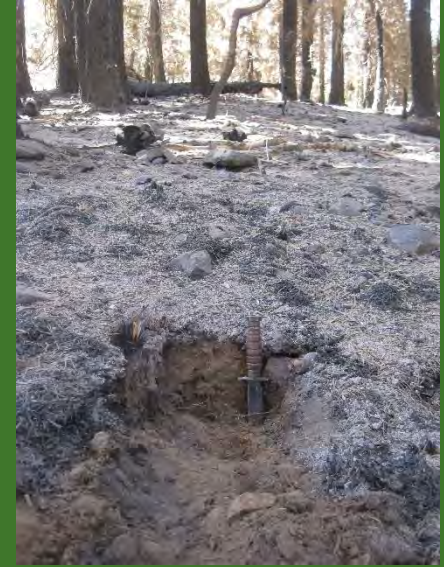
Soil burn severity effects shown in pictures above (left to right): high, moderate, low soil profiles, and high and moderate soil burn landscapes.

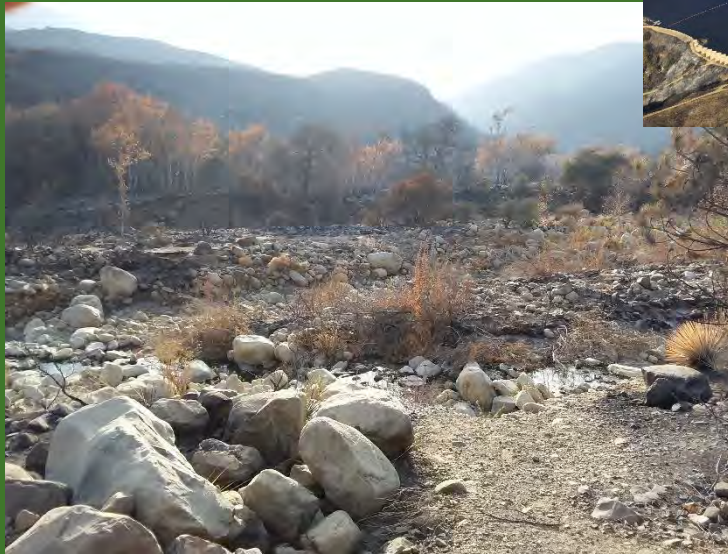
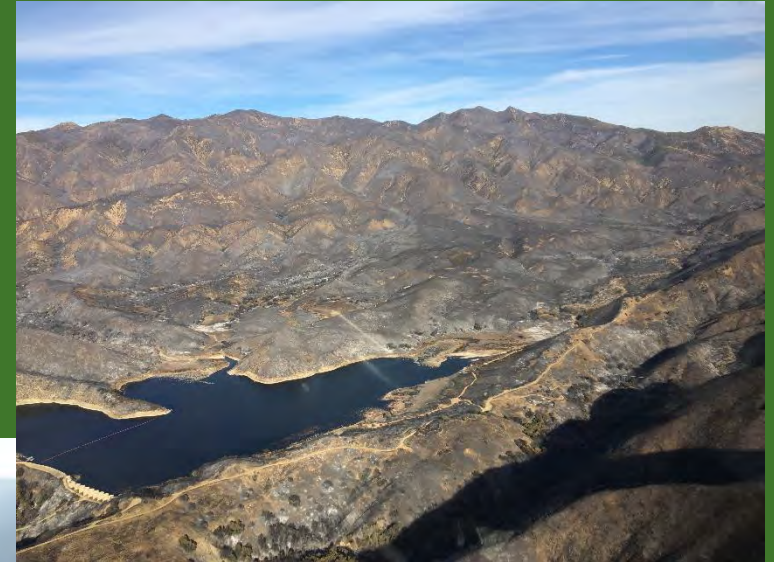
- **Flooding, Sedimentation**
- **Evidence of past debris flows**
- **Reservoirs trap sediment**

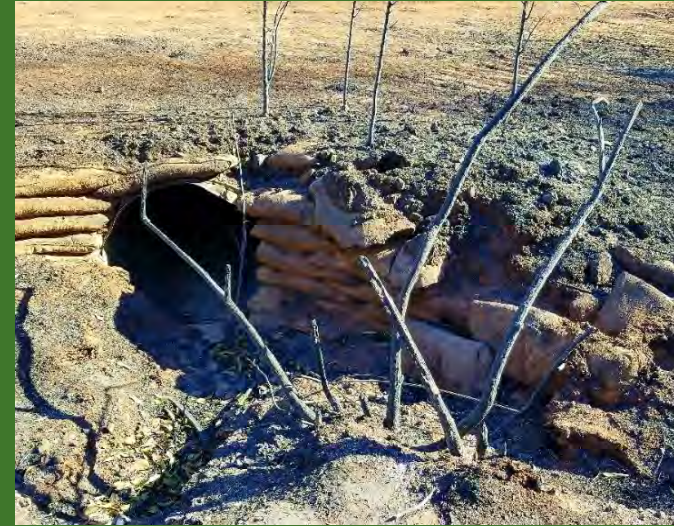
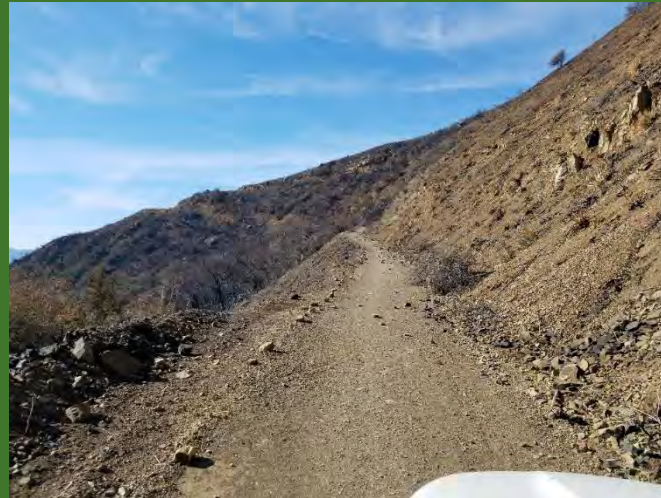
- Moderate/High Severity above many roads
- Rockfall/dry ravel hazard
- Road washouts expected

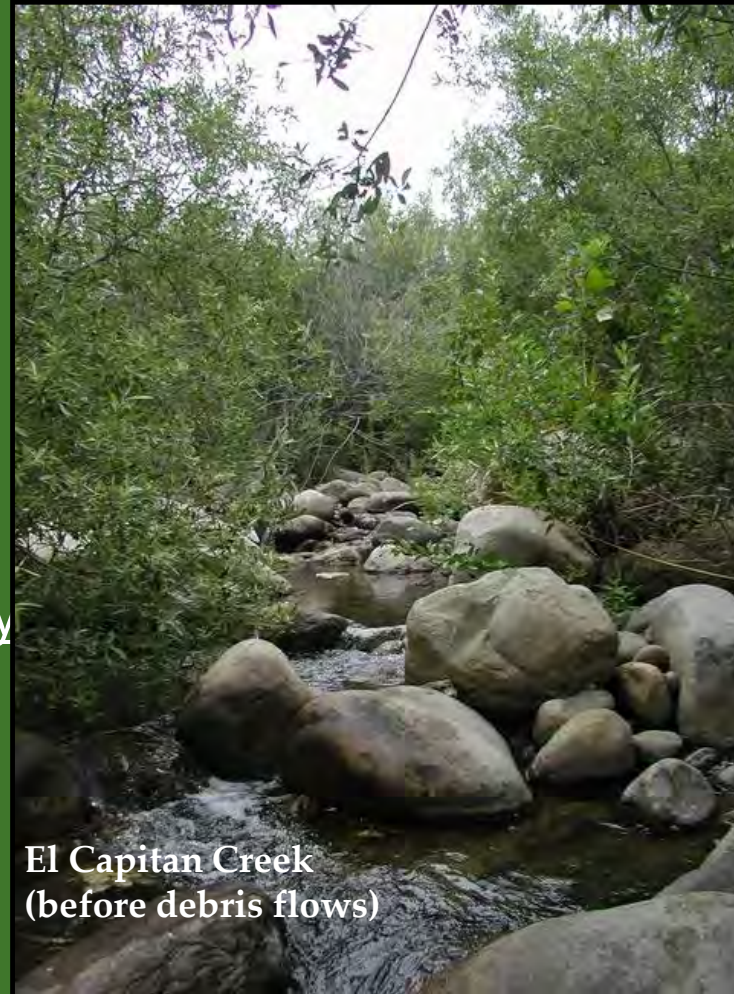
El Capitan Creek
(before debris flows)

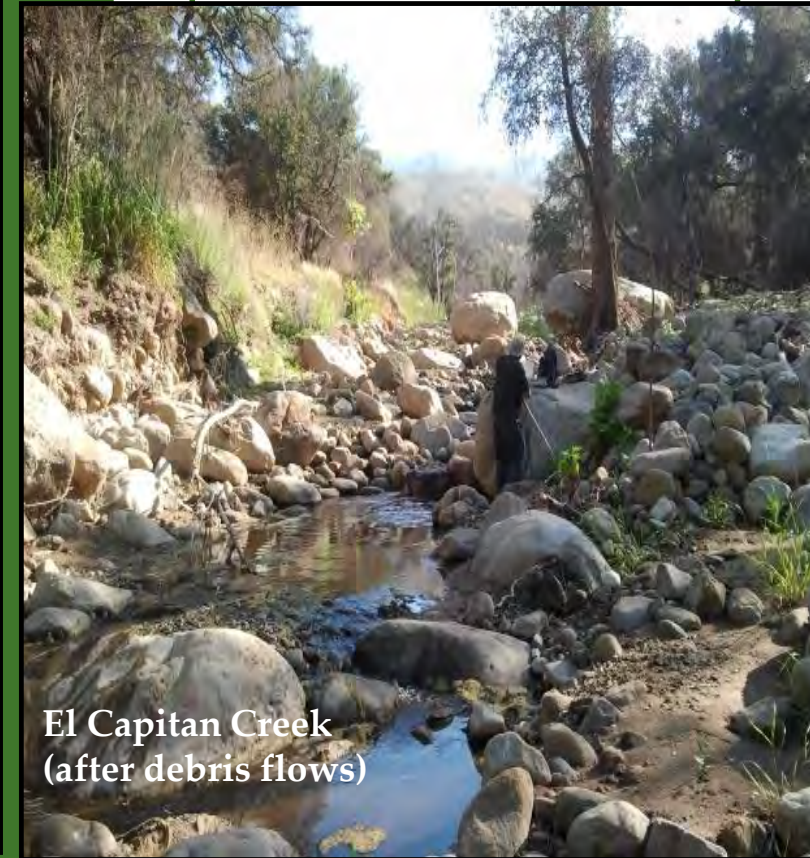
El Capitan Creek
(after debris flows)

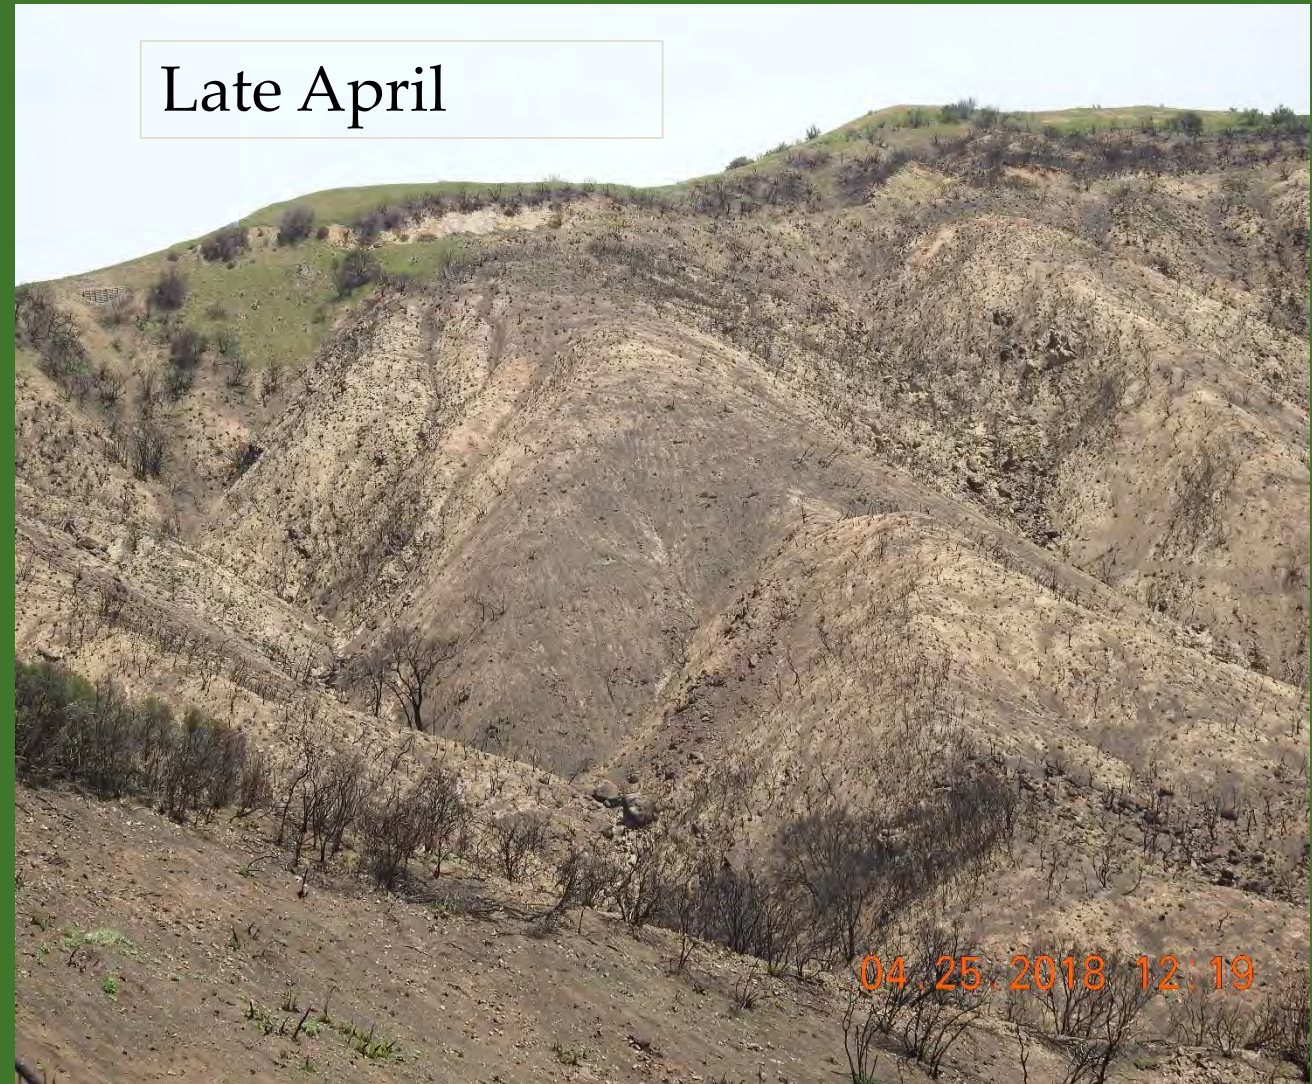
Hazardous 2019

- 5 – 10% cover now
- More expected?

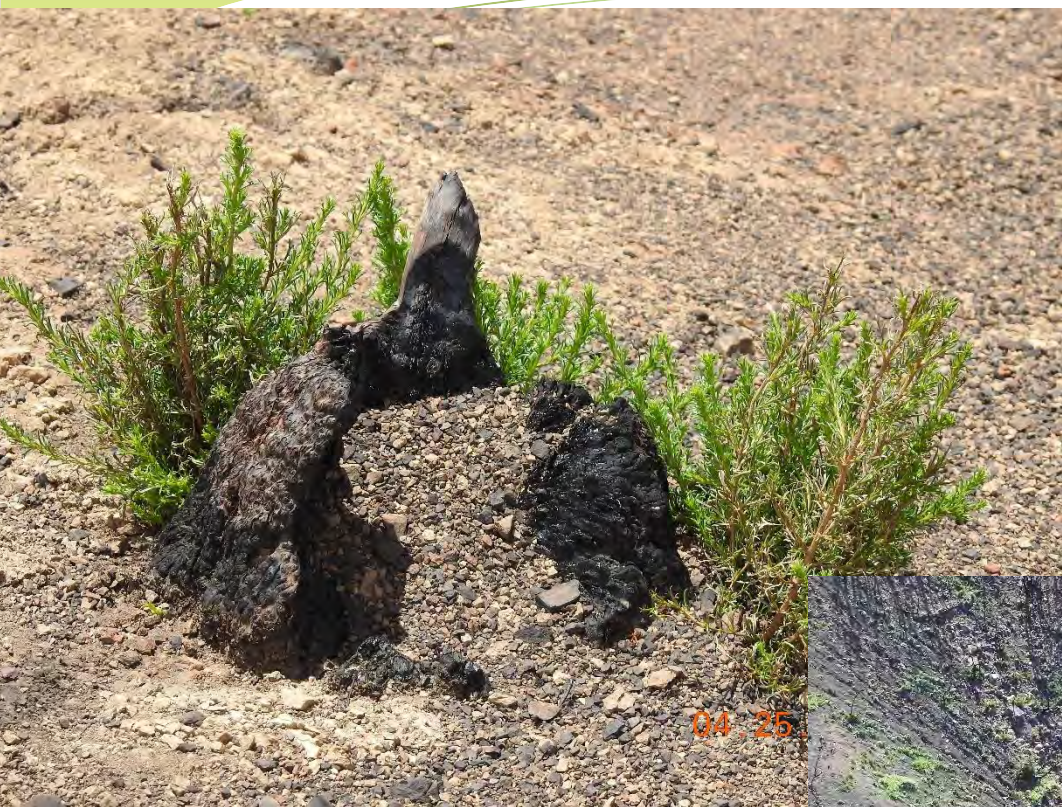
Chamise and marah sprouting.

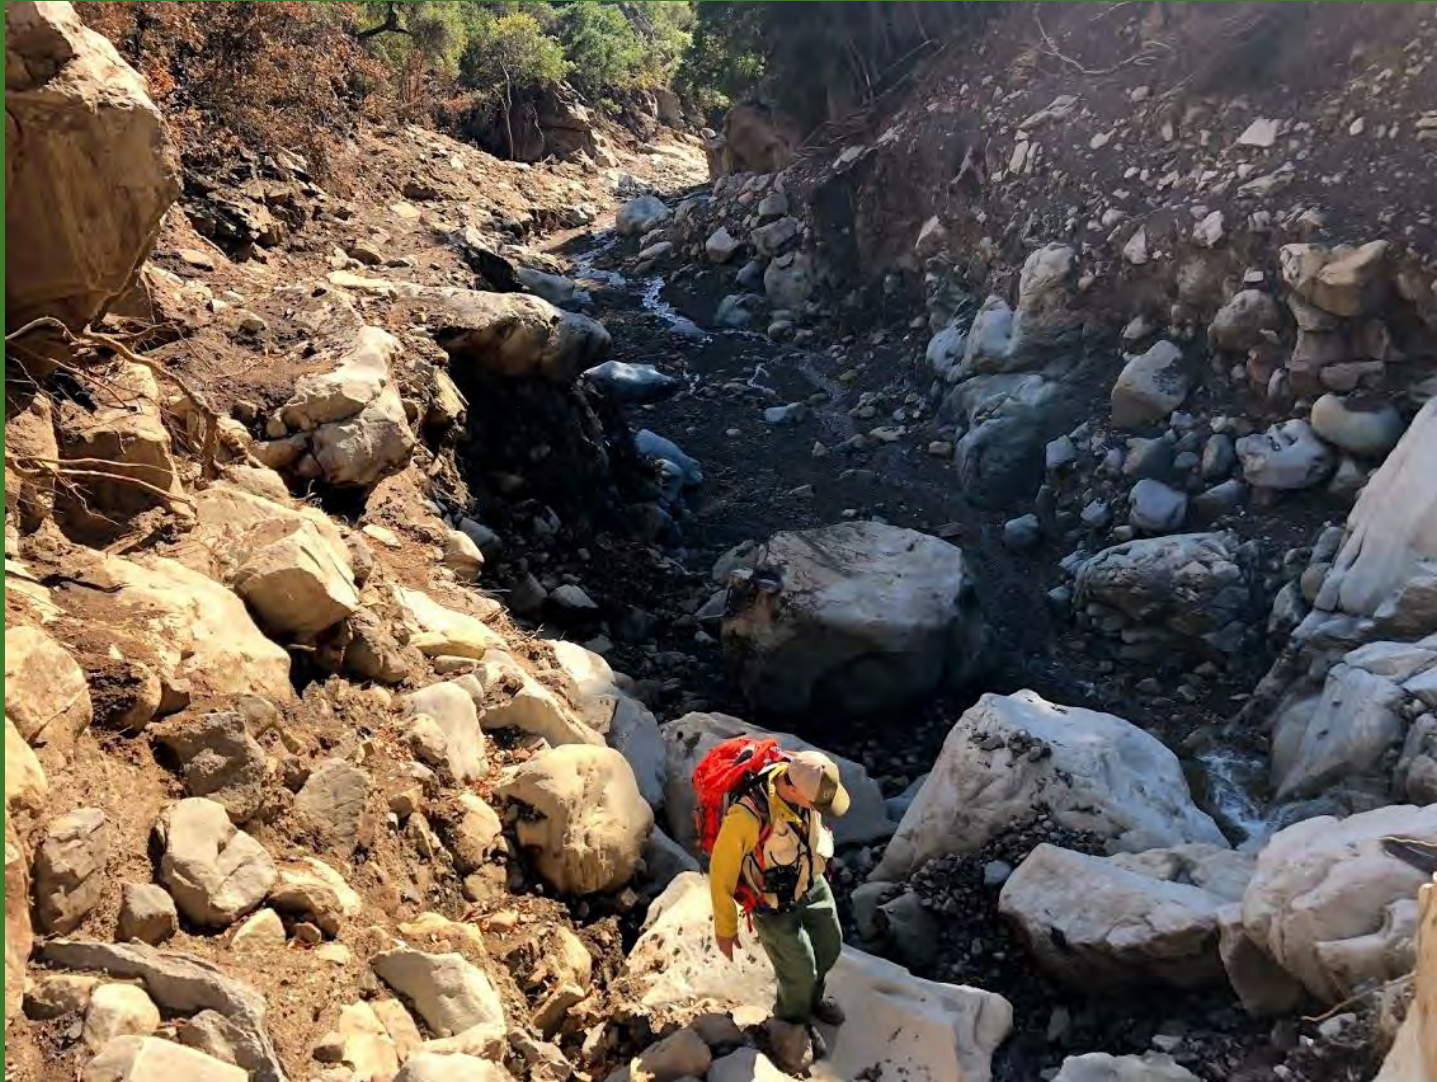
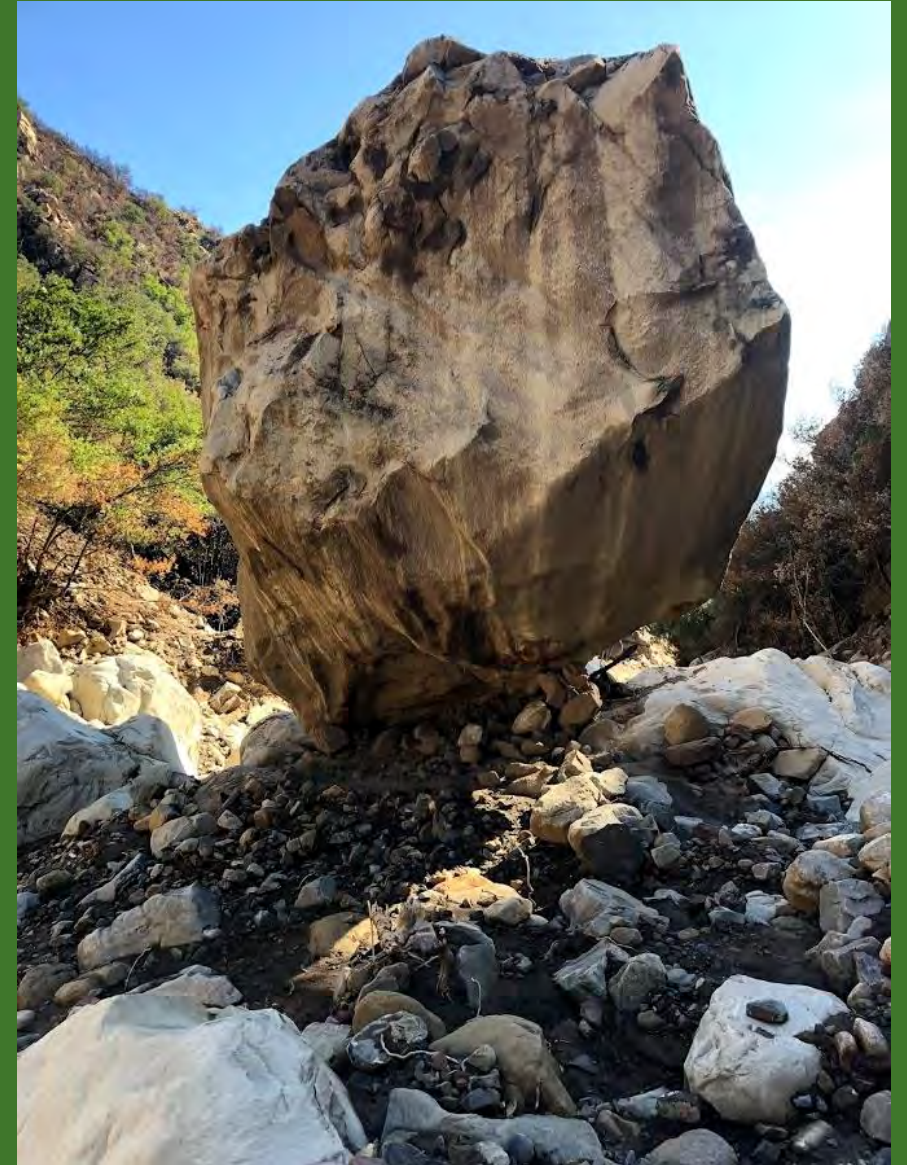
Woody Material and much debris removed, but much left in channels and on slopes.
