**PHASE 2 CULTURAL RESOURCES STUDY
HISTORIC RESOURCES
461 SAN YSIDRO ROAD
MONTECITO, CALIFORNIA
APN 009-060-049**

**Prepared for
AB Design Studio
27 East Cota Street
Santa Barbara, CA 93101**

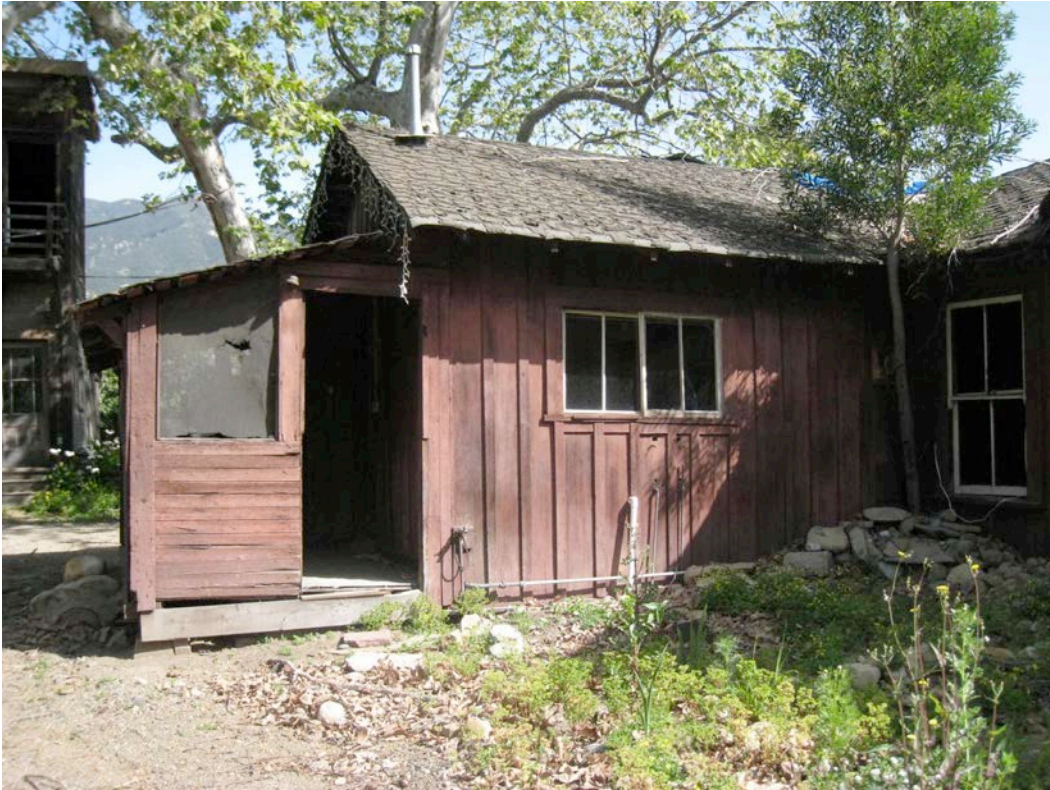
Plate 3. South side of kitchen wing. Lean-to at left to be replaced with a gabled extension and paired 2/2 pane windows to be added. Facing north. April 2010. A. C. Cole

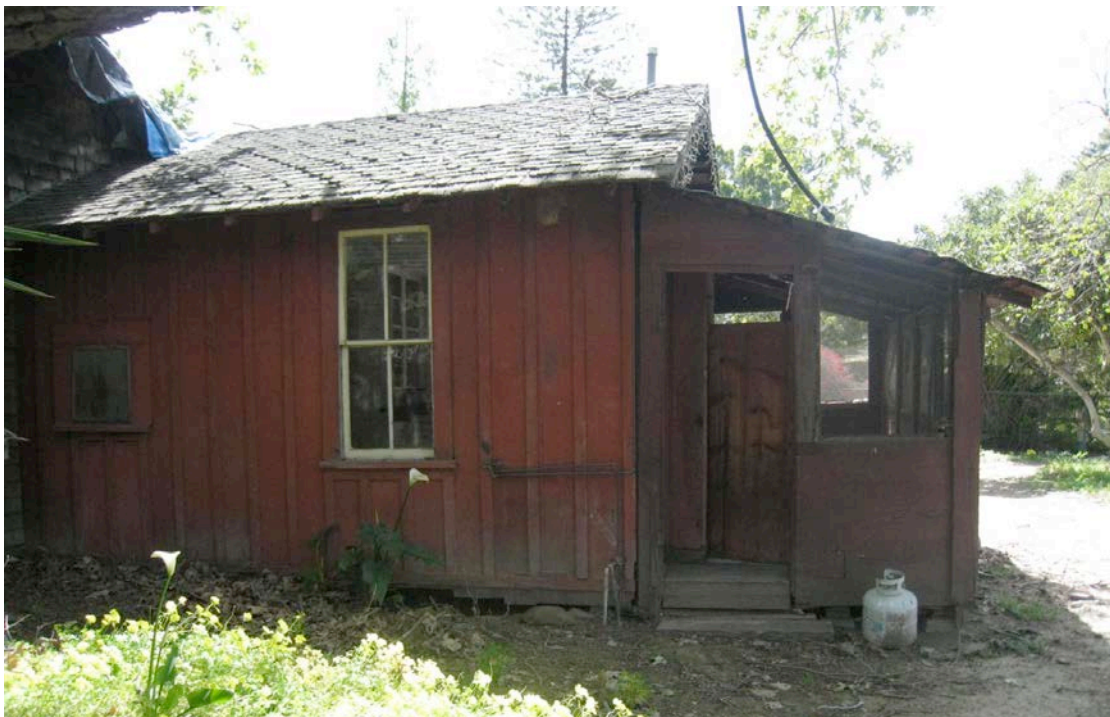
Plate 4. North side of kitchen wing. Lean-to at right to be replaced with a gabled extension and paired 2/2 pane windows to be added. Facing south. April 2010. A. C. Cole

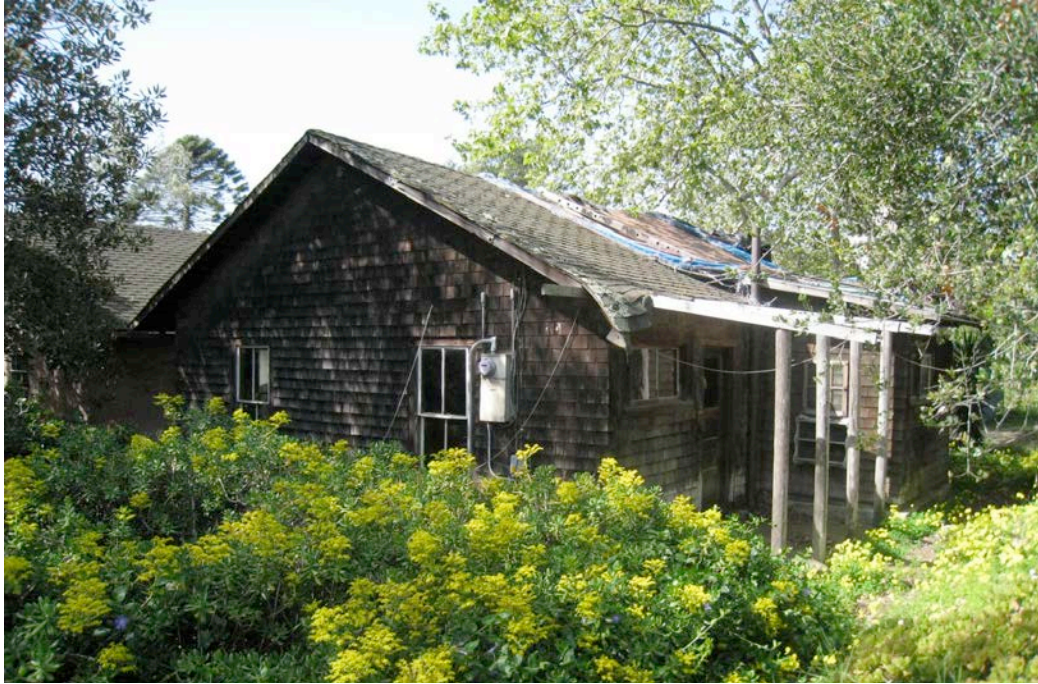
Plate 5. Detail of east and north elevations of 1870s shingled addition. Wall will be extended east and a third 2/2 pane window added on east elevation. Facing southwest. April 2010. A. C. Cole

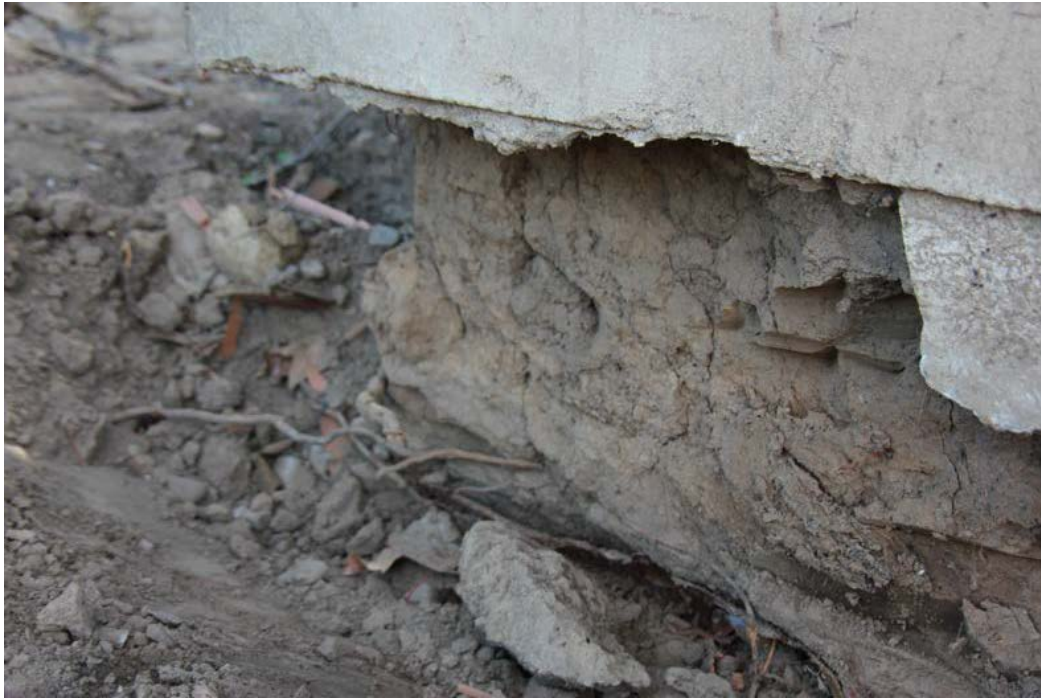
Plate 8. Deteriorated adobe walls at foundation. November 2013.

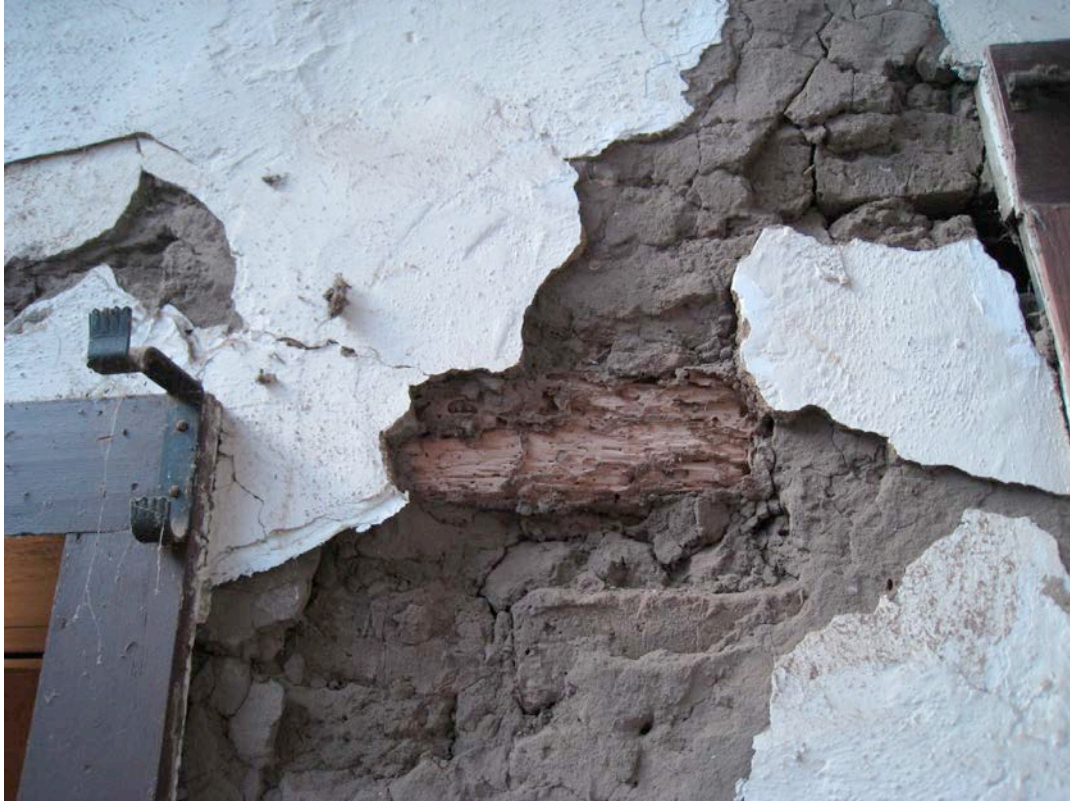
Plate 9. Detail of adobe west wall showing dry rot in structural wood member. November 2013.

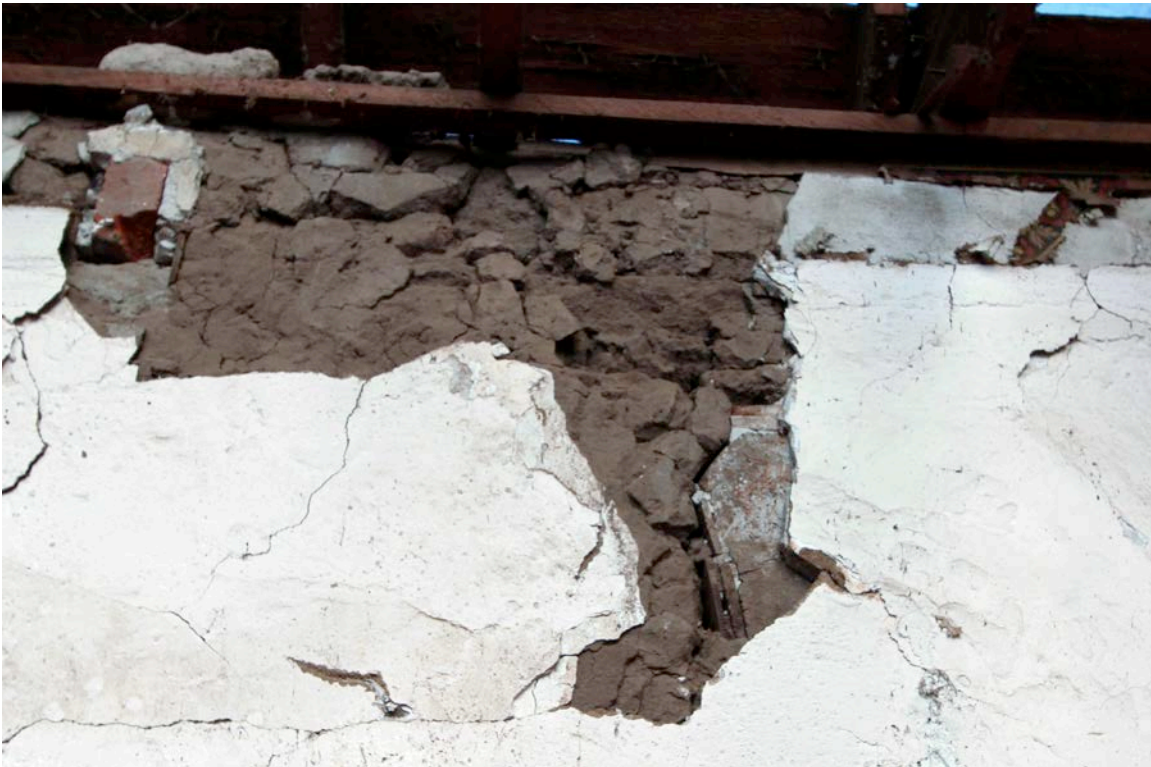
Plate 10. Upper adobe wall showing crumbling blocks. November 2013.

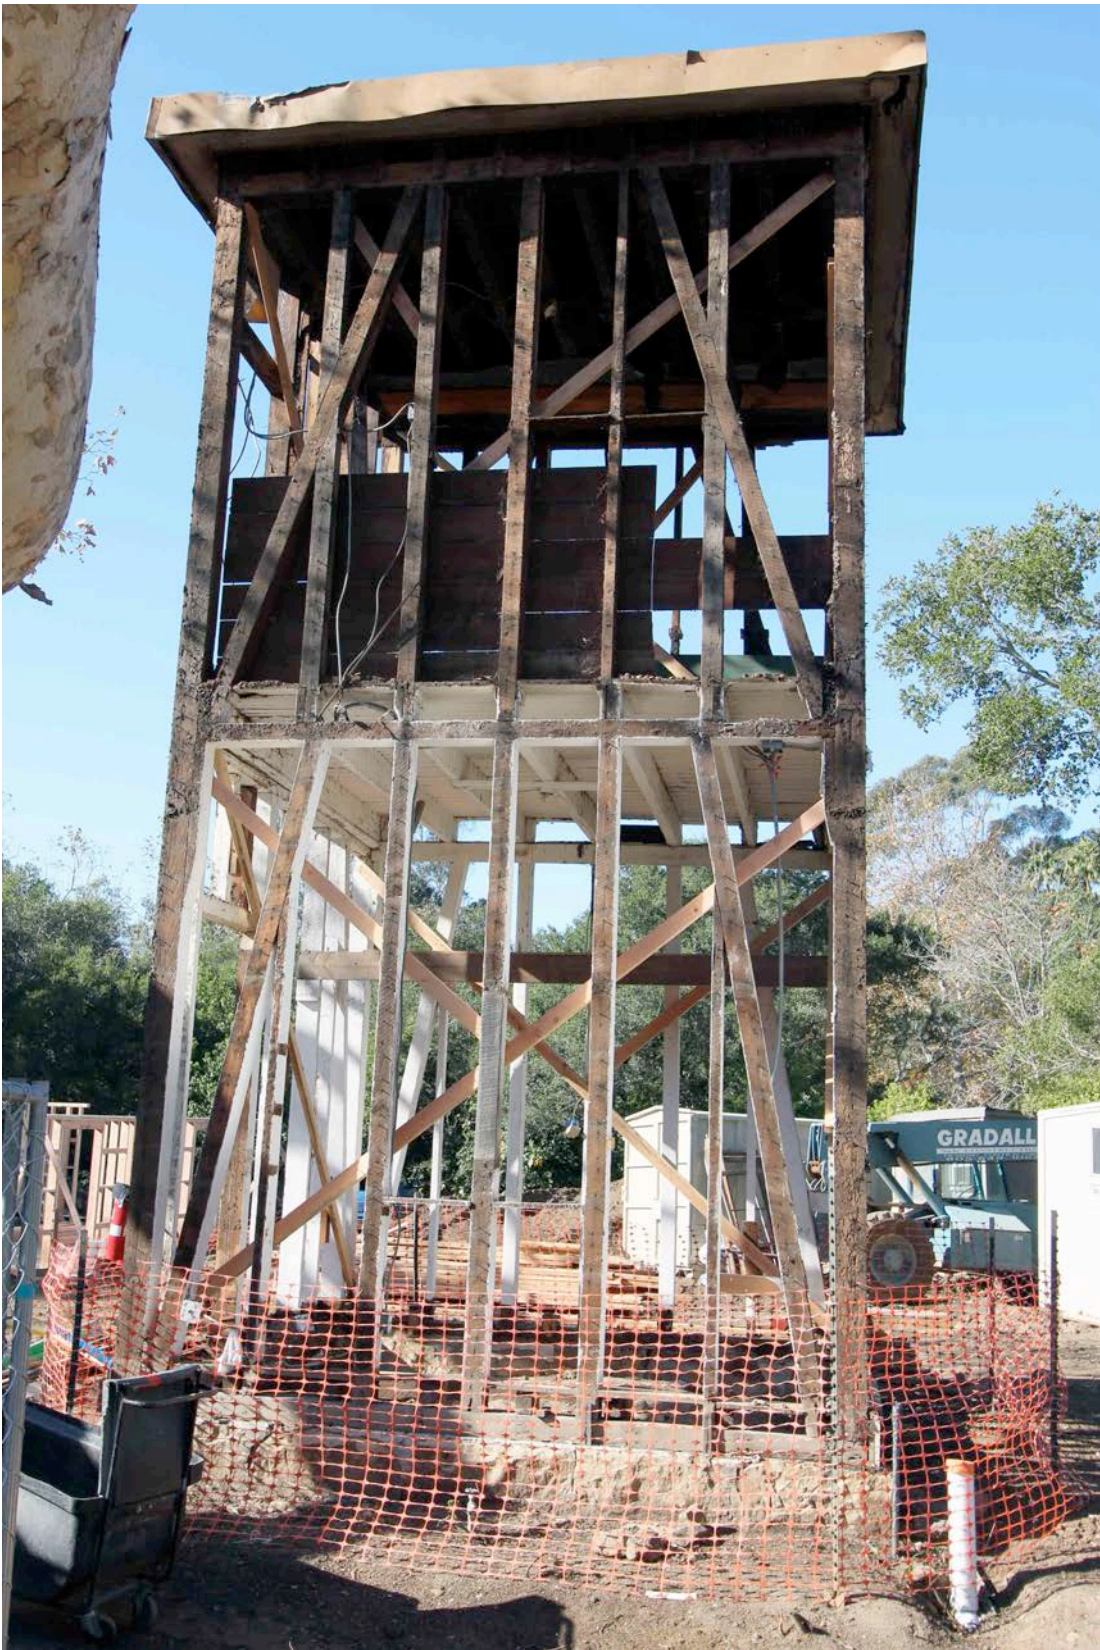
Plate 18. Tower showing deteriorated structural members.

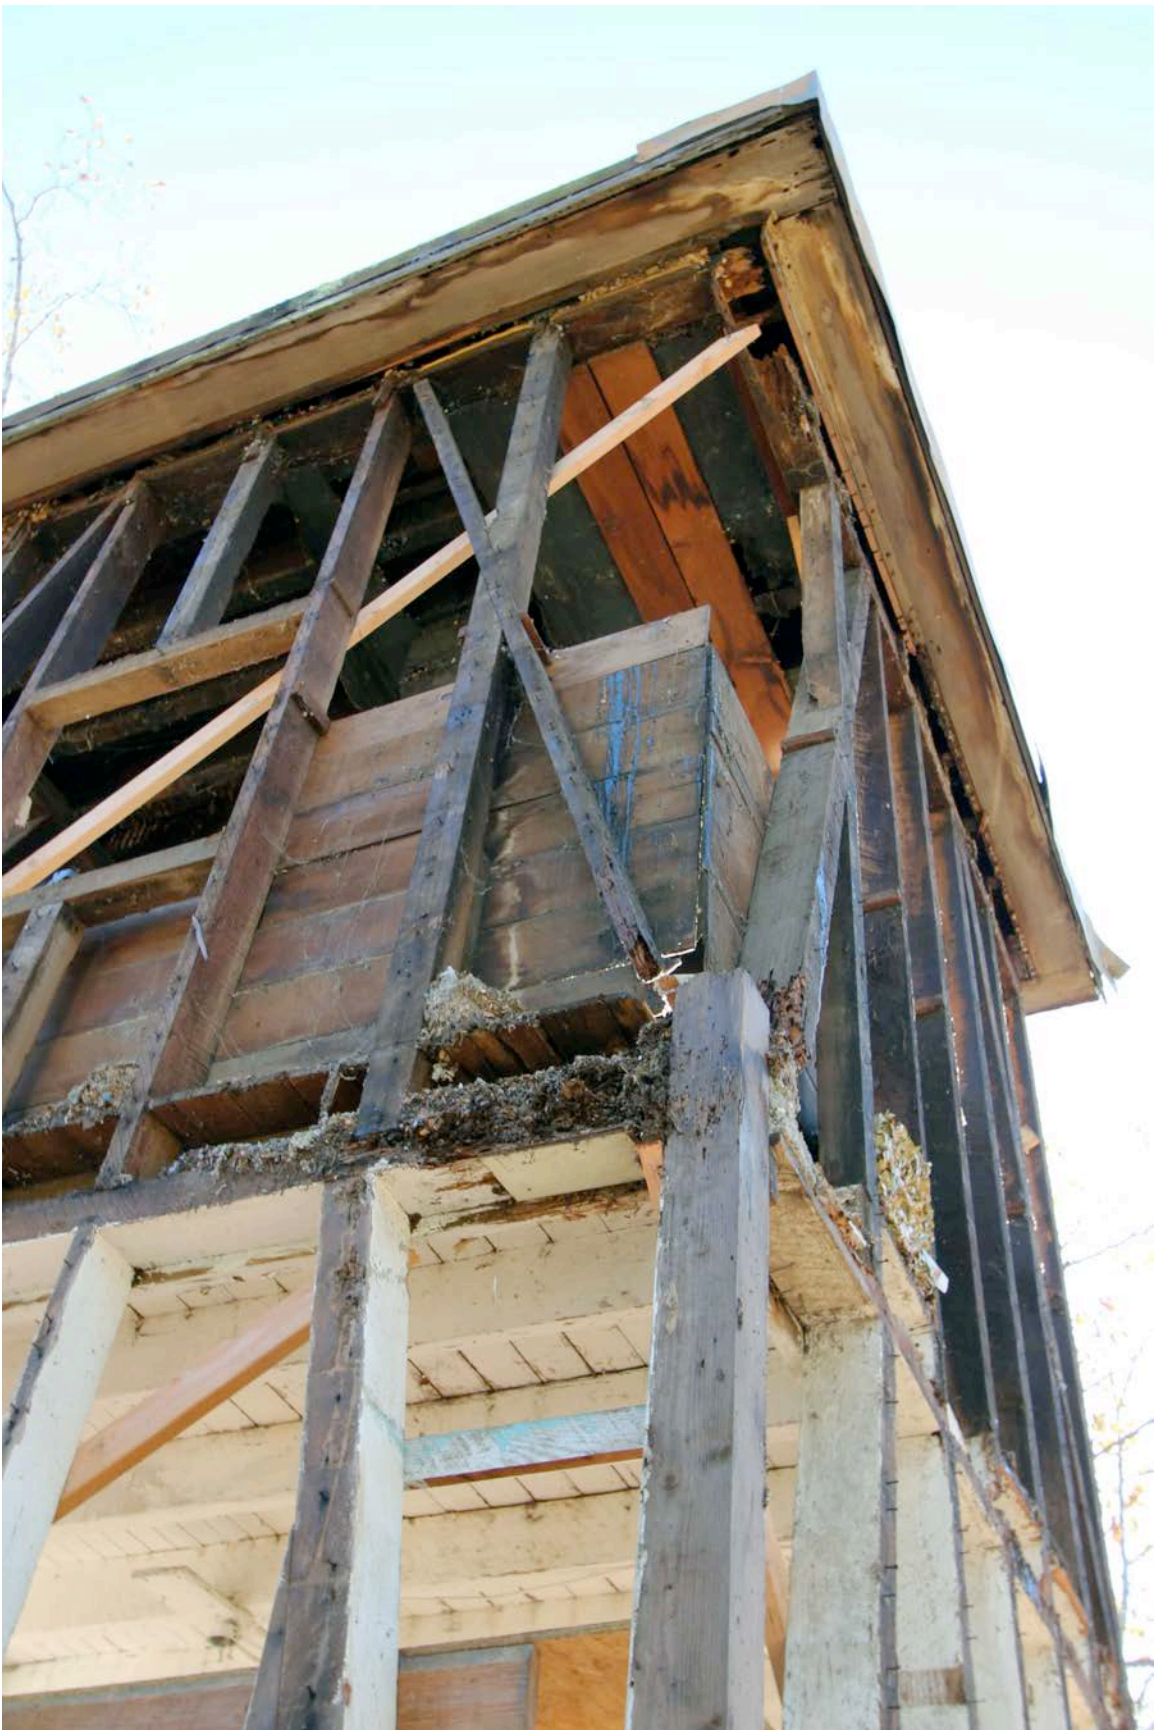
Plate 19. Deteriorated tower structural members.

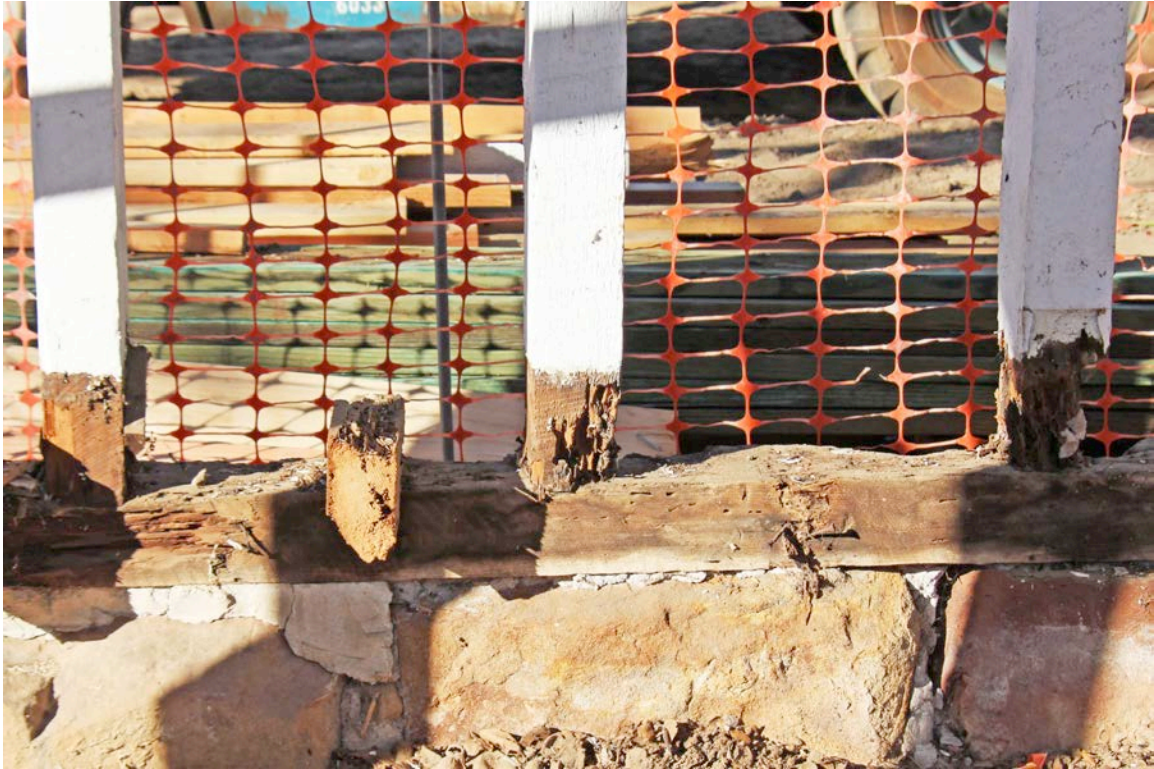
Plate 20. Deteriorated tower structural members resting on stone foundation.

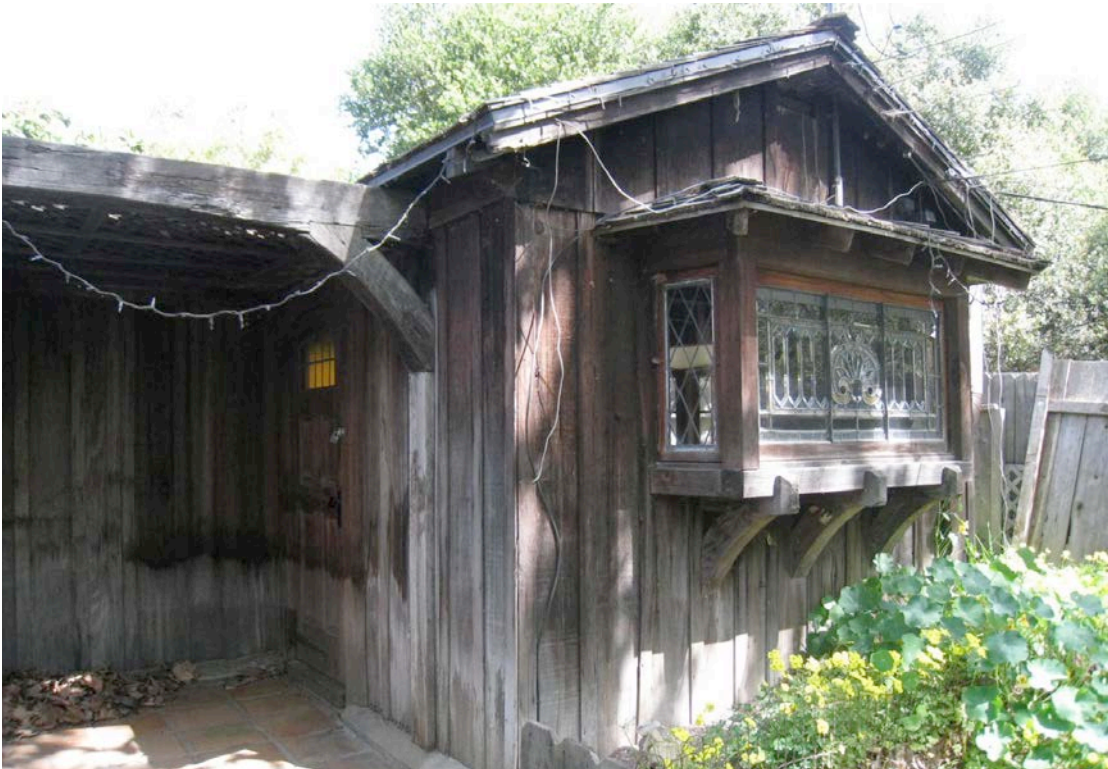
Plate 21. Cottage. South elevation showing recessed porch area to be replaced with storage addition. Facing north. April 2010. A. C. Cole

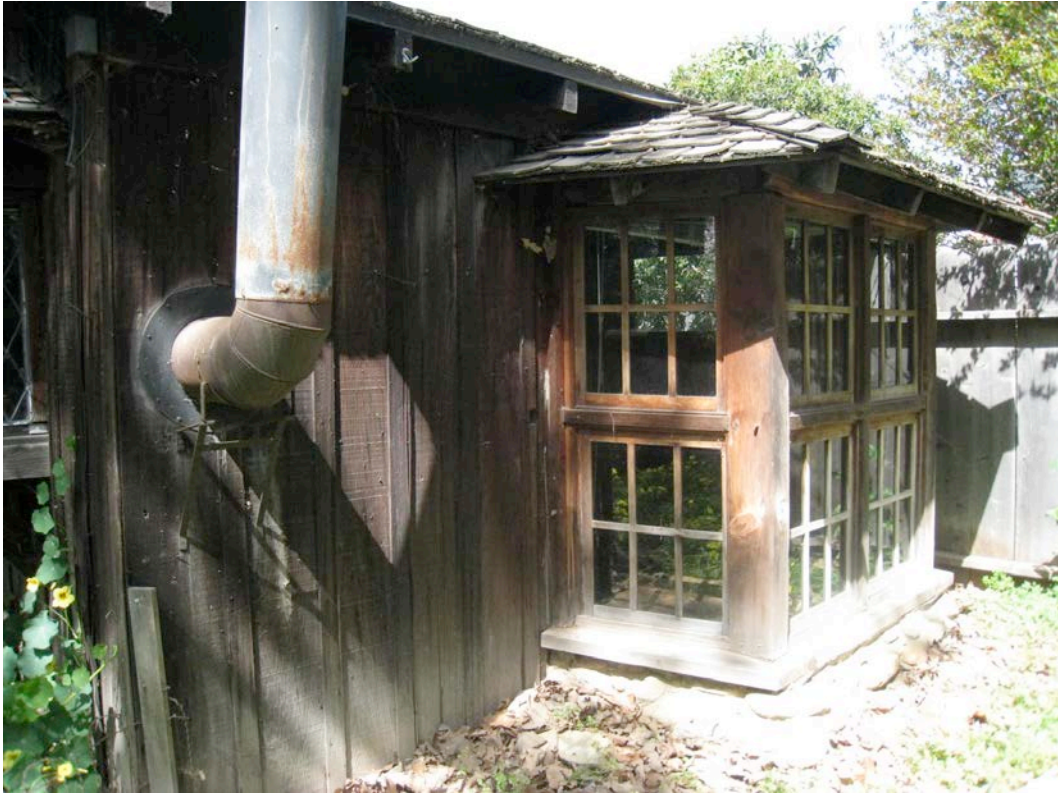
Plate 22. Cottage. East elevation. Facing northwest. April 2010. A. C. Cole

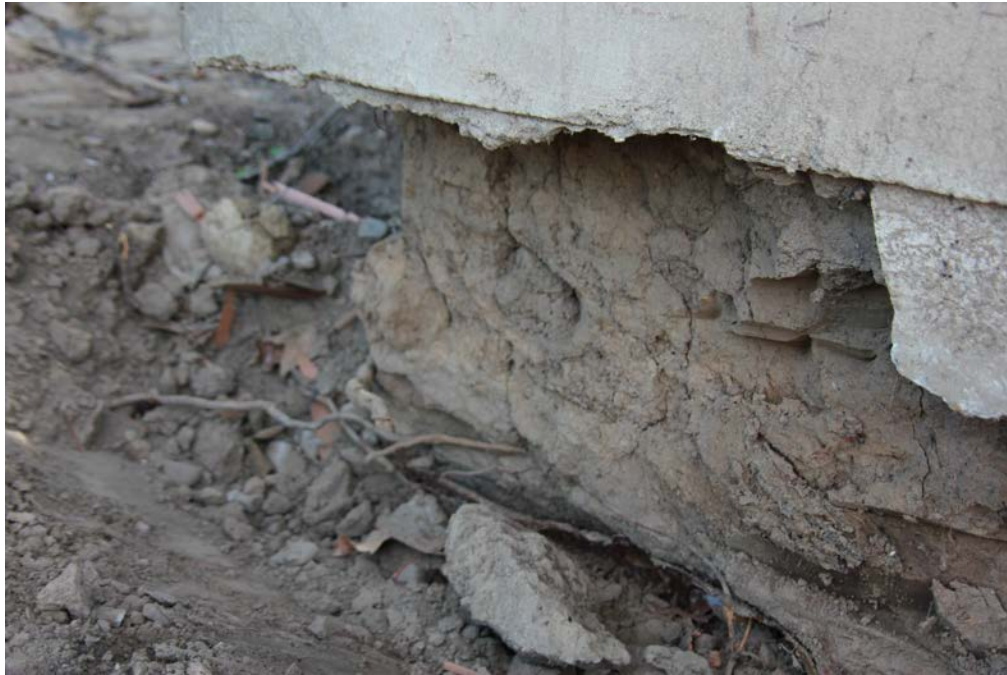
Photo 2 : Area of Wall where mortar and adobe brick are indiscernible

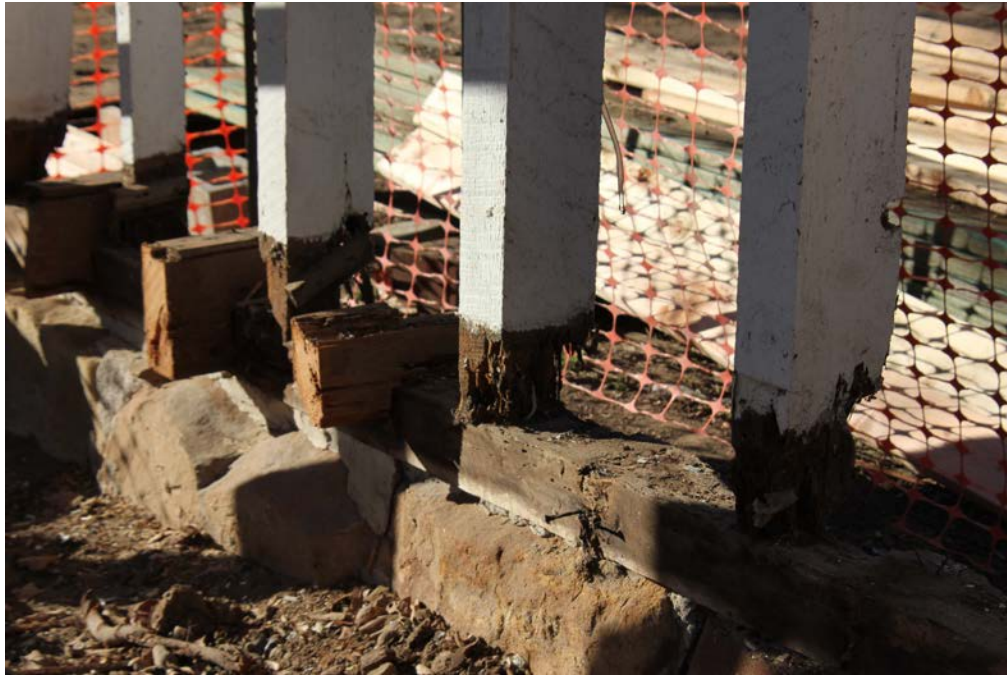
Photo 6 : Rot at upper floor where cross bracing meets floor plate. Corner post completely gone.

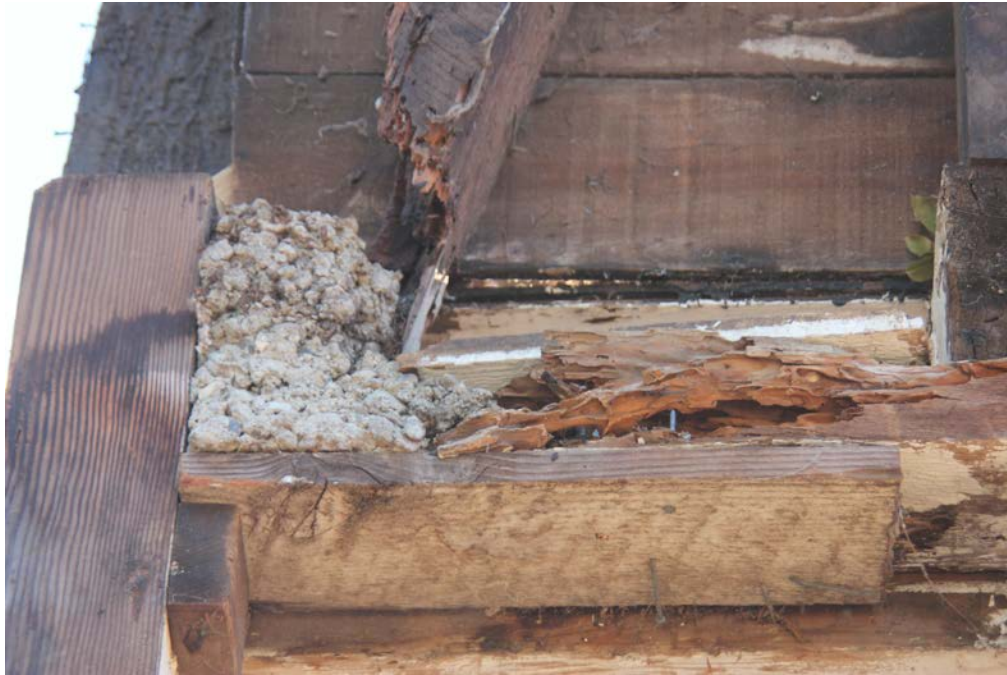
Photo 8 : Connection of brace post to sill plate completely rotted away

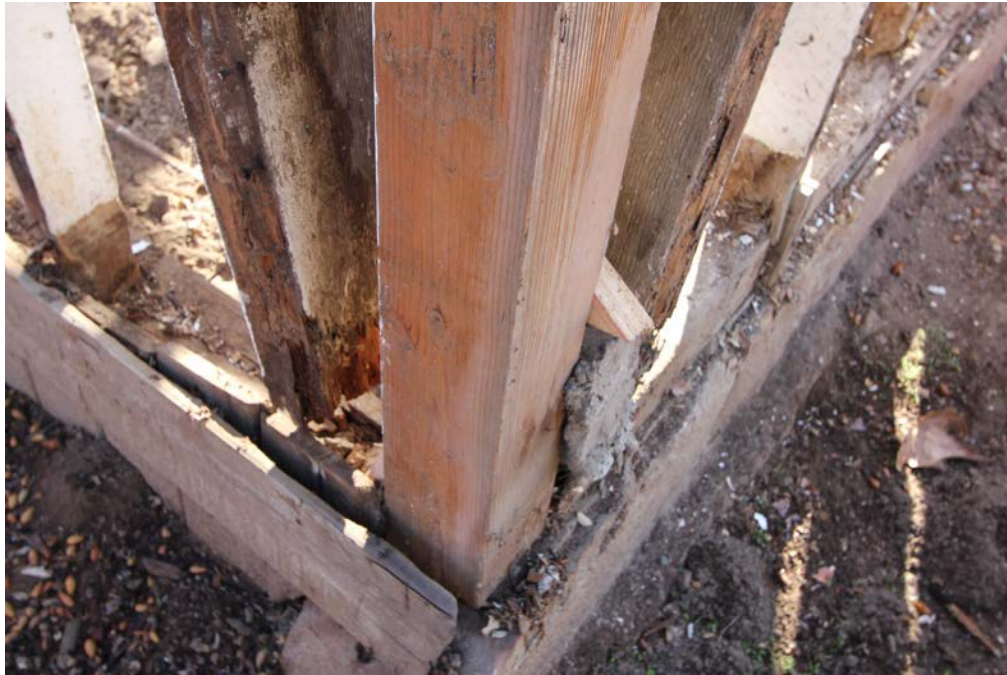
Photo 10: Excavation at perimeter of slab at Cottage showing the absence of a footing

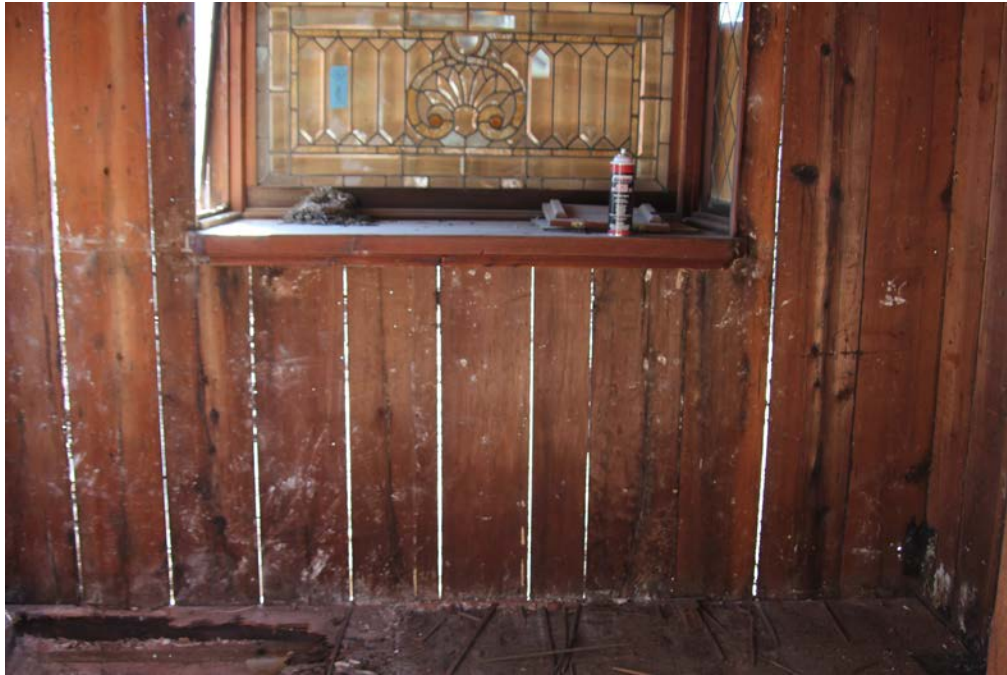
Photo 12: Rot at Floor Framing joists
