Assessment of the post-fire debris flow and flooding events of January 20, 2017 in the Sherpa Fire burned area:

Jonathan Yonni Schwartz – Minerals & Geology Program Manager, Los Padres NF

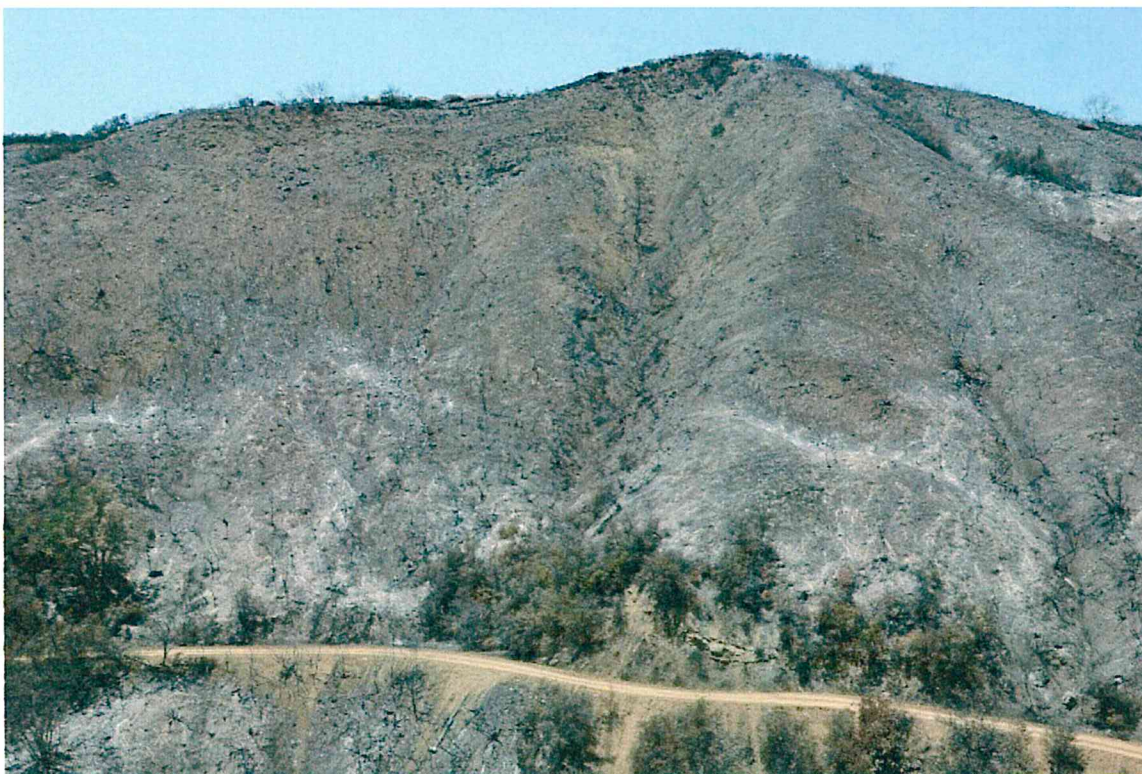
Based on pre-flooding aerial and ground surveys it is clear that in the past, mass wasting have occurred in areas dominated by the Sespe and Sacate Formations. Along the El Capitan road above the El Capitan Canyon Resort, in the Sespe Formation mass wasting as rock-fall, and occasional debris slides dominate the active slope processes, even in the absence of wildfires (Figure 3)

Figure 3: Pre-fire, mass wasting in the Sespe Formation – Upper El Capitan Watershed

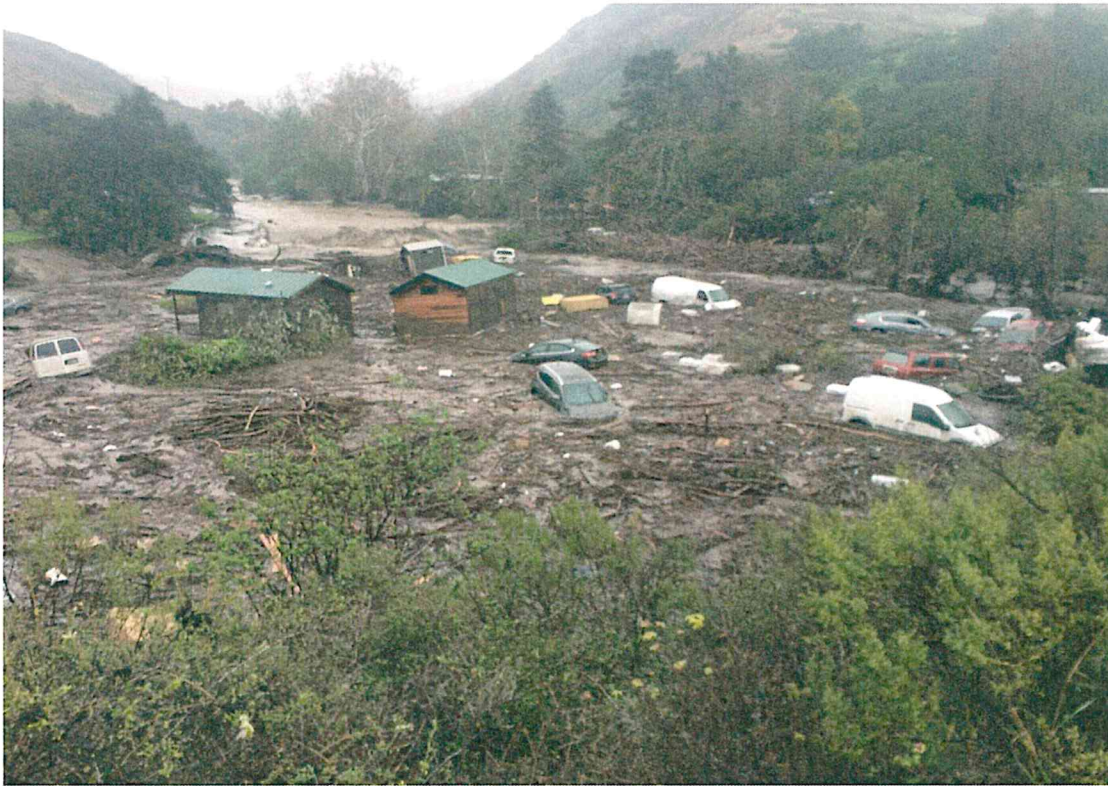
- As a result of debris plugging the concrete box culvert / underpass Hwy 101 (dimensions 12x15 feet) the large dirt parking lot turned into a debris catchment basin (Figure 7).

Figure 7: Debris flows and flooding – El Capitan Watershed just above Hwy 101

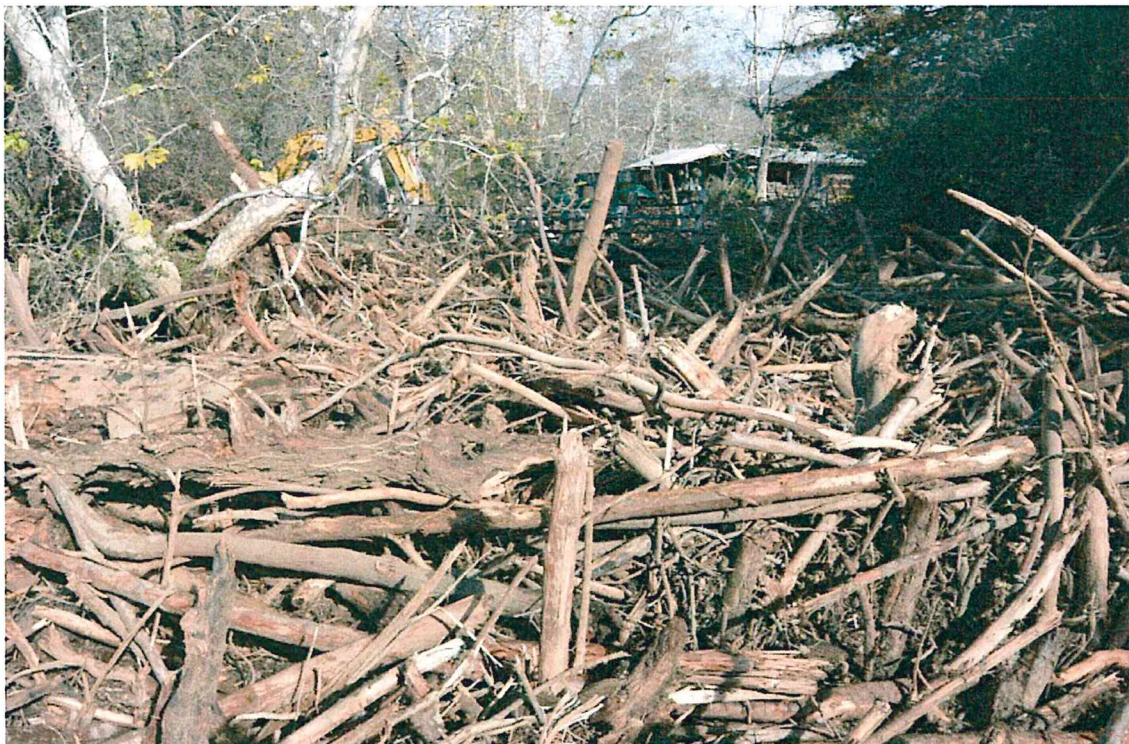
- Based on eyewitness's reports, the debris flow reached the lower portions of the El Capitan Canyon Resort at approximately 9:20 a.m. PST.
- The higher portions of the El Capitan watershed that were burned delivered large amounts of coarse woody debris that ended up plugging foot and vehicle bridges, culverts and the highway underpass. In addition, large amounts of riparian vegetation including trees and shrubs that survived the fire were stripped as a result of the powerful flooding and debris flow, which was all added to the burned coarse woody debris that plugged the bridges and culverts (Figure 8).

- As a result of coarse woody debris plugging the lower bridge in the El Capitan Canyon Resort (just below the Canyon Market), the flood was diverted out of the channel and into the large dirt parking lot space (below and to the west of the lower bridge).

Figure 8: Coarse woody debris clogging the lower El Capitan Creek Bridge

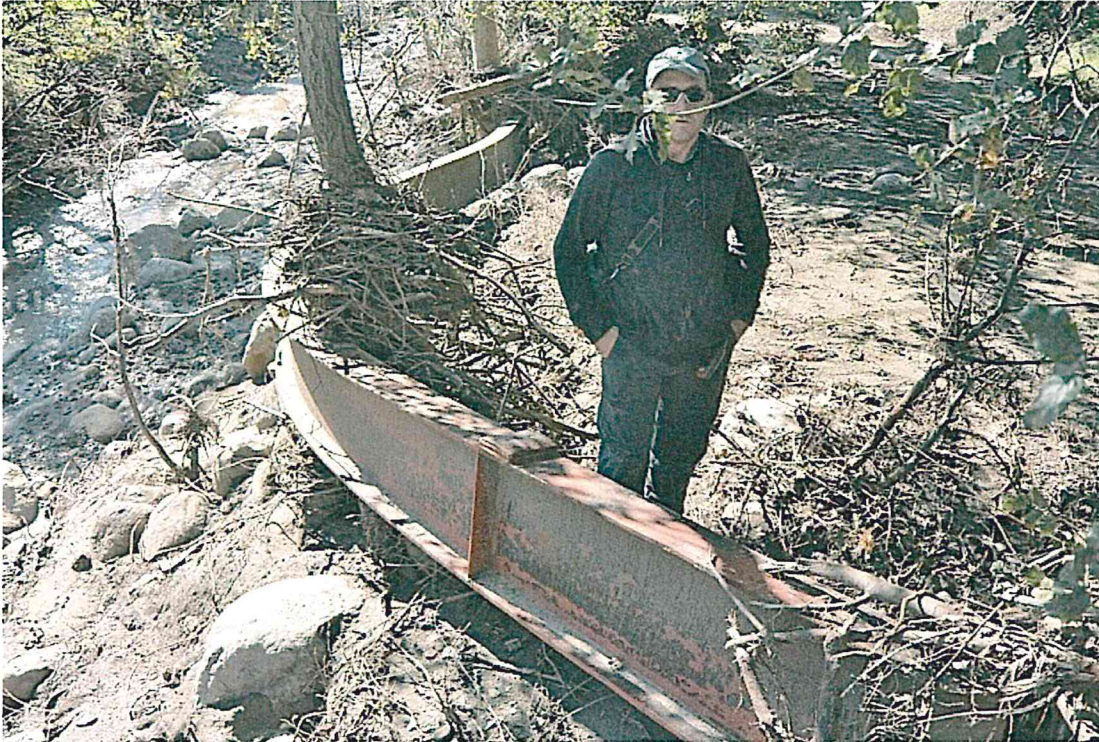
- The first bridge to be impacted by the debris flow was the Mid-canyon Bridge. This bridge was a large wood deck bridge (15 feet wide x 45 feet long) located half way up the El Capitan Canyon Resort. This bridge was supported on both sides of the creek by concrete foundation. Attached to the top of these foundations and supporting a wooden deck were 3 metal I-beams (18" high, 7.5" wide and 3/8" thick x 45 feet long). As a result of the debris flow this bridge was demolished. The metal I-beams were carried downstream and twisted against large trees (Figure 9).

Figure 9: Twisted metal I-beams which supported a bridge prior to the debris flow event

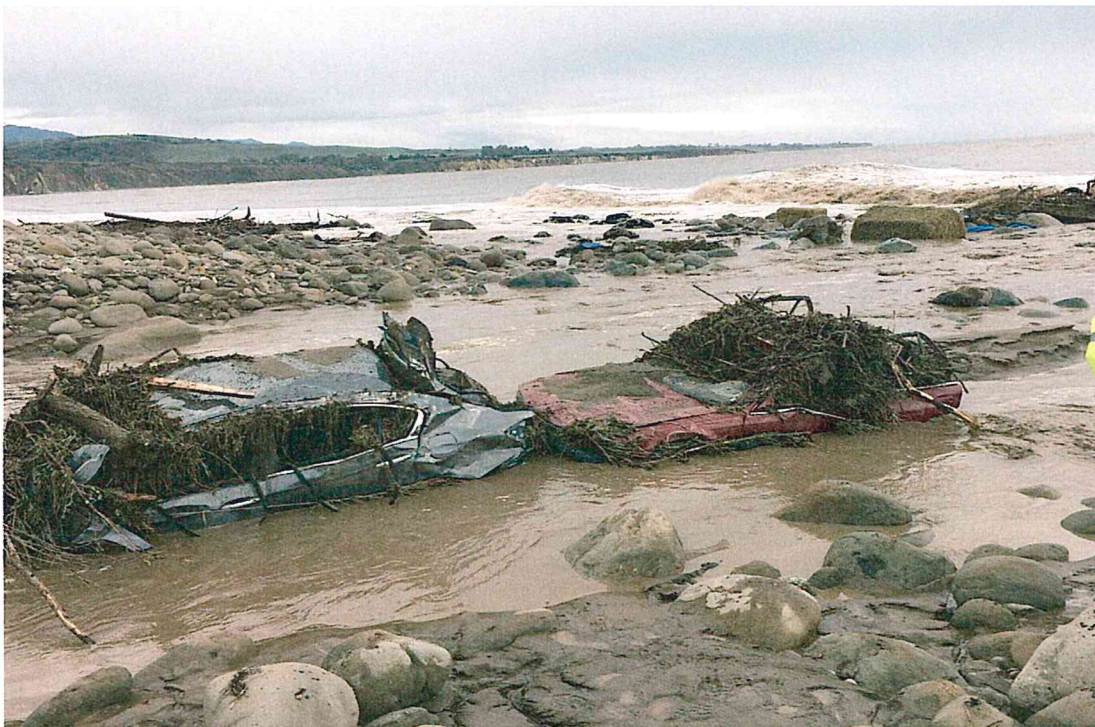
- Based on eyewitness's reports, at about 9:45 a.m. PST, when the pressure was high enough, the debris plugging the Hwy underpass broke through and large amounts of debris (including several cars) were transported all the way out to the ocean (Figure 10).

Figure 10: Cars and other debris deposited at El Capitan Beach

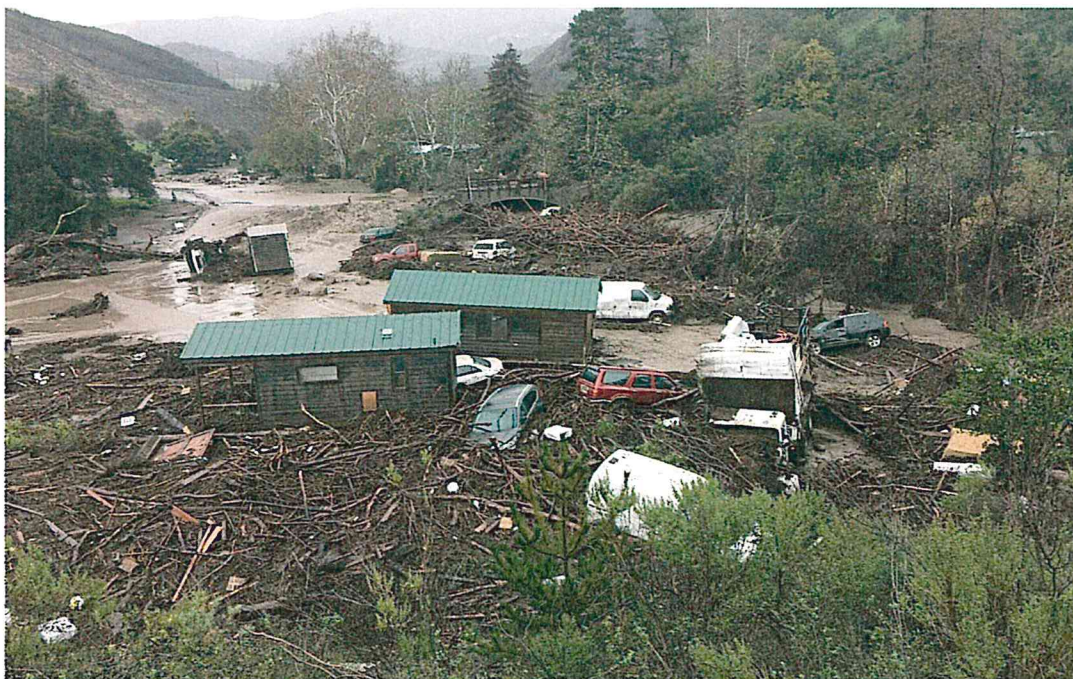
- As a result of Hwy 101 underpass being cleared of debris, the high level of water in the dirt parking lot area subsided and much of the debris (including cars and cabins) were deposited in this large dirt parking lot space (Figure 11).

Figure 11: Large amounts of debris deposits in the large dirt parking lot area

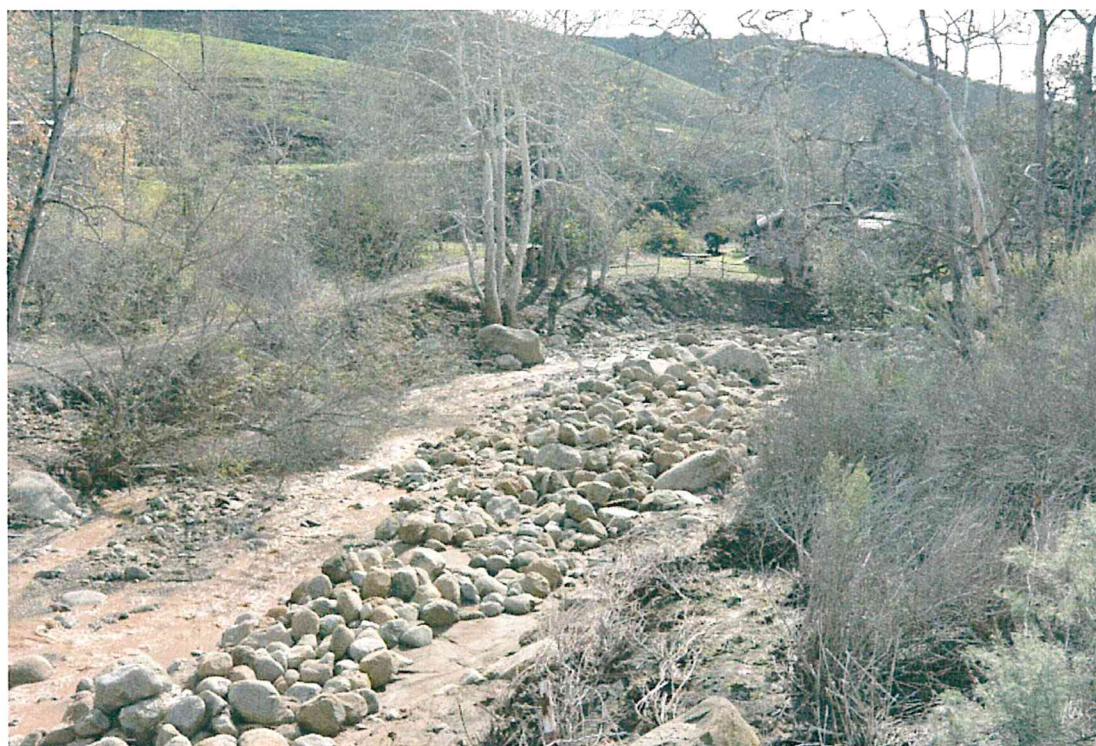
- Along 1.1 miles of the El Capitan creek from the Canyon Market (El Capitan Canyon Resort) all the way up to the large water tanks (above the resort) there are large rocky deposits of debris flows, including rocks ranging in size from 1 foot to over 8 feet in diameter (Figure 13). These debris flow deposits, for the most case, appear as elongated deposits, ranging in size from 200 to 450 feet long and about 30-60 feet wide (Figure 12).

Figure 12: Large elongated rocky deposits – El Capitan Creek

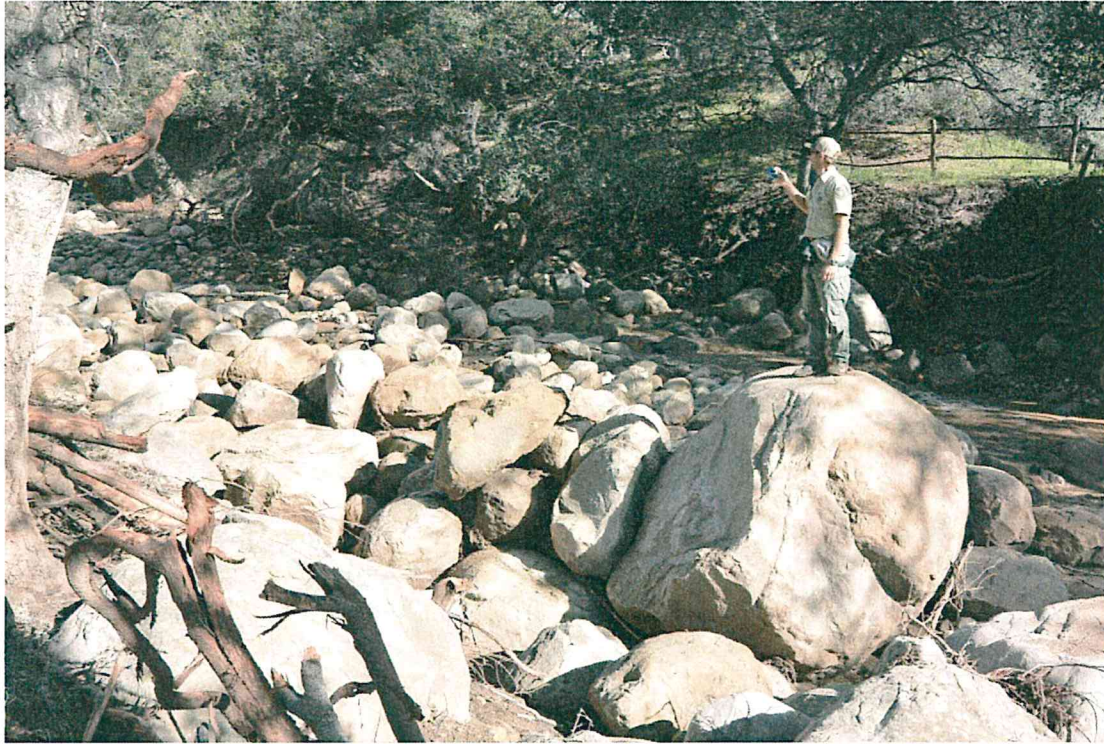
- Based on high water marks, the flooding of the channel in some areas (between the cabins) reached a width of 90+ feet.
- Based on accounts of local personal and field observations, the channel-bed (creek-bed) in some locations was excavated (degradation) 4-5 feet by the floods and in other locations accrued (aggradation) 15 feet deposition of rocks and other materials (Figure 13).

Figure 13: Rock deposits ranging in size from 1 foot to over 8 feet in diameter – El Capitan Creek
