Coastal Geology & Geotechnical Services Inc.

Reference V24125

337 Hot Springs Road
Montecito Ca 93108

Subject: Preliminary Geologic Investigation into the Current Condition of the Slope and Embankment, Located at 337 Hot Springs Road, Montecito, Ca 93108. APN 009-070-038.

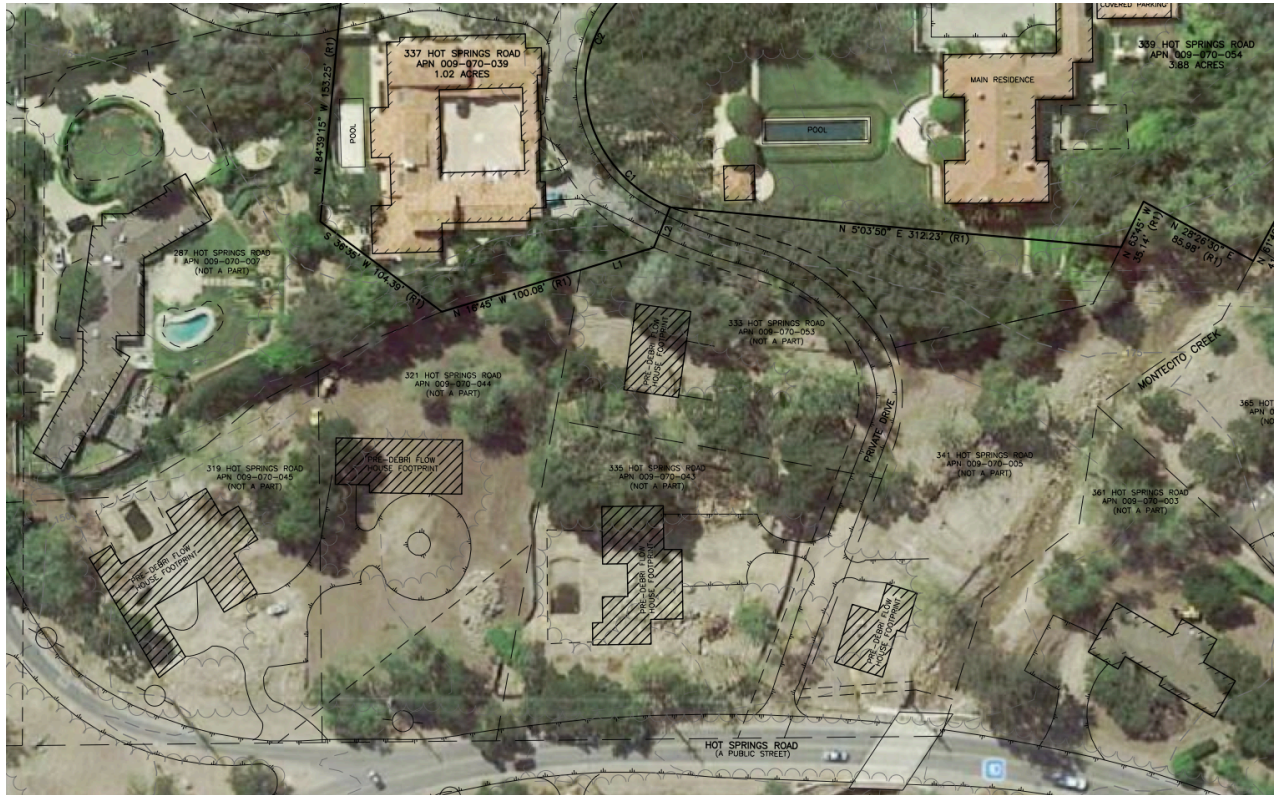
It is our understanding that during the catastrophic debris flow event of January 9, 2018, Montecito Creek overflowed its banks and destroyed five residences (see photo 1 of parcels affected) located directly east and adjacent to the subject parcel and embankment. It is our opinion that the 2018 debris flow event also impacted the subject embankment by undercutting the base of the embankment slope, causing increased erosion, debris slides and failures on the embankment slope. The effect of this undercutting is a contributing factor to the ongoing slope failures along the entire embankment as observed during the period of January 2018 to present. A historic atmospheric river storm event on January 9, 2023 also caused major flooding, evacuations, and damage to this same area of Santa Barbara. A representative of our office visited the subject site in March of 2023 and observed a large slope failure on the south end of the subject embankment (see photo 2), and observed other areas of slope instability and failures over the subject slope face. A site visit on February 15, 2024 and again on February 20, 2024, indicated multiple areas of slope failure along the subject slope (see photos 3 & 4), and other areas of cursory slope failure and slippage was observed along the entire slope face. A check of the rainfall totals for the past 5 days (February 15 to 20, 2024) for the Montecito area indicates that 7.12 inches of precipitation has occurred.

Photo 1 – Locations of Five Houses Destroyed in January 9, 2018 Montecito Debris Flow

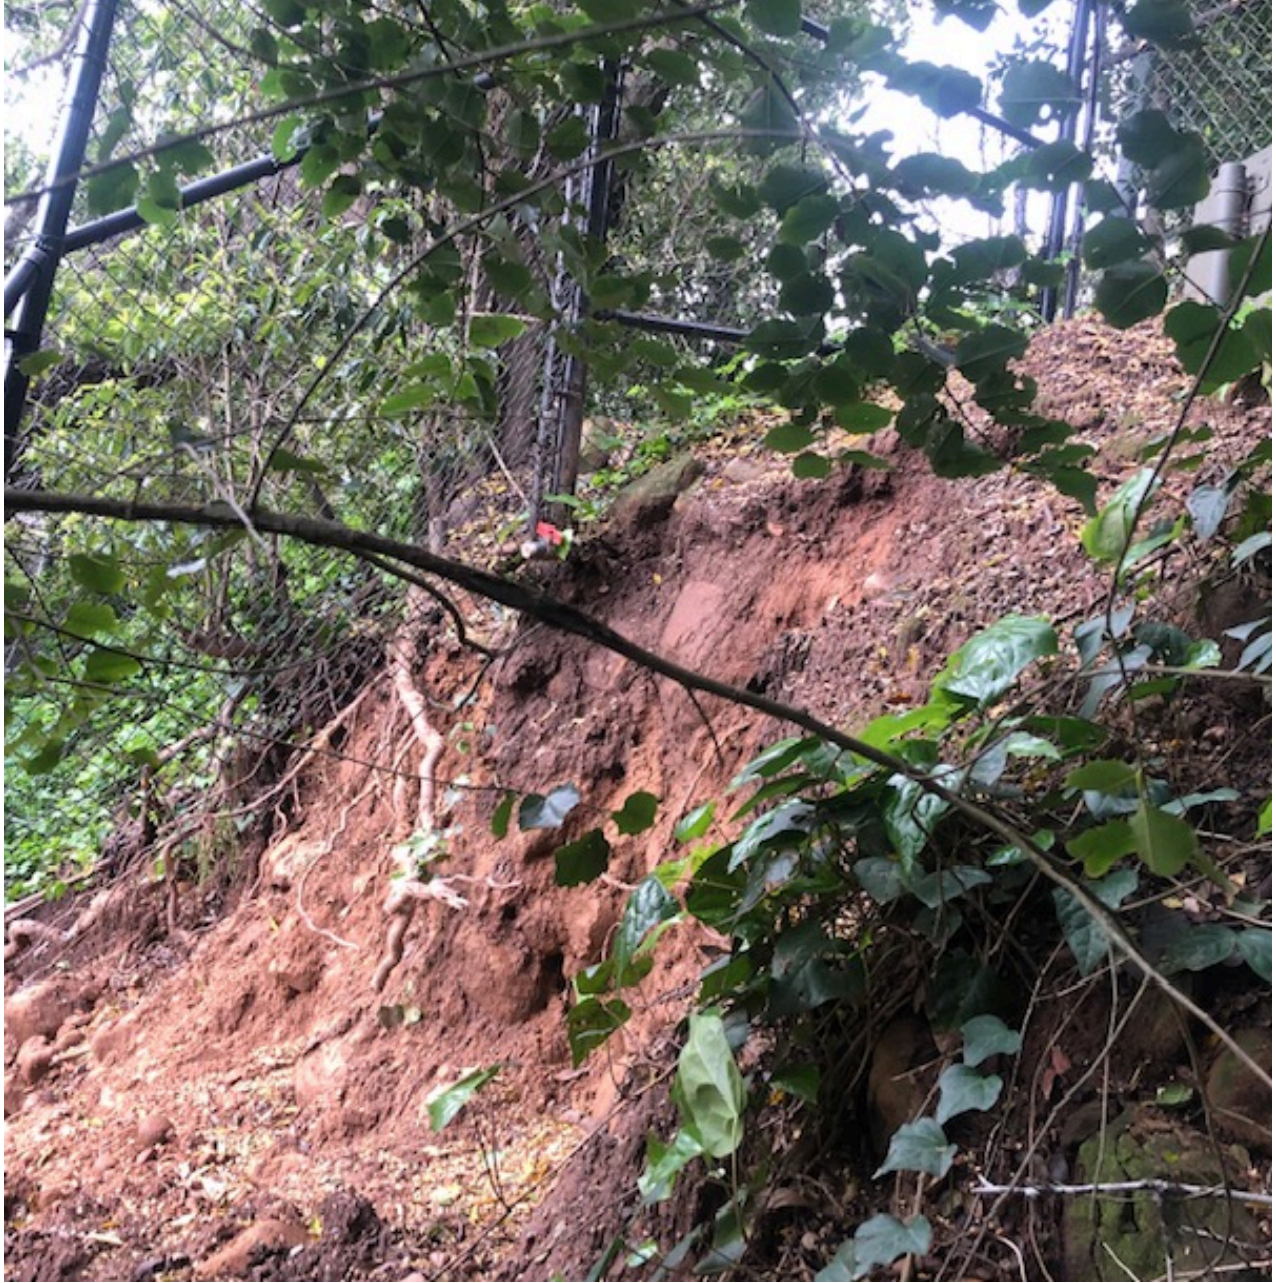
Photo 2 – Looking South Showing Slope Failure on East Facing Slope/Embankment from January 9, 2023 Historic Rain Event.

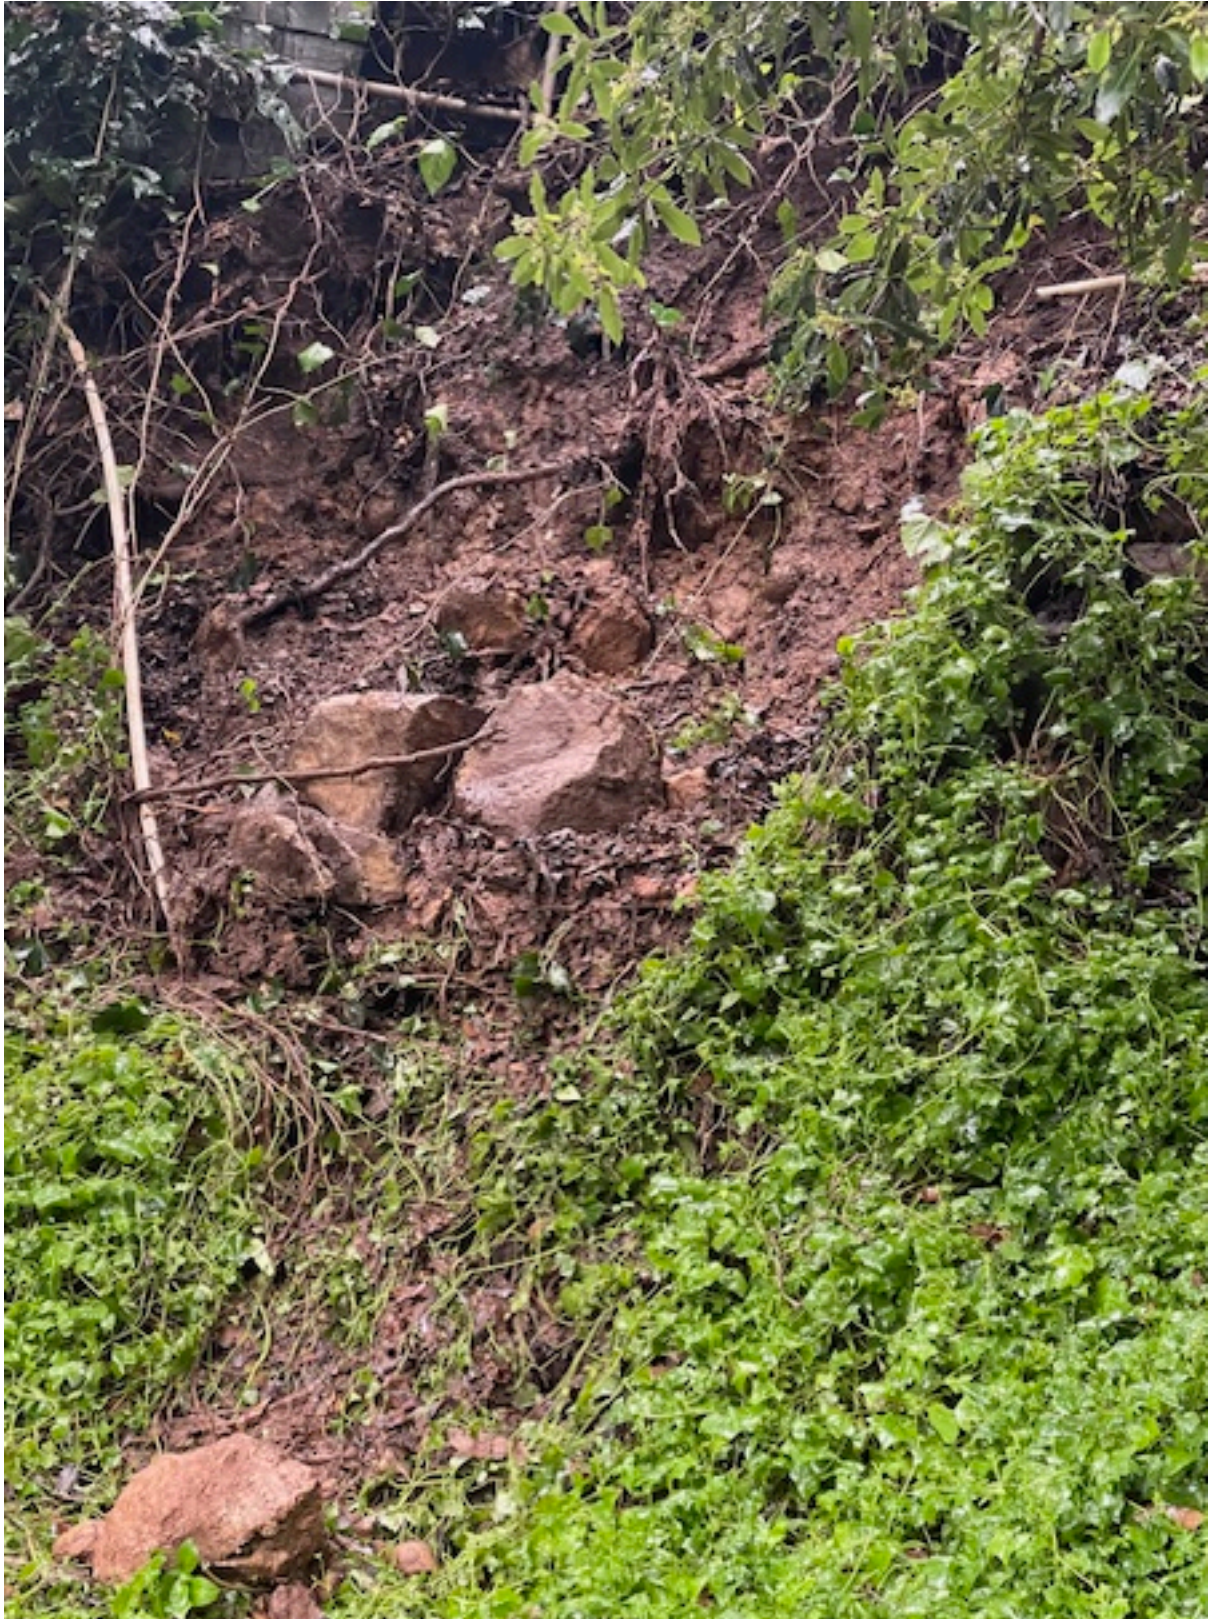
Our site visit on February 15, 2024 also observed signs of continued slope failure and distress at the top of the slope in planter areas, sidewalks, and on existing retaining and building walls, along the entire stretch of the slope. The area at the south end of the embankment, which experienced the large slope failure on January 9, 2023, and has an old, poorly constructed, retaining wall at the top of slope, is currently over steepened and catastrophic slope failure is imminent. This area of the slope is also relatively close to the existing residence (8 to 10 feet from top of slope in the old stone and mortar wall area) and has an HVAC system on a concrete pad in immediate danger of distress. A large oak tree (24" oak shown on map in photo 5) in this area is located at the top of the slope in the vicinity of the HVAC system and is in immediate danger of being undermined on the descending slope below it and is adding to the immediacy of the need for slope repair. We further understand that the bedroom portion of the residence is located in this area of the residence, immediately adjacent to the south end of the embankment, which is the most unstable portion of the slope.

Photo 3 – February 2024 Slope Failure on East Embankment

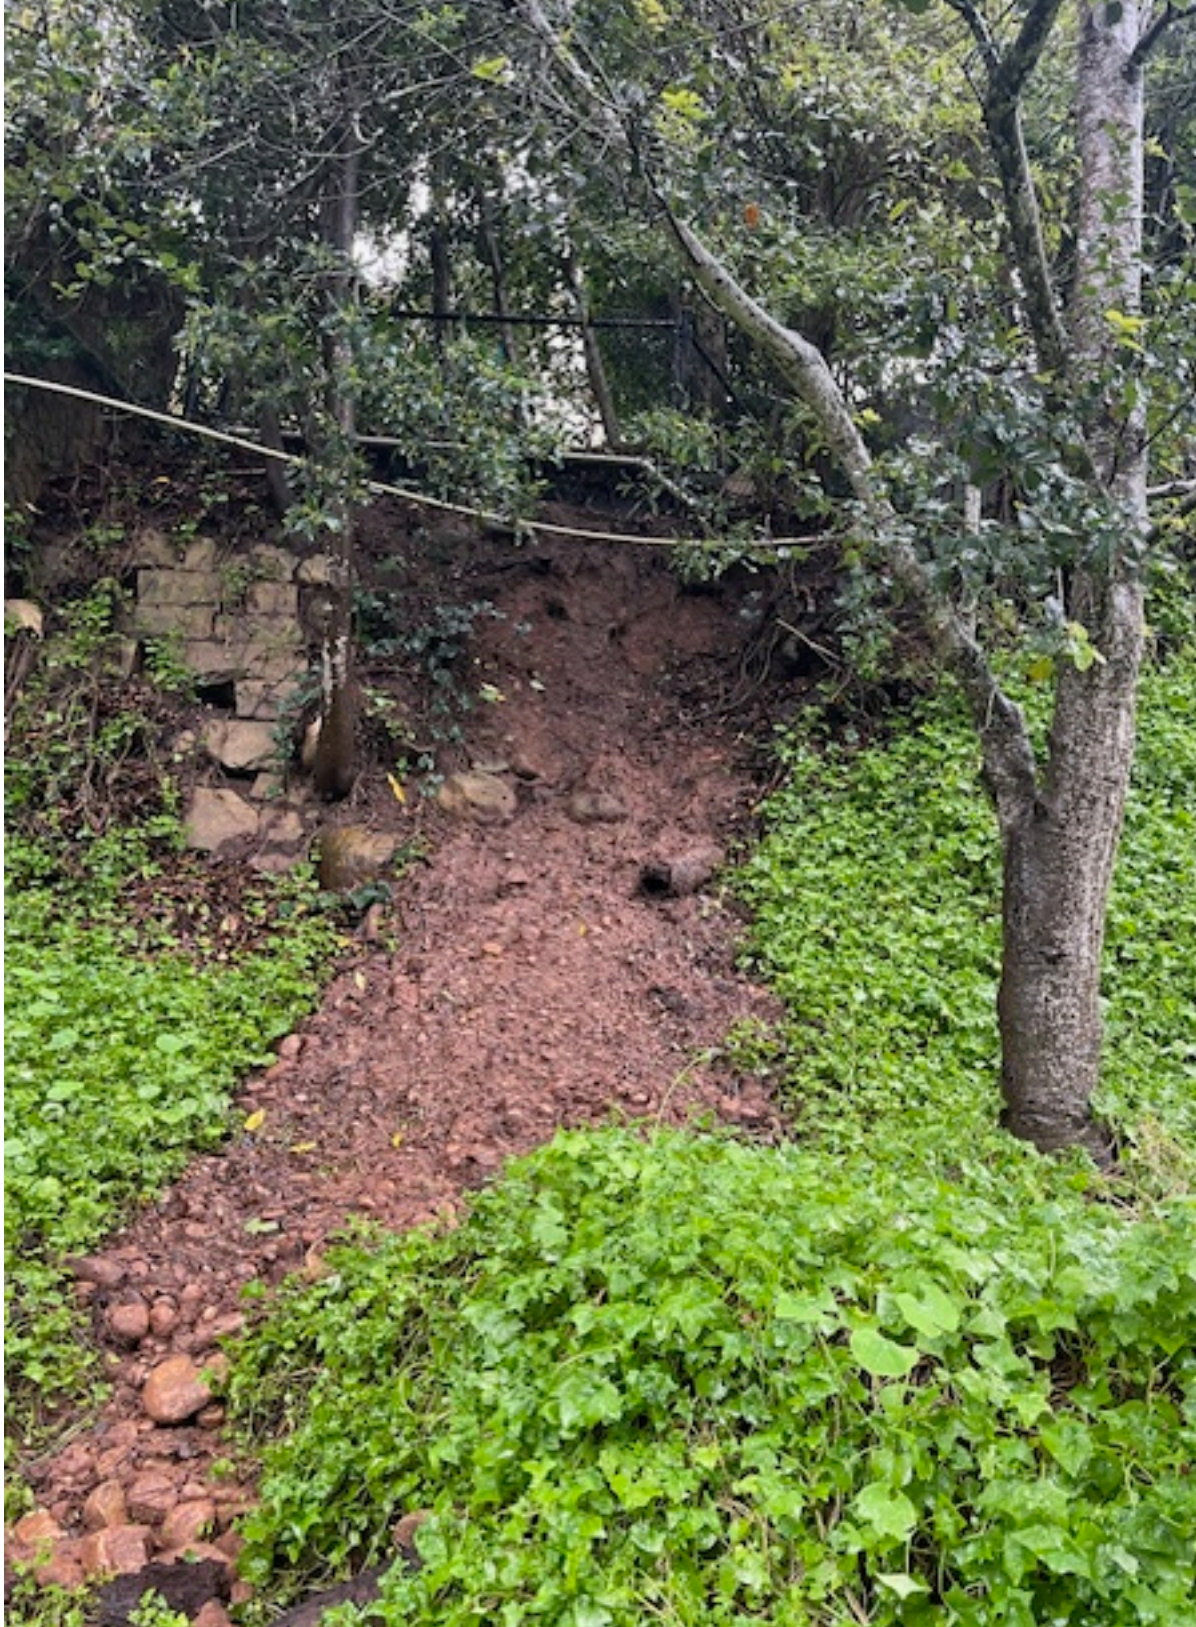
Photo 4 – February 2024 Slope Failure on East Embankment

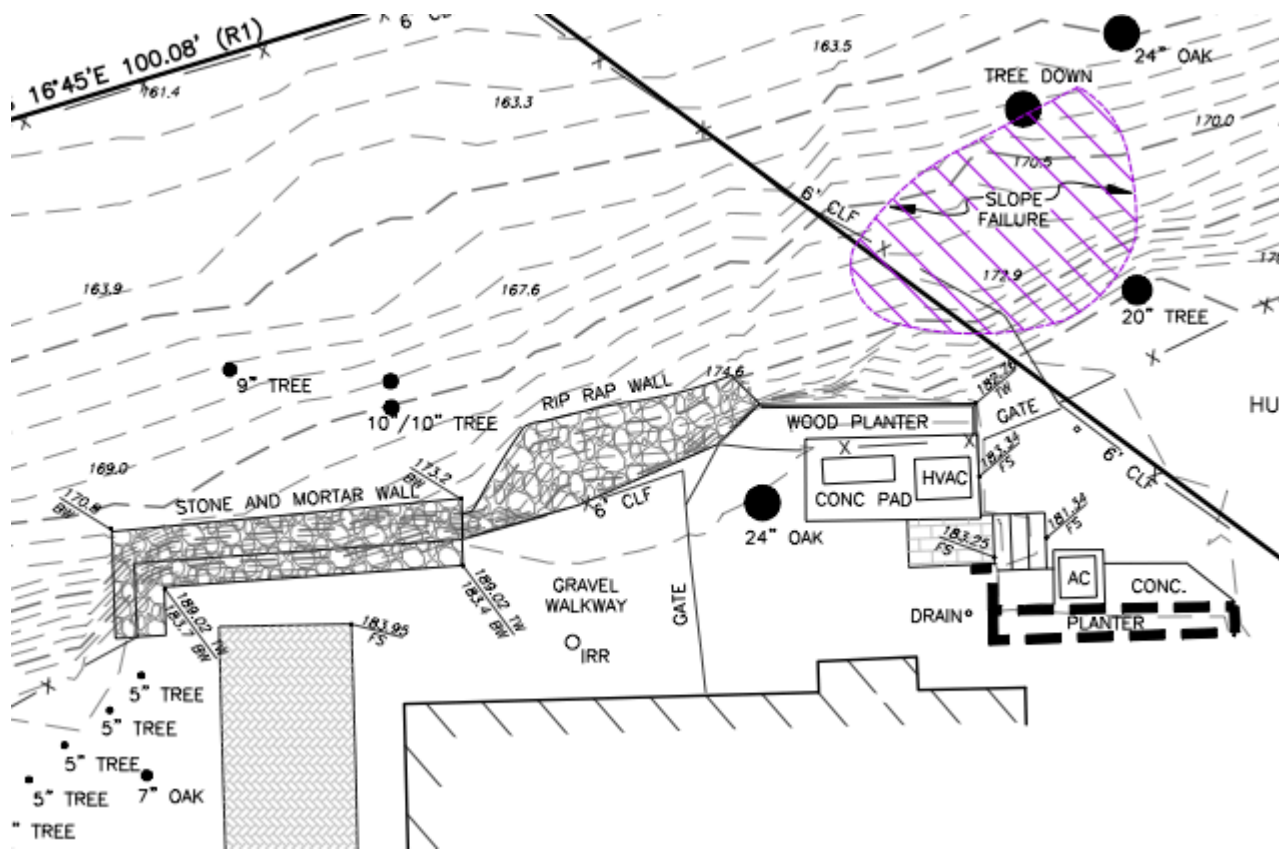
Photo 5 – Showing Location of January 9, 2023 Slope Failure, Stone and Mortar Wall, 24” Oak, HVAC System, and East Side of Residence Located Immediately Adjacent to the South End of the Slope.
