SANTA BARBARA COUNTY
HISTORIC LANDMARKS ADVISORY COMMISSION

APPLICATION FOR REVIEW AND APPROVAL OF WORK OR ACTIVITY
AFFECTING LANDMARKED PROPERTY

Project Name: 461 SAN YSIDRO ROAD / HOSMER - TURNER ADOBE

Re: Revised Treatment of Hosmer Adobe, Water Tower, 461 San Ysidro Road, Montecito

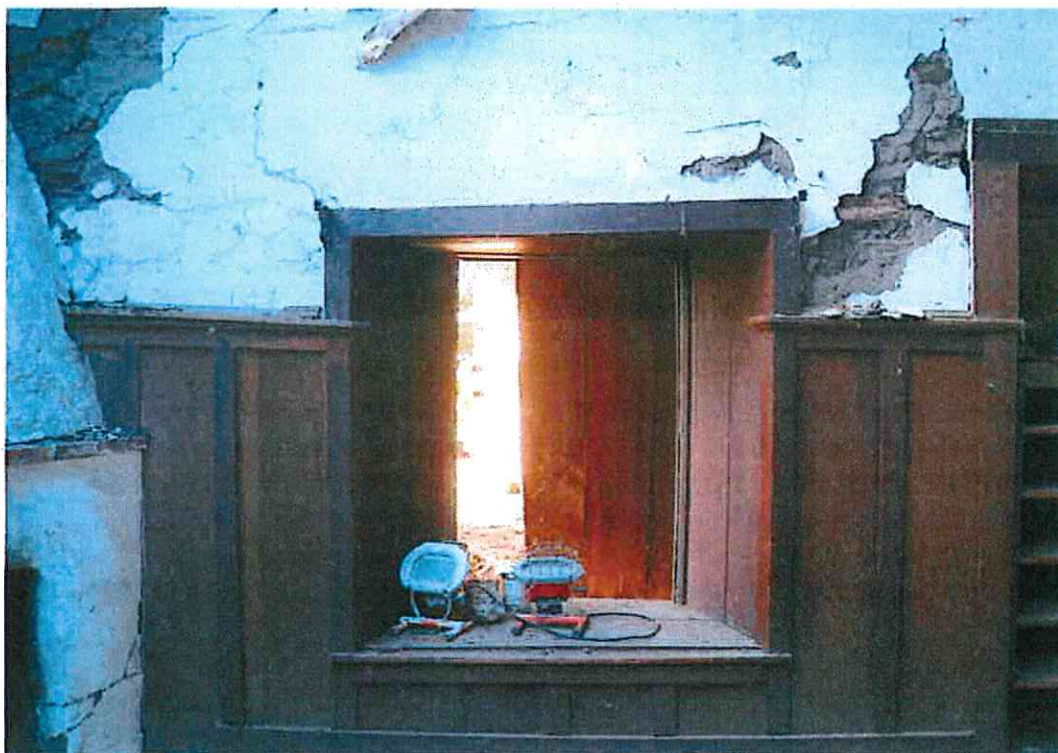
As the actual work to stabilize the foundations began this autumn, it became clear that the adobe was crumbling to a dangerous degree and that there appeared to be no foundation under the walls. On the interior, where the adobe plaster and whitewash have fallen off, the crumbling state of the adobe blocks is evident. When the bowed window frame was removed on the east elevation, the adobe blocks over the window frame sagged more, as apparently the window frame was supporting the blocks (see Plates 1-5).

Plate 1. Adobe west wall showing deteriorated blocks.

1. Carefully dismantle existing adobe building.

2. Reconstruct building, using existing measured drawings, with stabilized 4" x 8" x 18" adobe bricks fabricated on-site.
3. Reconstruct new windows to match existing.
4. Reconstruct new roof, using wood shakes to match existing.
5. Reuse original south-facing entry door.
6. Carefully disassemble the redwood wainscoting and reassemble on the reconstructed building.

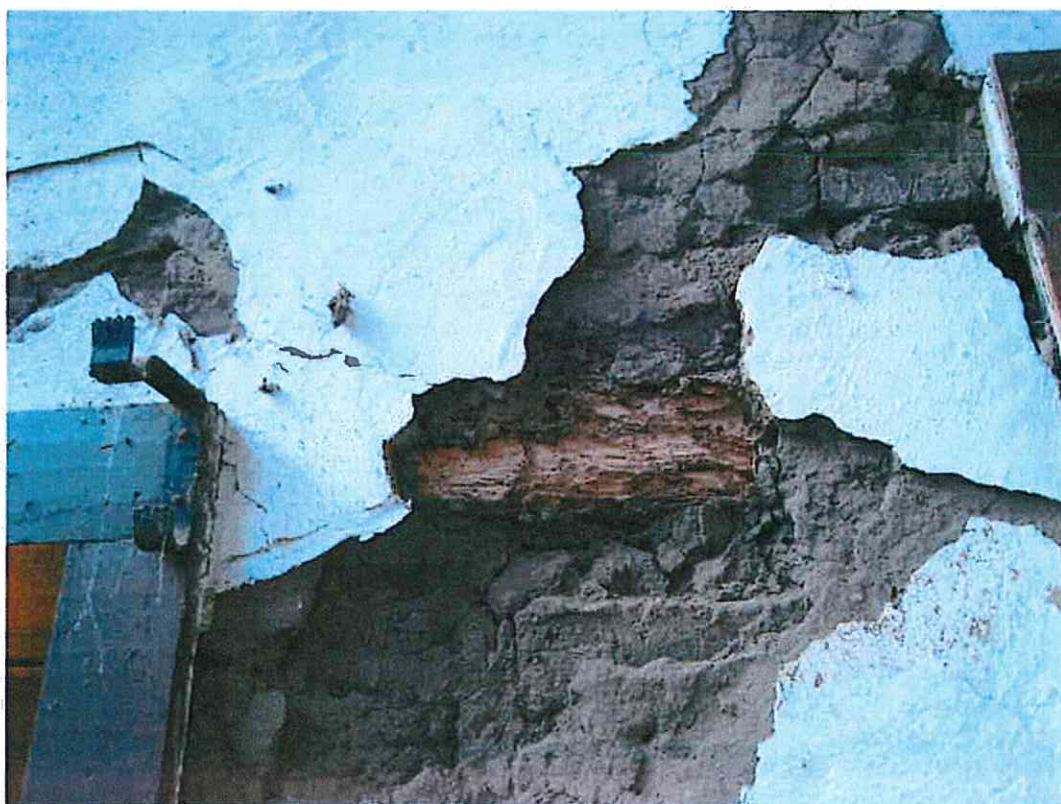
Plate 2. Detail of adobe west wall showing dry rot in structural wood member.

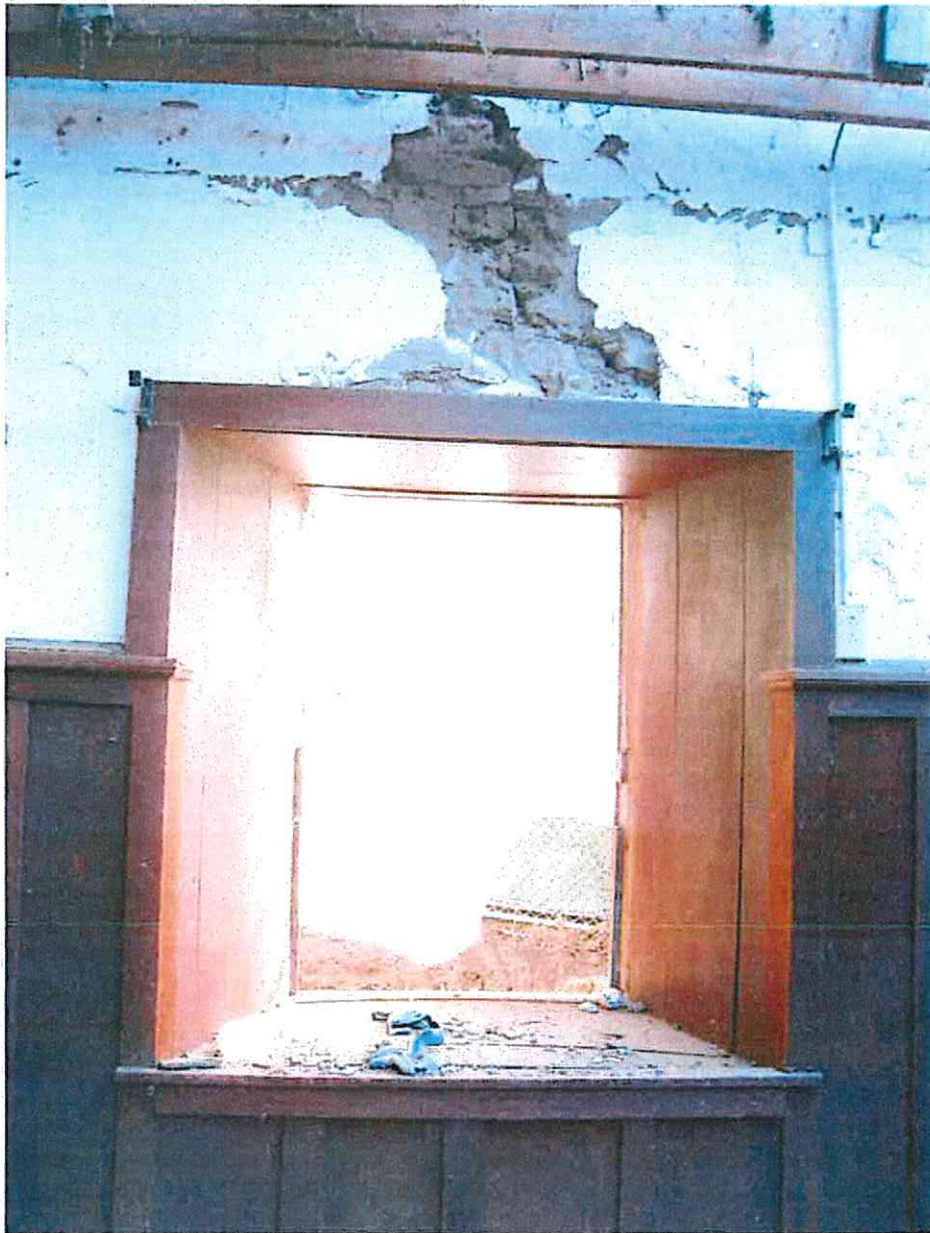
Plate 3. Adobe east wall showing structural cracks in adobe blocks

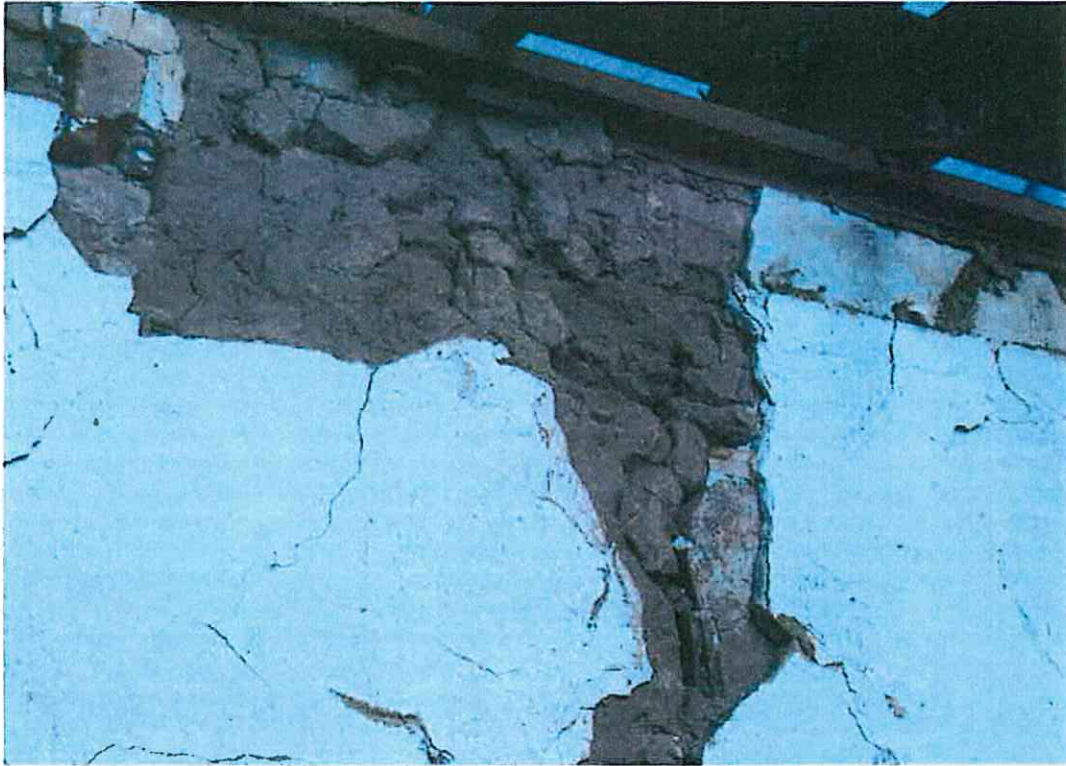
Plate 4. Upper adobe wall showing crumbling blocks.

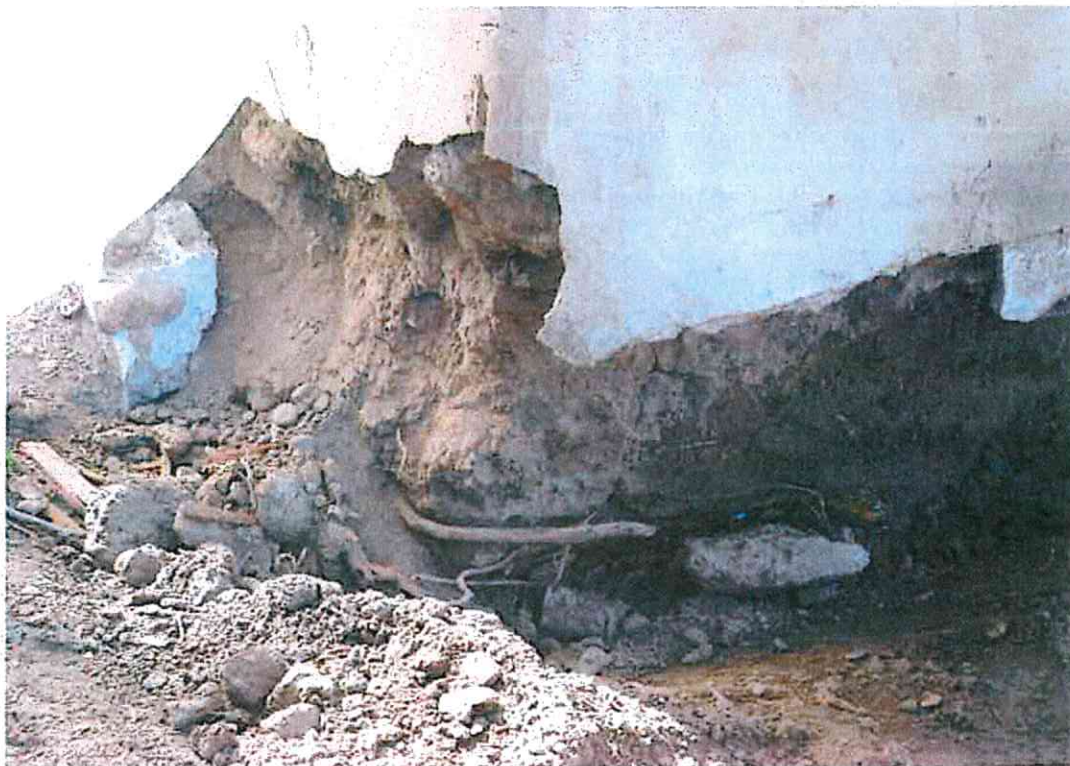
Plate 5. Detail of crumbling adobe blocks at base of northeast wall.

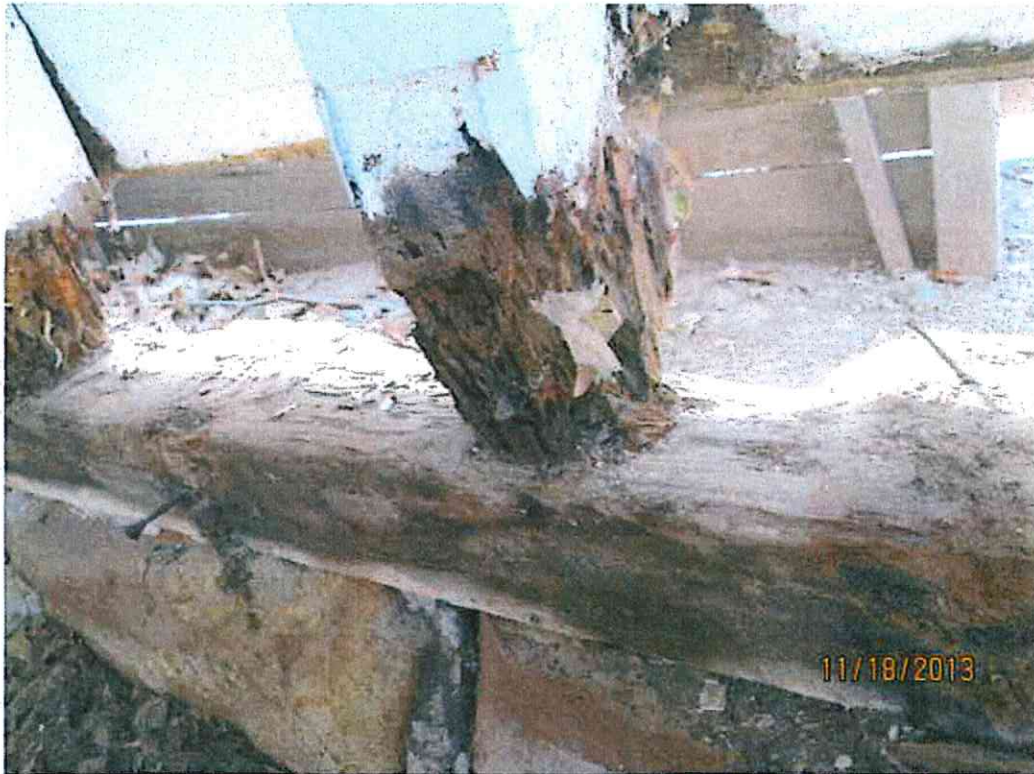
Plate 6. Deteriorated tower structural members resting on stone foundation.
Photo: Danny Townsend

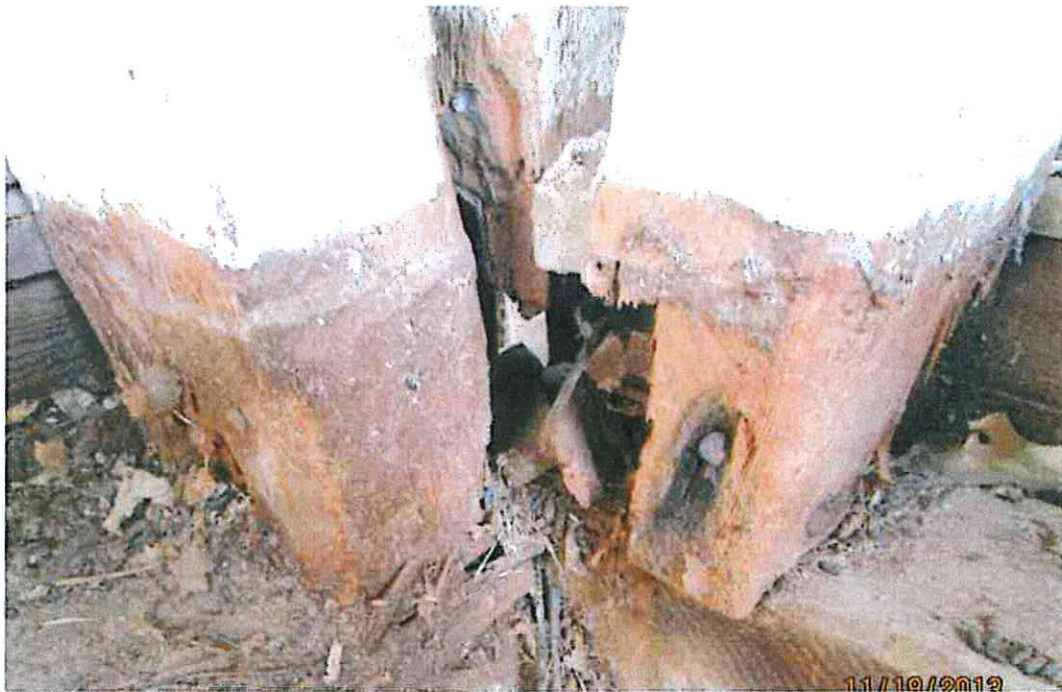
Plate 7. Deteriorated tower structural members. *Photo: Danny Townsend*

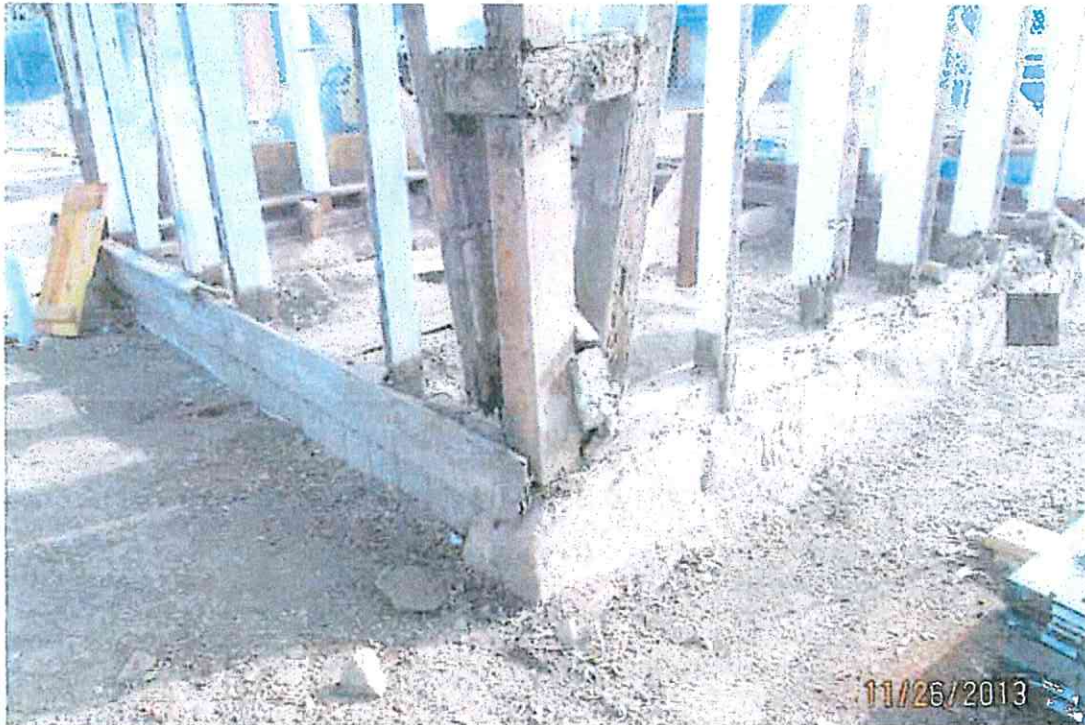
Plate 8. Deteriorated tower structural members. *Photo: Danny Townsend*

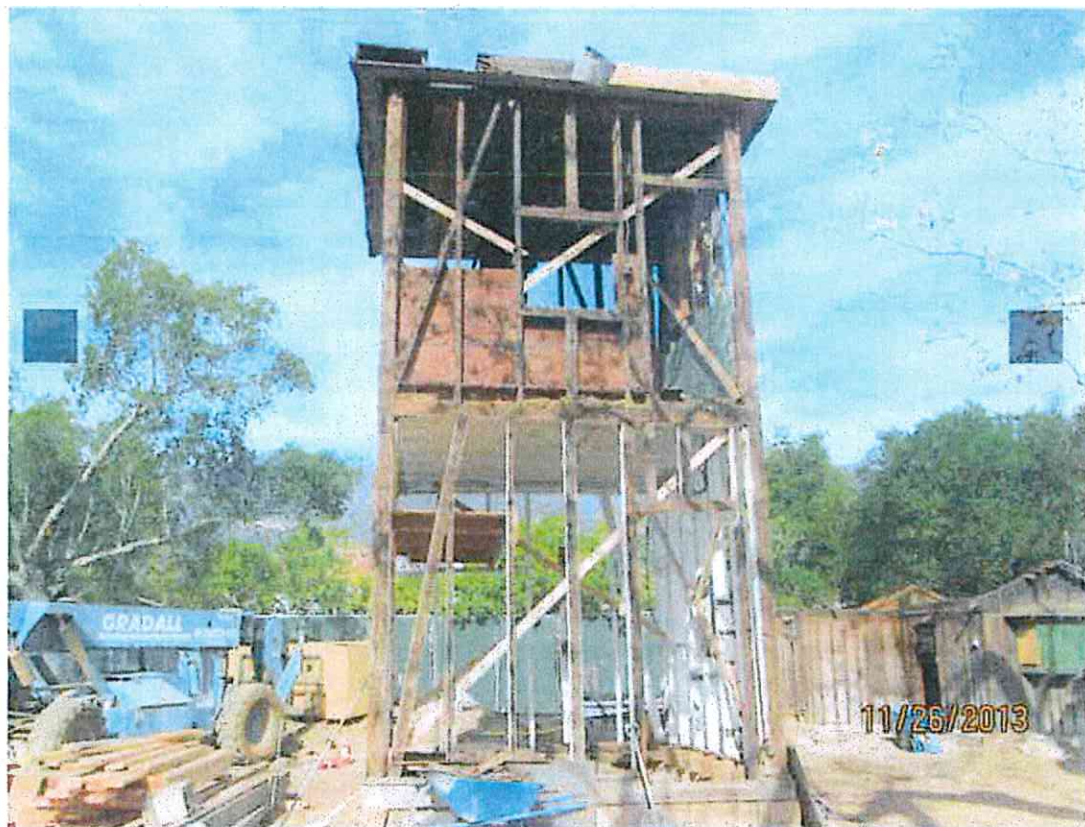
Plate 9. Tower showing deteriorated structural members.
