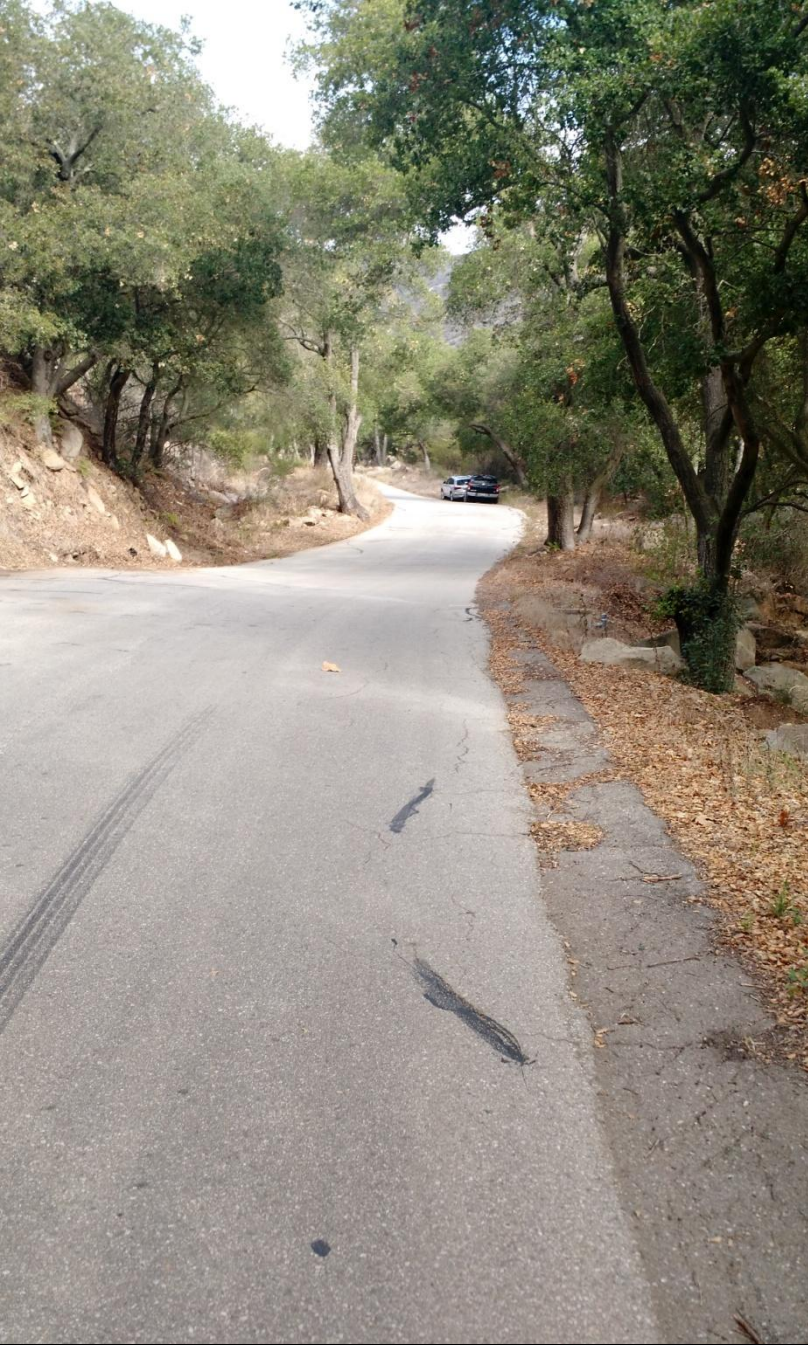
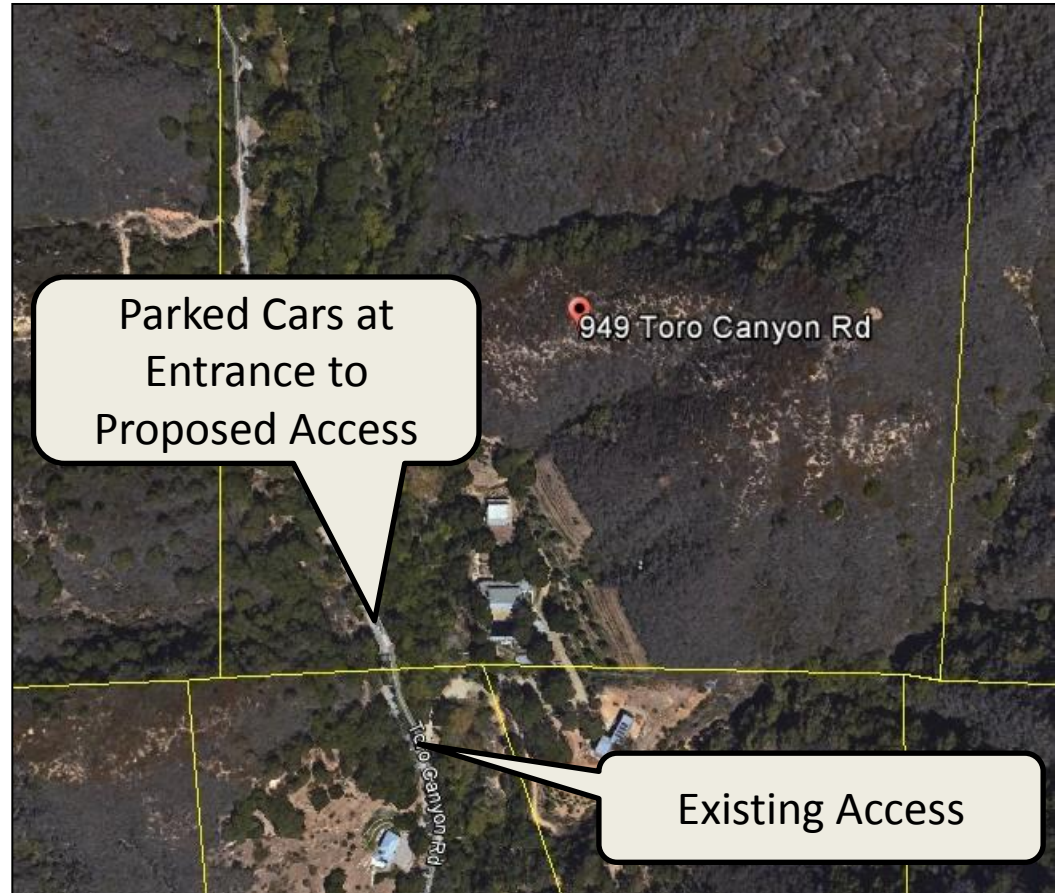
Figure 2: Entrance of proposed access as viewed from entrance to existing access

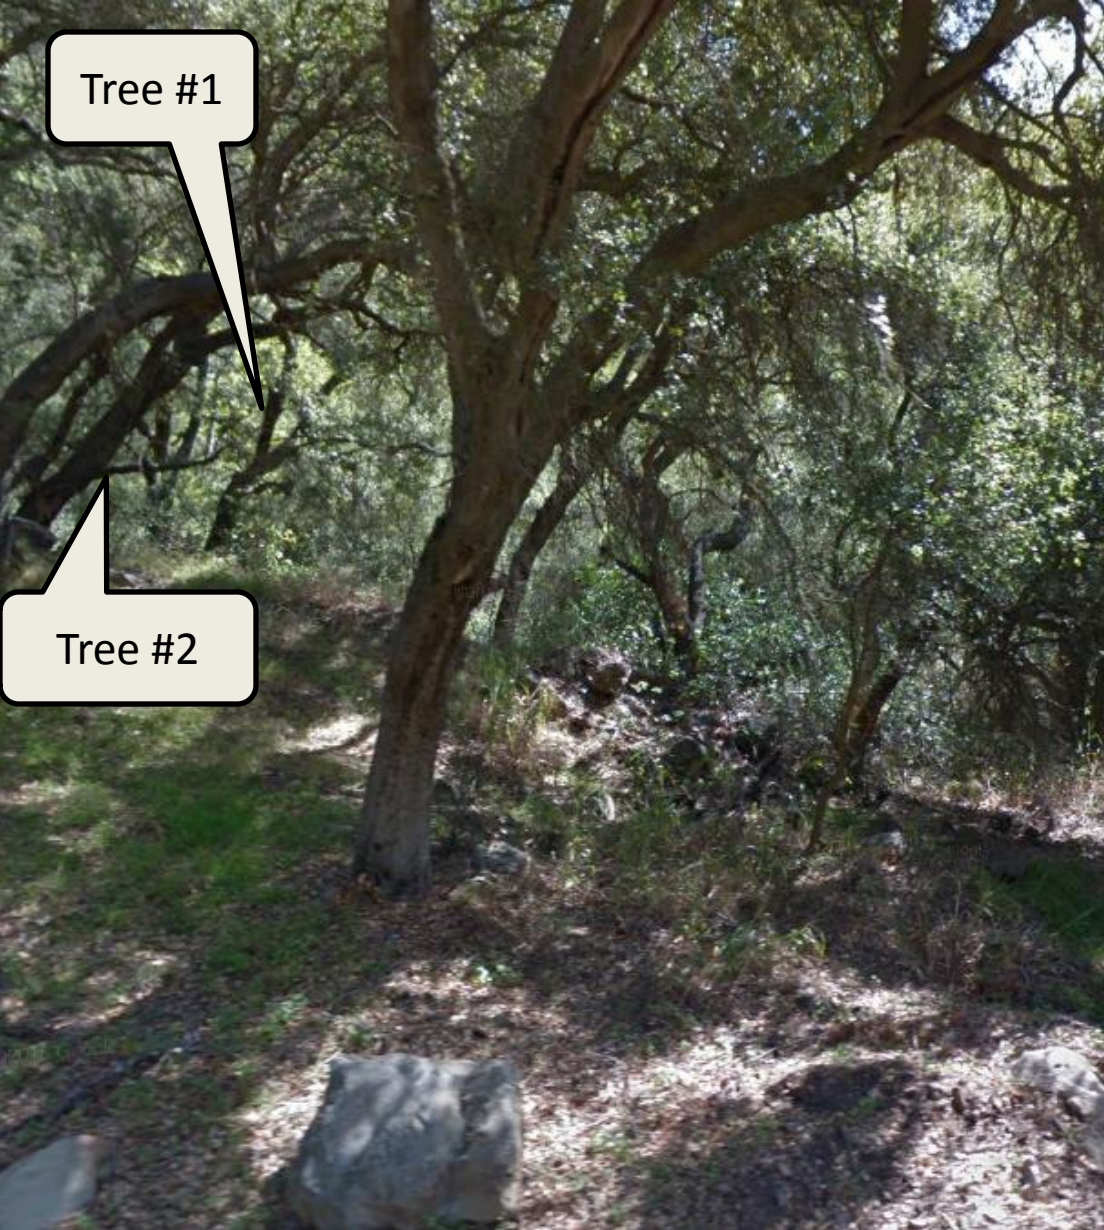
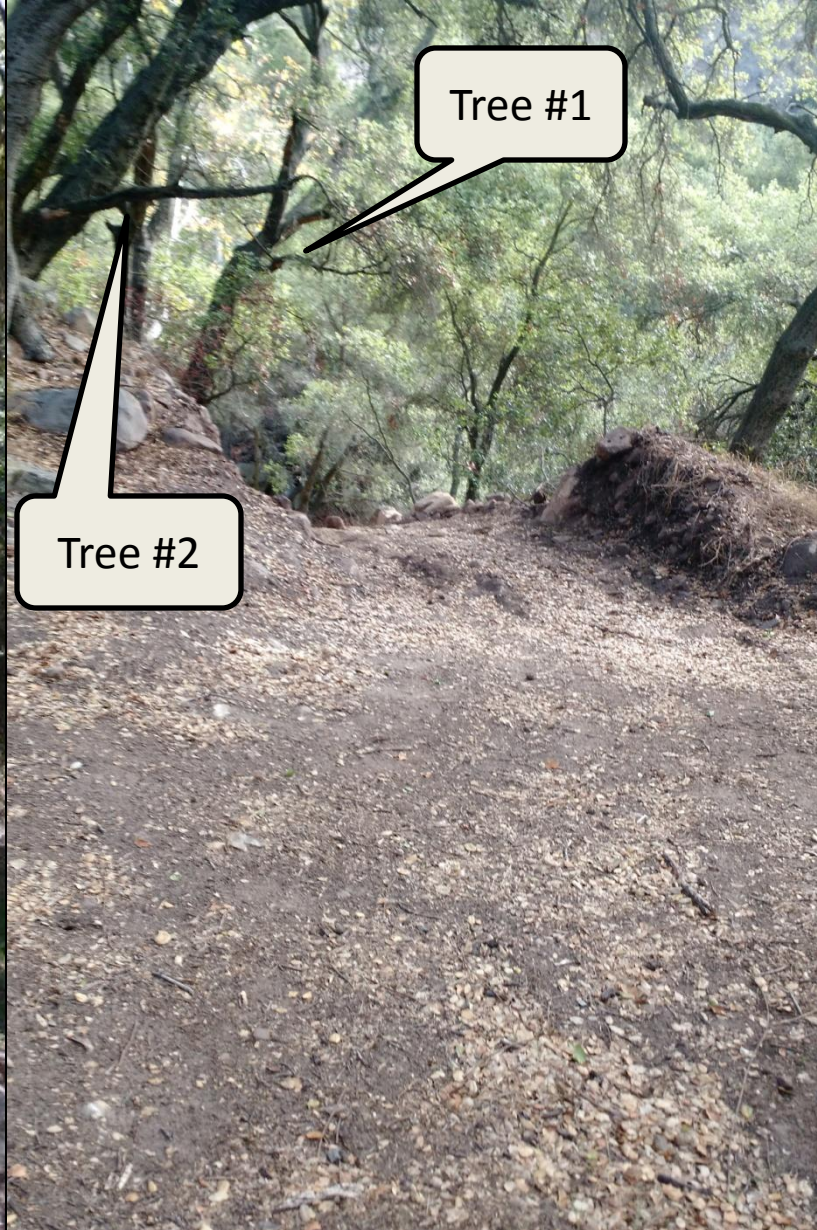
Figure 3: View of secondary access road from Toro Canyon Road. Staff used Google Streetview to show the area in 2012 and compare the area with site visit photos from 2015. A comparison of the photos shows vegetation before and after the unpermitted grading.

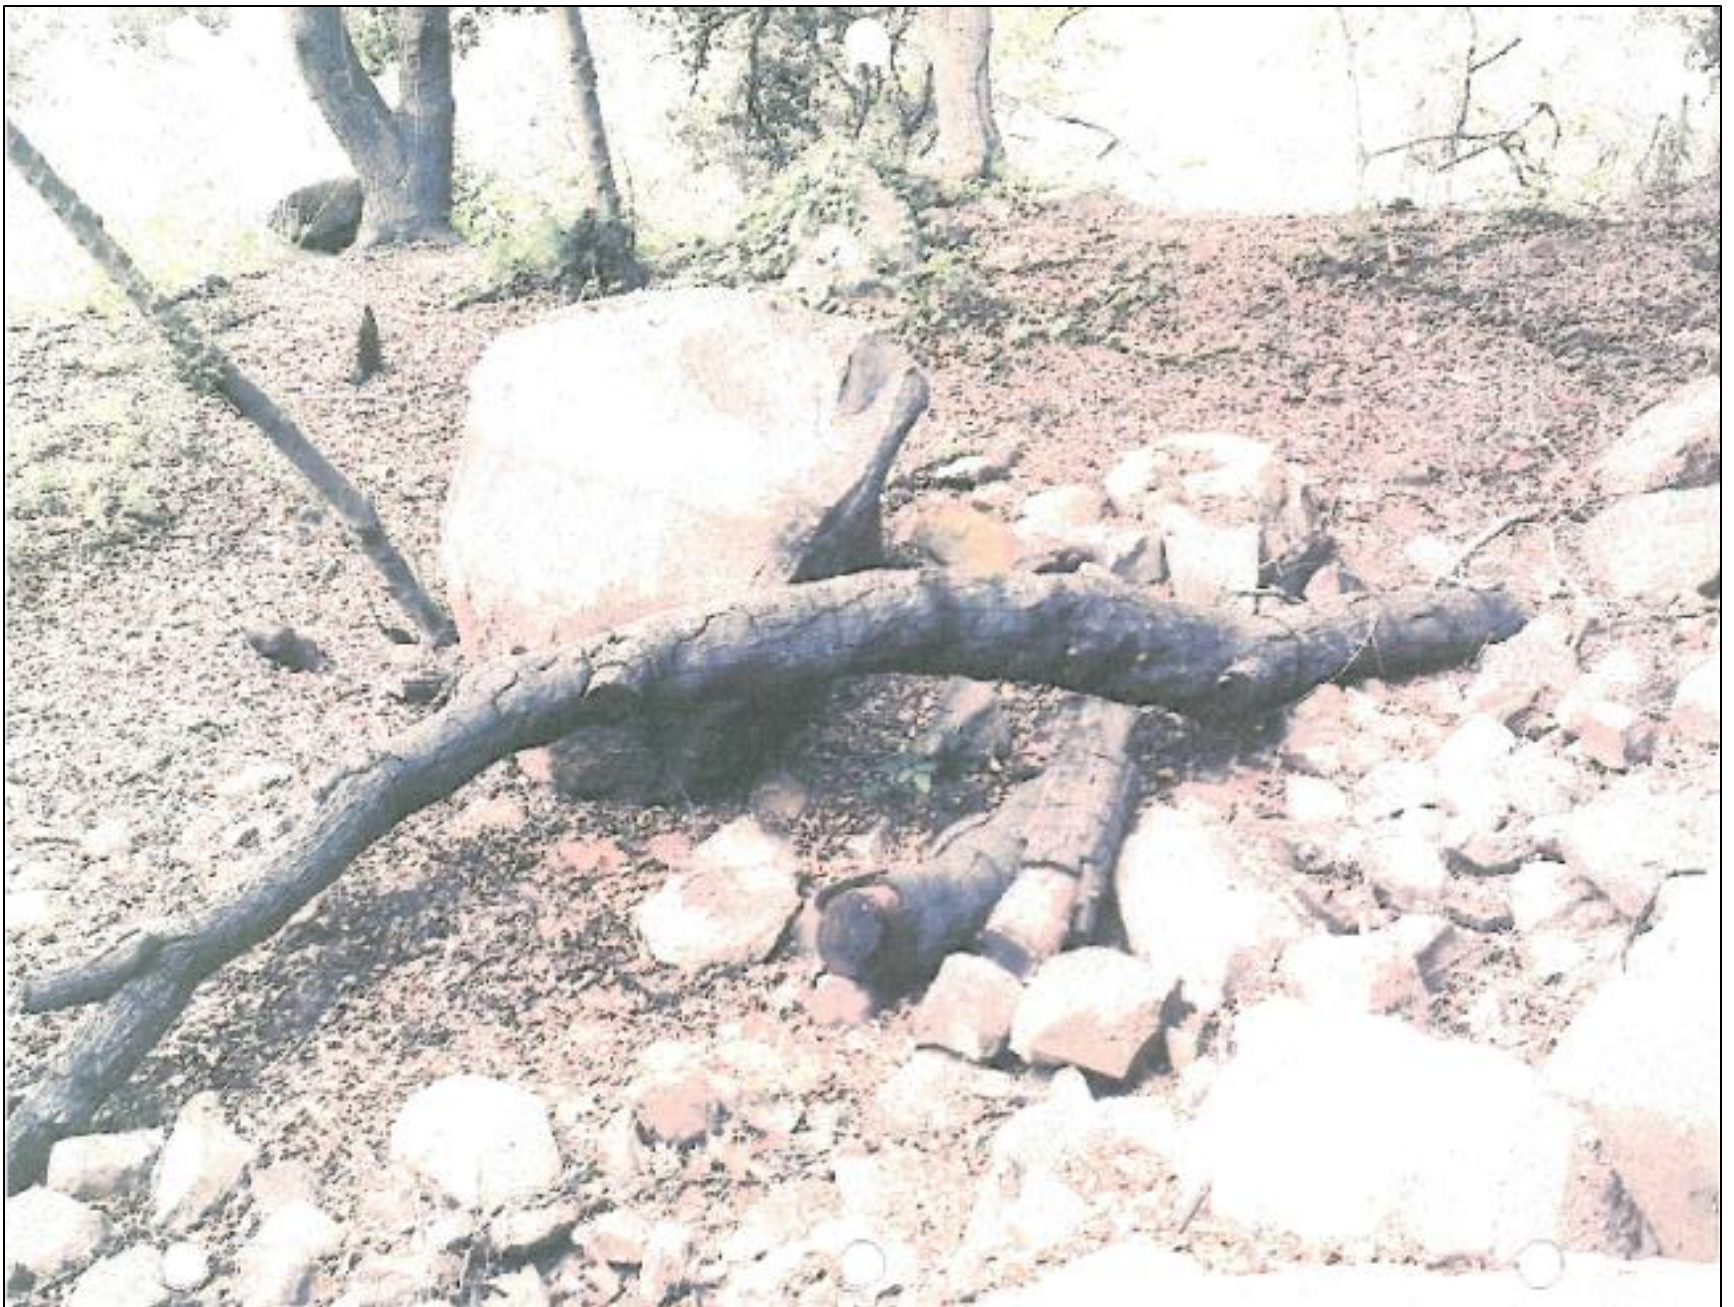
Figure 4: Photo of chopped down oak tree provided by appellants

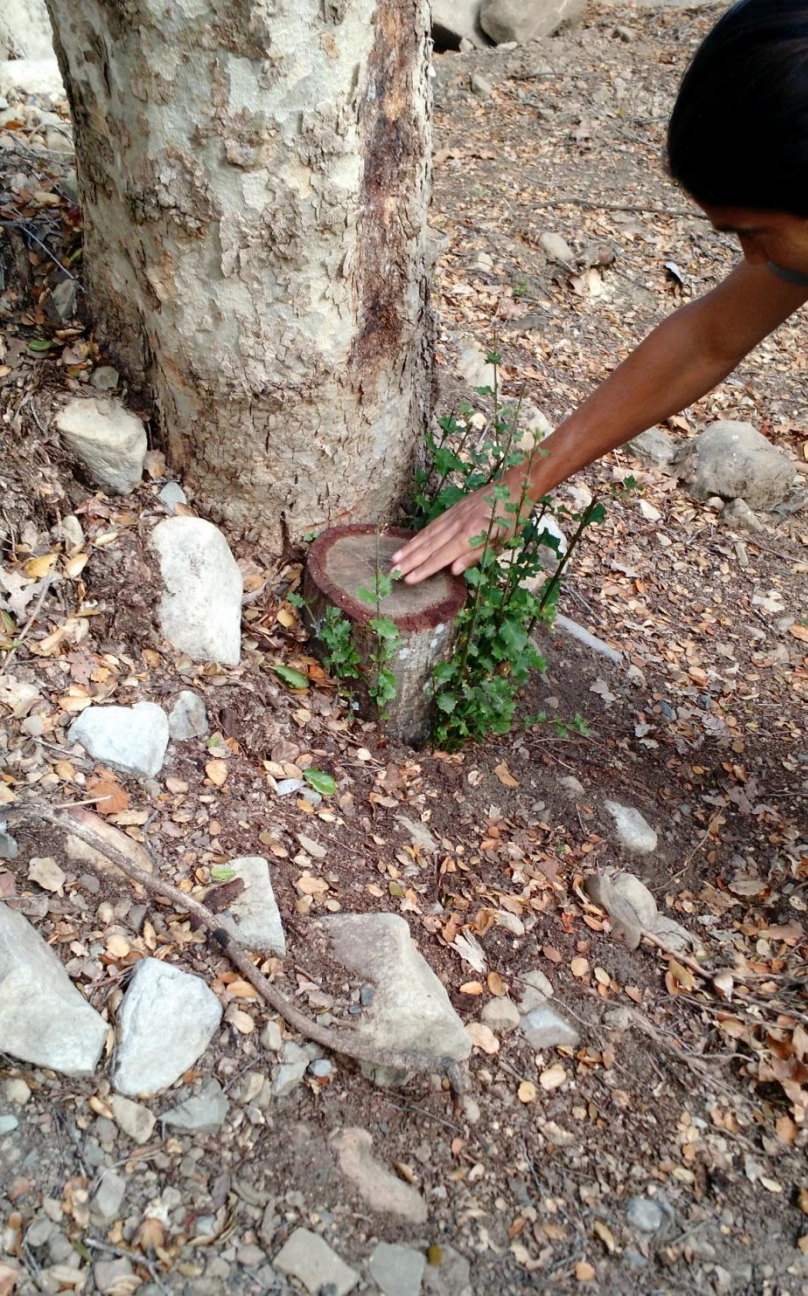
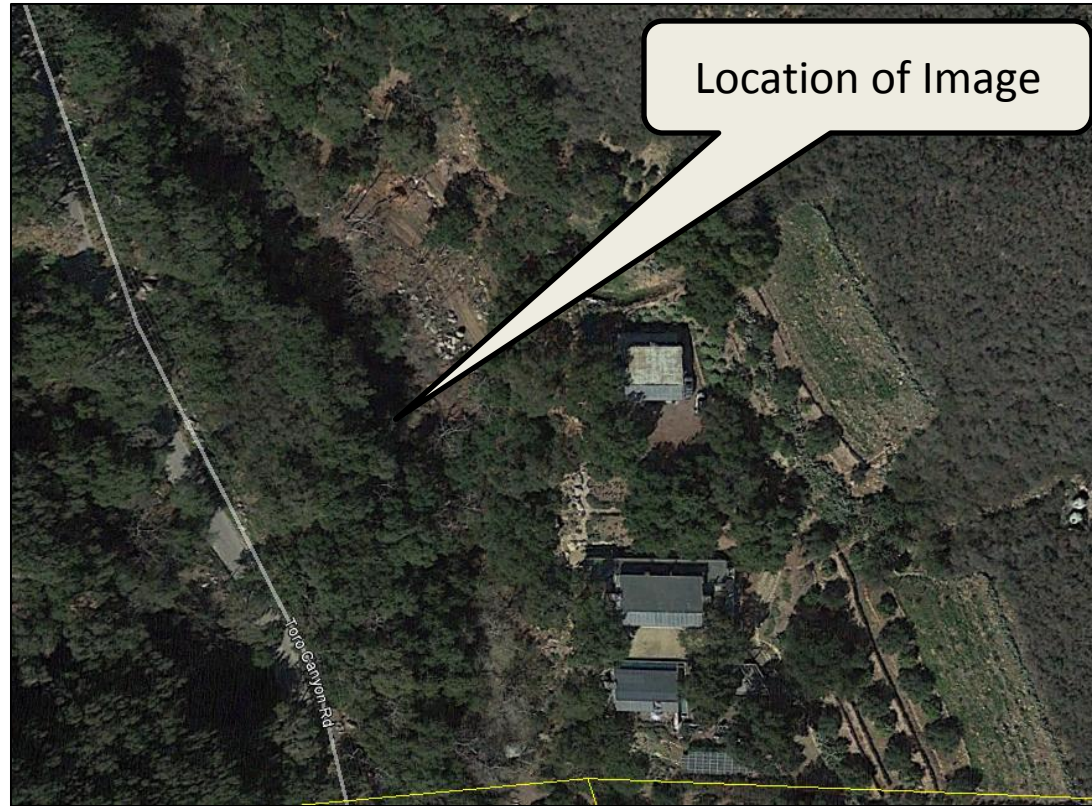
Figure 5: Photo of appellants' former biologist showing P&D staff where an oak tree was chopped down

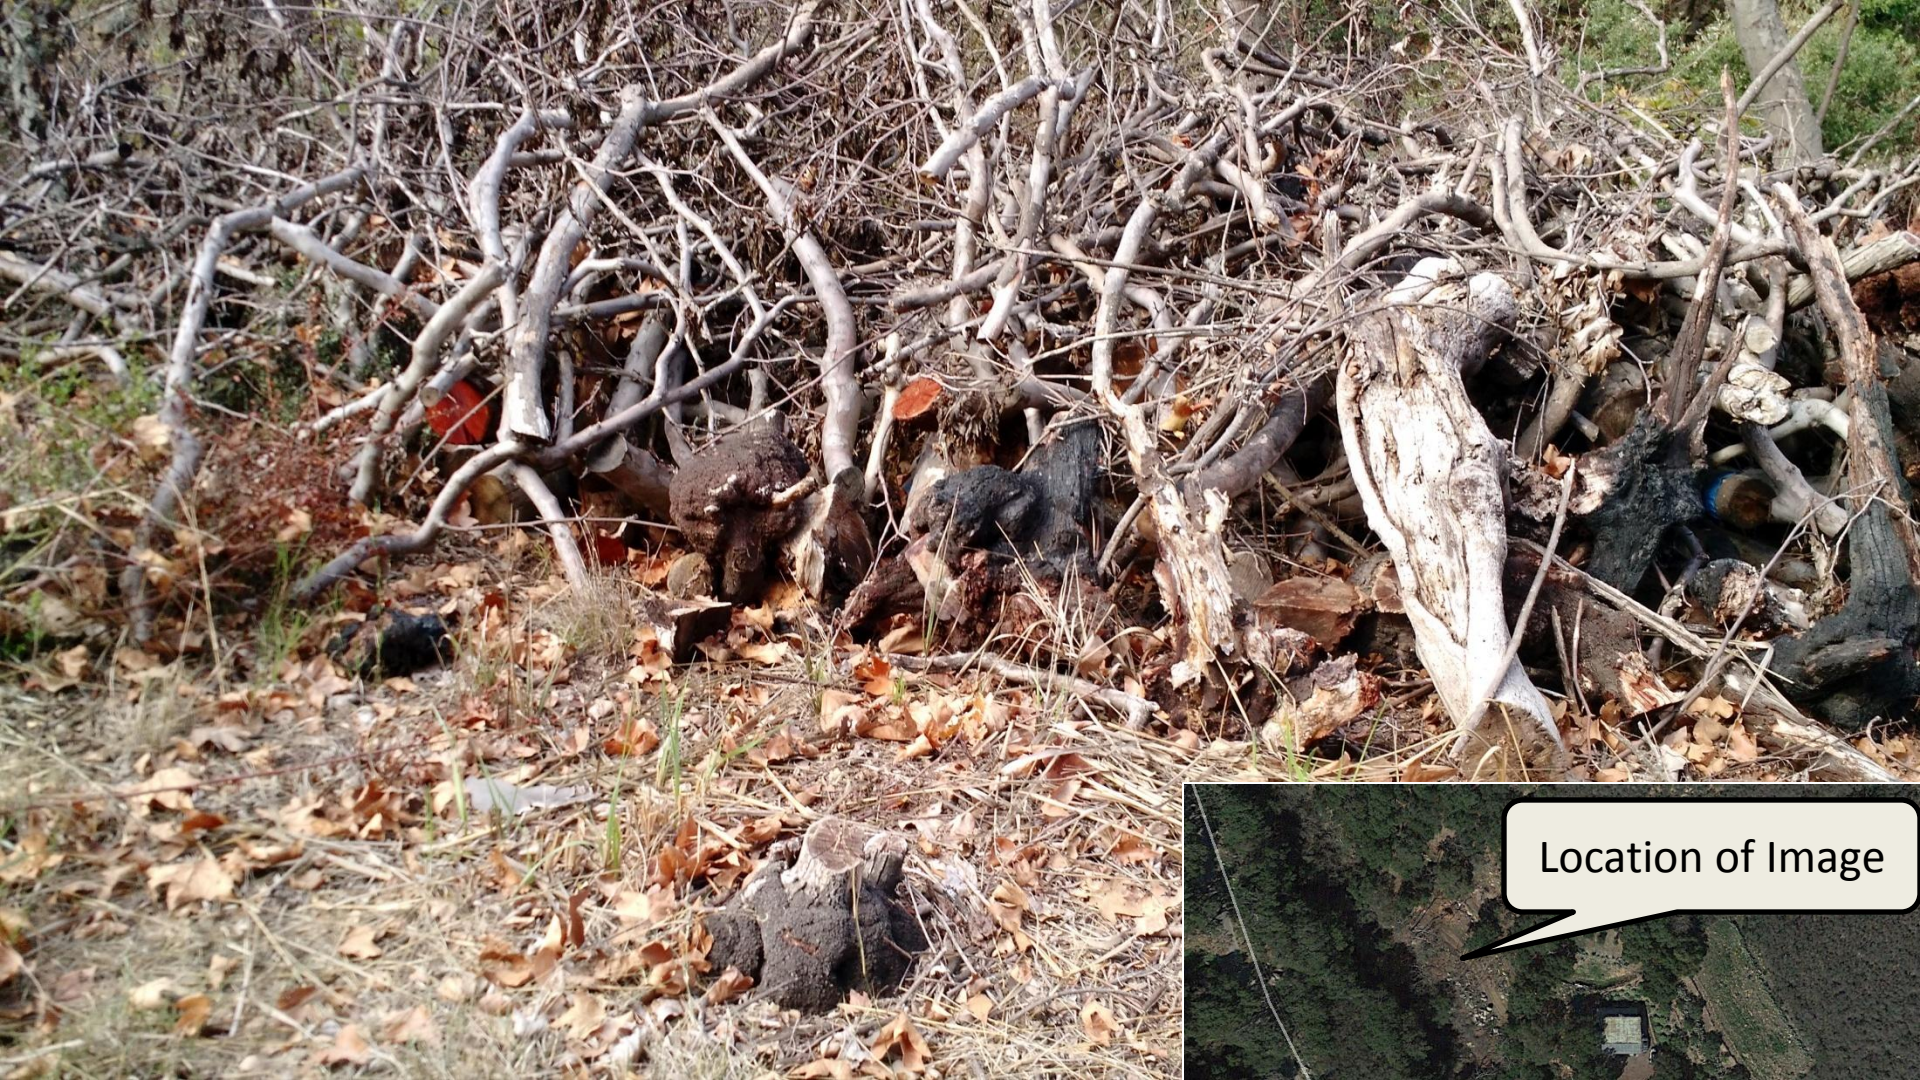
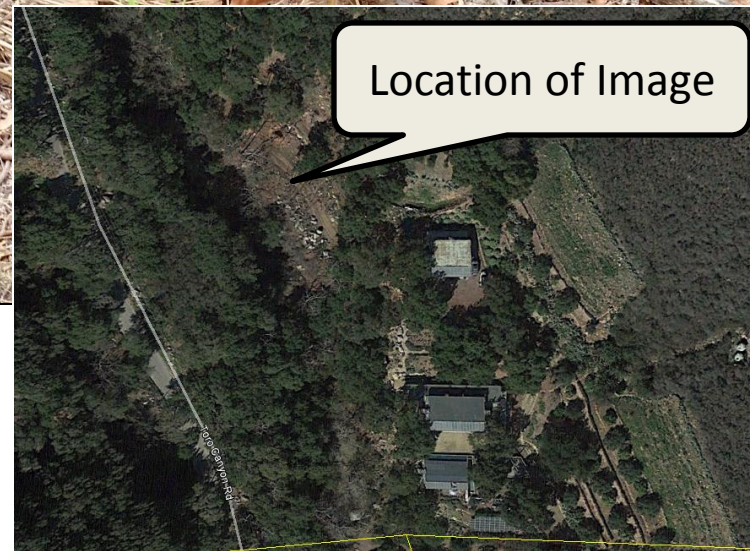
Figure 6: Photo of native plant debris adjacent to unpermitted secondary access road

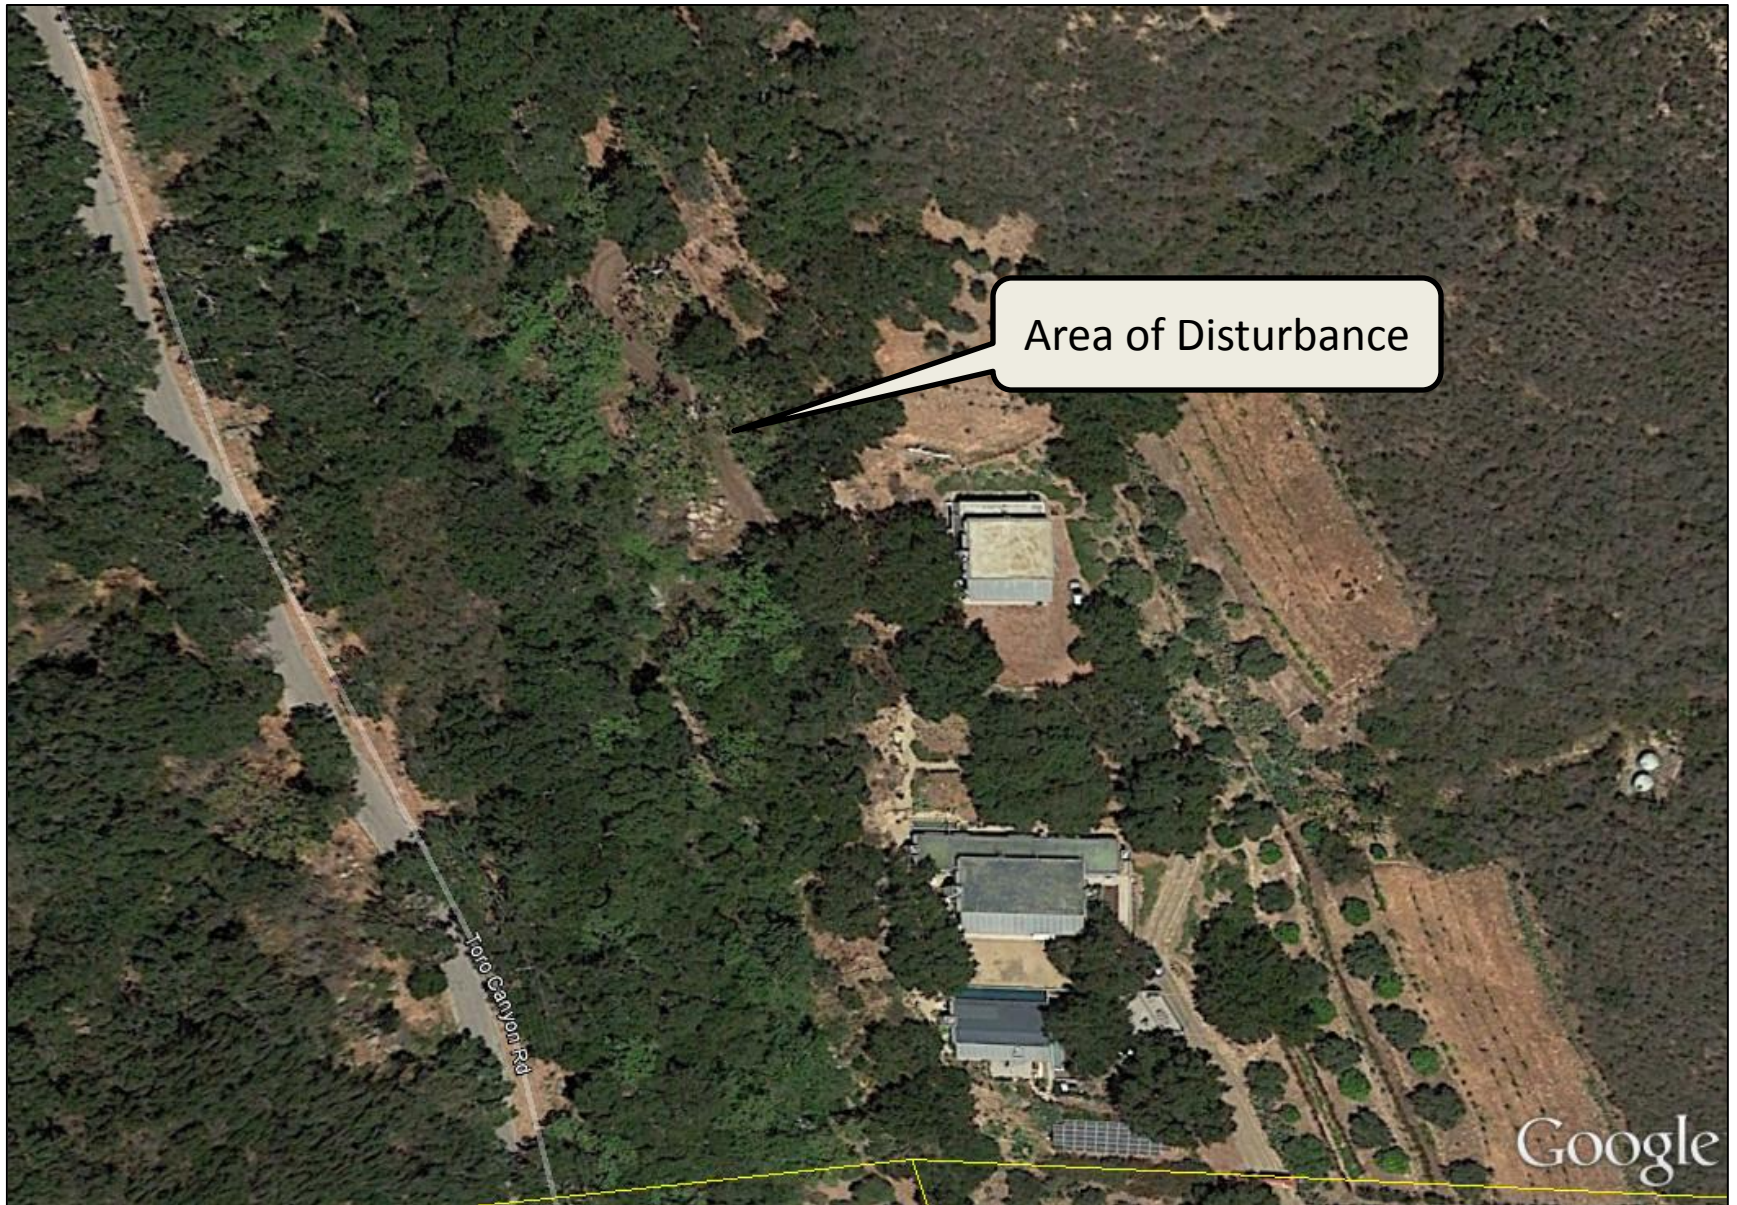
Figure 8.a: Photo of area of disturbance in May 2015. Source: Google Earth

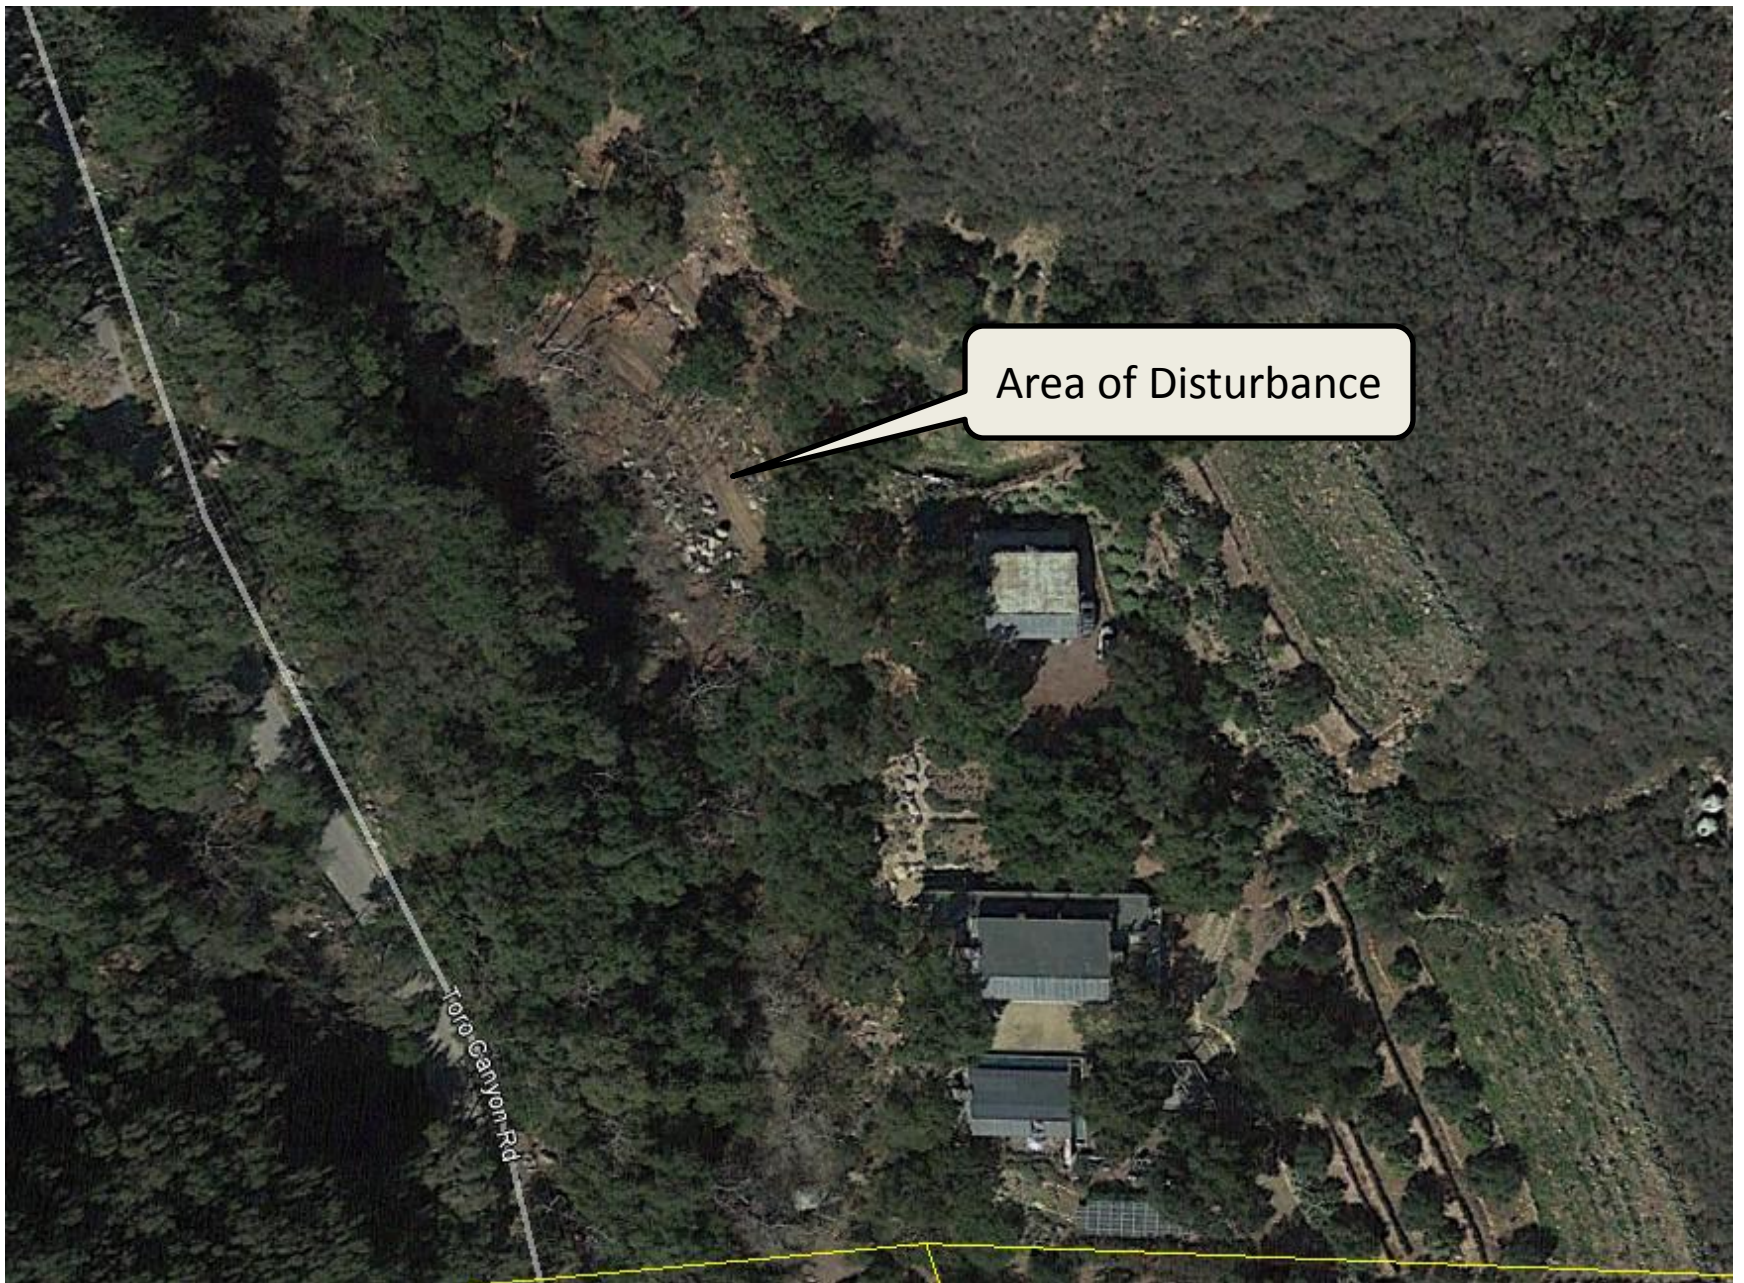
Figure 8.b: Photo of area of disturbance in February 2016. Source: Google Earth

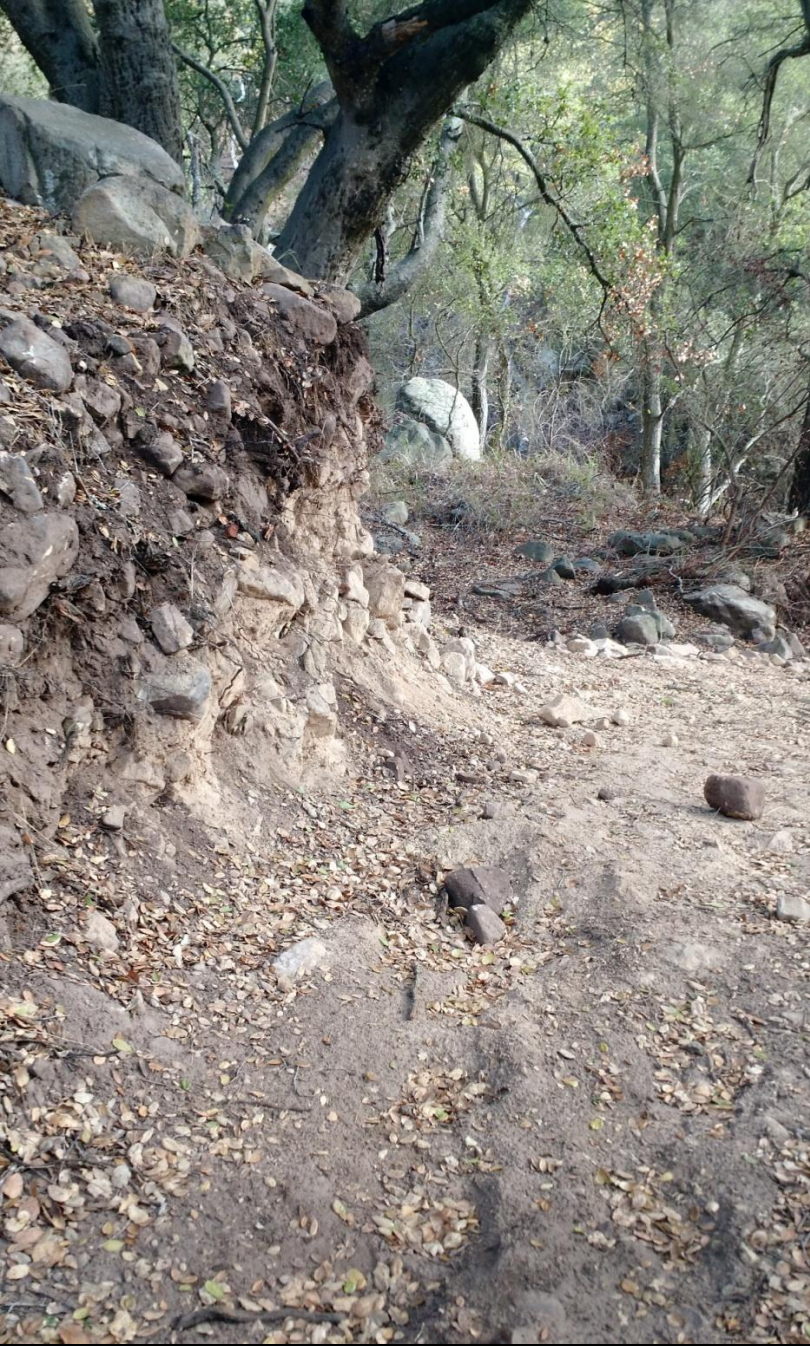
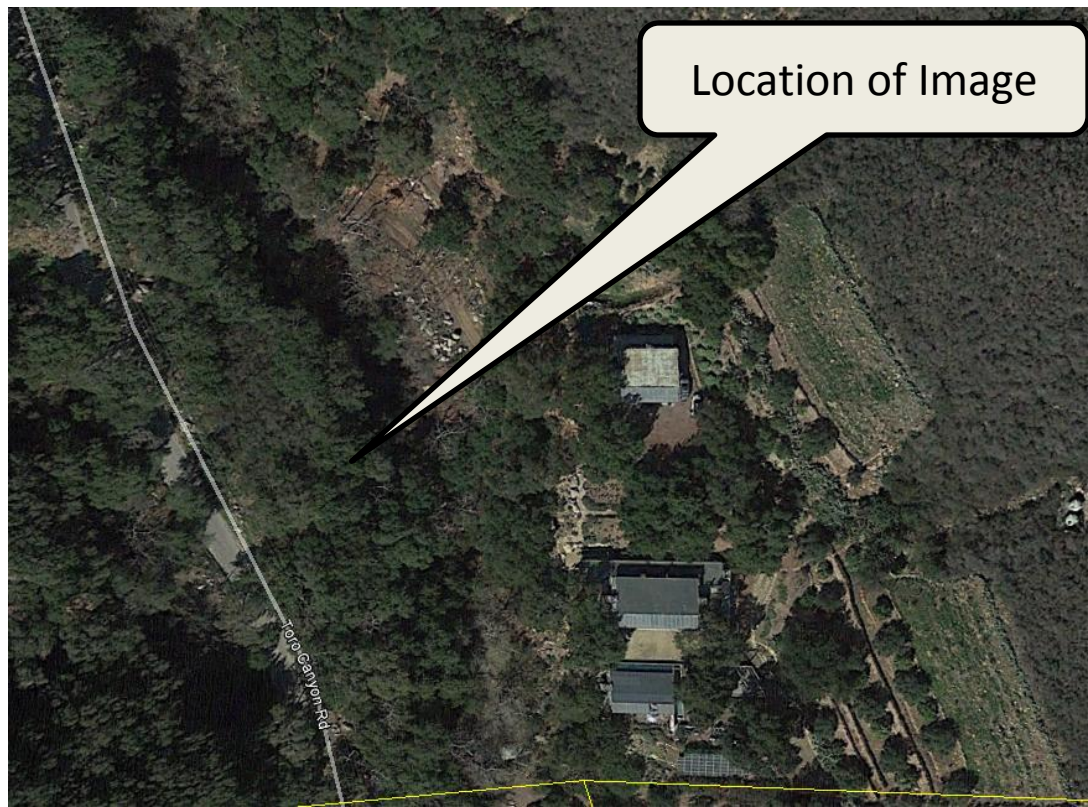
Figure 9: Photo of unpermitted grading adjacent to Toro Canyon Creek

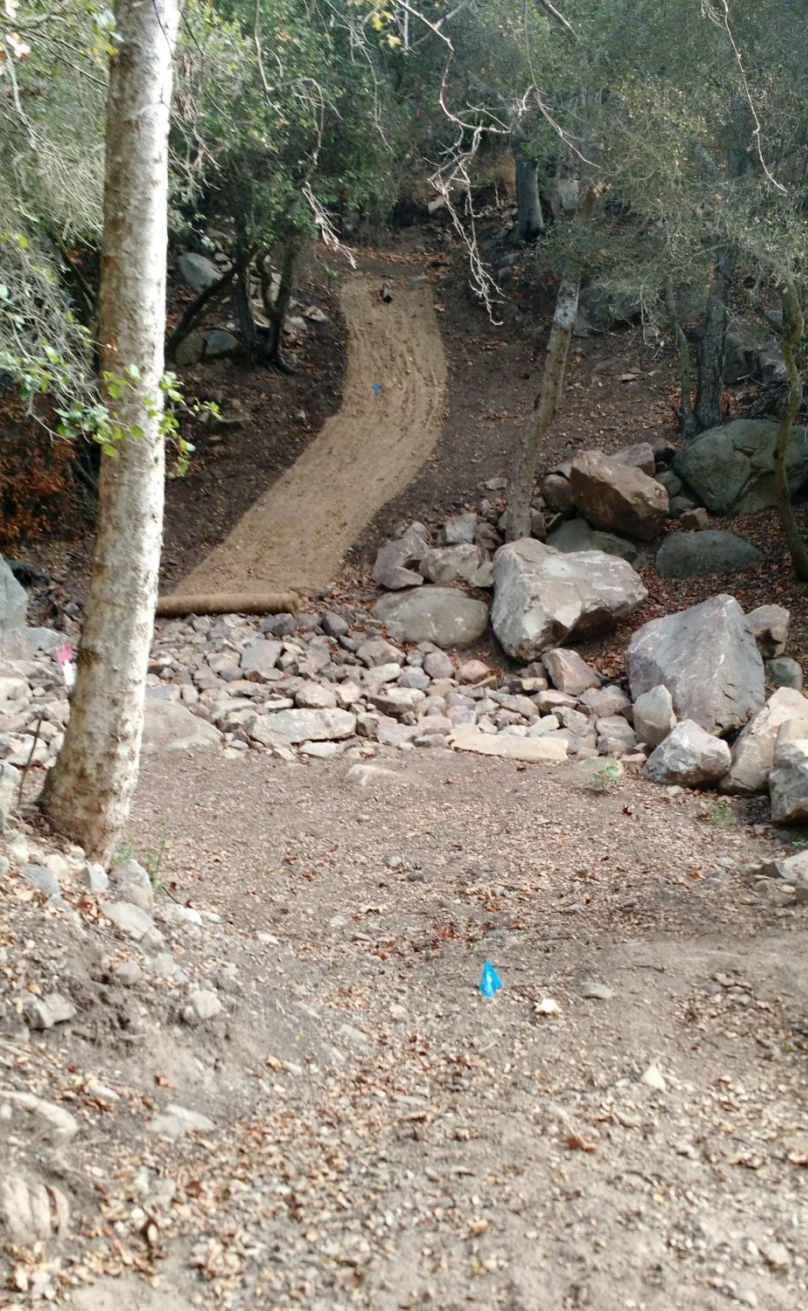
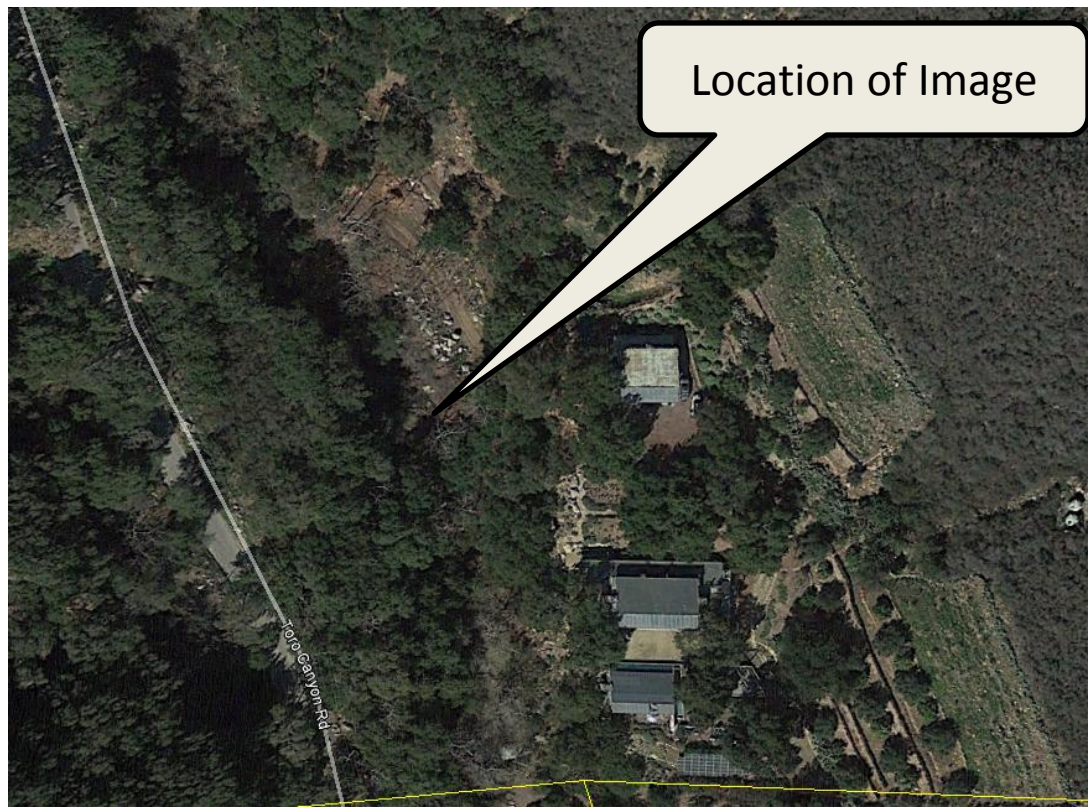
Figure 10: Photo of area of disturbance and boulders placed by appellants within Toro Canyon Creek

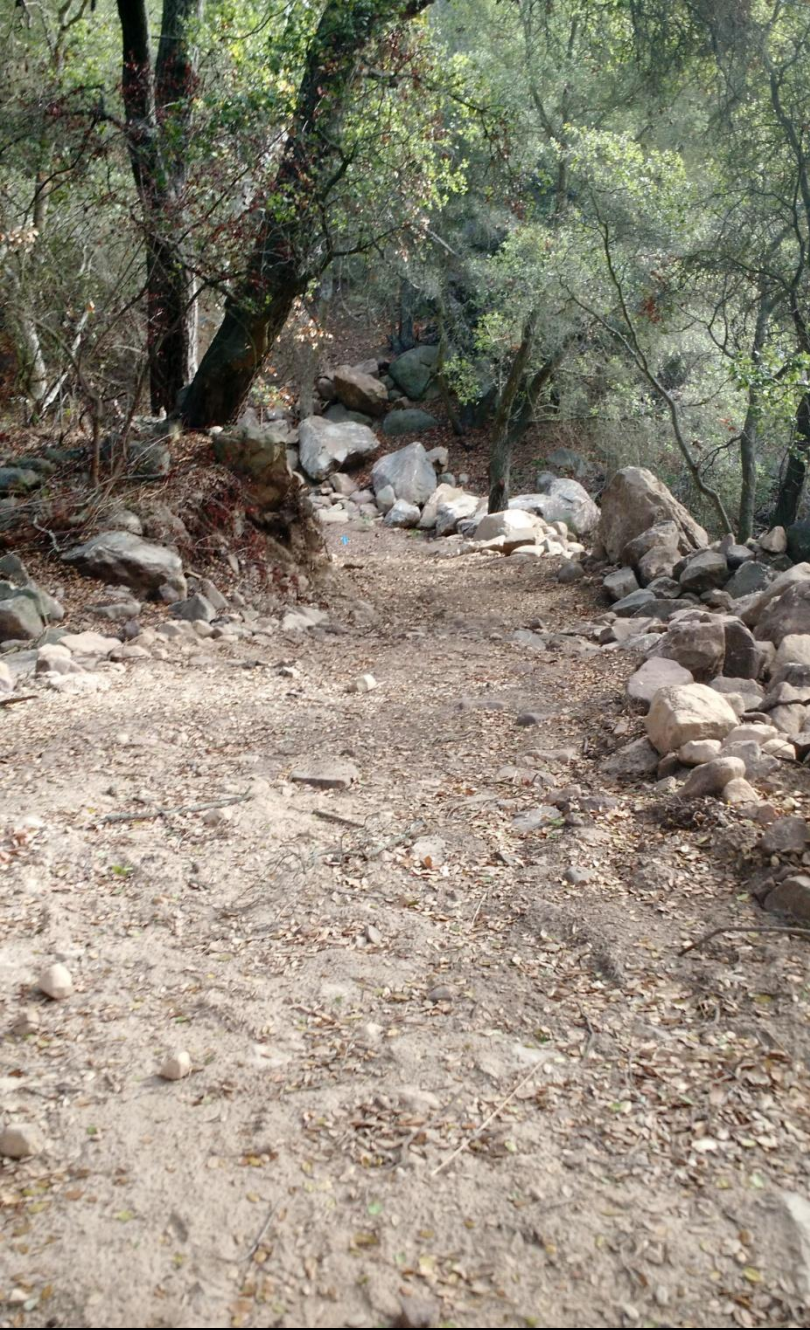
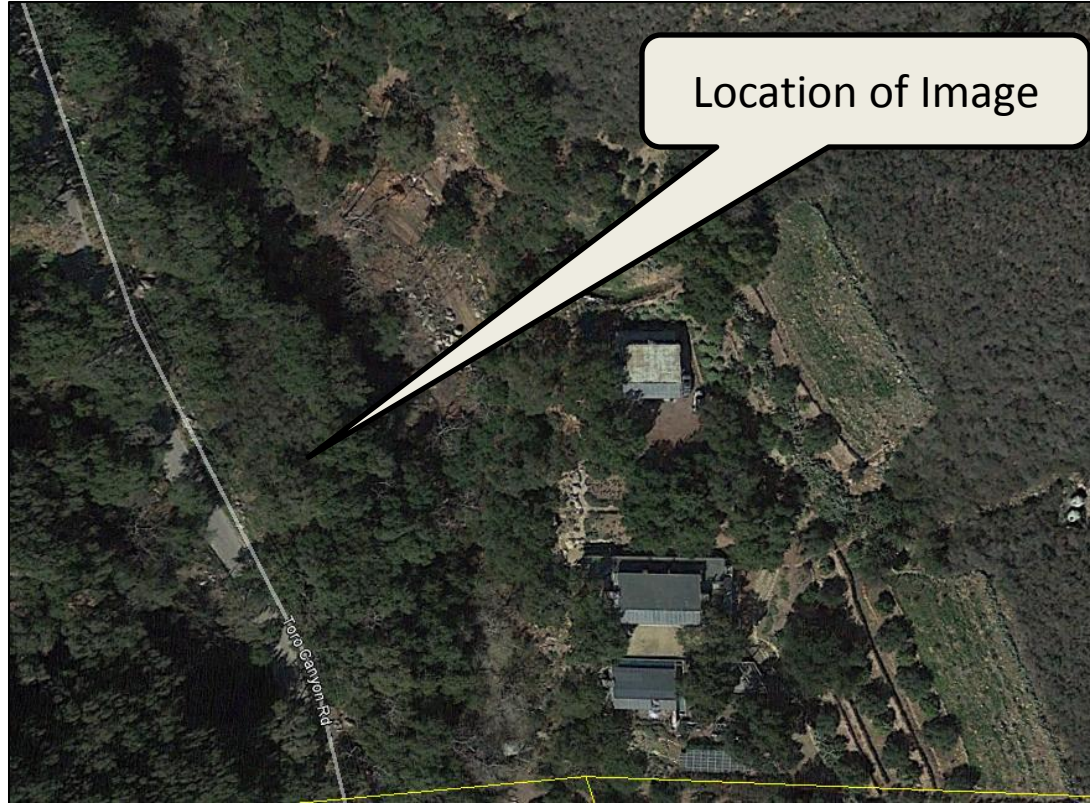
Figure 11: Photo of area of disturbance

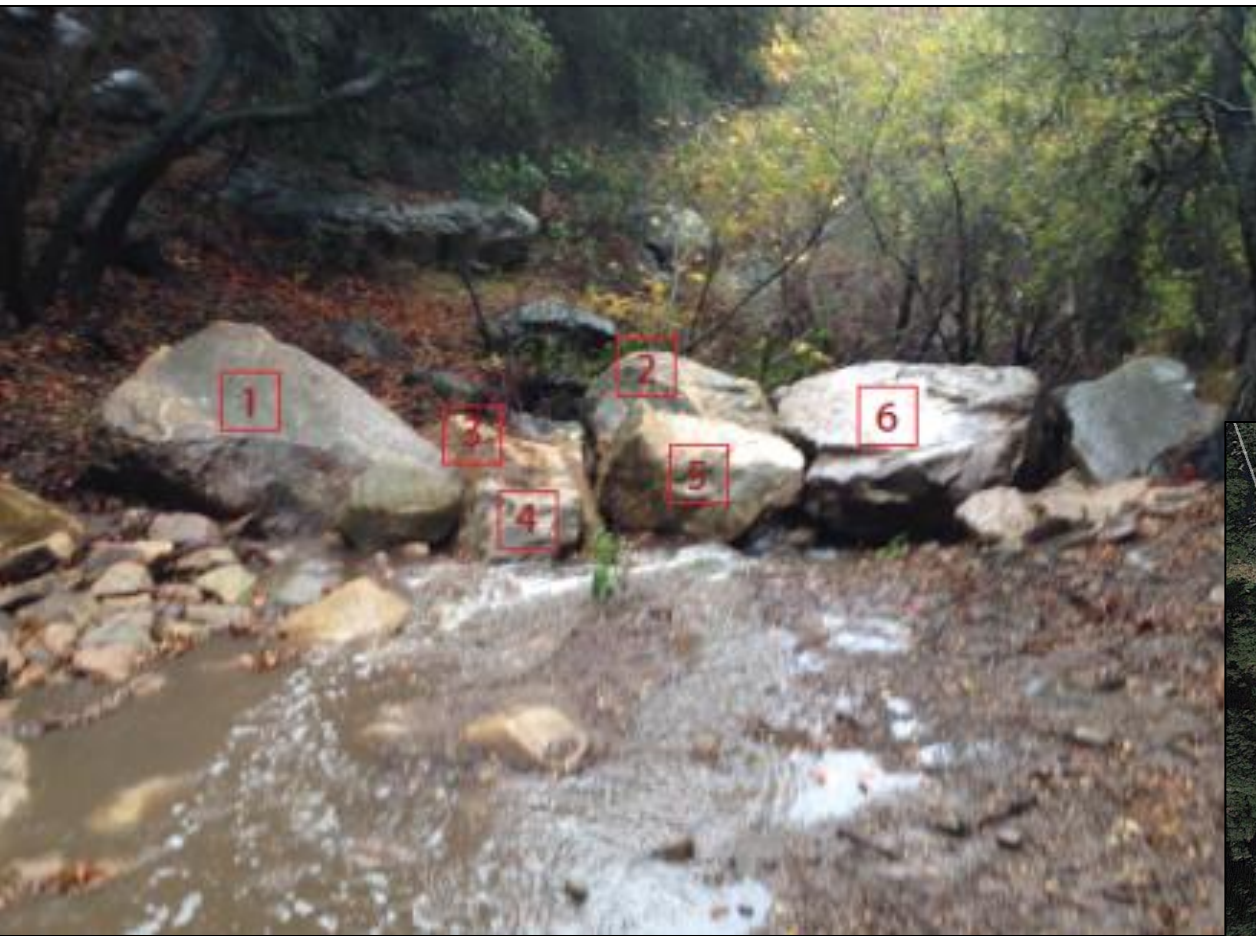
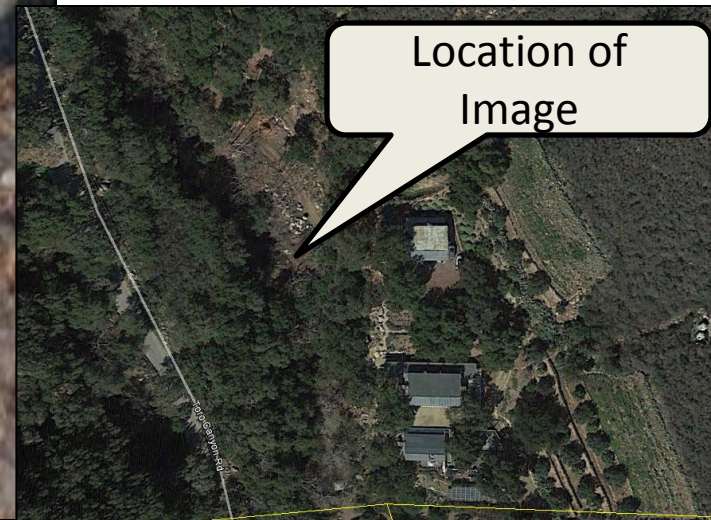
Figure 12: Photo of boulders placed within Toro Canyon Creek provided by appellants
