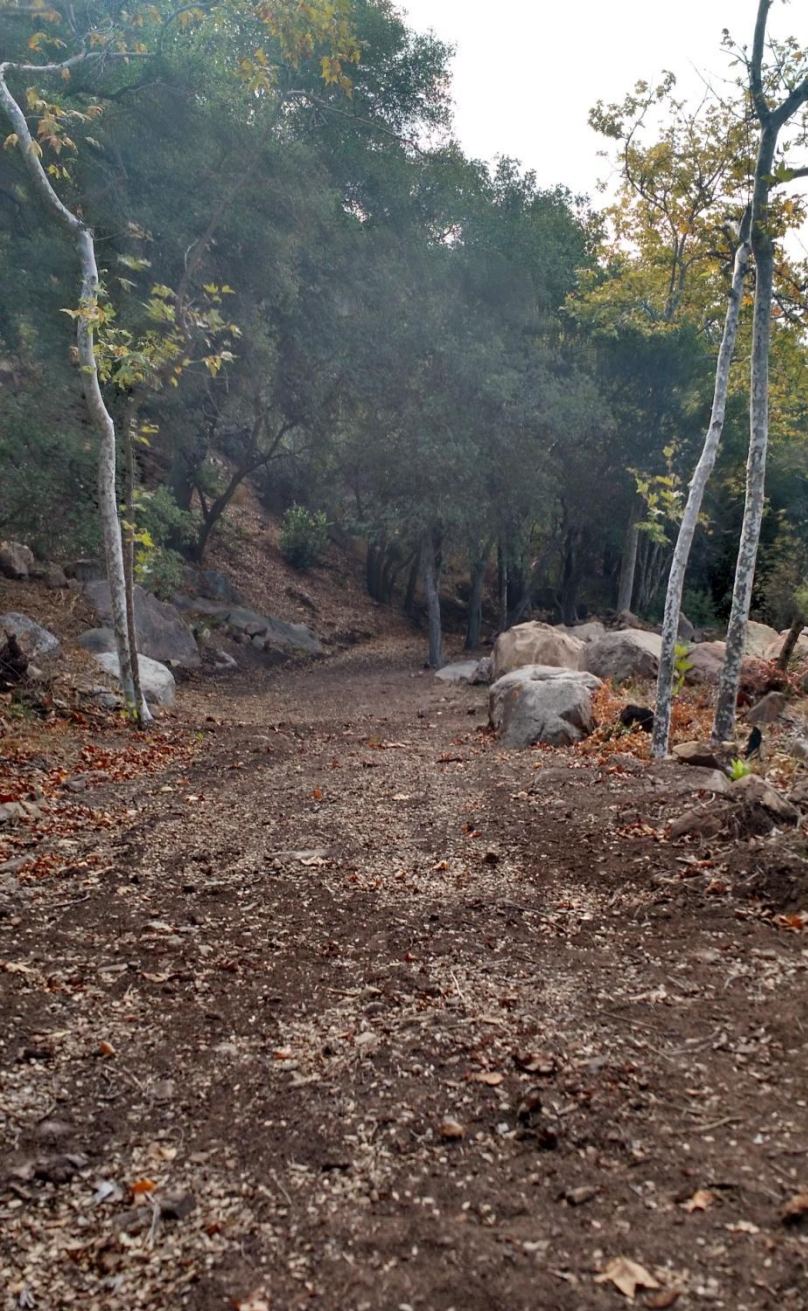
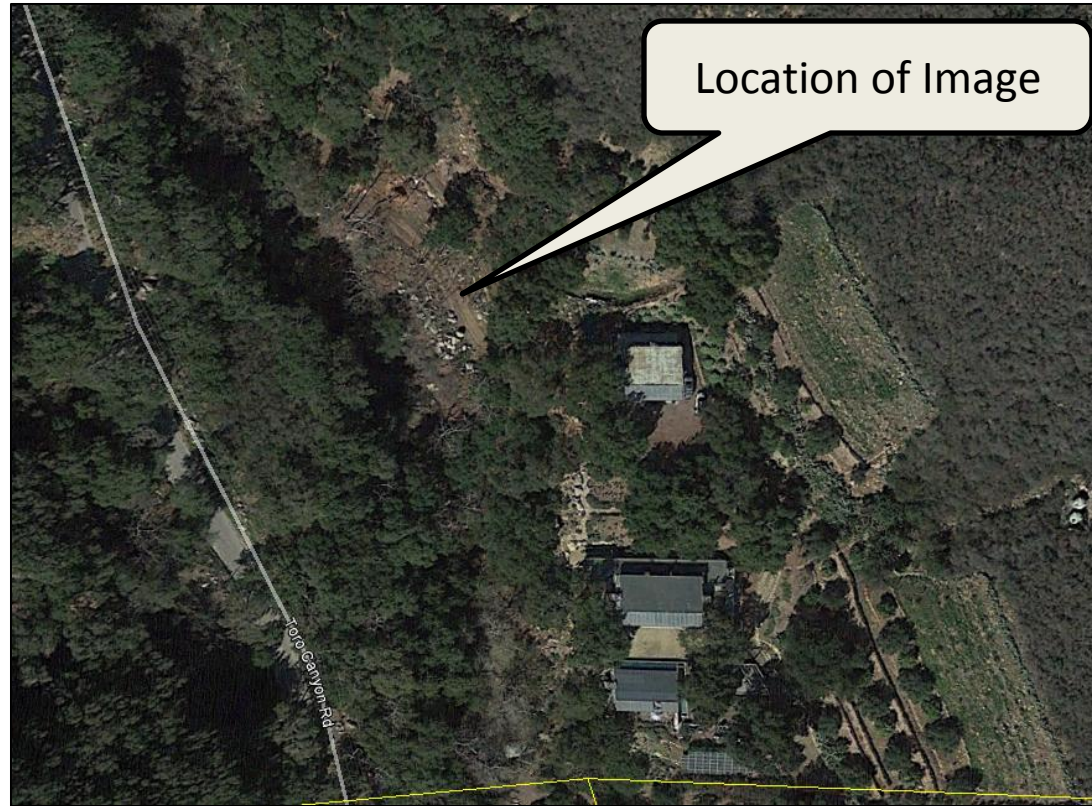
Figure 13: Photo of area of disturbance

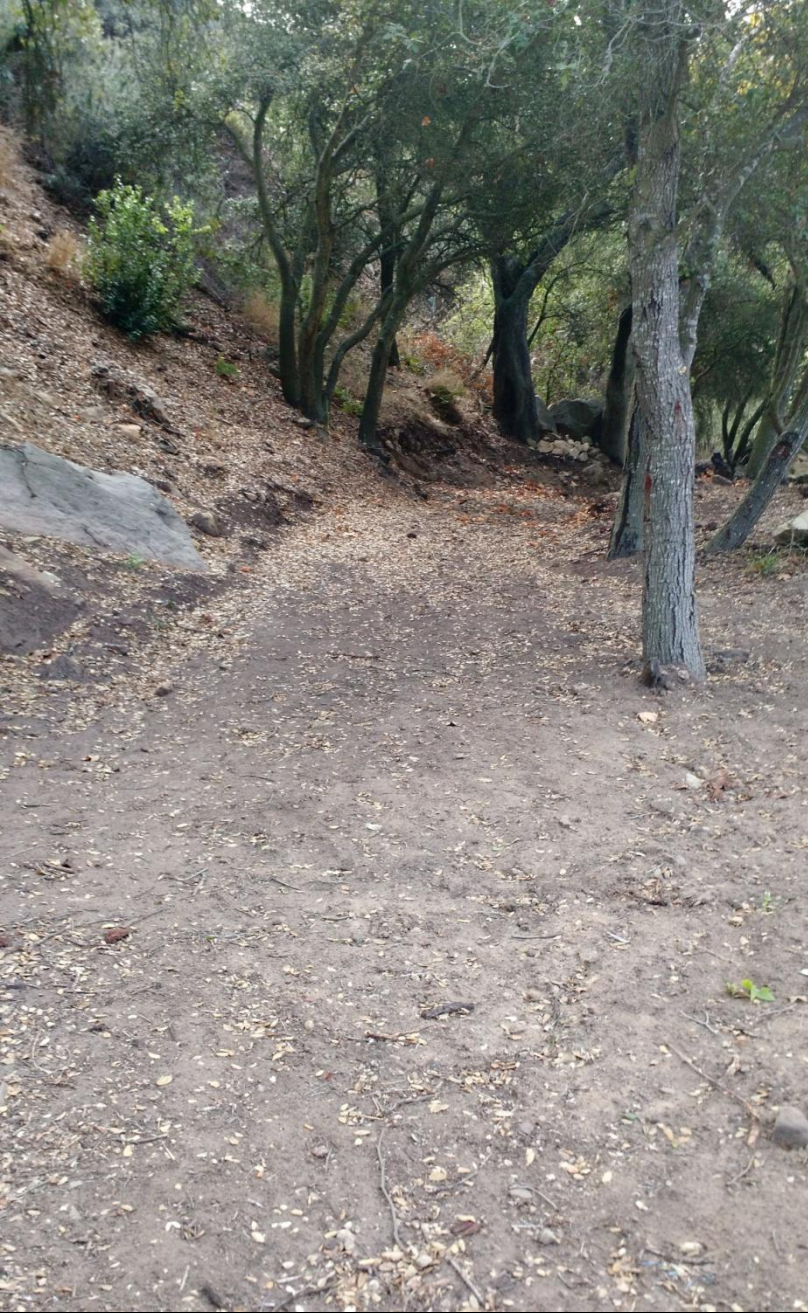
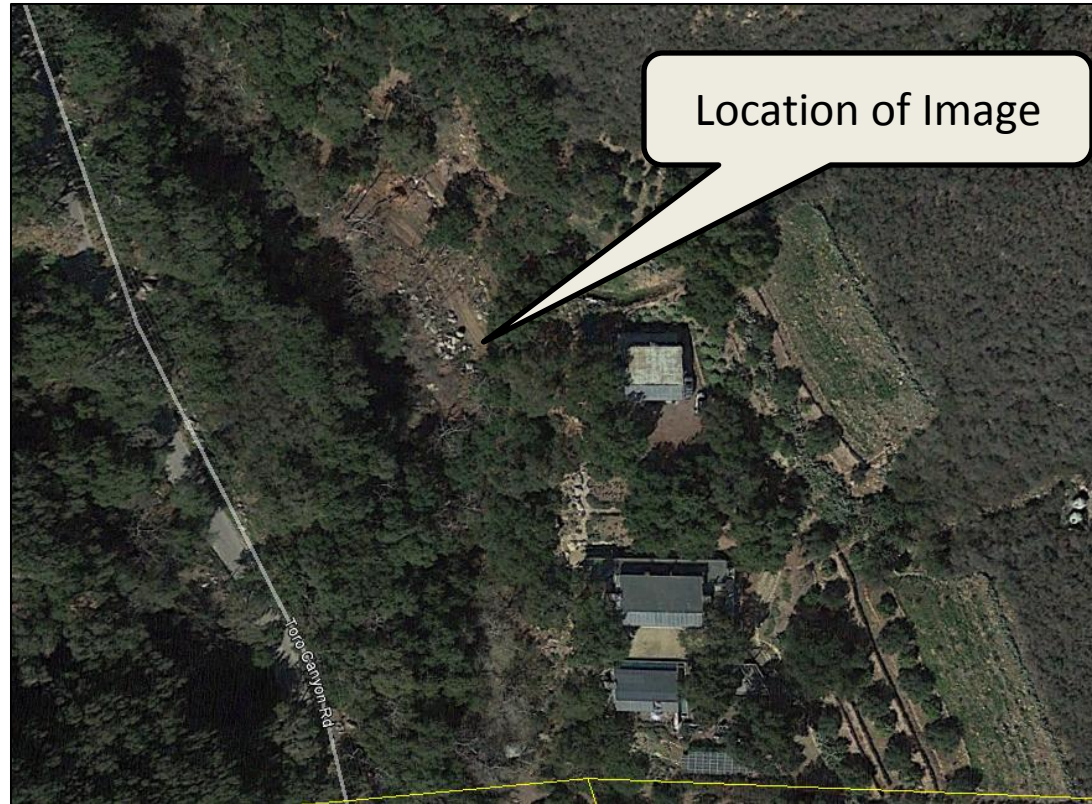
Figure 14: Photo of area of disturbance

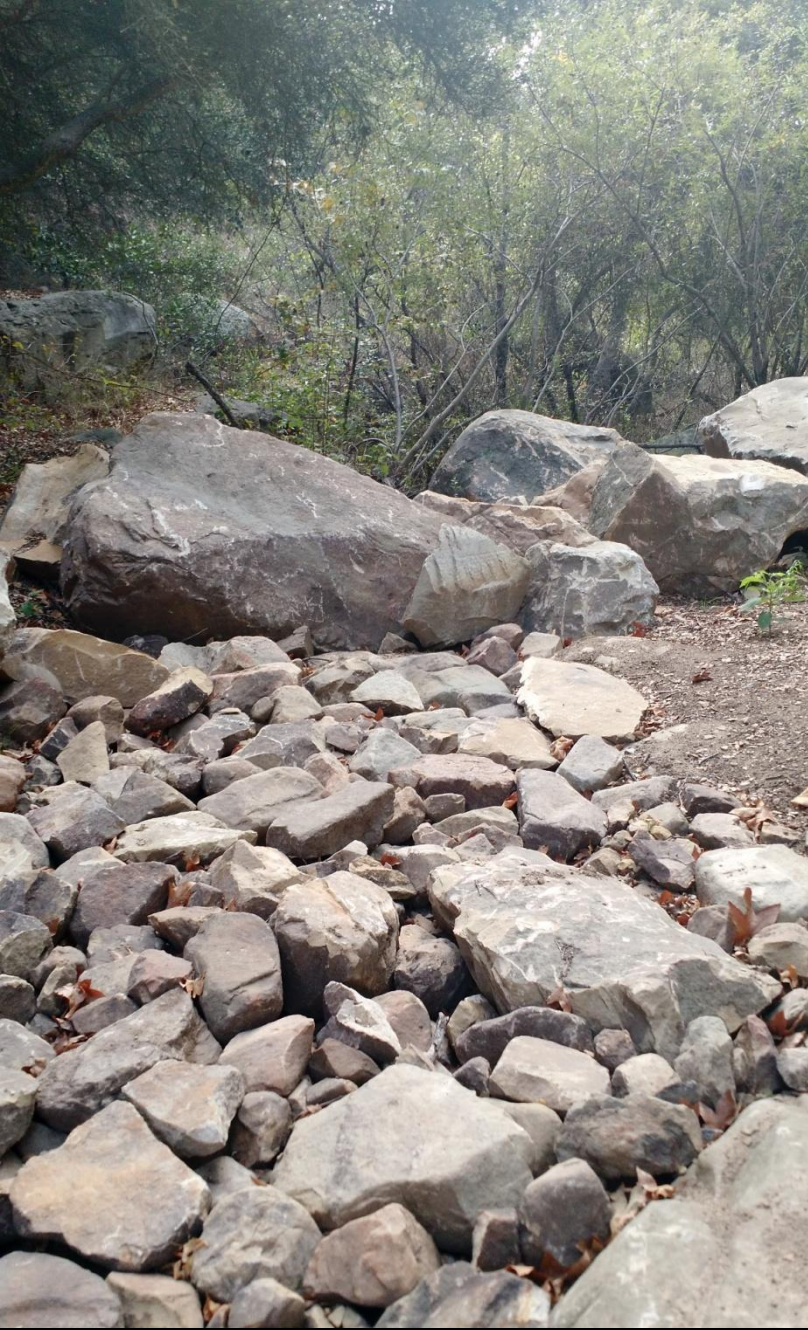
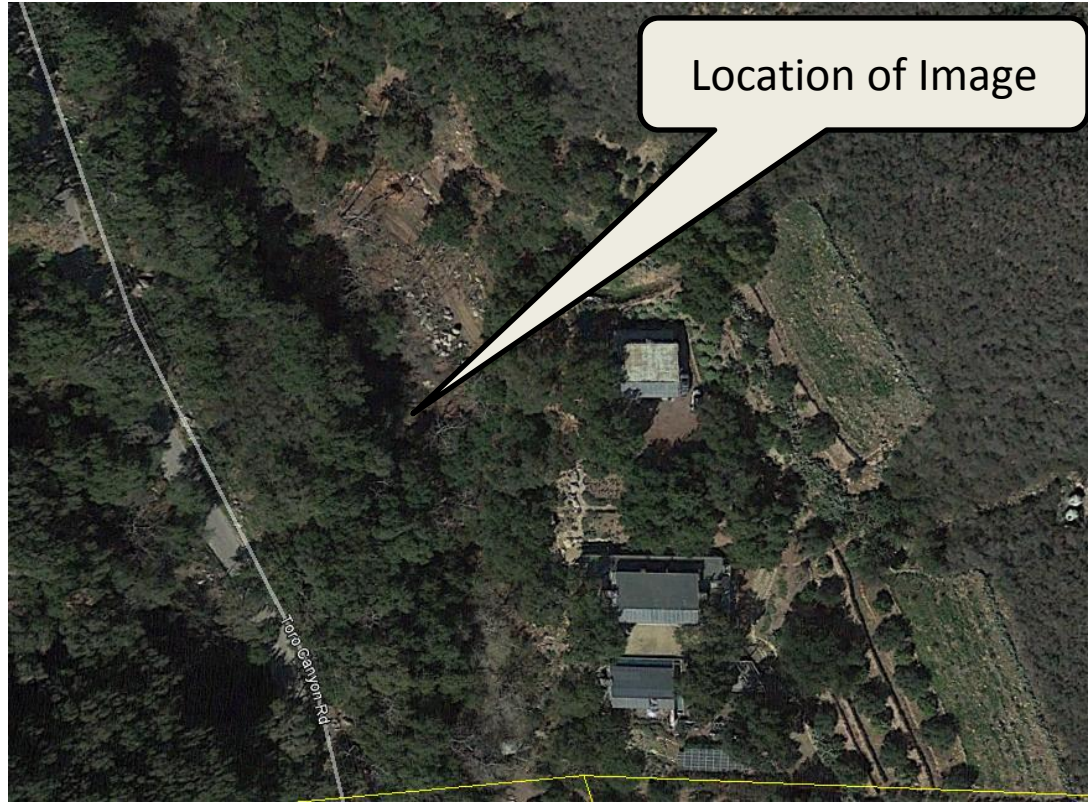
Figure 15: Photo of boulders placed within Toro Canyon Creek by appellants

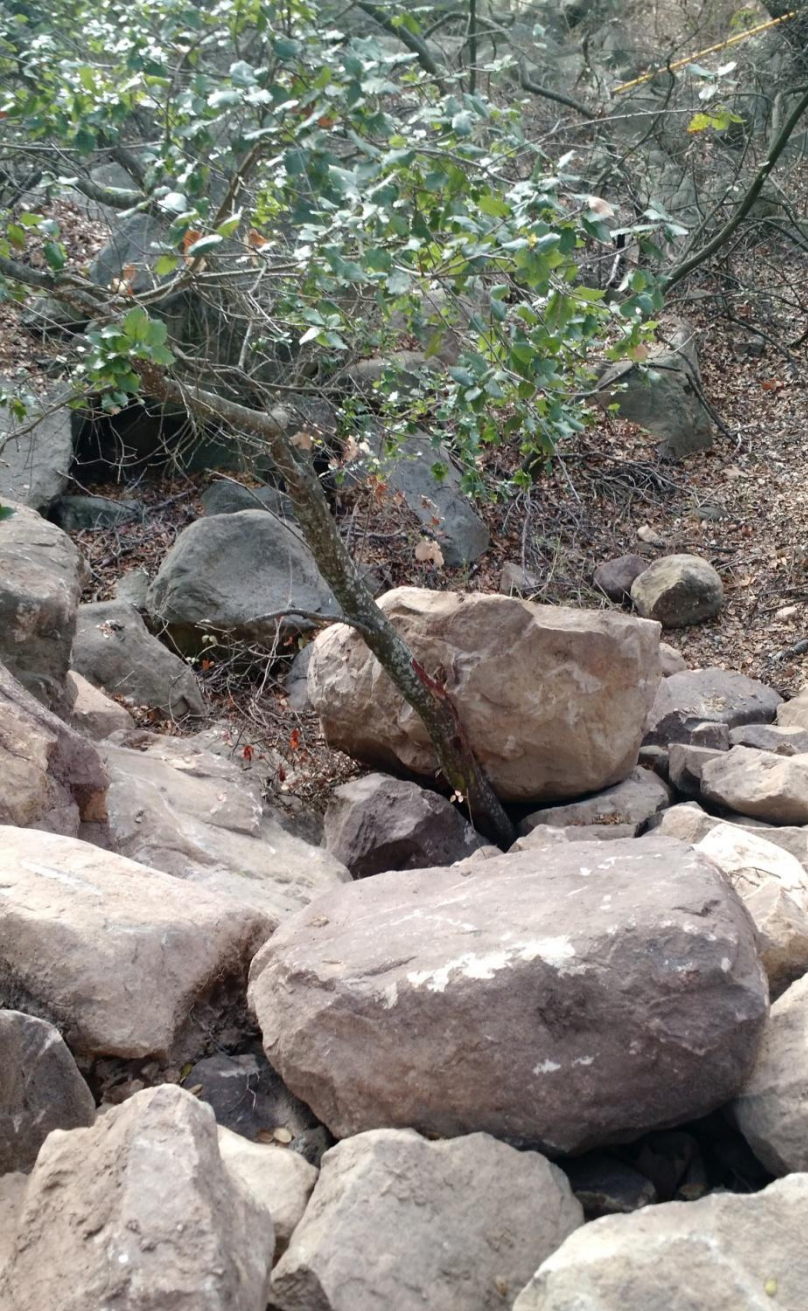
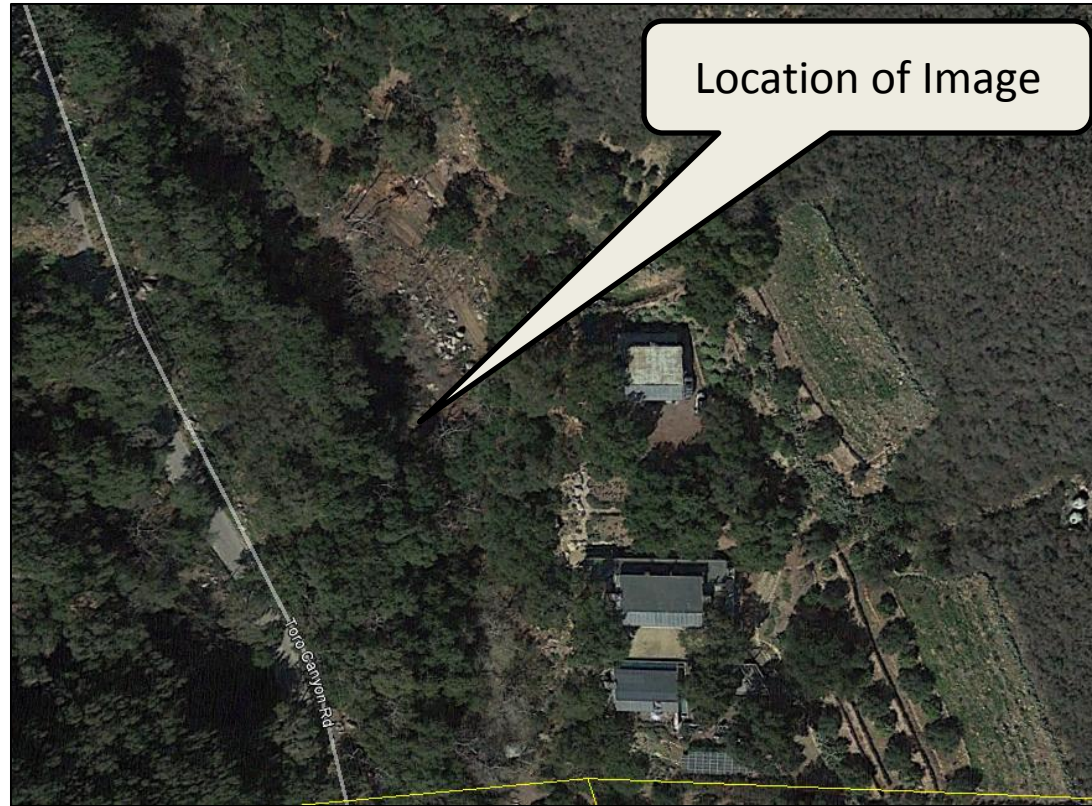
Figure 16: Photo of boulders placed by appellants adjacent to creek and around trunk of an oak tree
