**Failure Investigation Report**

**Plains Pipeline, LP, Line 901  
Crude Oil Release, May 19, 2015  
Santa Barbara County, California**

**May 2016**

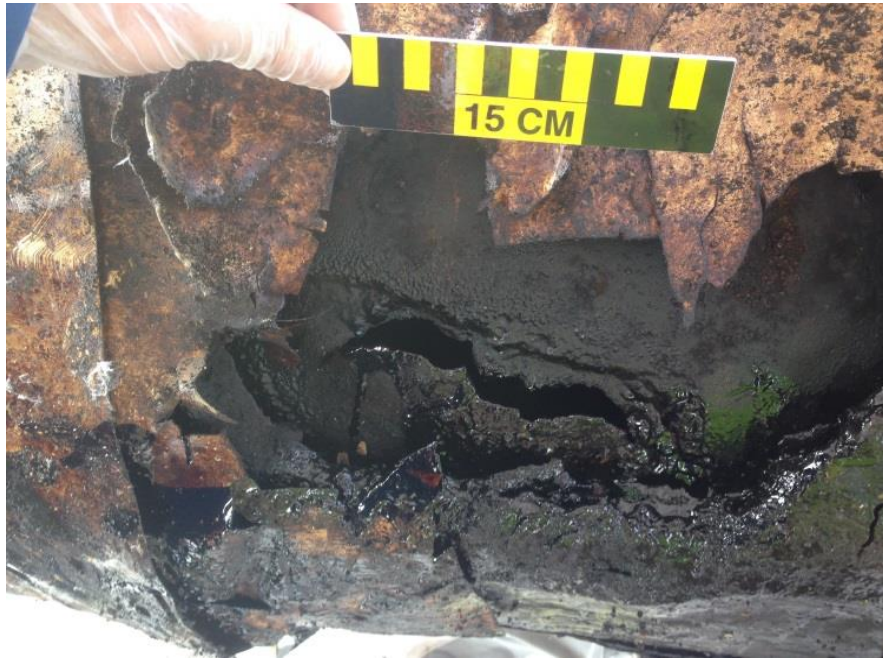
**Figure 4.** The failed pipe and surrounding insulation and coating.

“The results of the metallurgical analysis indicate that the leak occurred at an area of external corrosion that ultimately failed in ductile overload under the imposed operating pressure. The morphology of the external corrosion observed on the pipe section is consistent with corrosion under insulation facilitated by wet-dry cycling.”<sup>xi</sup>

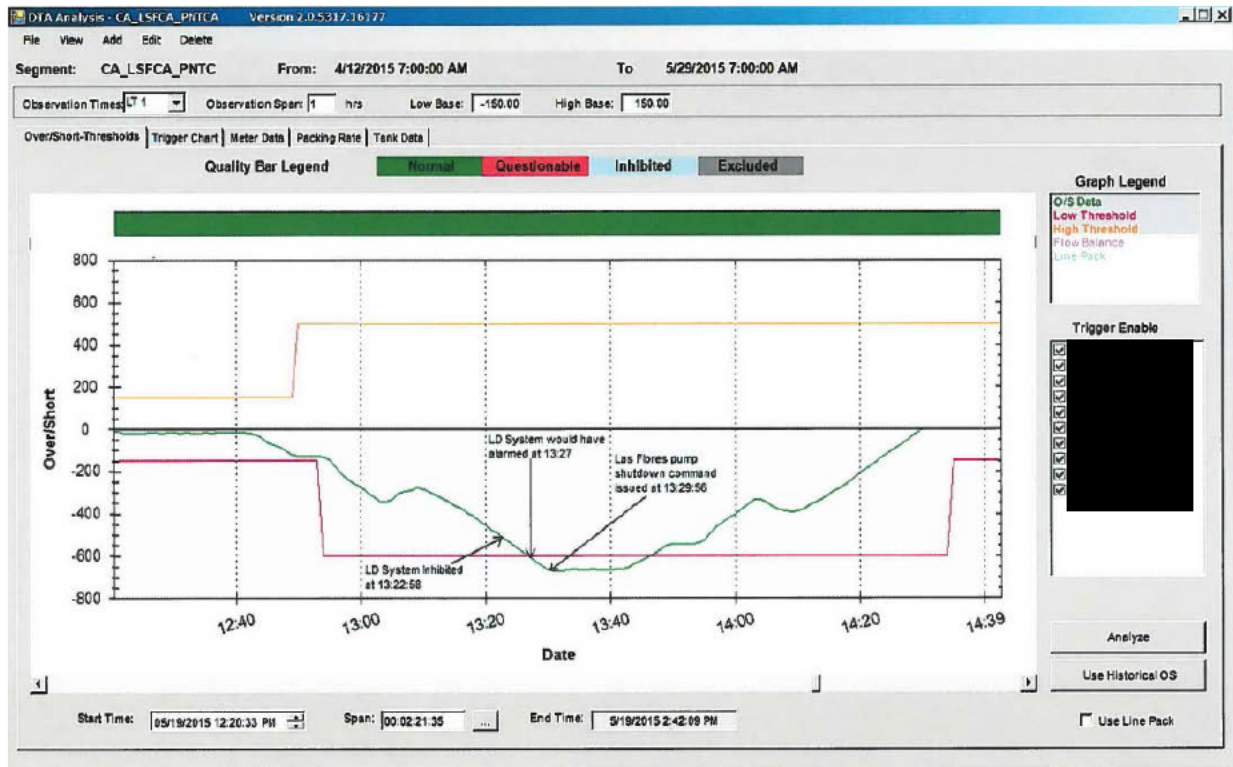
Plains submitted documentation showing the parameters of the PLM and extrapolated what would have occurred if the PLM system had not been inhibited. The submitted documentation shows that the PLM would have alarmed at approximately two minutes before the controller issued the command to shut down the pump at Las Flores PS at approximately 11:30am PDT. The graphical representation is shown on this page.

Graphical Representation of when the PLM System would have alarmed had it not been “inhibited”. Times in the graph and explanation are in Central Time. Pacific Time is two hours earlier.

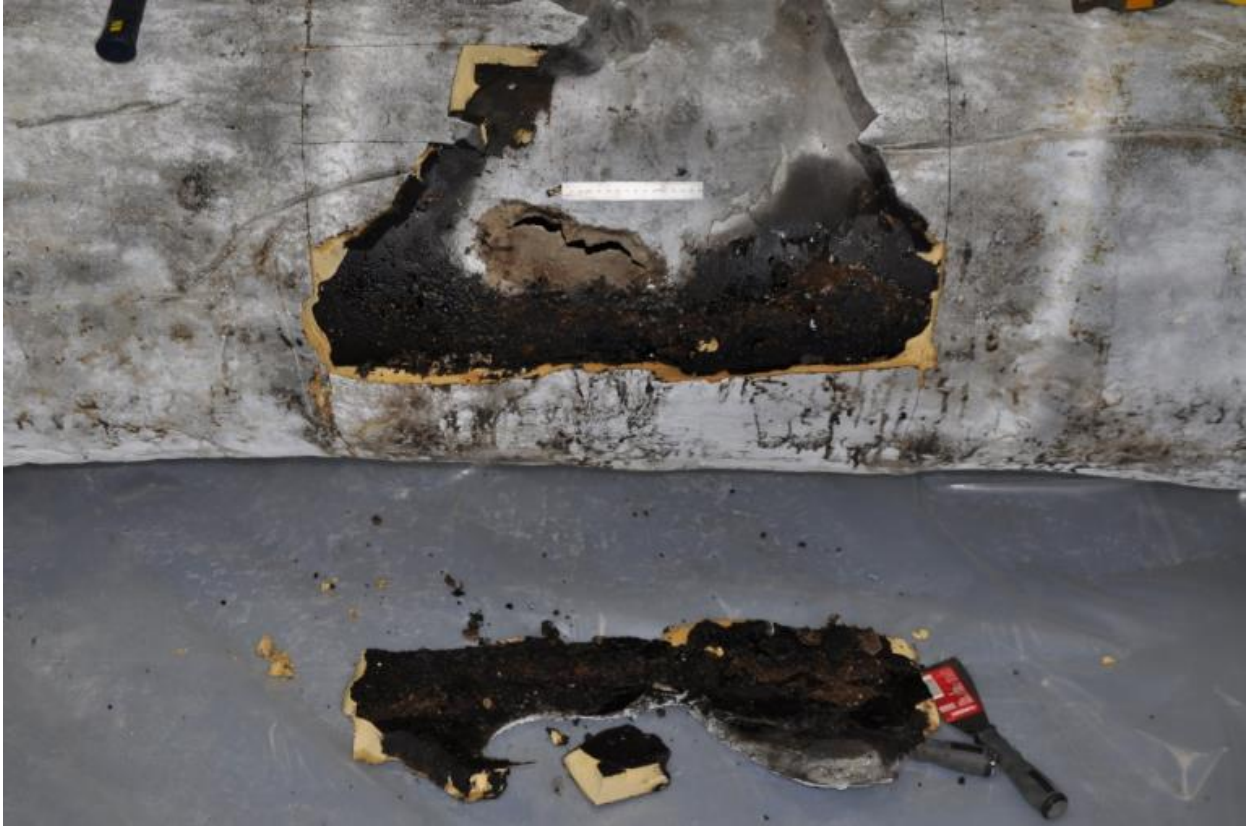
This is similar to the mechanism of CUI that occurred on Line 901. The following picture is excerpted from the metallurgical report.

This picture is excerpted from the final metallurgical report. “Figure 16. Photograph showing a piece of insulation removed from adjacent to the failure location; near 4:30 orientation.”

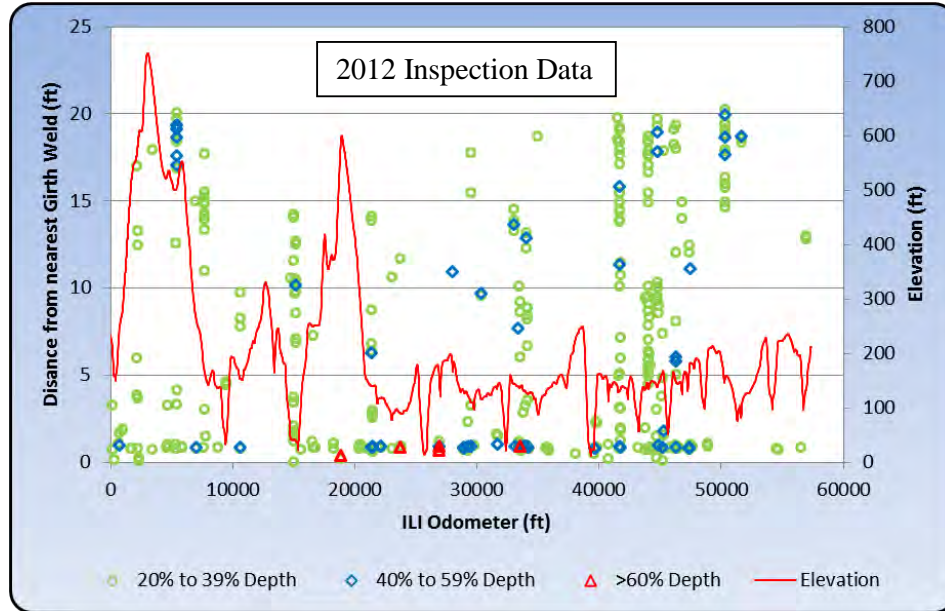
Plains had previously identified the shrink sleeve coating applied over the girth welds as a priority corrosion issue. Figure 5 shows the distance of each metal loss >20% depth in relation to the nearest girth weld as identified in the 2012 inspection.

**Figure 5. Distance of metal loss to the nearest girth weld in 2012.**

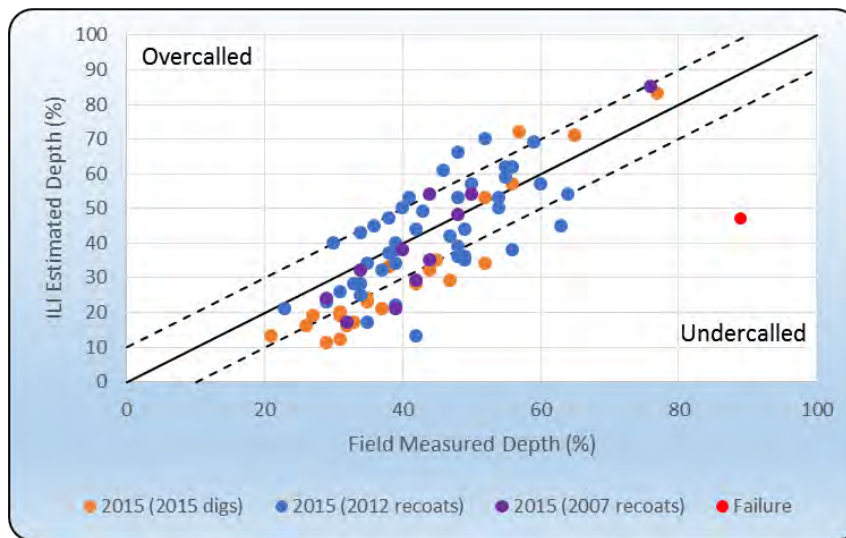
The Rosen stated depth sizing accuracy is  $\pm 10\%$  with 80 % certainty for pitting and general corrosion. The unity plot in Figure 9 examines the 2015 MFL inspection tool accuracy. The 2015 ILI estimated depths are compared to field measured depths either from the 4 excavations following the failure or the areas recoated after the 2007 and 2012 inspections. The unity plot shows that the 2015 Rosen inspection is within  $\pm 10\%$ , 57% of the time. It may be seen that the failure location has an uncharacteristically high deviation from the ILI estimate.

**Figure 9. Unity plot for the 2015 MFL inspection.**

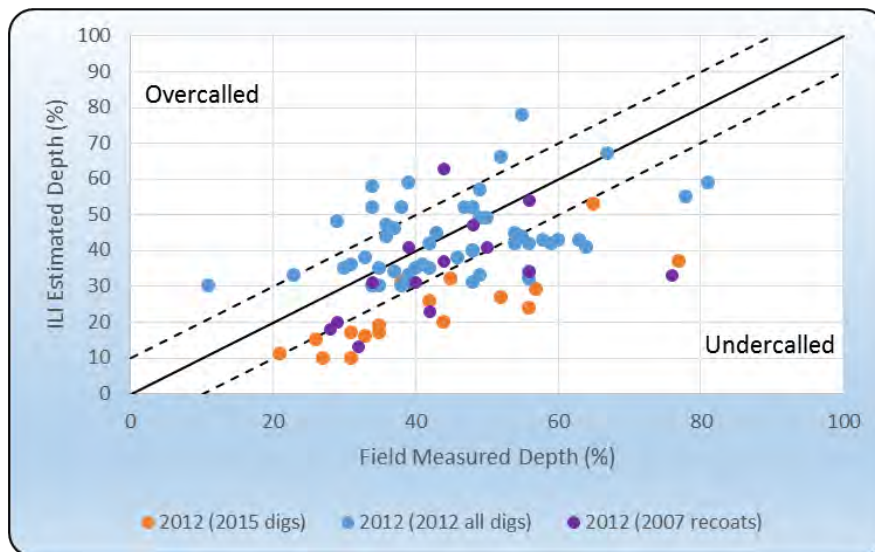
The unity plot for the 2012 inspection is provided in Figure 10. The 2012 Rosen inspection is within  $\pm 10\%$ , 58% of the time with respect to the 2012 excavations (blue) and 2007 excavation recoats (violet). When comparing to the 2015 field excavated results based on the 2012 ILI data, growth may have occurred, causing the comparisons between field and ILI to be undercalled (orange). The 2015 digs were not considered in the above stated accuracy.

**Figure 10. Unity plot for the 2012 MFL inspection.**

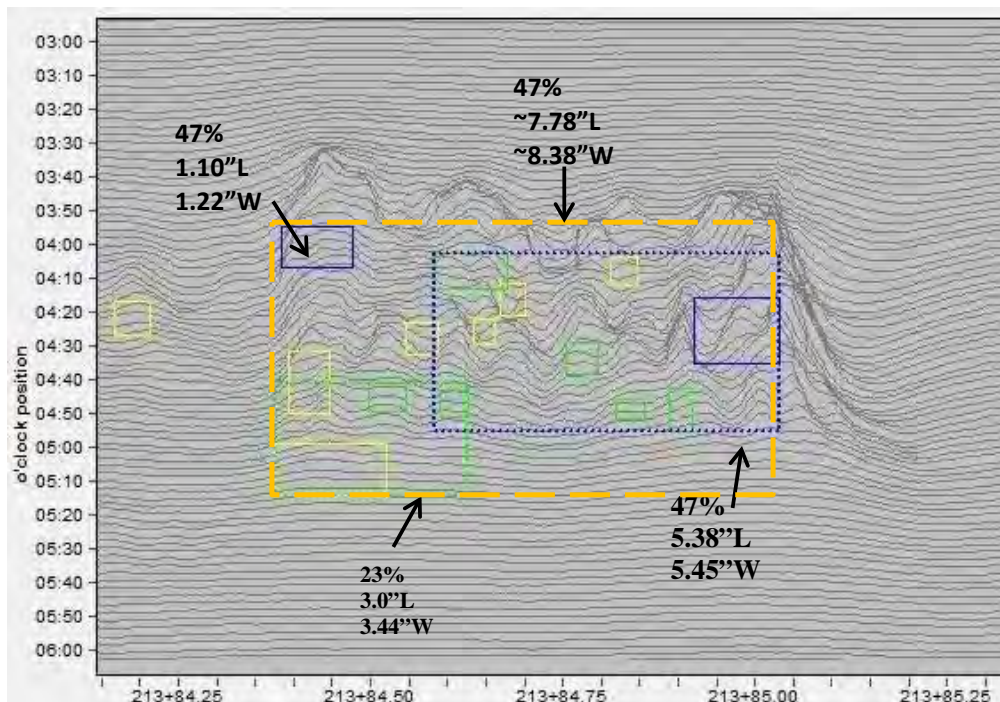
The importance of interacting “boxes” appropriately to form “clusters” of an area as closely approximating the actual corrosion area cannot be emphasized enough. The importance of the depth and length measurement will be explored in more detail in the discussion to follow.

Figure 12. Interacted MFL metal loss in failed anomaly.

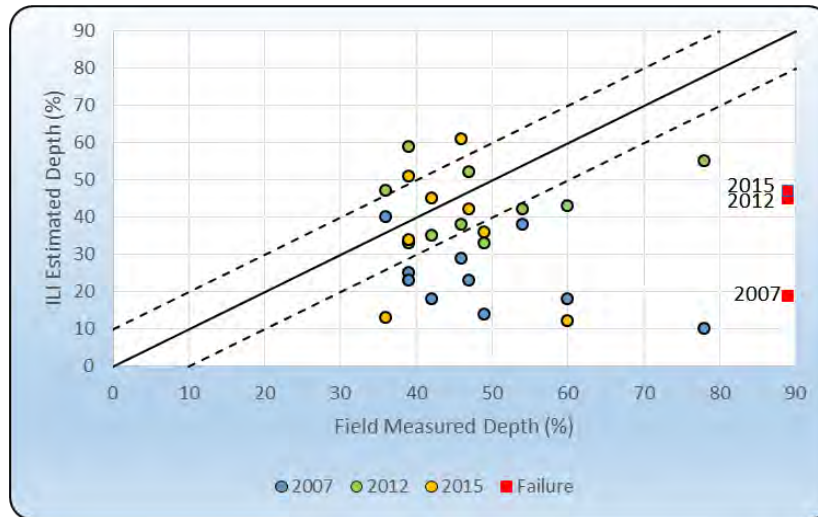
Figure 15 details the depth comparison of the same anomalies. The 2007 depths are primarily undercalled but this could be a result of the 5 years growth from the time of inspection to excavation. The 2012 and 2015 inspections had 56% and 63% of the anomalies overcalled or within specification, respectively. The red markers representing the failure depths will most assuredly not be 89% in 2007 or 2012, this only represents the depth as called by the ILI in that year.

Figure 15. ILI estimated depth compared to field measured.

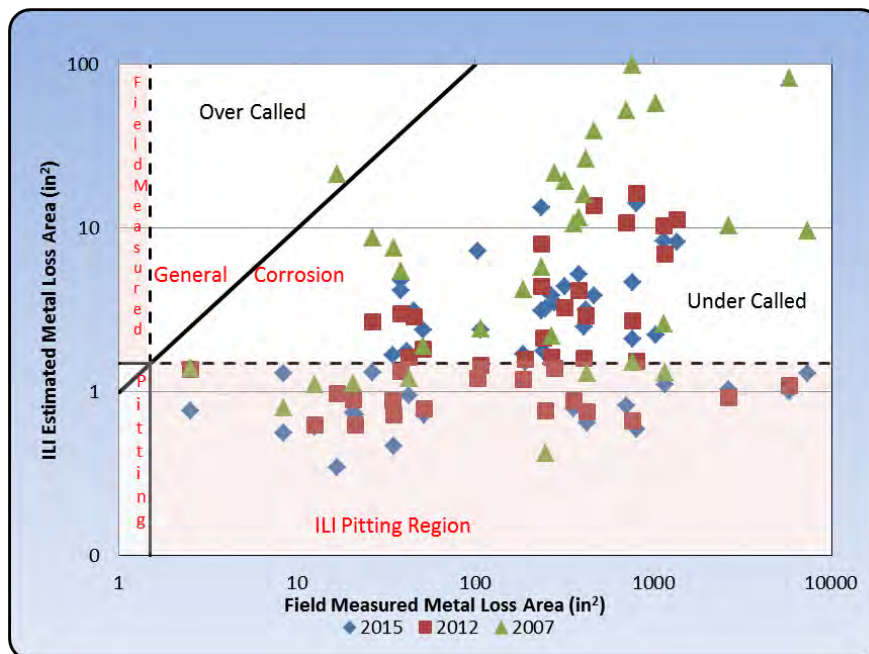
The issue of underestimating the length and width of a corrosion anomaly will lead to gross underestimations of the corrosion area. Figure 16 delineates all of the Line 901 anomalies with width and length reported from ILI estimates versus excavations made, on a logarithmic scale. As an example, it is showing that 38% of the anomalies had an area stated by the ILI of  $\leq 1.5 \text{ in}^2$  when in fact the corrosion areas were between  $2.5 \text{ in}^2$  and  $7300 \text{ in}^2$ . This being said, there may be a difference in the field measurement technique to consider. It is important that the techniques used in the field be comparable to that required by the ILI analysis to enable a proper assessment of the ILI performance.

Figure 16. Metal loss area; ILI vs field measurement.

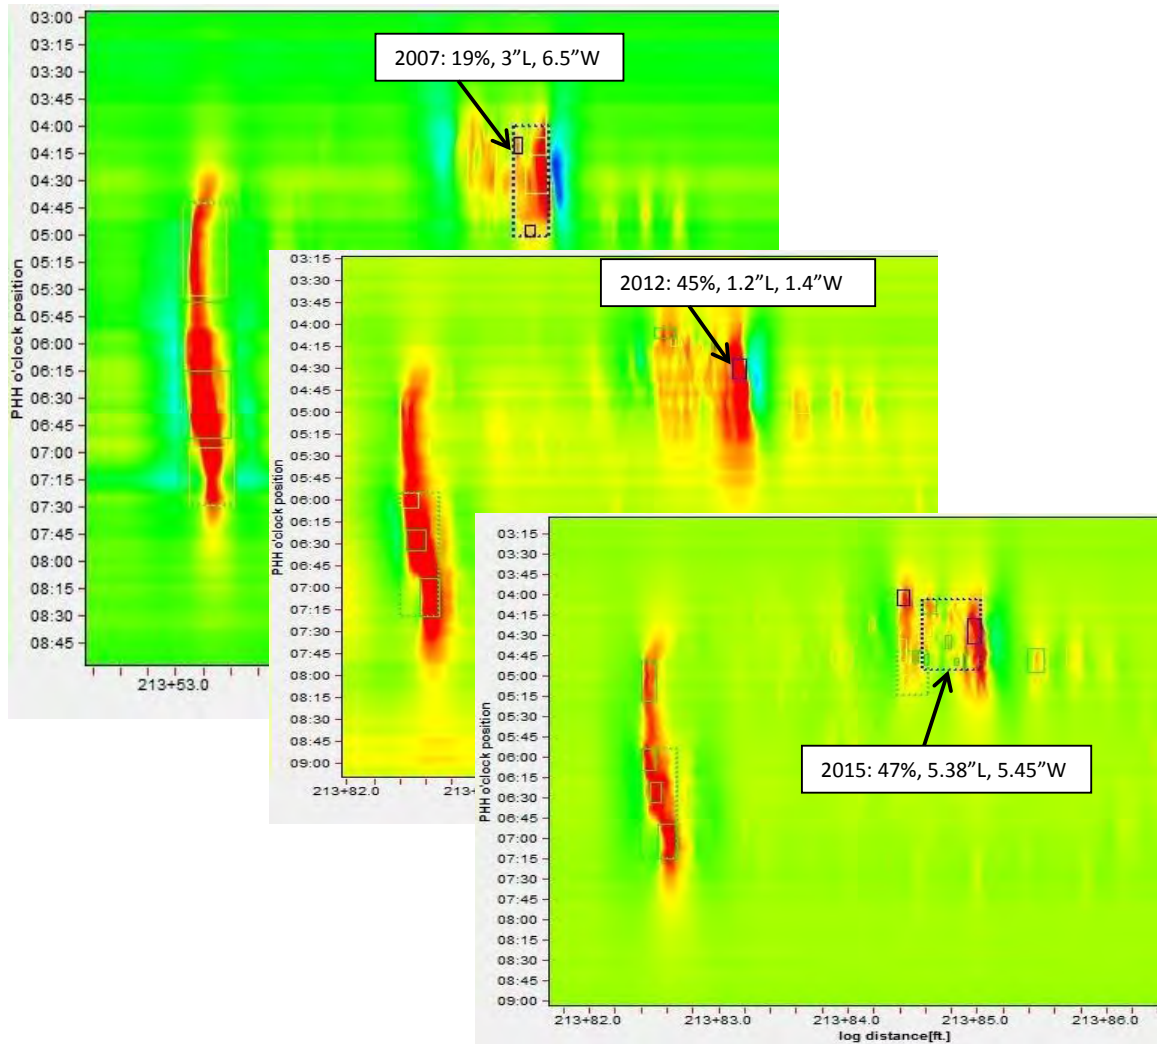
**Figure 17. C-Scans with boxes of the failed location as detailed by the 2007, 2012 and 2015 inspections**

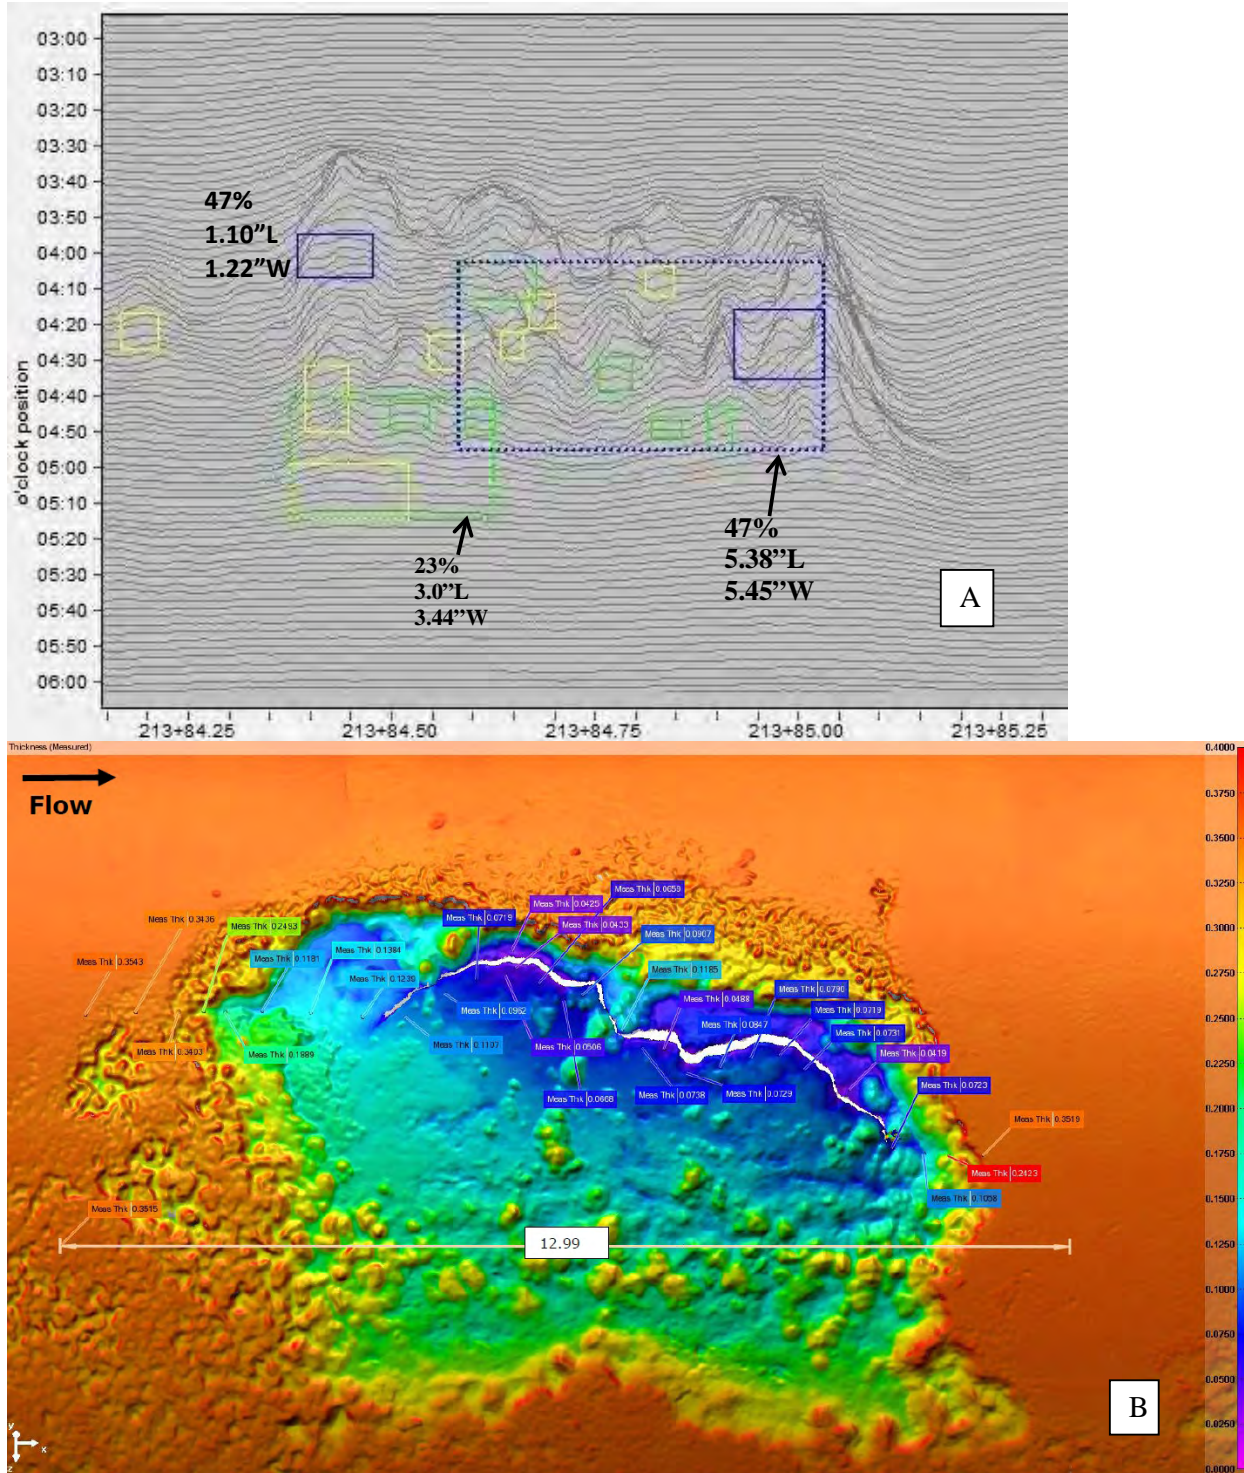
Figure 18. The failed area, A) the Rosen 2015 A-Scan, B) the Laser Scan.

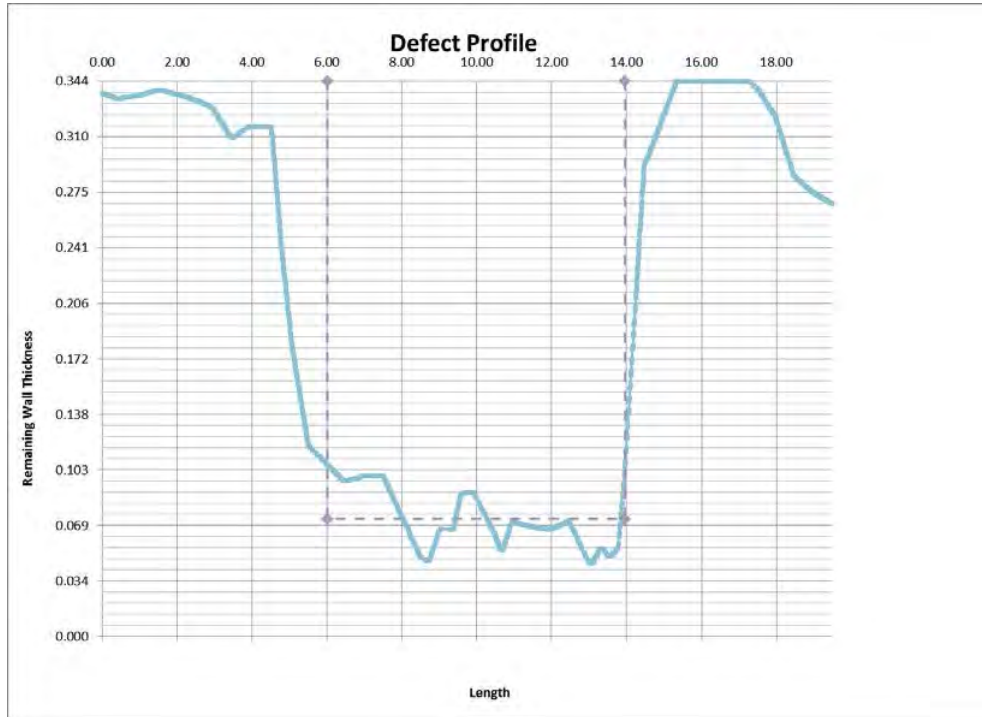
The metallurgical report by DNV provided the following information for the depth profile of the failed anomaly in Figure 19. The remaining strength of the anomaly was determined using industry accepted and publicly available software (KAPA, Kiefner and Associates) and is provided in Table 8.

Figure 19. Depth profile of failed anomaly (DNV).

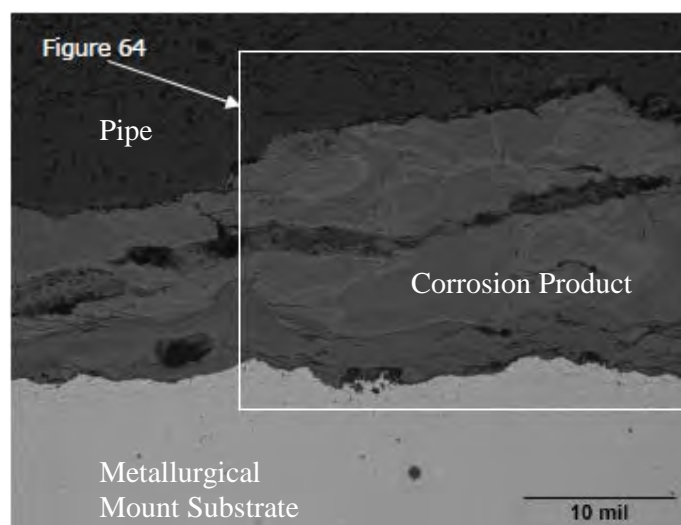
**Figure 20. Tightly adhered corrosion product (Fig. 58 from metallurgical report).**

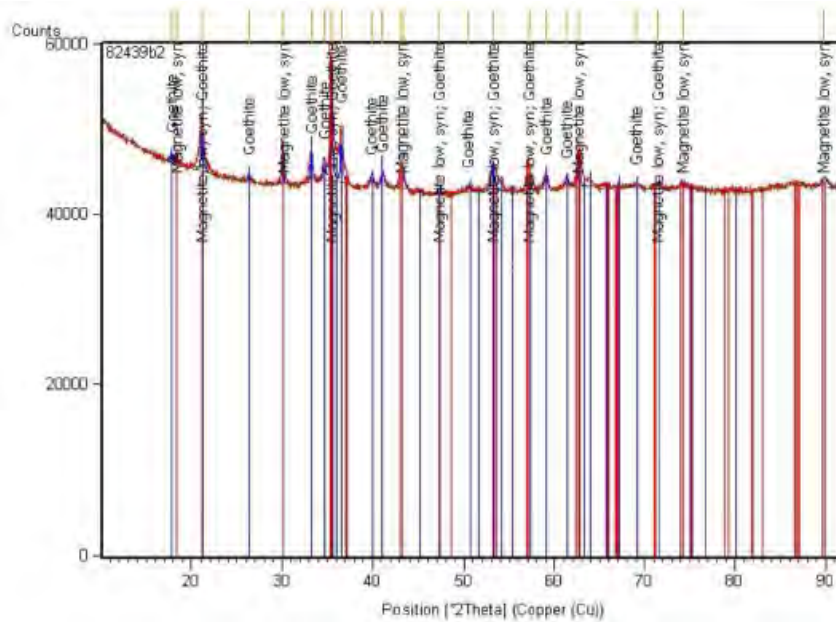
Figure 21. X-Ray Diffraction (XRD) of the corrosion product indicating layering of Magnetite and Goethite (Fig. 62 from metallurgical report).

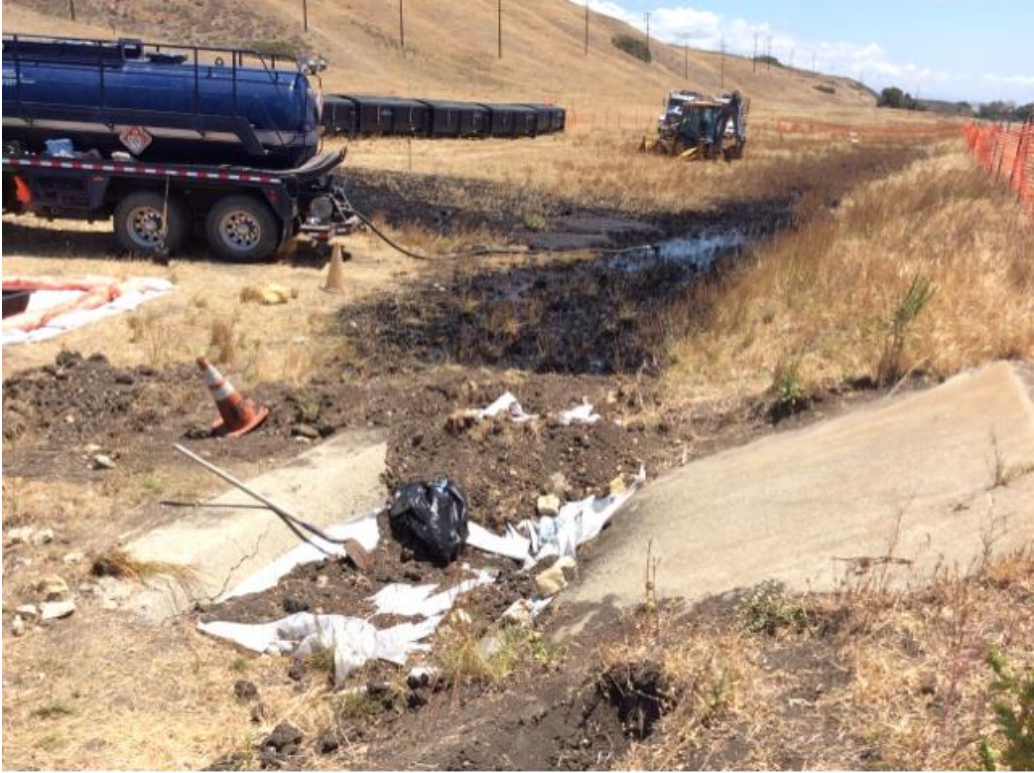
Release Site with Culvert in the foreground. Vacuum Truck sucking up pooled oil in the background.

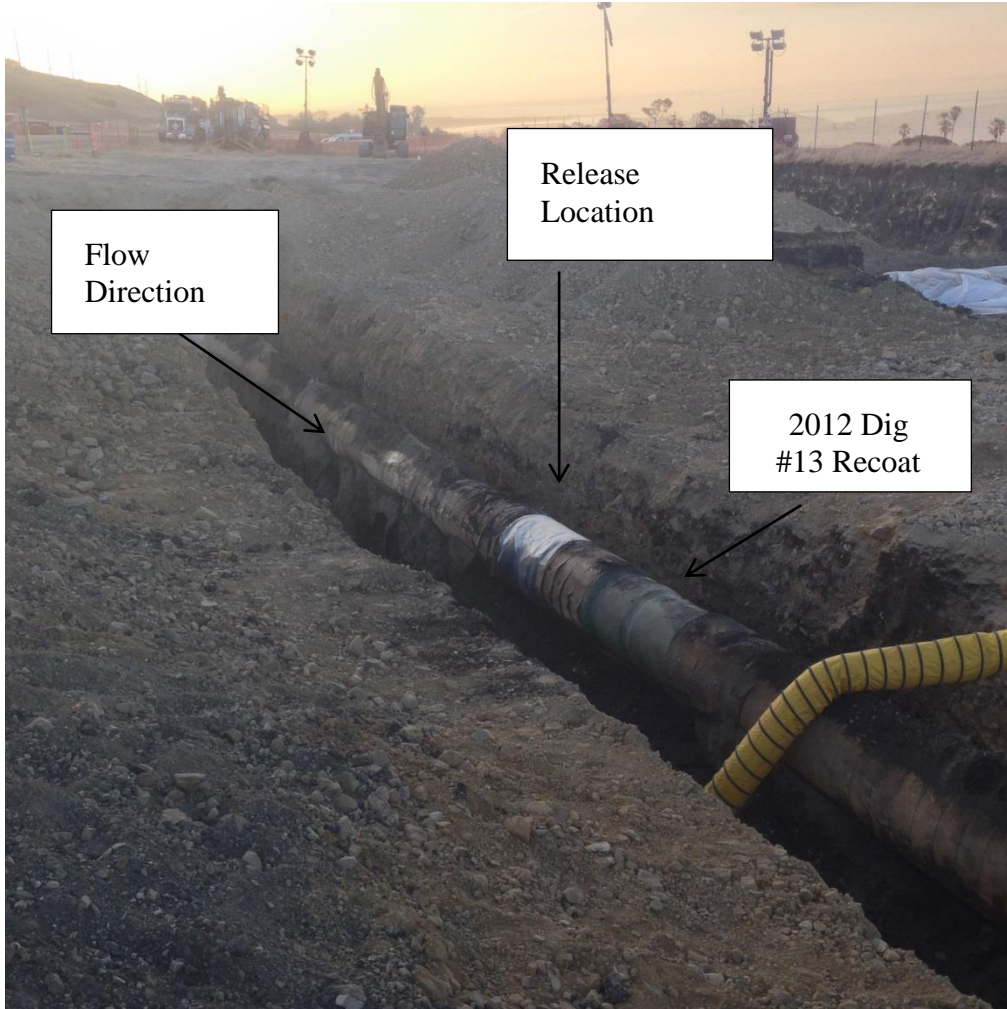
This picture shows the release site wrapped in plastic 6 feet upstream from girth weld 5940 where the coating repair is visible. The repair was identified as Dig #13 from the Post 2012 ILI Survey Anomaly Digs.

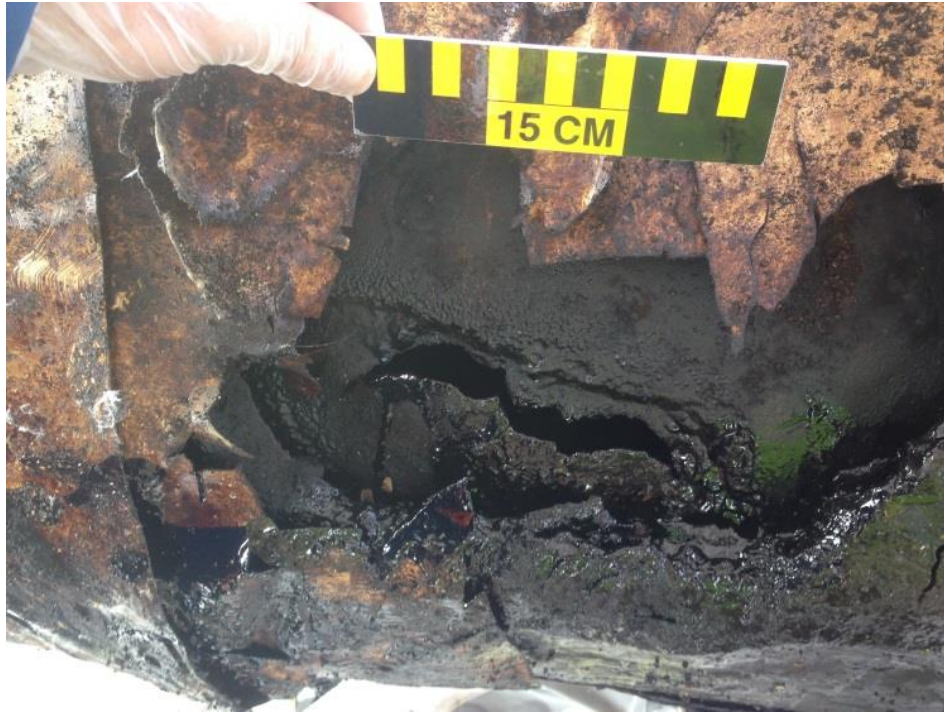
This is one of the first pictures of the release location after removal from the ditch.

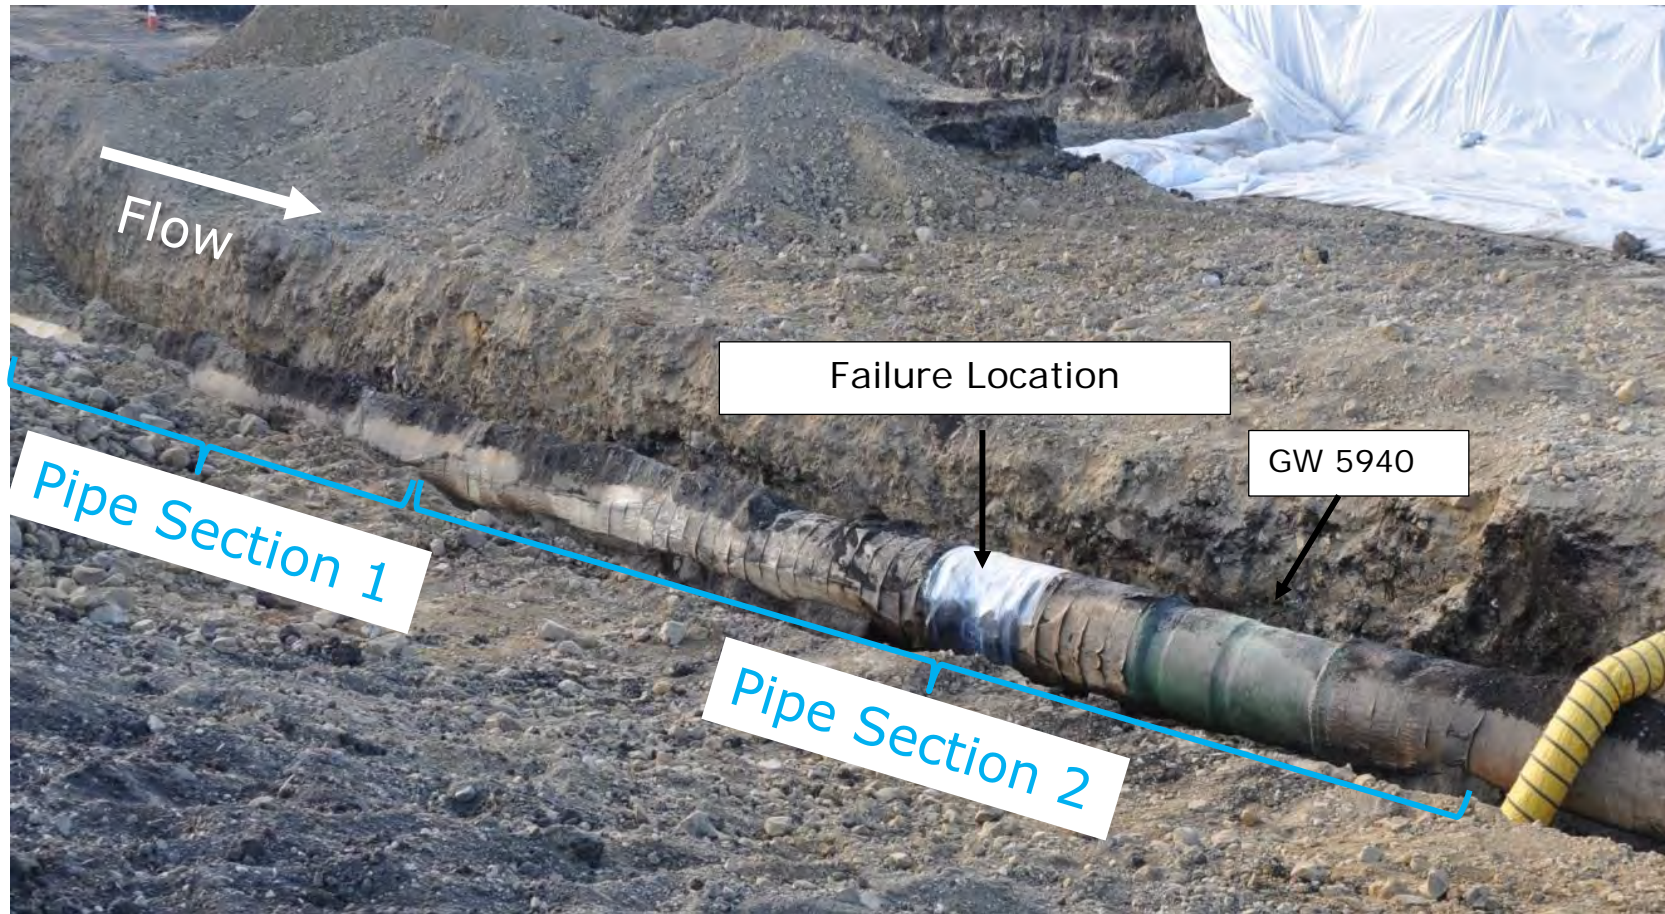
Figure 1. Photograph showing the failure location and the locations of the two pipe sections, during excavation.

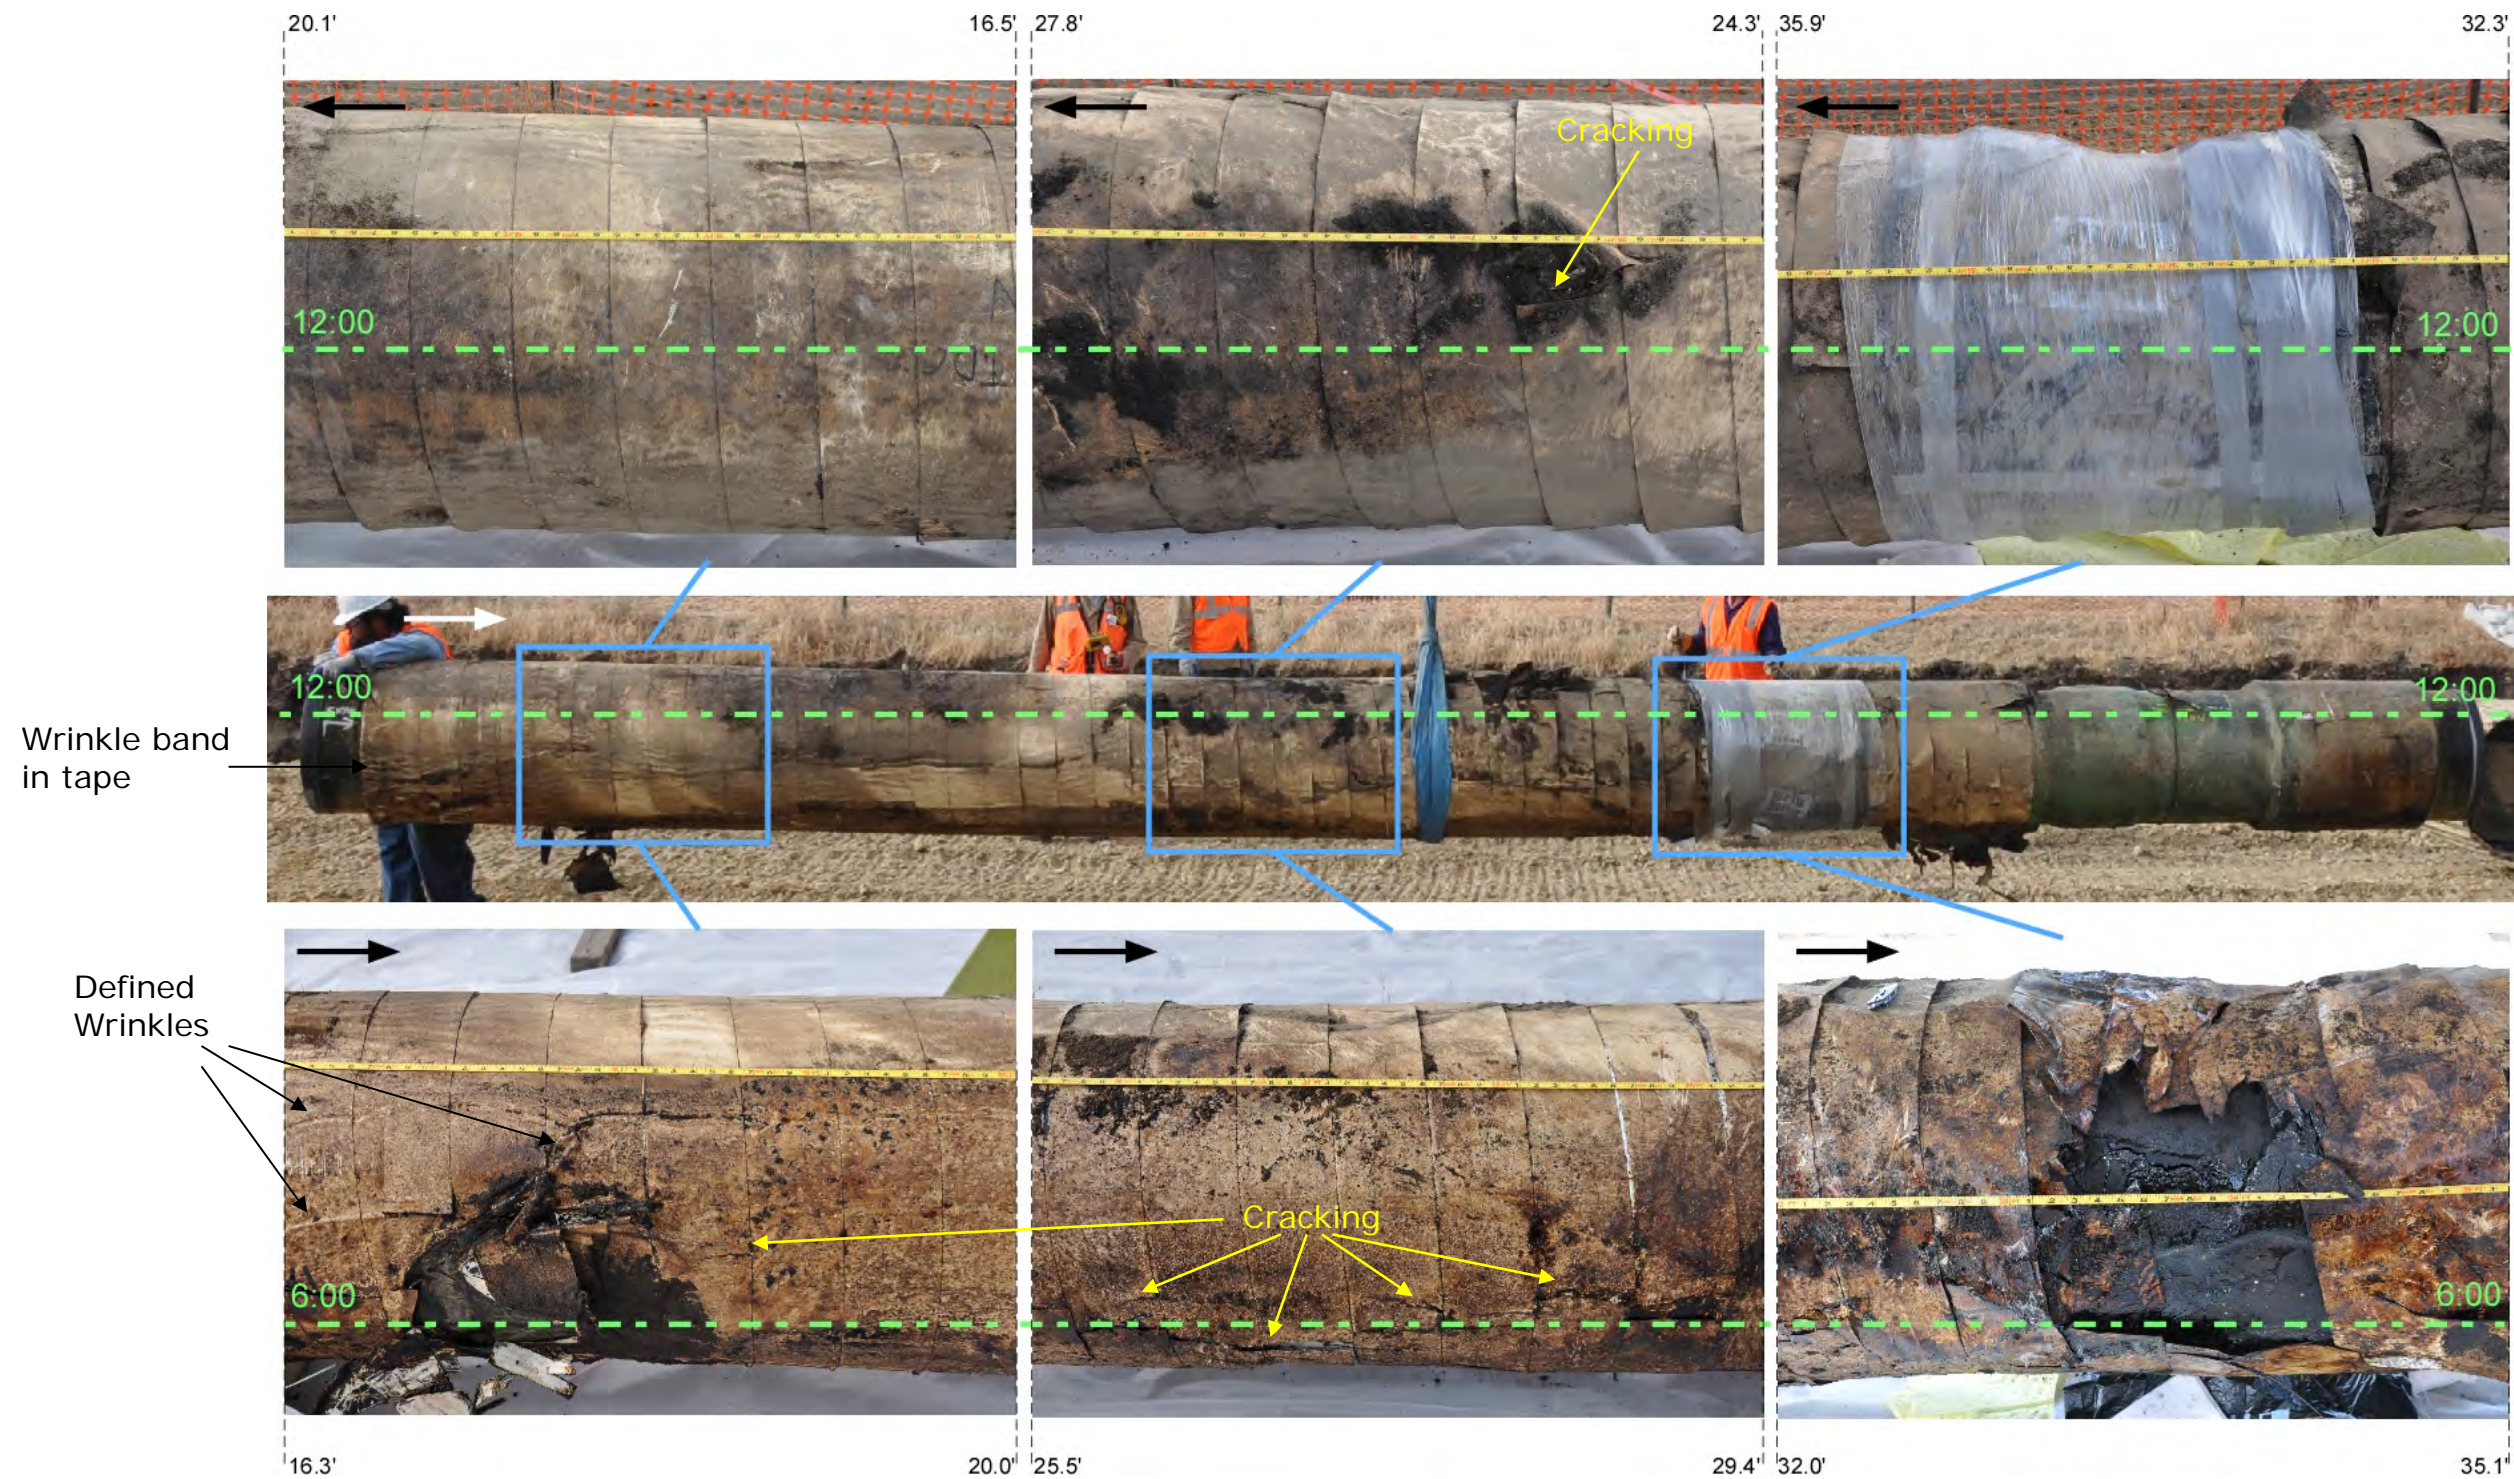
Figure 10. Photographs showing the condition of the external tape on the failure joint. Tape measure indicates distance to upstream girth weld.

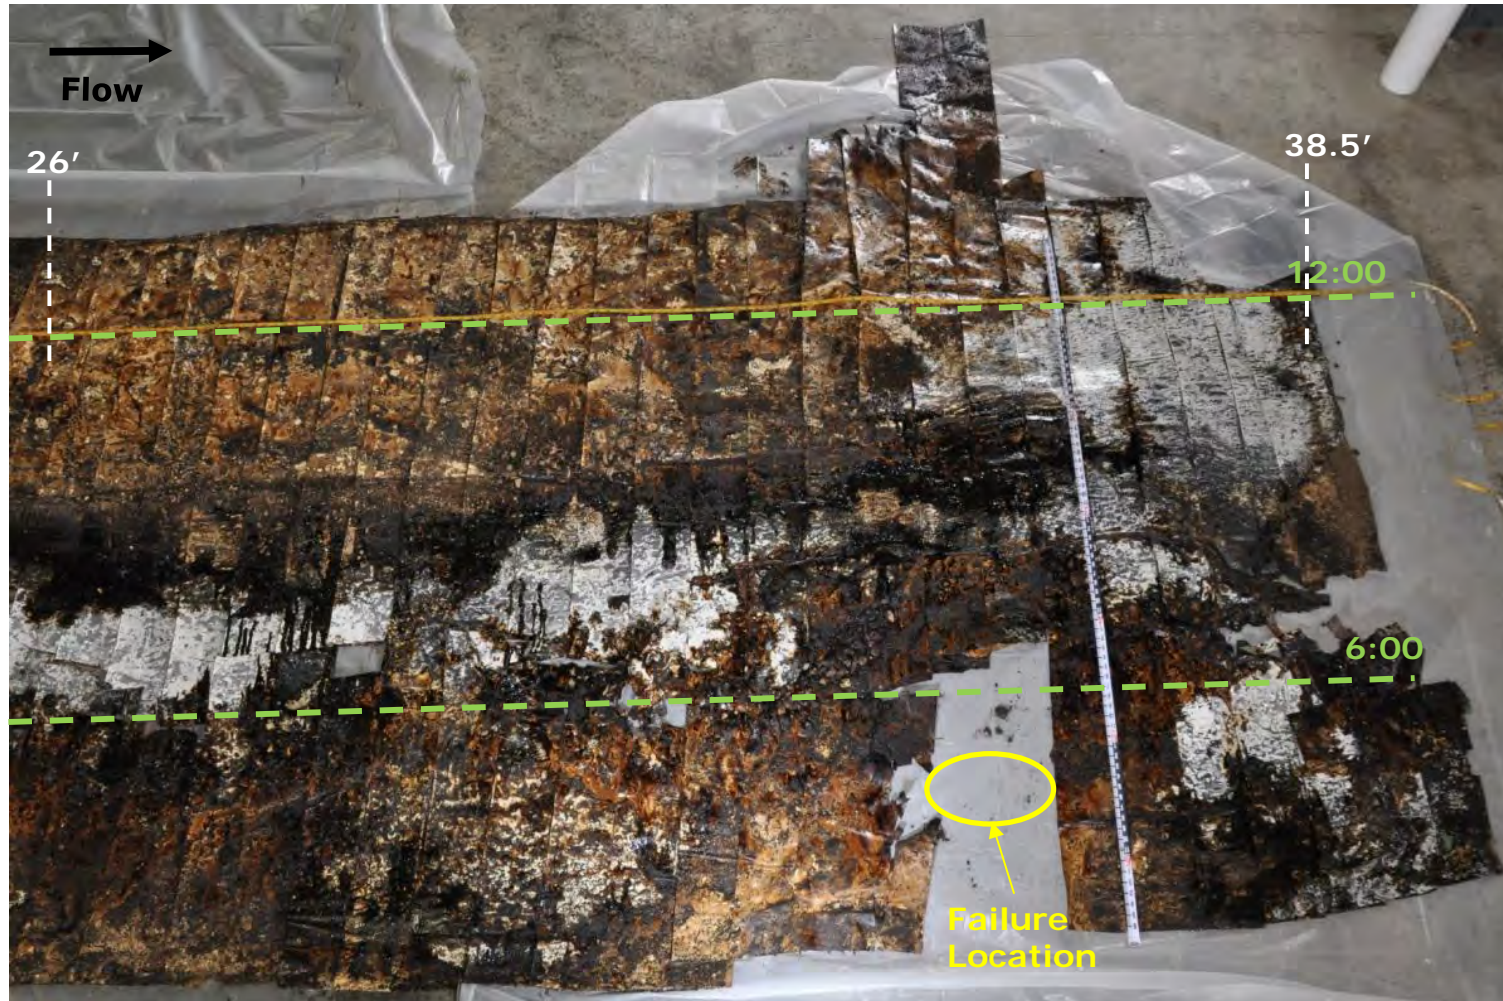
Figure 12. Photograph showing the internal surface of the external tape at the failure location. Tape measure indicates distance to upstream girth weld.

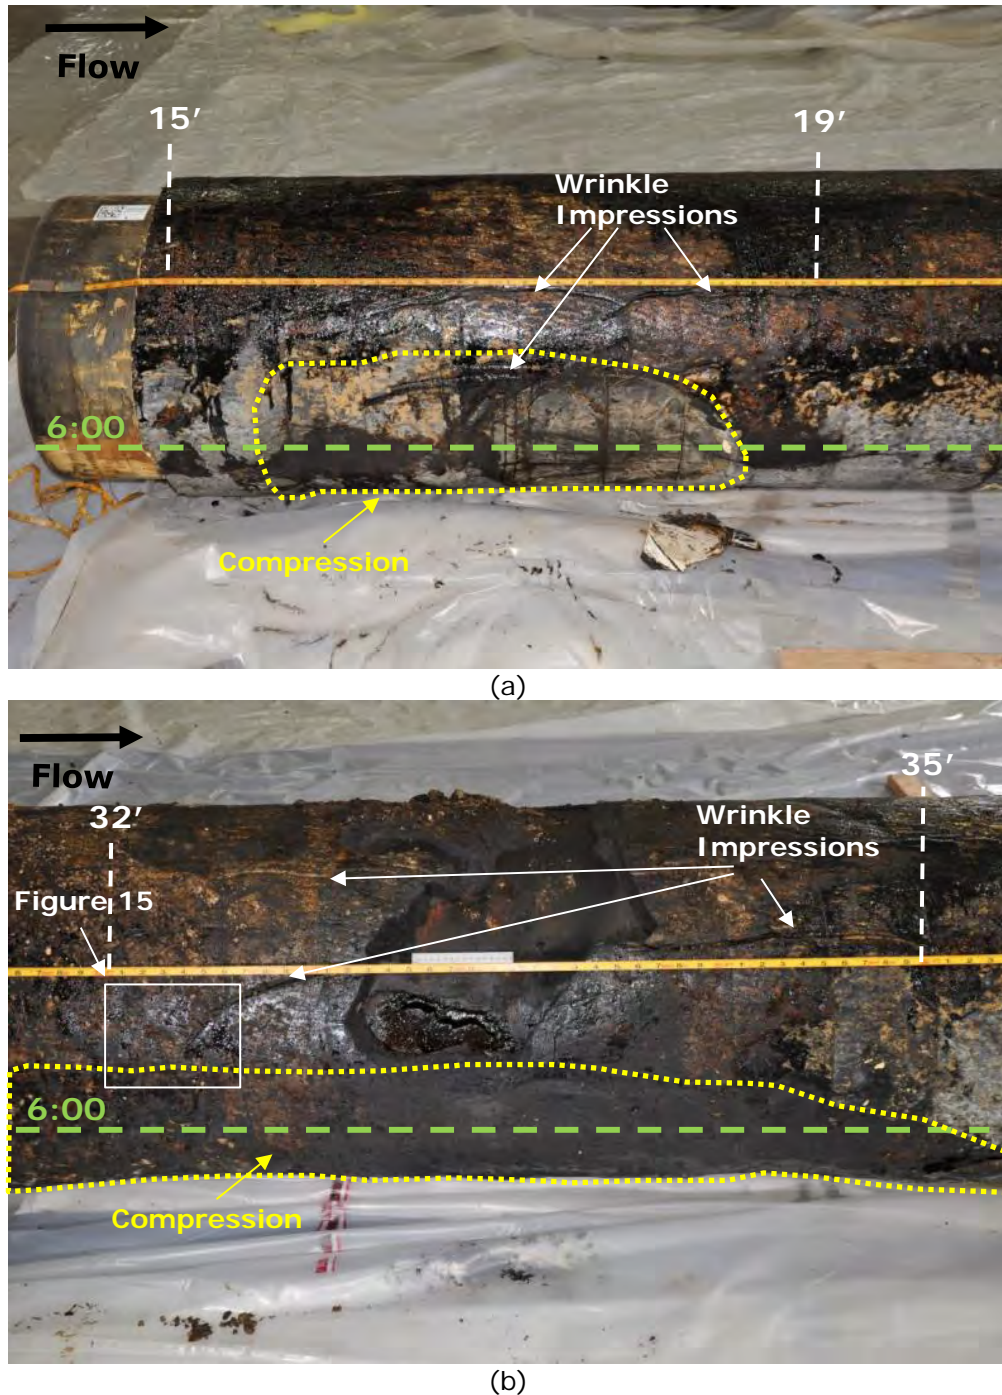
Figure 14. Photographs showing the external surface of the PU insulation at a) the U/S end of PS 2 (14' to 20' from U/S GW) and b) the failure location (31.5' to 36.4' from U/S GW). Tape measure indicates distance to upstream girth weld.
