**Failure Investigation Report**

**Plains Pipeline, LP, Line 901  
Crude Oil Release, May 19, 2015  
Santa Barbara County, California**

**May 2016**

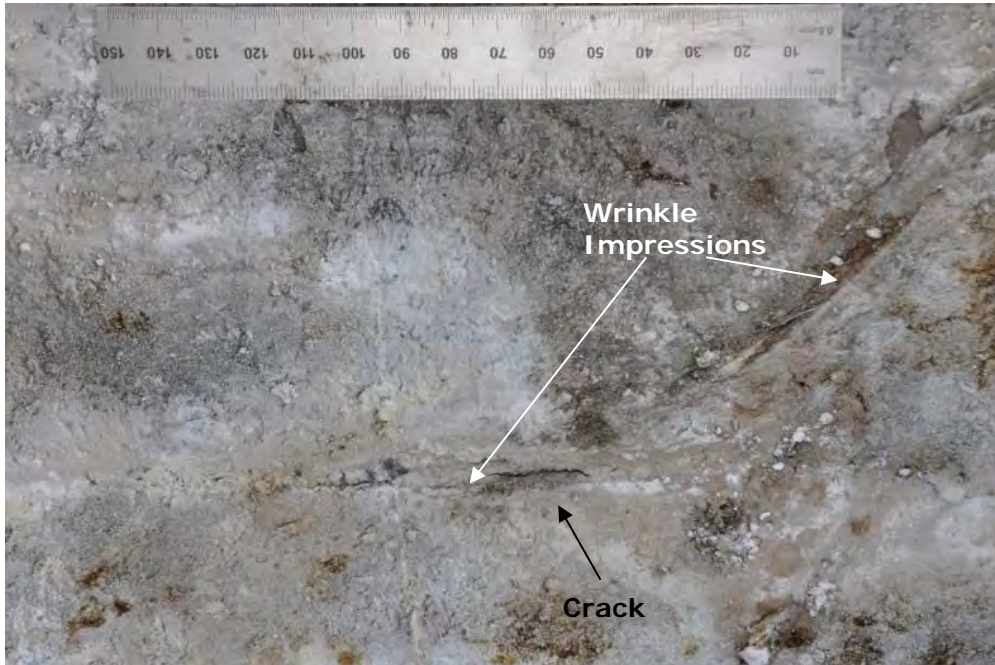
Figure 15. Photograph showing a crack in the PU insulation within a wrinkle. White contrast paint was applied to the surface to facilitate laser scanning and visual inspection. Area shown in Figure 14; scale in mm.

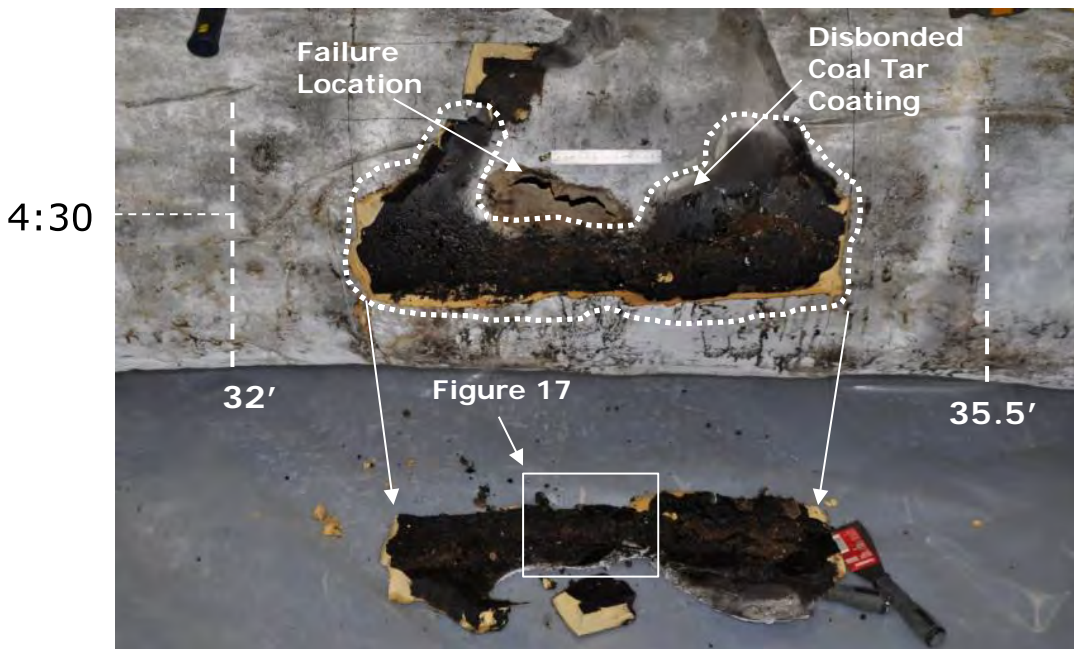
Figure 16. Photograph showing a piece of insulation removed from adjacent to the failure location; near 4:30 orientation.

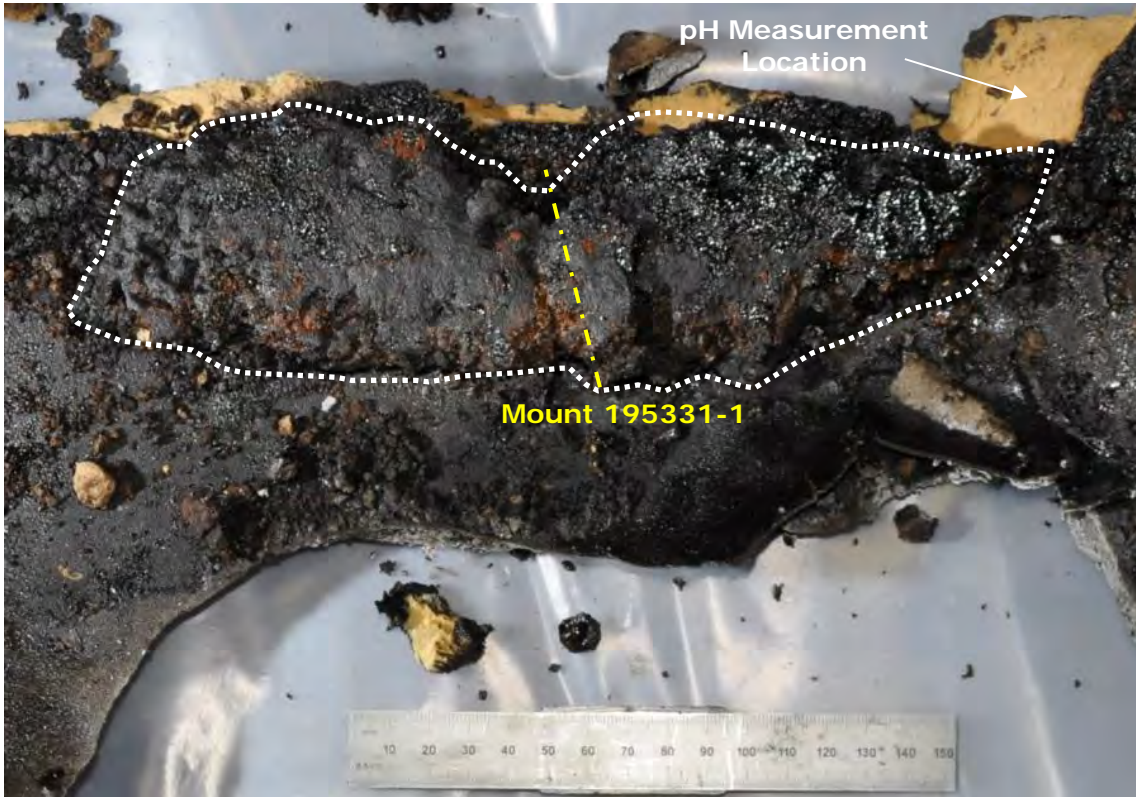
Figure 17. Photograph showing corrosion product that was wedged between the pipe surface and polyurethane insulation. Location indicated in Figure 16; scale in mm.

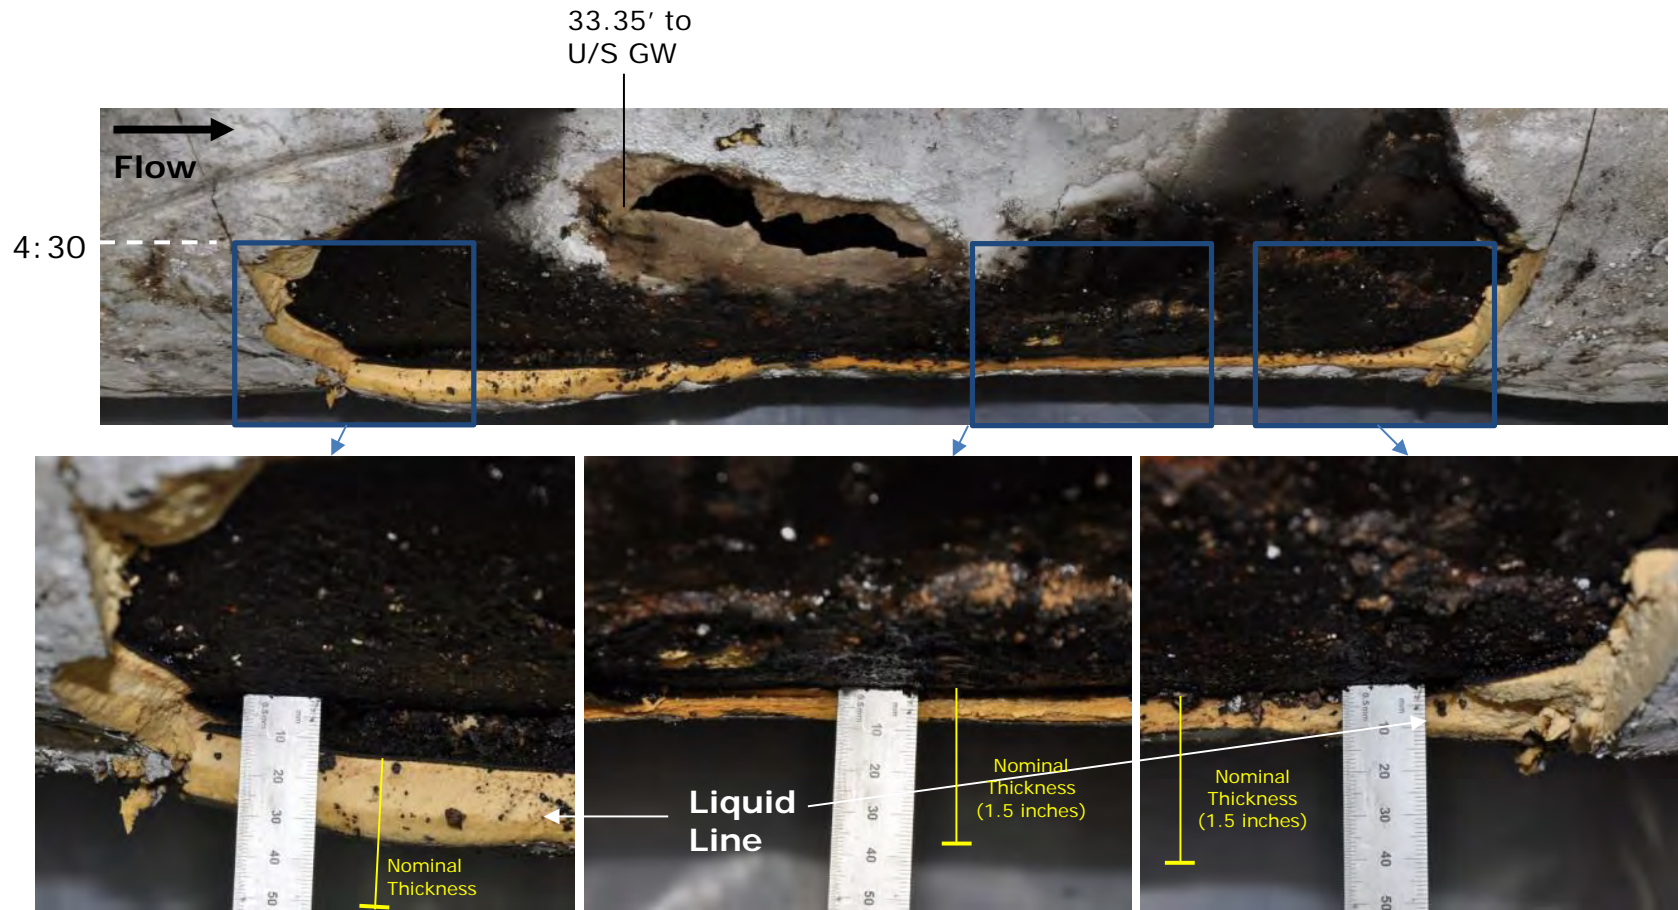
Figure 18. Photographs showing the amount of compression in the insulation adjacent to the failure location; near 6:00 orientation. Scale in mm.

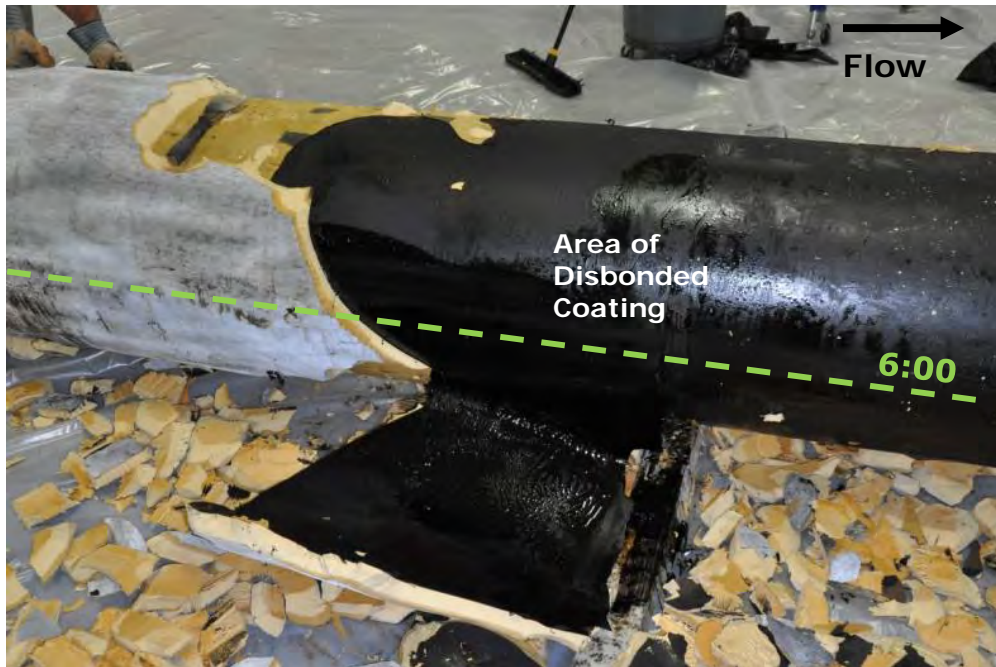
Figure 19. Photograph showing the insulation and coal tar coating separating from the pipe in large sheets on the underside of the pipe; approximately 29' from U/S GW.

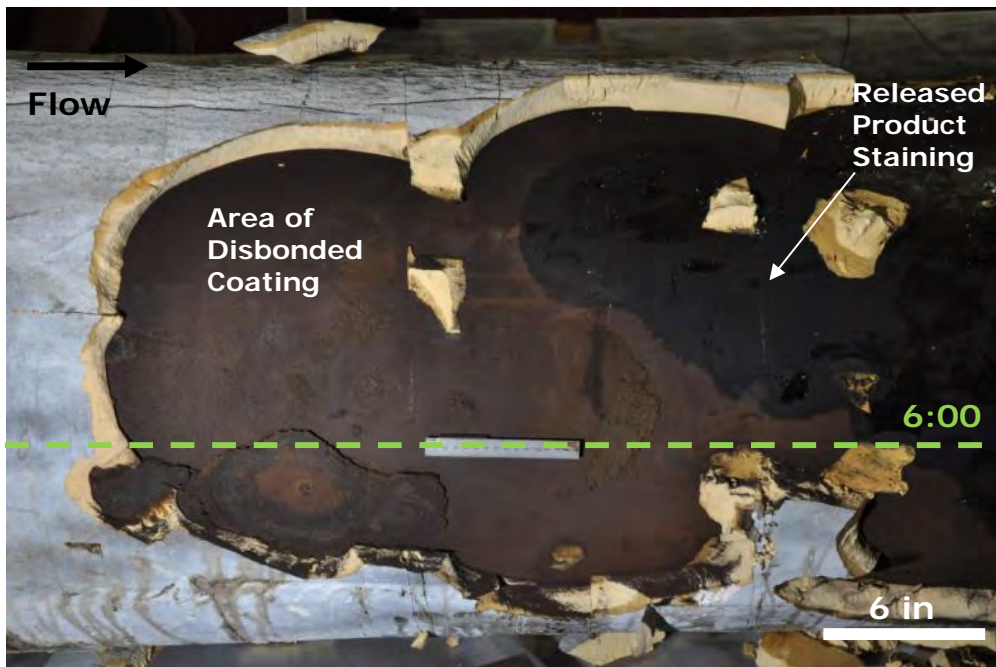
Figure 20. Photograph showing the insulation and coal tar coating separating from the pipe in large sheets on the underside of the pipe; approximately 17' from U/S GW.
