**From:** Charles Jackson <outlook\_45A2FAB701F87CE4@outlook.com>  
**Sent:** Sunday, July 9, 2023 8:42 PM  
**To:** sbcob  
**Subject:** Materials for Public Comment at 7/11/23 Board of Supervisors meeting by Charles "C.J." Jackson  
**Attachments:** Romero Photos.pdf

I am attaching herewith photos for use in conjunction with my remarks to be made during Public Comment at the July 11, 2023 Board of Supervisors meeting. I would like to have the pictures available on the screen hopefully with a pointer and remote to move from picture to picture. I intend for my remarks to fall within the 3-5 minutes available for public comment and I am aware I should not expect interplay or questions from the board and will ask the Board to agendize at as early a date as possible, the matters to which I am speaking.

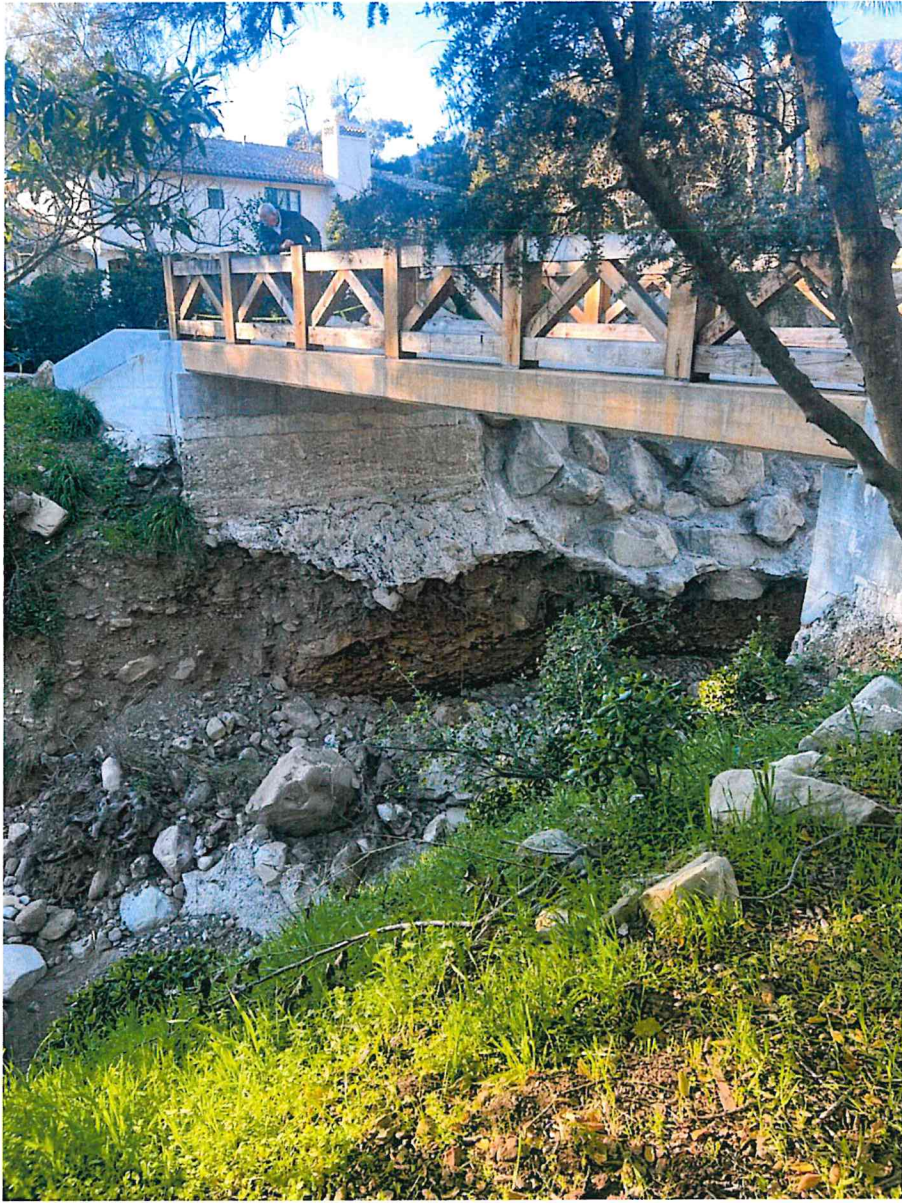
*Figure 1View of bridge installed in 2022. Previous bridge was destroyed in 2018 debris flow following the Thomas Fire.*

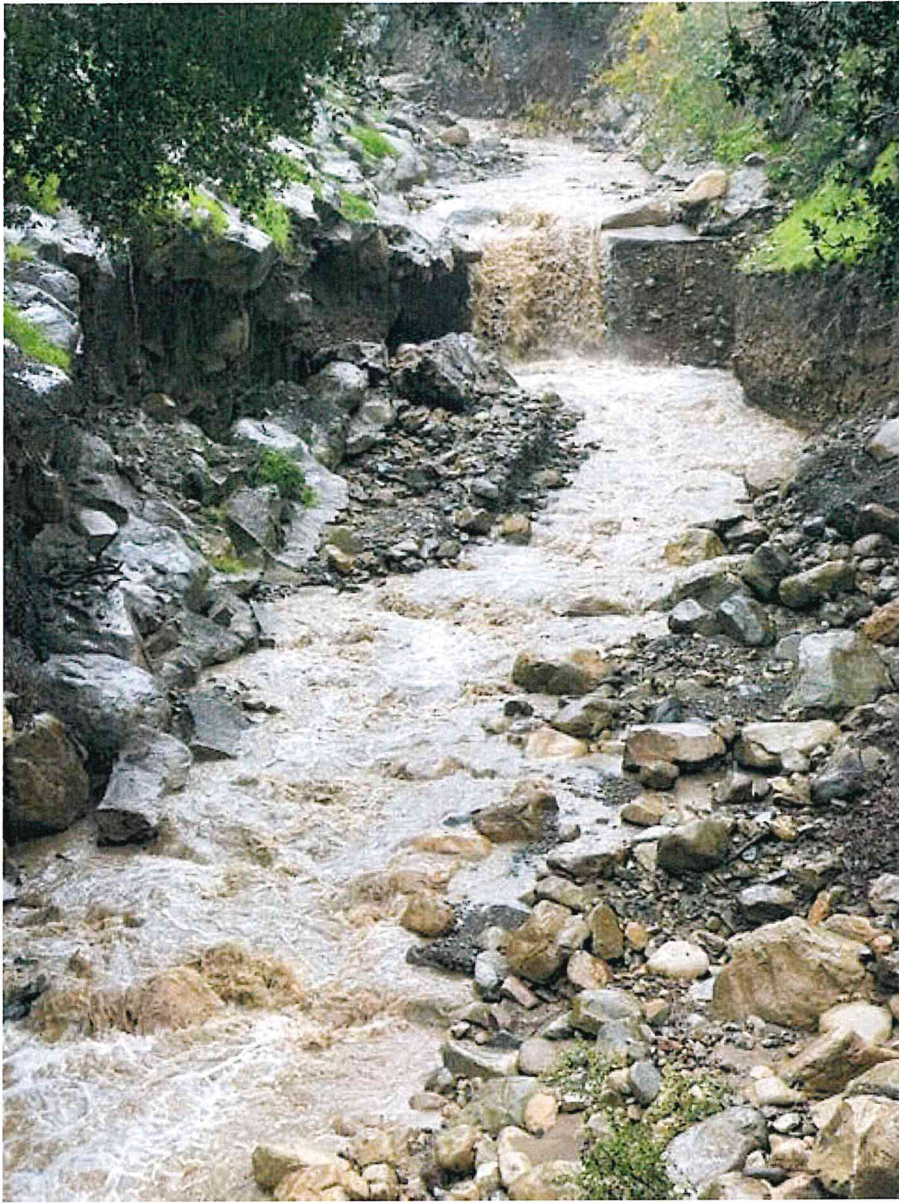
*Figure 2*View of Romero Creek looking upstream. Note, grade control structure and erosion on downstream end of approximately 8 feet.

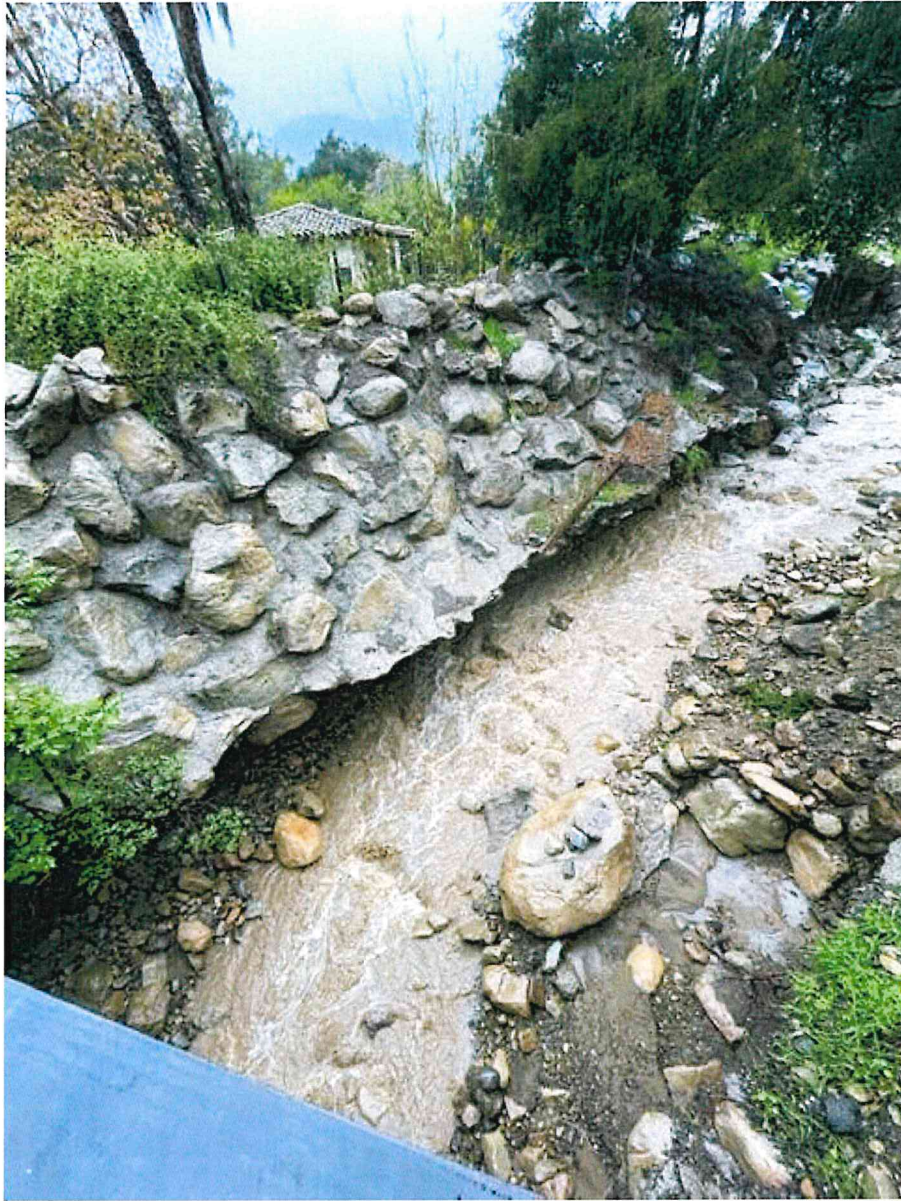
*Figure 3*View of Romero creek looking upstream. Photo taken from bridge installed in 2022. Note undercut grouted rock slope protection.

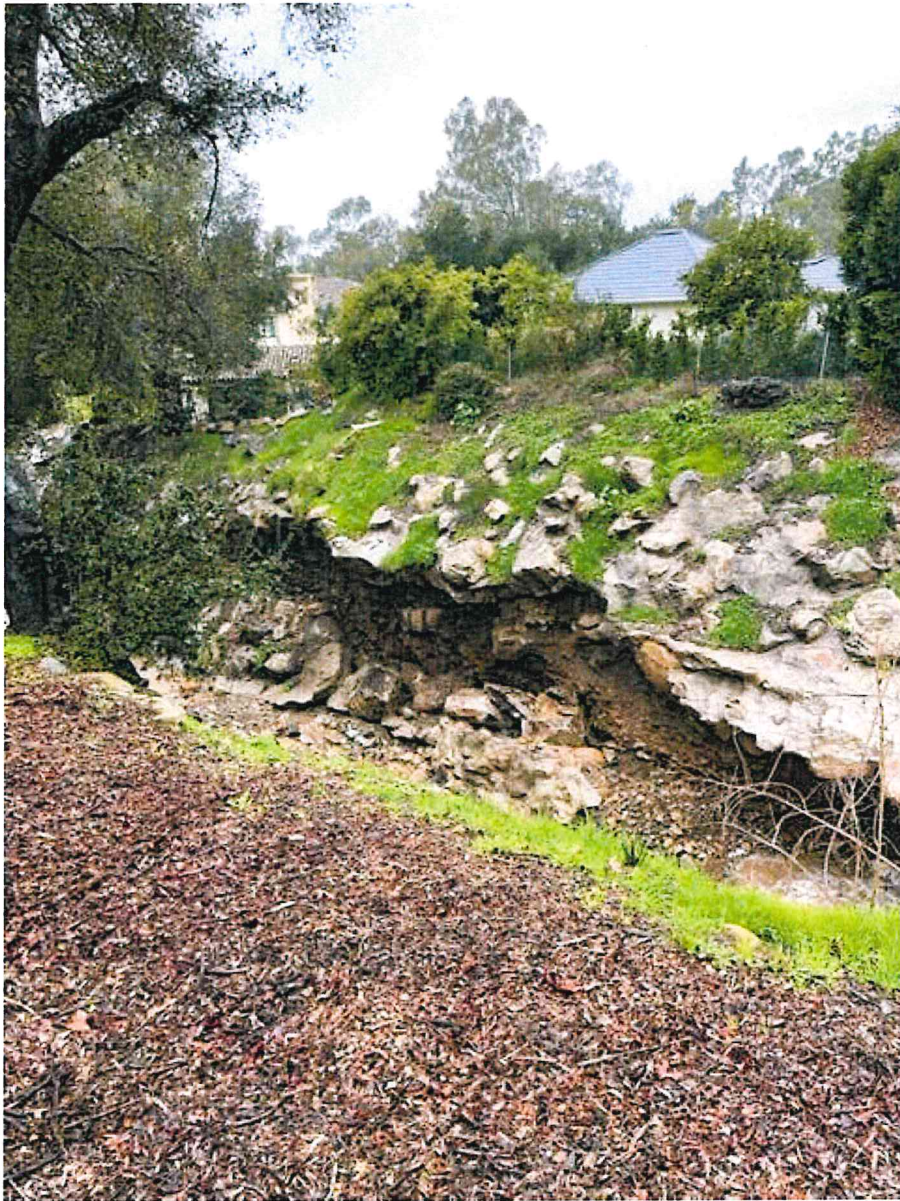
*Figure 4*View of west bank of Romero Creek taken from east bank. Note the scour and broken sections of the grouted rock slope protection.

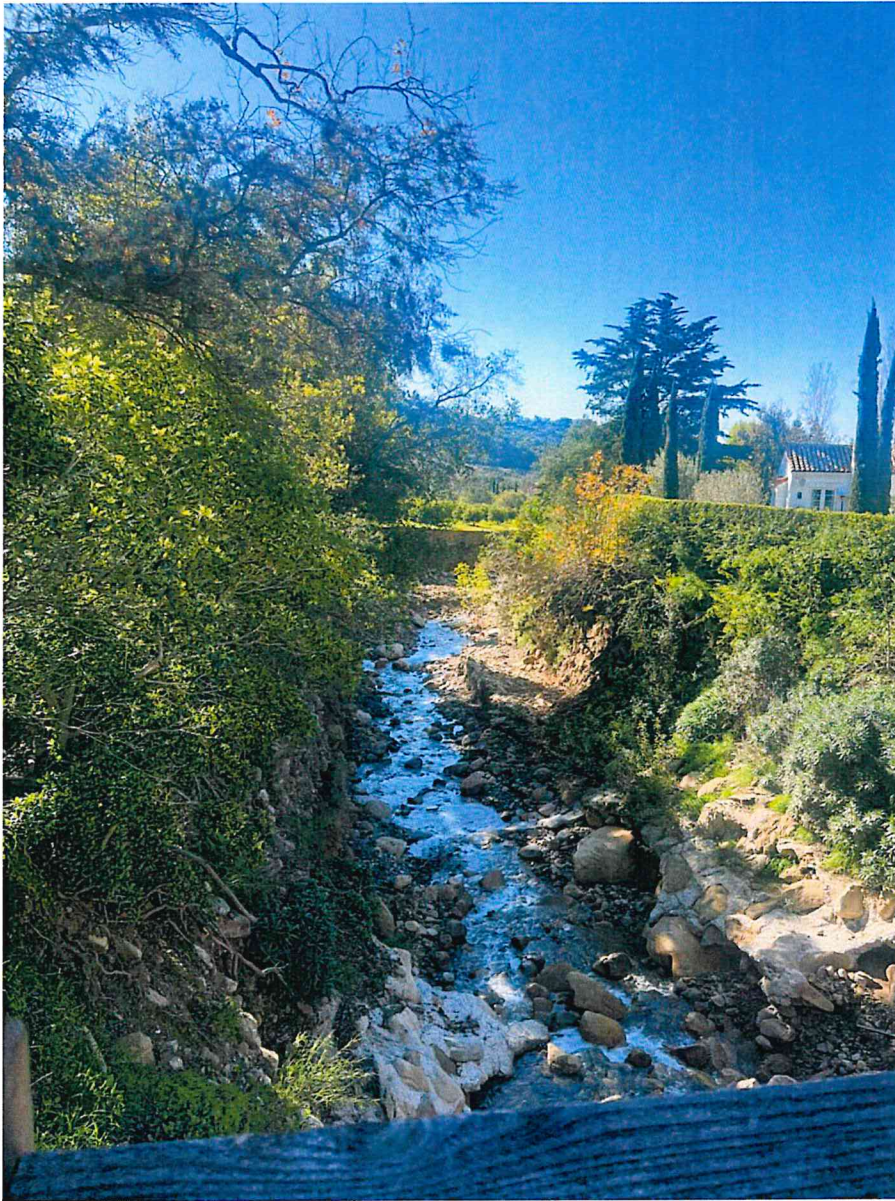
*Figure 5 View of Romero Creek looking downstream from the bridge installed in 2022. Note - Channel has incised in this reach approximately 8 feet.*

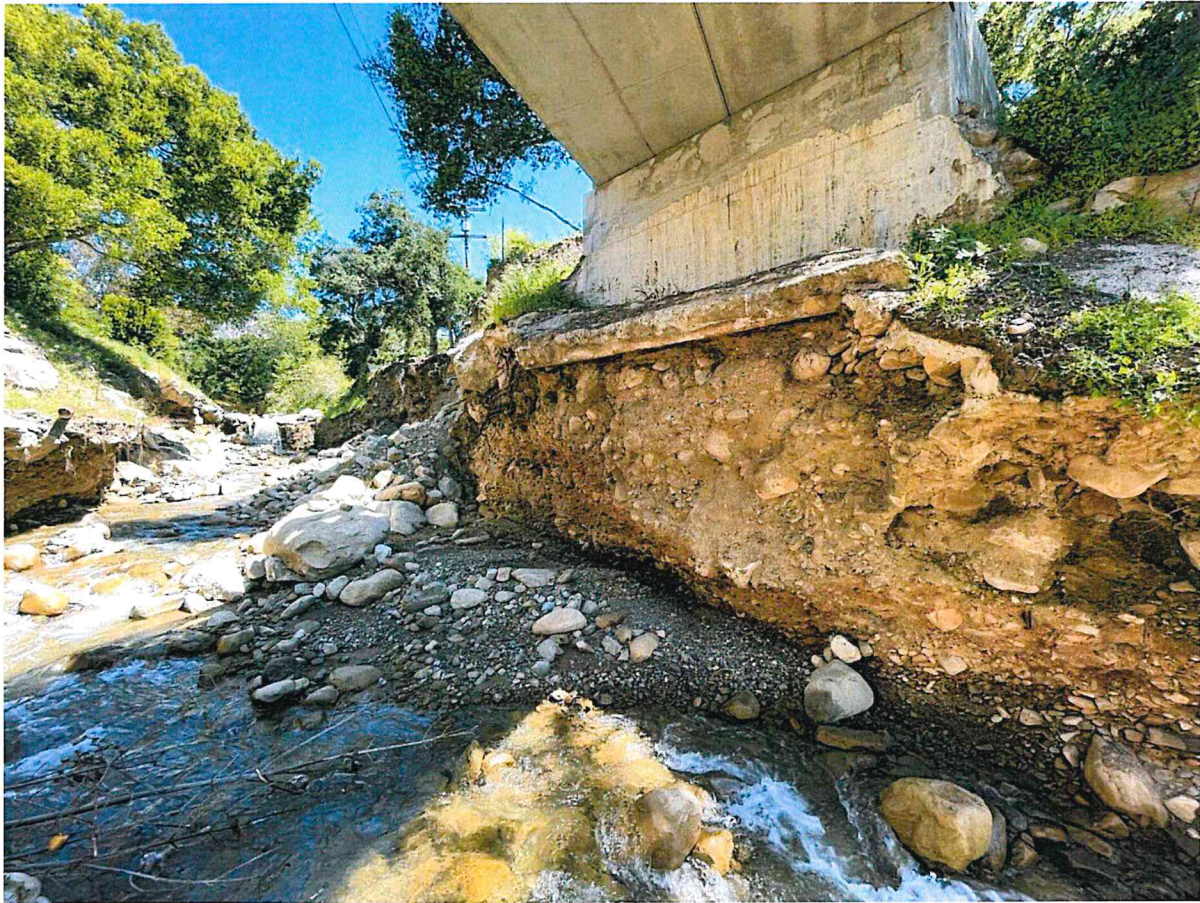
*Figure 6 View of river left abutment looking upstream showing incision in creek. Note grade control structure upstream.*

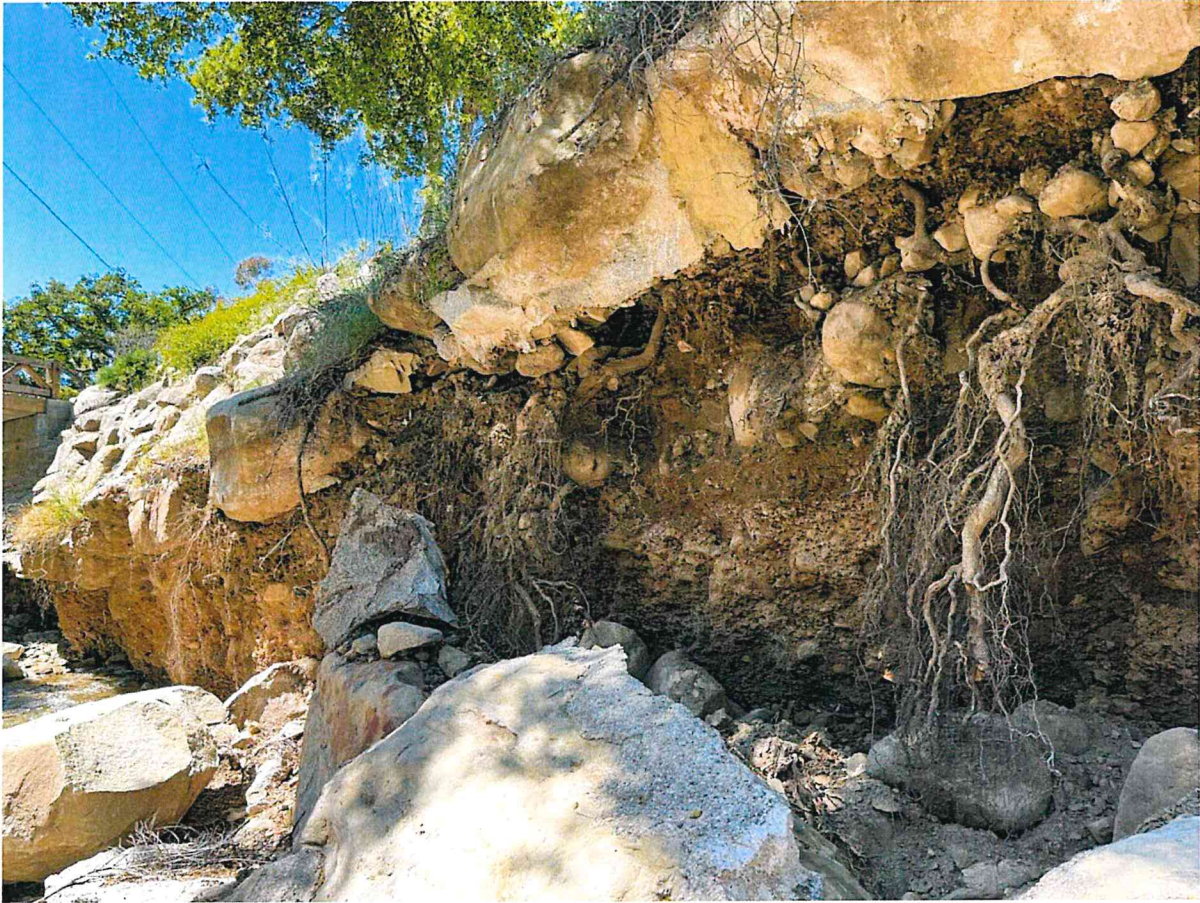
*Figure 7View of ACOE grouted RSP upstream of new bridge on river right. Note concrete broken off where channel incised and now in stream channel.*

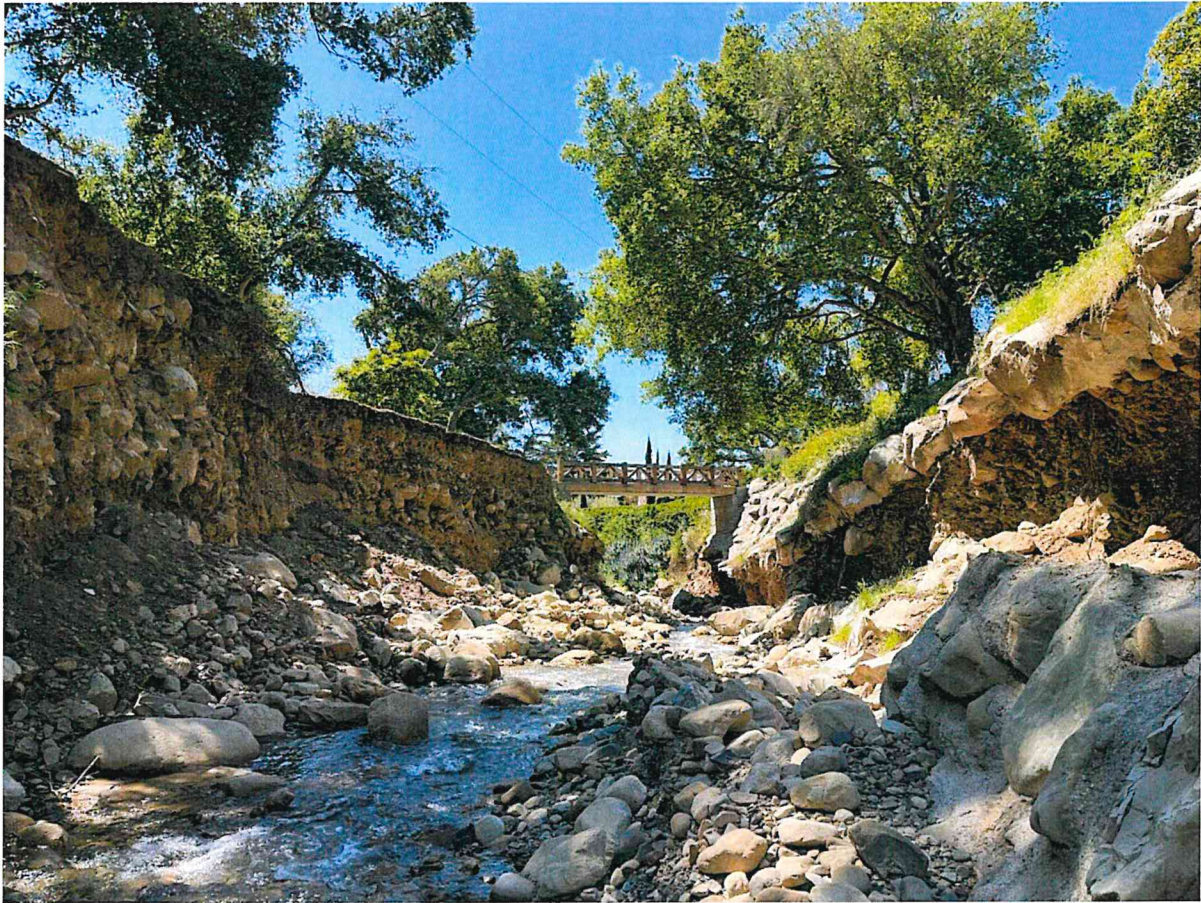
*Figure 8 Looking downstream. Note incision and undercut RSP on river right.*

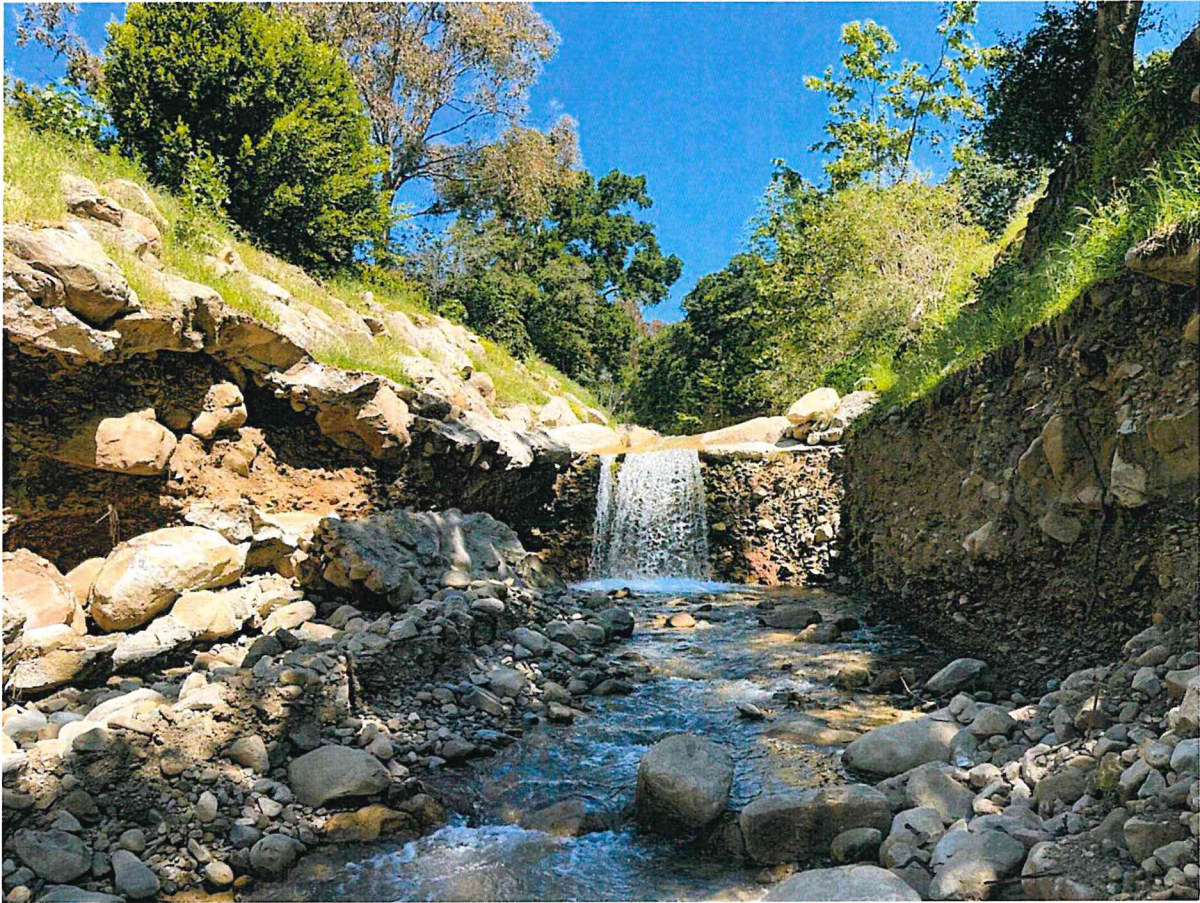
*Figure 9ACOE installed grade control structure where channel further incised. note broken grouted RSP on left side of photo.*

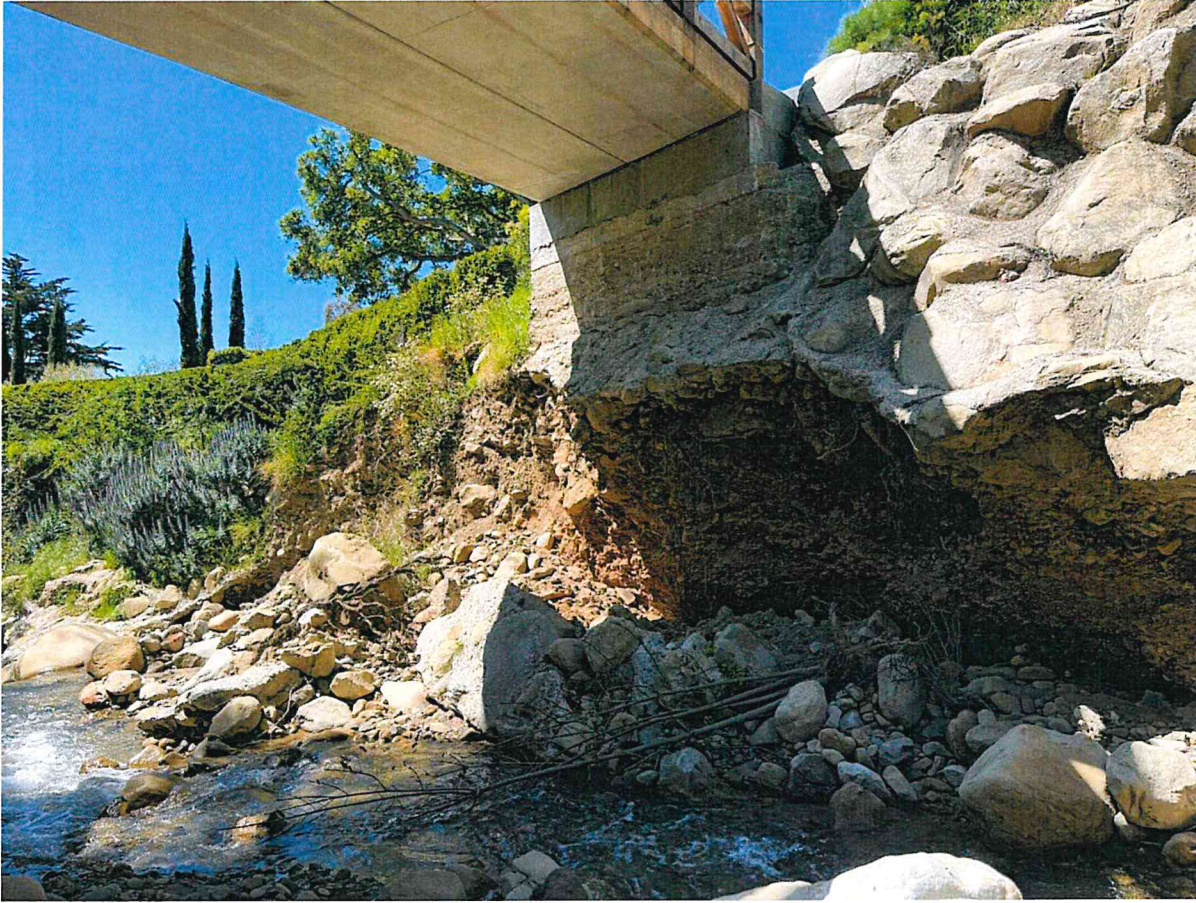
*Figure 10*View of river right bank showing broken grouted RSP at bridge.

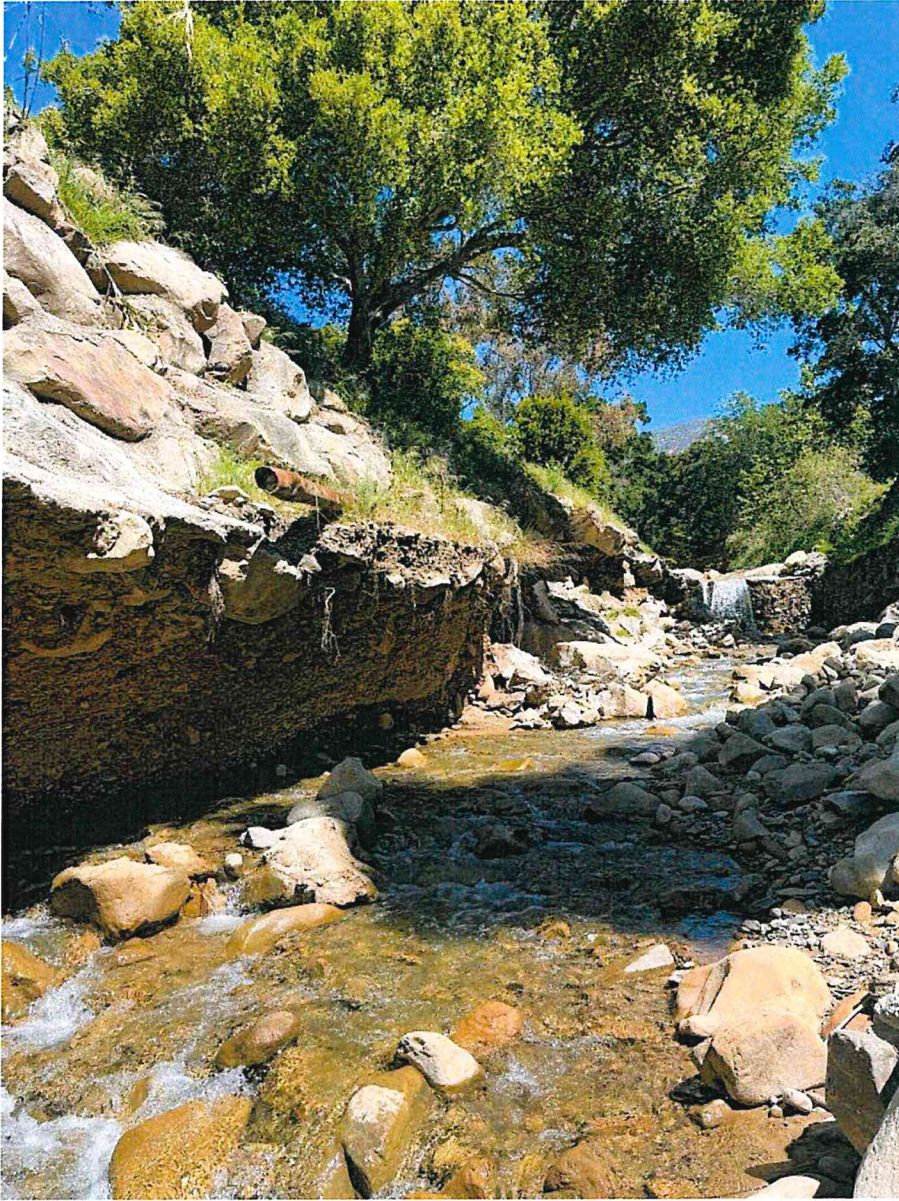
*Figure 11 View of undercut bank between bridge and grade control structure on river right.*

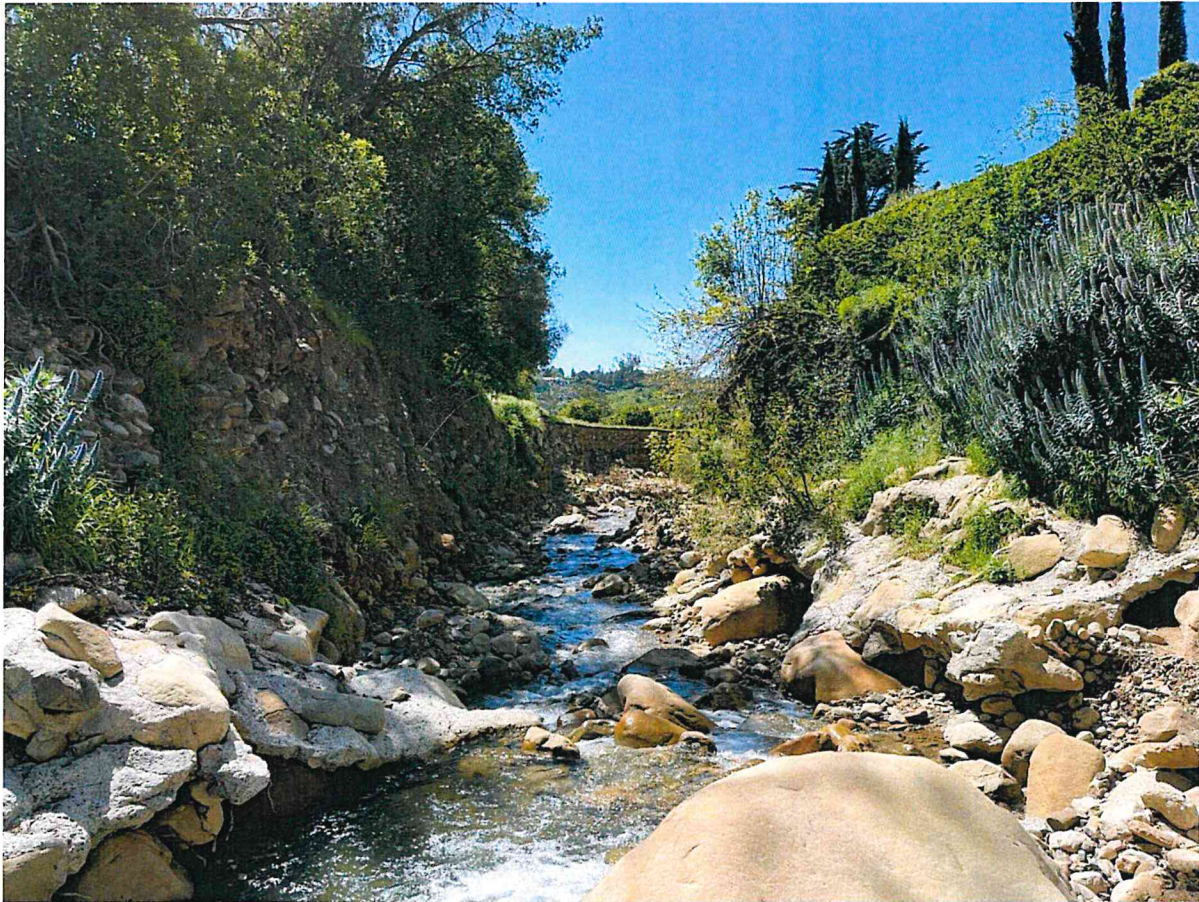
*Figure 12 View looking downstream. concrete on both toe slopes. Used to connect into a grade control structure that is failing.*
