DRAFT WHITTIER BURNED AREA REPORT
(Reference FSH 2509.13)

- A. Fire Name: Whittier Fire
- B. Fire Number: CA-LBOR-001770
- C. State: CA
- D. County: Santa Barbara
- E. Region: 5
- F. Forest: Los Padres
- G. Districts: Santa Barbara Management Unit
- H. Fire Incident Job Code: PFK4VE
- I. Date Fire Started: July 8, 2017
- J. Date Fire Contained: pending
- K. Suppression Cost: \$35+ million
- L. Fire Suppression Damages Repaired with Suppression Funds
 - 1. Dozerline repaired / waterbarred: 35 out of 66 miles as of 08/9/2017
 - 2. Hand line repaired: 7 out of 16 miles as of 08/9/2017

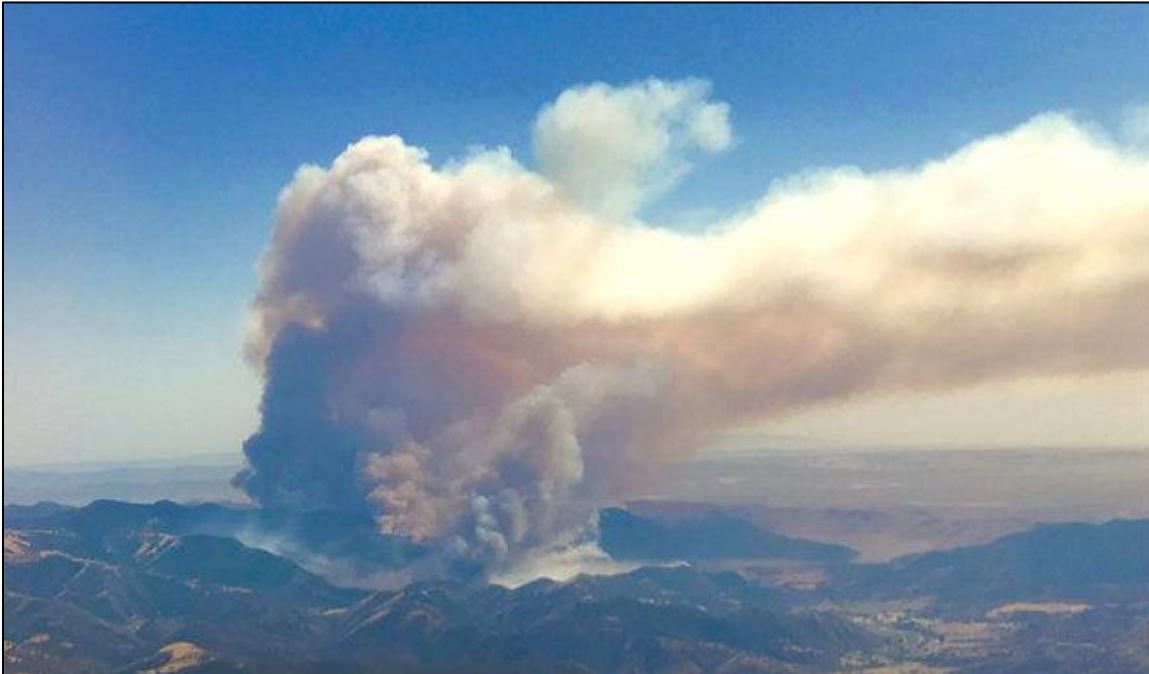
The Whittier Fire of 2017 looking at Santa Ynez River drainage into Lake Cachuma.

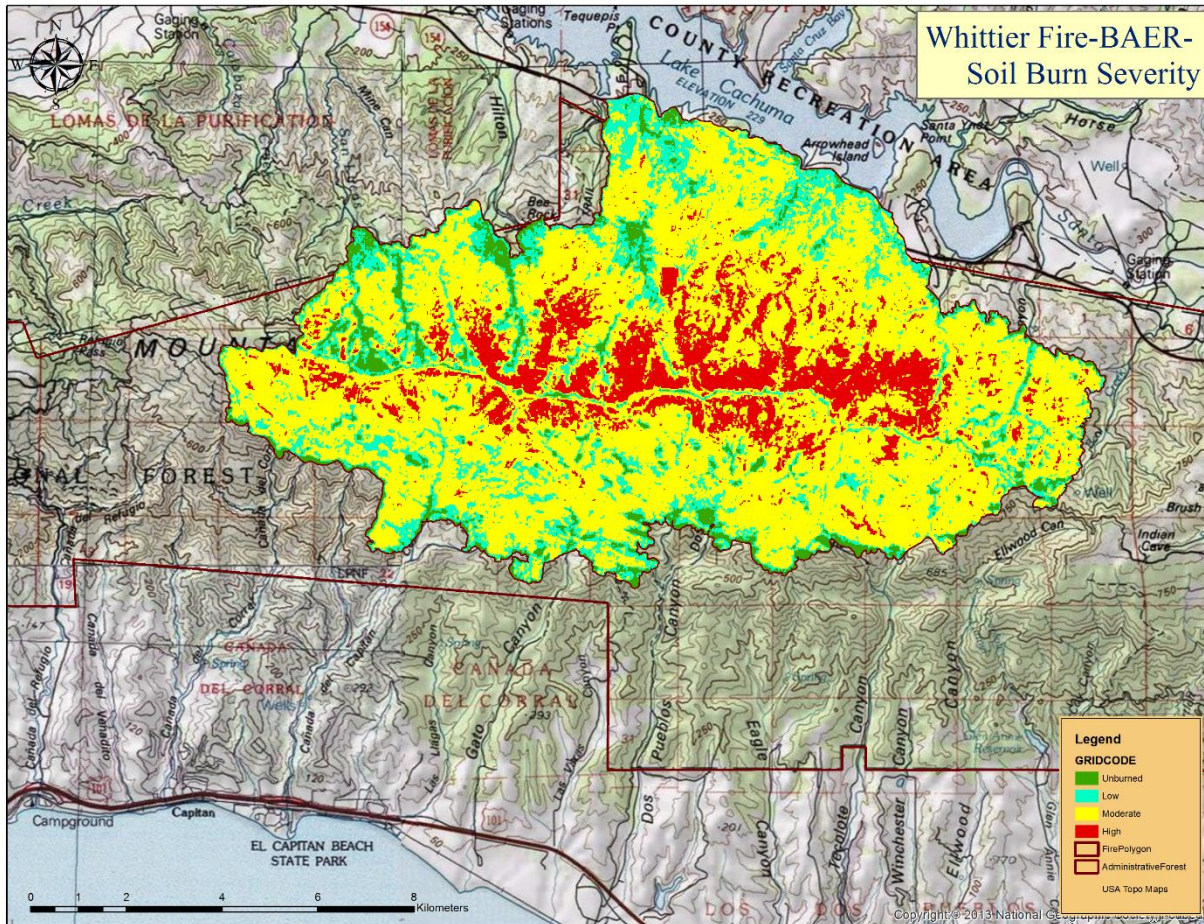
Figure 1 – Soil Burn Severity Map for the Whittier Fire

The following soil burn severity map (Figure 1) illustrates the general soil burn severity pattern on the landscape. The soil burn severity is overwhelmingly moderate (65%) and high (15%). In most of the moderate burn severity, and some of the high burn severity (particularly on south-facing slopes), there is very little vegetation or ground cover remaining except surface rock. There is only 15% low soil burn severity because of the high pre-fire ground cover, and partly because the fire was heavily wind-driven and in deep chaparral that has not burned since 1955. Very low soil burn severity was 6% of the fire area.

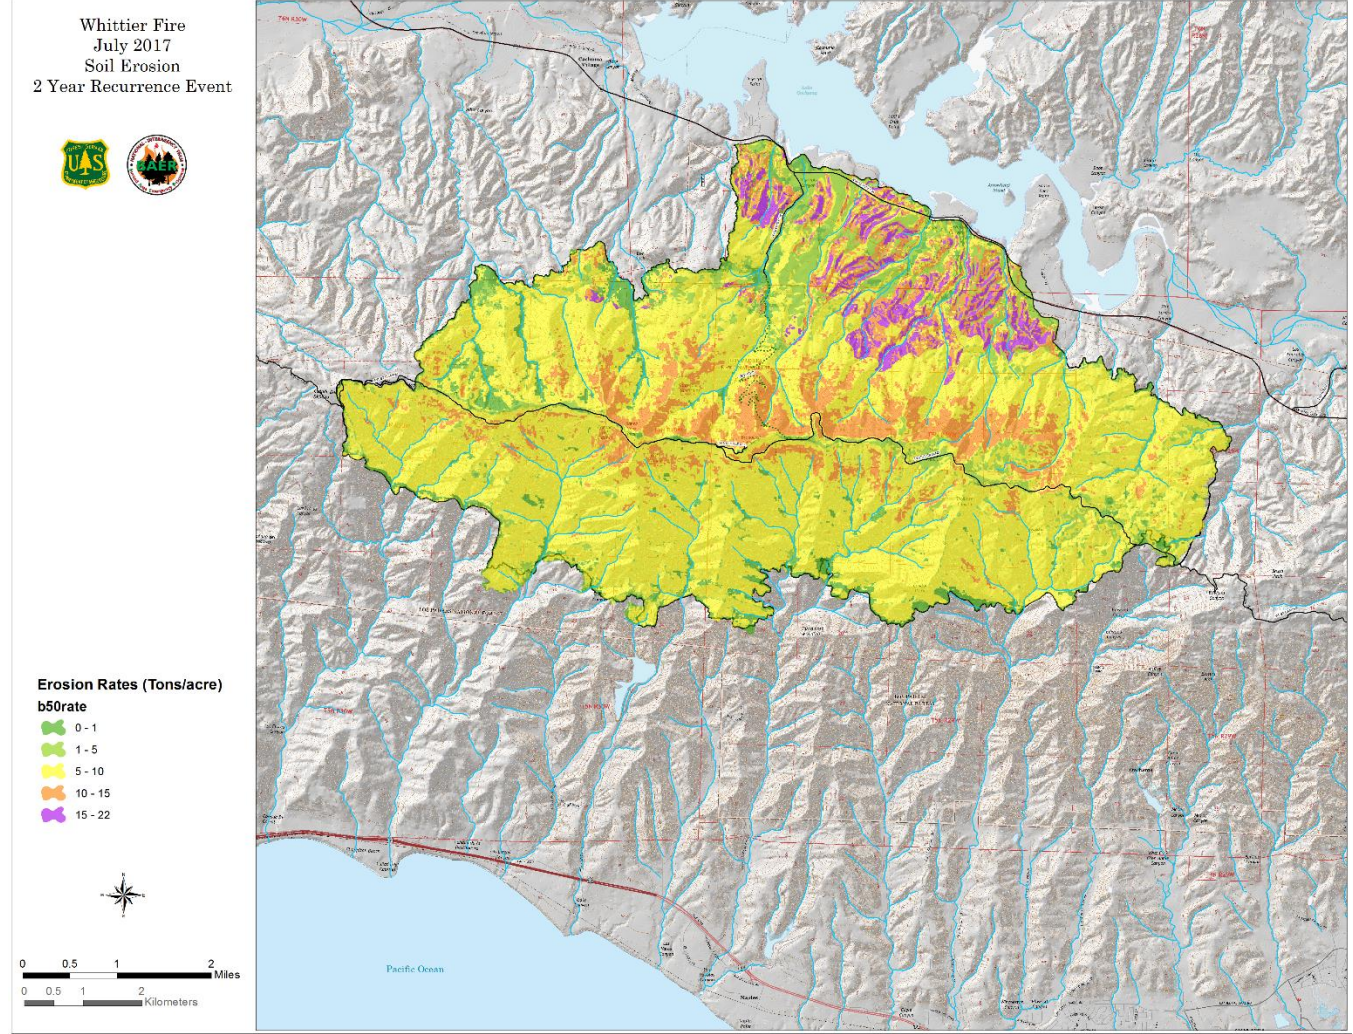
Figure 4 – Sediment Delivery for 2-Year Runoff Event

The largest watershed is the Dos Pueblos Watershed with 4,564 acres and is projected to contribute 4.2 tons/acre on a 2 year storm. Duvall and Tequepis Canyons, both located on the north-facing side of the burned area, are expected to experience the highest rates of soil transport from both hillslopes as well as fan remnants that contain high amounts of erodible silt. Tecolote, a south facing watershed that burned incompletely, is predicted to experience the lowest net soil lost but this value is still substantial. Interested readers are directed to the Whittier Soil BAER report for more detailed information.

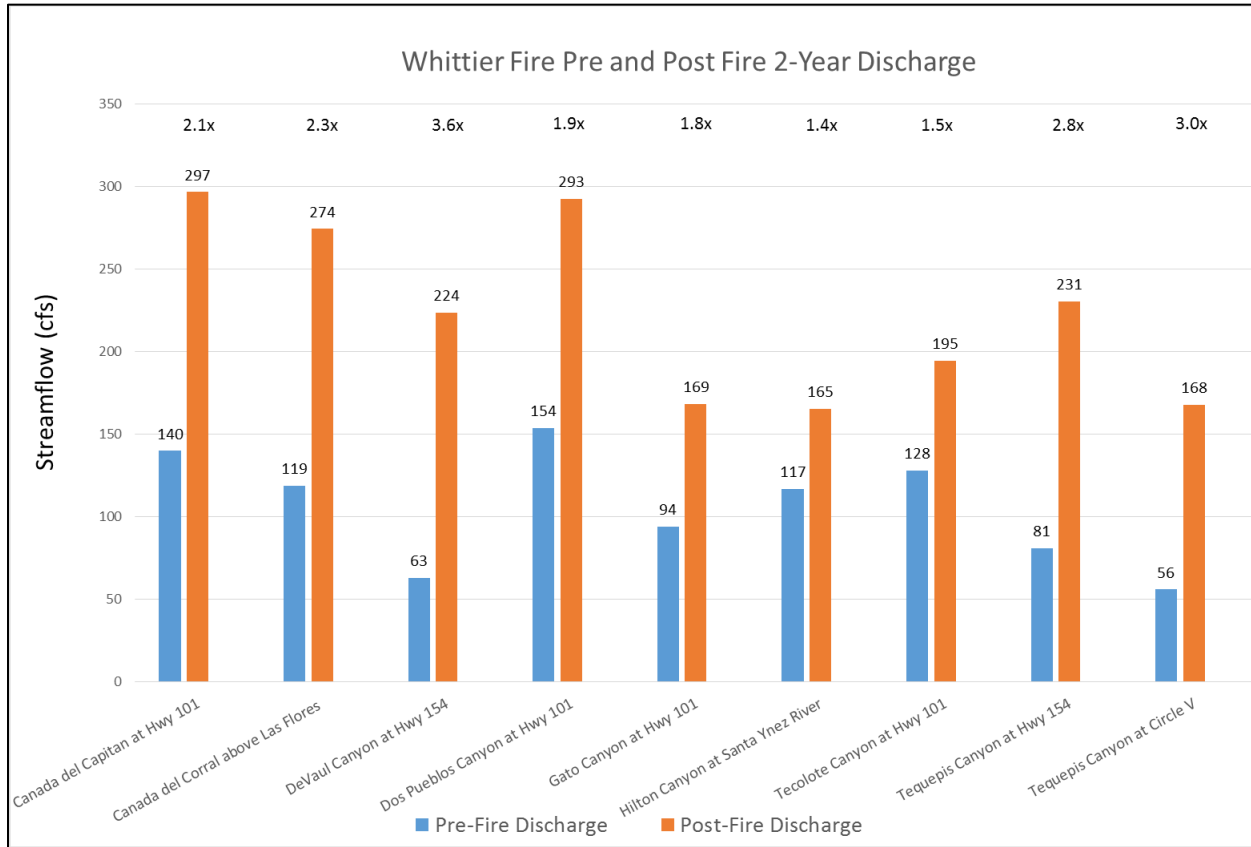
Whittier Fire Pre and Post Fire 2-year Discharges at designated Pour Points.

The watershed that was modeled to have the biggest relative increase is DeVaul with a 3.6 times increase with a flow that increases from 63 cfs pre-fire to 224 cfs post fire.

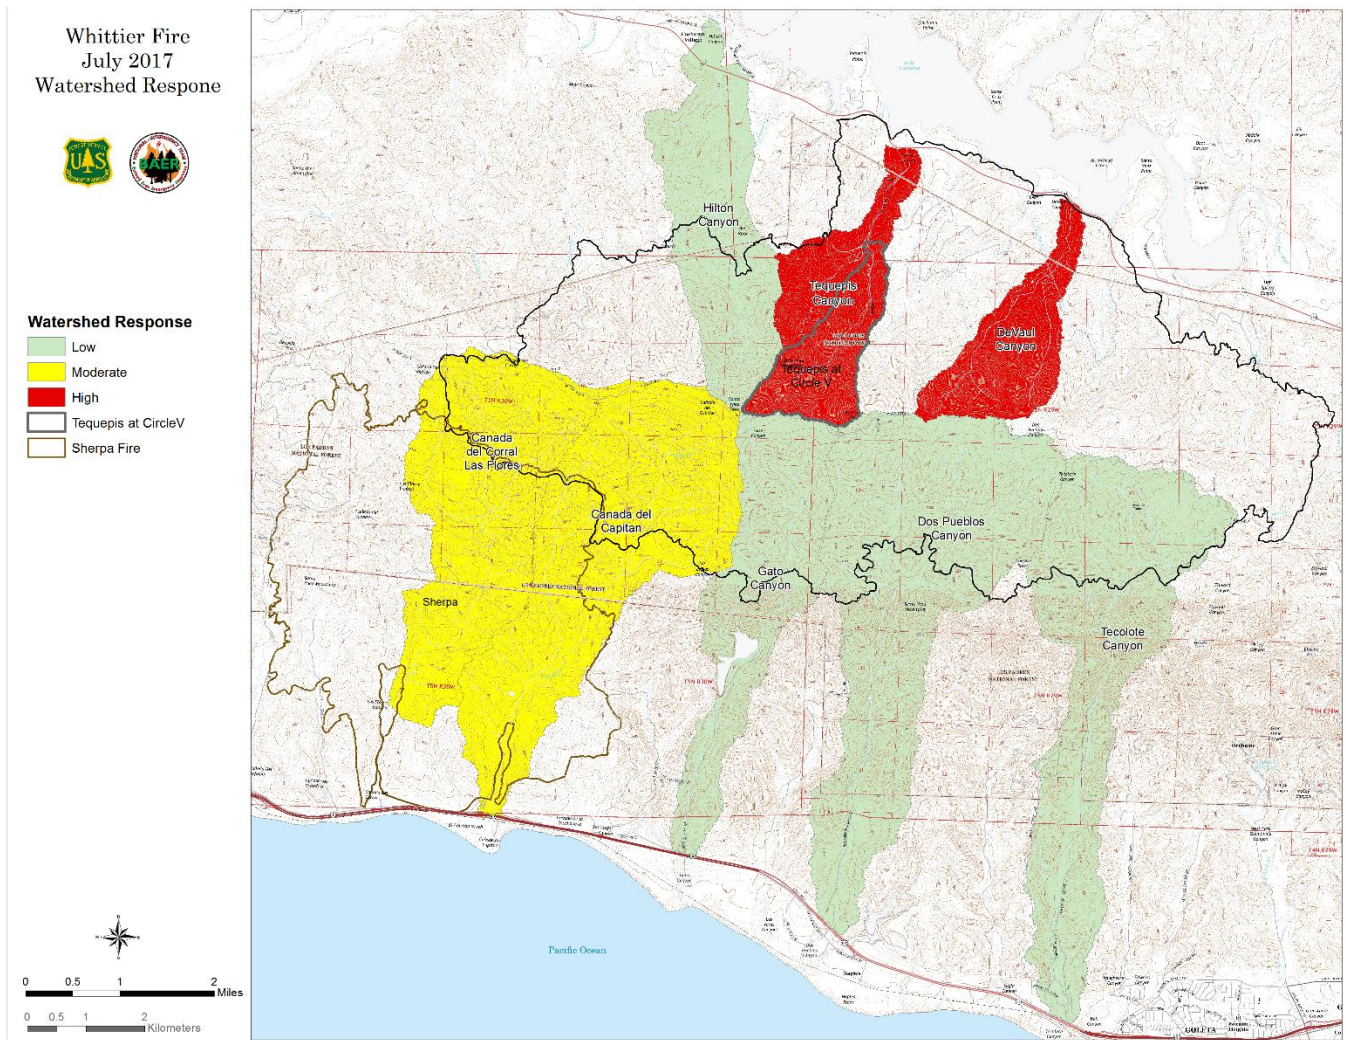
Figure 5 – 2-Year Storm Watershed Response

Due to the steepness of these drainages and the amount of high and moderate burn severity (large areas now devoid of vegetation and groundcover) after the fire, the first large runoff producing storm is expected to create increased surface flow, erosion and sediment production. This scenario coupled with existing wet antecedent soil conditions from previous storms could trigger a potential flood event and/or debris flow with high sediment volumes. The highest amounts of sediment yields from the burned watersheds are expected during the first three years after the fire.

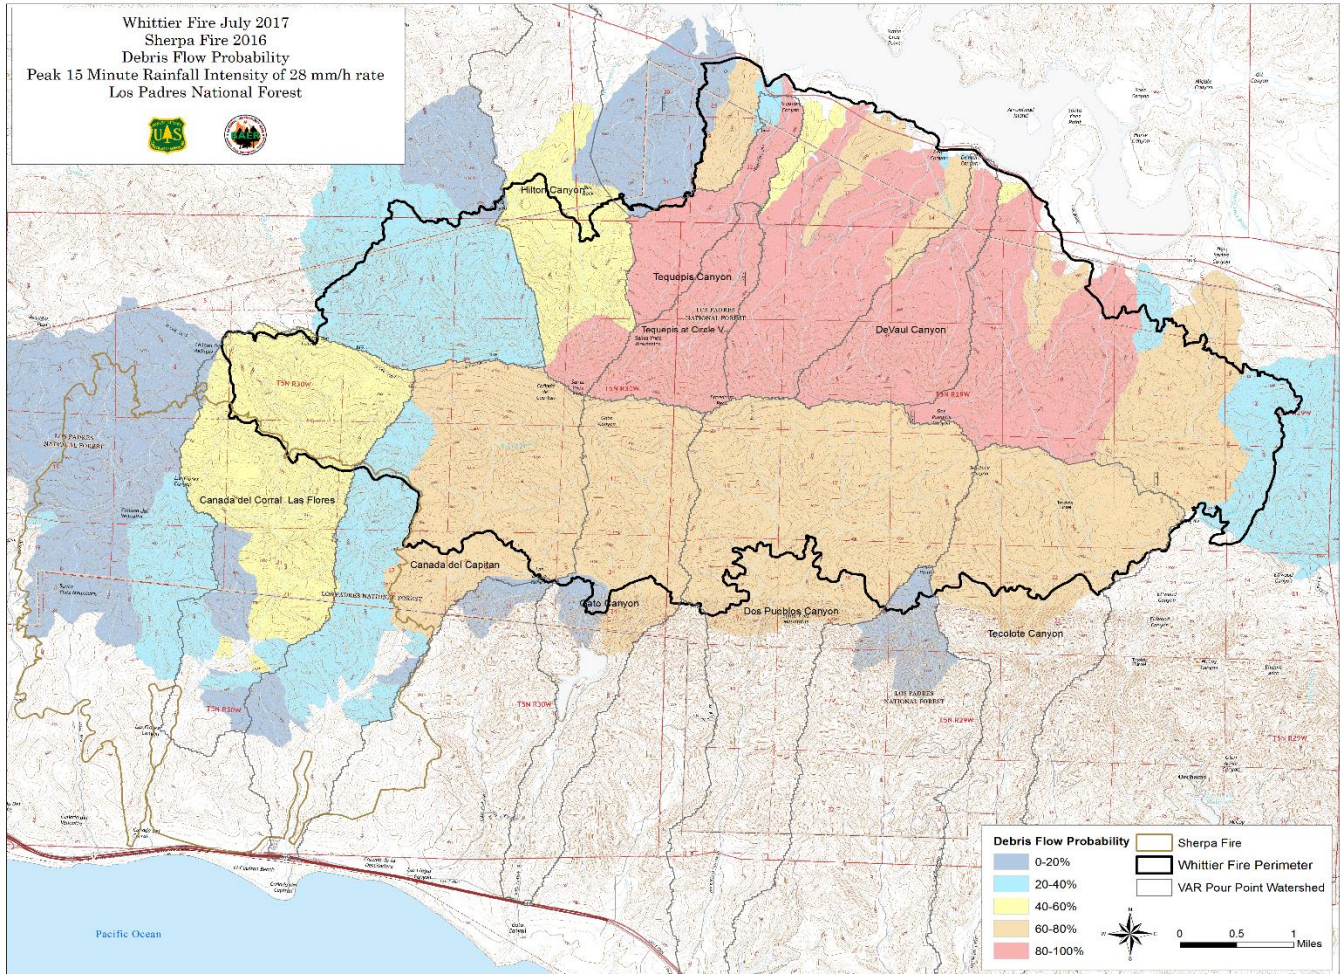
Figure 6 – Predicted Debris Flow Probabilities for the Whittier Fire

Based on USGS debris flow modeling it appears that under conditions of a peak 15-minute rainfall intensity storm of 28 millimeters per hour (1.1 inch/hr.), the probability of debris flows occurring is 80-

100% in the majority of the main channel/creeks in the burn area. Under these same conditions, predicted volumes of these debris flows are expected to range from 10K-100K cubic meters in these same channels. From the debris flow combined hazard map it appears that the majority of creeks in the burn area are predicted to produce debris flows of a high combine hazard.

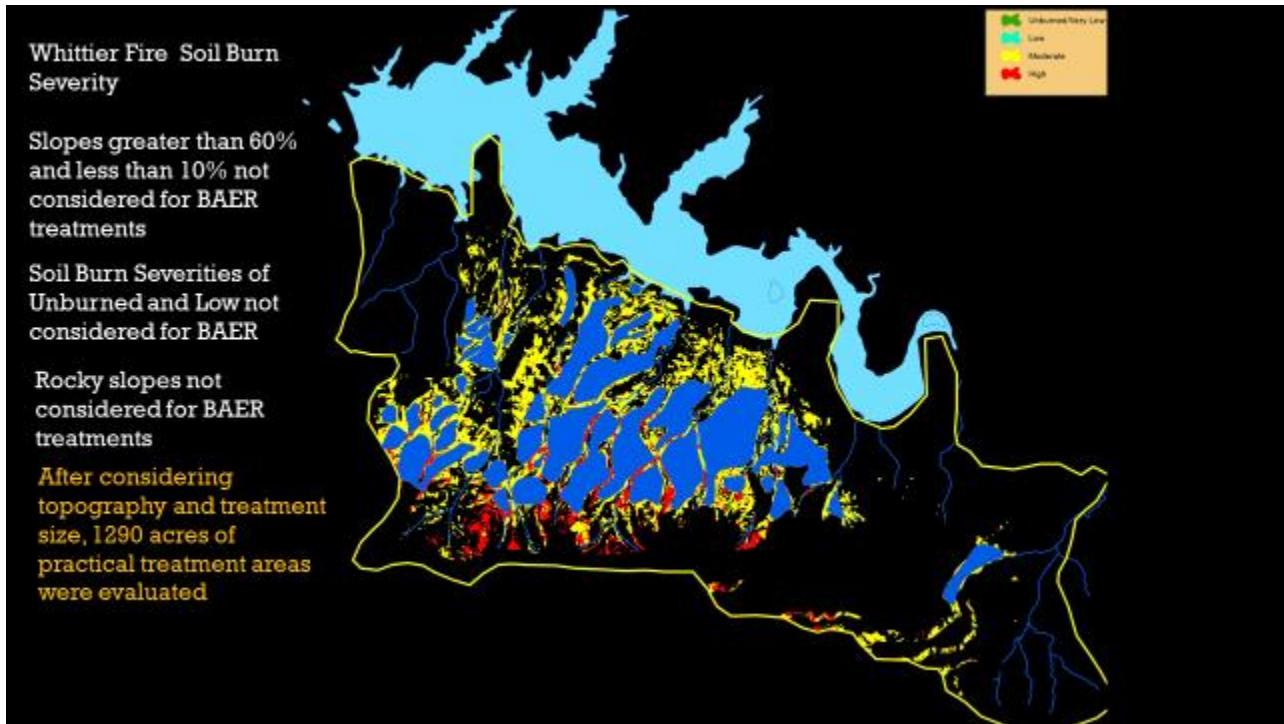
Figure D-1. Maximum feasible area that could be treated for slope stability. For maximum cost/benefit only soils with high erosion rates within these polygons would be treated.
