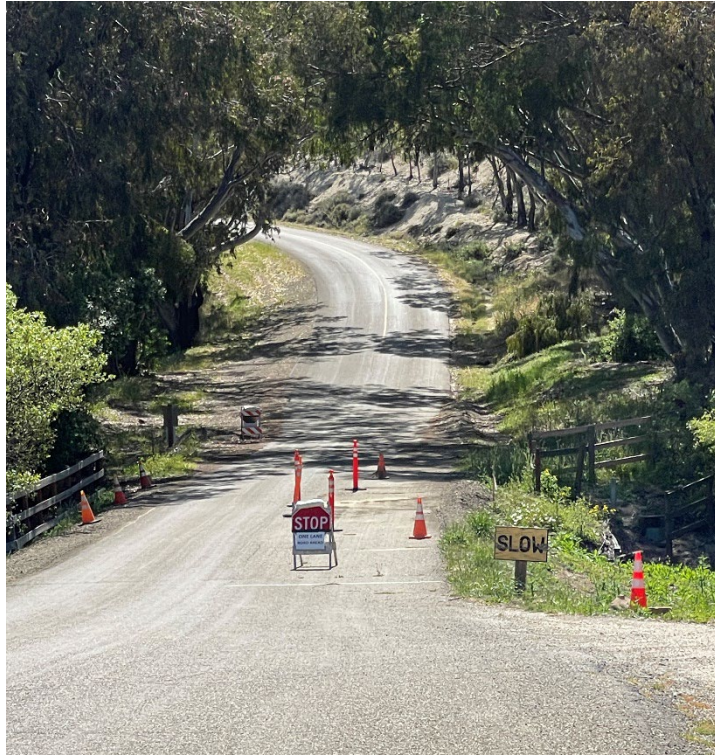
**View looking west at Hollister Ranch Road.**

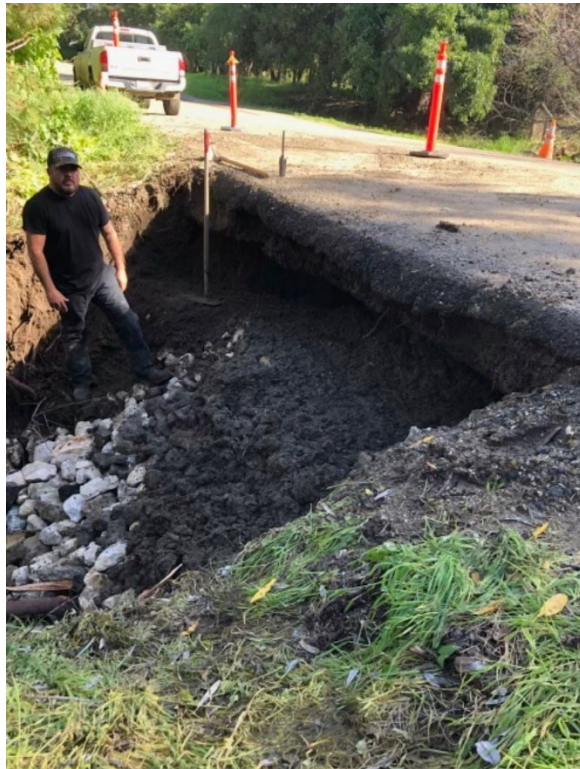
**Portion of Hollister Ranch Road undermined by January rains to the east of existing culvert crossing.**

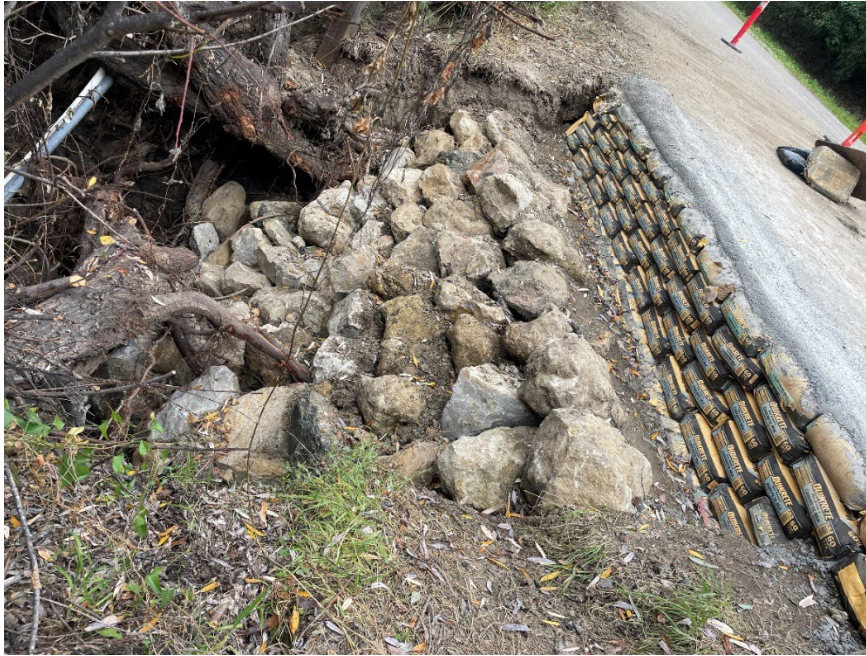
**Initial emergency repair performed to stop water undermining road (to be removed as part of this project). Void in Hollister Ranch Road was filled with native material and angular rock at the exposed edge created by the flood waters. Bags of Quikrete concrete were placed between top of rip rap and bottom of road for added stability.**

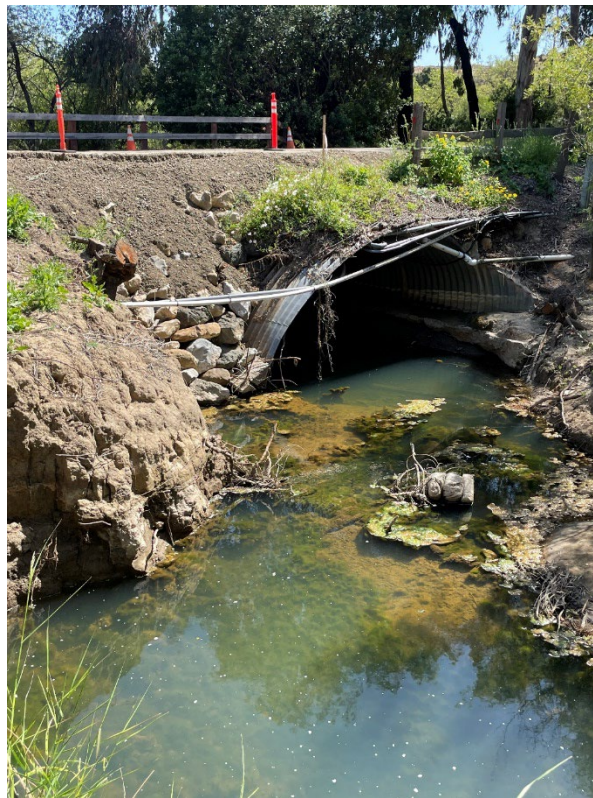
**View looking downstream (south) at Santa Anita Creek existing culvert crossing.**

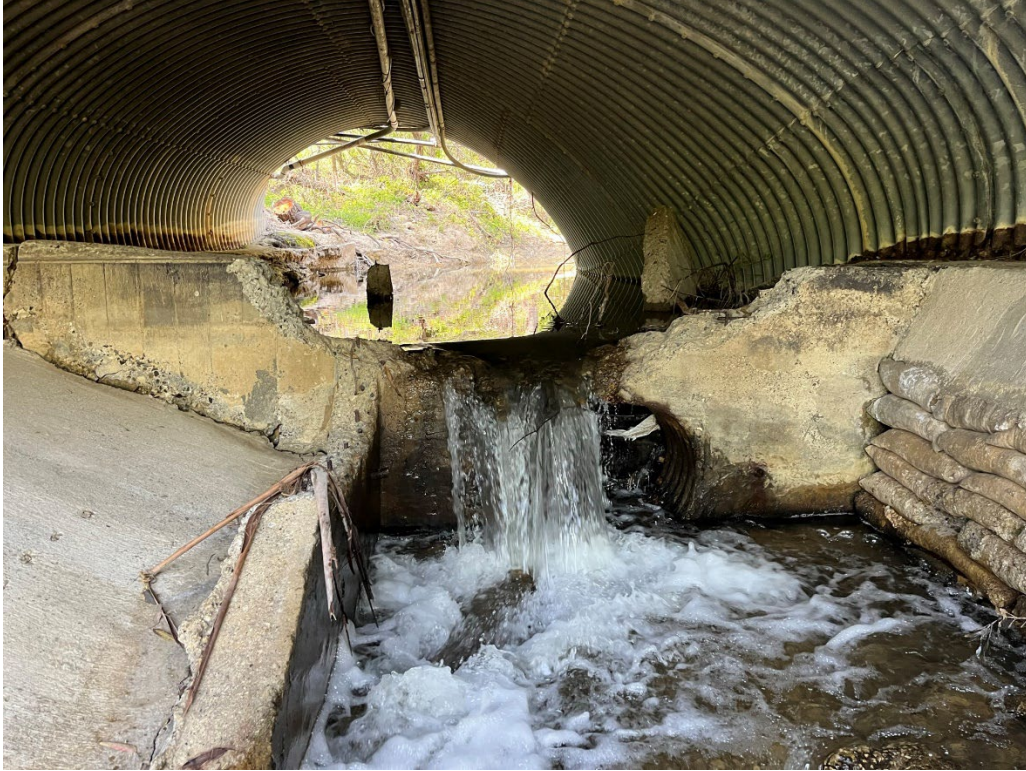
**View looking upstream (north) at previous at grade concrete crossing and failed bottomless arch corrugated metal pipe culvert.**
