PROPERTY CONDITION ASSESSMENT

SANTA BARBARA COUNTY DETENTION CENTER

**4434 Calle Real
Santa Barbara, California**

October 29, 2015

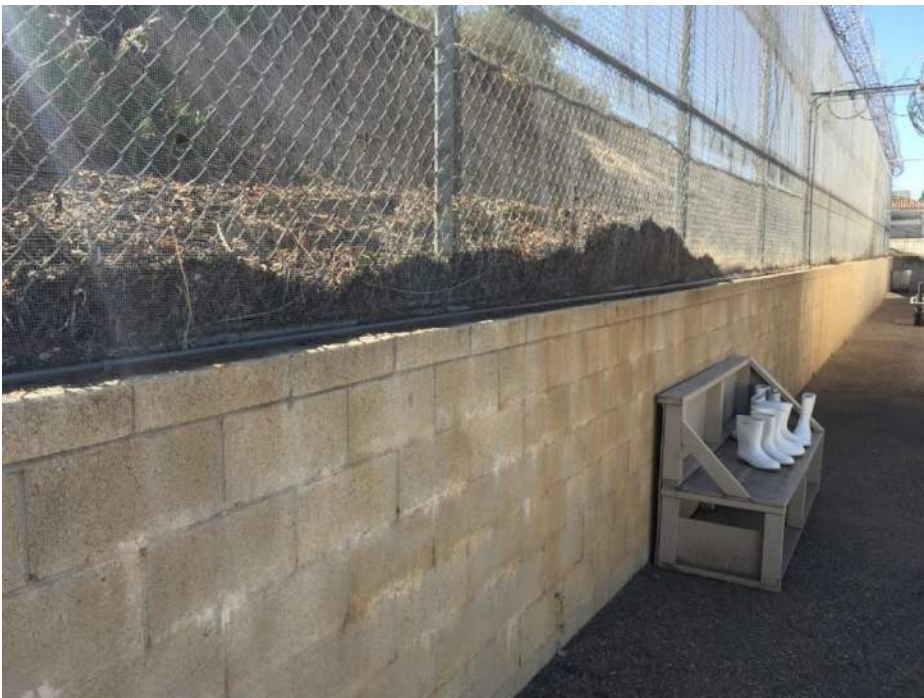
Photograph #4

At the east fence of the Honor Farm, damaged fencing and signs of erosion were noted.

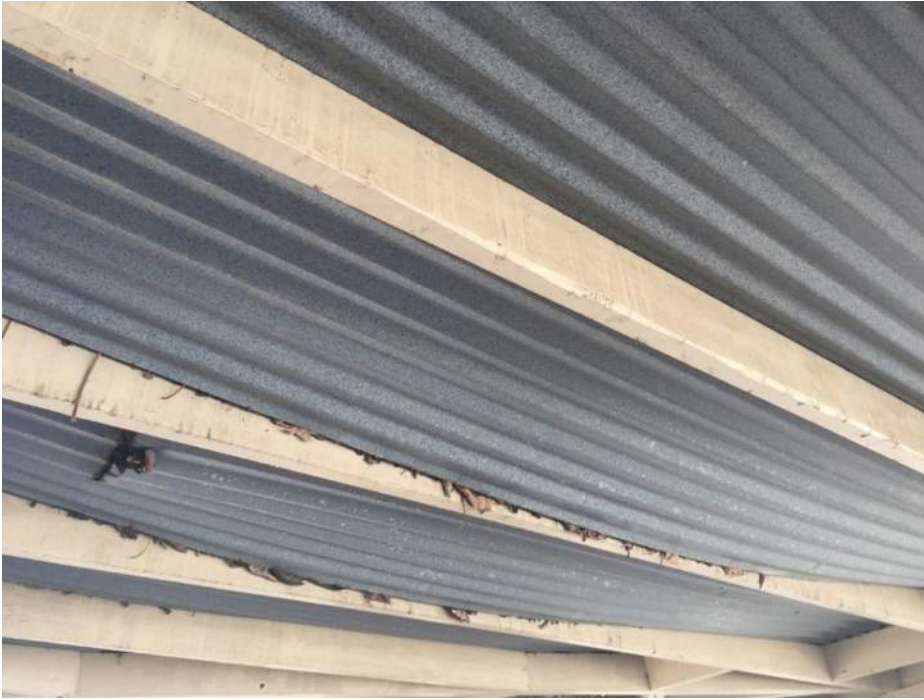
Photograph #9

Damaged roofs were noted at the shelters in the recreation yards at the Honor Farm.

Condition: Outdoor amenities for inmates are generally limited to recreation yards. At the Honor Farm, several wood-framed shade structures are provided, and are in need of roof and termite damage repair.

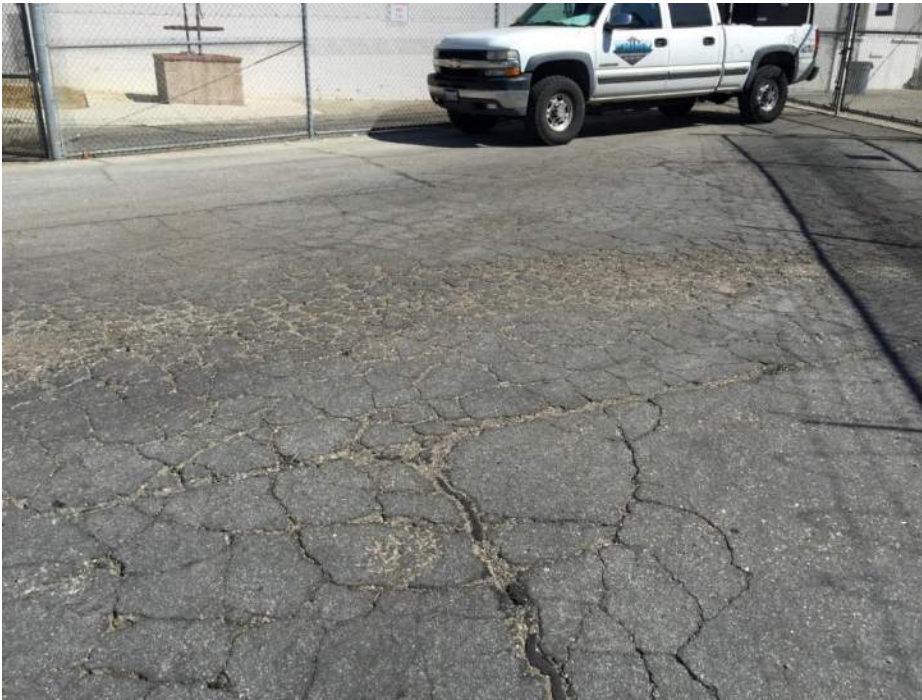
Photograph #11

Paved areas of the Honor Farm were noted to be cracked and raveled.

Condition: At the Honor Farm, the asphaltic concrete-paved parking lot is in generally fair condition and repaving is recommended. Minor cracking and differential settlement should be addressed within the term for the poured in place concrete curbs, gutters, and sidewalks.

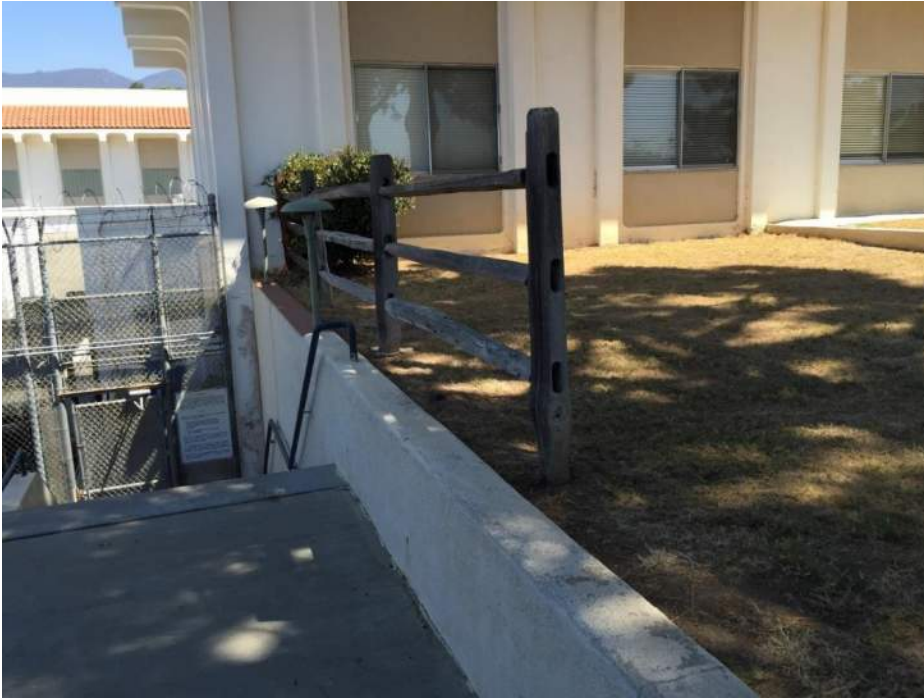
Photograph #21

Wood rails near the Main Jail entrance were noted to be in poor condition.

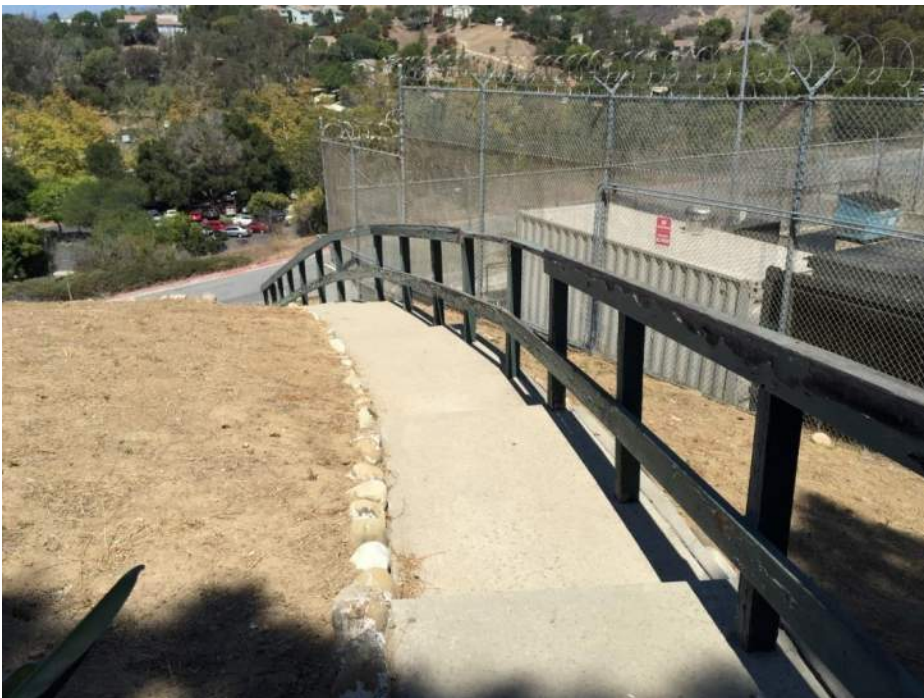
Photograph #22

The existing concrete stair and handrail at the Main Jail was noted to be in poor condition.

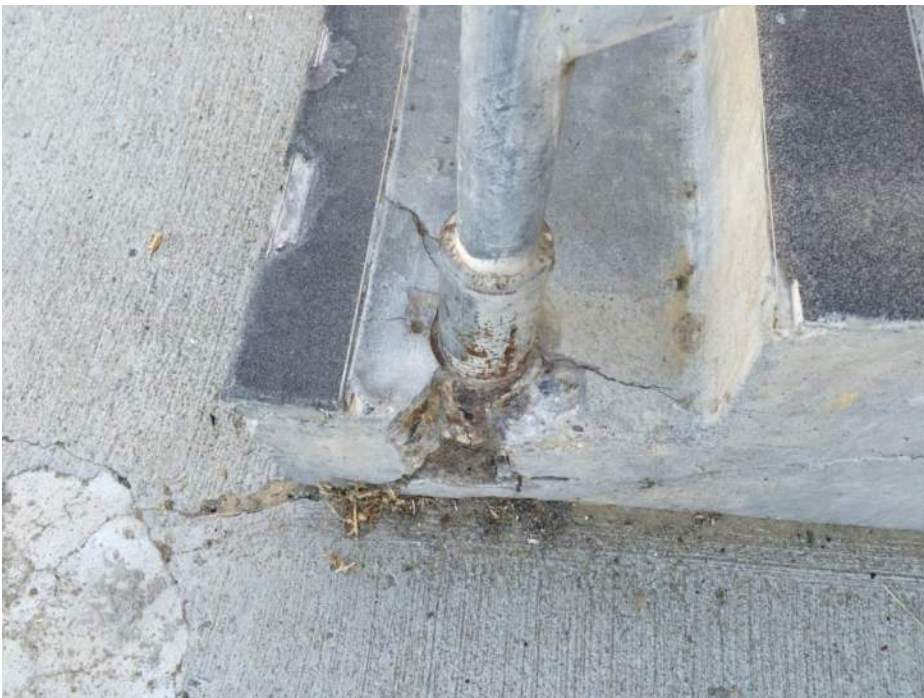
Photograph #24

Damaged areas of
concrete were noted
at several areas at
the Main Jail in the
West Dock area.

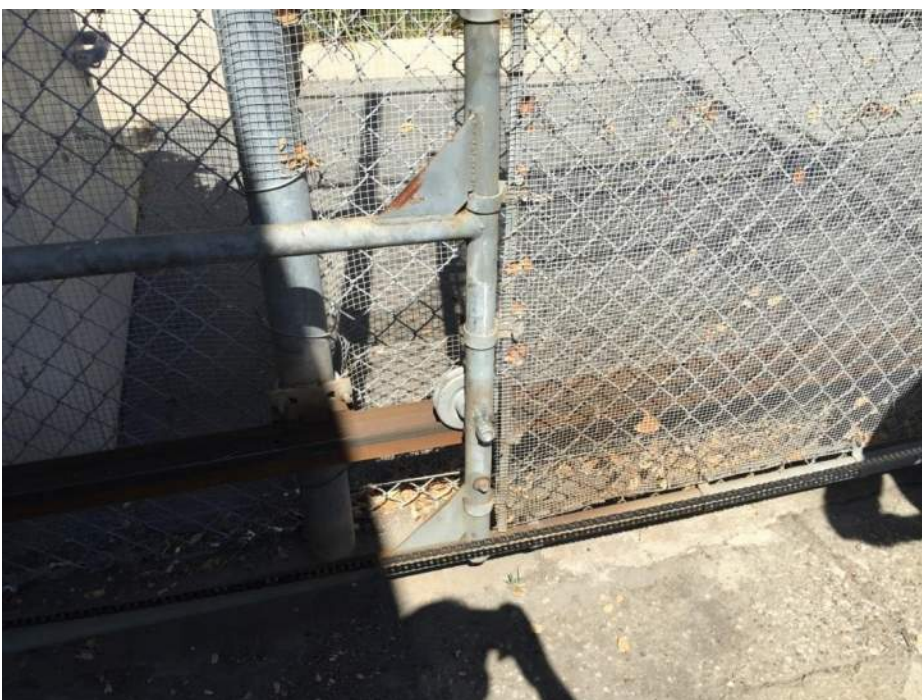
Photograph #30

Rust and wear was
noted at the IRC
gate.

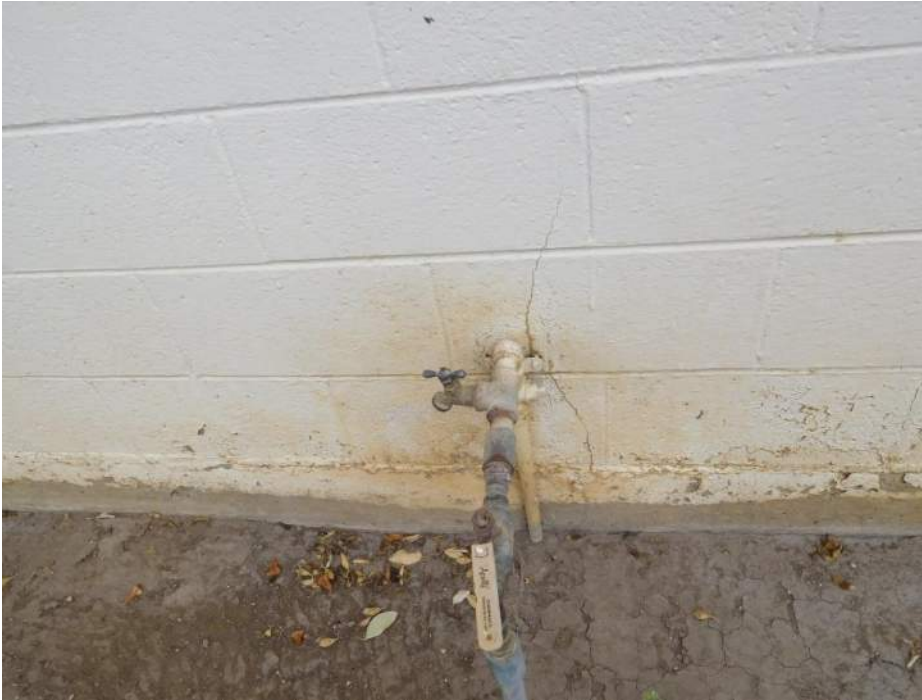
Photograph #37

Exterior walls with cracks, stains from dirt splash, and peeling paint in numerous locations at the Honor Farm will require repainting.

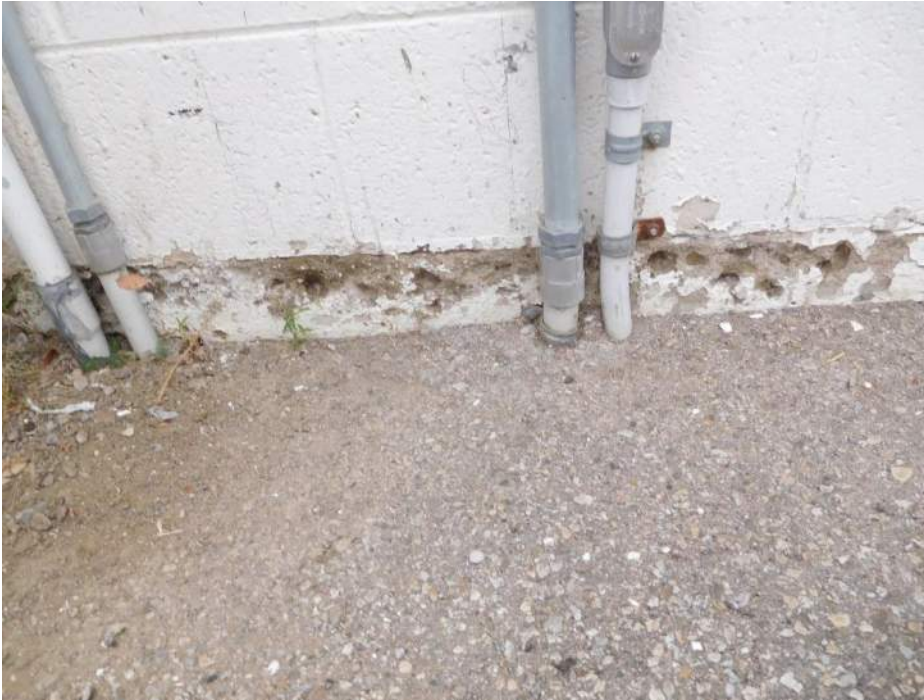
Photograph #41

Condition: The Honor Farm perimeter edges have spalling and popping due to reactive concrete aggregate, which expands in contact with moisture. Spalled areas should be patched and a protective sealant should be applied at exposed surfaces and up to 6" below the grade level.

Perimeter edges of the slab-on-grade have spalling and popping due to reactive concrete aggregate at the Honor Farm.

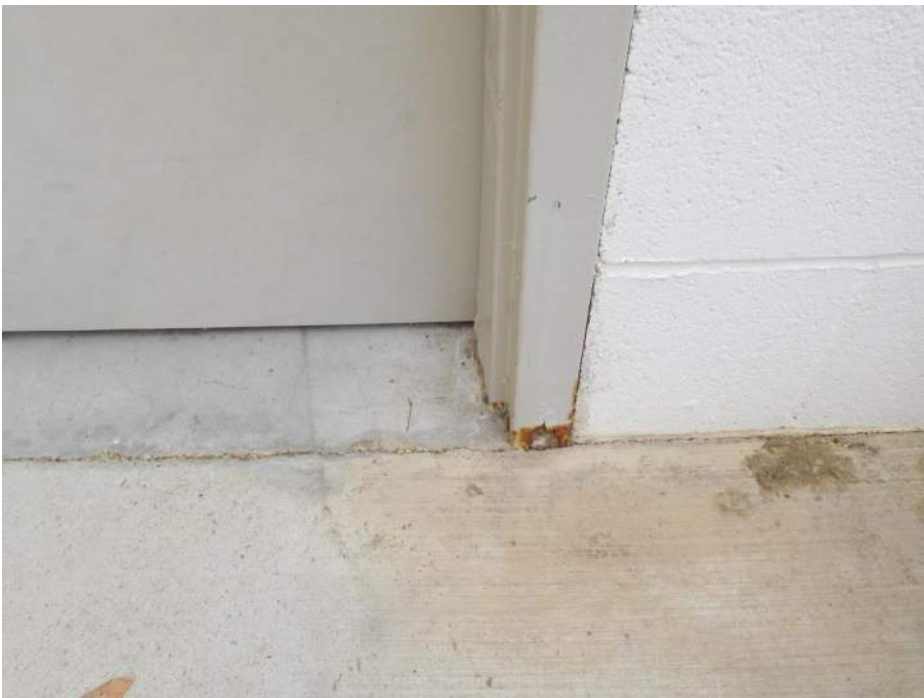
Photograph #42

Rusting perimeter door frames needing replacement at the Honor Farm.

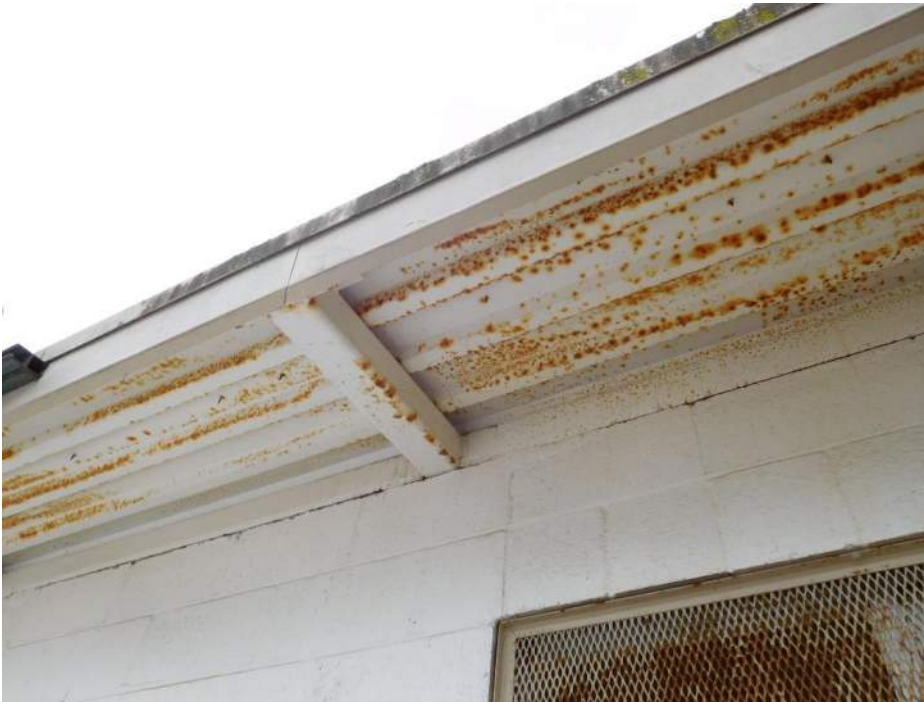
Photograph #43

Rusting perimeter metal deck and steel framing of overhang and window screen grate needing to be repainted at the Honor Farm.

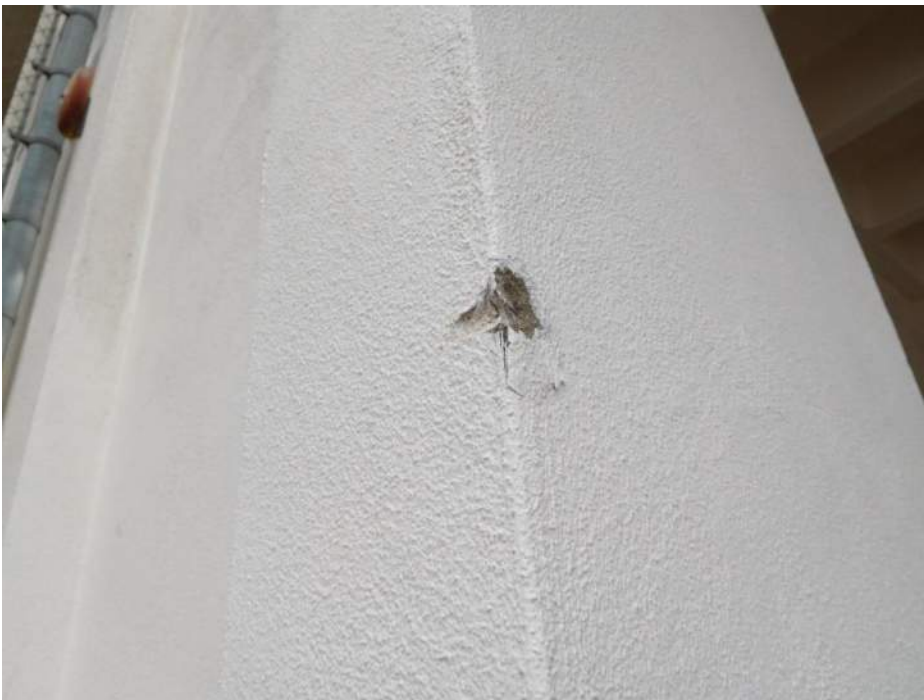
Photograph #44

Damaged plaster surface requiring repair at the Northwest Building.

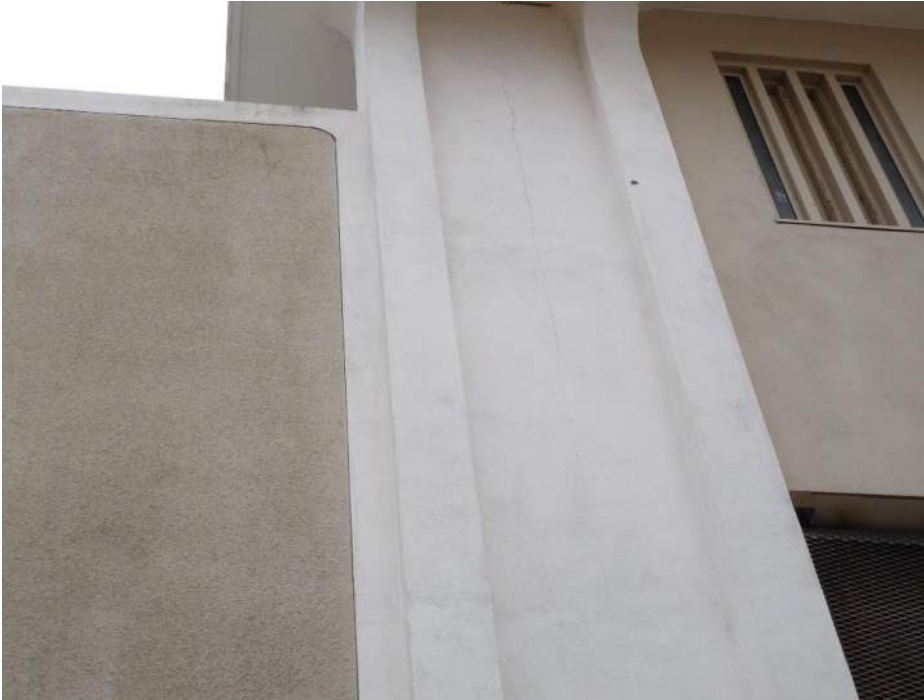
Photograph #45

Concrete masonry unit (CMU) walls have numerous cracks reading through the plaster surfacing, which is spalled in some areas, these will need repair and filling prior to painting at the Northwest Building.

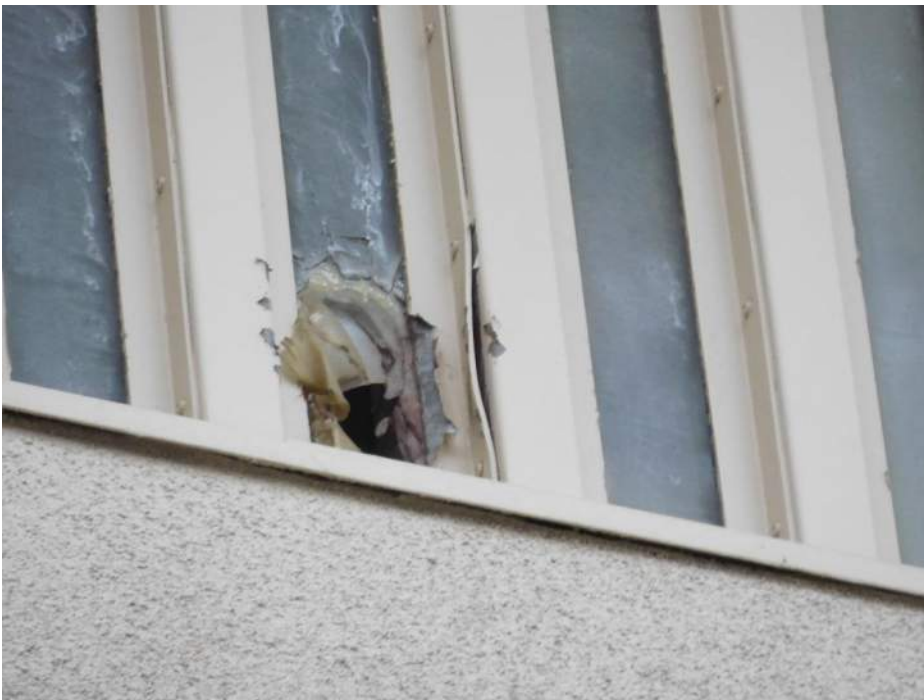
Photograph #46

Exterior single security window is broken and needs replacement at the Northwest Building.

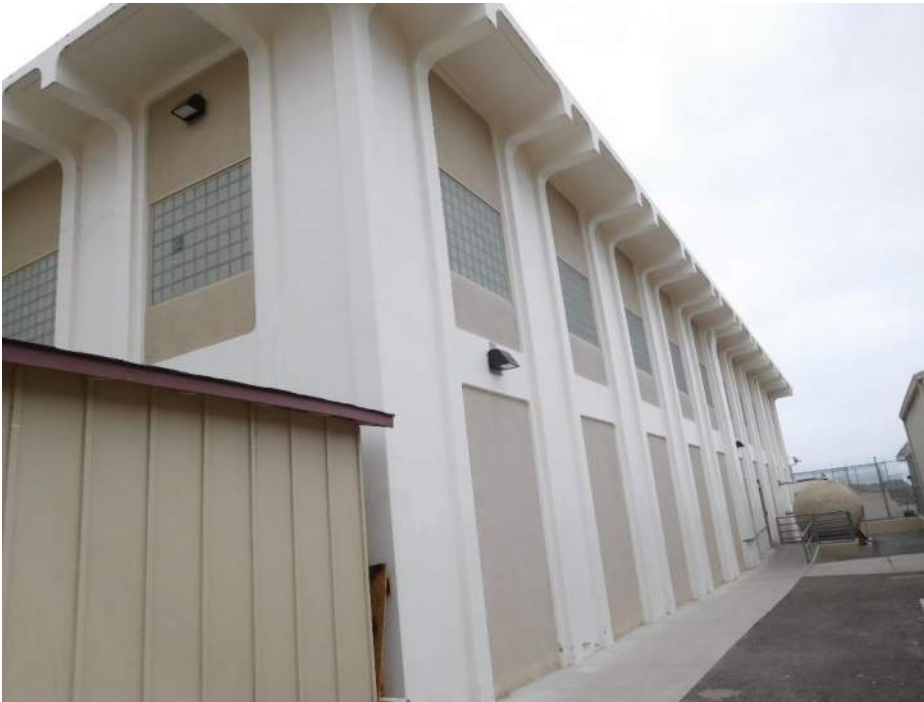
Photograph #47

Exterior walls need repainting at the Main Jail.

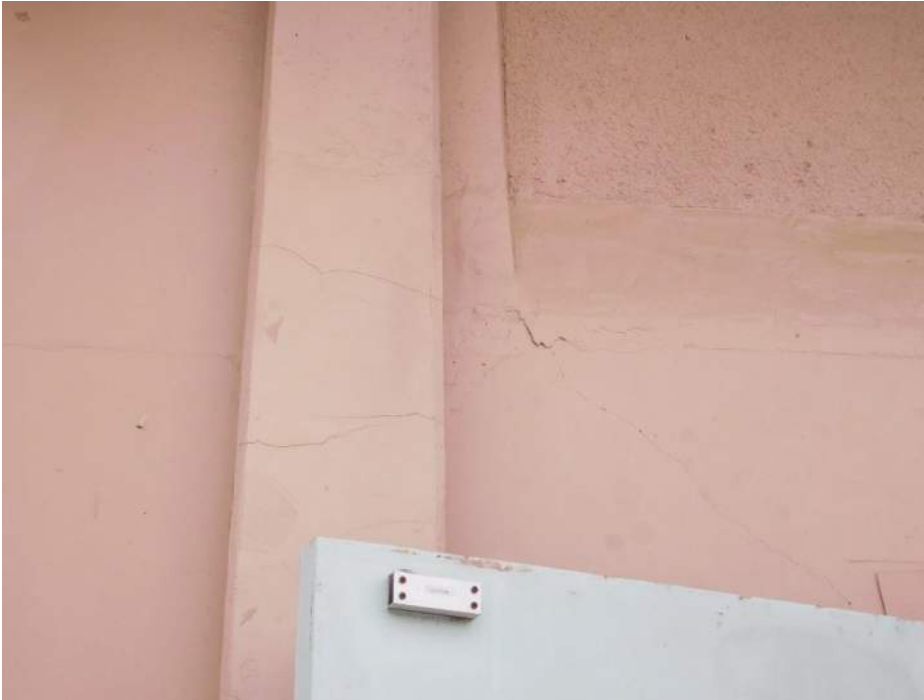
Photograph #49

At the main exercise yard side entry door, cracking was noted at the concrete column and the CMU wall pier, which will require epoxy repair at the Main Jail.

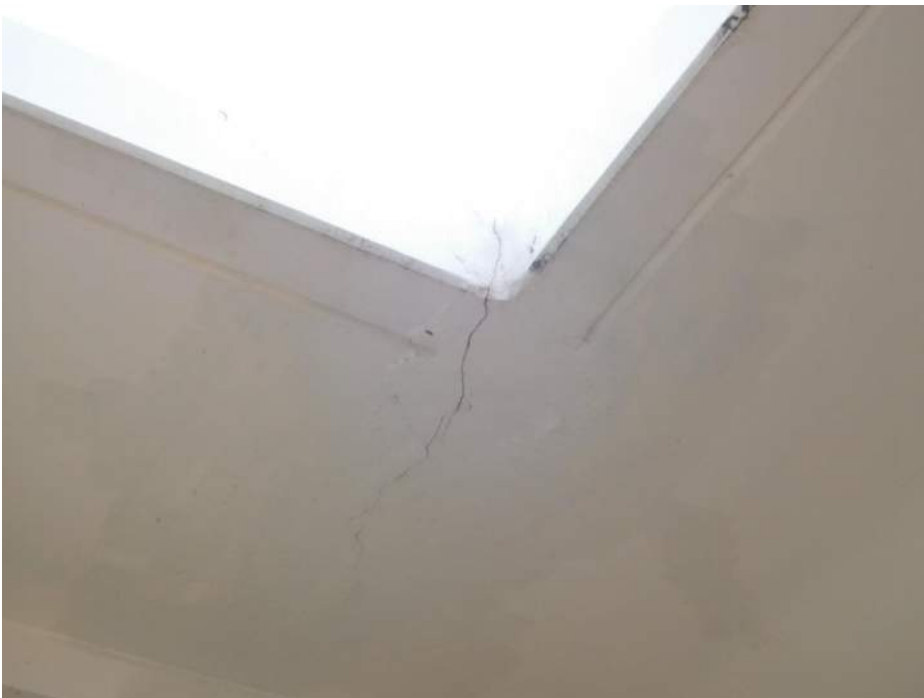
Photograph #50

Cracking was noted at the exterior concrete door canopies and roof slab reentrant corners, which will require epoxy repair at the Main Jail.

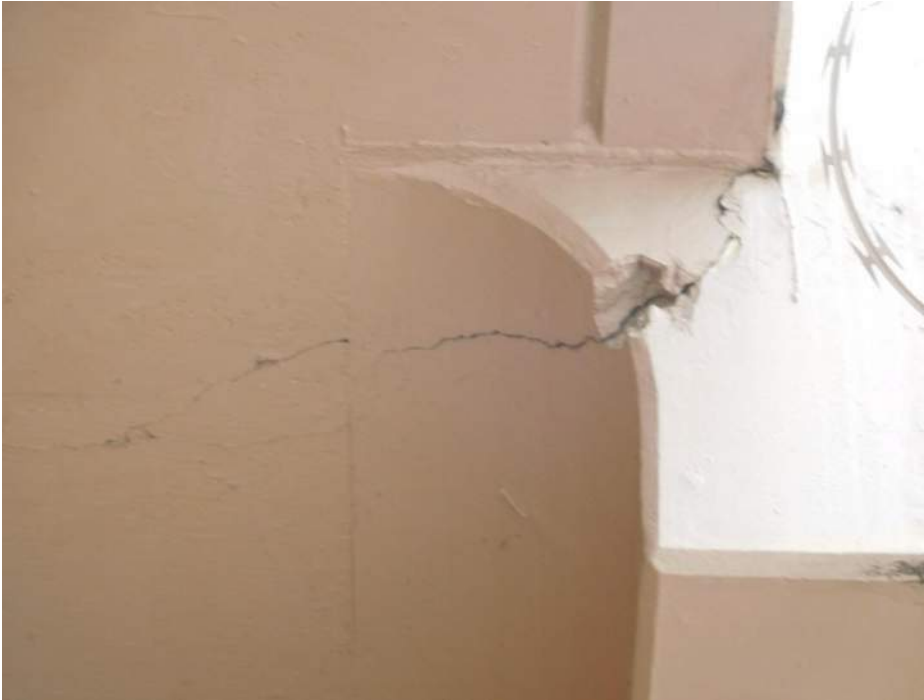
Photograph #51

Cracking was noted at the exterior concrete roof slab reentrant corner, which will require epoxy repair at the Main Jail.

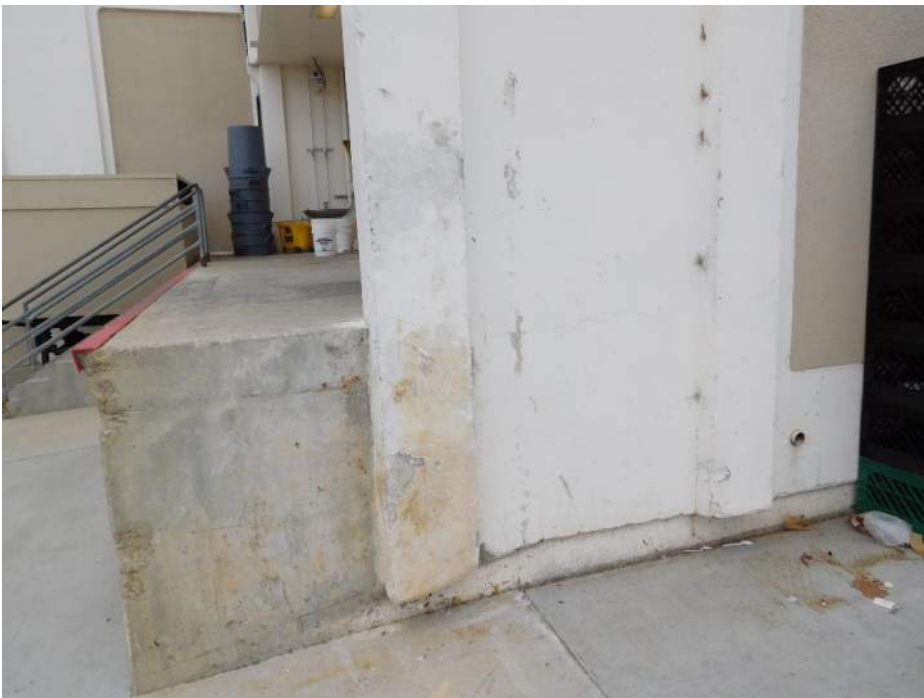
Photograph #52

Building exterior walls require repainting at the Main Jail.

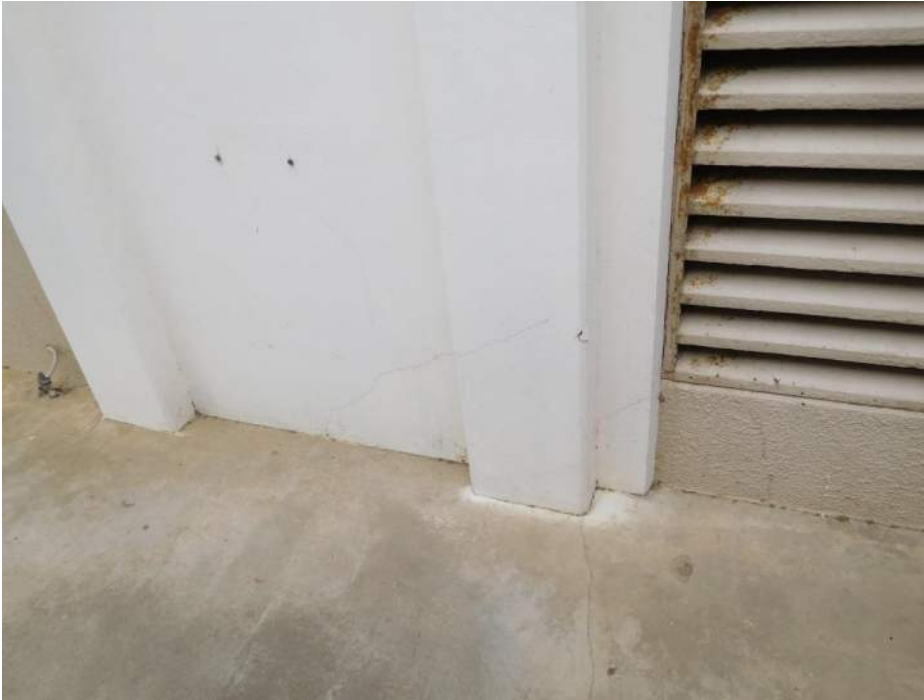
Photograph #53

CMU walls have numerous cracks reading through the plaster surfacing, which is spalled in some areas, these will require repair and filling prior to painting at the Main Jail.

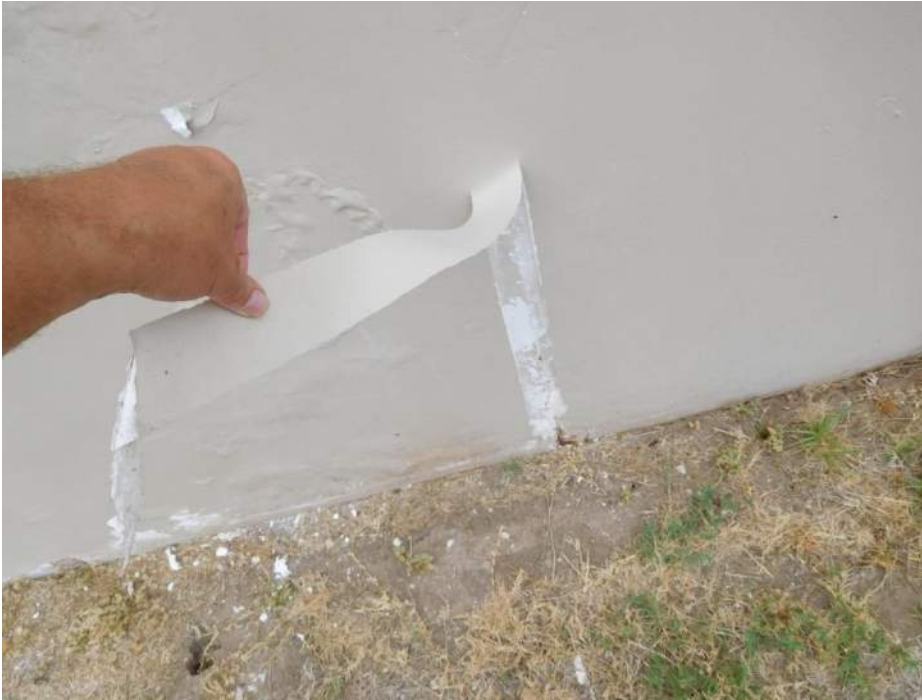
Photograph #55

South entry, women's section walls have one area of infill with metal studs and plaster where the plaster is deteriorating and drywall tape is separating at the Main Jail.

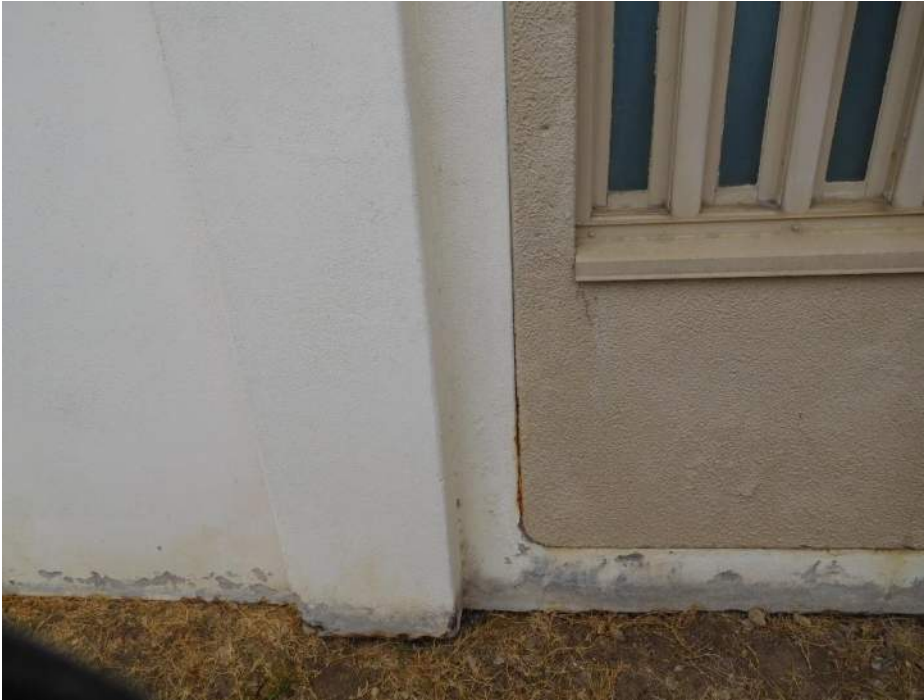
Photograph #57

The metal screeds of the architectural plaster are rusting and will need to be replaced at the IRC.

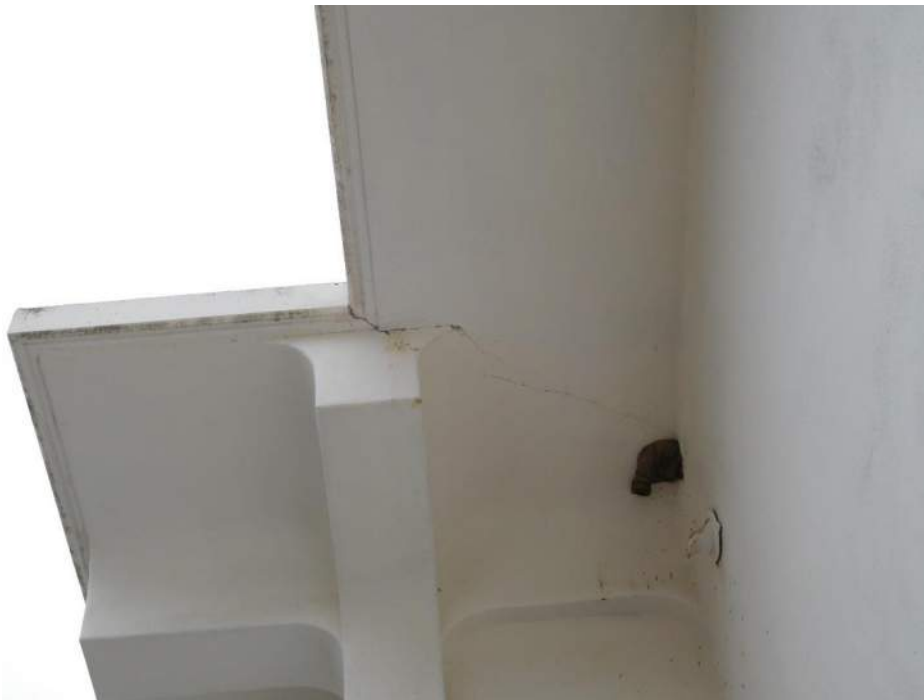
Photograph #58

Exterior concrete roof slab reentrant corners have cracking that needs Epoxy repair at the IRC.

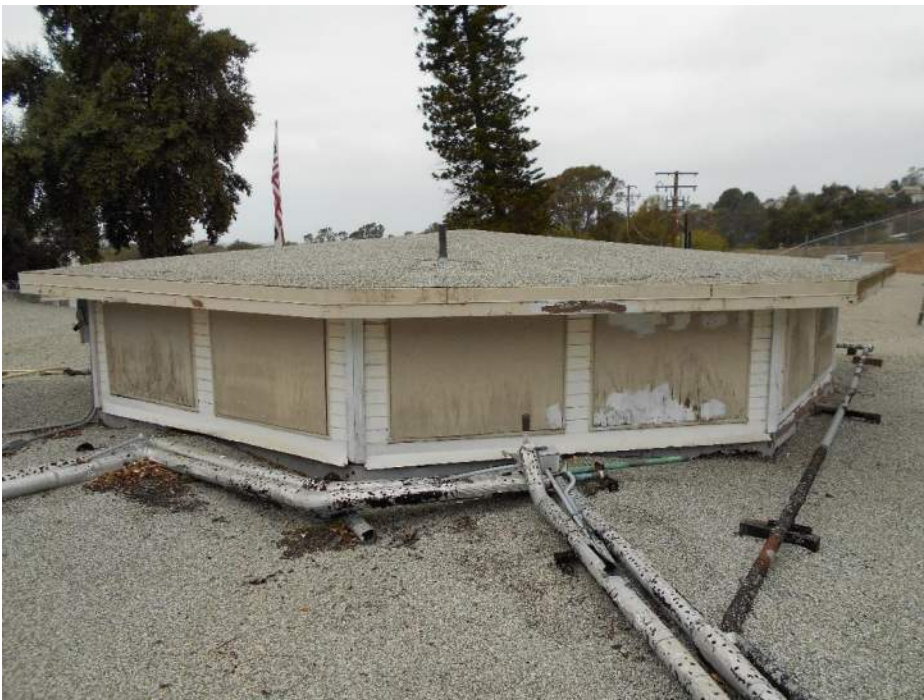
Photograph #60

Roof tower with moisture damaged wood at the Honor Farm.

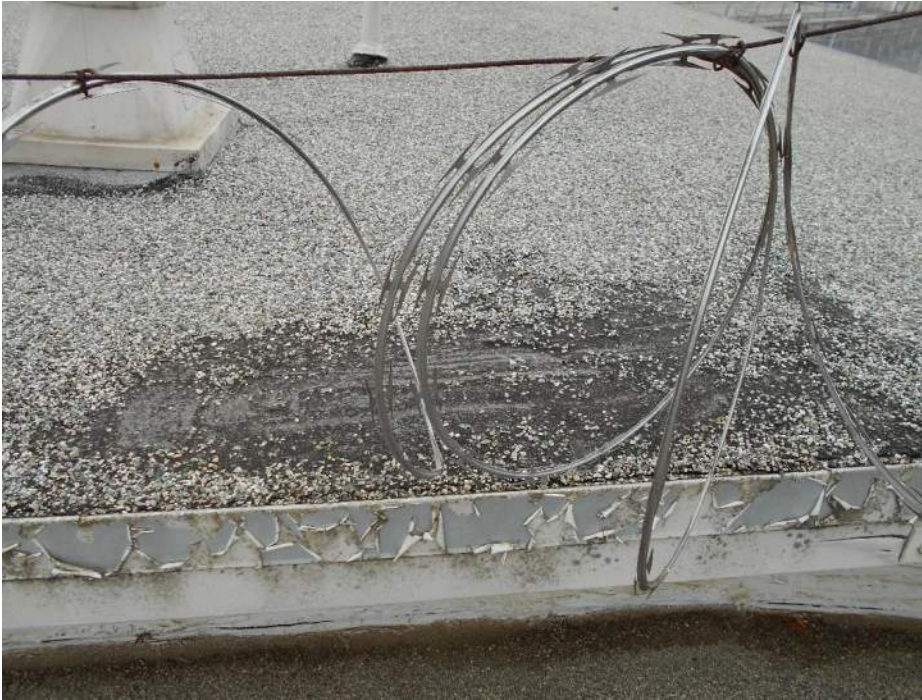
Photograph #61

Gravel scraped off by the razor wire, deteriorated paint at metal, and cracked sealant at the base flashing at the Honor Farm.

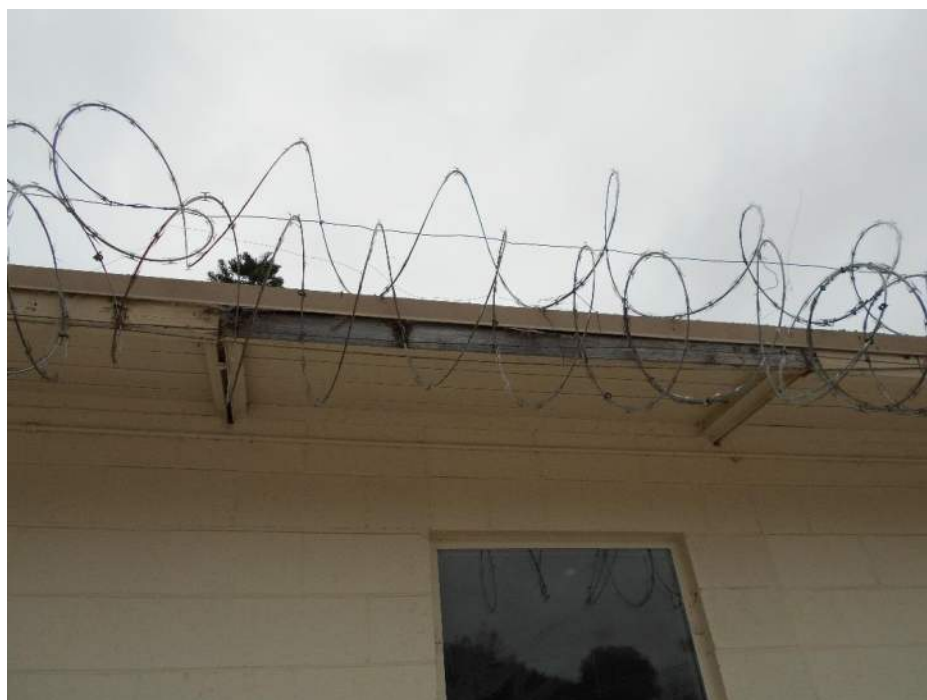
Photograph #64

Wood fascia and soffits with moisture damage at the Honor Farm.

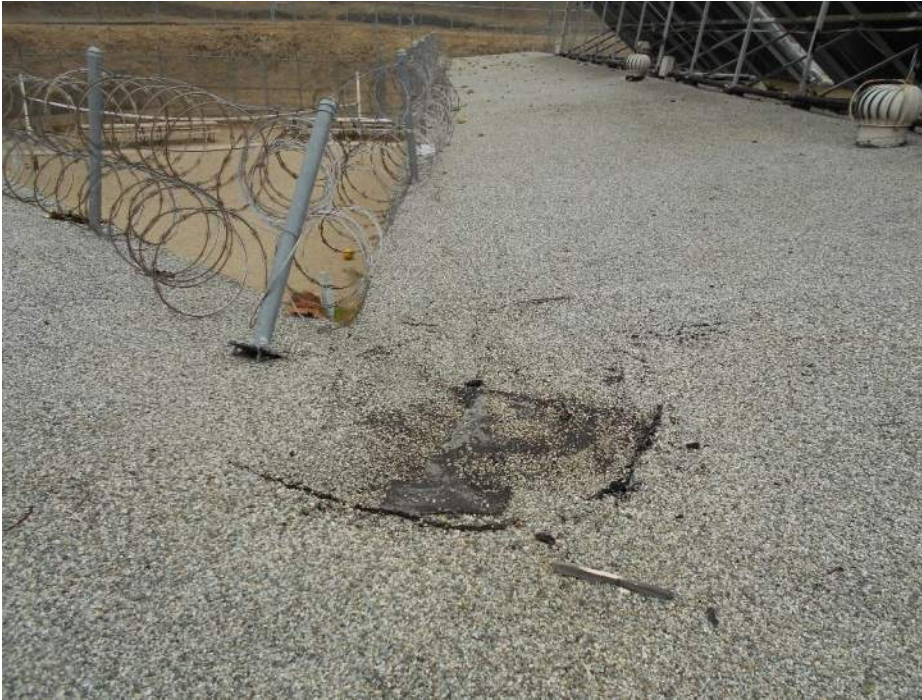
Photograph #65

Patched roof areas at the Honor Farm where leaks have been reported.

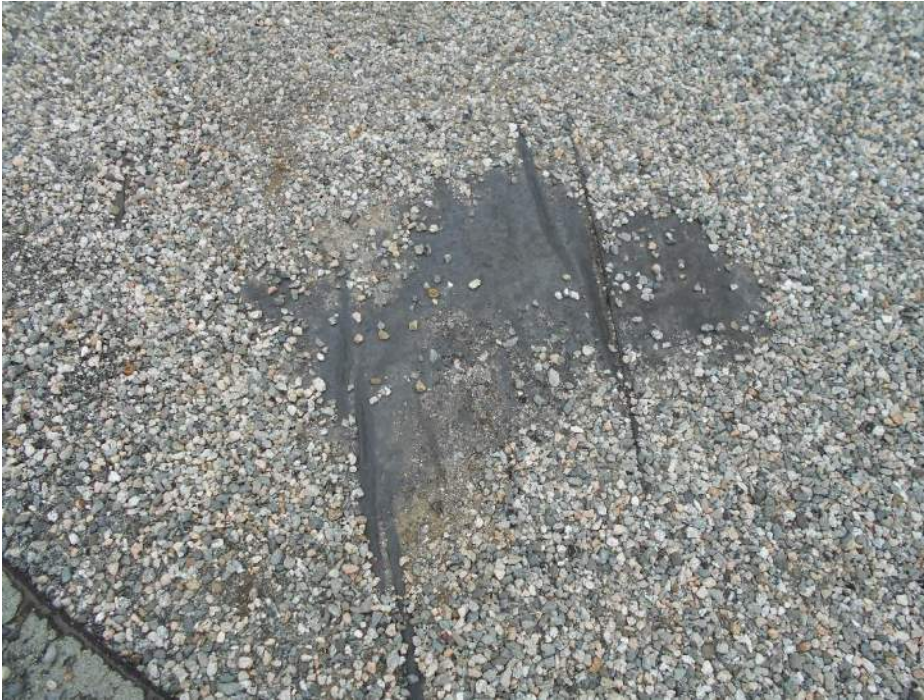
Photograph #69

Roof materials are ridging in some areas at the Northwest Building.

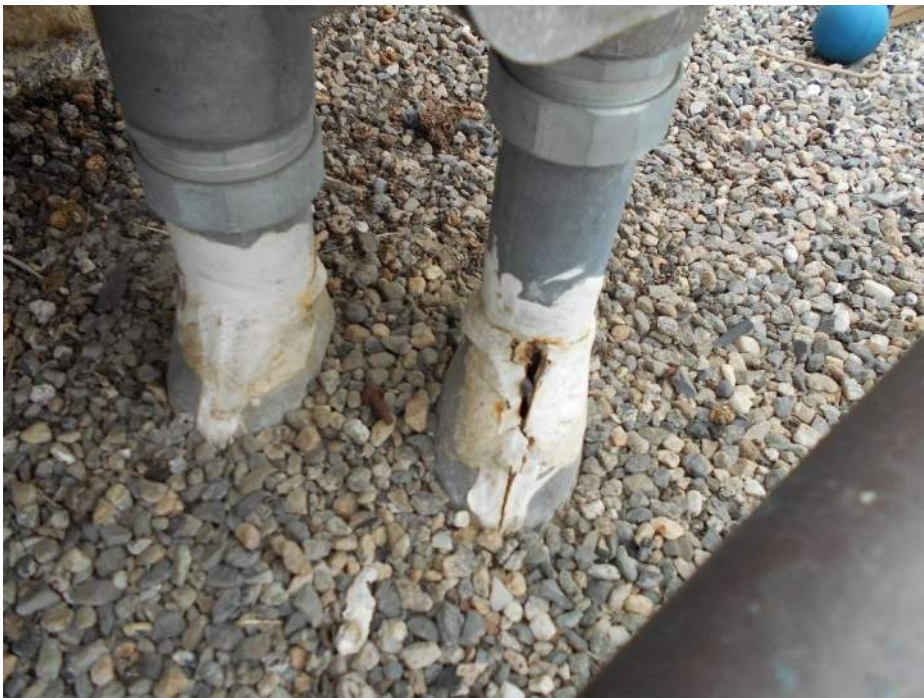
Photograph #70

Cracked flashing was noted at the pipe penetration at the Northwest Building.

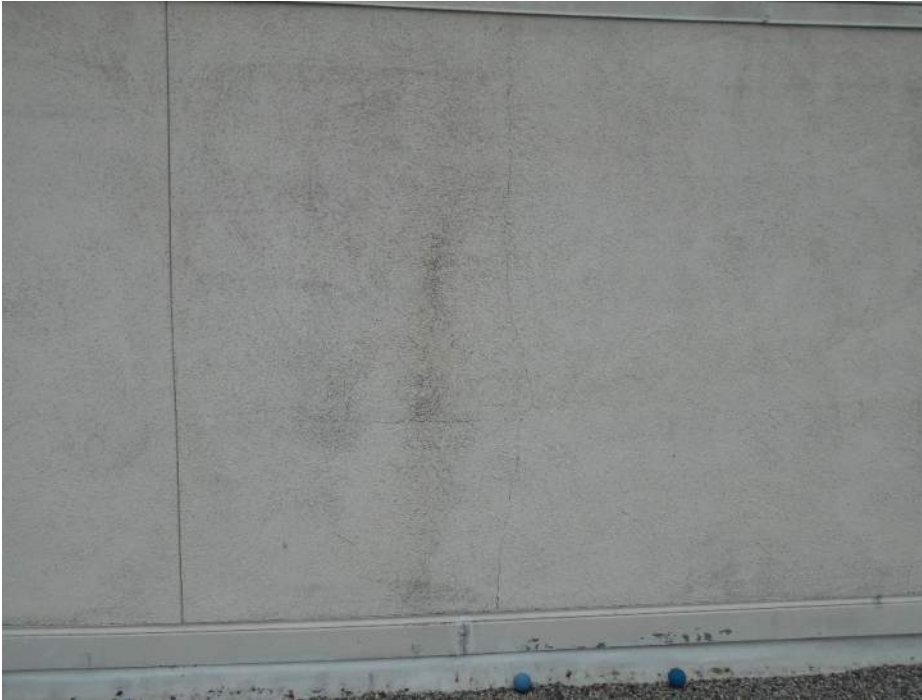
Photograph #71

Cracked stucco was noted at the backside of the parapet walls at the Northwest Building.

Condition (cont.): Stucco cracks were observed at the main roof parapet walls and should be painted with an elastomeric paint. The sheet metal parapet cap sealant is cracked at the joints and should be removed and replaced. Loose Plexiglas sheets, racquetballs, and wood sleepers were observed on the roof and should be removed as part of the budget for annual roof maintenance. Minor localized areas of cracked clay roof tiles should be replaced. An annual budget should be provided for annual roof maintenance.

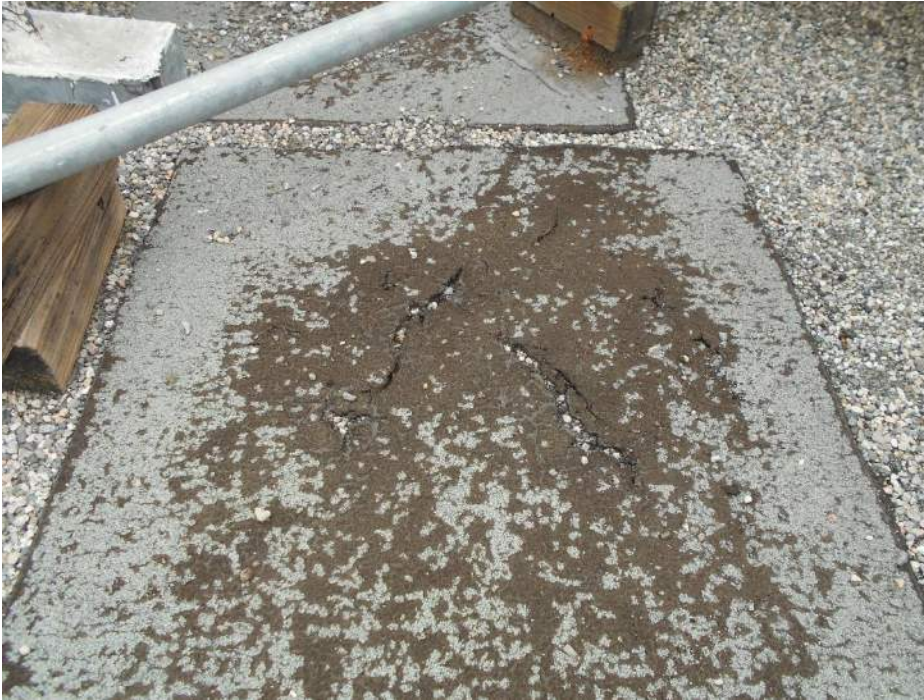
Photograph #73

Deterioration of the
roof walk pads at the
Northwest Building.

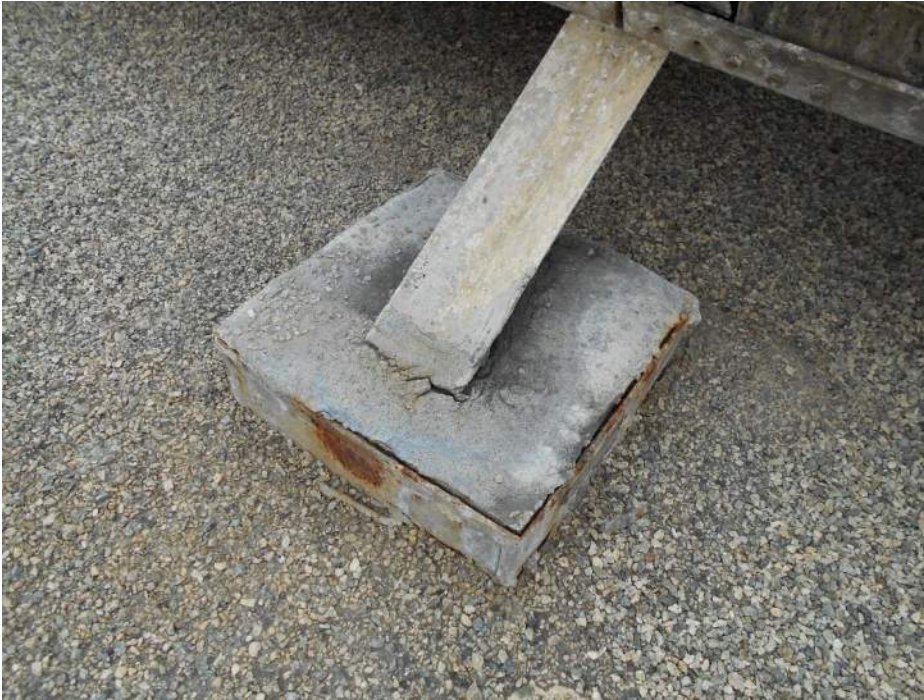
Photograph #77

Metal corrosion occurring at the roof pitch pocket flashing and cracked sealant at the Main Jail.

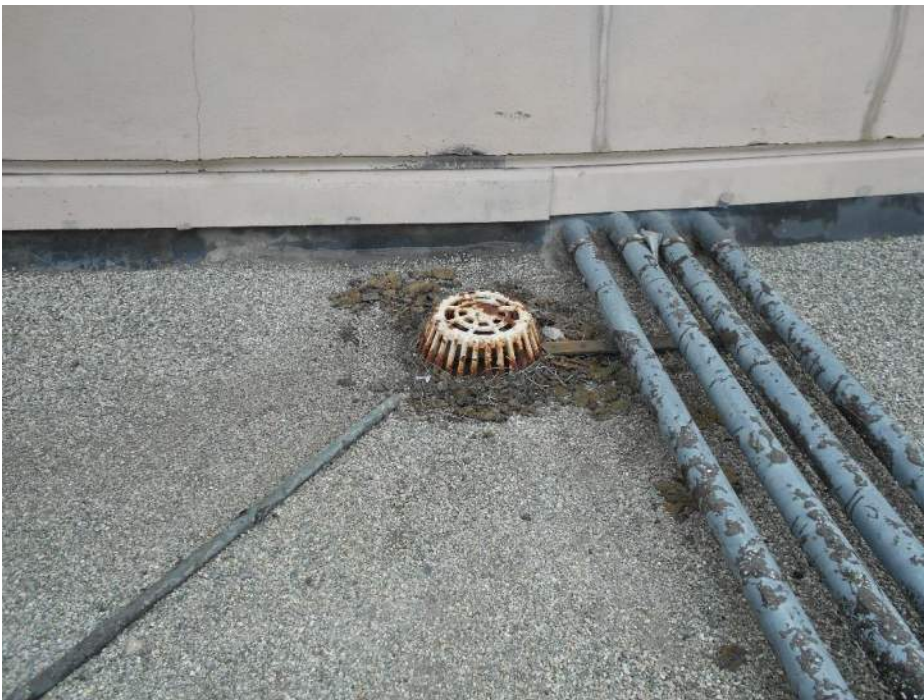
Photograph #78

Debris at the roof drains at the Main Jail.
