PROPERTY CONDITION ASSESSMENT

SANTA BARBARA COUNTY DETENTION CENTER

**4434 Calle Real
Santa Barbara, California**

October 29, 2015

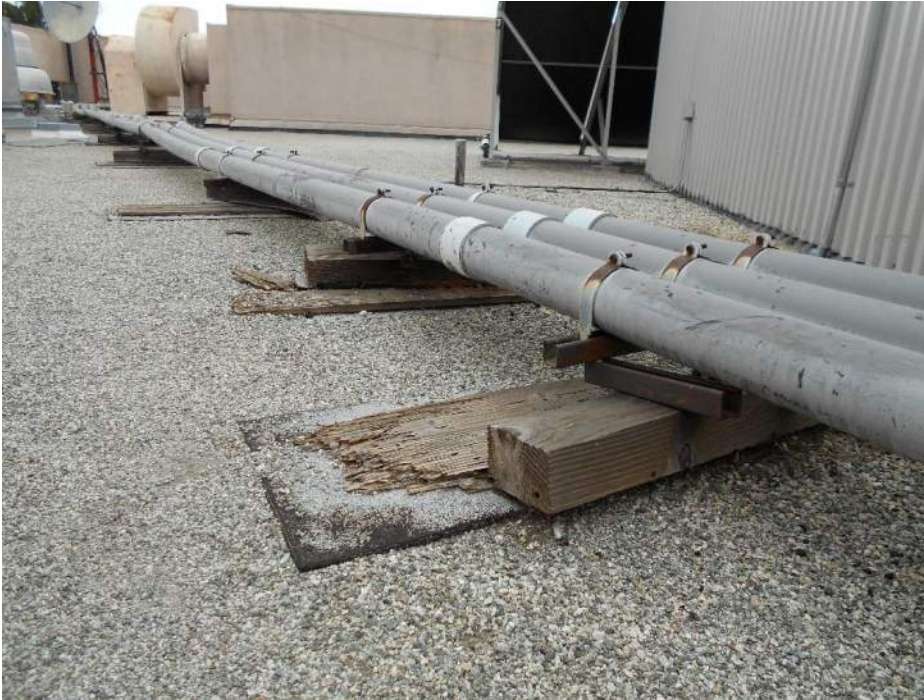
Photograph #79

Wood supports at the 911 system conduits are deteriorated and need to be replaced at the Main Jail.

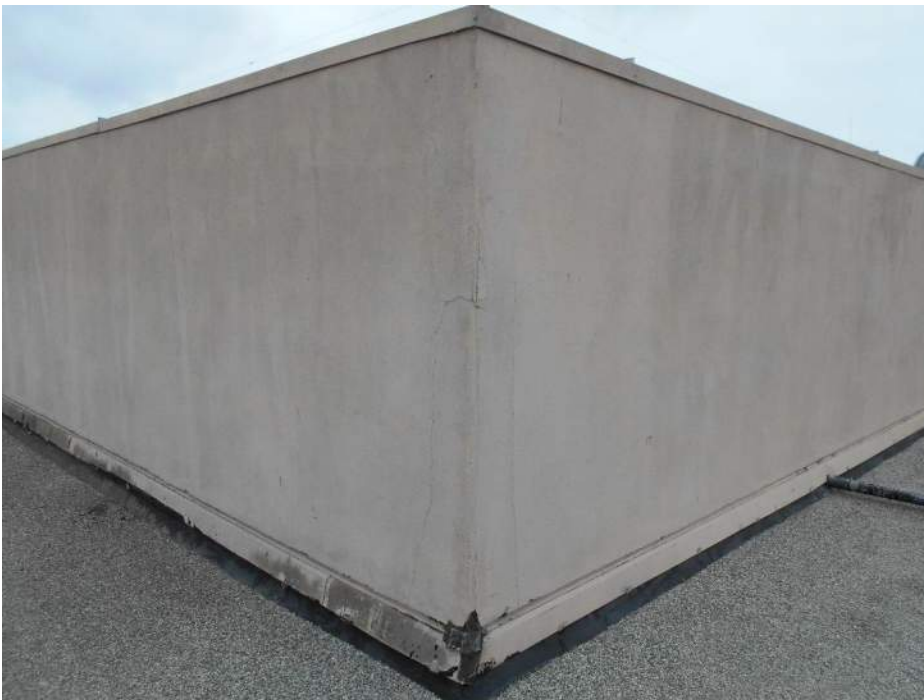
Photograph #80

Typical stucco roof parapet wall with cracking occurring at the Main Jail.

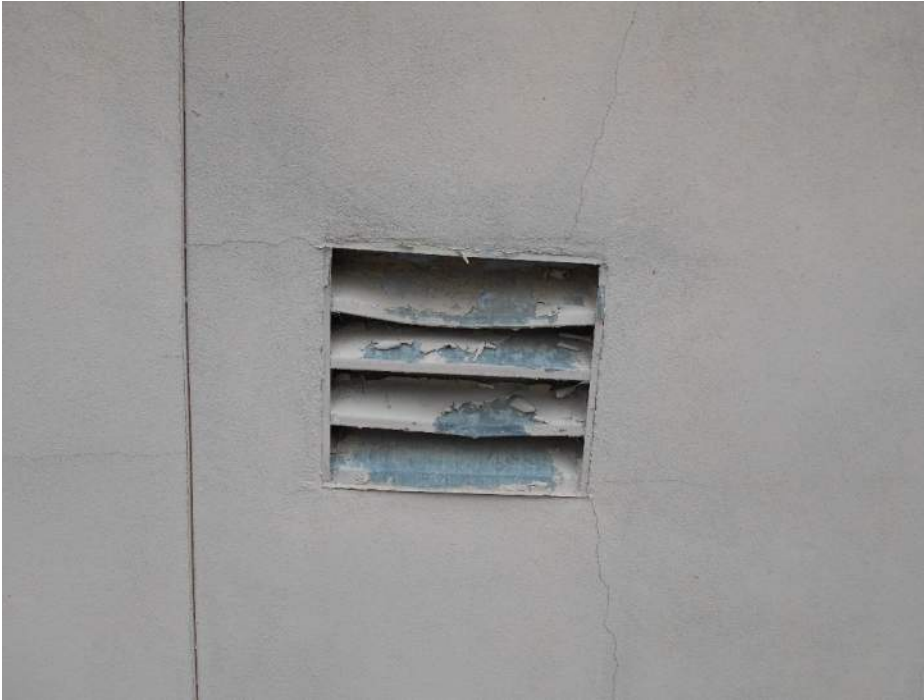
Photograph #81

Damaged metal vents and stucco cracking at the roof parapet walls at the Main Jail.

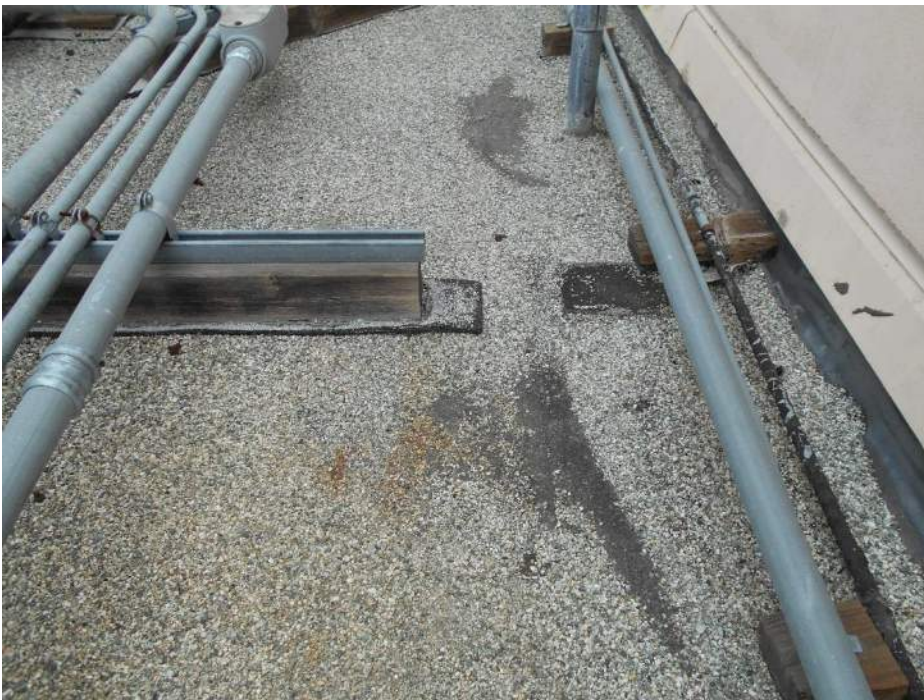
Photograph #82

Exposed roofing and cracking of the roof ply at the Main Jail.

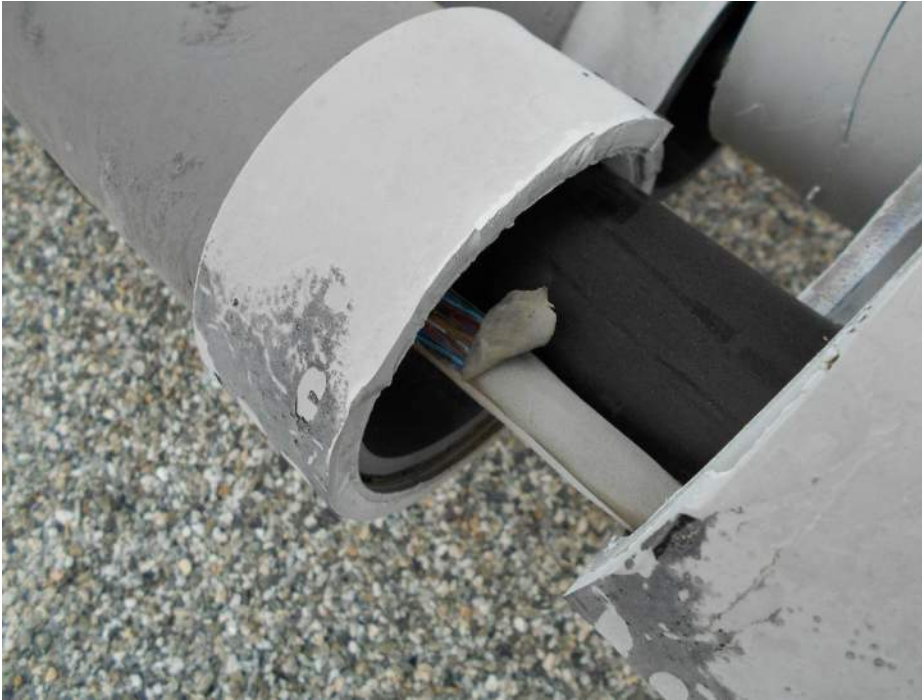
Photograph #83

Exposed cables at the 911 system conduits on the roof at the Main Jail.

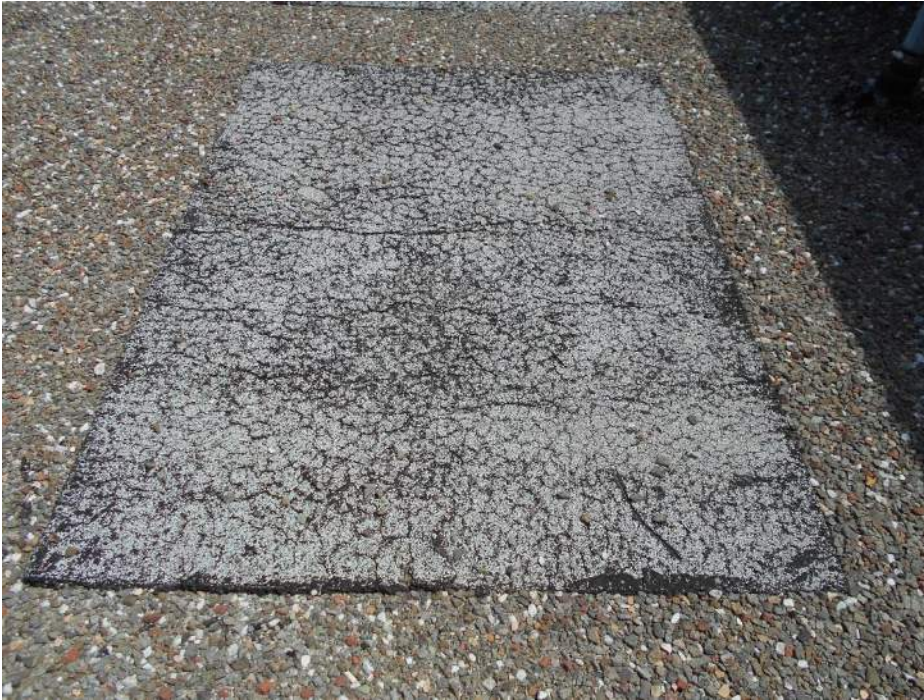
Photograph #87

Deteriorated roof walk pads at the IRC building.

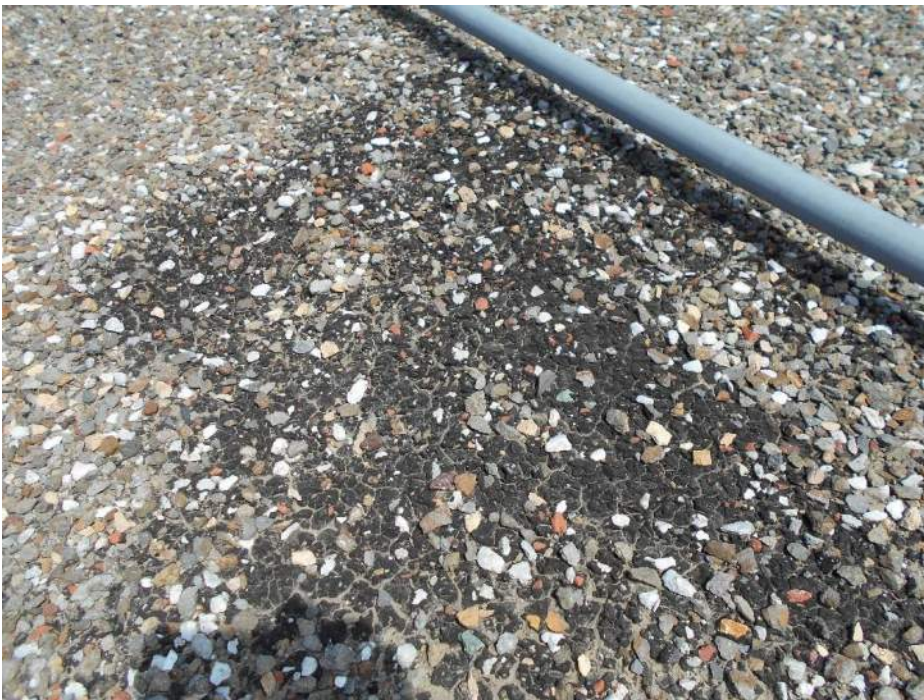
Photograph #88

The IRC building roofing system is generally in poor condition. The roof has exceeded its useful life and should be replaced at the beginning of the term. It was reported by the facilities manager that the roof is approximately 20 years old and has had experienced occasional minor leaks. Areas of exposed roofing were observed with cracking and fraying of the roof membrane with little to no gravel coverage in some areas.

Areas of roofing with missing gravel and exposed roof ply with cracking and deterioration at the IRC building.

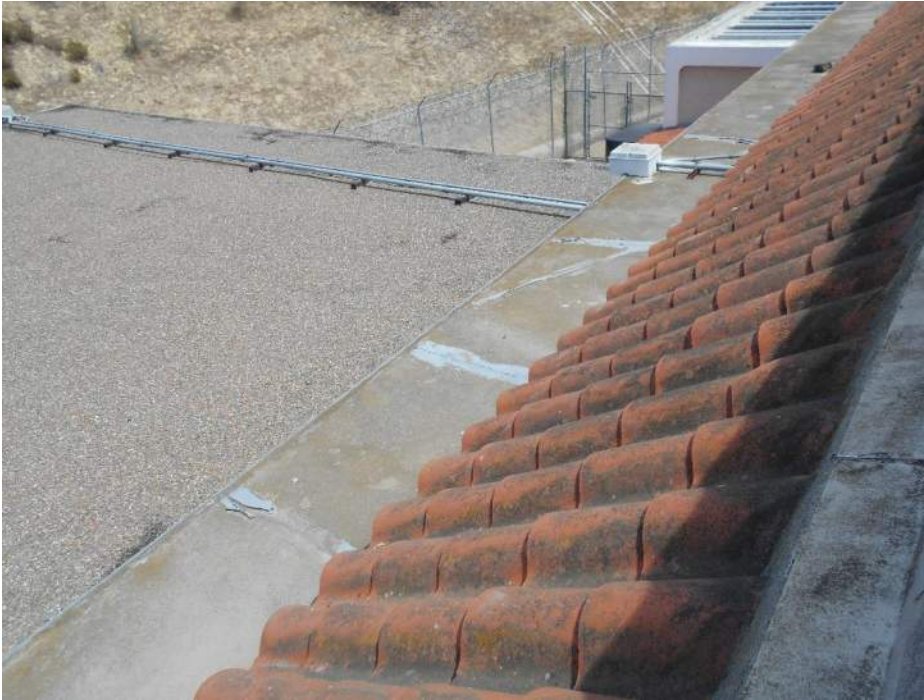
Photograph #89

Clay tile roofing and rolled roofing at the roof edge with failed sealant at the IRC building

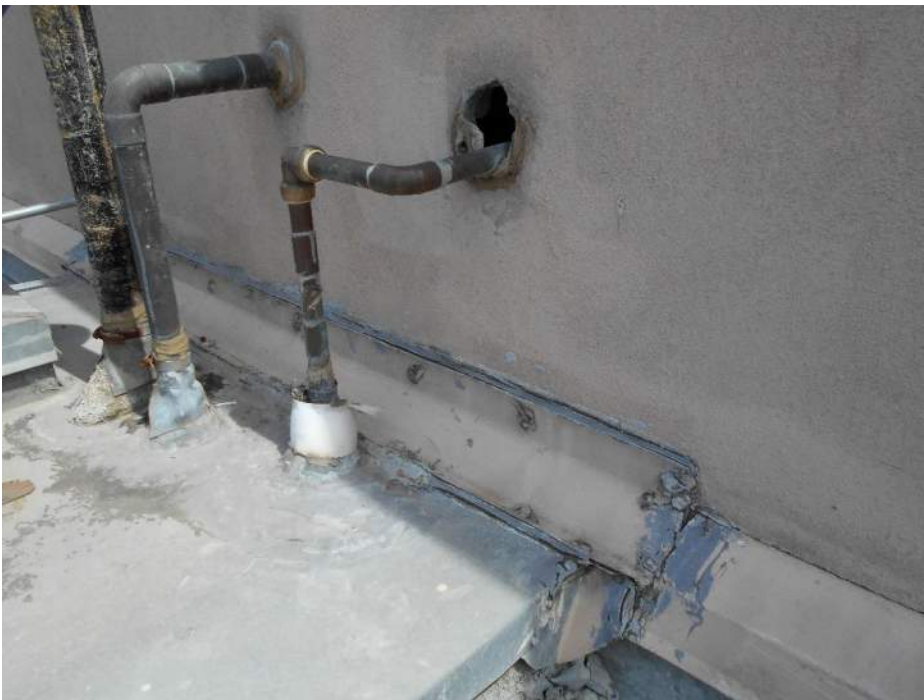
Photograph #90

Hole in the parapet wall pipe penetration, improperly flashed pipe boots, and failed sealant at the metal flashing at the IRC building.

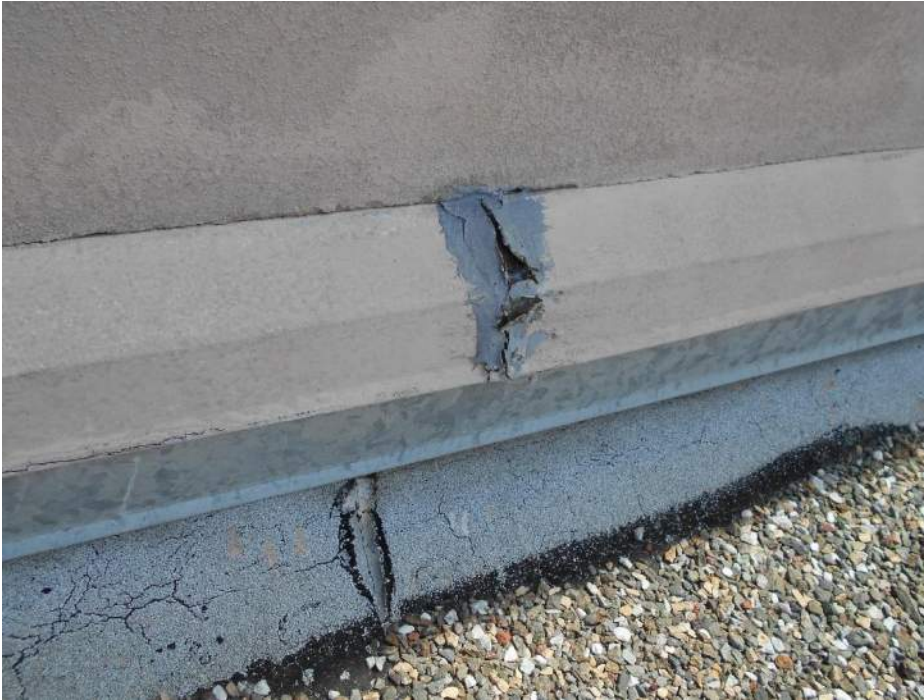
Photograph #91

Metal corrosion at the roof flashing and open joint at the rolled roofing at the IRC building.

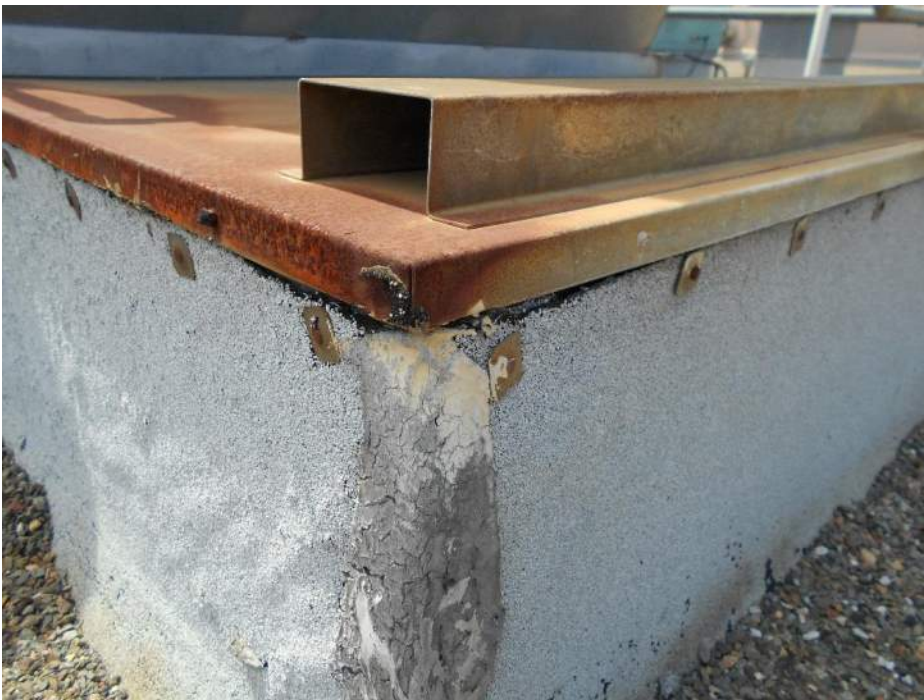
Photograph #92

Improperly installed roofing at the mechanical platform with open joint at the top of the IRC building.

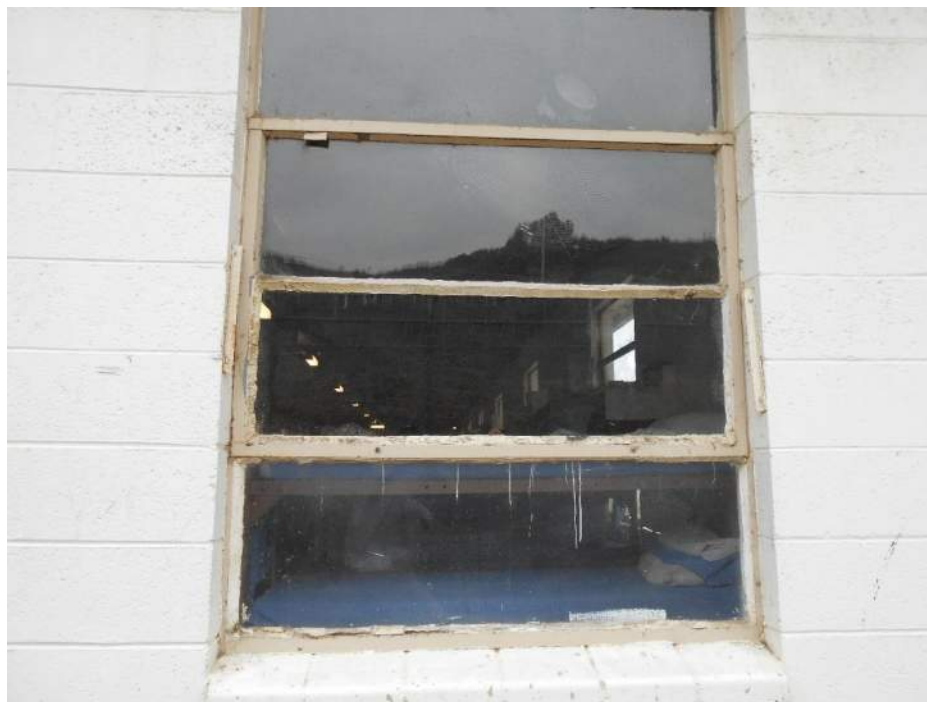
Photograph #95

Windows with cracked and deteriorated sealants at the Honor Farm.

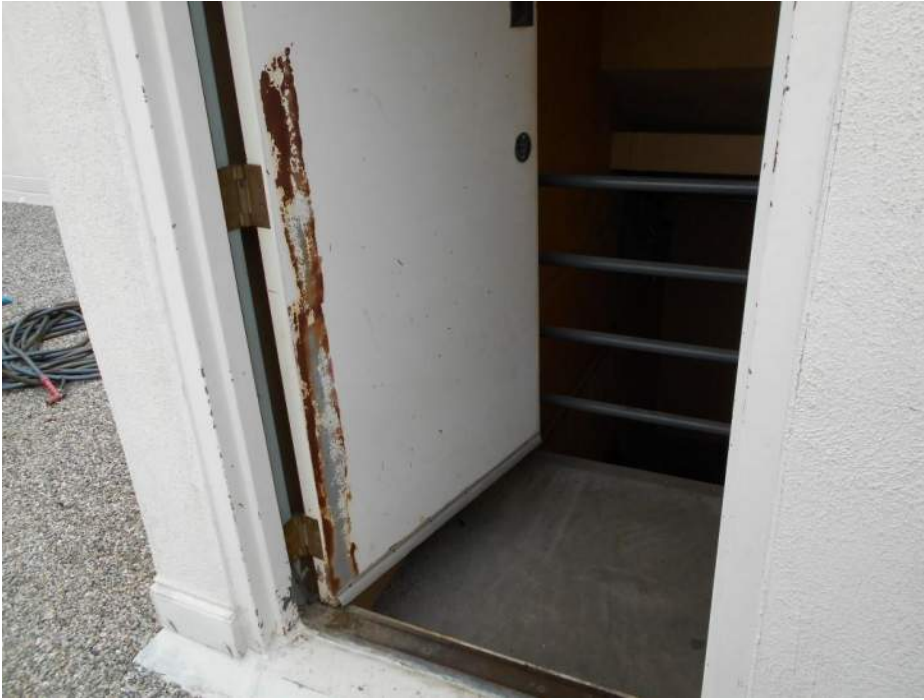
Photograph #97

Rusted hollow-metal door at roof access with deteriorated weather stripping at the Northwest Building.

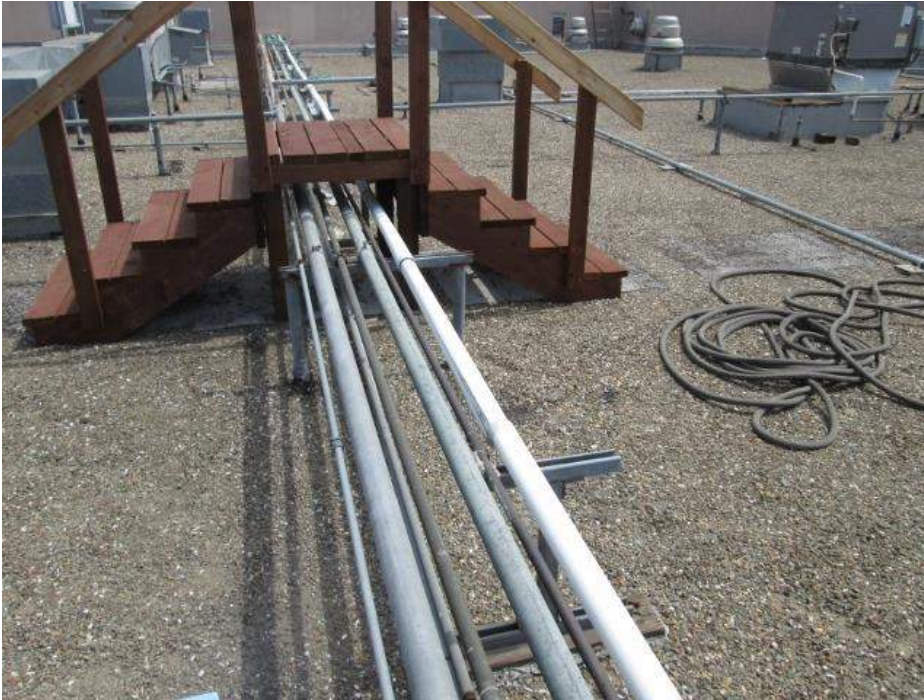
Photograph #161

Insulation missing at the hot water piping on the roof of the IRC.

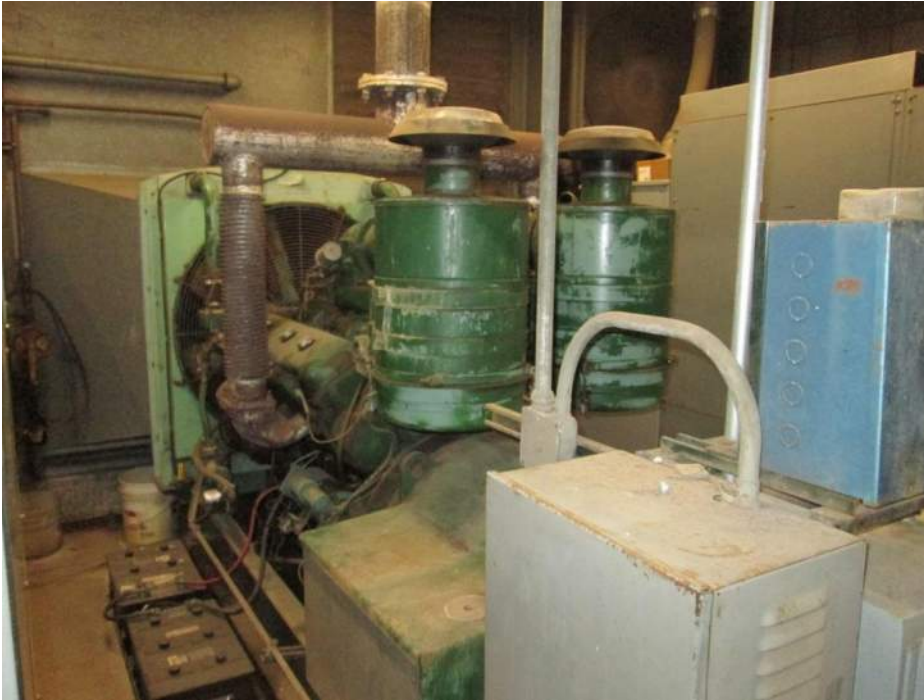
Photograph #185

Emergency generator for the Main Jail that is scheduled for replacement.
