Subject: **ADDENDUM to Pre-Design Assessment Report
For the New Cuyama Pool Incident Reconstruction Project
290 Wasioja Street, New Cuyama, Ca 93254**
County of SB – P.O. #CN15986
County of SB Project No. 8736 NCPI
W+W Project No. 13032

Joseph Centeno Cuyama Pool & Aquatics Complex Needs Assessment

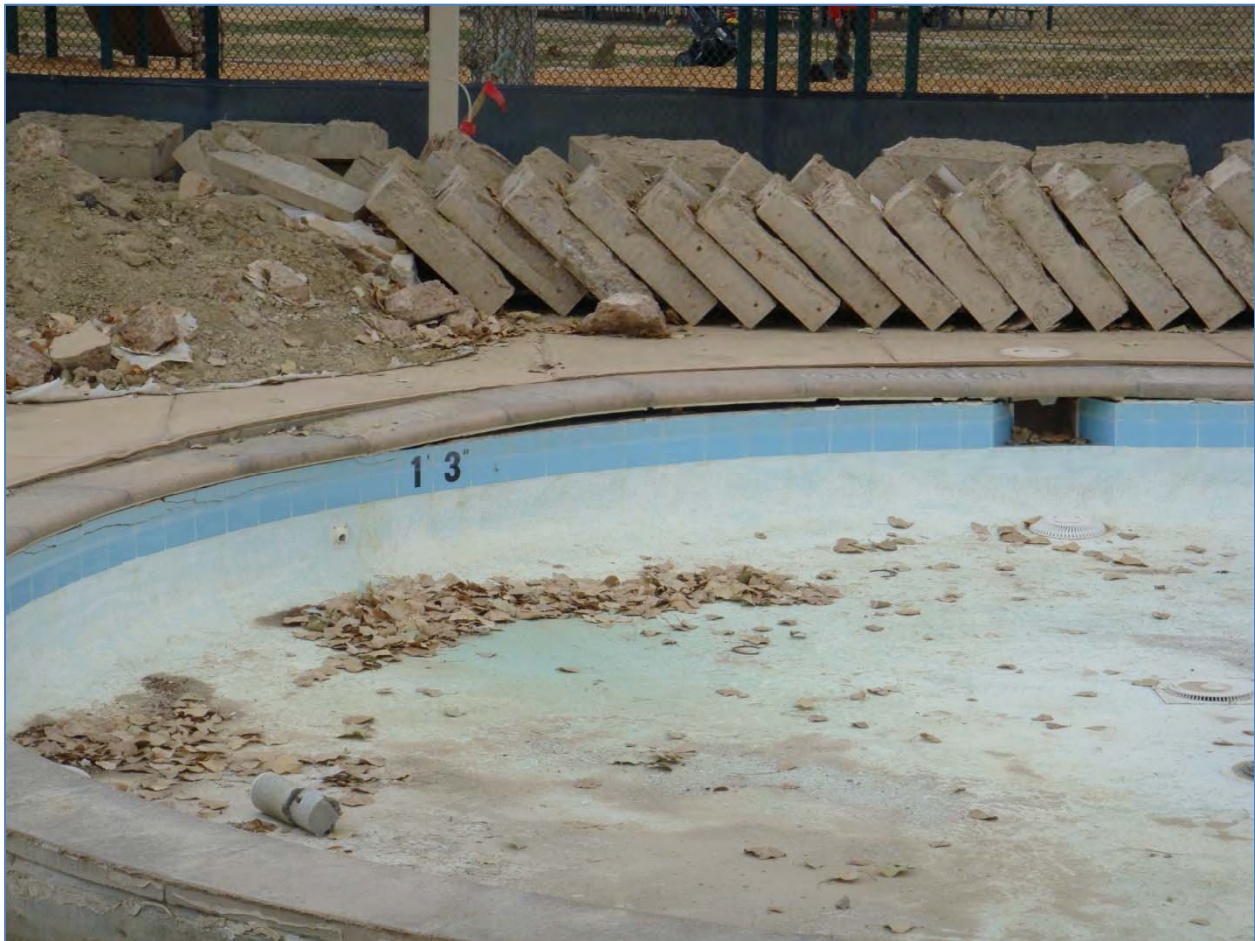
5. The wading pool has a diameter of 22 feet (22') and ranges in depth from 12 inches (12") to 18 inches (18") (See Figure 4).
6. When we first approached the pool area, it was obvious that the wading pool had suffered massive differential settlement. The deck around the wading pool had settled at a different rate from the wading pool; the wading pool coping had separated from the wading pool (See Figure 5). The wading pool's bond beam was cracked.

Figure 5: Photo of the wading pool showing the deck separating from the wading pool coping and the wading pool coping separating from the pool. On the left side of the photo, it can be seen that the wading pool's bond beam has cracked through the waterline tile. Also on the left side of the photo, an 11-inch (11") core taken from the wading pool floor can be seen (See Figure 6).

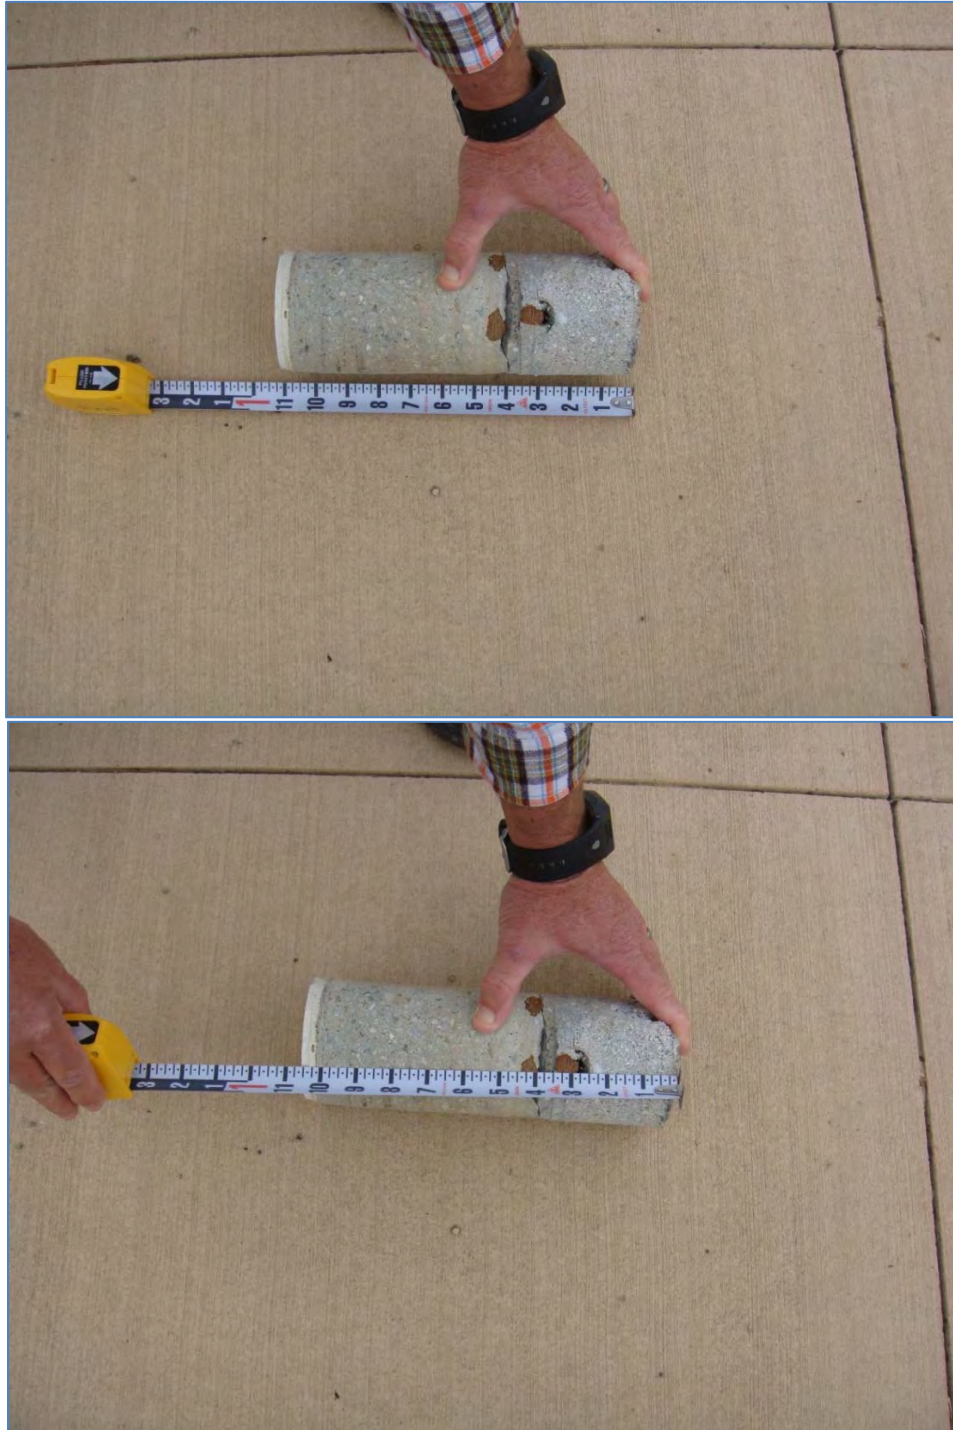
Figure 6: Measurements of the 11-inch (11") core taken from the floor of the wading pool. Drawing SP-7 required that thickness of the wading pool floor be 6 inches (6") thick. The pool contractor did better than the requirements and made a stronger wading pool floor. It is also noted that the structural steel is approximately 3 inches (3") off the dirt, which is per code requirements.

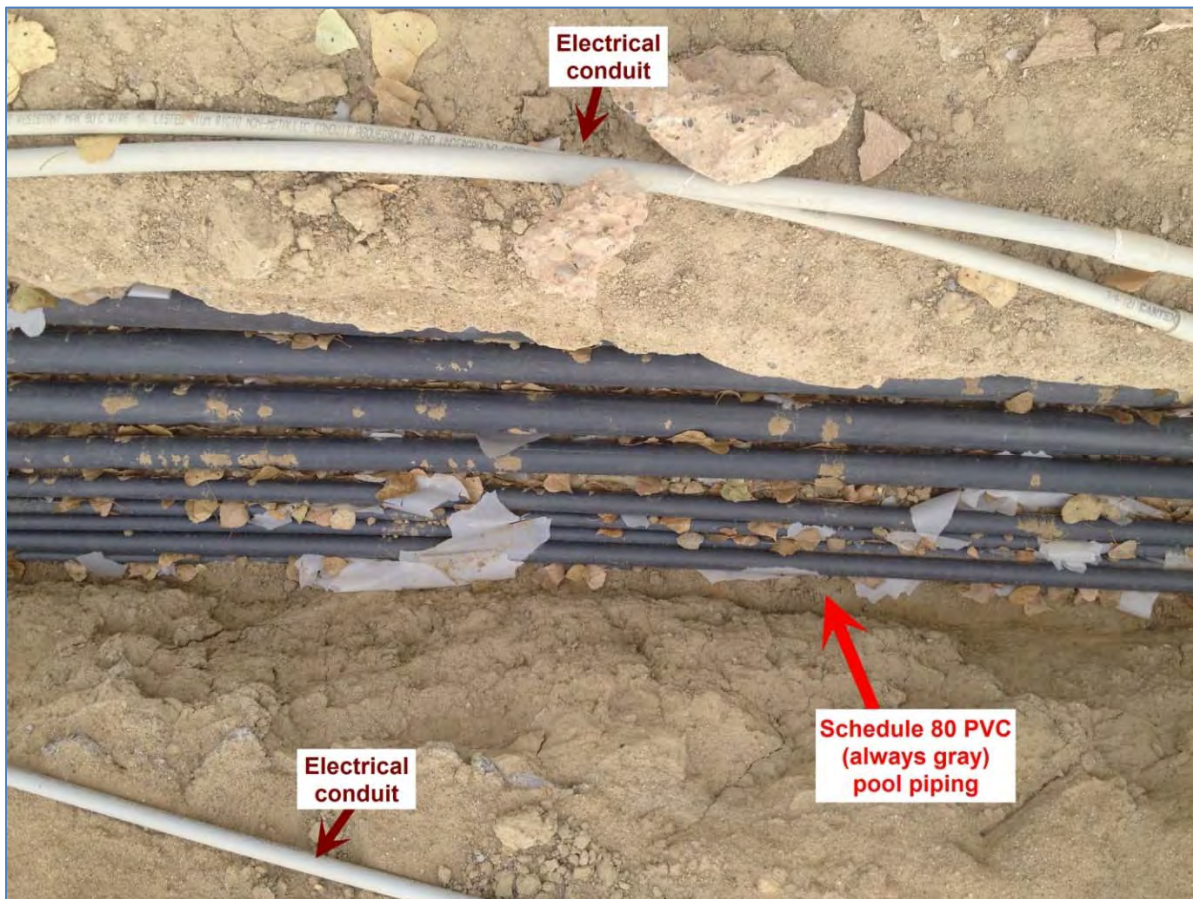
7. Due to the exposure of some of the piping, we were able to determine that the pool contractor utilized Schedule 80 PVC (max working pressure 400 lbs.) for the pool piping (See Figure 7), which is much stronger and more durable than the Schedule 40 PVC pipe (max working pressure 240 lbs.) specified in the drawings. Schedule 80 PVC pipe has approximately 40% more wall thickness than Schedule 40 PVC pipe. The tensile strength of all PVC is 7,300 psi.

Figure 7: Photo of Schedule 80 PVC pipe put in by the pool contractor.

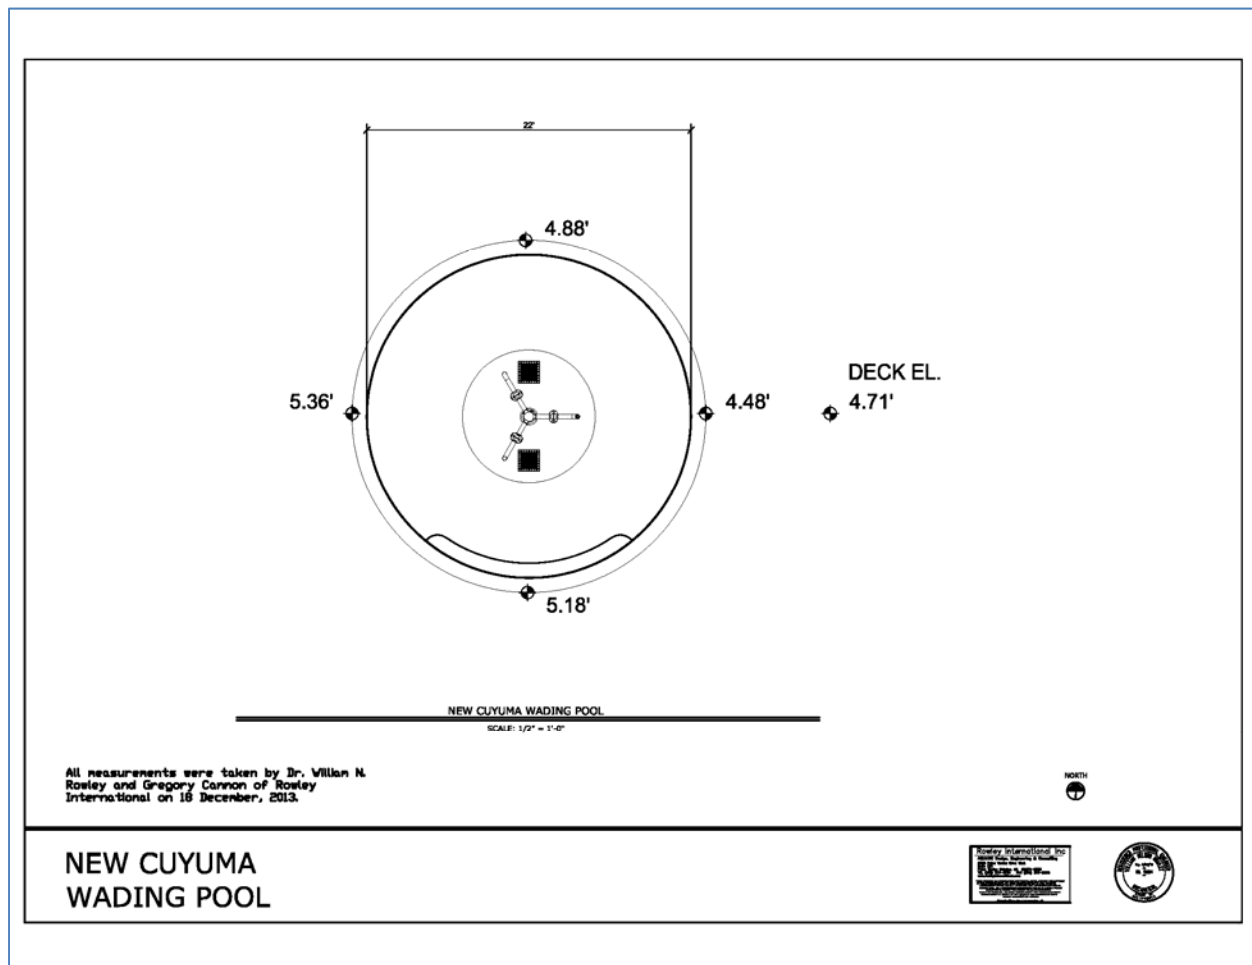
Figure 23: Diagram of the elevation measurements taken around the wading pool at the Rowley International site inspection on December 18, 2013.

12. We took four elevation measurements around the wading pool, one in each quadrant (See Figure 23). The measurements showed that greatest difference (5.36 feet minus 4.88 feet) was 0.48 feet (0.48'), or approximately 6 inches (6"), which is consistent with the amount of deck settlement at the corner of the building (See Figure 27). The wading pool at its highest point (these measurements were off the coping) was 4.88 feet (4.88'). Its lowest point was 5.36 feet (5.36').

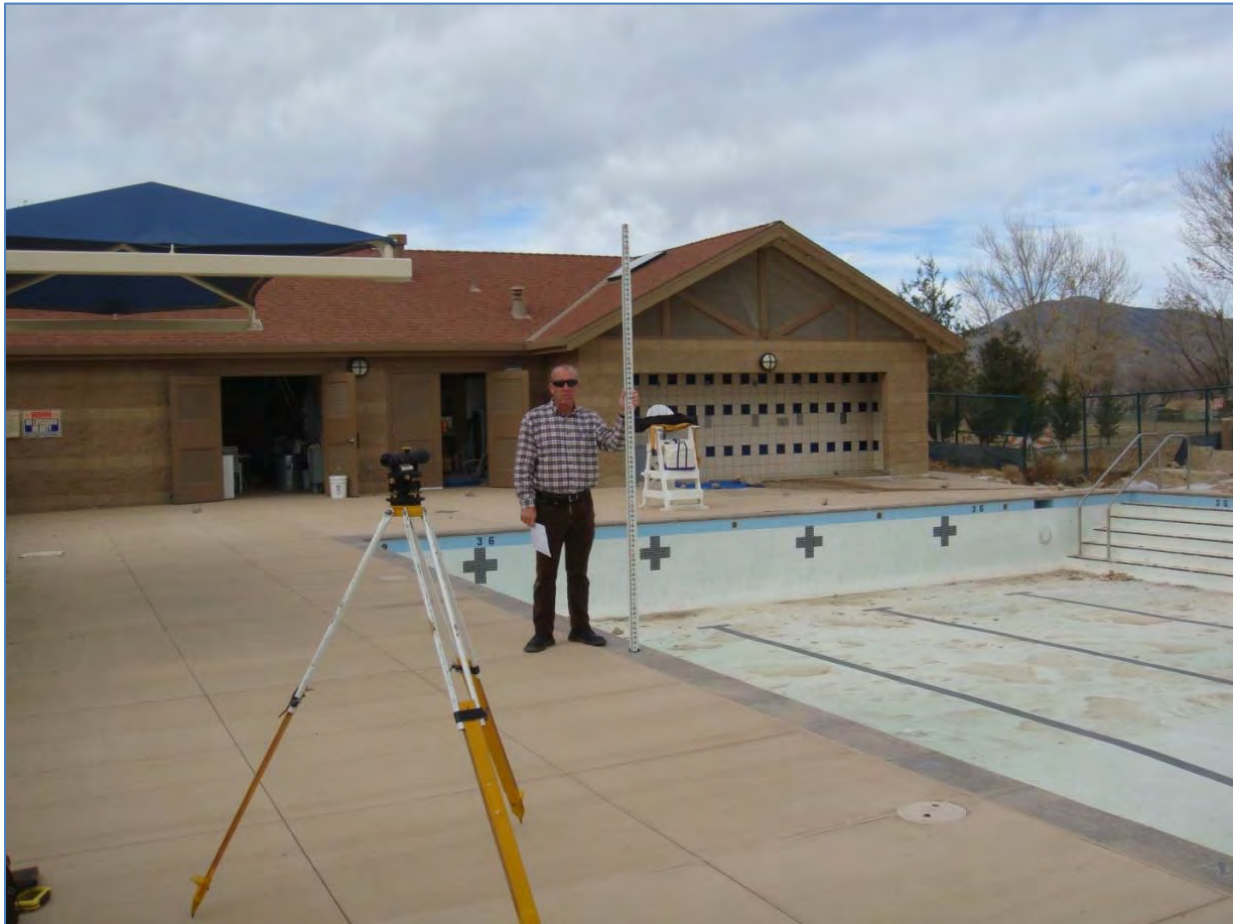
Figure 24: Photo of Managing Principal Greg Cannon holding the measuring rod on the south side of the swimming pool. The northwest corner of the swimming pool (and the area with the most differential settlement) can be seen in the right background.

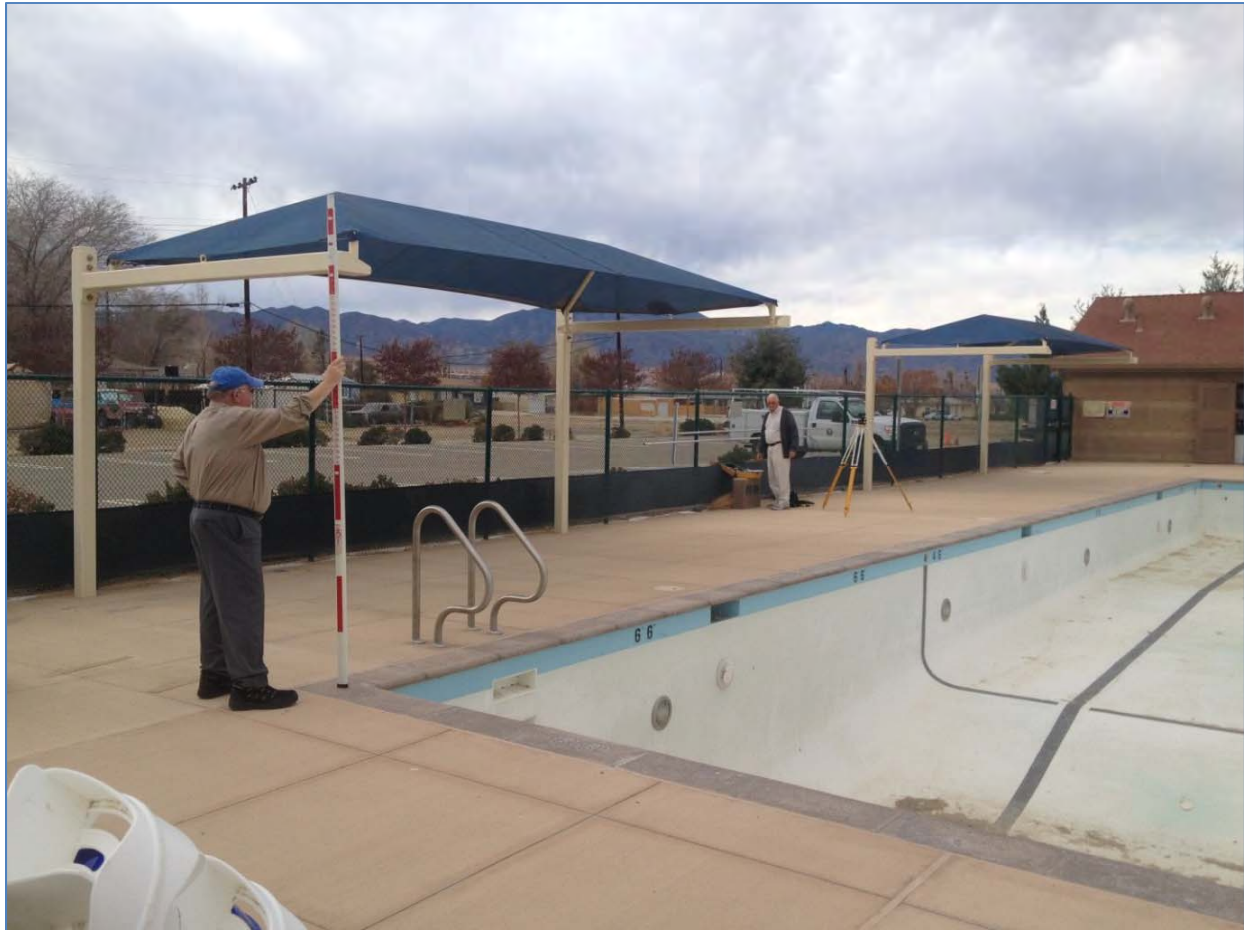
Figure 25: Photo of Principal Architect Don Hertel, RA, holding up the measuring rod at the southeast corner of the swimming pool. From the measurements, this corner had the highest elevation of any point on the pool coping. Note the skimmers in the pool wall.

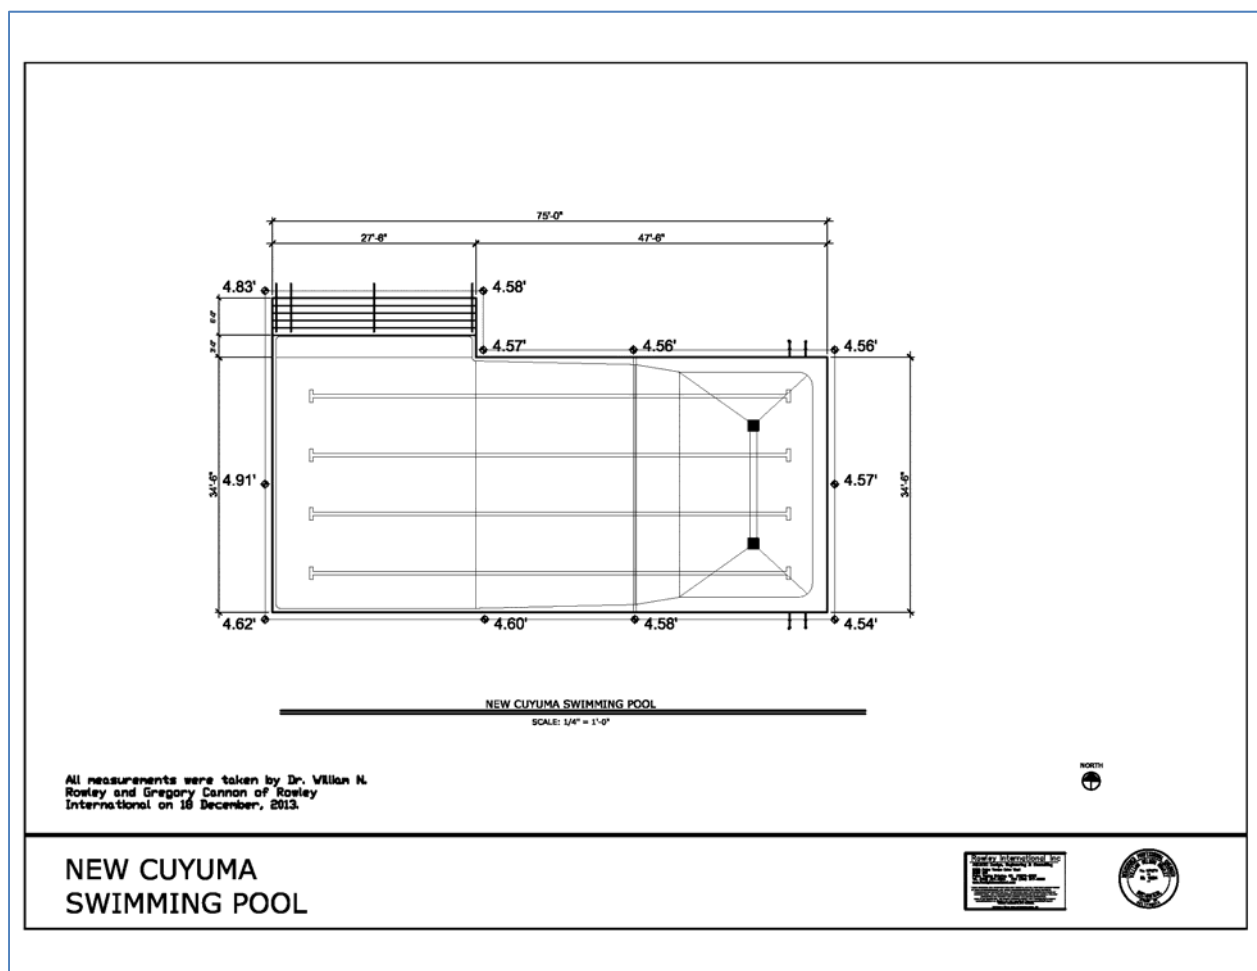
14. In previous reports, it was stated that the differential settlement in the pool was approximately one inch (1") (See Figures 2, 12, 16). From the reports, it appears that this measurement was indicated by the waterline witness mark (See Figures 12, 16). Waterline witness marks are whitish calcium deposits made over time at the water level. The waterline witness mark would have been made before the swimming pool was drained. If the swimming pool was drained during or within days after the soils collapse event, then the waterline witness mark would indicate how much the swimming pool settled prior to the soils collapse event on October 14, 2012.

Figure 26: Elevation measurements taken around the swimming pool at the Rowley International site inspection on December 18, 2013.

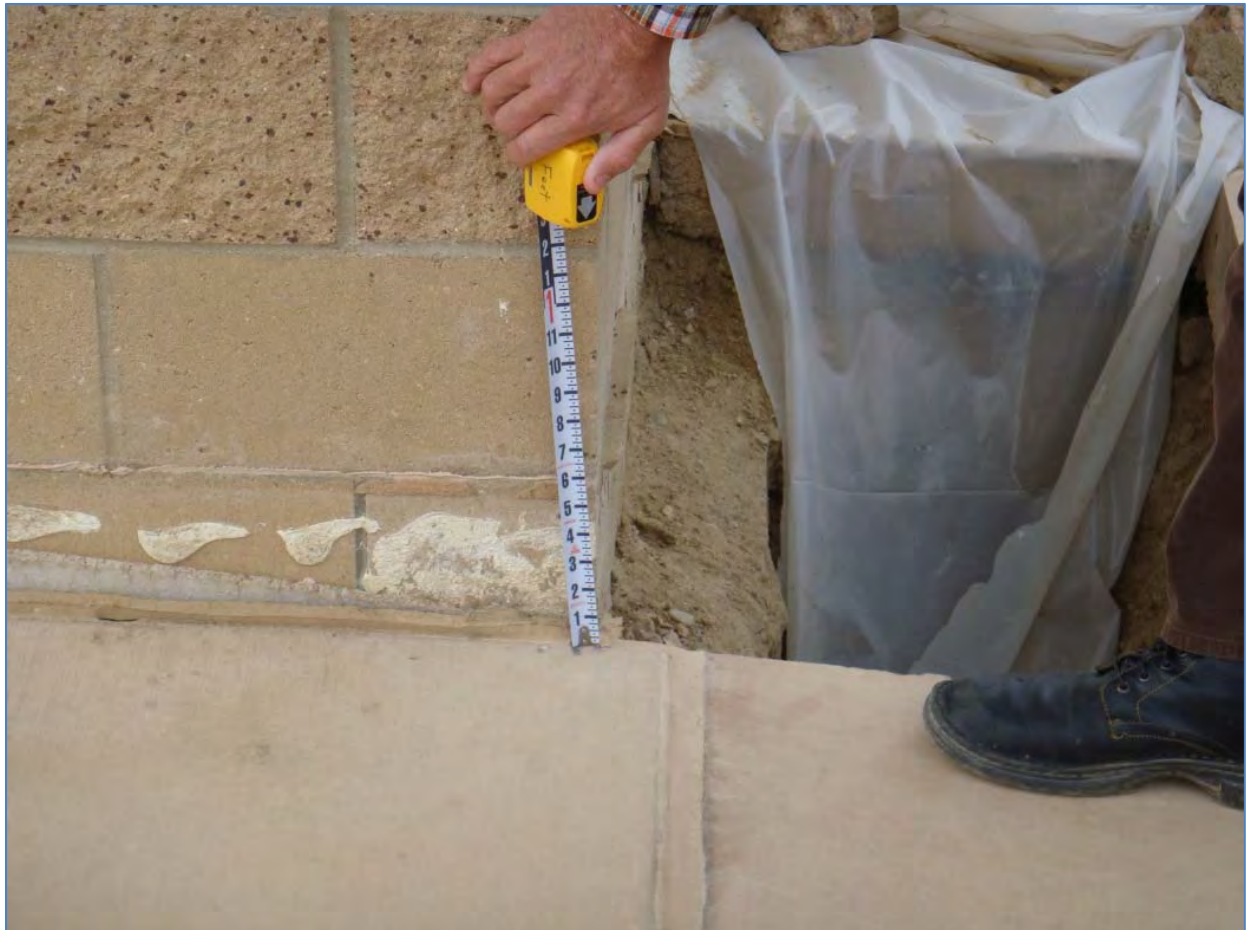
21. The differential settlement of the deck in front of the showers at the corner of the building is 6 inches (6") below its as-built level in relation to the building (See Figure 27), which may have also settled (per Fugro Consultants' May 2013 Report, the results of an elevation survey conducted in the area around the wading pool indicated that settlements of up to 12 inches (12") had occurred (See Figure 8)). The differential settlement occurred in the corner of the deck by the showers. There is a gutter drain along the back wall of the shower area (See Figure 28); some splashout water from the showers would have fallen on the deck and drained into the slot drain in the deck drainage system. After the deck began settling, some of the shower water would have seeped into the ground through the separation between the deck and the building (See Figures 15, 28).

Figure 27: Closeup photo of the corner of the building seen in Figure 28. The deck at this corner settled to 6 inches (6") below its original level in relation to the building at our inspection on December 18, 2013.

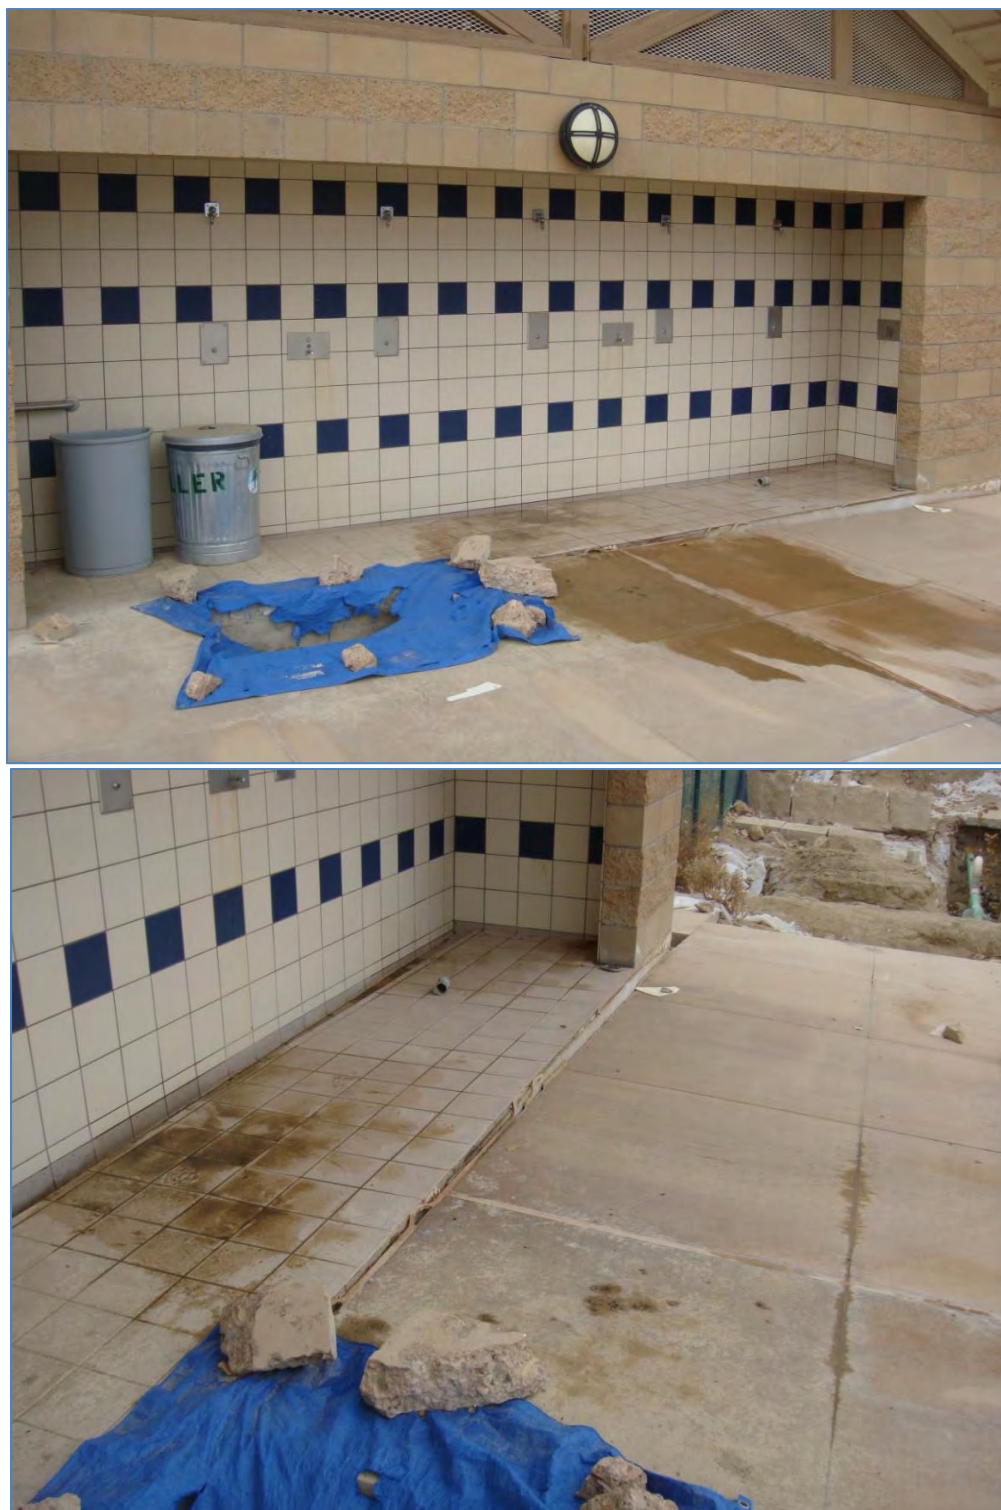
Figure 28: Photos of the shower area. Although there is a gutter drain along the back wall of the shower area, some splashout water would have fallen on the deck and drained into the slot drain in the deck drainage system. After the deck began settling, some of the shower water would have seeped into the ground through the separation between the deck and the building.

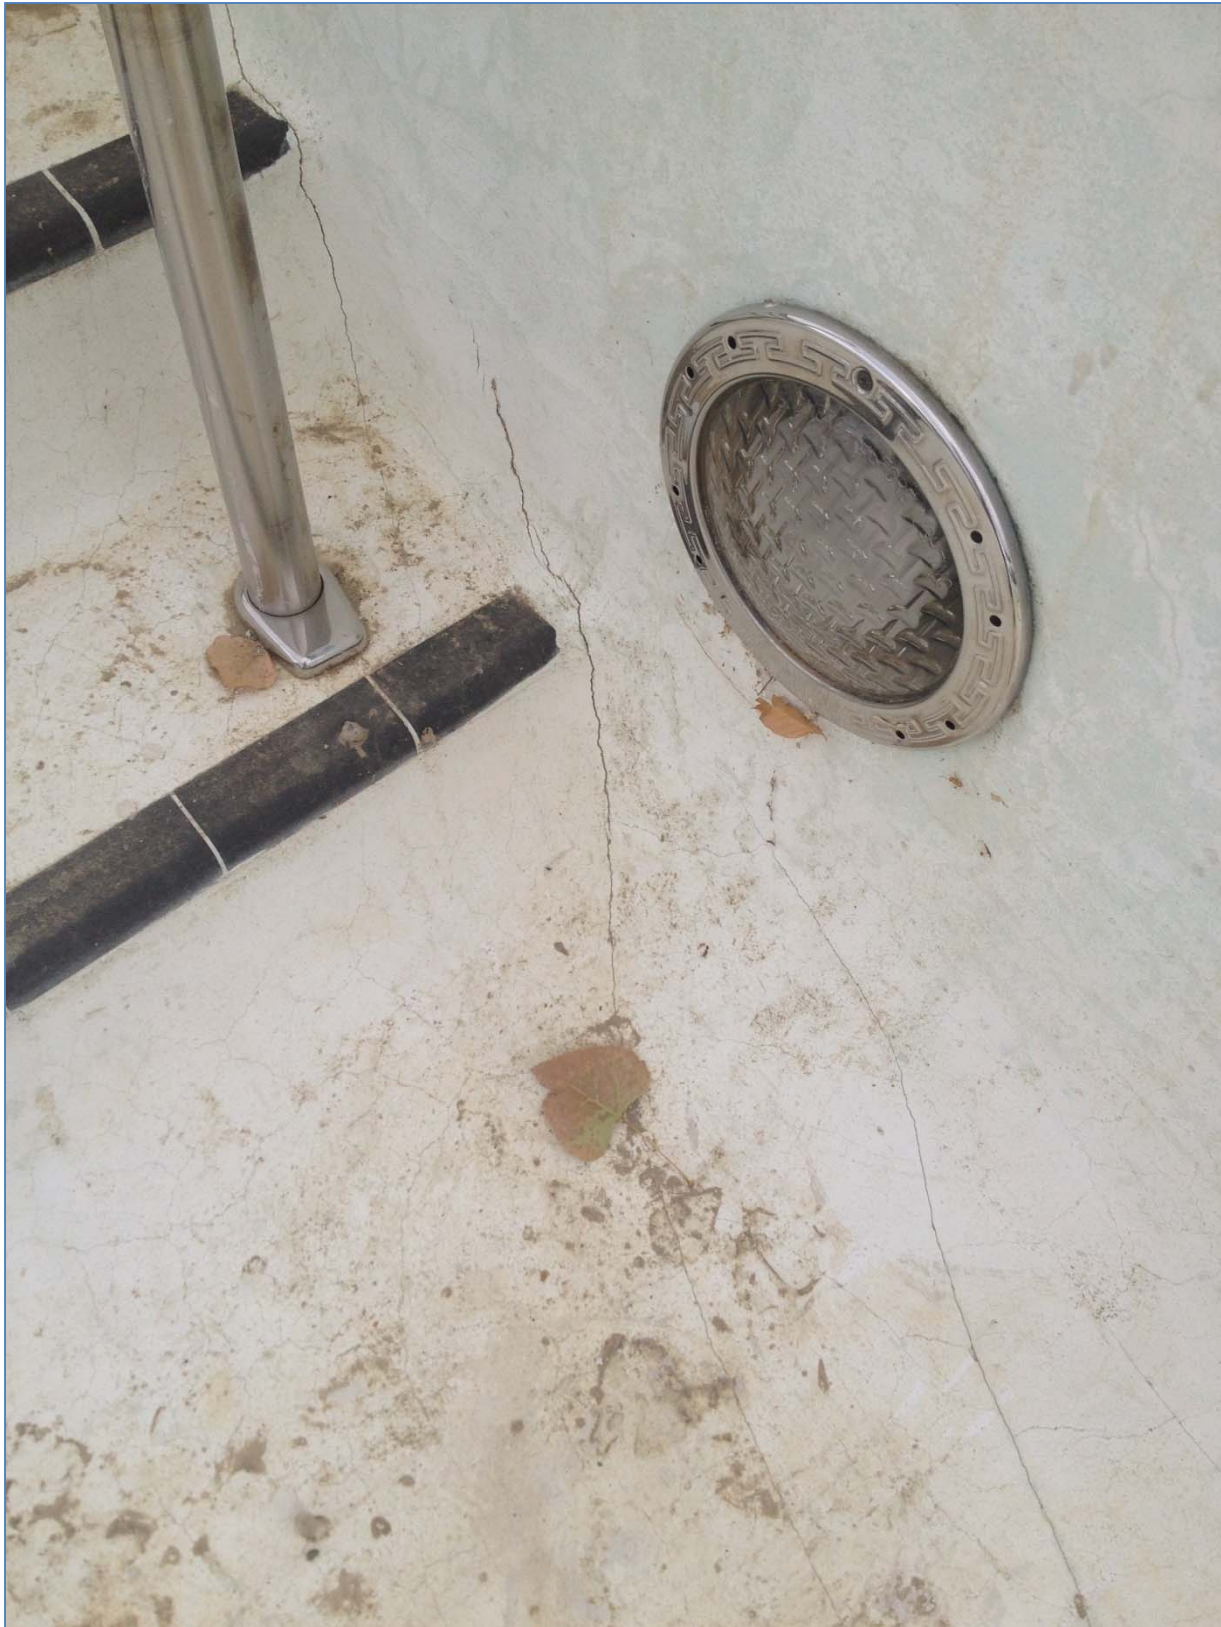
Figure 30: Photograph of cracks in the swimming pool wall over the steps in the shallow end.

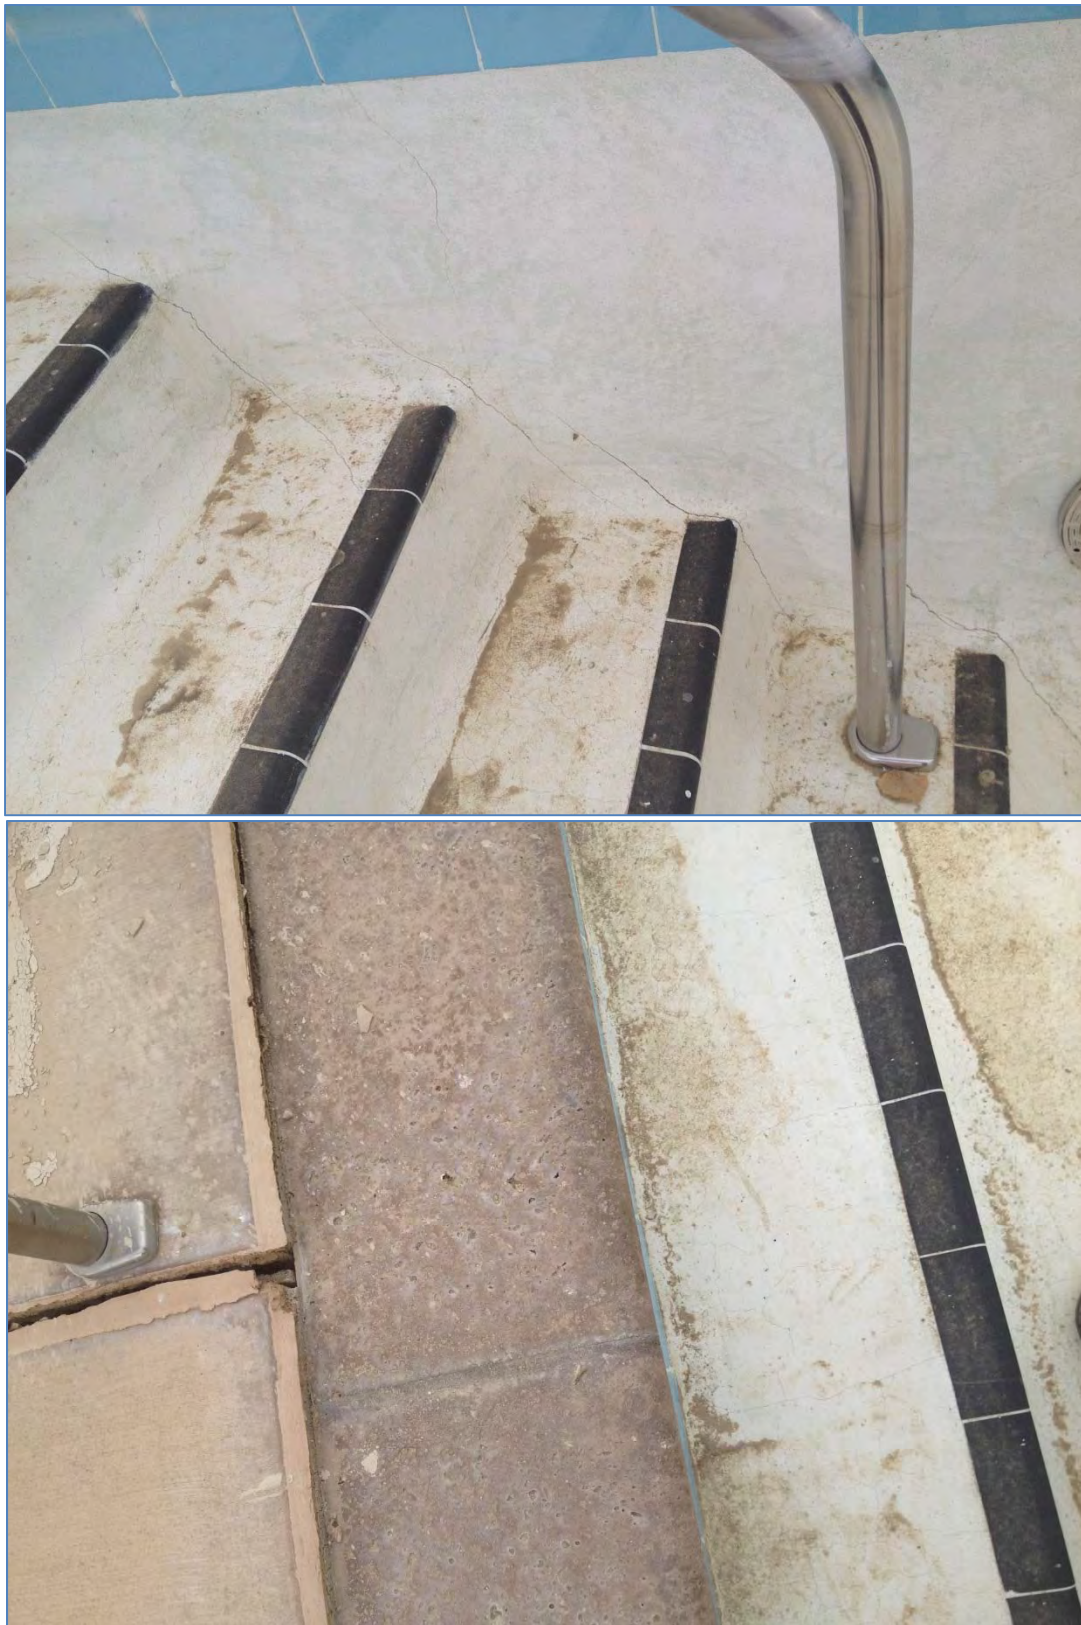
Figure 31: Photographs of cracks in the swimming pool steps and nearby pool wall.

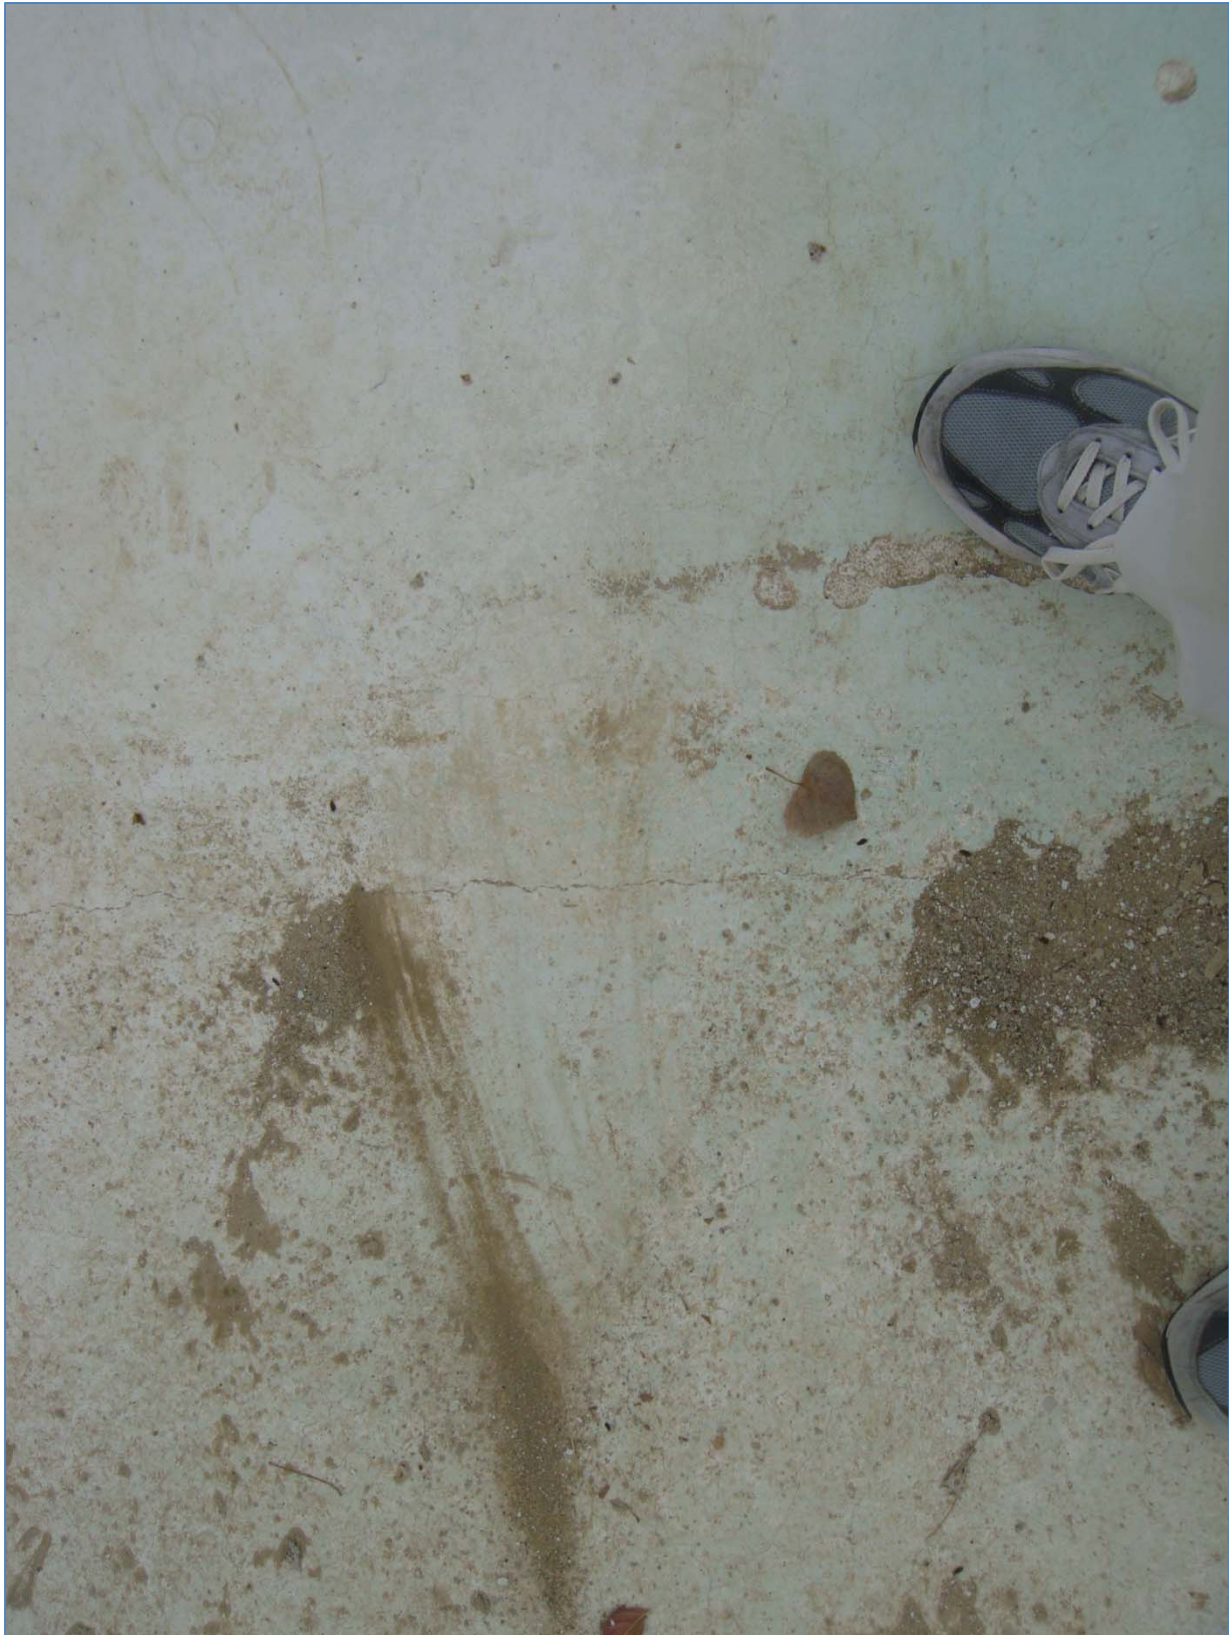
Figure 32: Photograph of crack in the swimming pool floor.

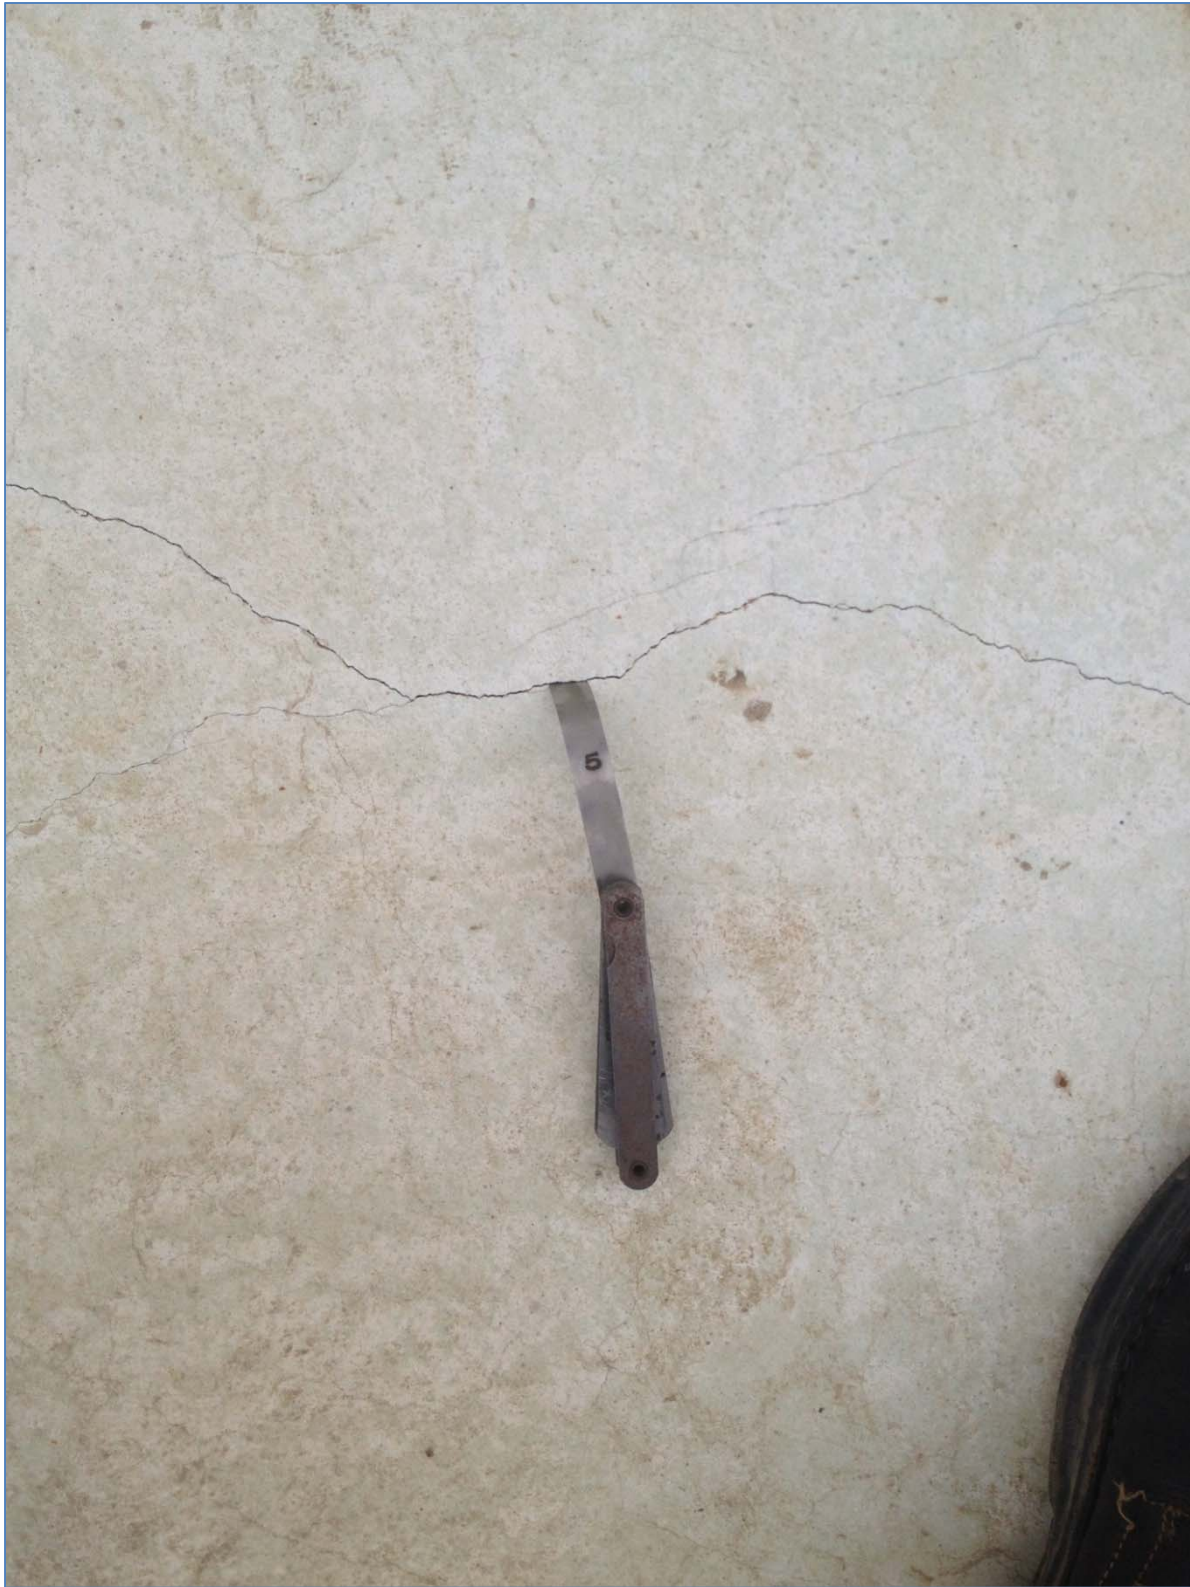
Figure 33: Photograph of a 0.005-inch-(0.005")-thick feeler gauge in a crack in the swimming pool floor.

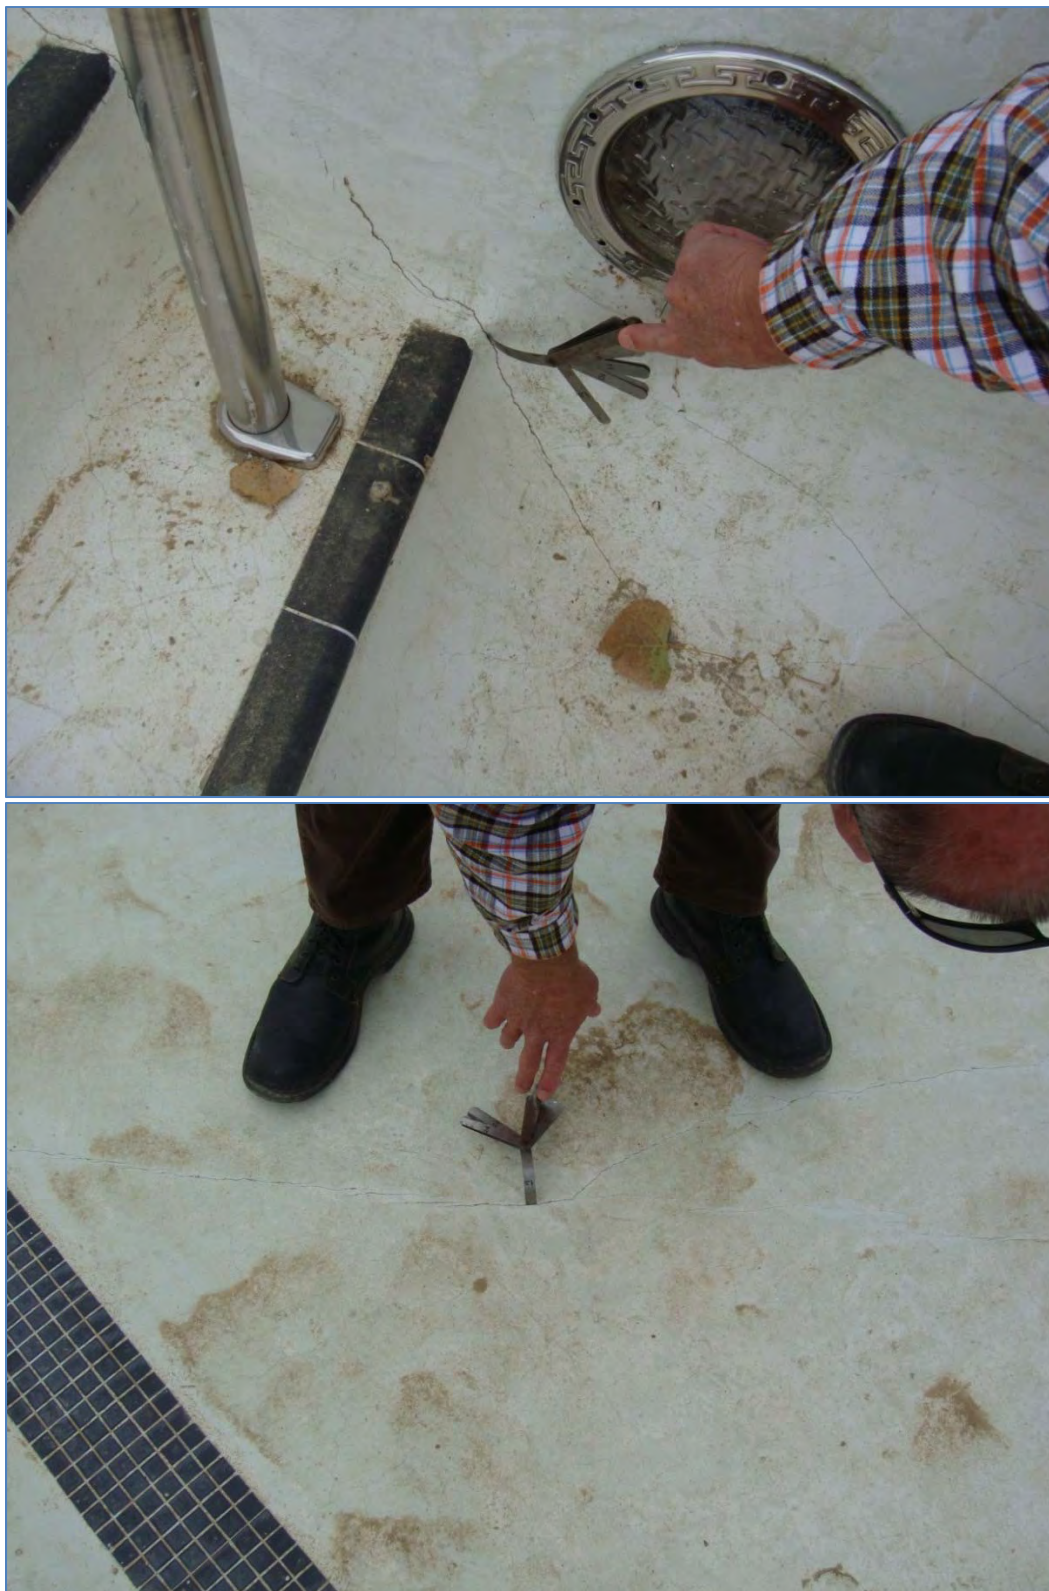
Figure 34: Photograph of a 0.025-inch-thick feeler gauge (nearly 1/32") in cracks in the swimming pool floor and steps.
