Subject: **ADDENDUM to Pre-Design Assessment Report
For the New Cuyama Pool Incident Reconstruction Project
290 Wasioja Street, New Cuyama, Ca 93254**
County of SB – P.O. #CN15986
County of SB Project No. 8736 NCPI
W+W Project No. 13032

Joseph Centeno Cuyama Pool & Aquatics Complex Needs Assessment

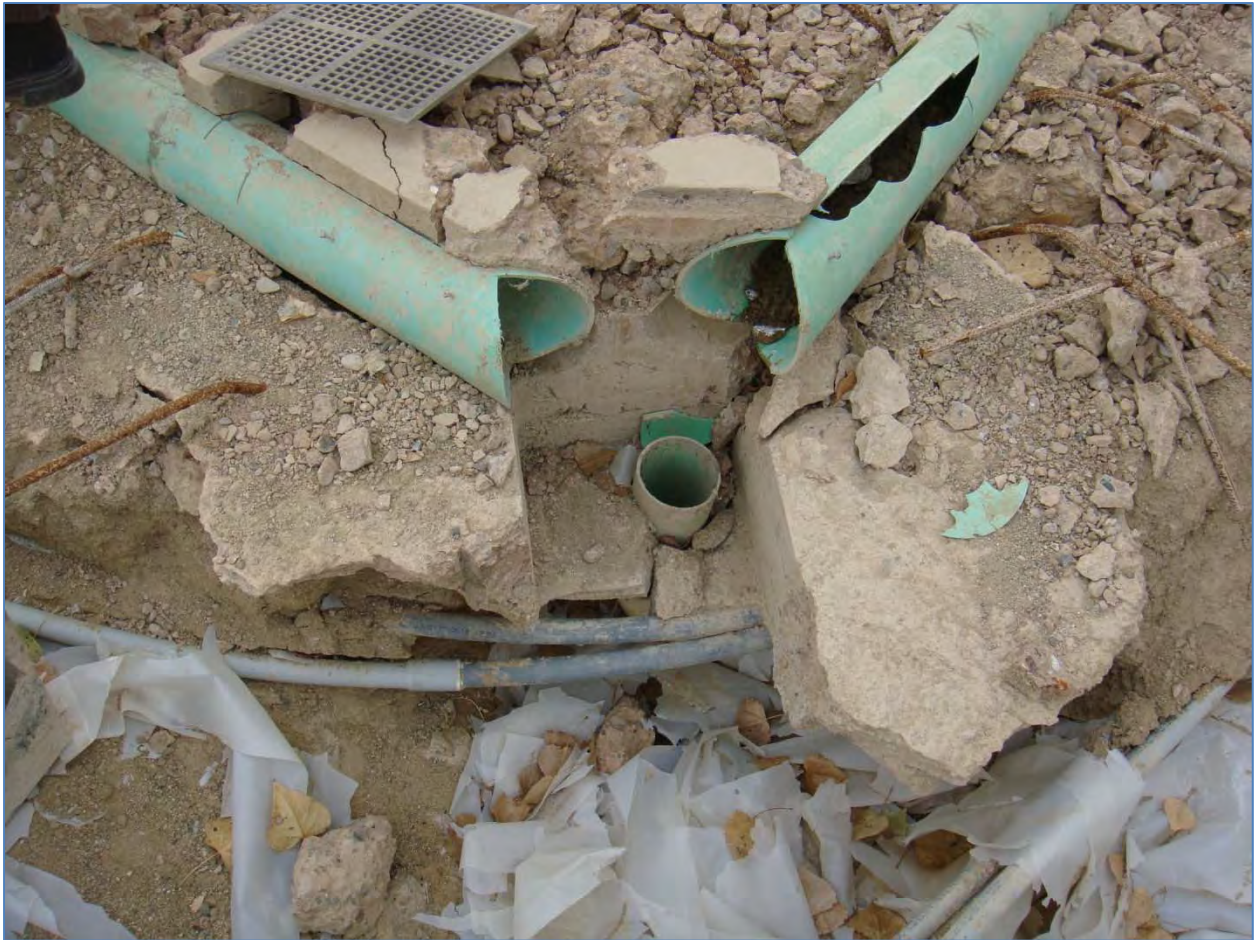
Figure 38: The green piping shown here was used for the deck slot drain. This is not Schedule 40 PVC (as required by Drawing SP-15 Detail 3; See Figure 37), but is a type of thin-walled piping that is much thinner than Schedule 40 PVC. The boxlike cavity is the place where the slot drain clean out was installed (See Figures 37, 39). Note that the required 5.5 inches (5-1/2") of concrete underneath the slot drain clean out does not exist (See Figure 37). Also note that the required reinforcing steel (i.e., rebar) around the slot drain clean out was not put in (See Figure 37). Additionally, the strength of the concrete structure around the slot drain clean out was compromised by the electrical conduit that was emplaced where there should have only been concrete and rebar (See Figures 37, 39).

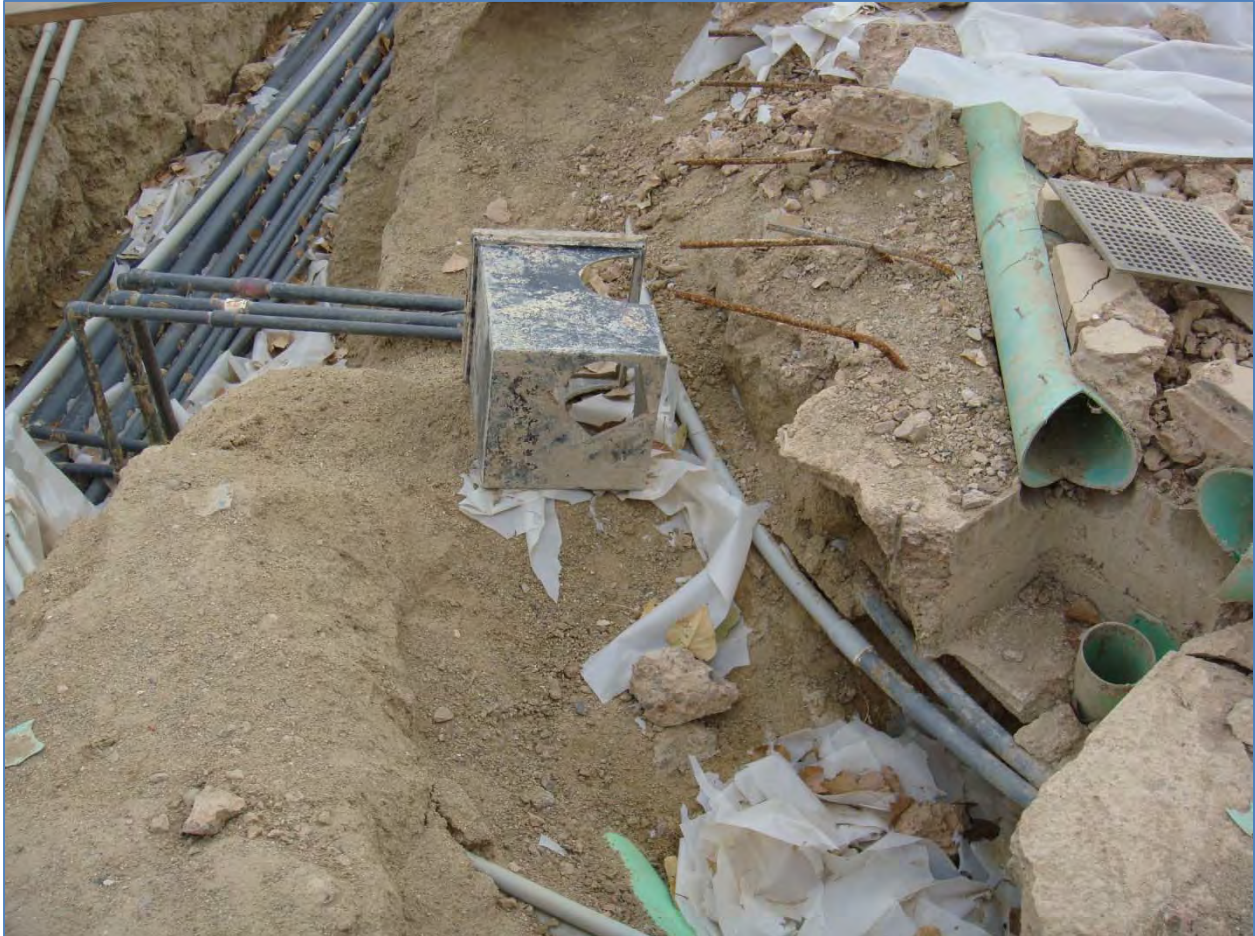
Figure 39: The green piping shown here was used for the deck slot drain. This is not Schedule 40 PVC (as required by Drawing SP-15 Detail 3; See Figure 37), but is a type of thin-walled piping that is much thinner than Schedule 40 PVC. The boxlike cavity is the place where the slot drain clean out was installed (See Figures 37, 38). The box with holes lying on the ground was the catch basin for the slot drain clean out (See Figure 37). Note that the required 5.5 inches (5-1/2") of concrete underneath the slot drain clean out does not exist (See Figure 37). Also note that the required reinforcing steel (i.e., rebar) around the slot drain clean out was not put in (See Figure 37). Additionally, the strength of the concrete structure around the cleanout box was compromised by the electrical conduit that was emplaced where there should have only been concrete and rebar (See Figure 37, 38).

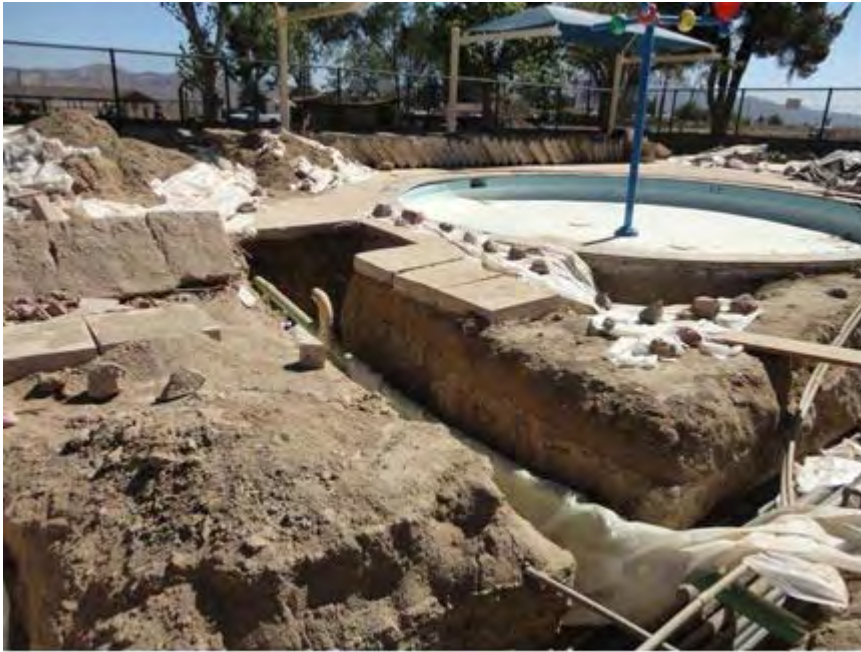
Photo No. 2 – Wading Pool Area, Concrete Deck and Deck Demolition

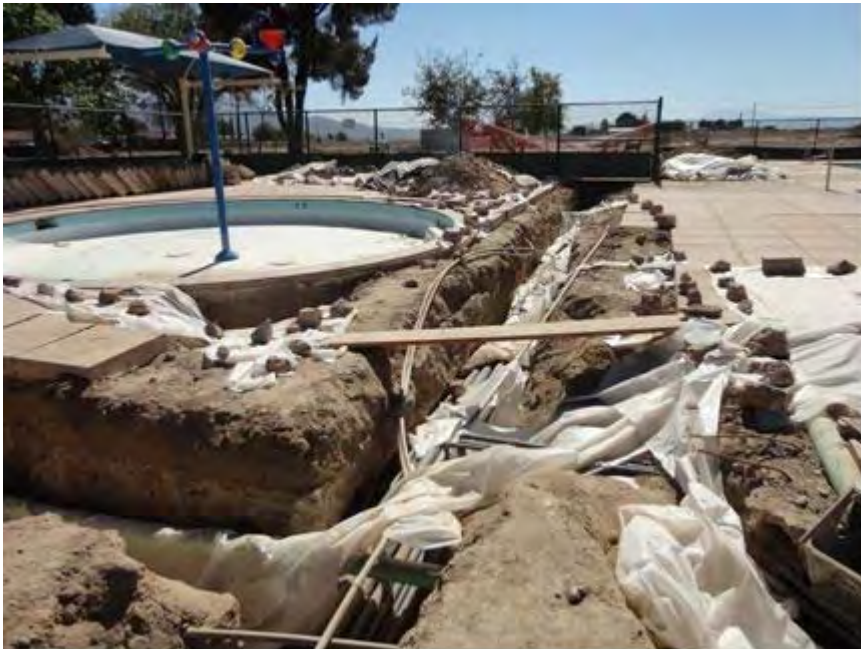
Photo No. 3 – Wading Pool Area, Concrete Deck and Deck Demolition

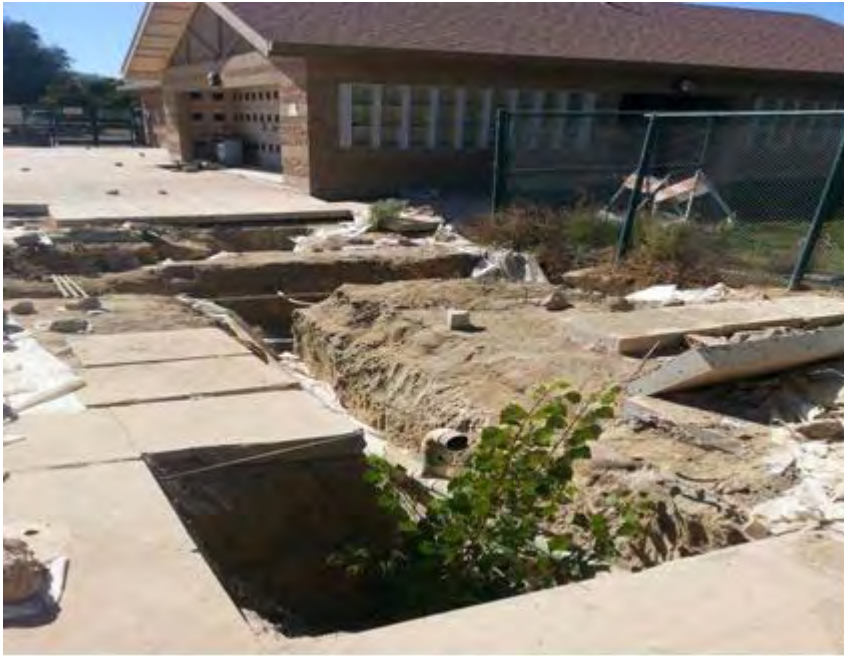
Photo No. 4 – Concrete Deck at NE Corner of Masonry Building

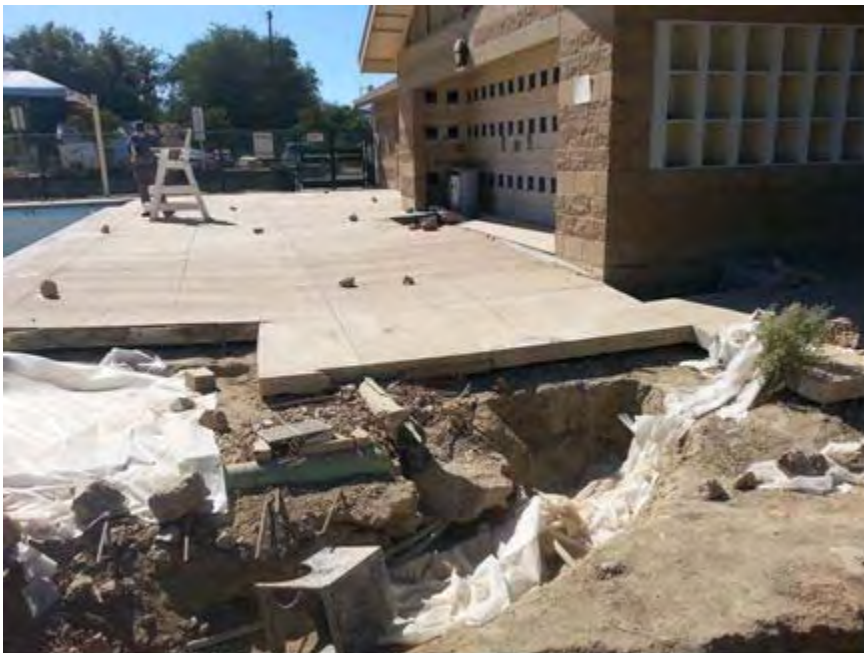
Photo No. 5 – Settlement and Cavity under NE Corner of Masonry Building

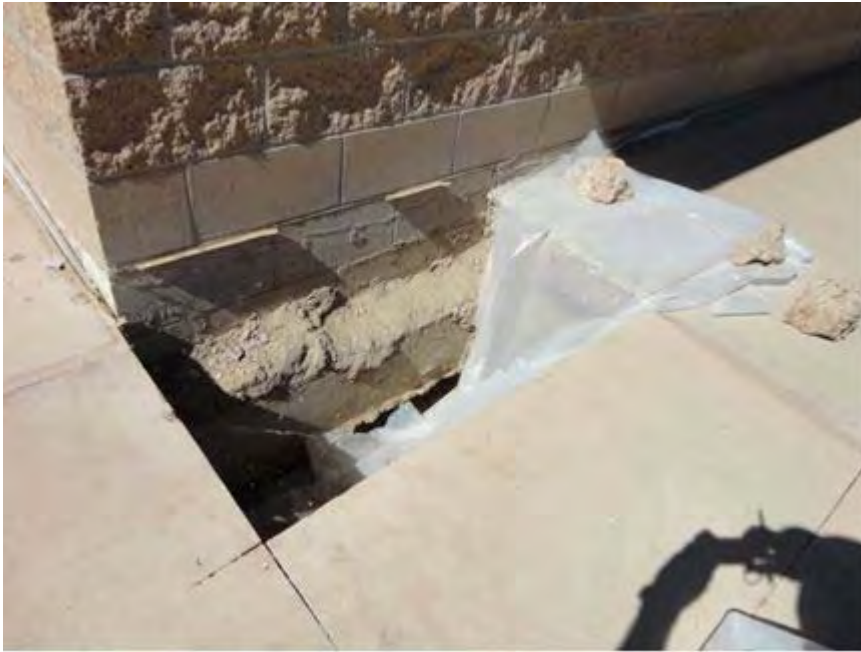
Photo No. 6 – Cavity below NE Corner of Masonry Building

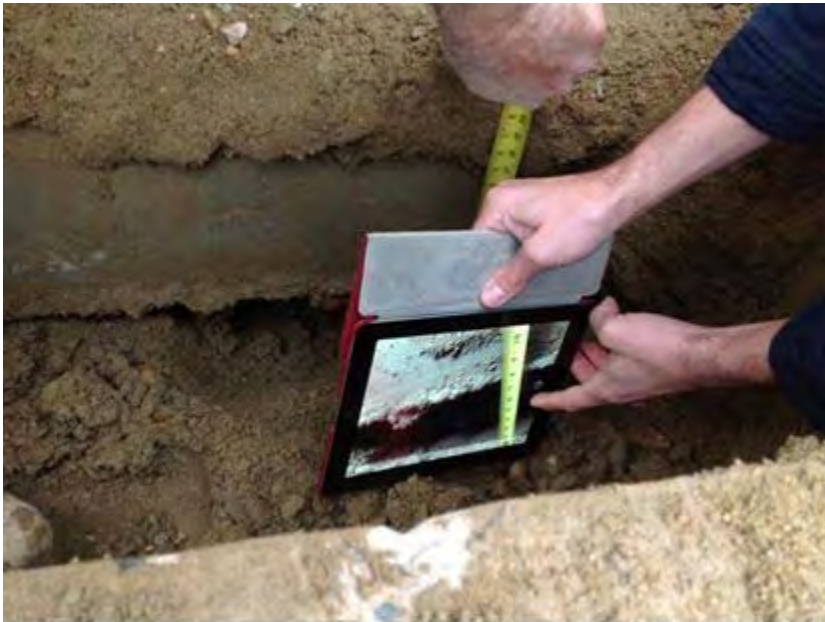
Photo No. 7 – Cavity under NE Corner of Masonry Building

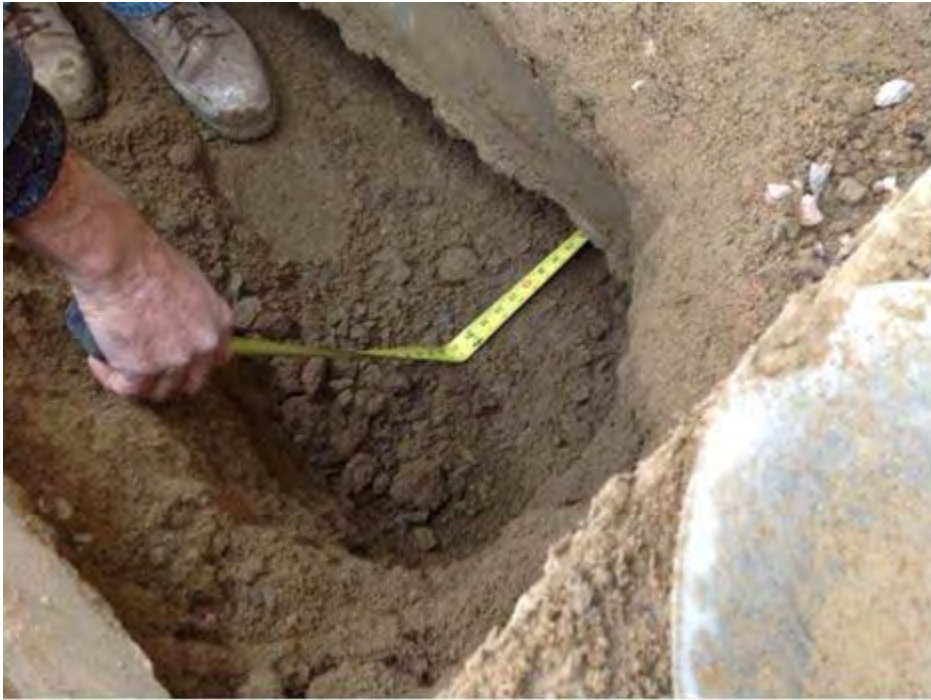
Photo No. 8 – Concrete Deck at NW Corner of Pool (1" Pool Settlement Location)

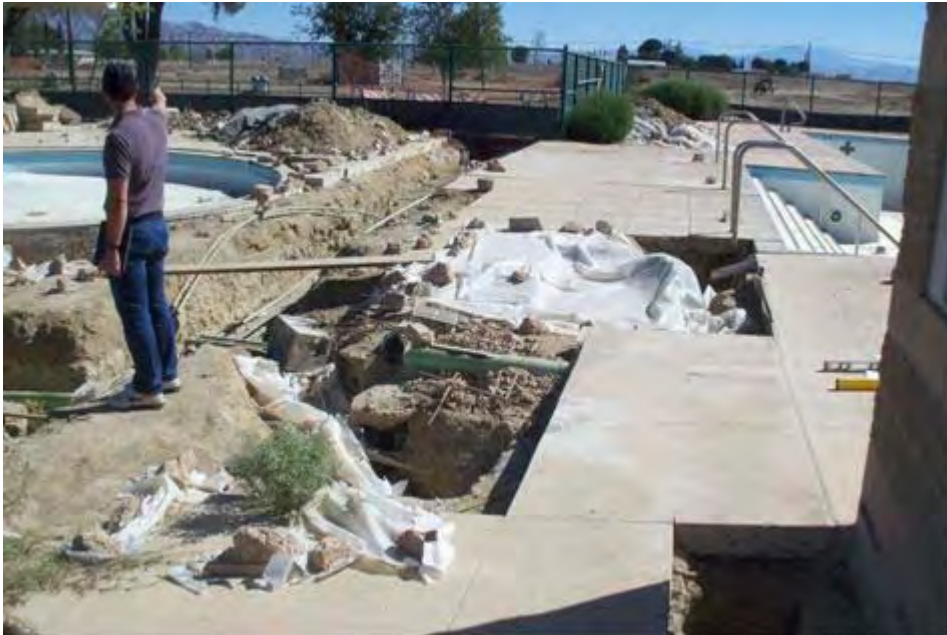
Photo No. 9 – Exterior Shower at NE Corner of Masonry Building

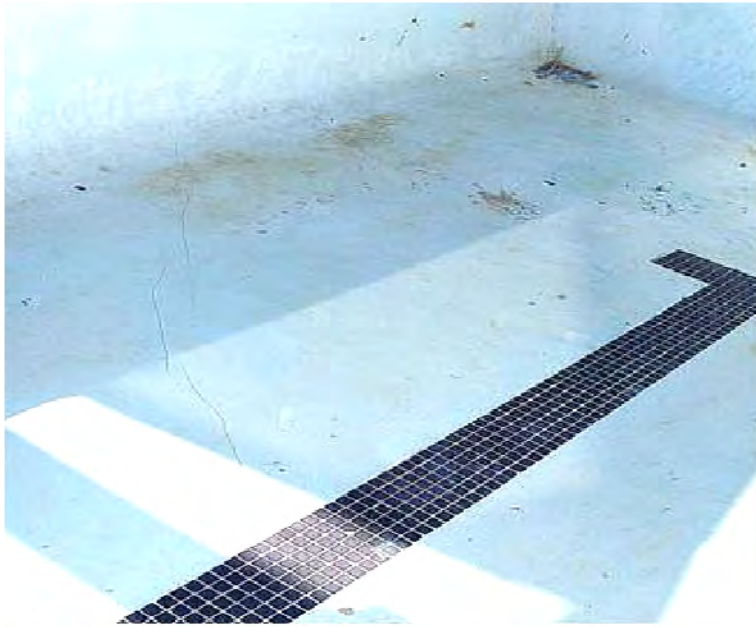
Photo No. 18 – 90 Degree Trans-Pool Cracking Patterns

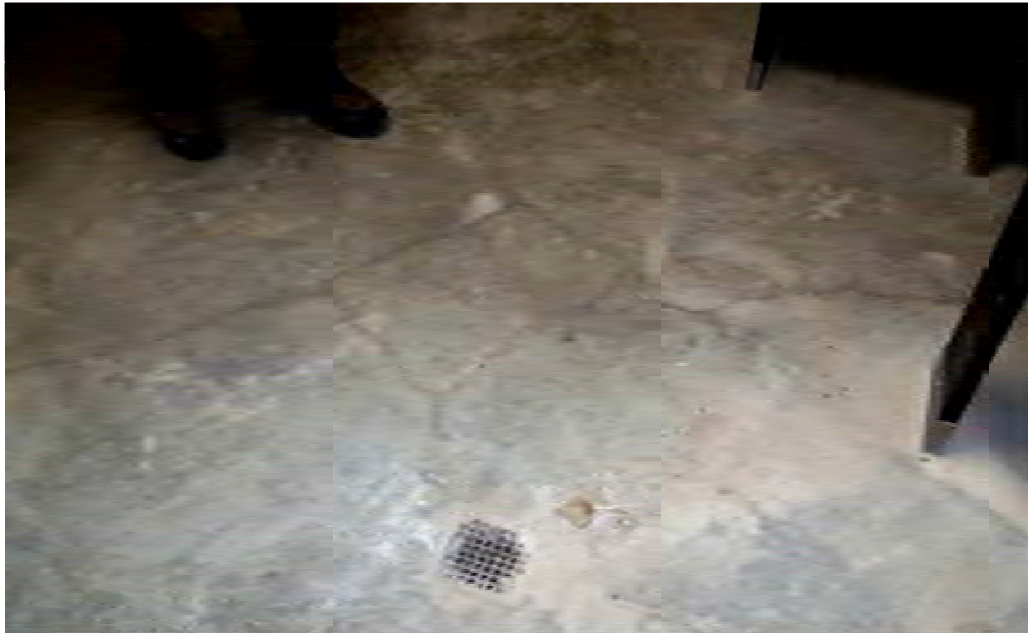
Photo No. 24 – Spider-like Cracking at Floor Drain in Women's Restroom
