DOS PUEBLOS CREEK RESTORATION, MAINTENANCE AND MONITORING PLAN

JUNE 2015

PREPARED FOR:
California Rangeland Trust
1225 H Street
Sacramento, California 958149

PREPARED BY:
DUDEK
621 Chapala Street
Santa Barbara, CA 93101

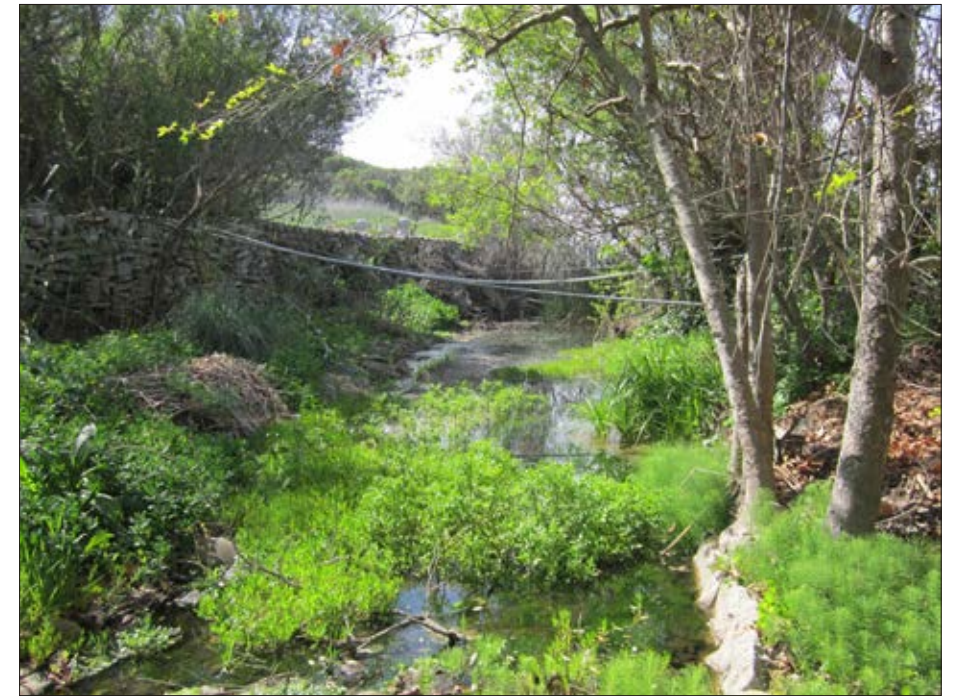
Photo 3: Creek channel bank protection looking south

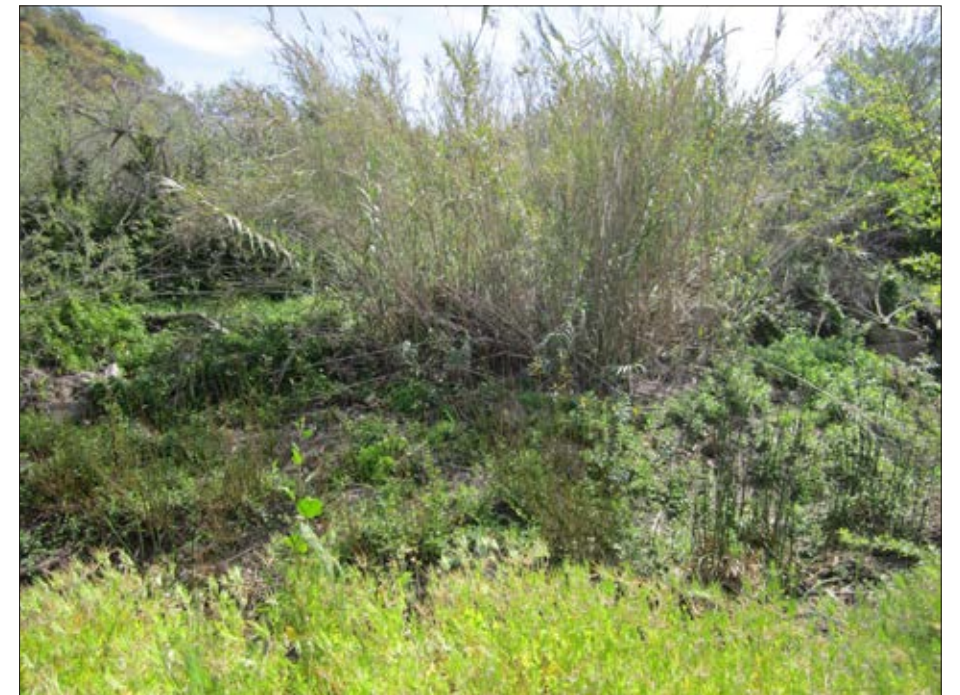
Photo 6: Palm to be removed on creek bank and willows in creek looking north

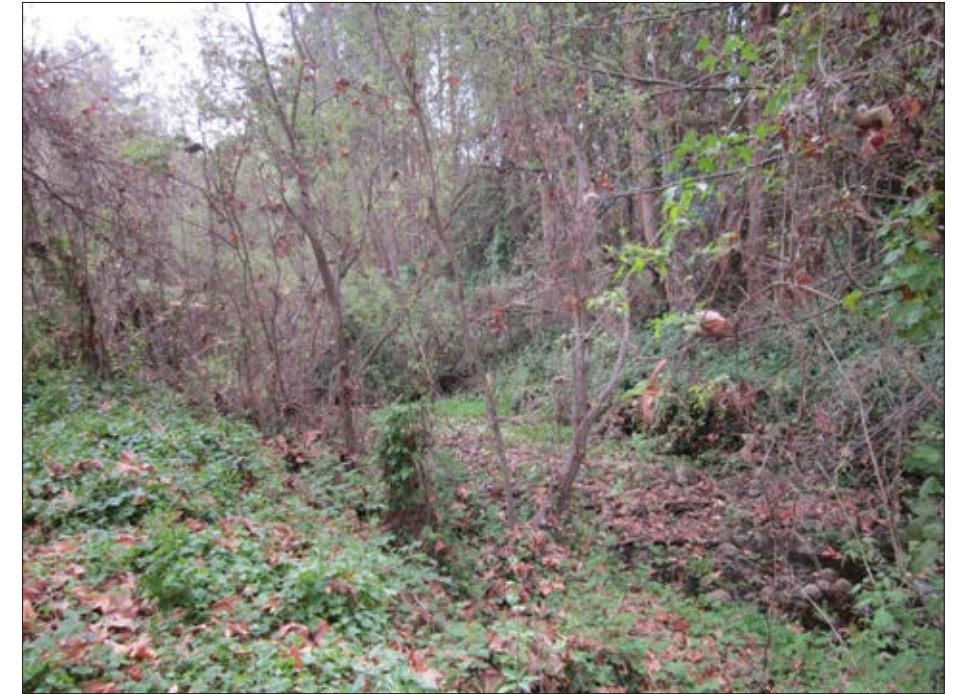
Photo 3: Exotic ground cover in creek north of beach access road bridge

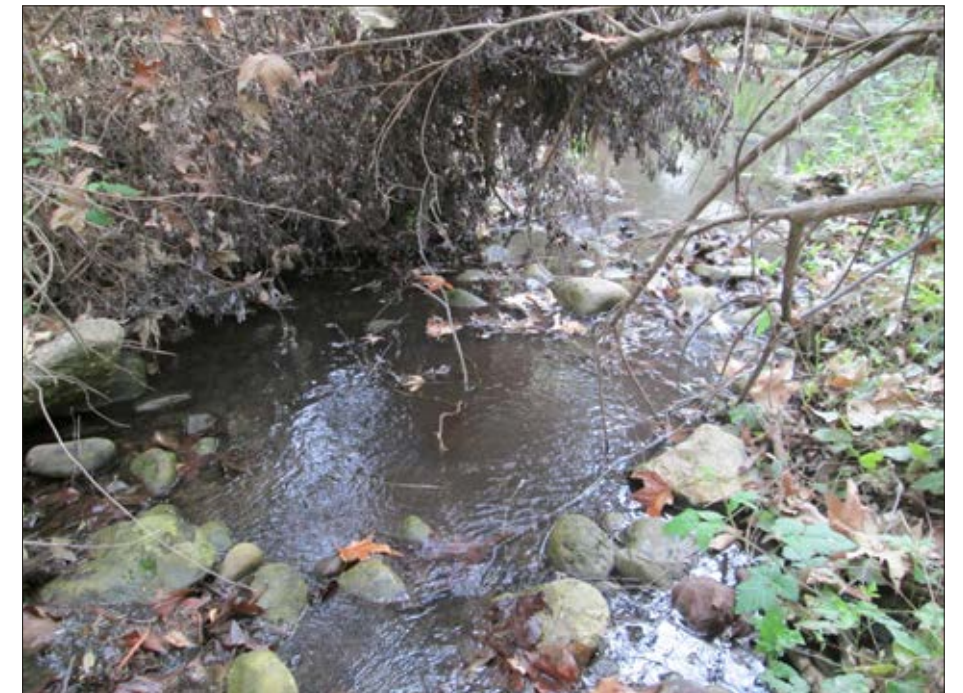
Photo 6: Typical creek condition with eucalyptus debris

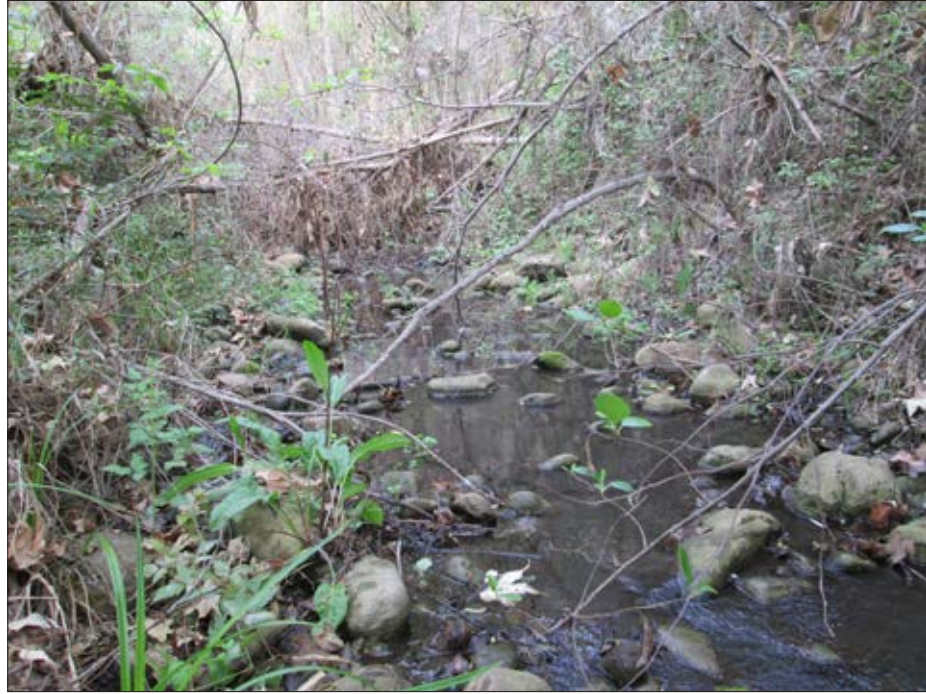
Photo 1: Creek conditions downstream of La Casa Grande Bridge

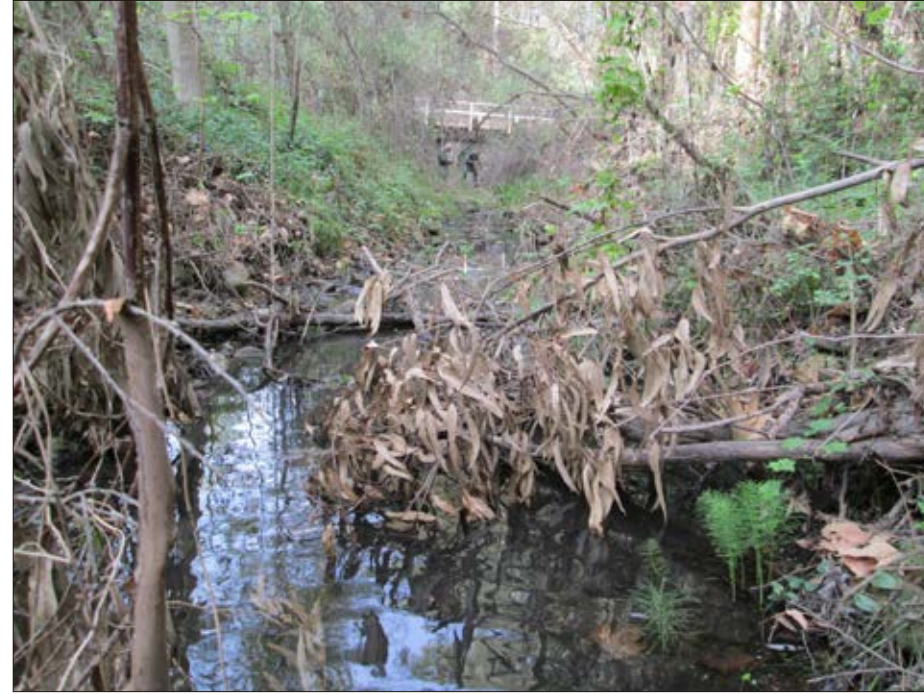
Photo 2: Looking upstream toward La Casa Grande Bridge (eucalyptus debris)

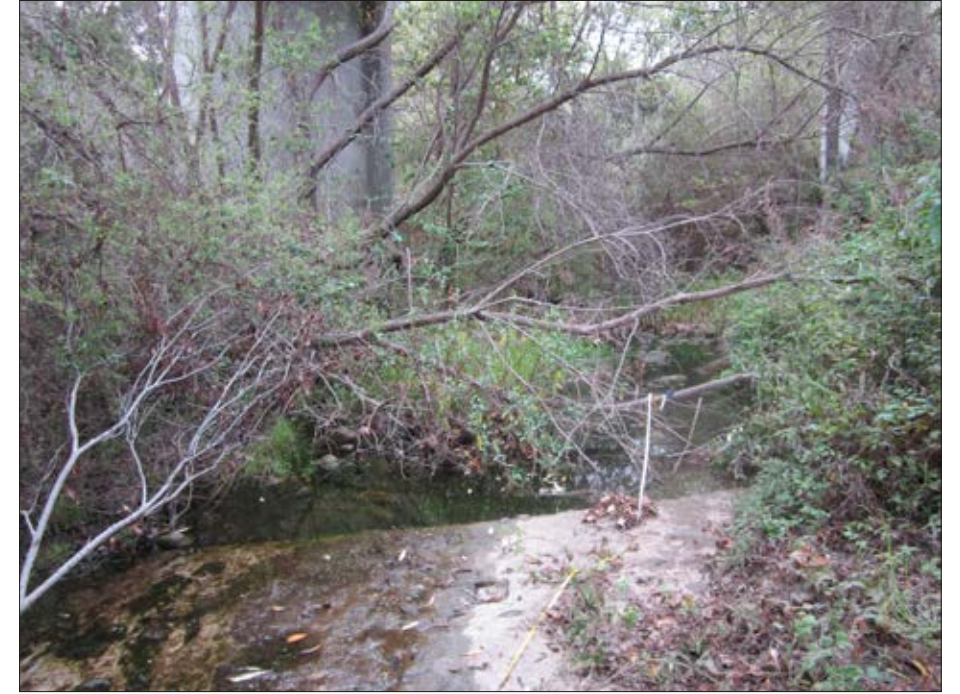
Photo 3: Looking upstream from old concrete paving

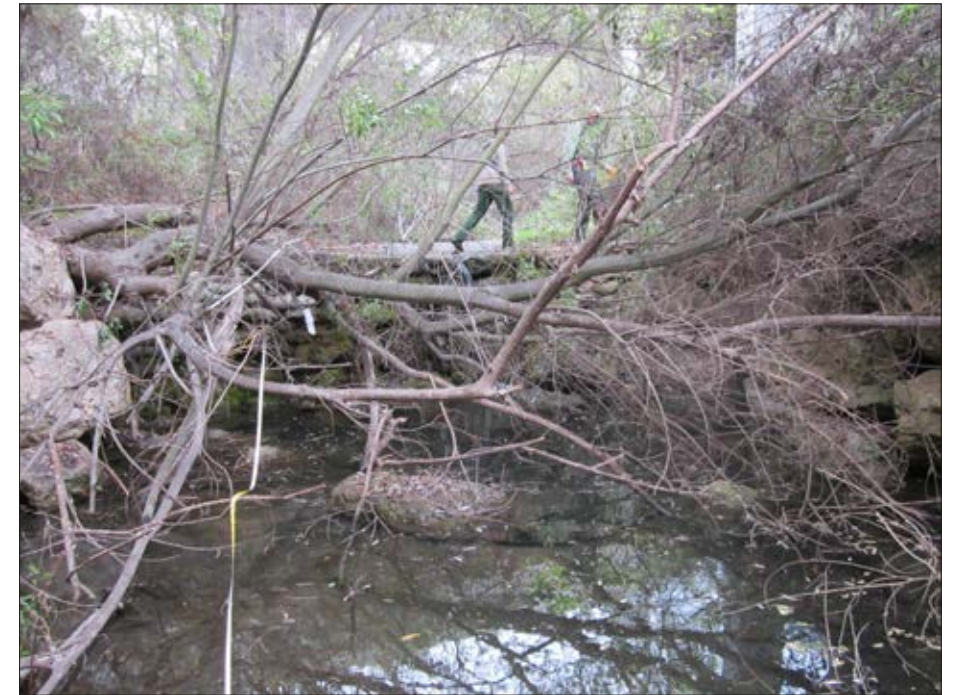
Photo 6: View looking north along lower pool towards spillway of drop structure

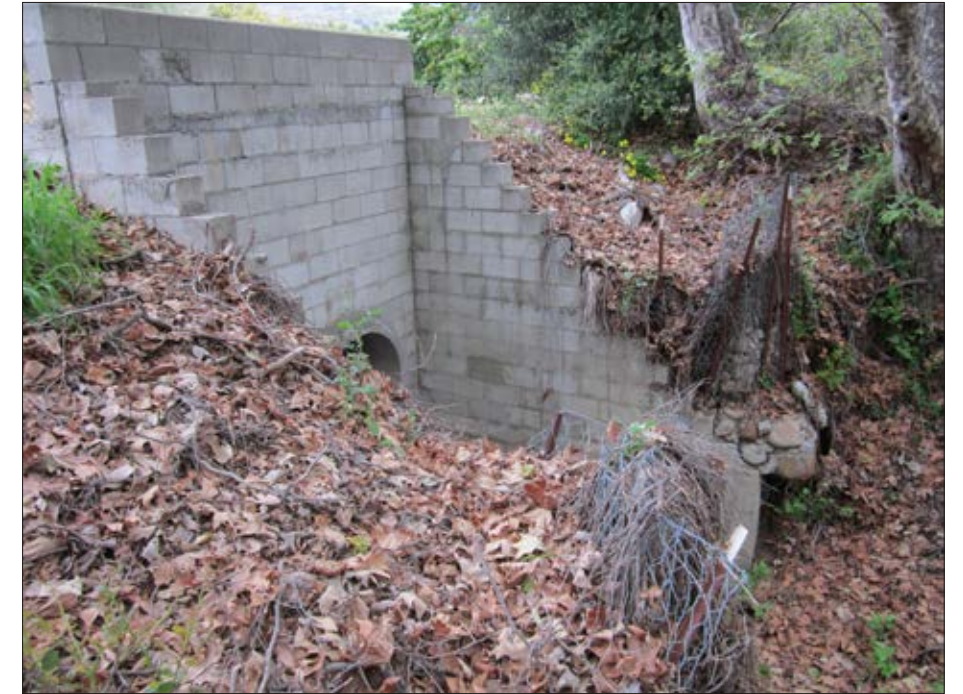
Photo 3: View of agriculture drain structure/culvert on east side of access road

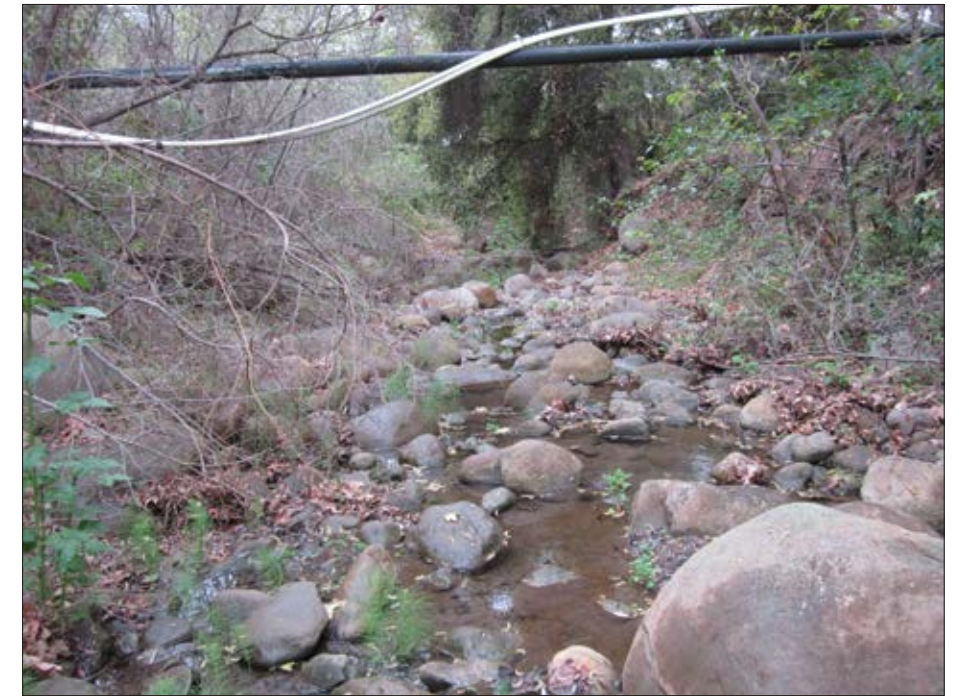
Photo 3: View of unpaved low water crossing looking downstream (south)

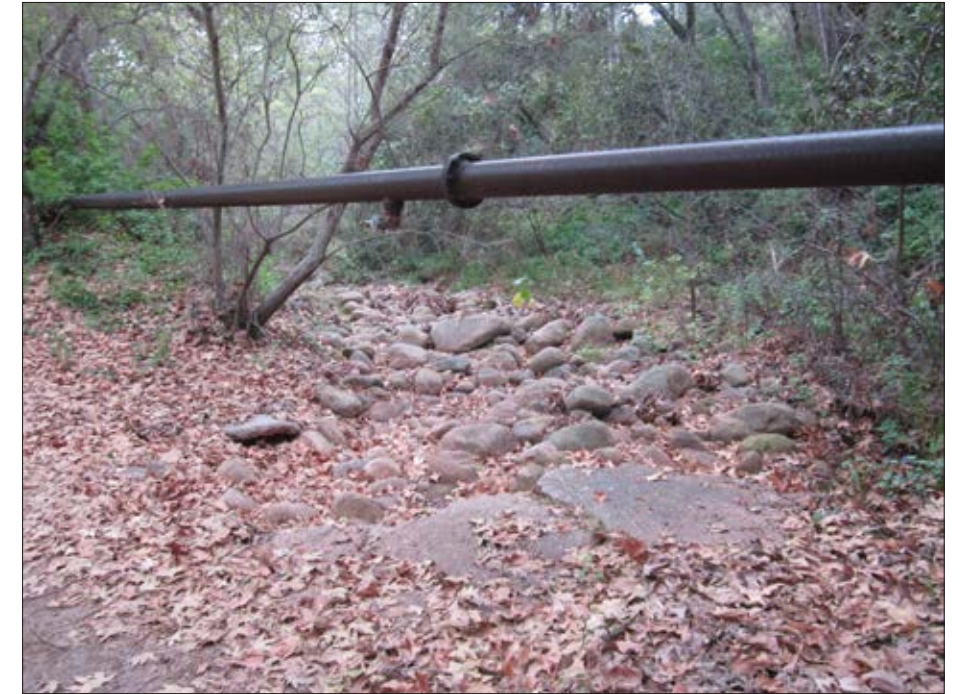
Photo 3: View of paved low water crossing looking north

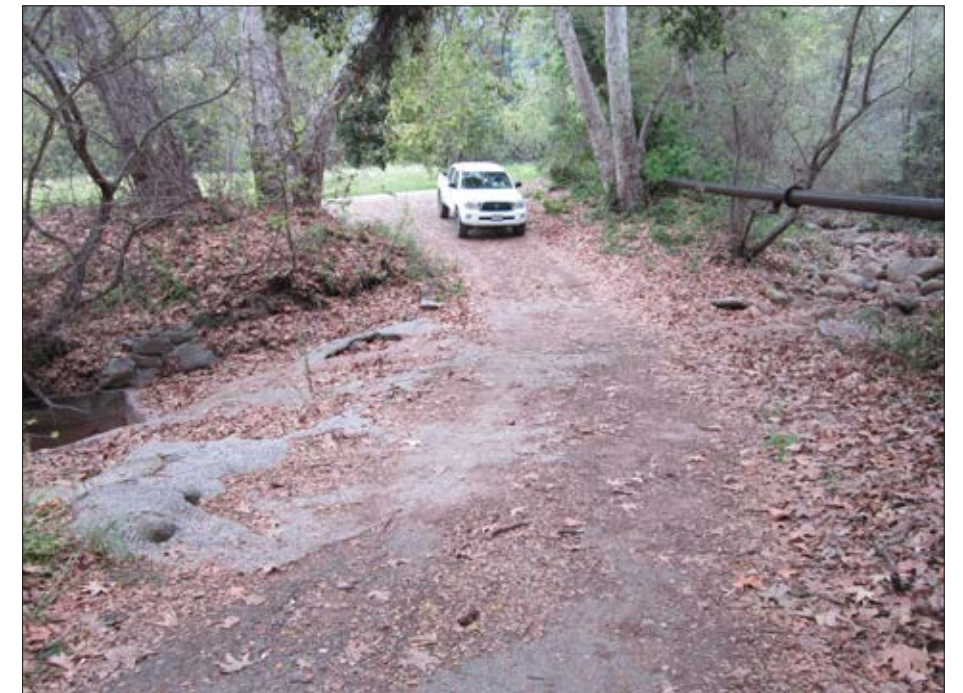
Photo 6: View of paved low water crossing looking west

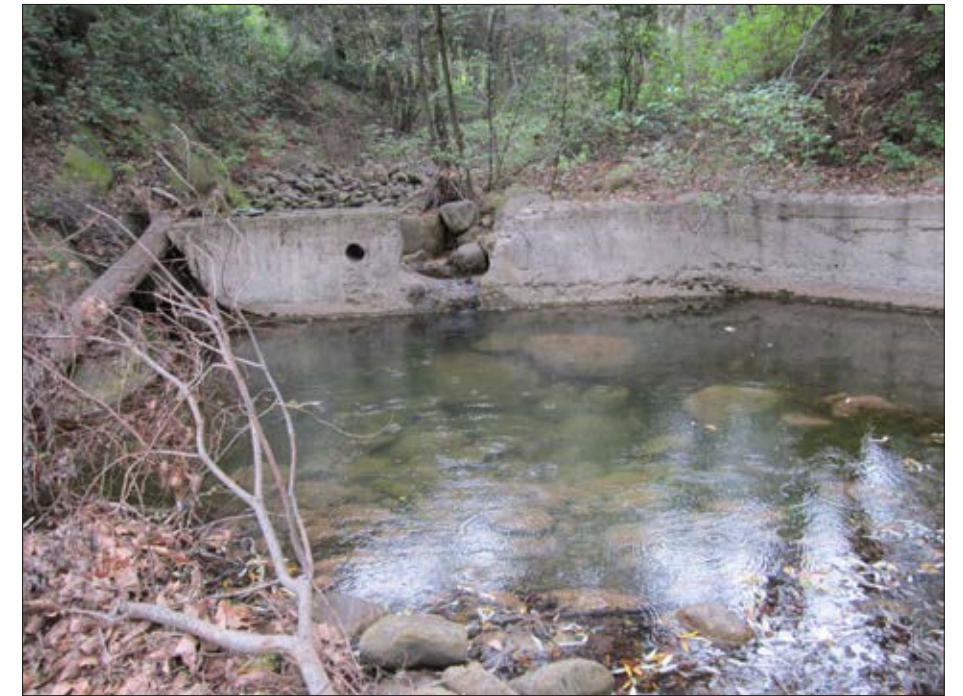
Photo 3: View of old flood gate and wall structure looking north

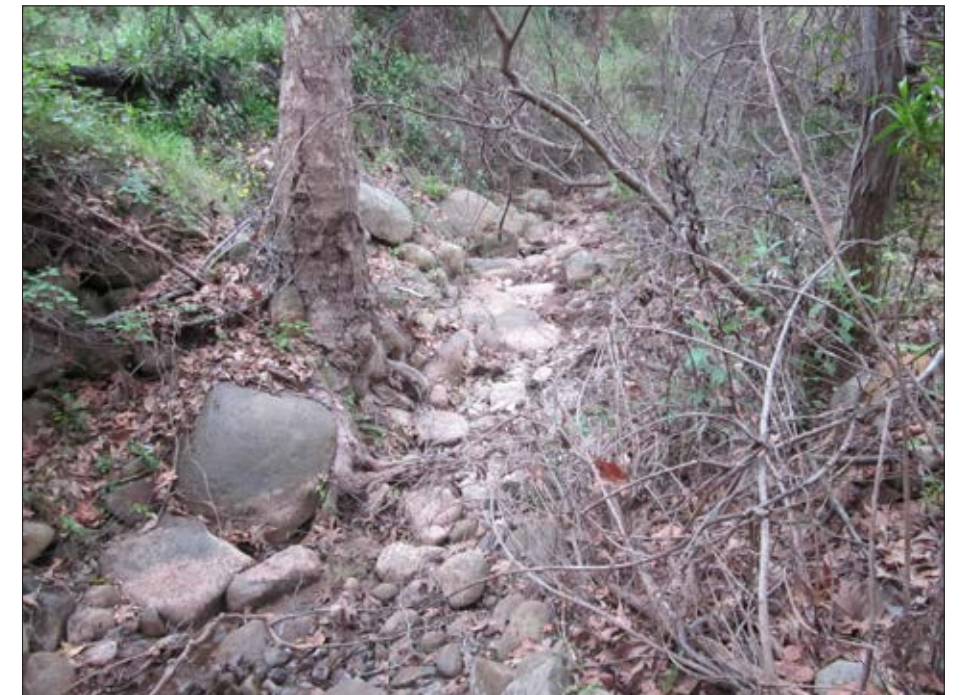
Photo 6: View of creek downstream of old flood gate and wall structure

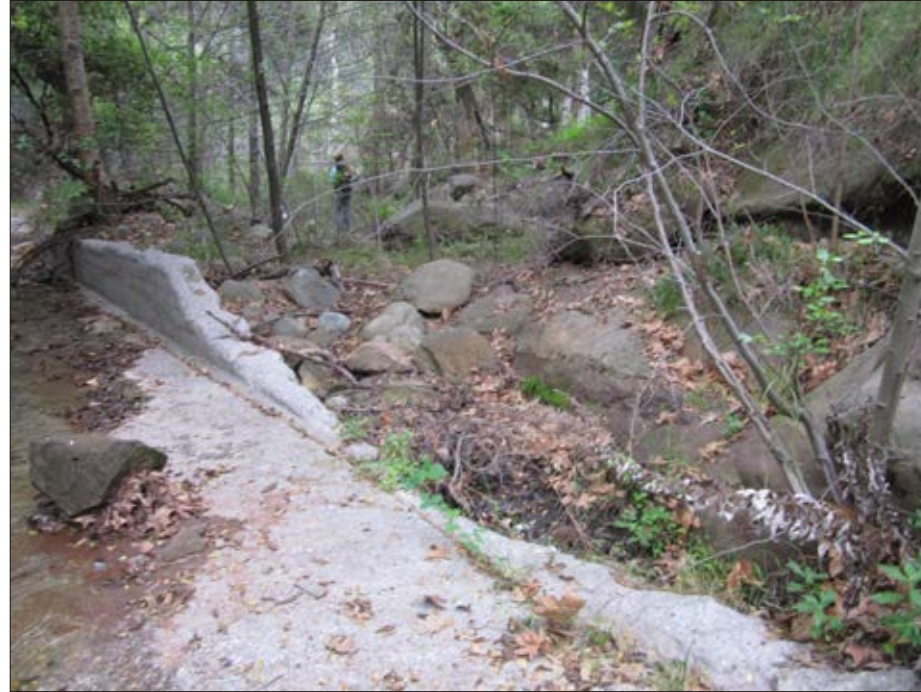
Photo 2: View of upstream end of creek diversion channel at broken wall and start of proposed secondary channel

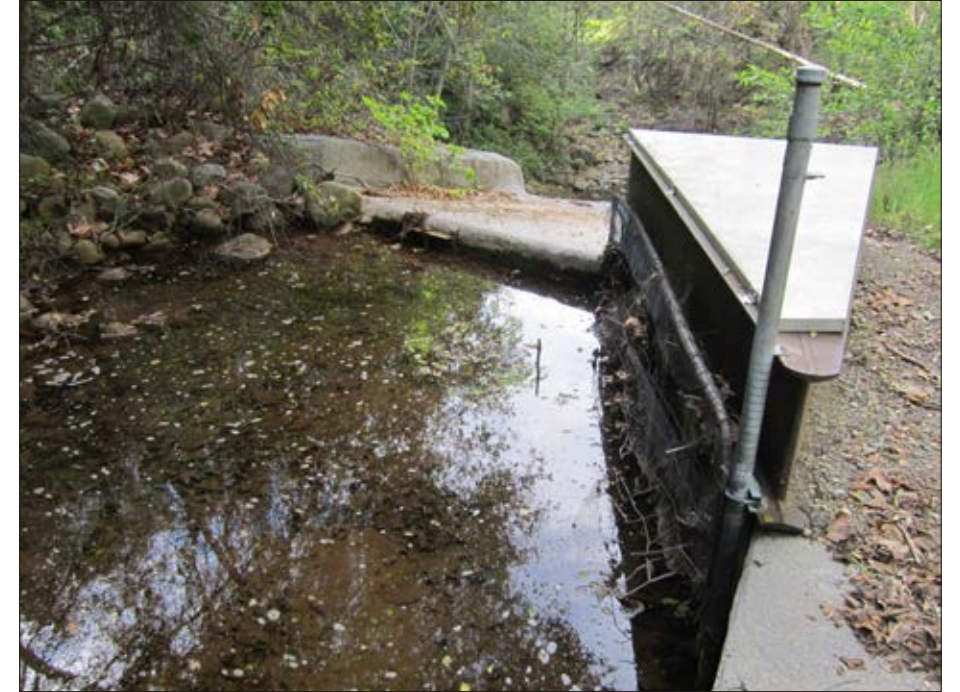
Photo 3: View of weir structure and pool looking south

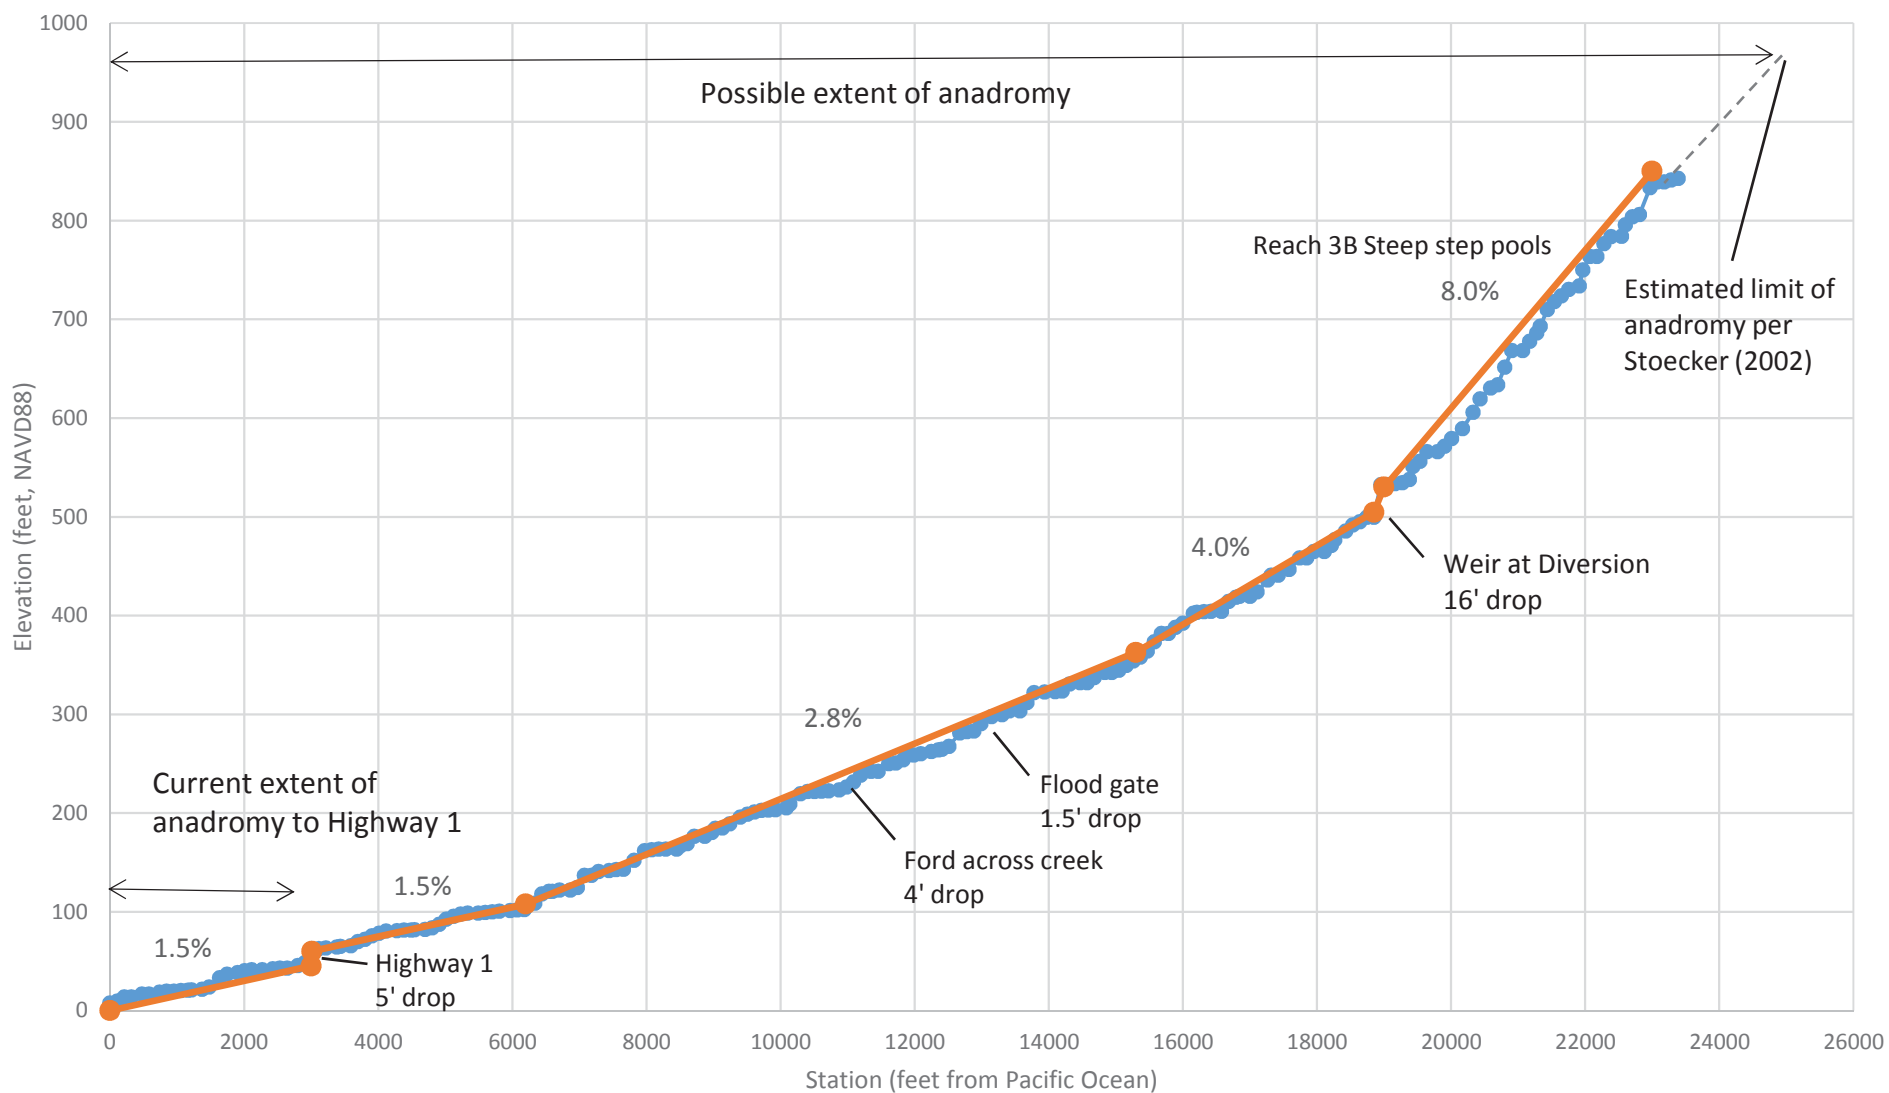
Figure B-2: Reach profile of Dos Pueblos Creek showing locations of main fish barriers and potential restoration of fish passage, Santa Barbara County, CA,
 Data source: USGS StreamStats GIS analysis March 2015, Stoecker (2002)
