ACIN RANCH HISTORIC MINING INVESTIGATION

1. Executive Summary

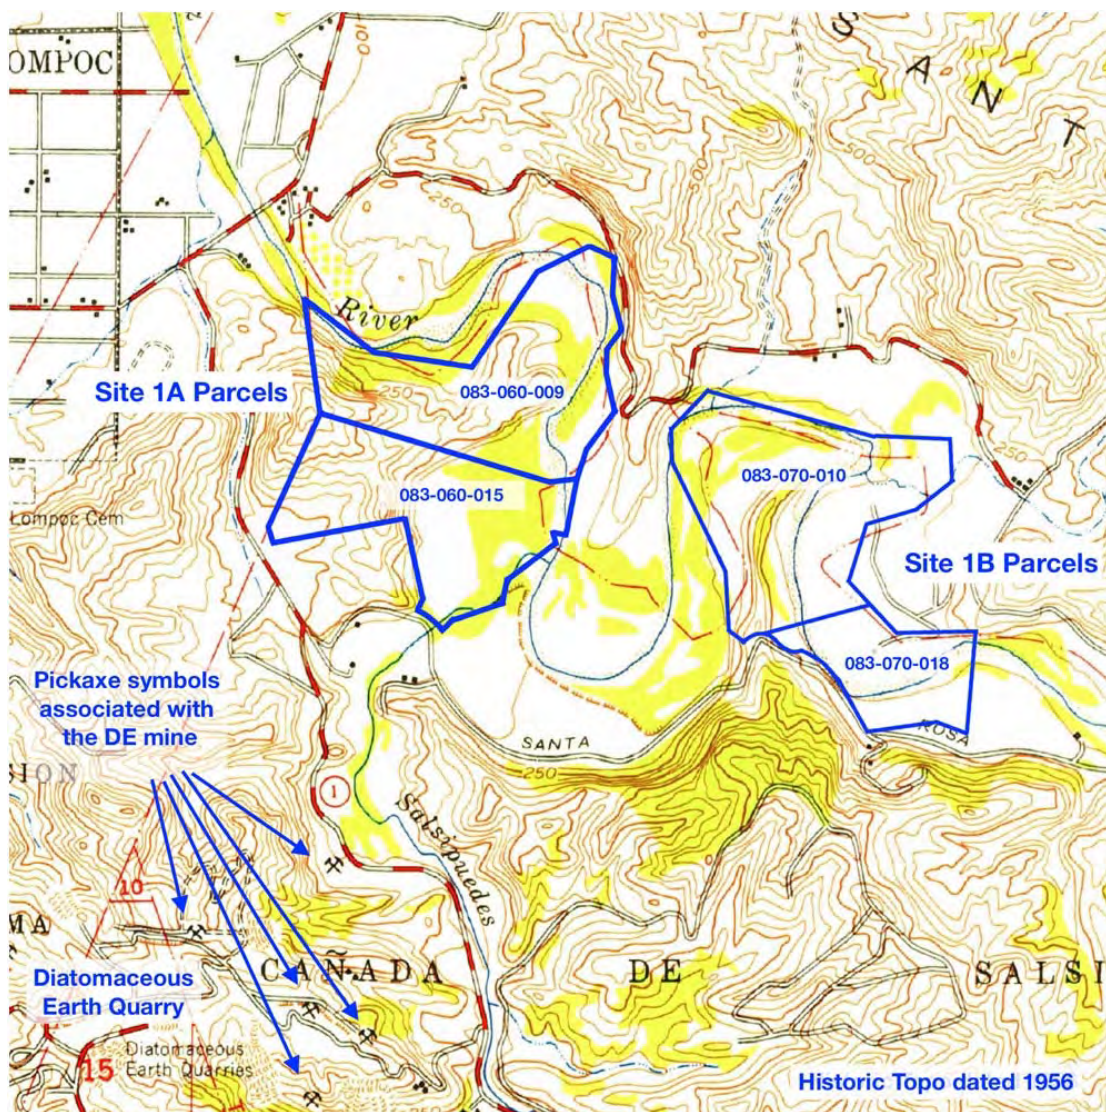
Fig. 1. Historic 1956 USGS topographical map

By superimposing the parcel outlines upon a larger section of a historic topo map from 1956 it is evident that the pickaxe symbol is clearly associated with the

diatomaceous earth mine approximately one mile to the south. No pickaxe symbols are associated with any part of the property.

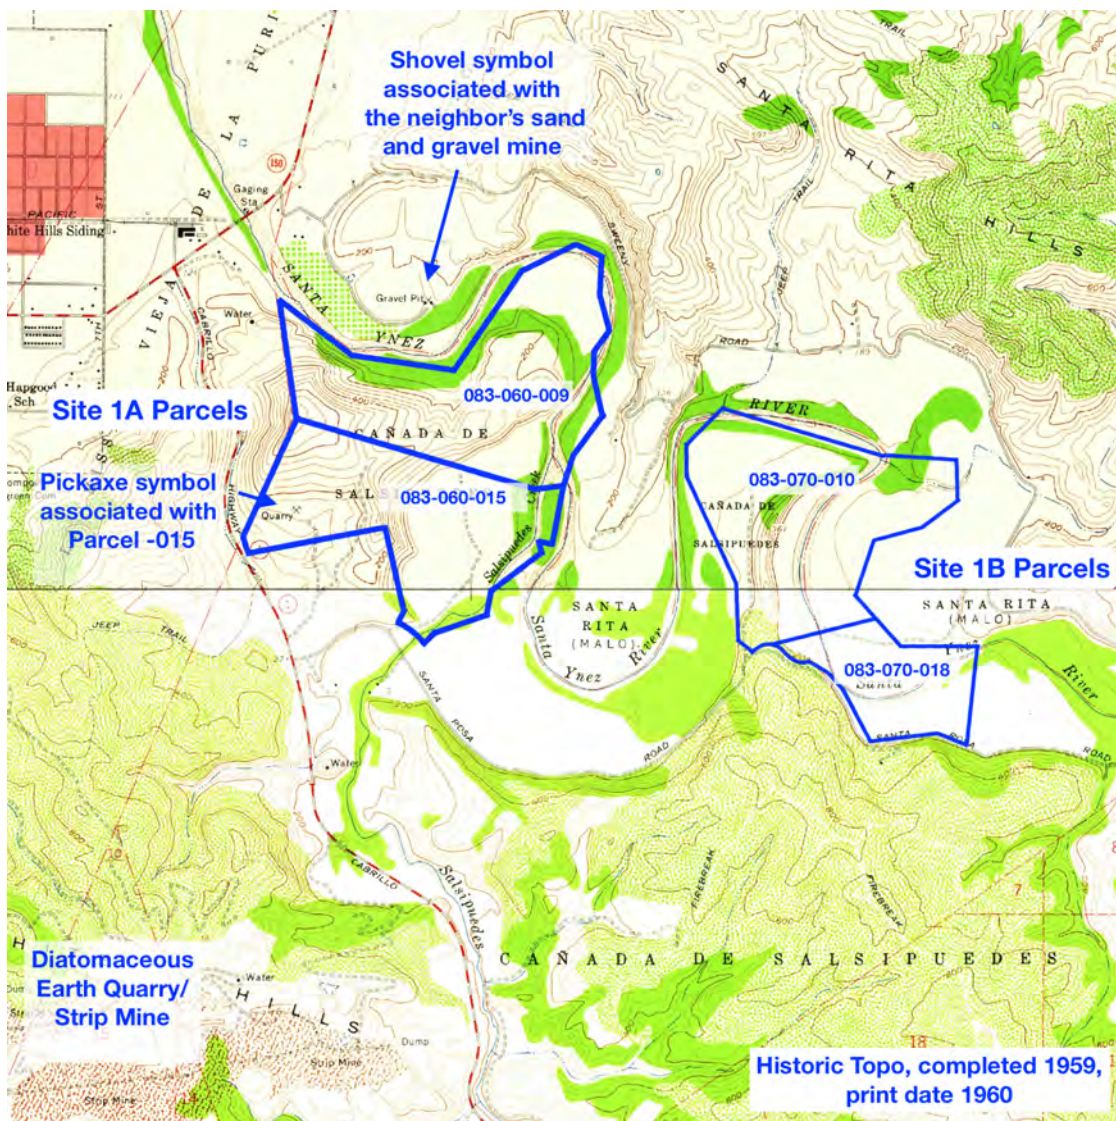
Fig. 2. Historic 1959 USGS topographical map, field work completed in 1958

The next update of the region's USGS topographical map is from 1959. According to Maria McCormick of the US Geological Survey, new survey work was undertaken beginning with aerial photographs taken in 1956 and field work which was completed in June, 1958. The updated map was completed and published in 1959. This topo map is the first to include a pickaxe symbol and the word 'quarry' beneath it on what is now the Acin Ranch, on Parcel 083-060-015. Dashed-line dirt road symbols associated

with pickaxe symbols **do not extend** into any other area of the property, nor are they present on any earlier topo map. USGS location of the quarry activities and its timeline is corroborated by historic aerial photographs documenting that **mining activity is limited exclusively to Parcel -015 in 1958.**

This historic 1959 USGS topographical map does not show any pickaxe symbols associated with Parcel 083-060-009 or the parcels that comprise Site 1B.

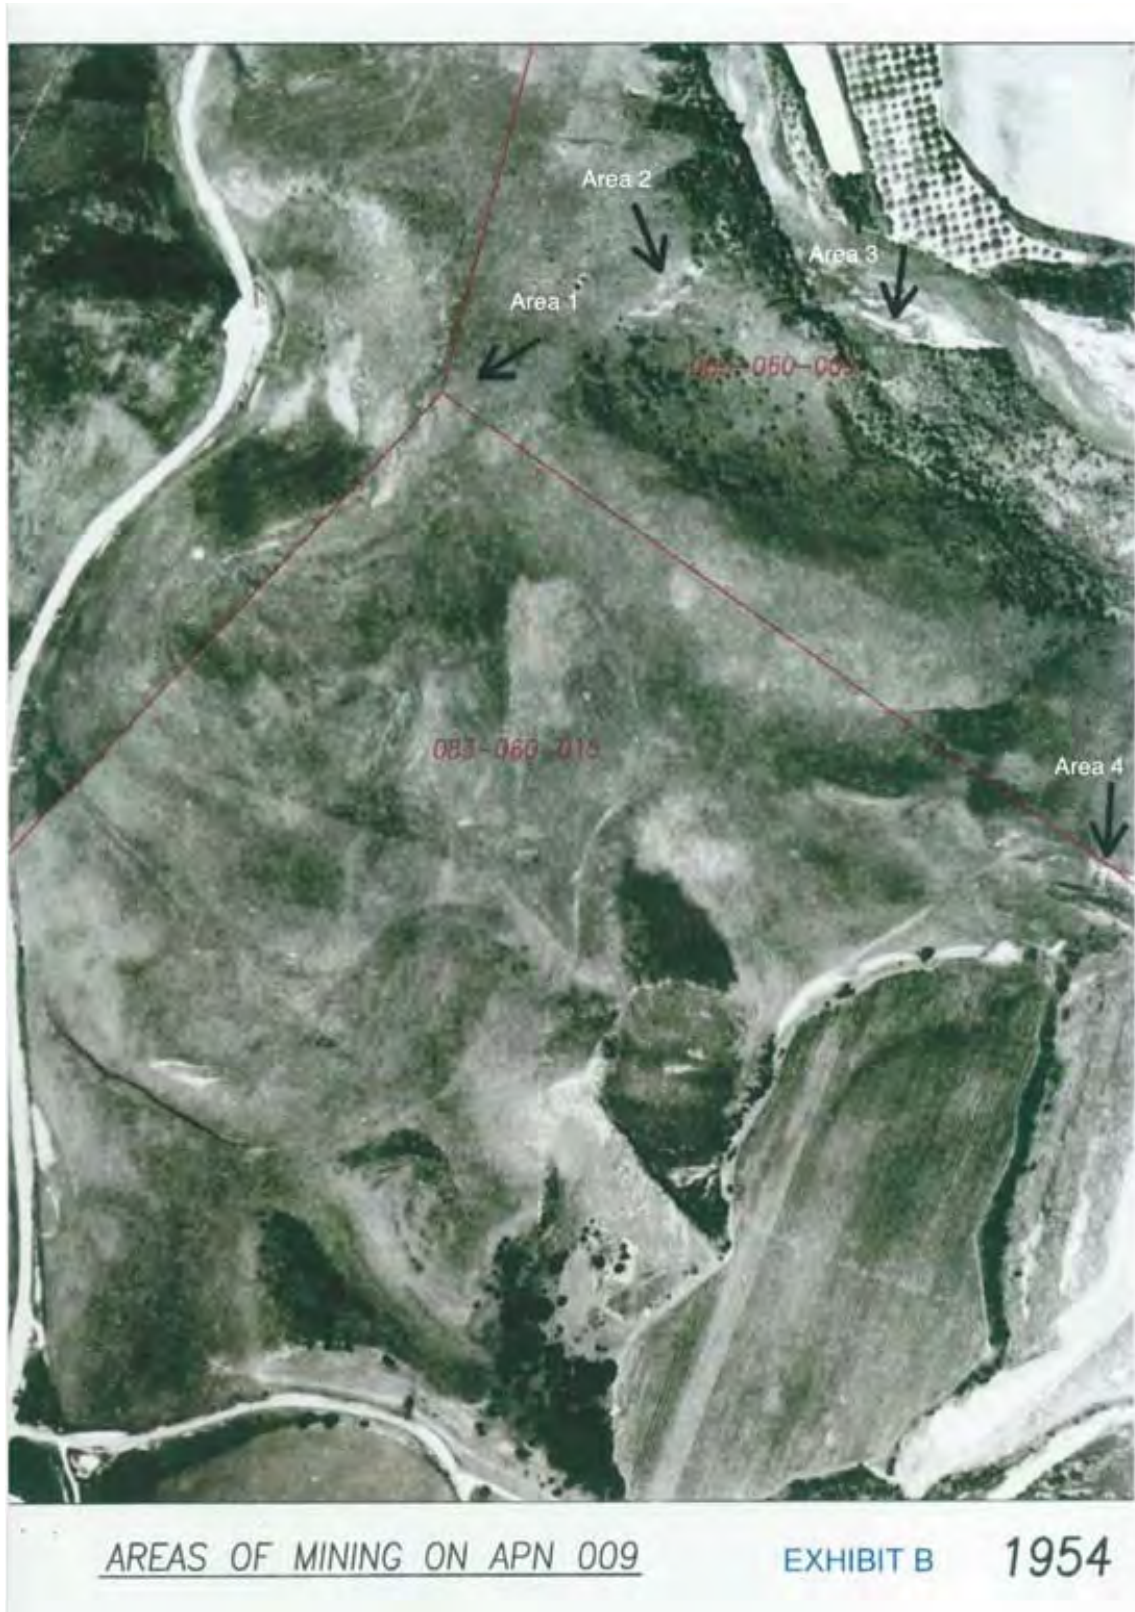
Fig 3. Claimant's 1954 aerial photograph, with arrows labeled 1 through 4.

A 1954 aerial photograph of Site 1A labeled "Exhibit B" was provided by the Applicant, with lines indicating the boundary between the parcels. (It should be noted that these boundaries in this exhibit are not accurate, and the boundary between -009 and -015 should be further to the south, as in the photos in Appendices A through E.)

Four areas of alleged mining on Parcel -009 were indicated by arrows superimposed on the photograph. These arrows were unlabeled in the original, but for clarity's sake in this discussion, each area and arrow in question have been assigned a number, as seen in Fig. 3 below.

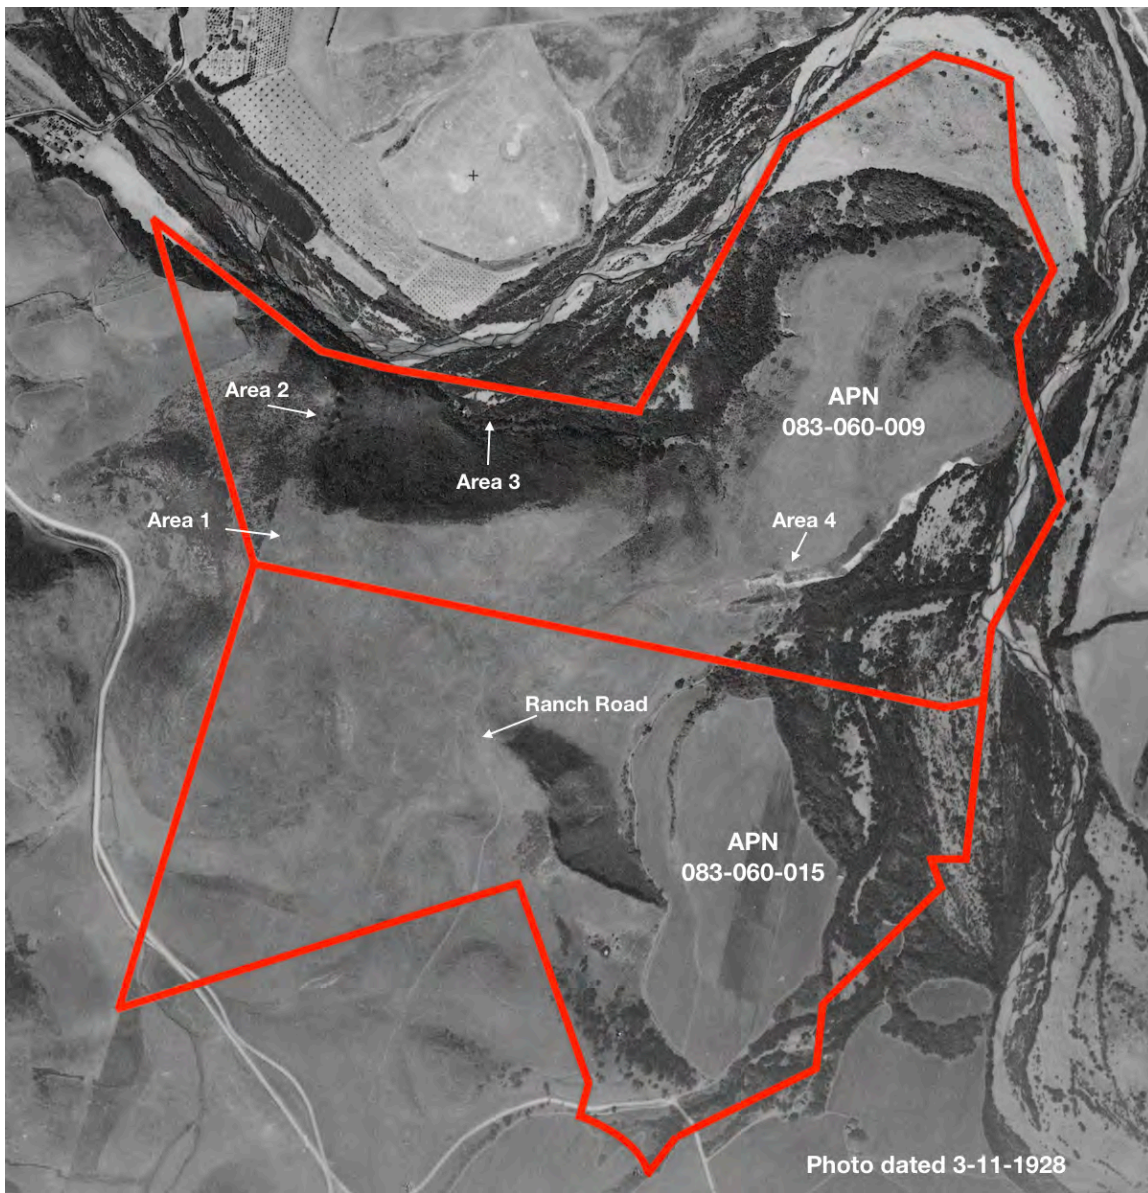
Fig. 5. 1928 aerial photograph of Site 1A.

This photo is the earliest available in the region. The locations identified in Exhibit B of Price, Postel, and Parma are labeled Areas 1 through 4, and are stated to be areas of mining on Parcel 083-060-009 before the effective date of County Ordinance 971 on September 29, 1958.

No mining or soil disturbance associated with surface mining are evident on the Site 1A parcels.

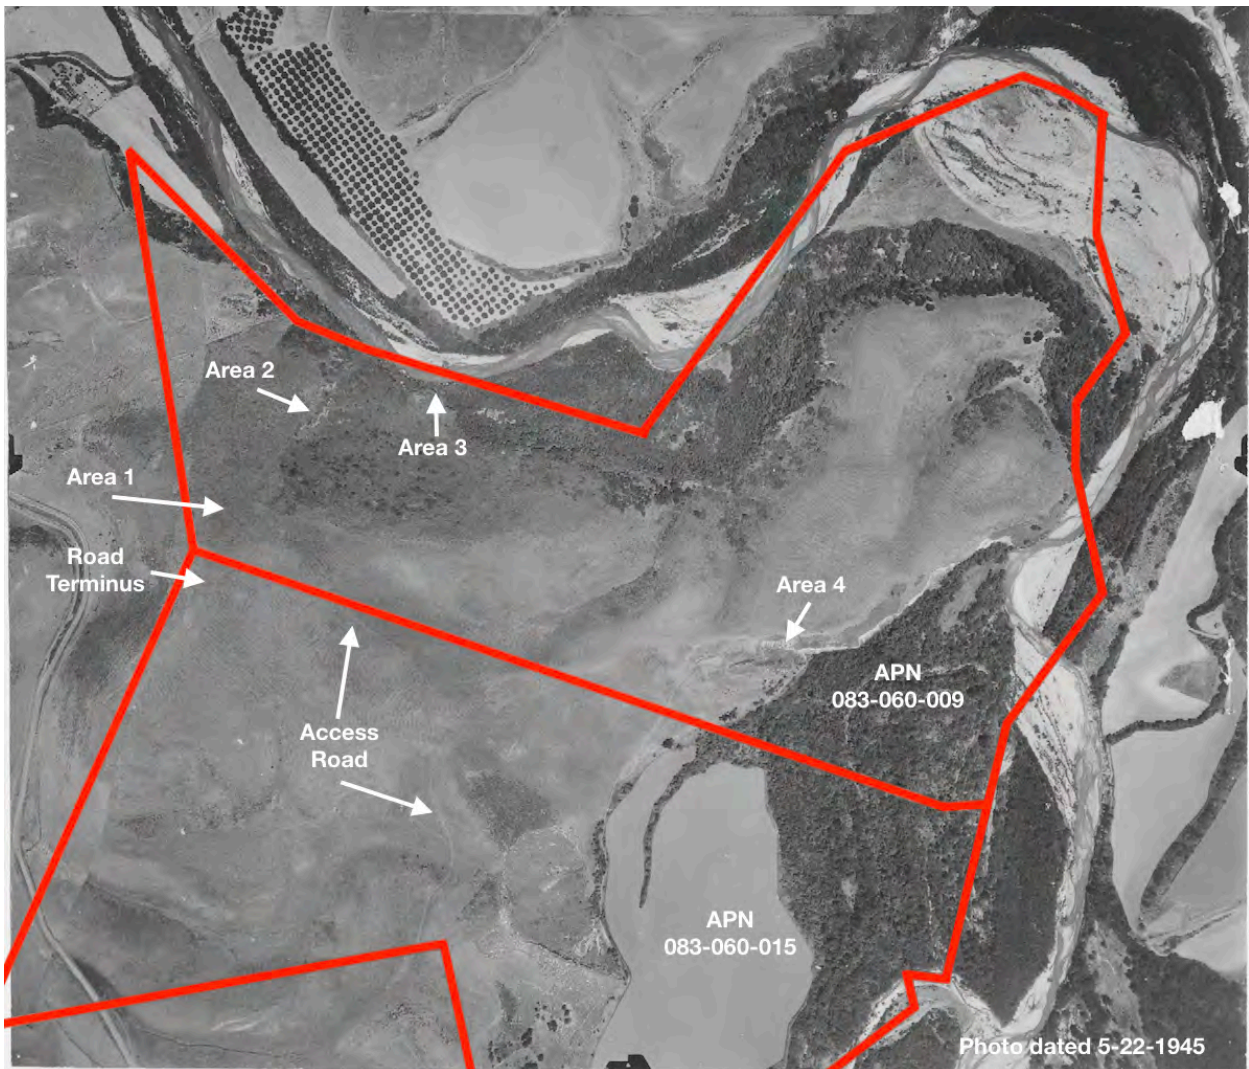
Fig. 6. 1945 aerial photograph of Site 1A.

A faint access road comes up from the southeast of Area 1, swings up into Parcel -009, and swings back down to terminate in Parcel -015. The route of this particular road stays the same in decades to follow.

No mining or soil disturbance related to surface mining is visible in Areas 1 through 4. Area 3 appears to be under water in Santa Ynez River bed.

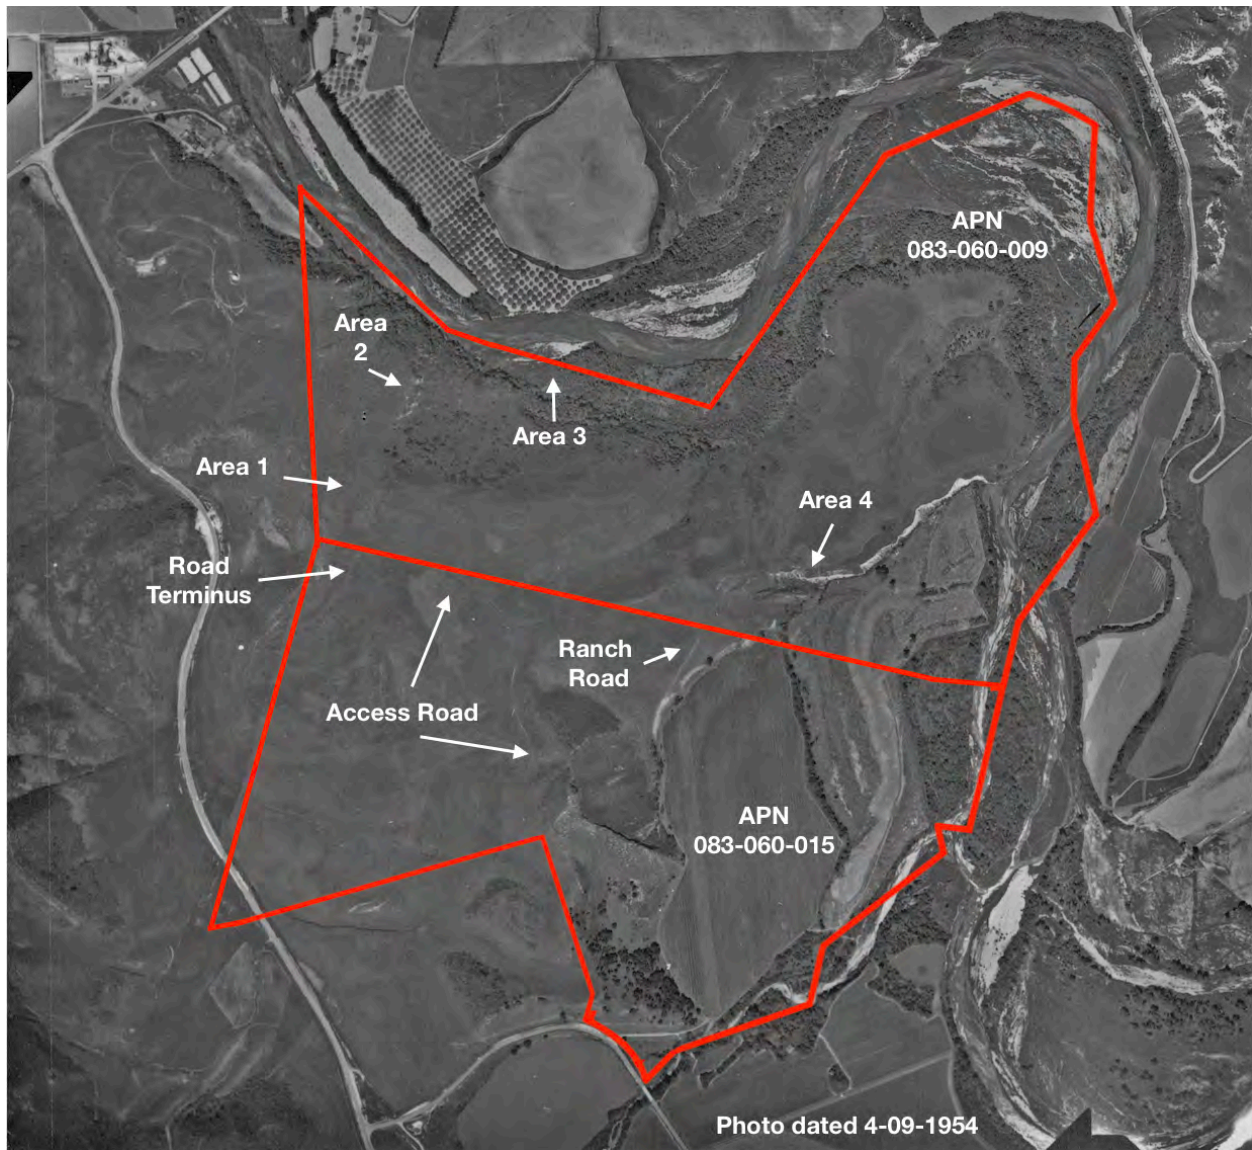
Fig. 7. 1954 aerial photograph of Site 1A.

No mining or soil disturbance associated with surface mining activity is discernible in Area 1 on Parcel -009. The Santa Ynez River has shifted its bed and Area 3 appears to be a recent alluvial deposit in the riverbed.

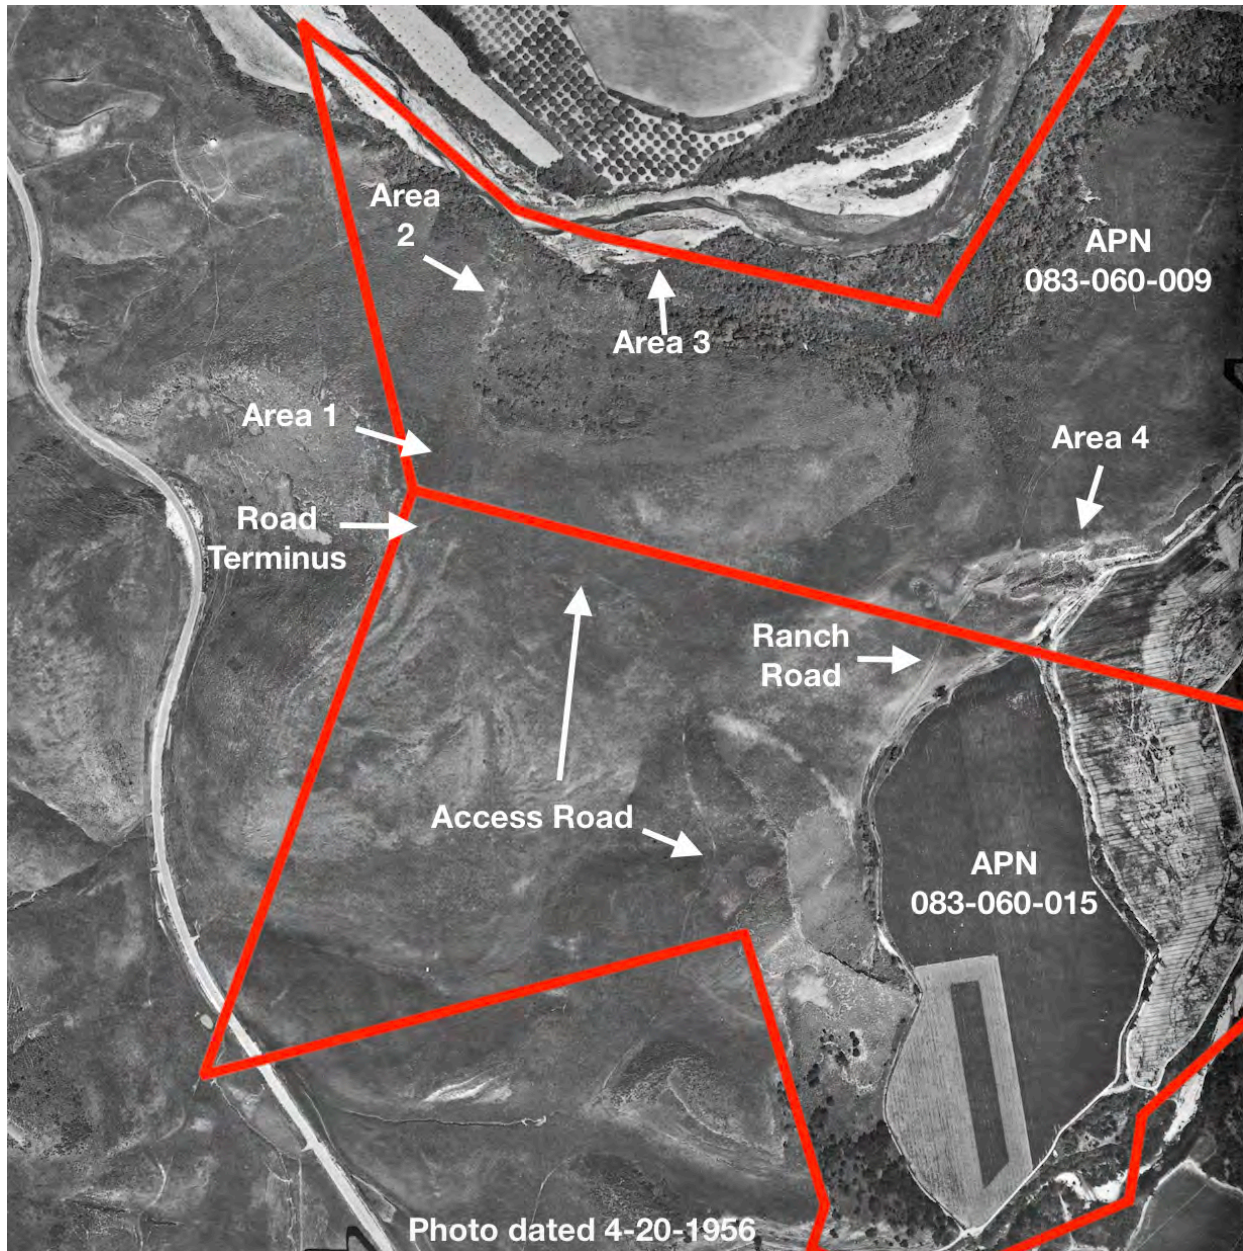
Fig 8. April 20, 1956 aerial photograph of Site 1A.

The same faint road coming from Parcel -015 is visible, crossing into -009 but its terminus is well within -015. At the terminus it looks like some small rock outcrops and activity areas exist near the boundary but are squarely within the -015 parcel boundary.

No mining or soil disturbance associated with surface mining activity is discernible in Areas 1 through 4 on Parcel -009.

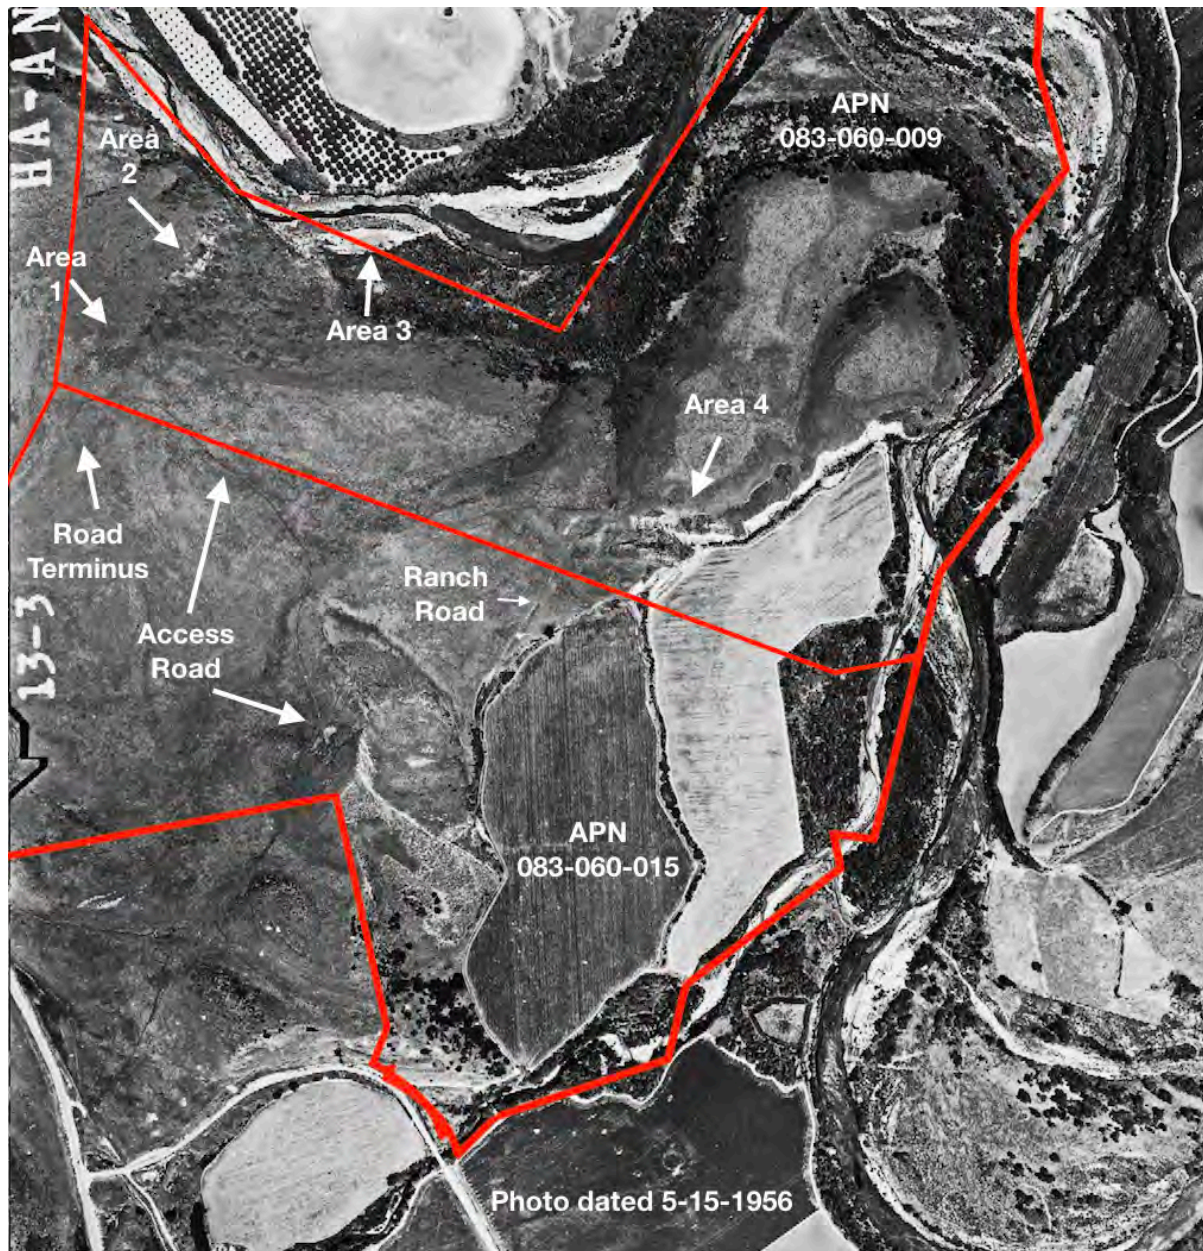
Fig. 9. May 15, 1956 aerial photograph of Site 1A.

No mining or soil disturbance associated with surface mining activity is discernible in Areas 1 though 4 on Parcel -009.

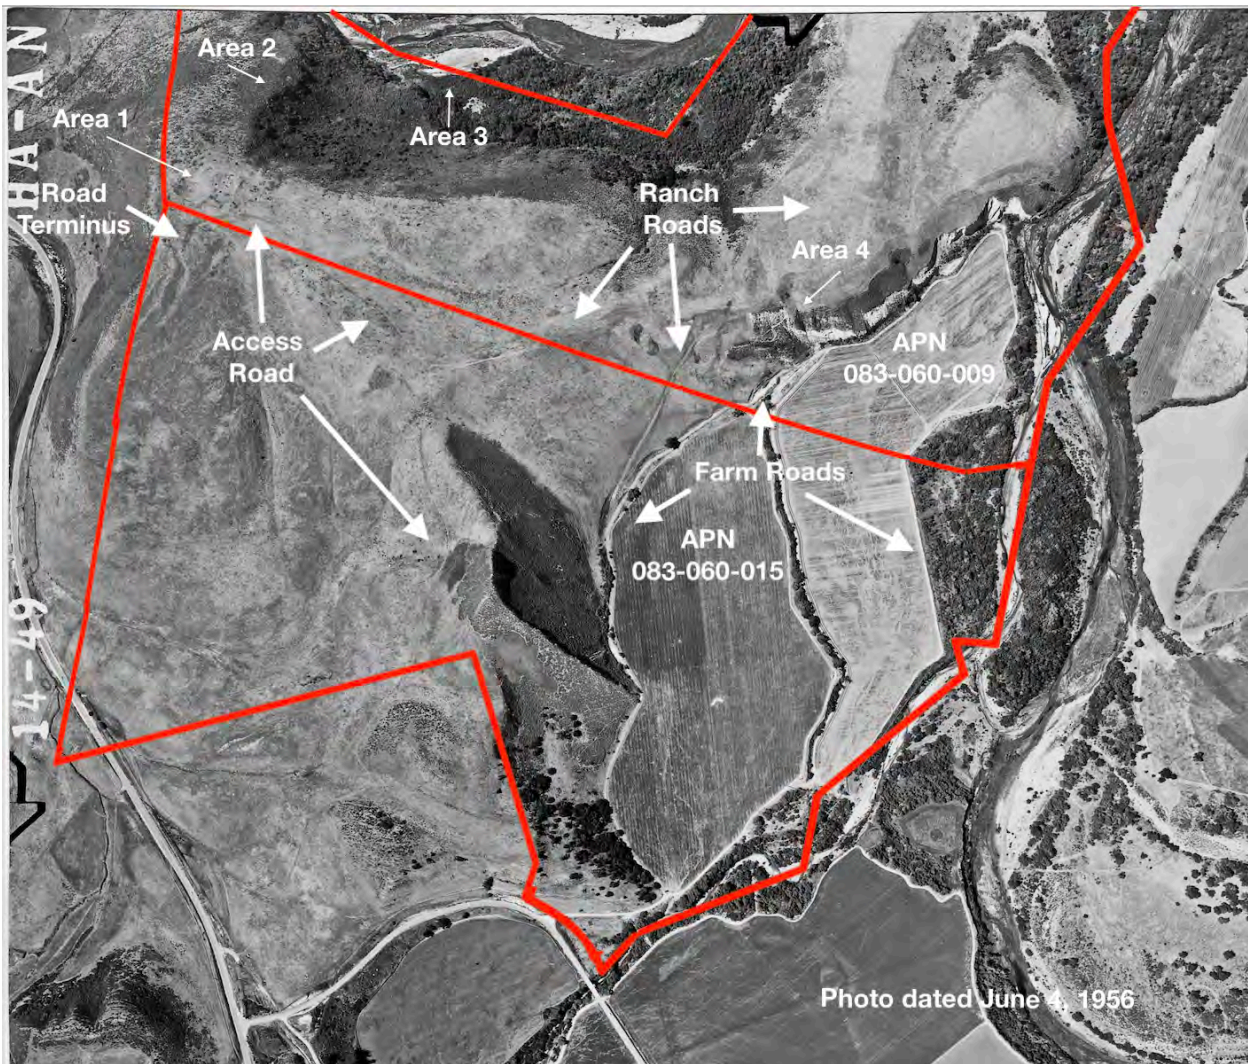
Fig. 10. June 4, 1956 aerial photograph of Site 1A.

No mining or soil disturbance associated with surface mining activity is visible in Areas 1 through 4, and the primary use of the site appears to be farming.

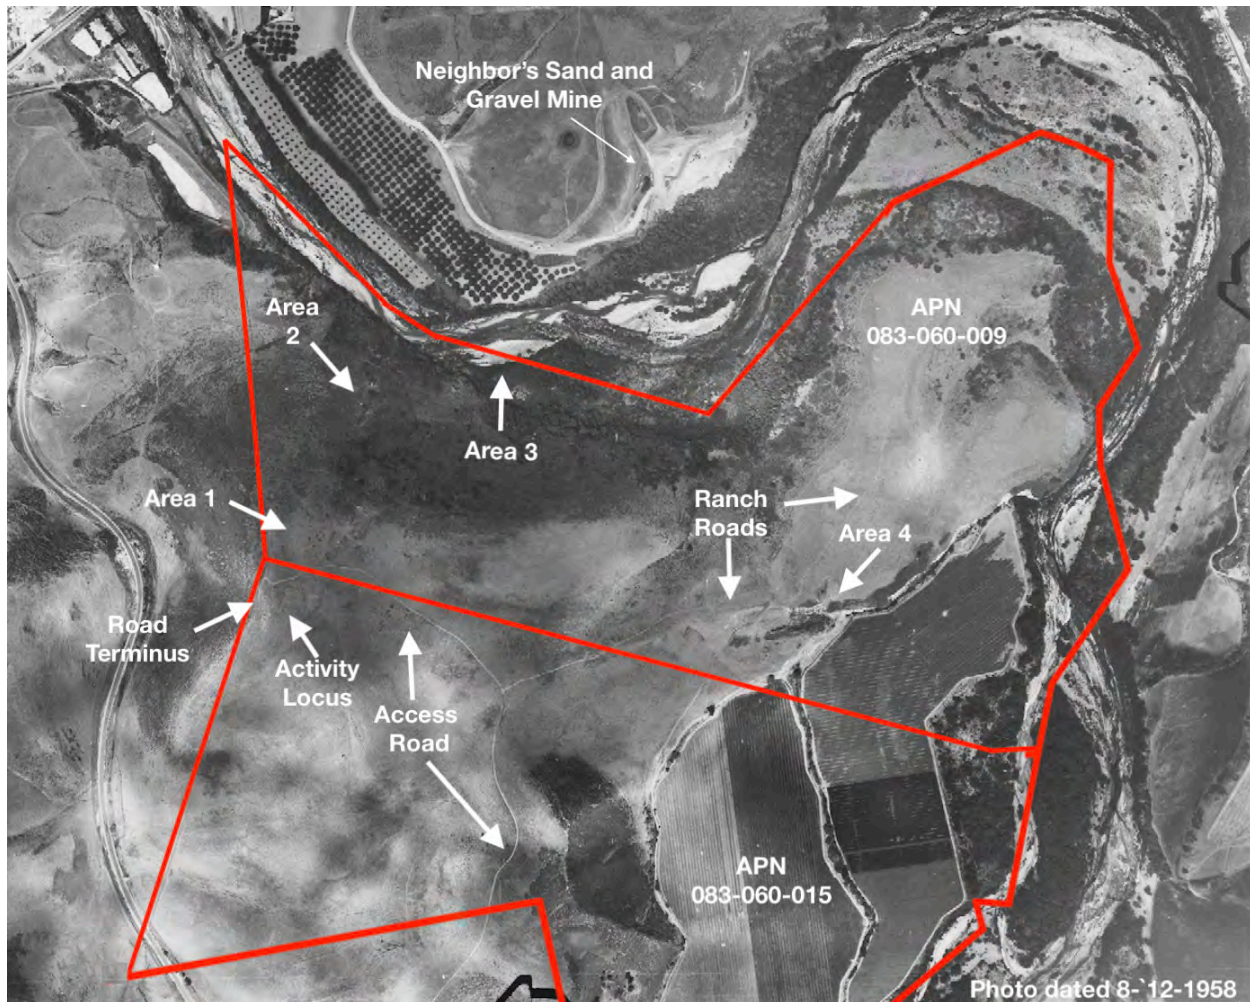
Fig. 11. August 12, 1958 aerial photograph of Site 1A.

This photo was taken approximately six weeks prior to the enactment of County Ordinance 971 on September 29, 1958. It can be inferred that this photo represents an accurate and objective manifestation of the intent of the owner for the use of the property in question at the time of implementation of County Ordinance 971, and that surface mining is restricted to -015.

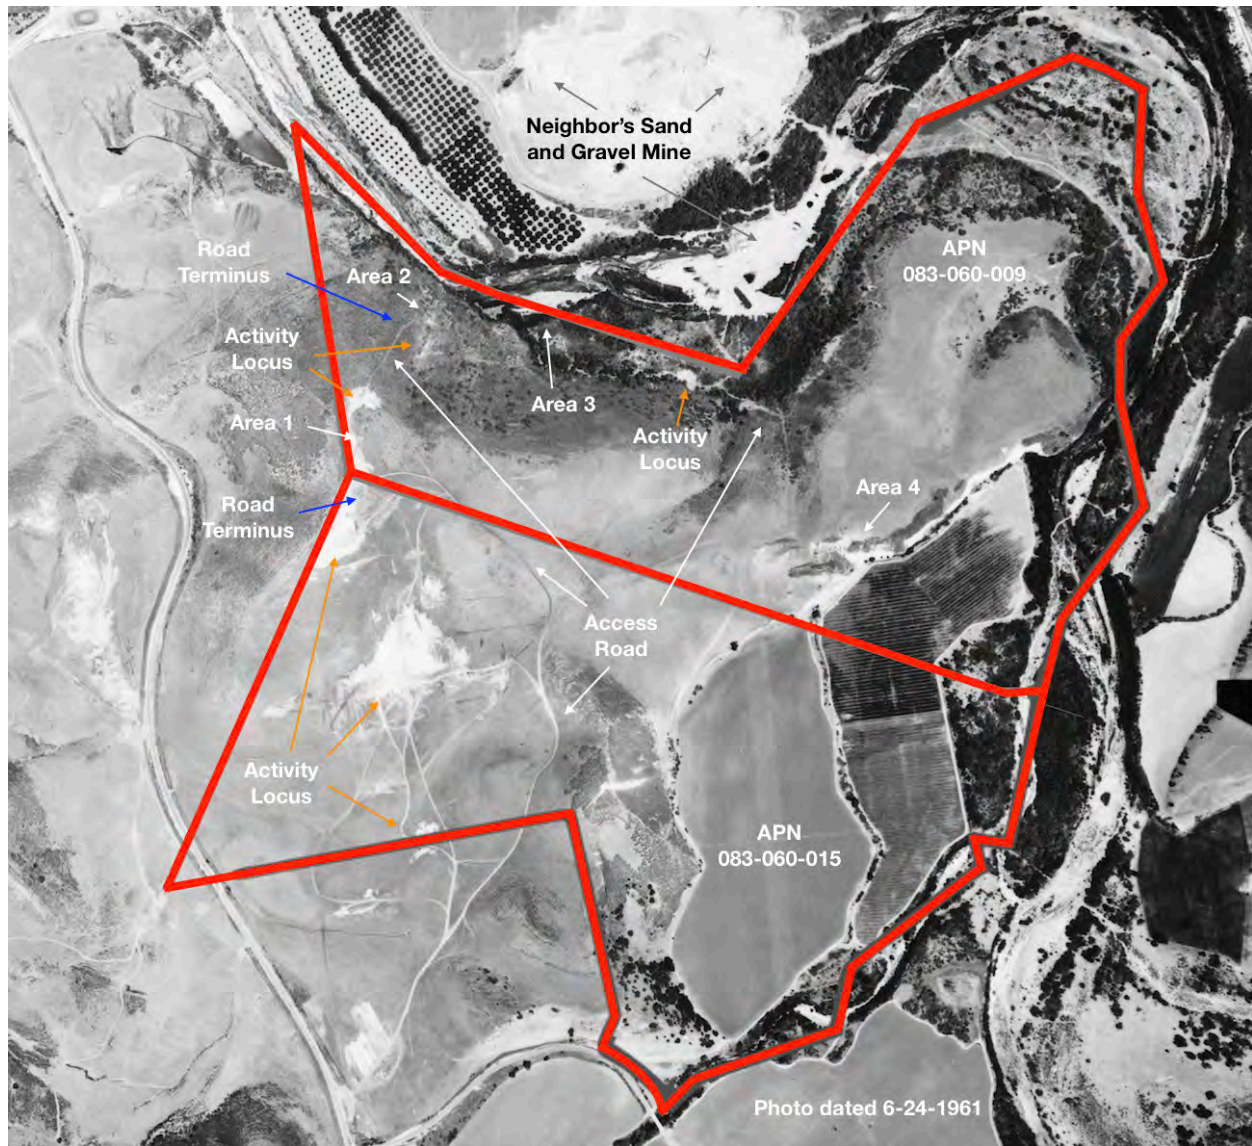
Fig. 12. June 24, 1961 aerial photograph of Site 1A.

This photograph is included to illustrate the expansion of mining activities in this location after the effective date of County Ordinance 971 on September 29, 1958.

Multiple areas of surface mining are noted on both parcels. Areas 1 and 2 show access roads and soil disturbance, and the original access road and road terminus can be seen. Area 3 has mining nearby to the east on -009. The neighbor's sand and gravel operation has expanded to the alluvial surface and borders the parcel boundary. The 1961 aerial photos show vegetation clearing along the parcel boundaries of Sites 1A and 1B, allowing a clear illustration of the boundaries for these historic photos. This photo in 1961 provides the first clear evidence of mining on -009. Significant expansion and intensification of mining activities are visible on Parcel -015 to the south. The expansion of mining activities onto -009 may account for anecdotal accounts of mining on -009, however, all of these activities on this parcel occur after the effective date of County Ordinance 971 of September 29, 1958.

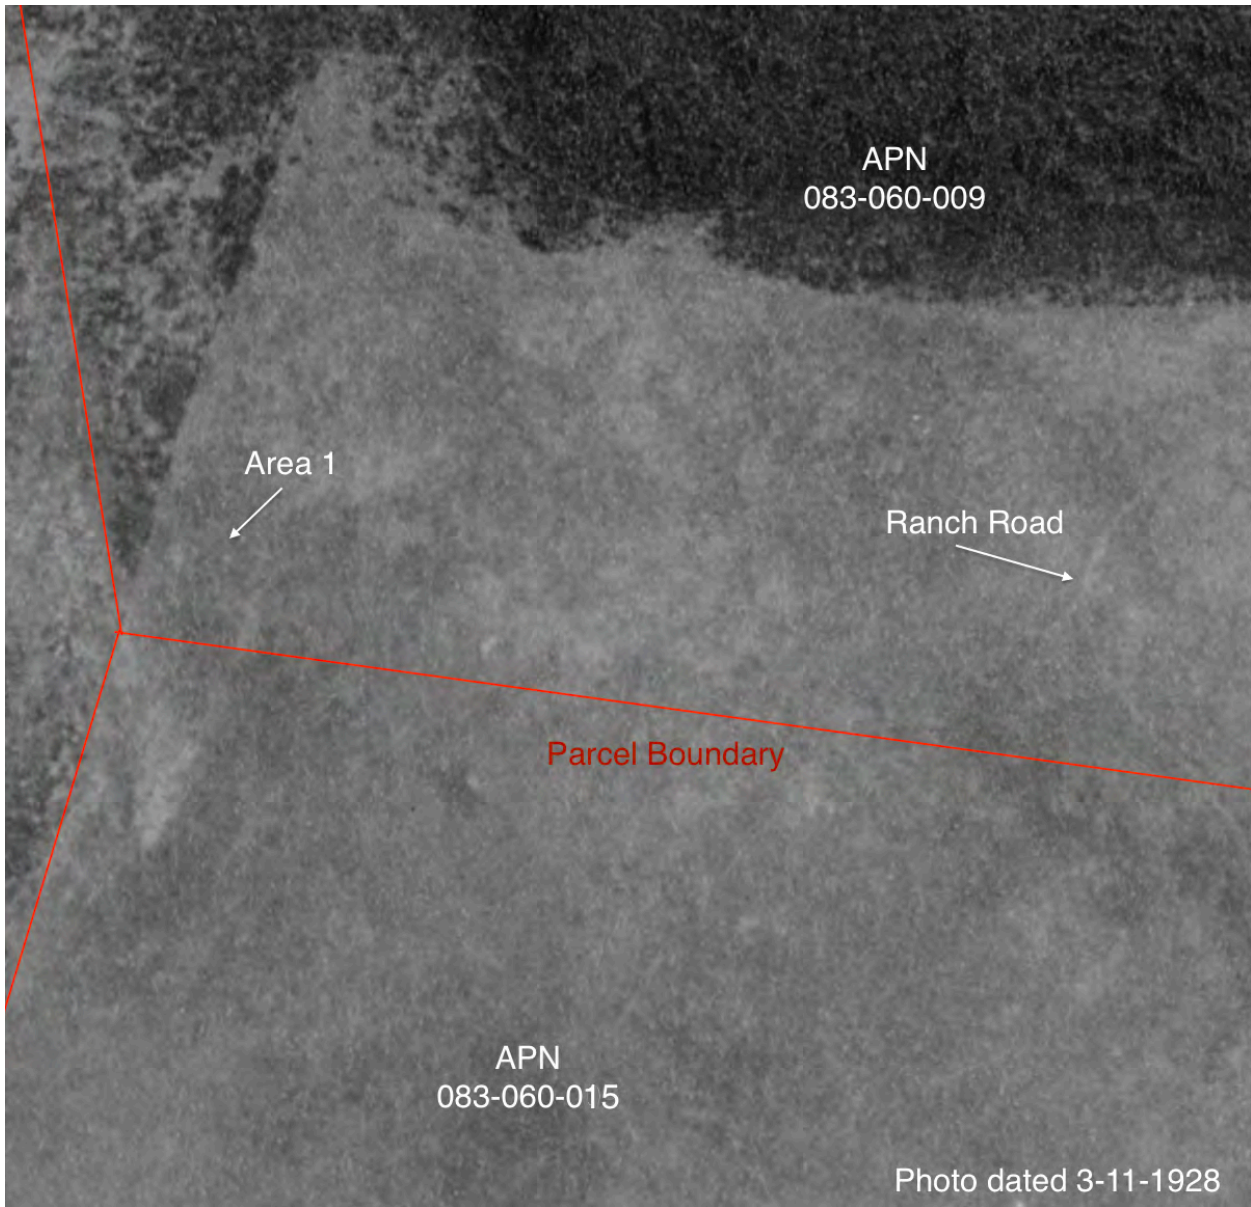
Fig. 13. 1928 aerial photograph closeup of Area 1.

No mining or soil disturbance associated with surface mining are evident in Area 1.

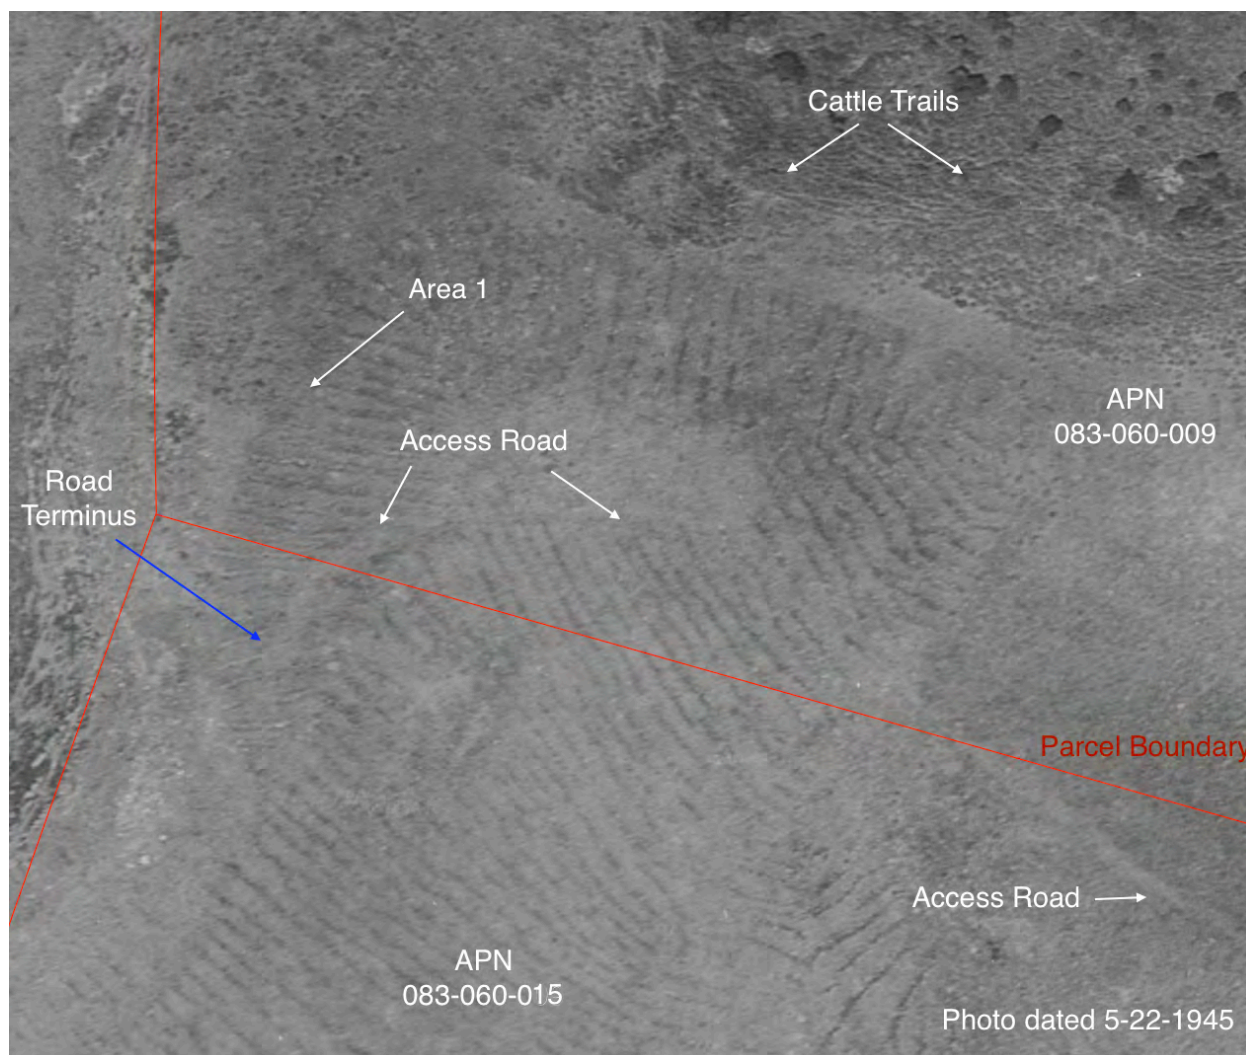
Fig. 14. 1945 aerial photograph closeup of Area 1.

This photo in 1945 shows greater definition of cattle trails on the slope north of Area 1.

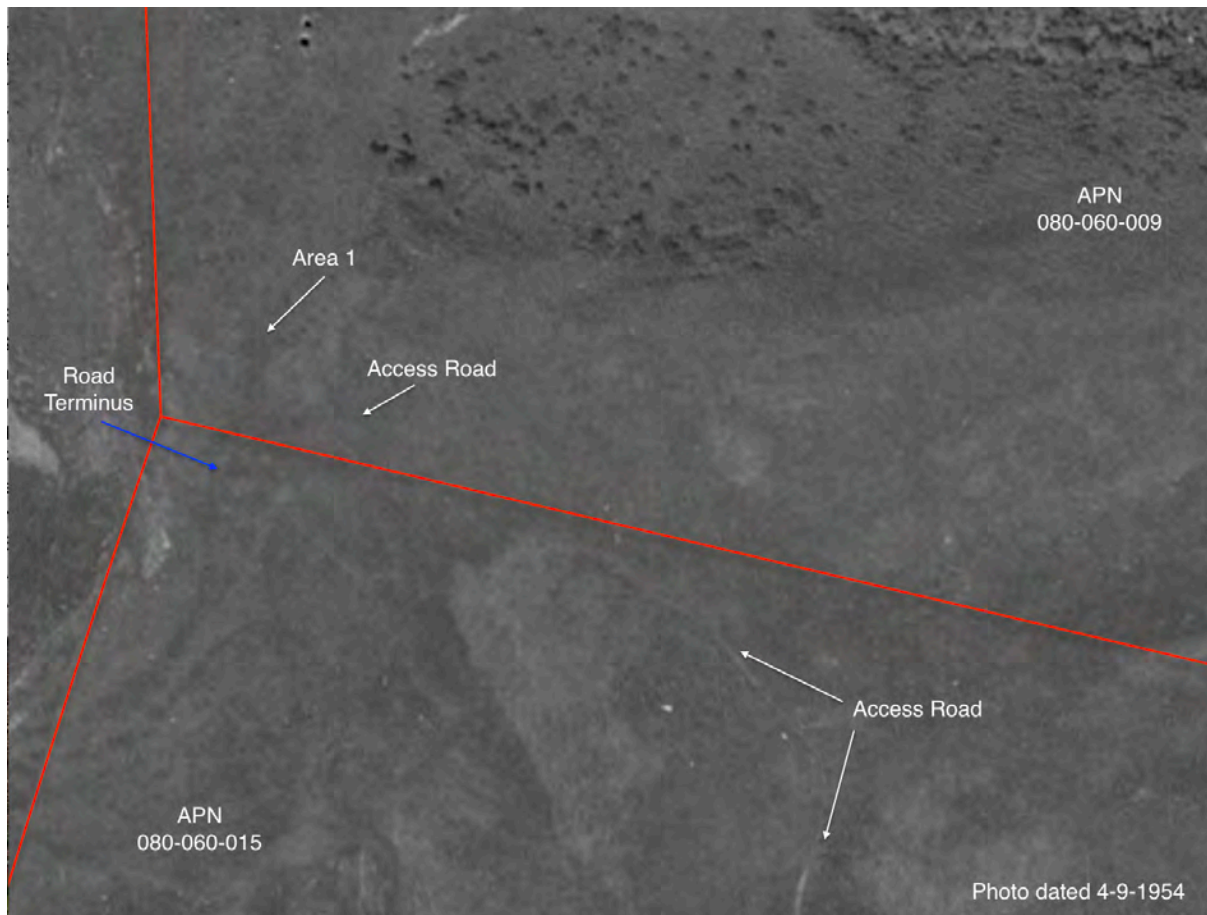
Fig. 15. 1954 aerial photograph closeup of Area 1.

No mining or soil disturbance associated with surface mining activity is discernible in Area 1 on Parcel -009.

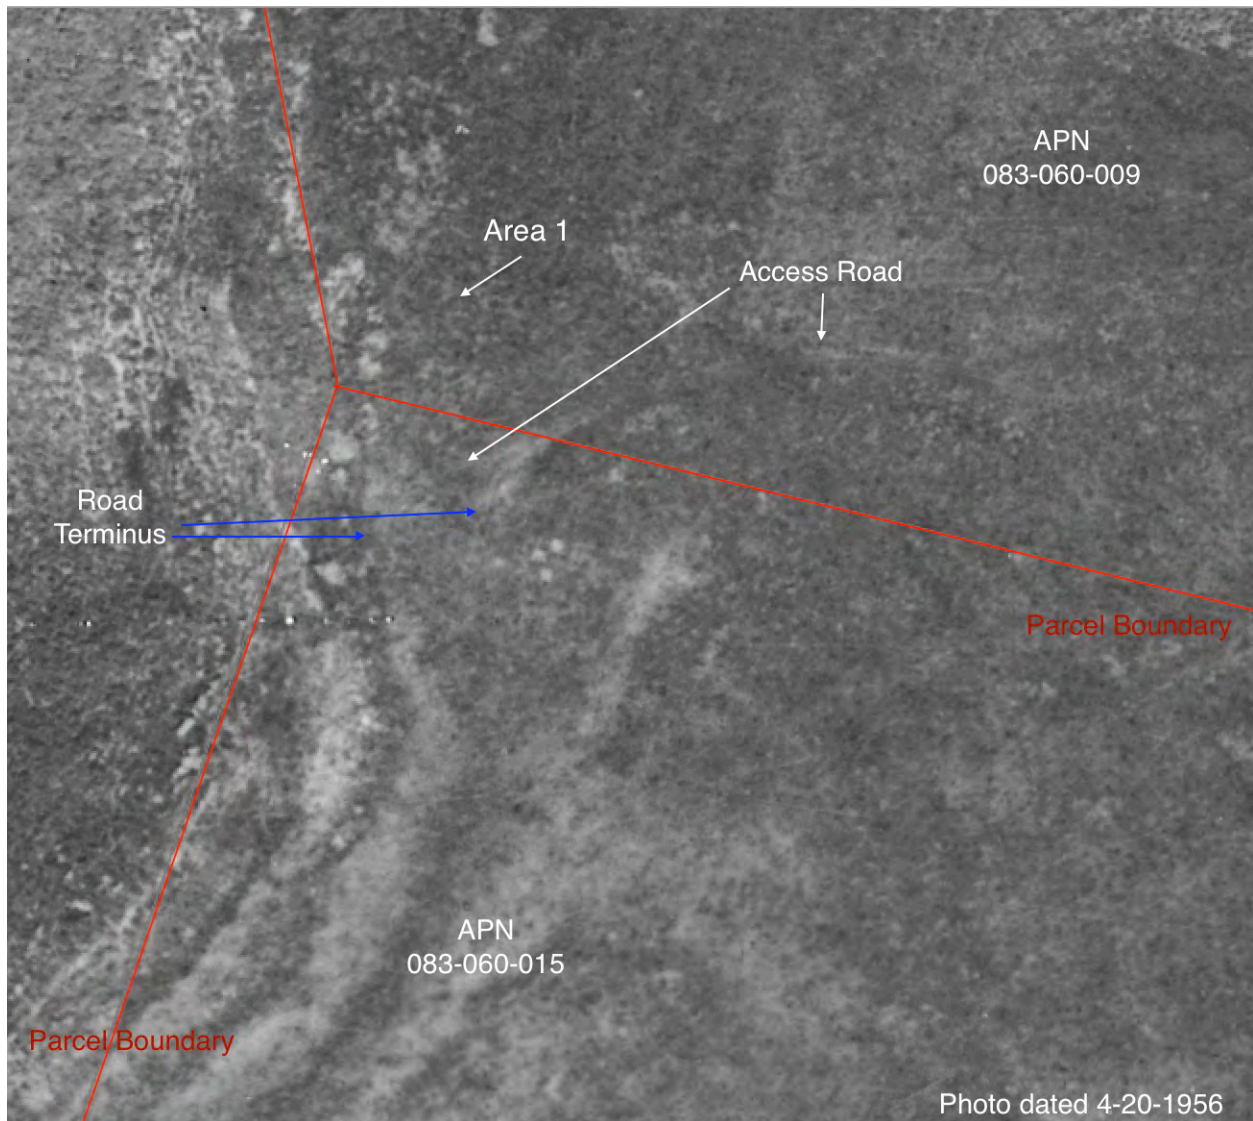
Fig. 16. April 20, 1956 aerial photograph closeup of Area 1.

The same faint road coming from Parcel -015 is visible, crossing into -009 but its terminus is well within -015. At the terminus it looks like some small rock outcrops and activity areas exist near the boundary but are squarely within the -015 parcel boundary.

No mining or soil disturbance associated with surface mining activity is discernible in Area 1 on Parcel -009.
