ACIN RANCH HISTORIC MINING INVESTIGATION

1. Executive Summary

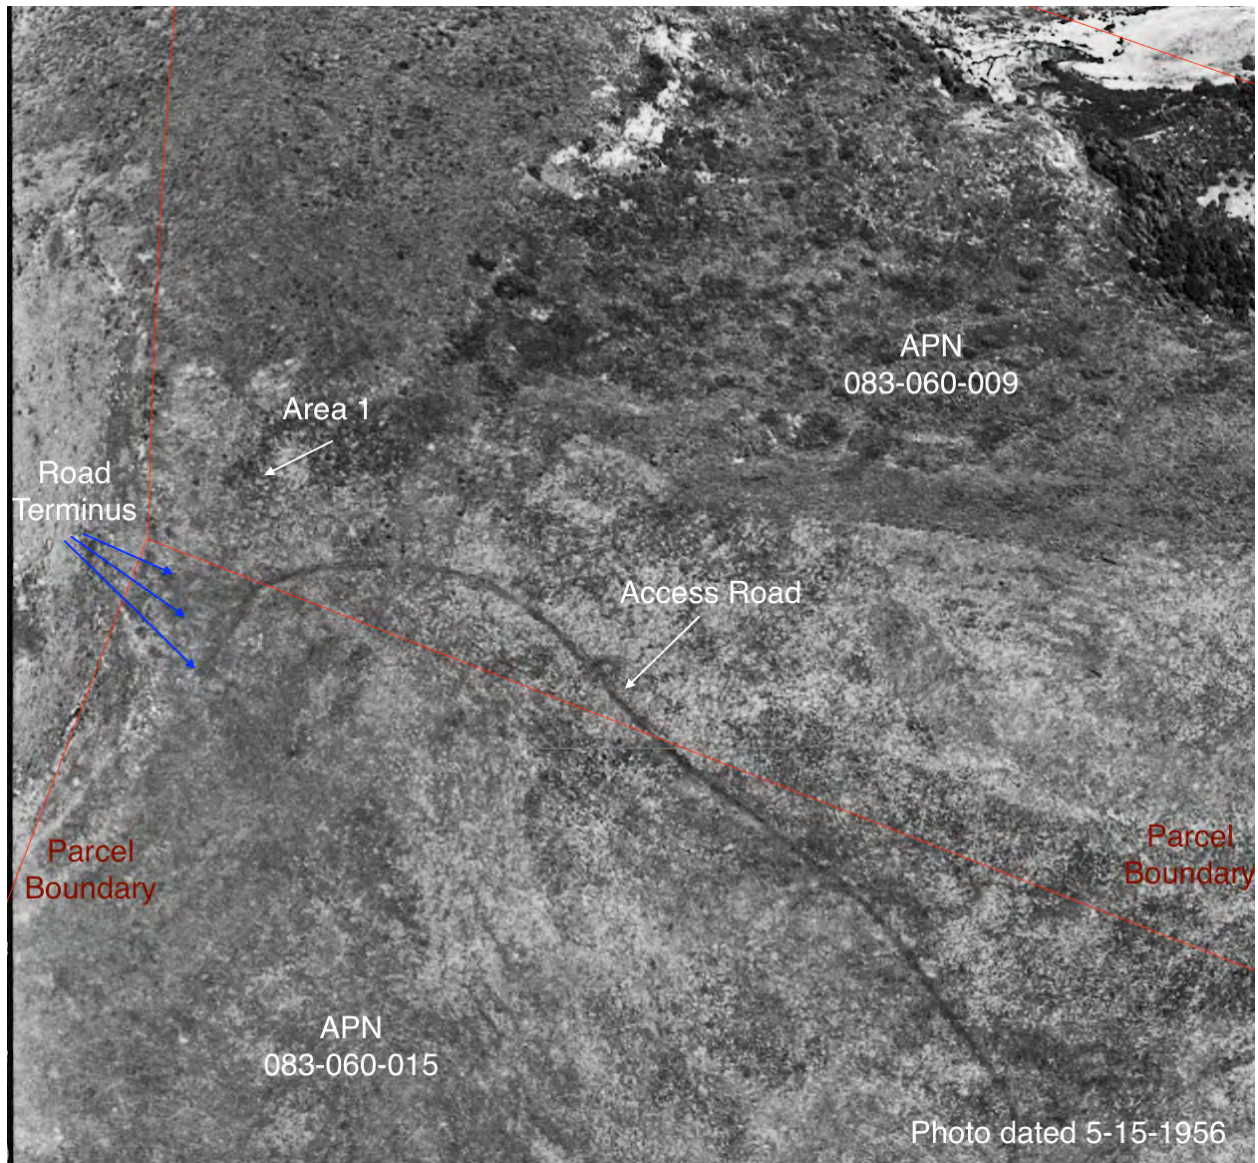
Fig. 17. May 15, 1956 aerial photograph closeup of Area 1.

No mining or soil disturbance associated with surface mining activity is discernible in Area 1 on Parcel -009.

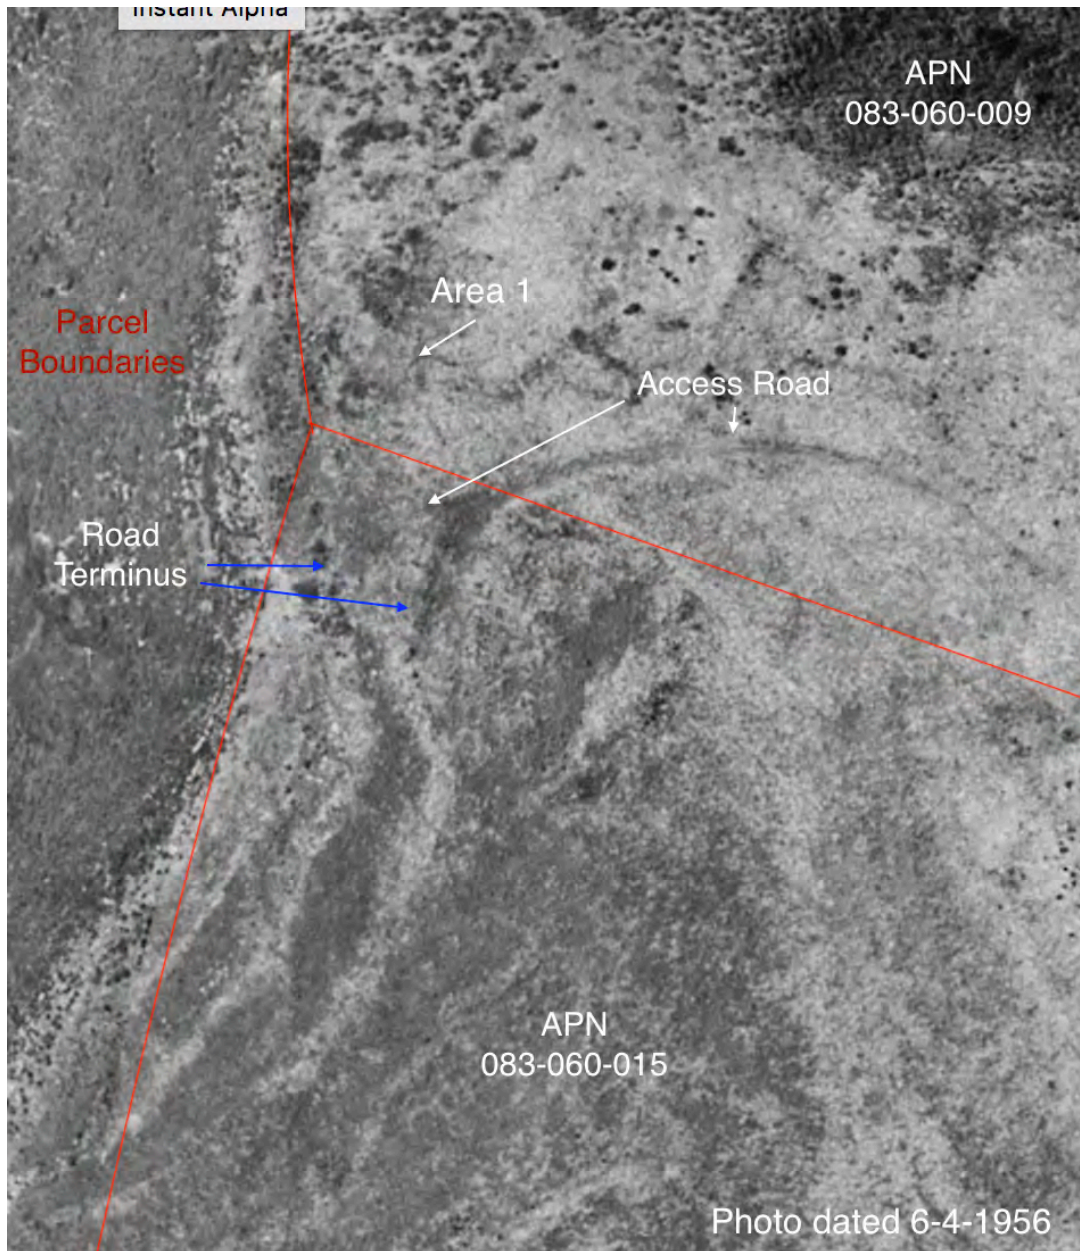
Fig. 18. June 4, 1956 aerial photograph closeup of Area 1.

No mining or soil disturbance associated with surface mining activity is discernible in Area 1 on Parcel -009.

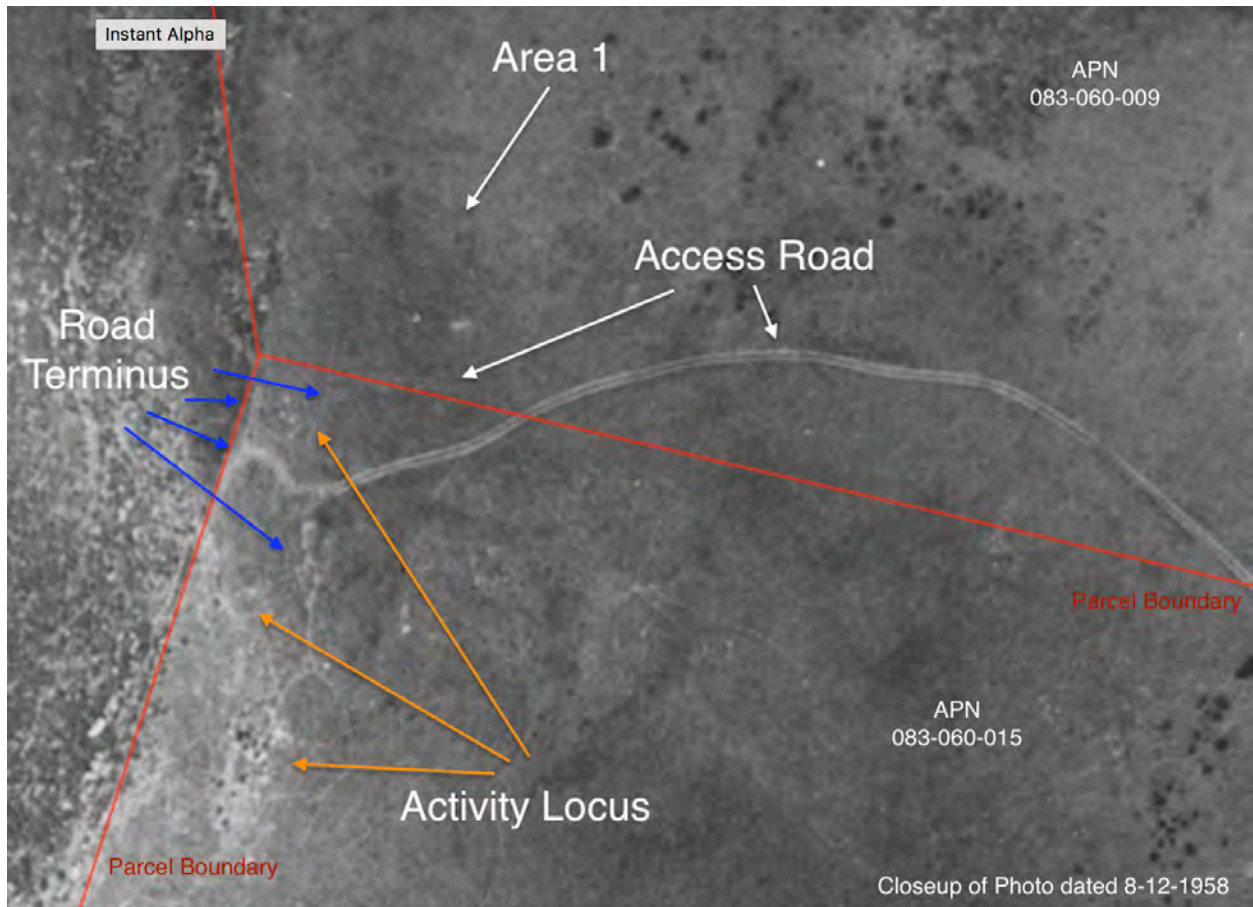
Fig. 19. August 12, 1958 aerial photograph closeup of Area 1.

No roads terminate in Area 1 or any other nearby location within Parcel -009. No mining or soil disturbance associated with surface mining are visible in Area 1.

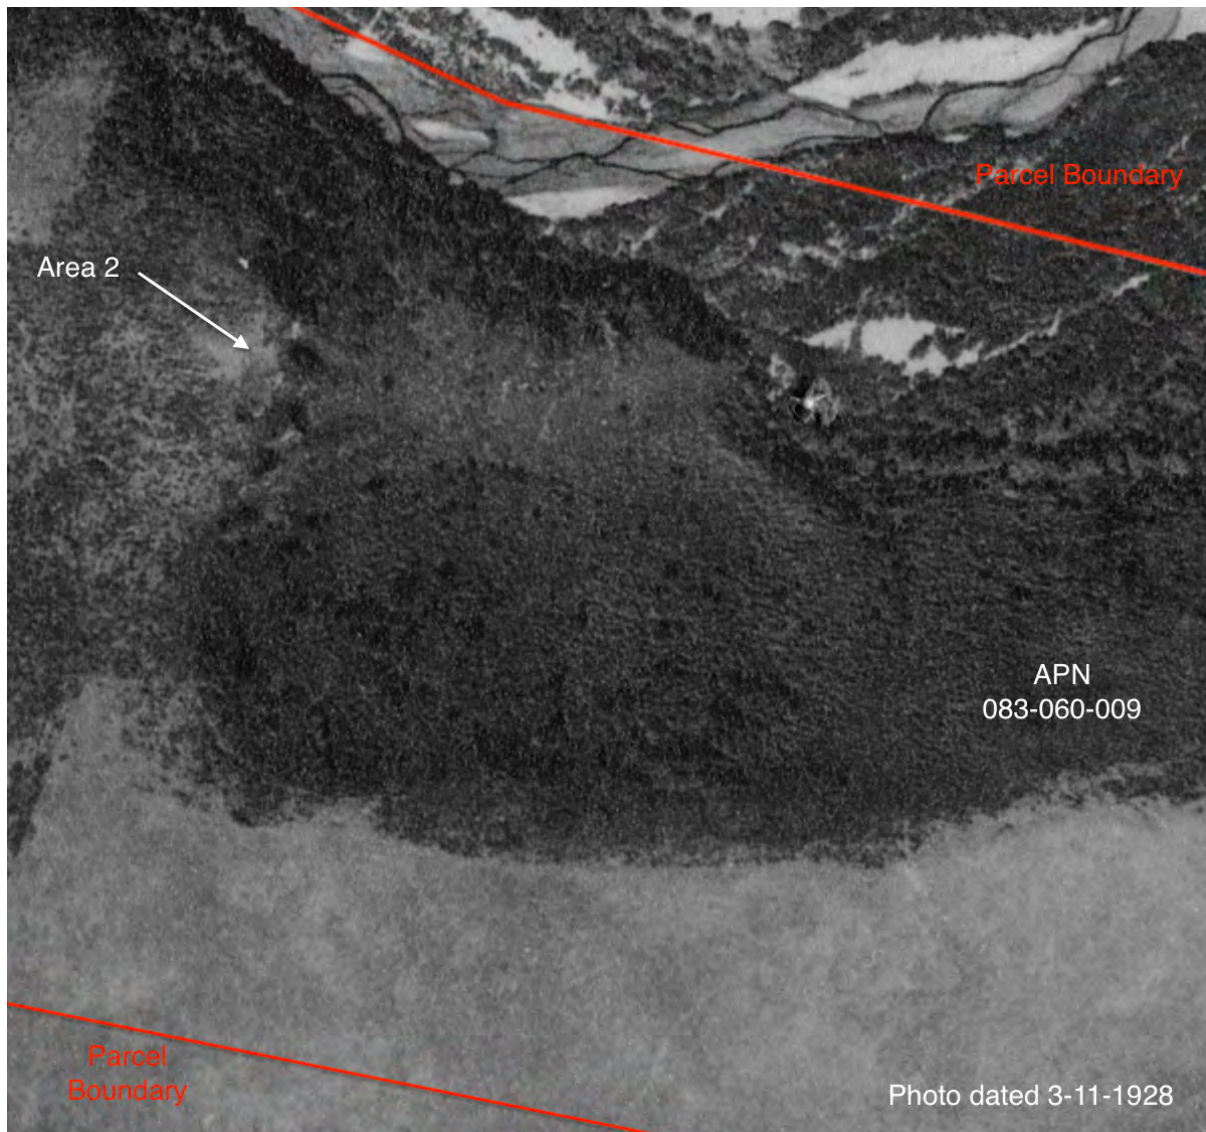
Fig. 21. March 11, 1928 aerial photograph closeup of Area 2.

This 1928 photo is the earliest available for this portion of Santa Barbara County. No definitive roads exist to this area, though cattle trails criss-cross through the brush nearby. No mining or soil disturbance related to surface mining is visible in this area.

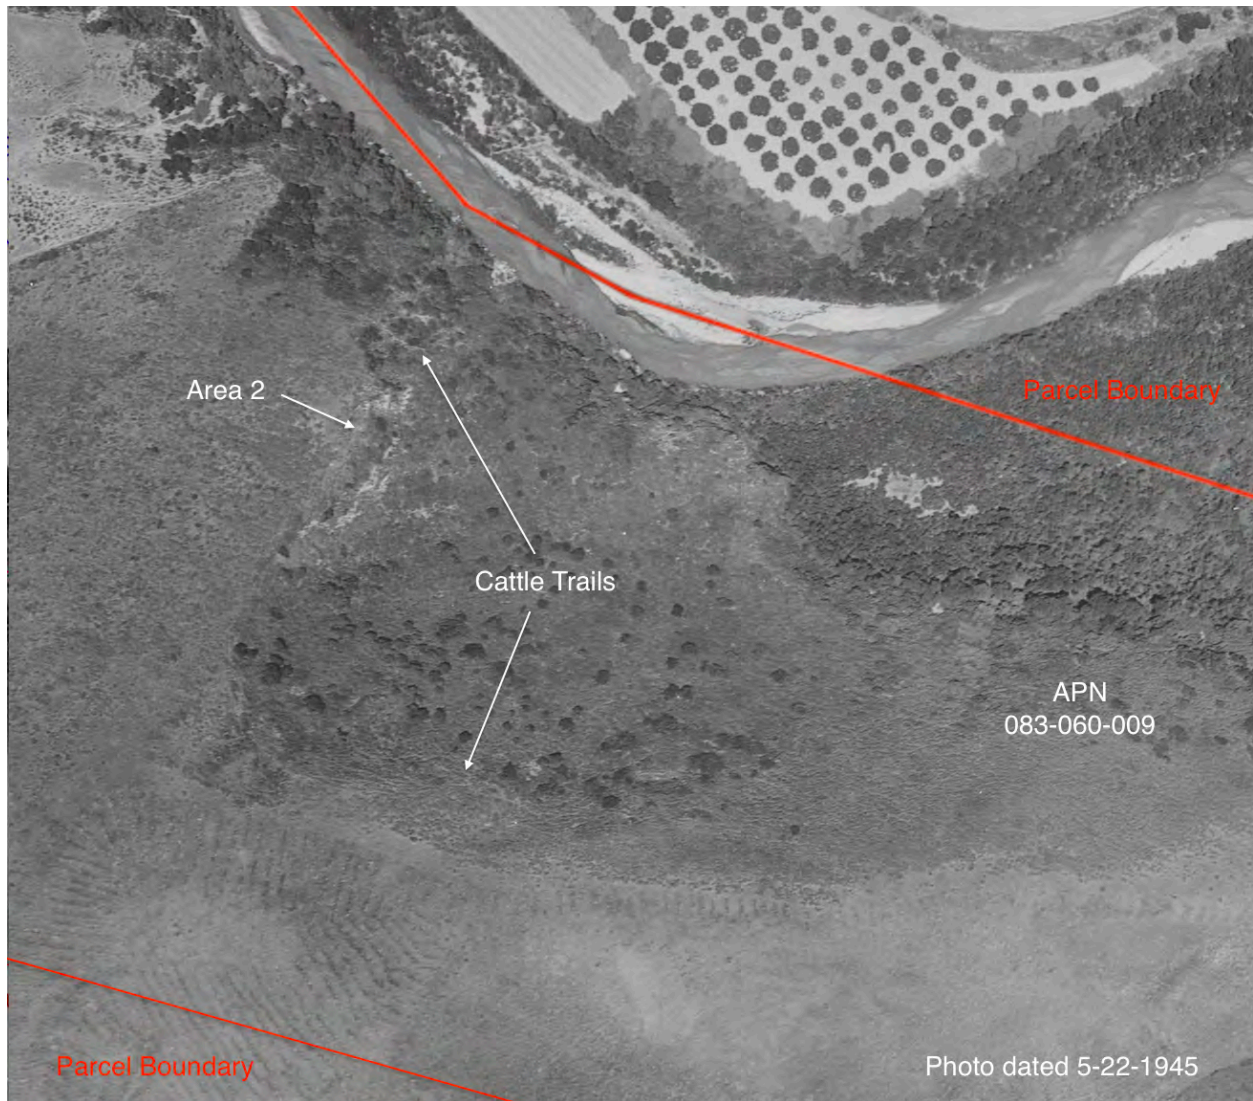
Fig. 22. May 22, 1945 aerial photograph closeup of Area 2.

Areas of flatter surface topography show lines in the soil, assumed to be agricultural 'ripping' or subsoiling as discussed in Appendix A, Fig. 6. This activity can create the appearance of false roads, both in the areas treated as well as the untreated areas, creating 'blanks' in the pattern.

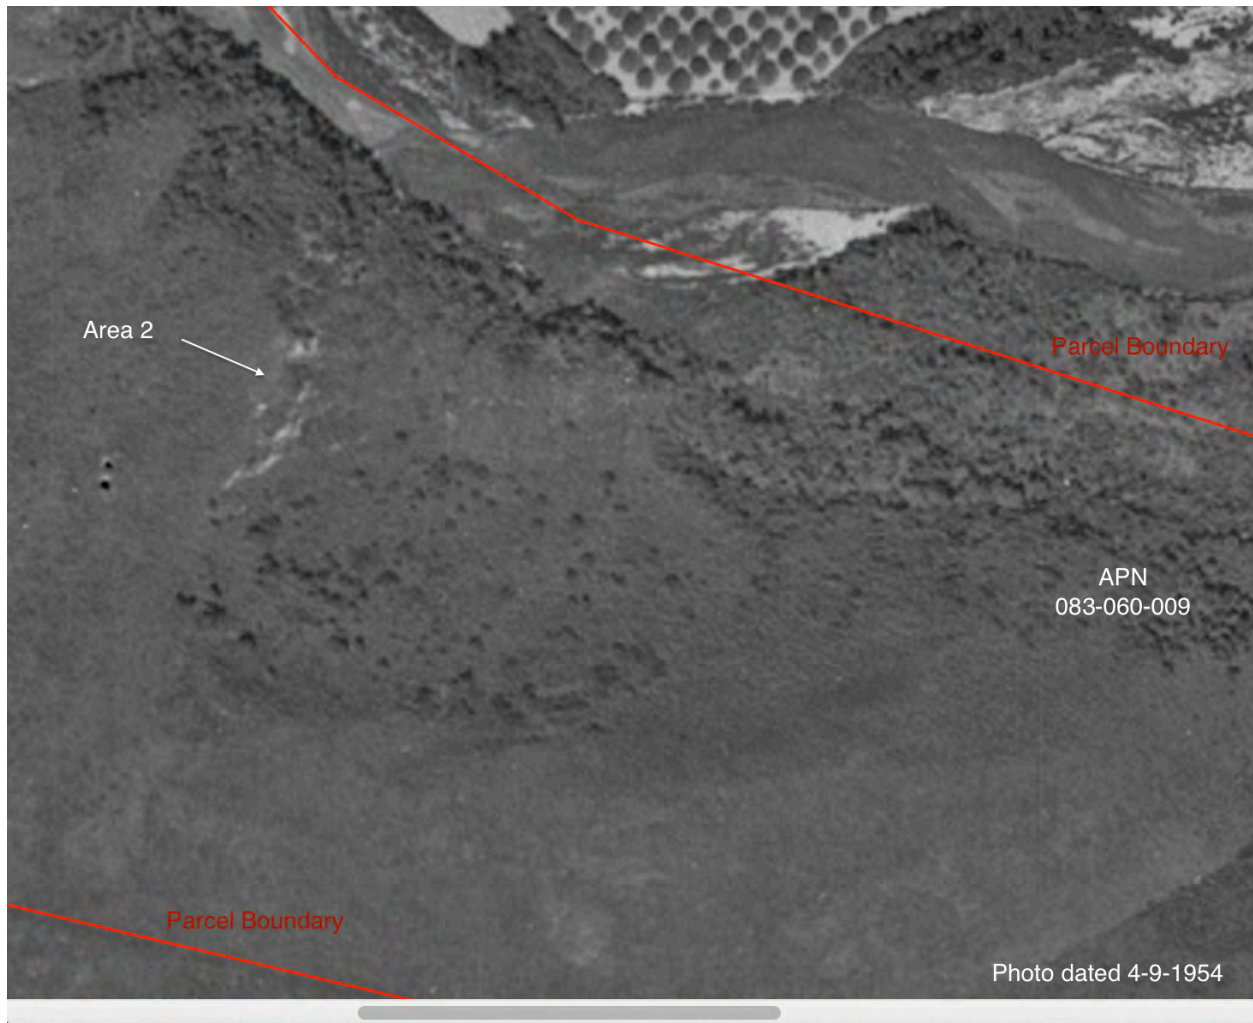
Fig. 23. April 9, 1954 aerial photograph closeup of Area 2.

No mining or soil disturbance related to surface mining is visible in this area.

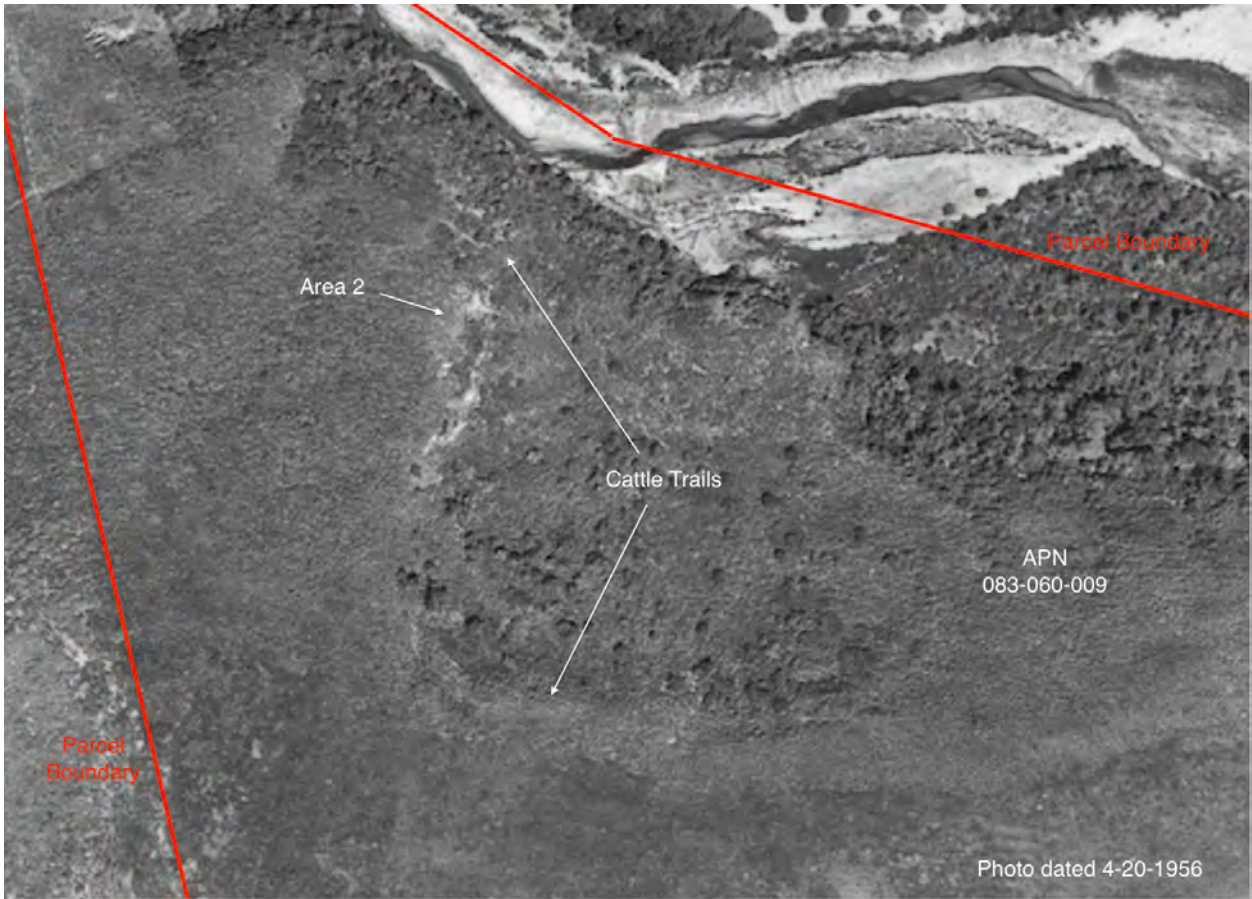
Fig. 24. April 20, 1956 aerial photograph closeup of Area 2.

No mining or soil disturbance related to surface mining is visible in this area.

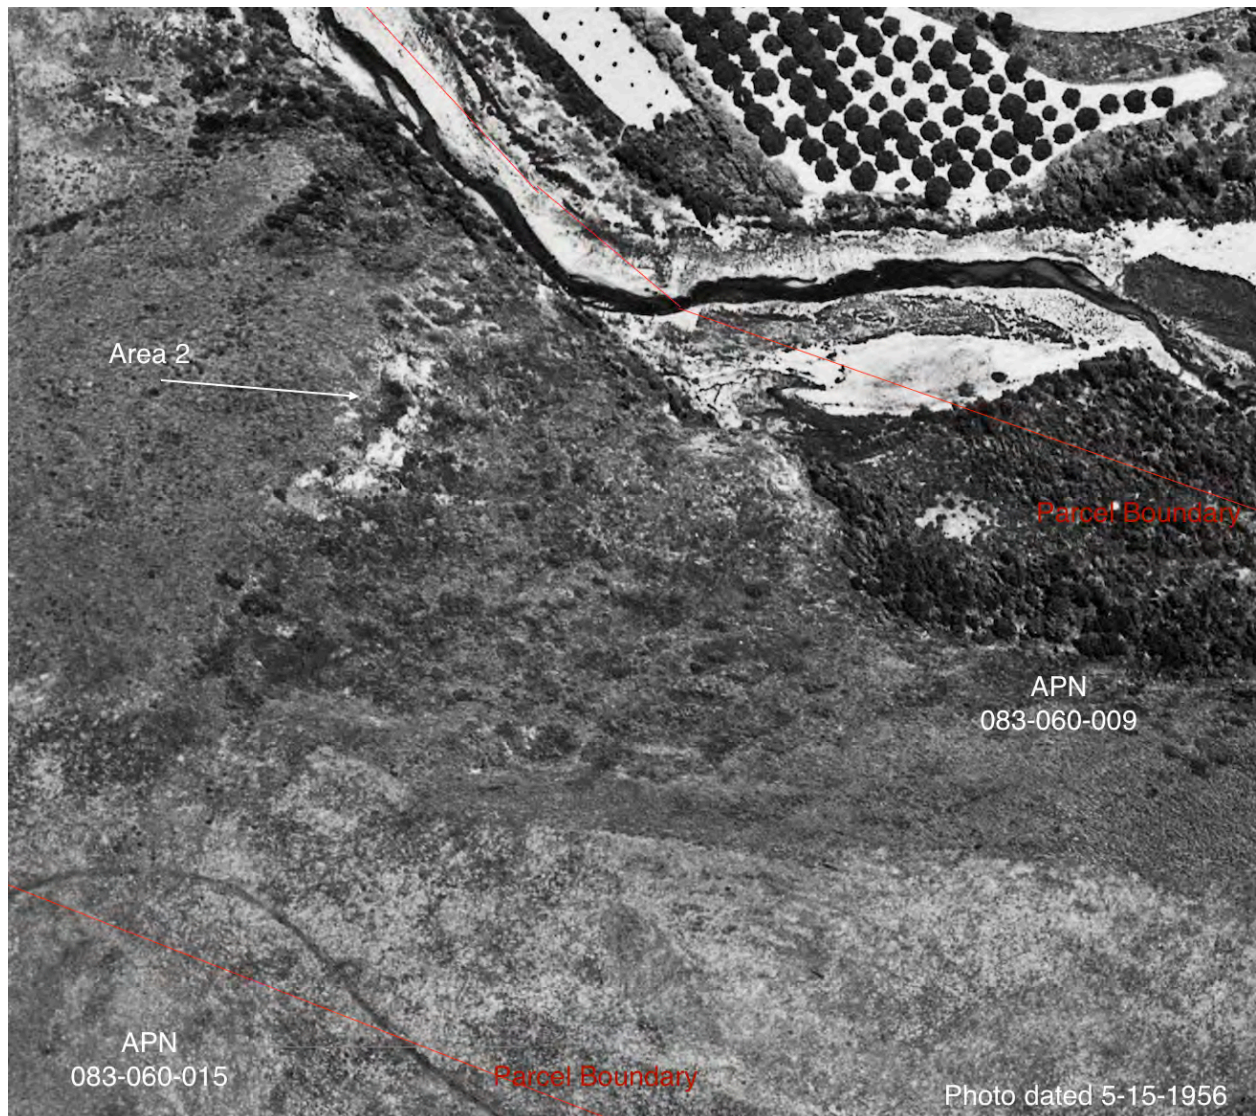
Fig. 25. May 15, 1956 aerial photograph closeup of Area 2.

No mining or soil disturbance related to surface mining is visible in this area.

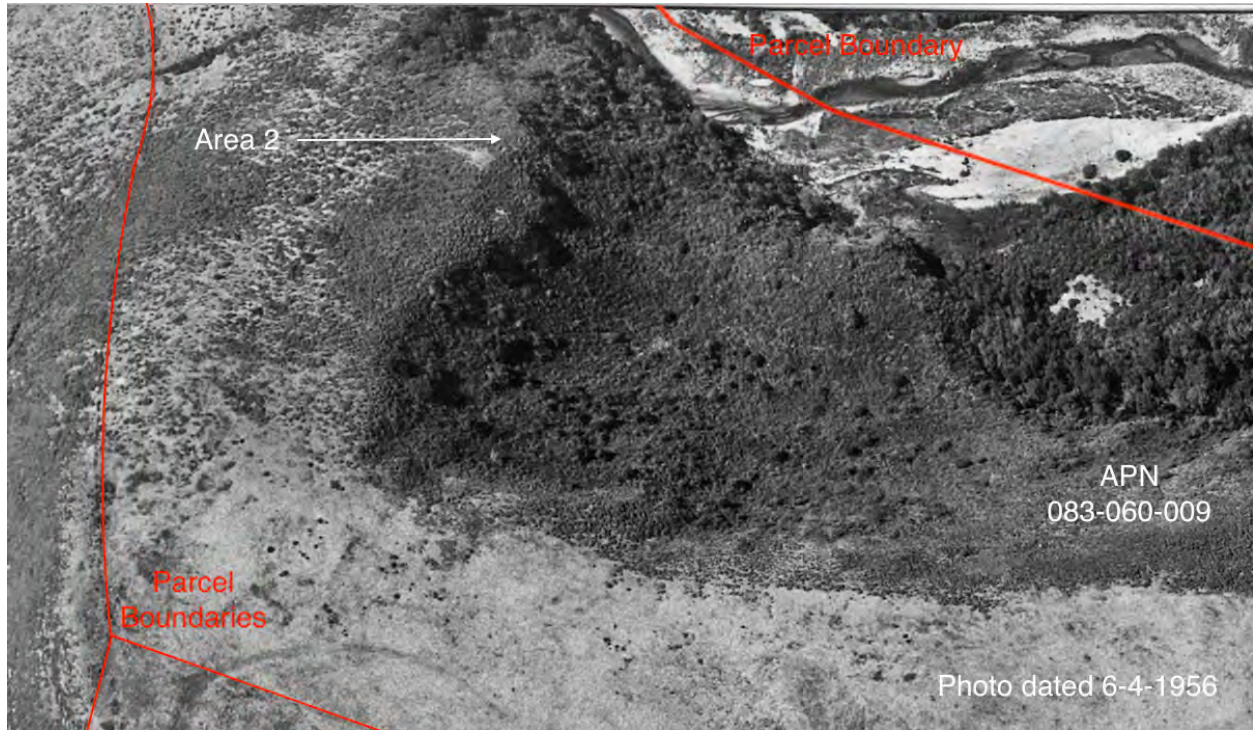
Fig. 26. June 24, 1956 aerial photograph closeup of Area 2.

No mining or soil disturbance related to surface mining is visible in this area.

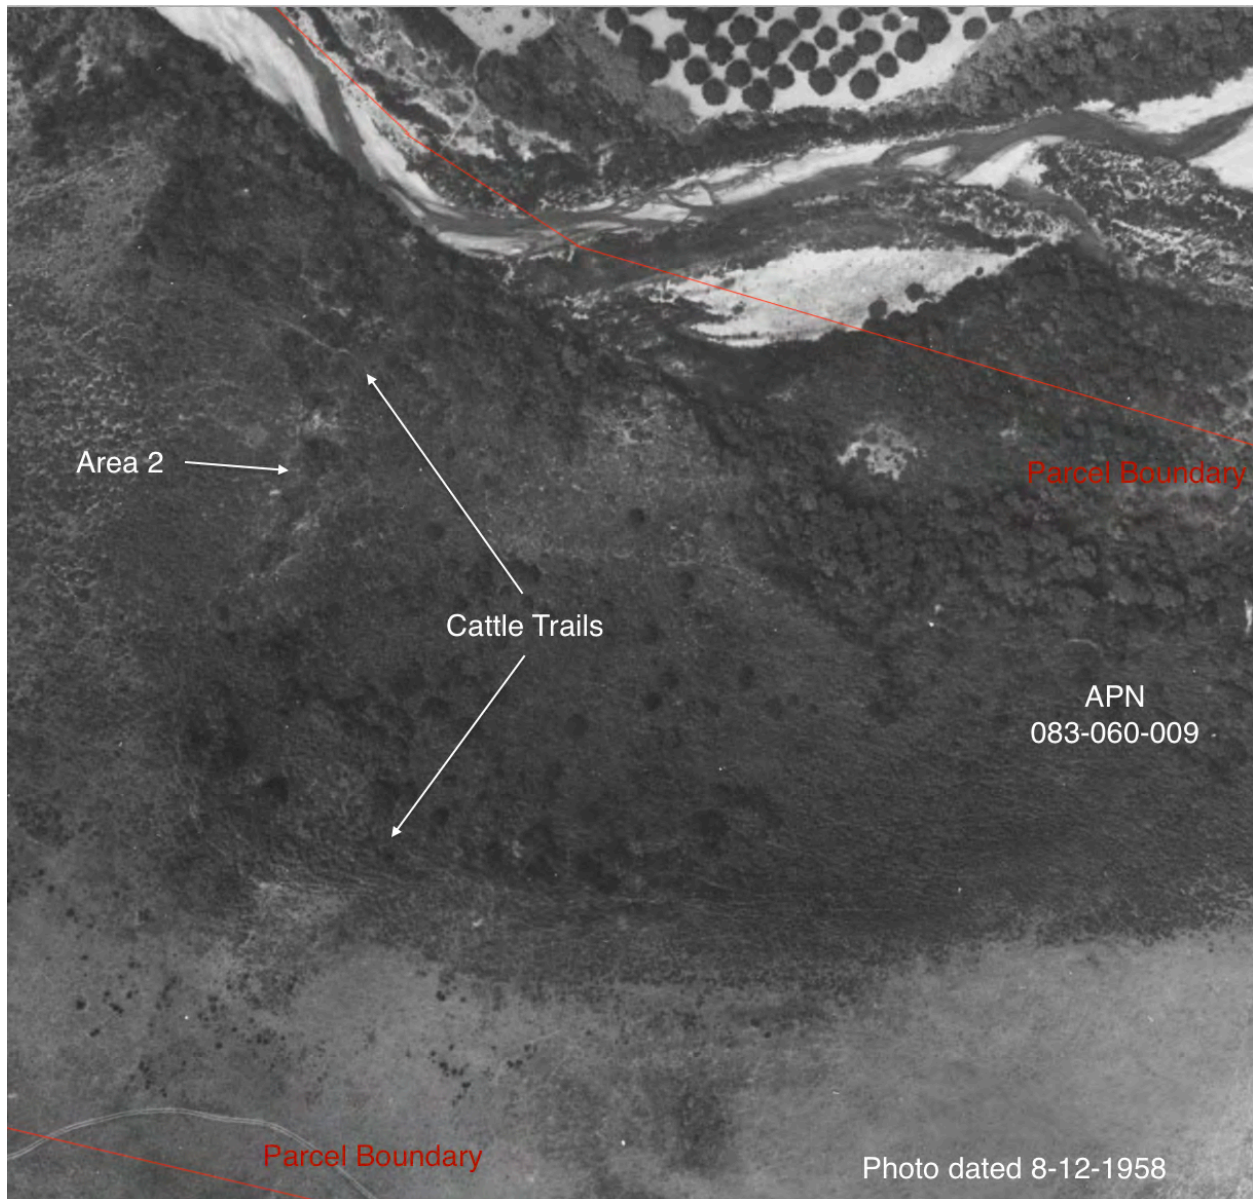
Fig. 27. August 12, 1958 aerial photograph closeup of Area 2.

No mining or soil disturbance related to surface mining is visible in this area.

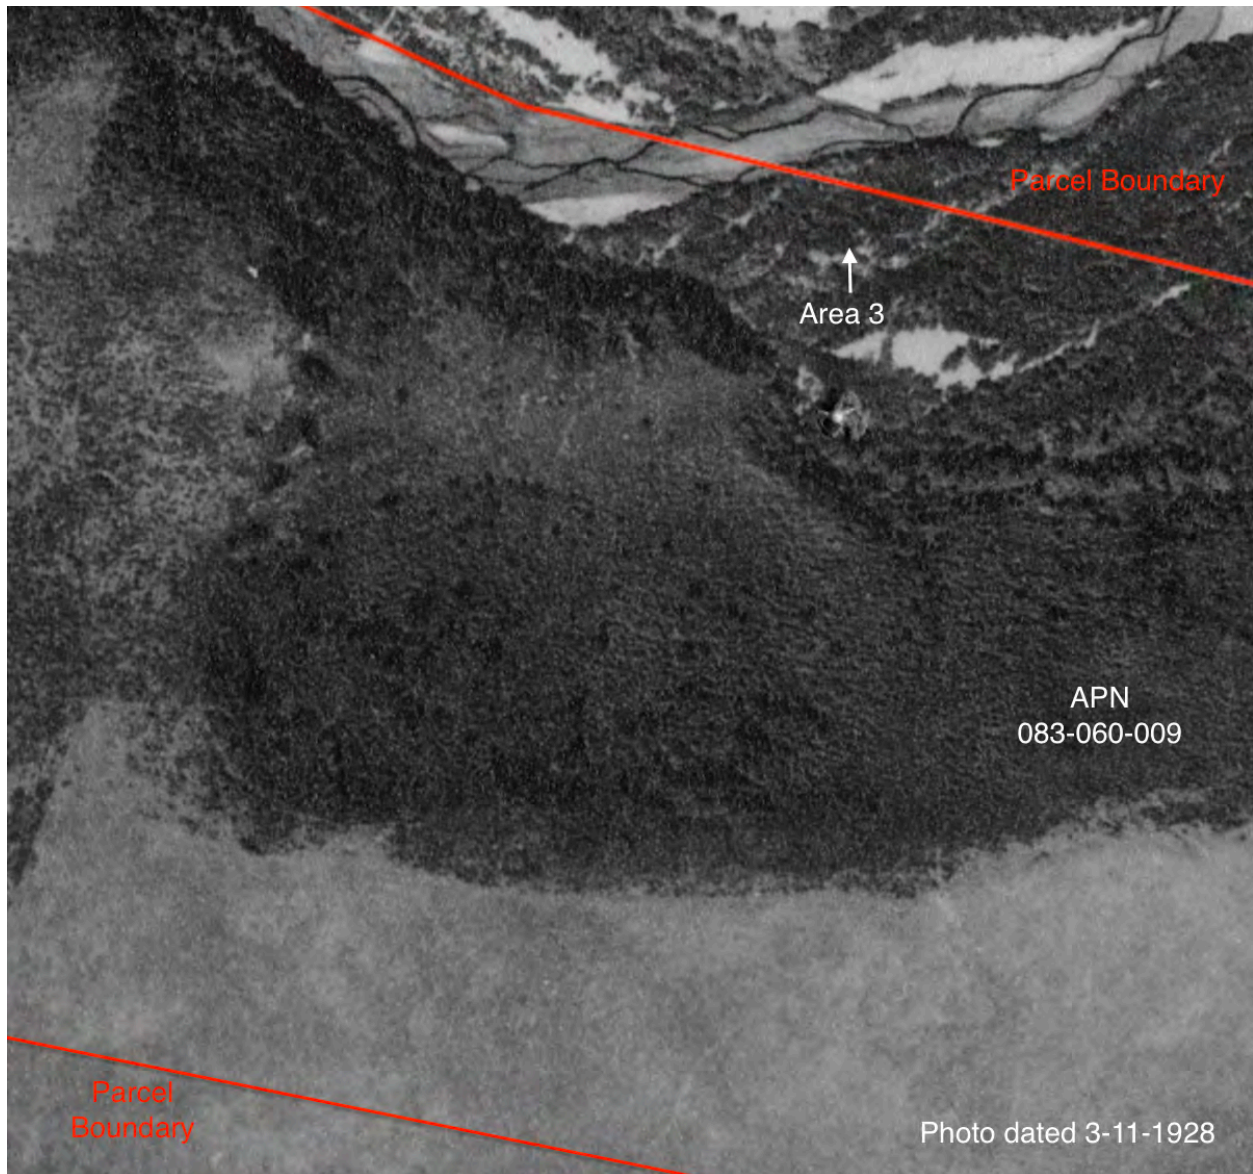
Fig. 29. March 11, 1928 aerial photograph closeup of Area 3.

This 1928 photo is the earliest available for this portion of Santa Barbara County. No definitive roads exist to this area, though cattle trails criss-cross through the brush nearby. The soils vegetation on an active riverbed are ephemeral at best, because of the potential for the shifting of the river itself.

No mining or soil disturbance related to surface mining is visible in this area.

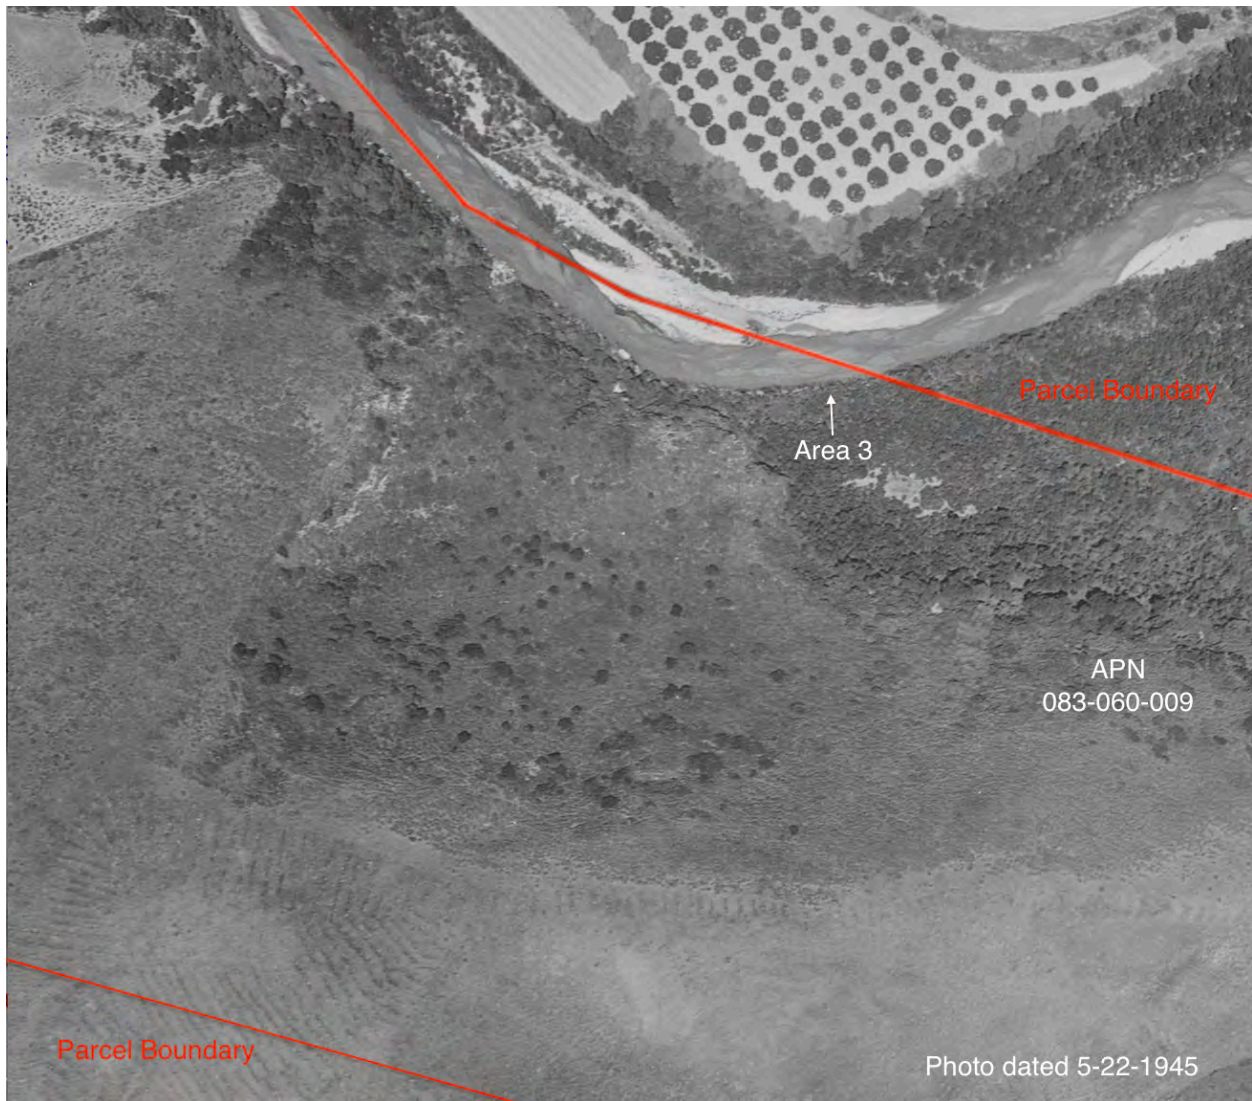
Fig. 30. May 22, 1945 aerial photograph closeup of Area 3.

No mining or soil disturbance related to surface mining is visible in this area.

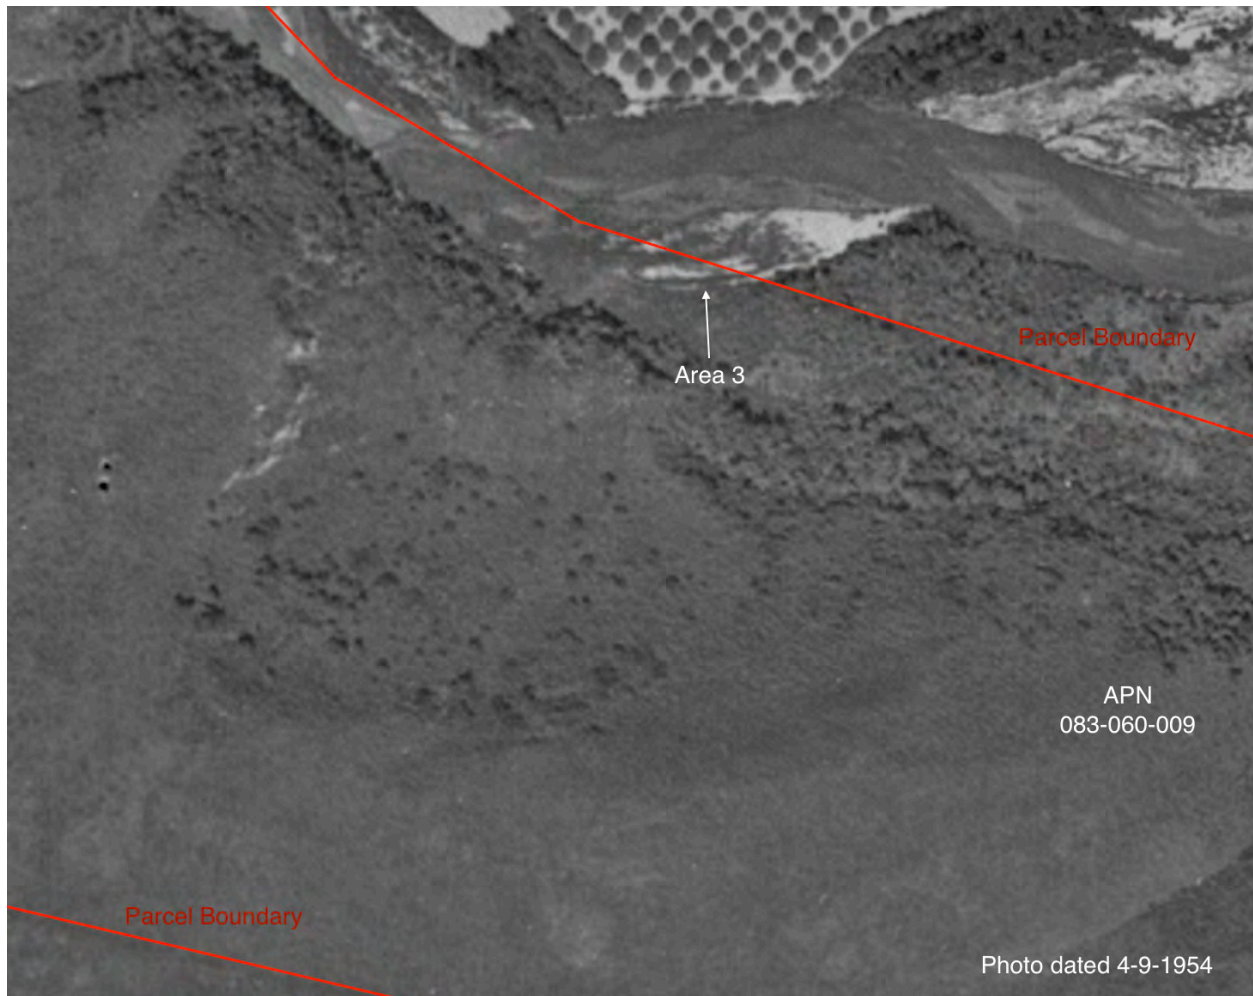
Fig. 31. April 9, 1954 aerial photograph closeup of Area 3.

No mining or soil disturbance related to surface mining is visible in this area.

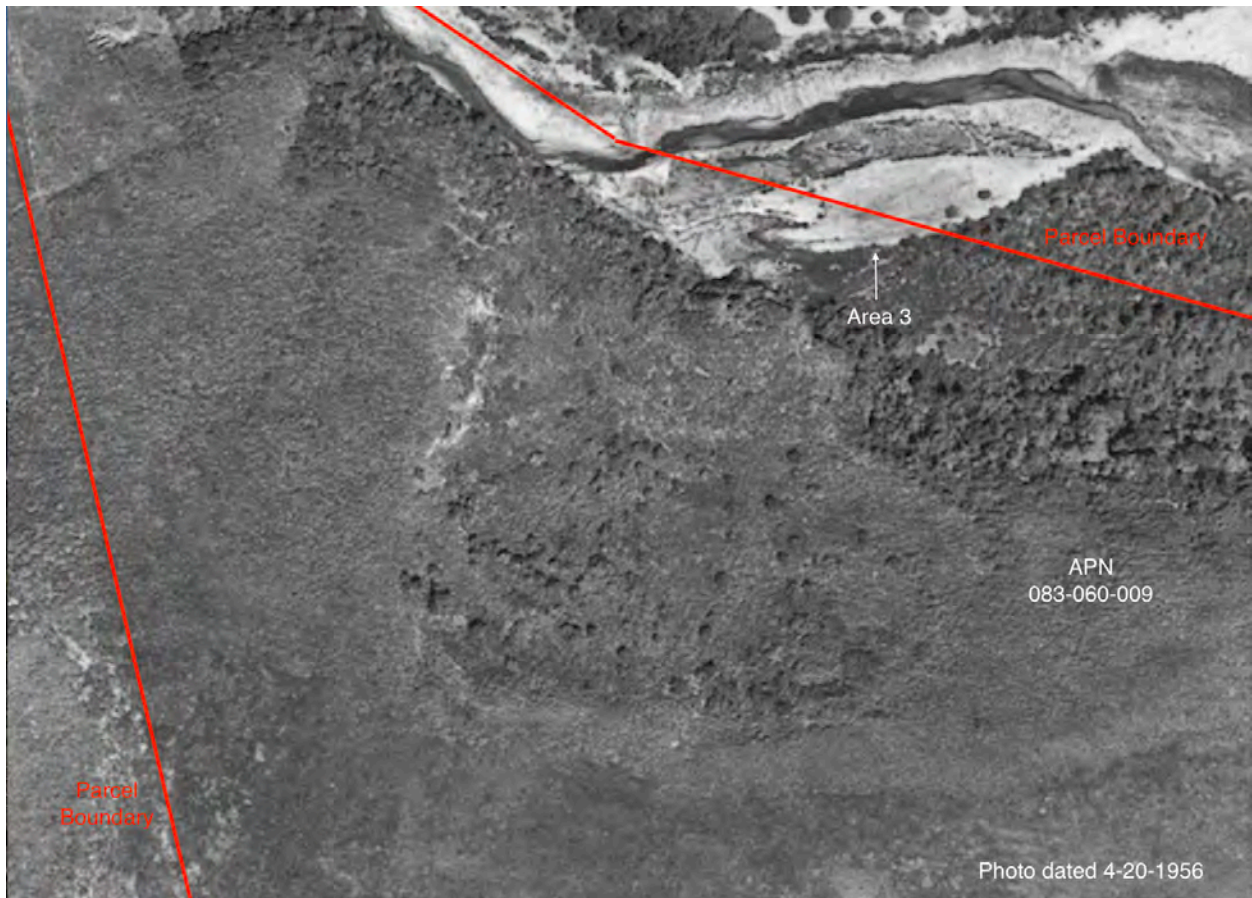
Fig. 32. April 20, 1956 aerial photograph closeup of Area 3.

No mining or soil disturbance related to surface mining is visible in this area.

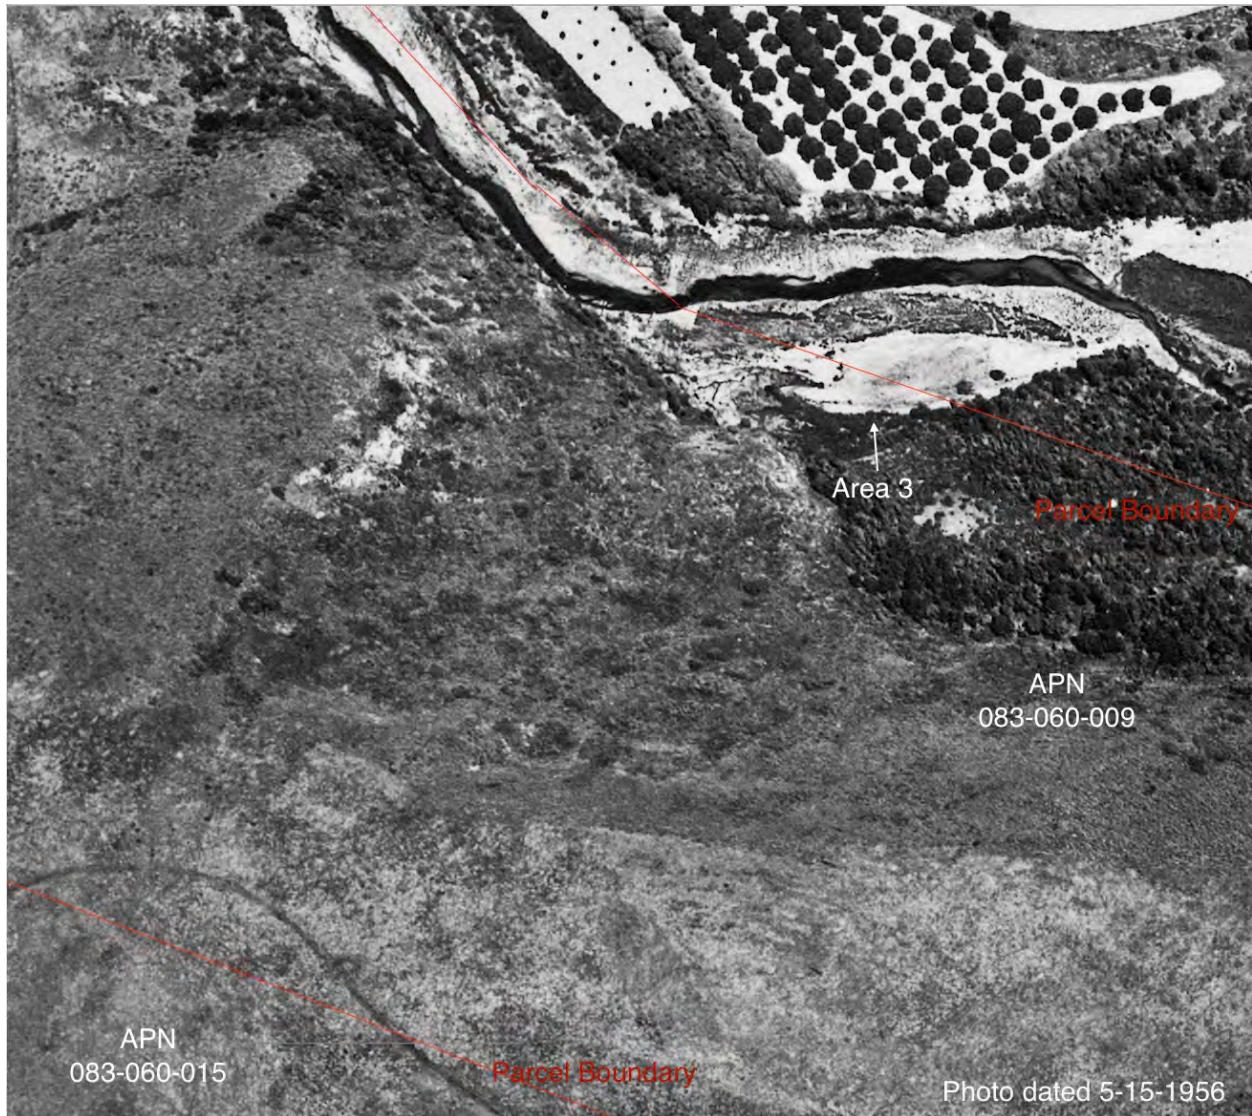
Fig. 33. May 15, 1956 aerial photograph closeup of Area 3.

No mining or soil disturbance related to surface mining is visible in Area 3.

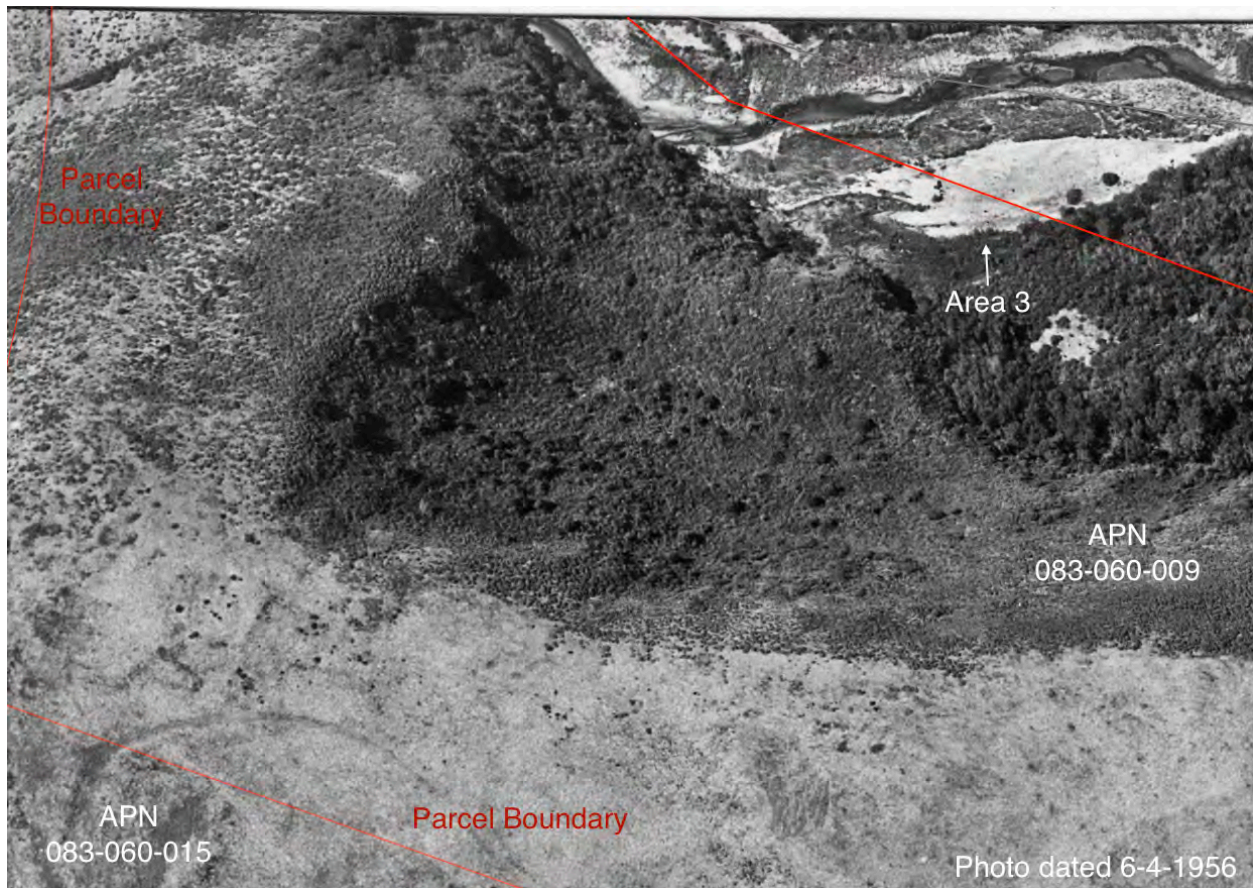
Fig. 34. June 24, 1956 aerial photograph closeup of Area 3.

No mining or soil disturbance related to surface mining is visible in this area.

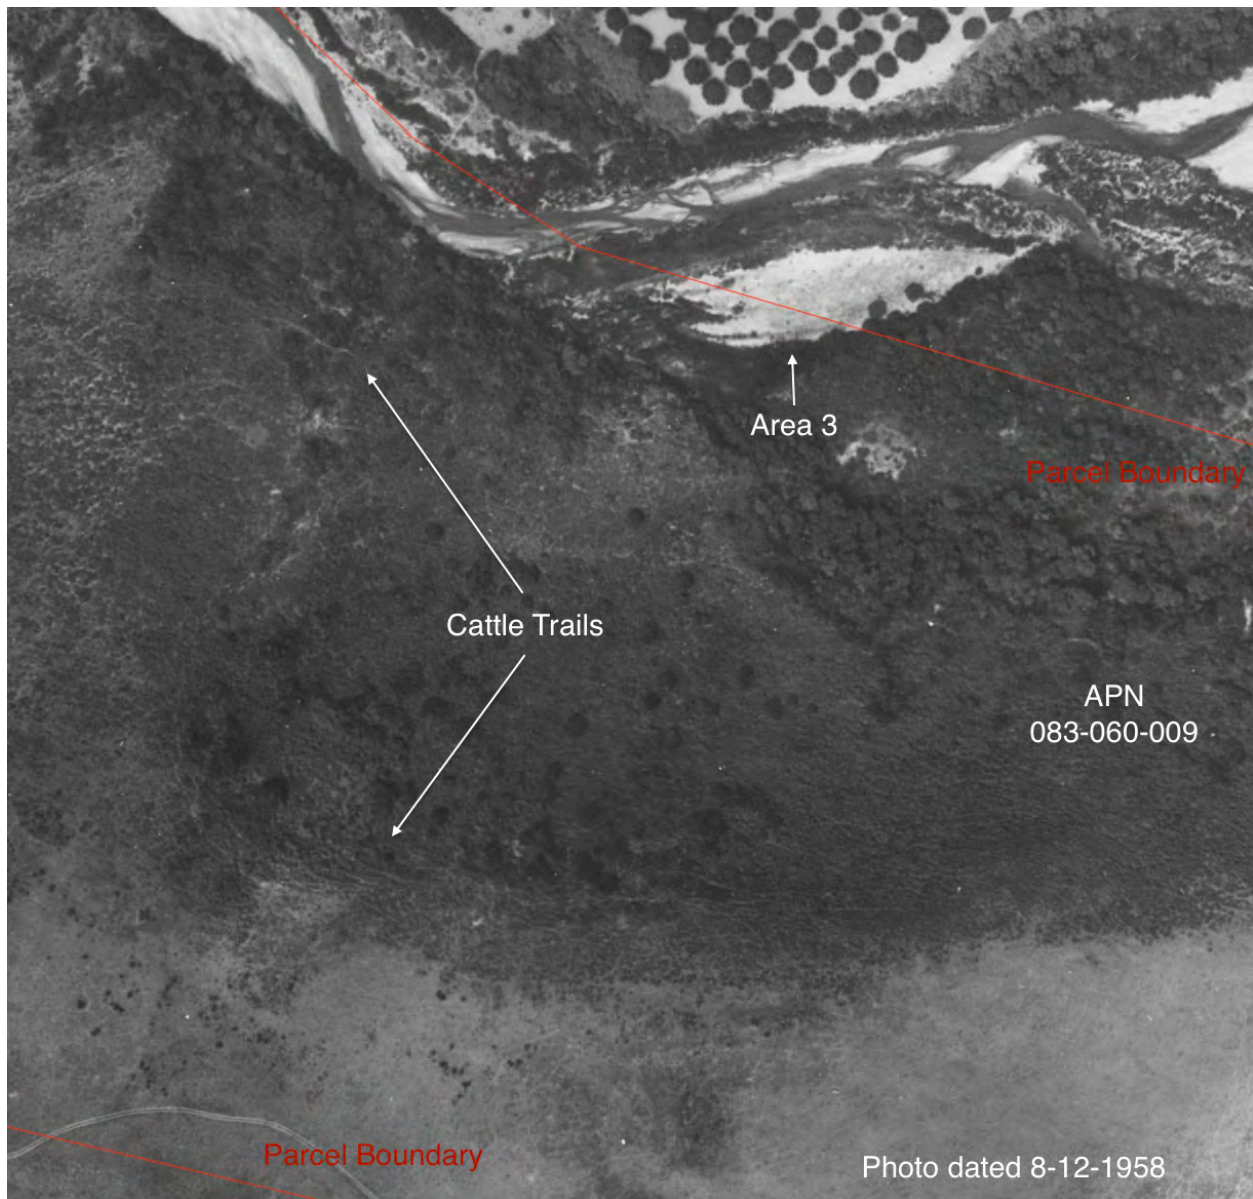
Fig. 35. August 12, 1958 aerial photograph closeup of Area 3.

No mining or soil disturbance related to surface mining is visible in this area.
