ACIN RANCH HISTORIC MINING INVESTIGATION

1. Executive Summary

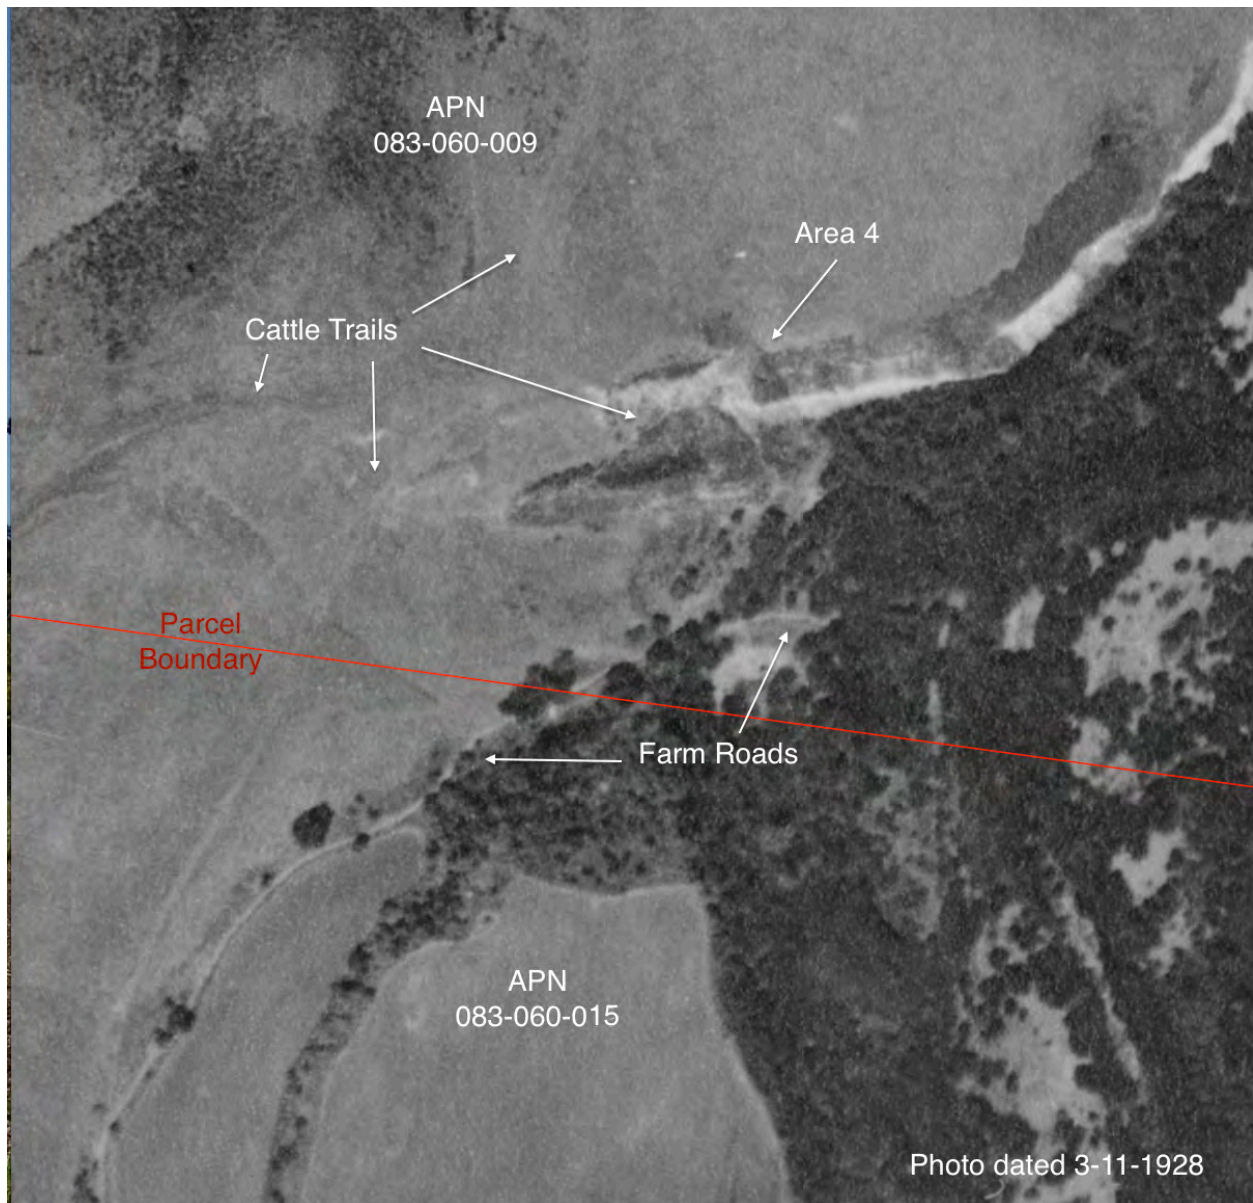
Fig. 37. March 11, 1928 aerial photograph closeup of Area 4.

No definitive roads exist in this area, with the exception of the roads associated with the flat row-crop farmland to the south and west of Area 4. Cattle have created trails from the declivity in Area 4 to the west and across the surrounding landscape.

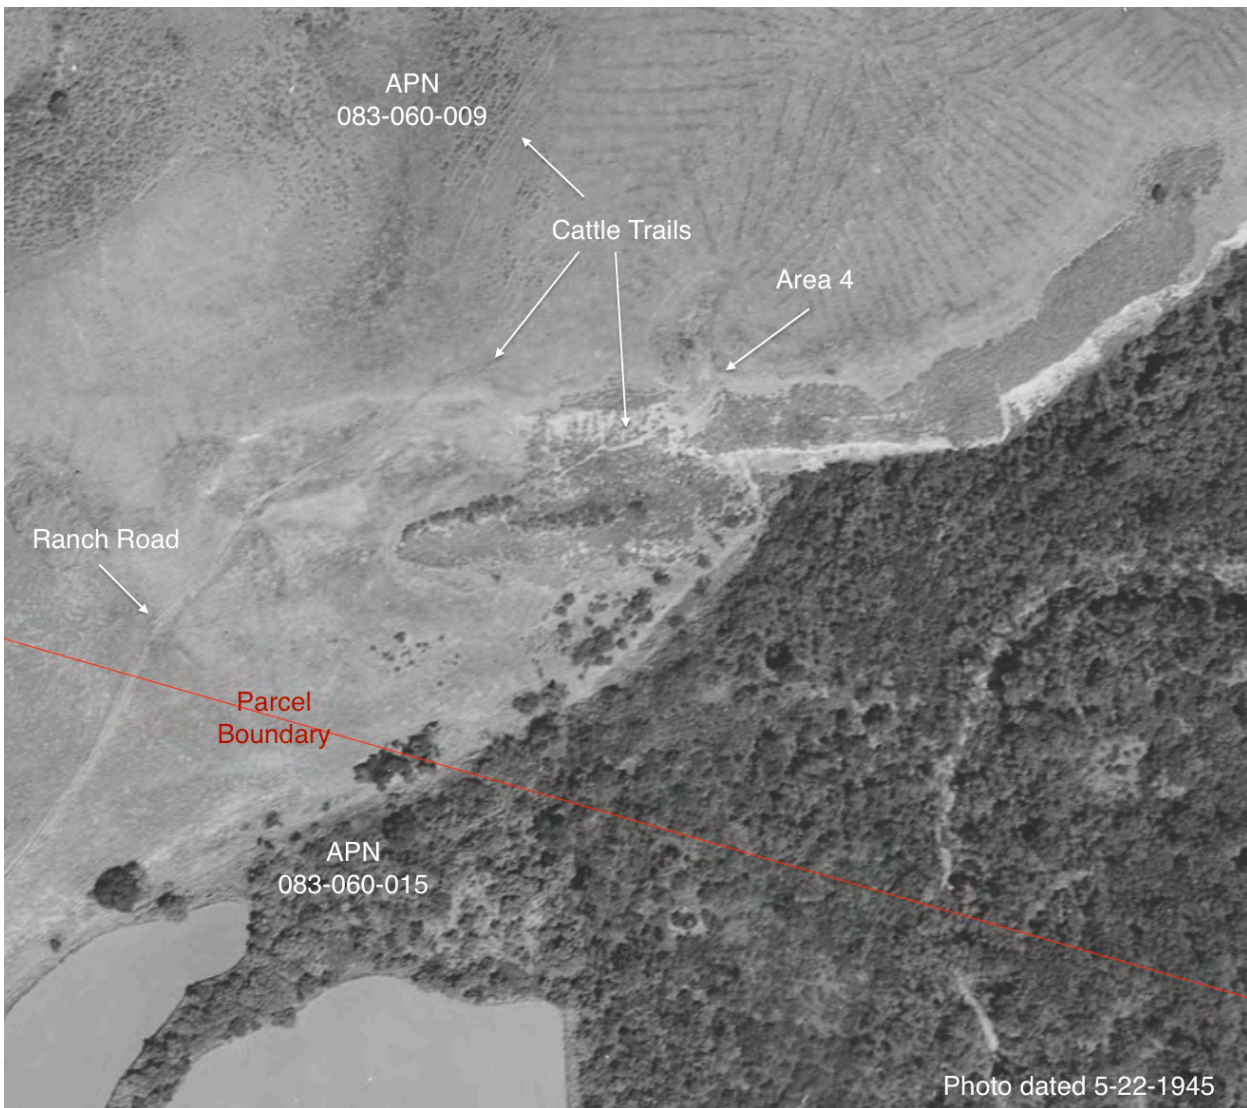
Fig. 38. May 22, 1945 aerial photograph closeup of Area 4.

No surface mining or soil disturbance associated with surface mining is visible in this location.

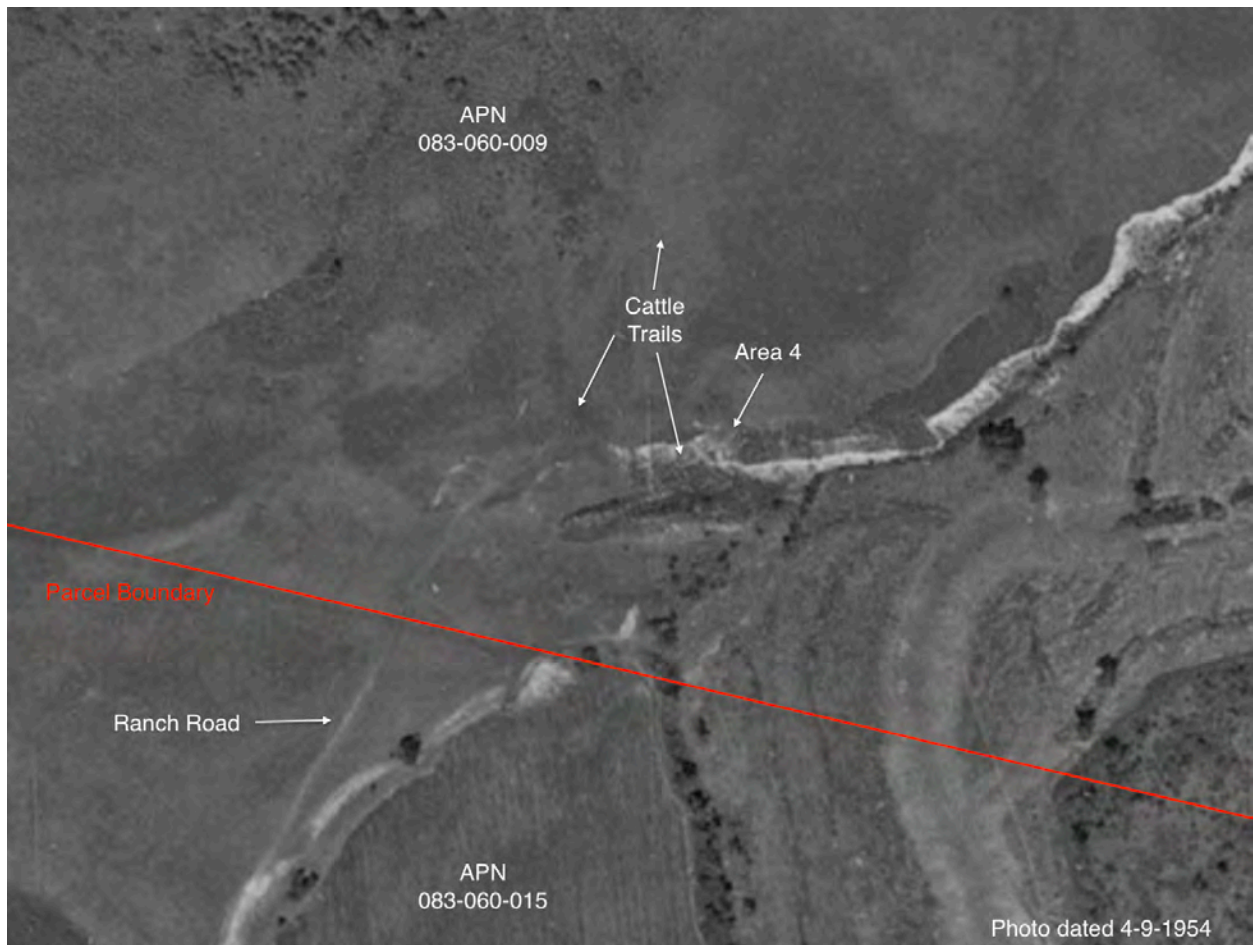
Fig. 39. April 9, 1954 aerial photograph closeup of Area 4.

No surface mining or soil disturbance associated with surface mining is visible in this location.

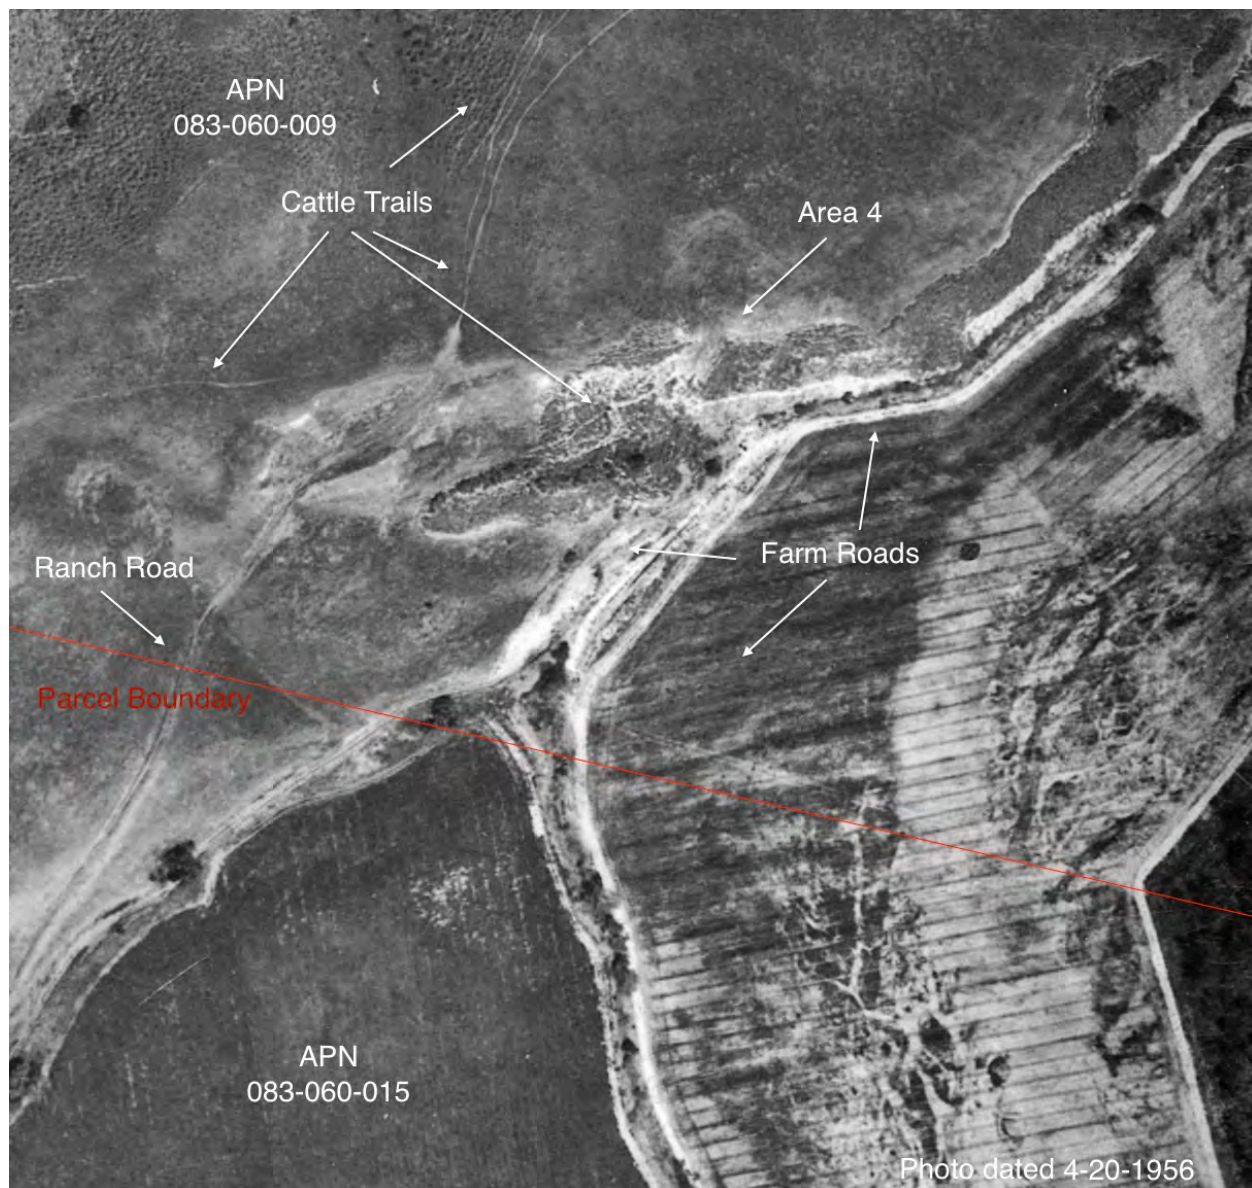
Fig. 40. April 20, 1956 aerial photograph closeup of Area 4.

No surface mining or soil disturbance associated with surface mining is visible in this location.

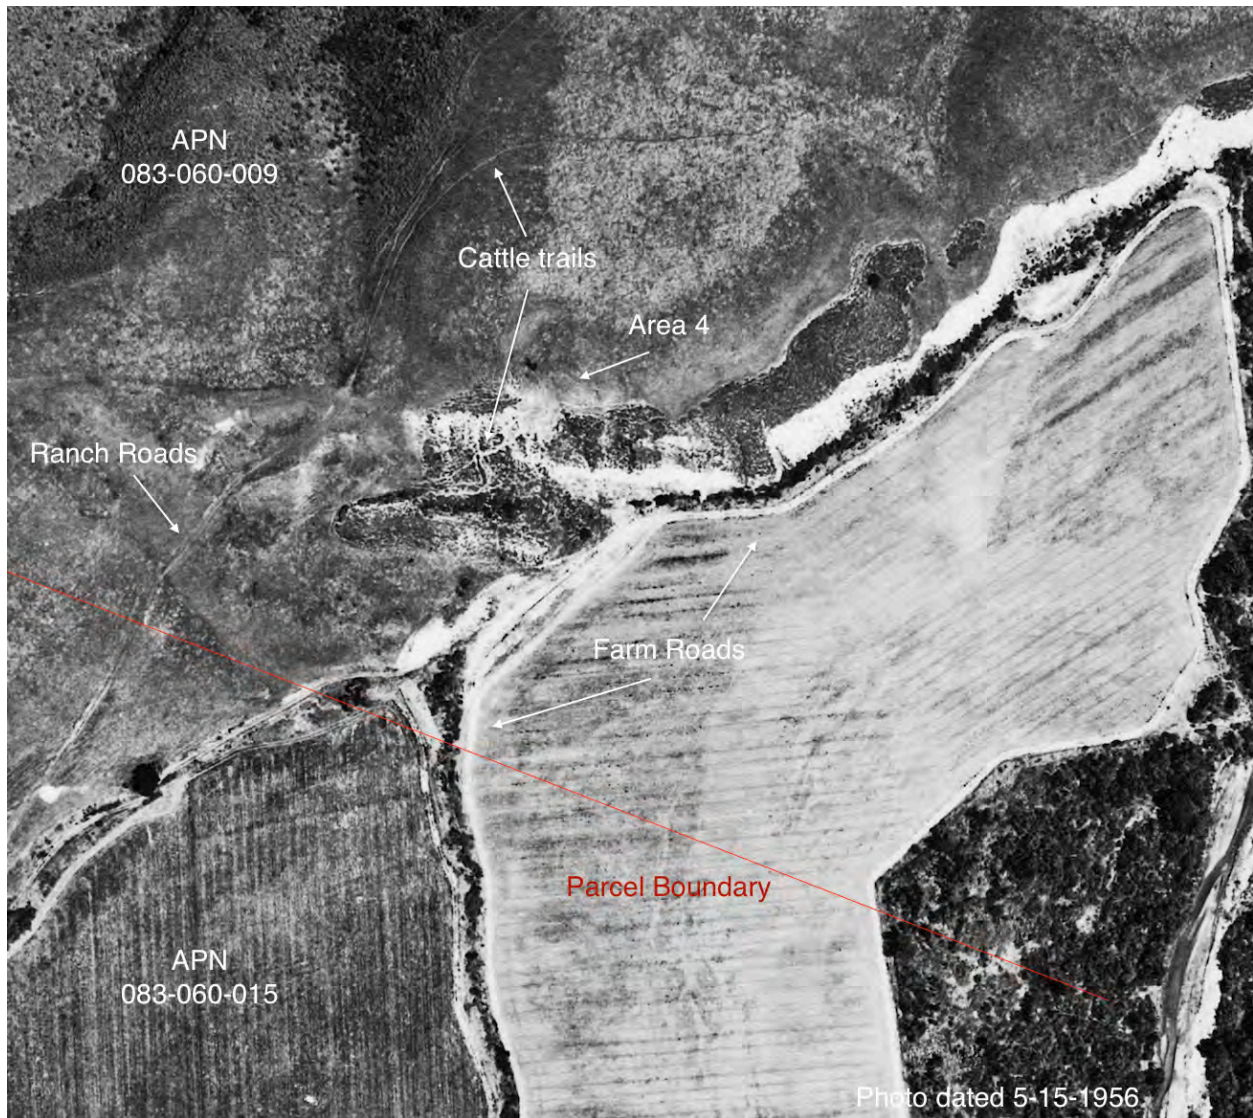
Fig. 41. May 15, 1956 aerial photograph closeup of Area 4.

No surface mining or soil disturbance associated with surface mining is visible in this location.

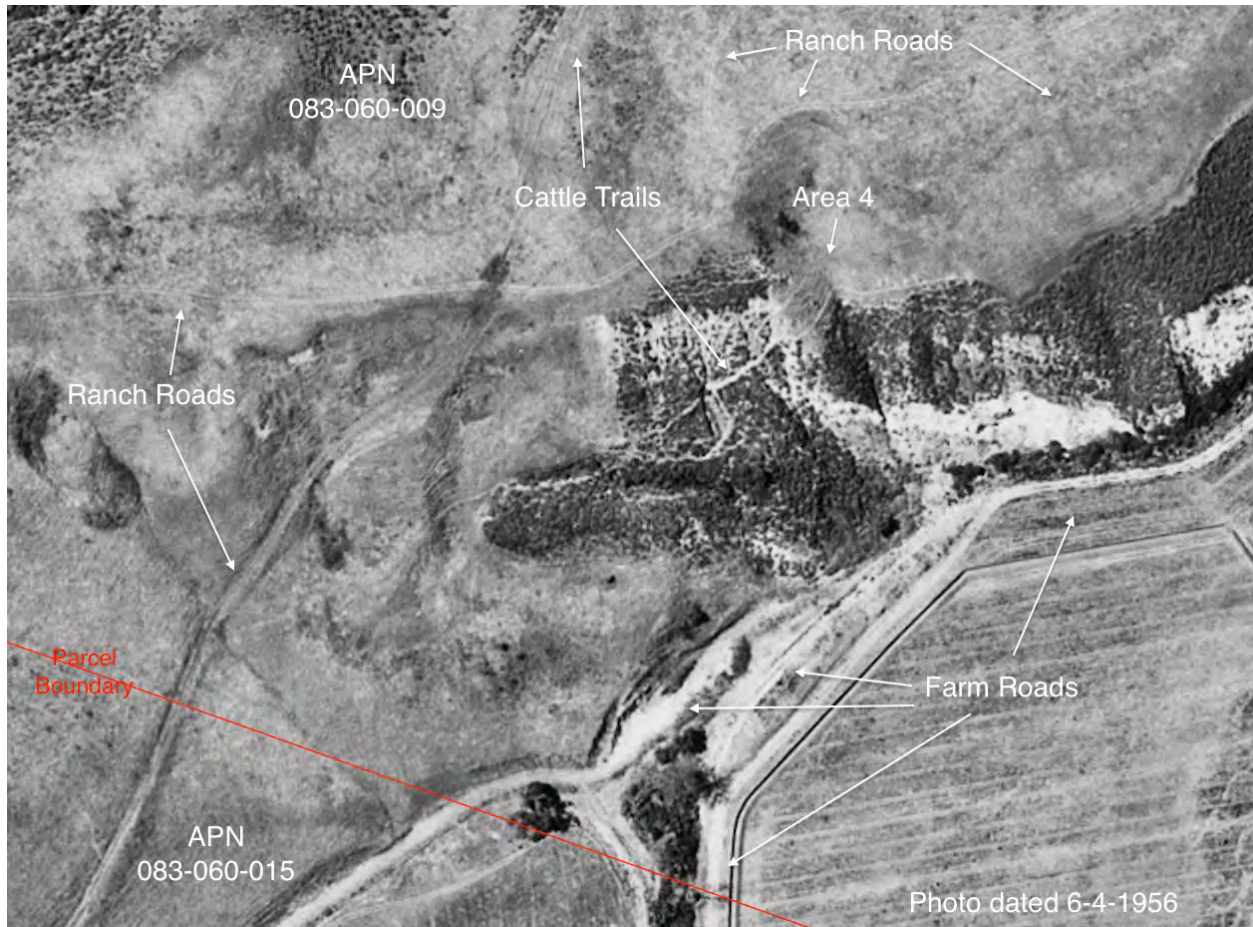
Fig. 42. June 4, 1956 aerial photograph closeup of Area 4.

No surface mining or soil disturbance associated with surface mining is visible in this location.

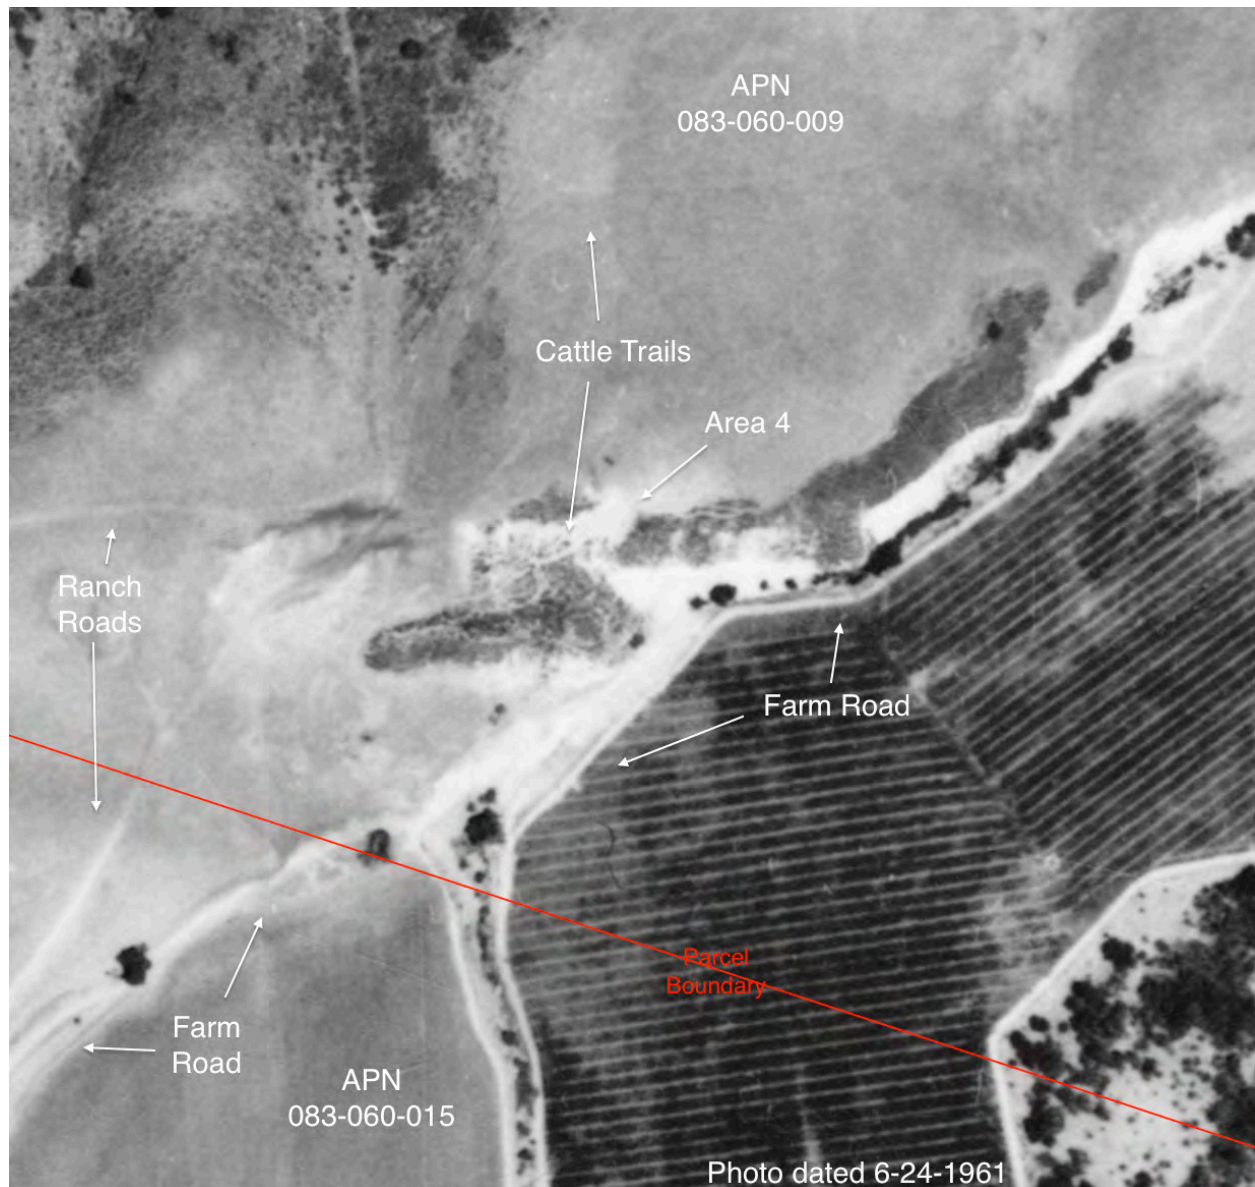
Fig. 44. June 24, 1961 aerial photograph closeup of Area 4.

This photo illustrates the conditions in Area 4 on June 24, 1961, after the implementation of County Ordinance 971, effective on September 29, 1958.

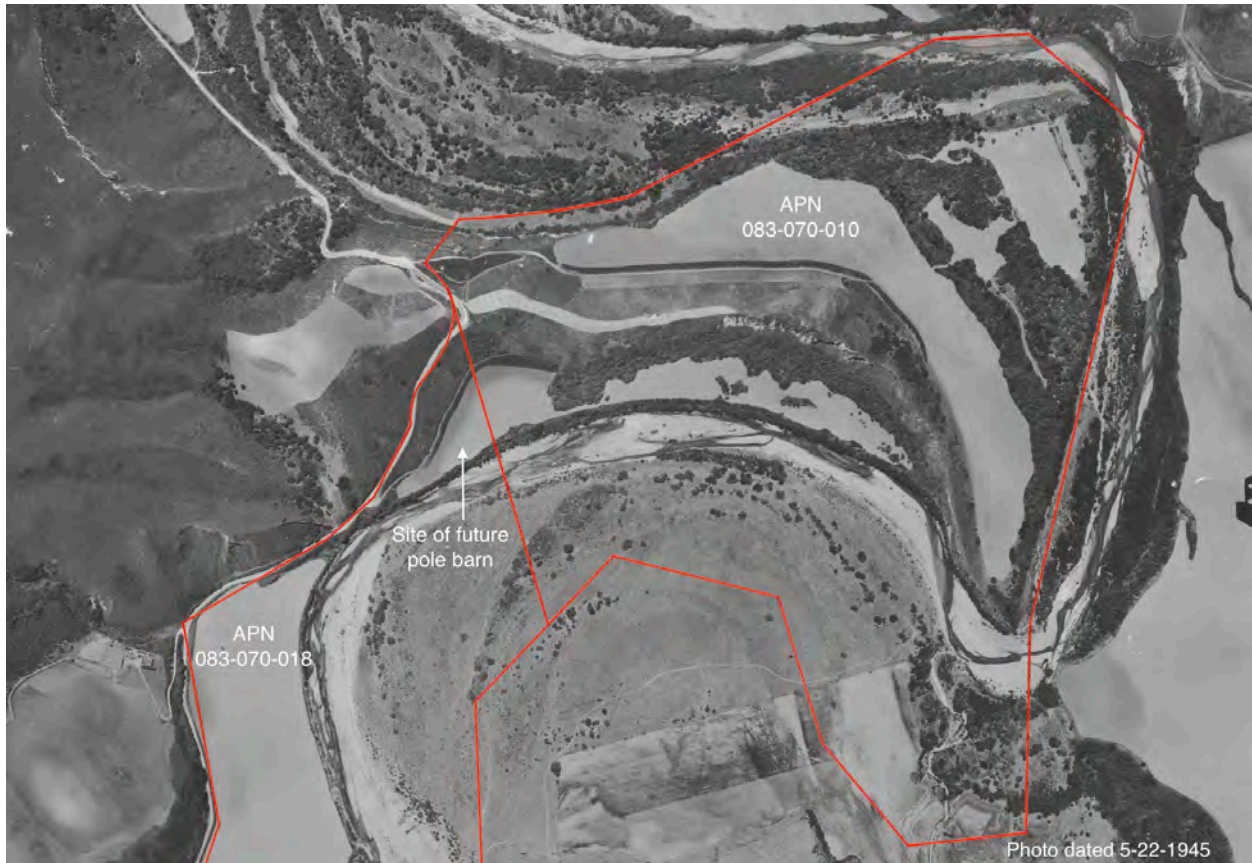
Fig. 46. May 22, 1945 aerial photograph of Site 1B.

No mining or soil disturbance is evident at this time. Road development, as evidenced by wide surfaces and two-wheel parallel tracks, on these parcels is slight and is associated solely with row-crop farming activities.

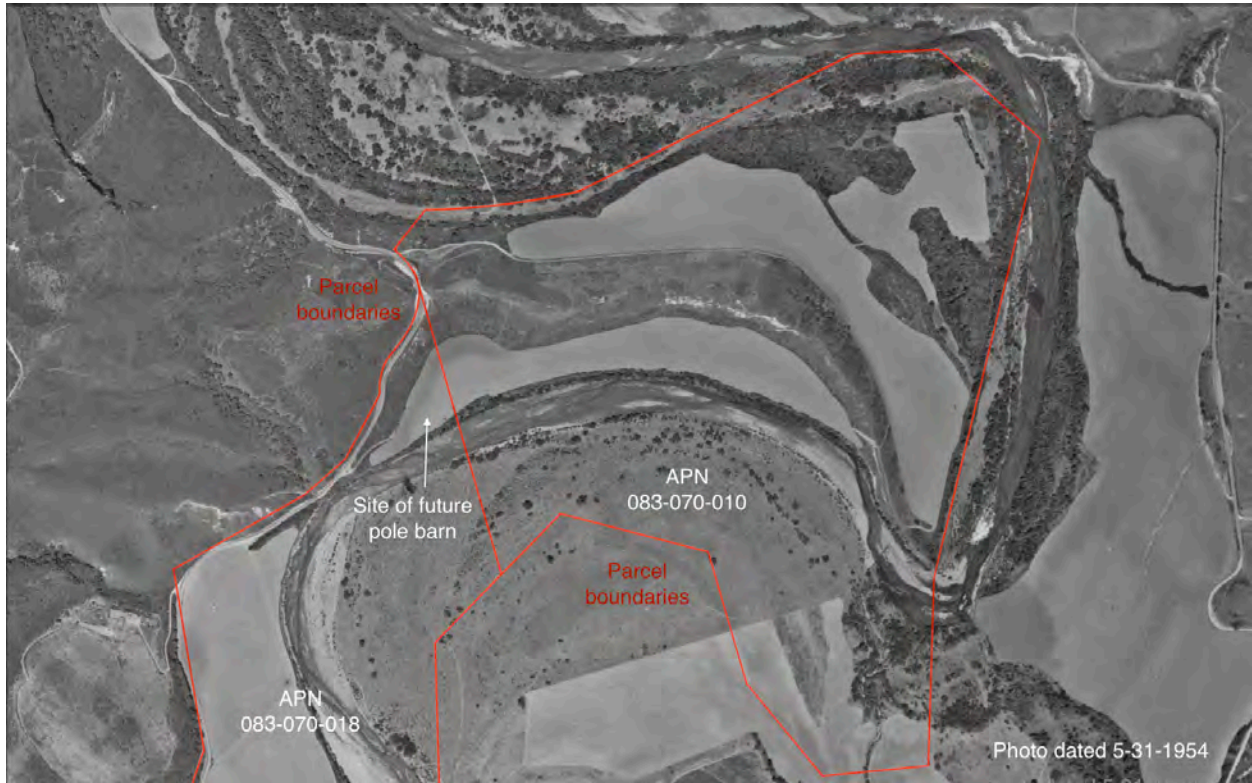
Fig. 47. May 31, 1954 aerial photograph of Site 1B.

Cattle trails are evident on the ridge, and road development appears to be restricted to farm use.

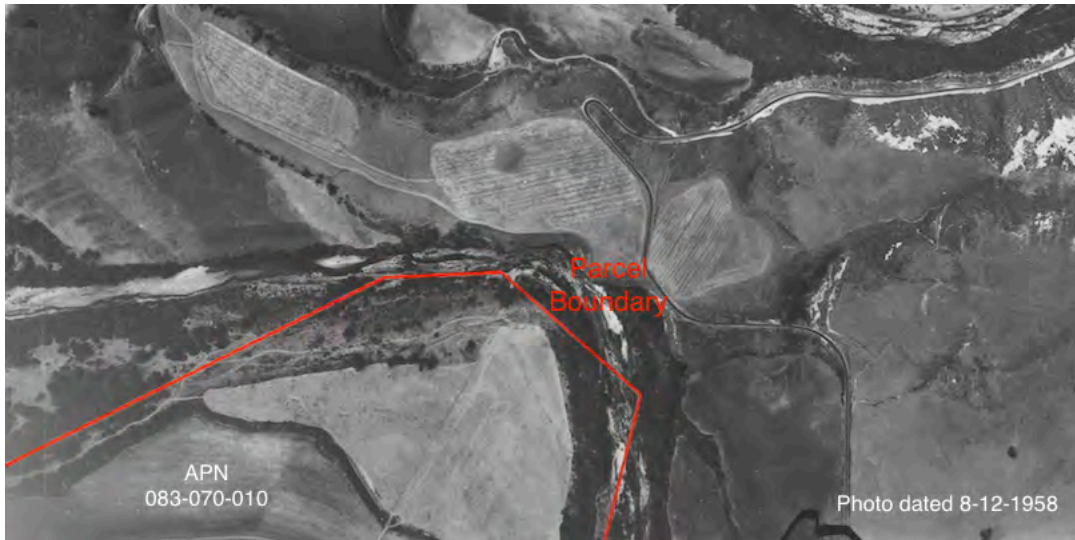
Fig. 49. August 12, 1958 aerial photograph of Site 1B.

No mining activities or storage of stone products are present in this limited view and the primary use of the land remains cattle grazing and row crops.

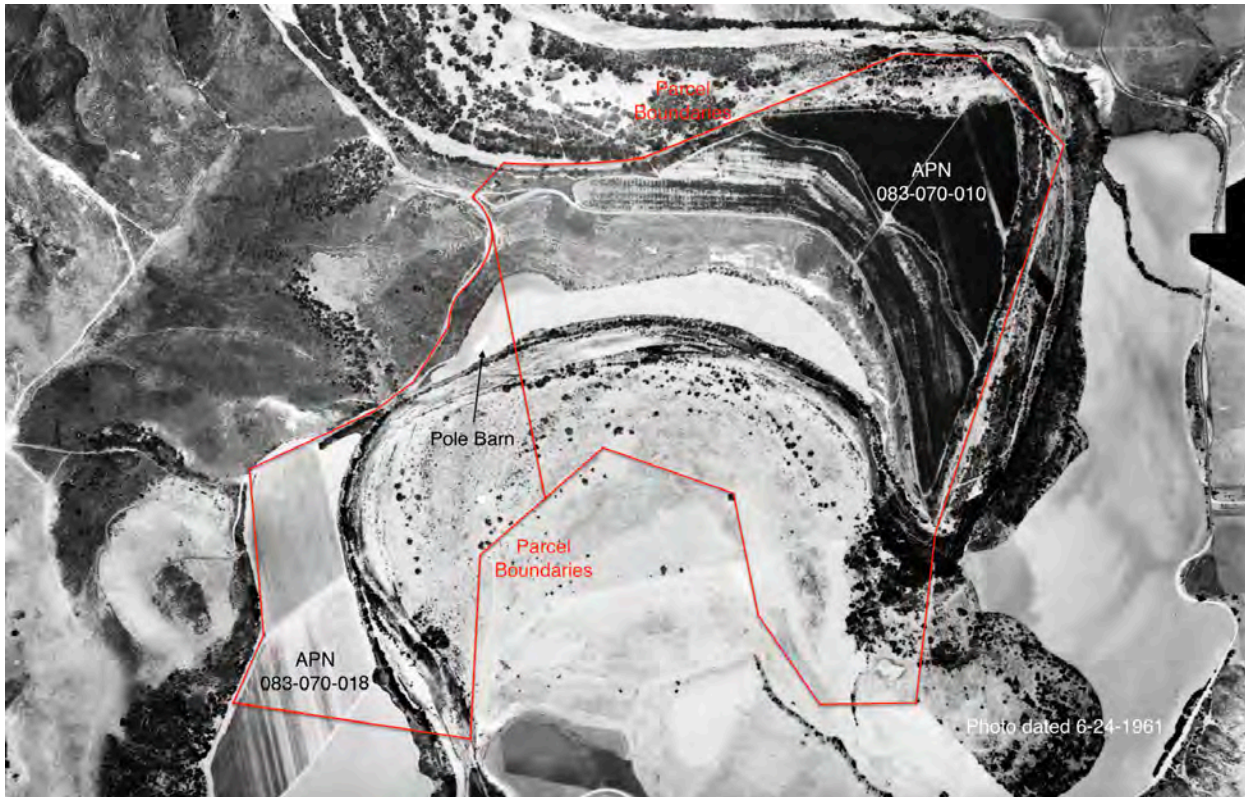
Fig. 50. June 24, 1961 aerial photograph of Site 1B.

This photo illustrates the conditions after the implementation of County Ordinance 971 on September 29, 1958.
