**RESTORATION “AS-BUILT” REPORT AND ADDENDUM  
TO  
CONCEPTUAL HABITAT RESTORATION AND  
REVEGETATION PLAN,  
2825 PADARO LANE, SUMMERLAND,  
SANTA BARBARA COUNTY, CALIFORNIA**

**25 May 2012**

**Hunt & Associates Biological  
Consulting Services  
5290 Overpass Road, Ste. 108  
Santa Barbara, CA 93111**

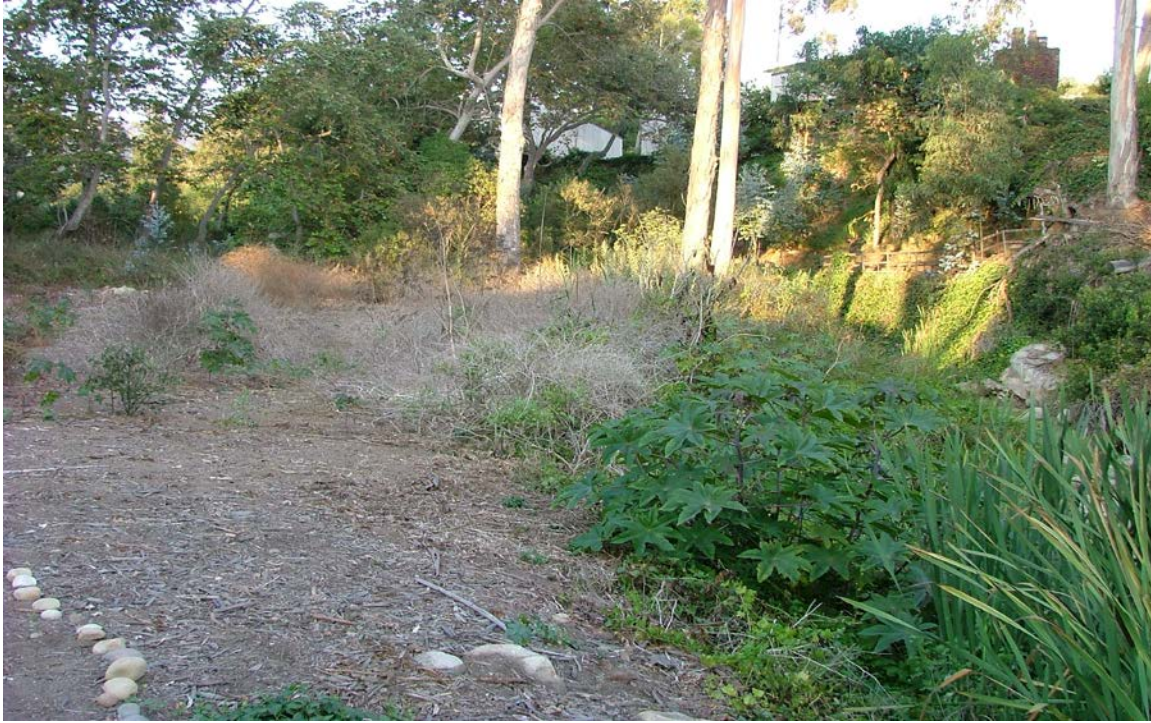
**3. Southern stream terrace and western bank of Toro Canyon Creek, looking northeast, prior to restoration. Terrace was highly disturbed, with bare soil and large patches of invasive, non-native vegetation (mustard, castor bean, periwinkle, etc.). 12 September 2009.**

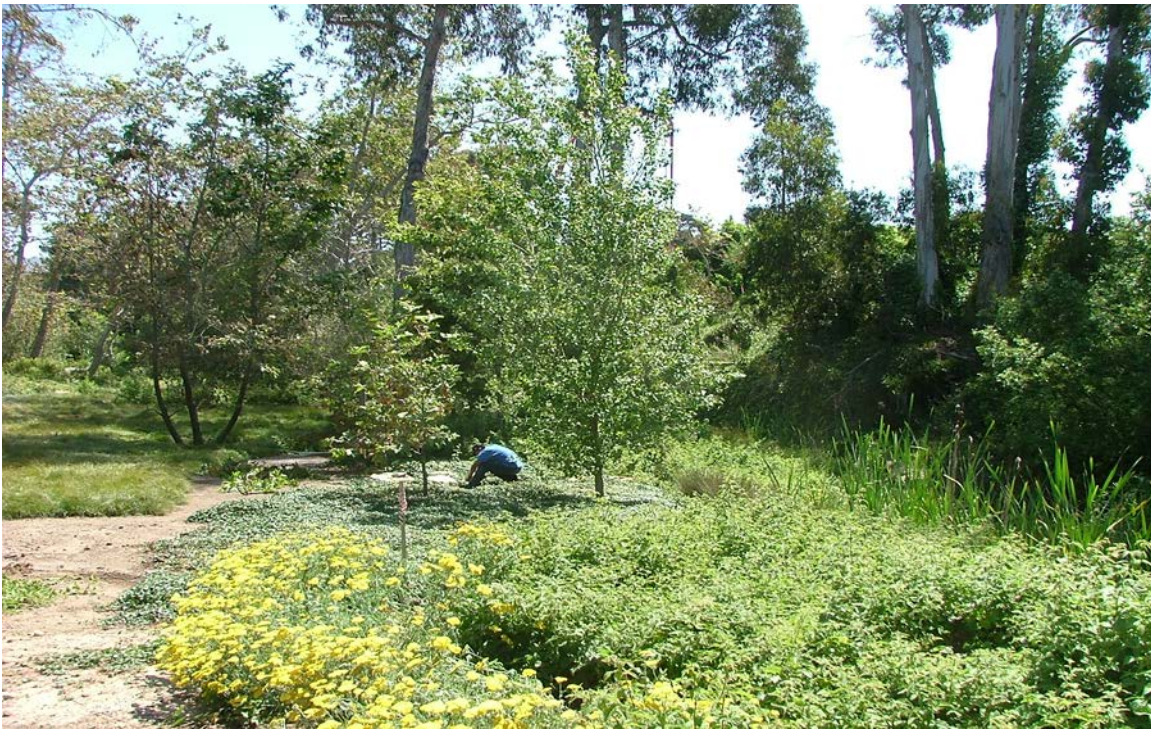
**4. Same site as above, after restoration. Non-native vegetation has been replaced with California blackberry, yarrow, beach strawberry. Planted trees include black cottonwood and western sycamore. Western bank of creek supports common horsetail, cattails, and yellow nut-grass. Eastern bank is covered with cape ivy and other non-native species (see next photo). 22 May 2012.**

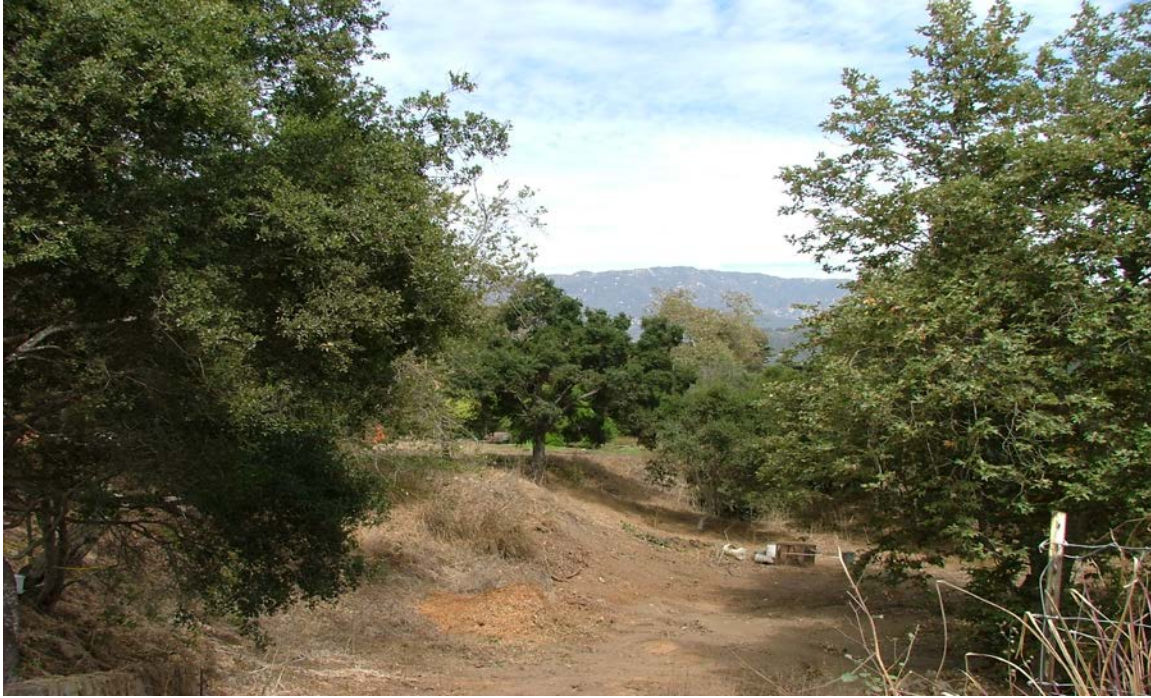
**8. Northern terrace, looking north, prior to restoration. Well is visible in center of terrace. Horse corrals have been removed. Note condition of terrace floor and adjacent slopes. 12 September 2009.**

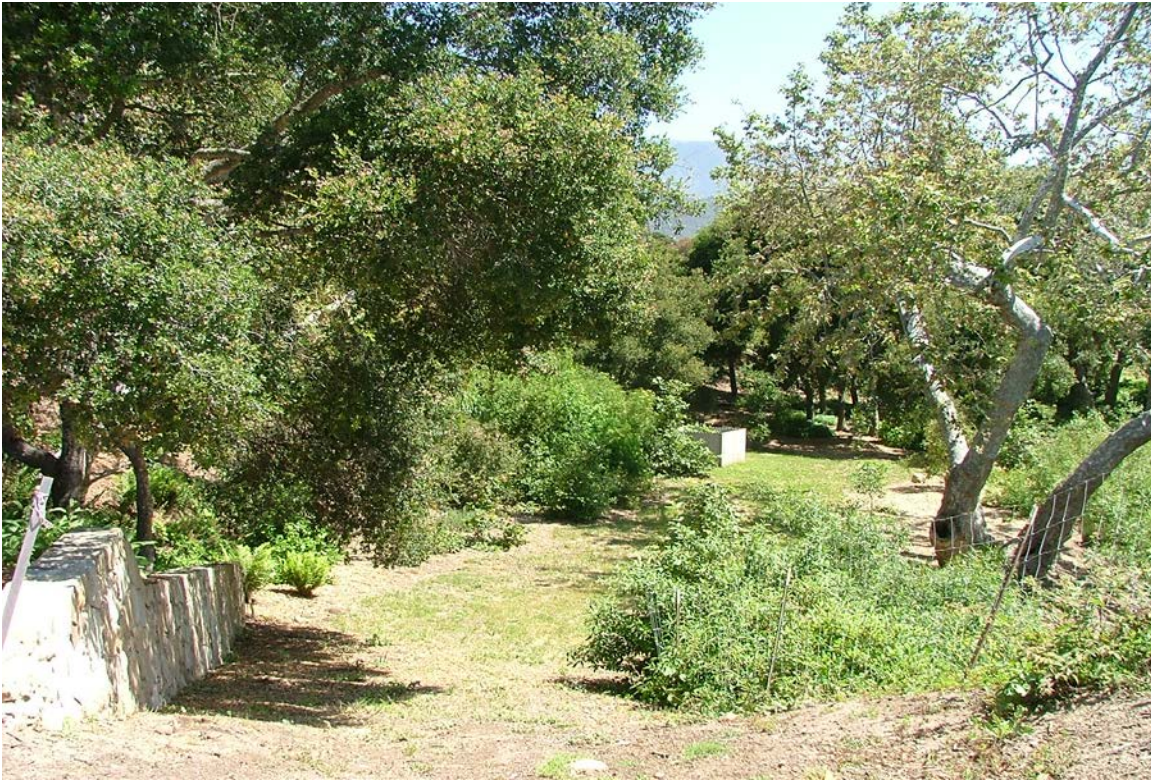
**9. Same view as above. Terrace floor has been planted with western sycamore, holly-leaved cherry, arroyo willow, coast live oak, elderberry, coffeeberry, box elder, and western spice bush. Slope at right retains natural coast live oaks. Giant chain fern, western sword fern, alum root, hummingbird sage, canyon sunflower, California grape, blue-eyed grass, seacliff buckwheat, and other species. 22 May 2012.**

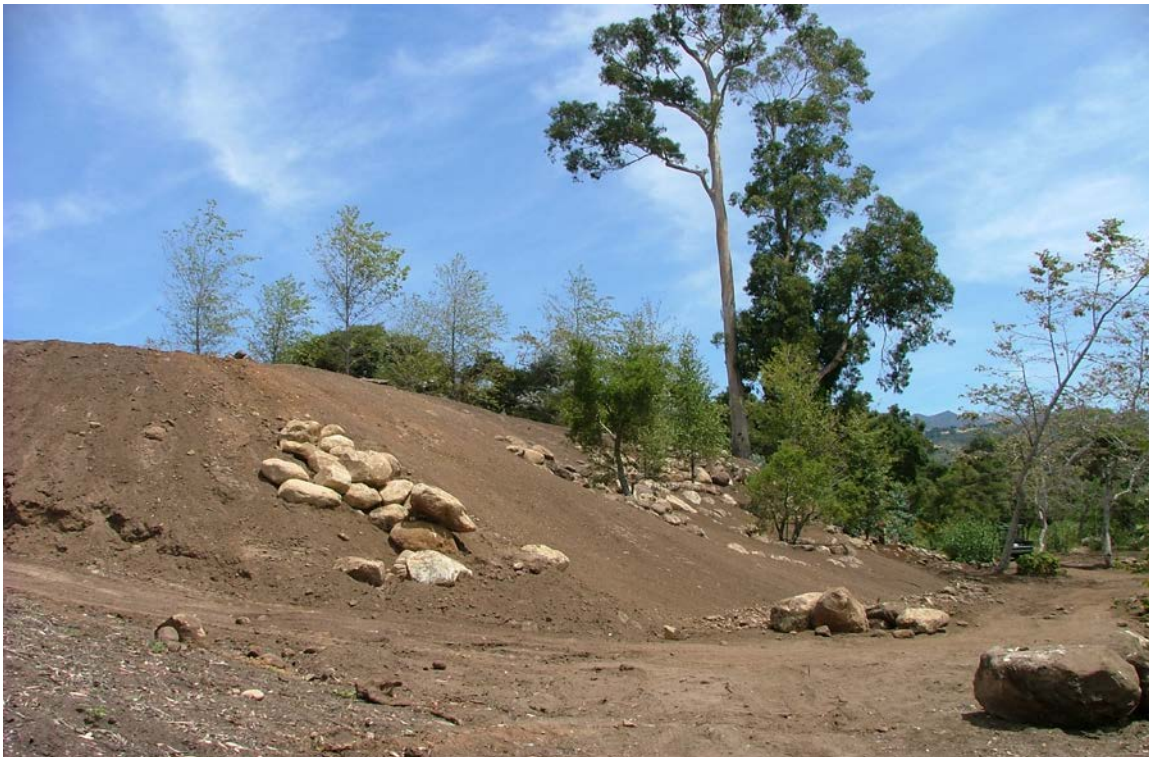
**13. Same view, after non-native vegetation has been removed. 28 May 2010.**

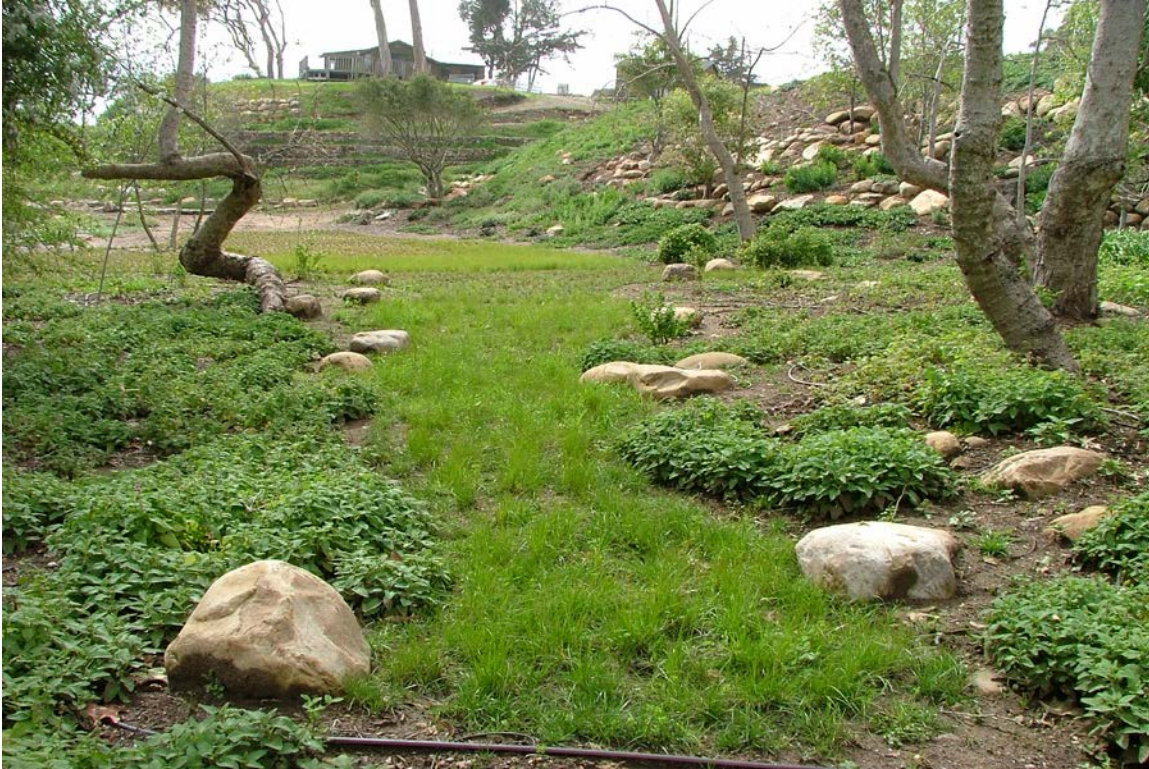
21. Southern terrace floor looking southwest, a few months after planting. Dune sedge covers footpath. Ground cover to left and right of path is wood mint, California rose, canyon sunflower, and California blackberry. 22 March 2011.

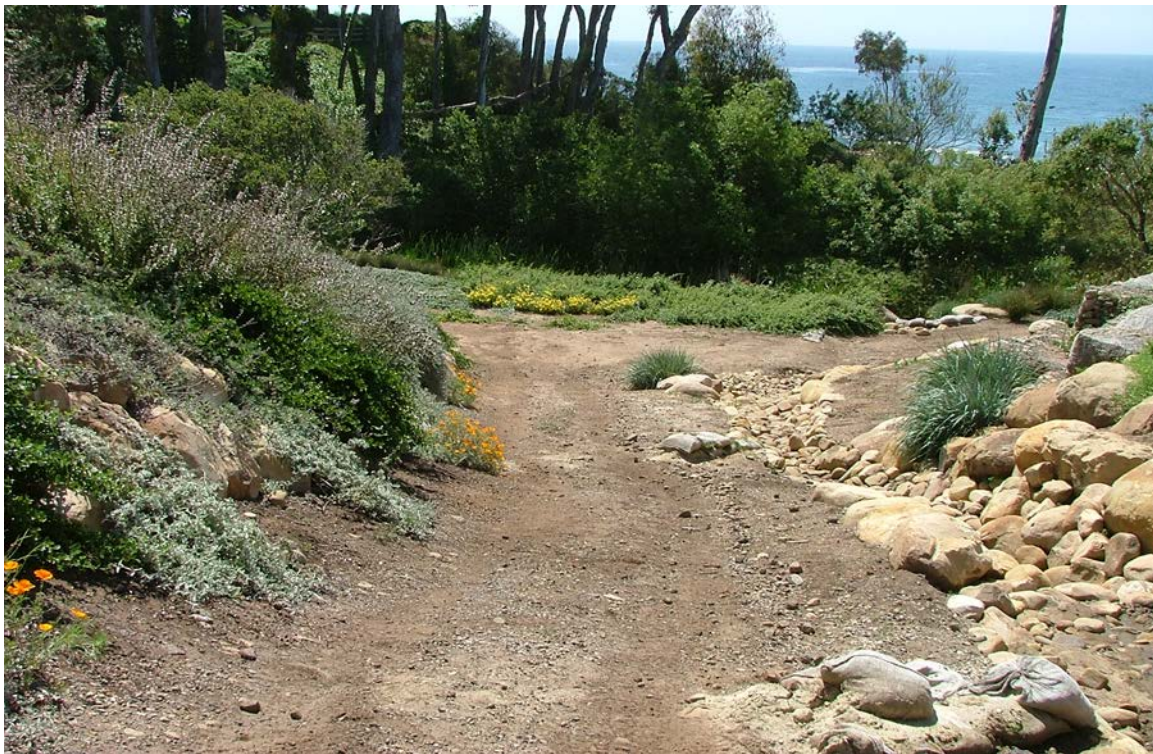
24. Same view. Terrace slope at left has been planted with purple sage, ceanothus, and other coastal bluff scrub shrubs. Slope at right has not yet been restored. Erosion channel has been lined with cobbles and will be restored with freshwater marsh species. Vegetation on terrace floor and bank of Toro Canyon Creek includes beach strawberry, CA blackberry, yarrow, Indian rush, yellow nut-grass, and other species. 22 May 2012.

As requested by California Coastal Commission staff during their site visit on 27 September 2011, these erosion features will be stabilized and revegetated using a “soft-touch” approach including use of small rocks covered with soil and planted with native wetland plants to decrease water velocity, allow runoff to percolate into the stream terraces, and de-silt the water before it enters Toro Canyon Creek. See Item 3 for additional information. Photos 14, 23-24, and 27 in Appendix 1 show current conditions of these features.

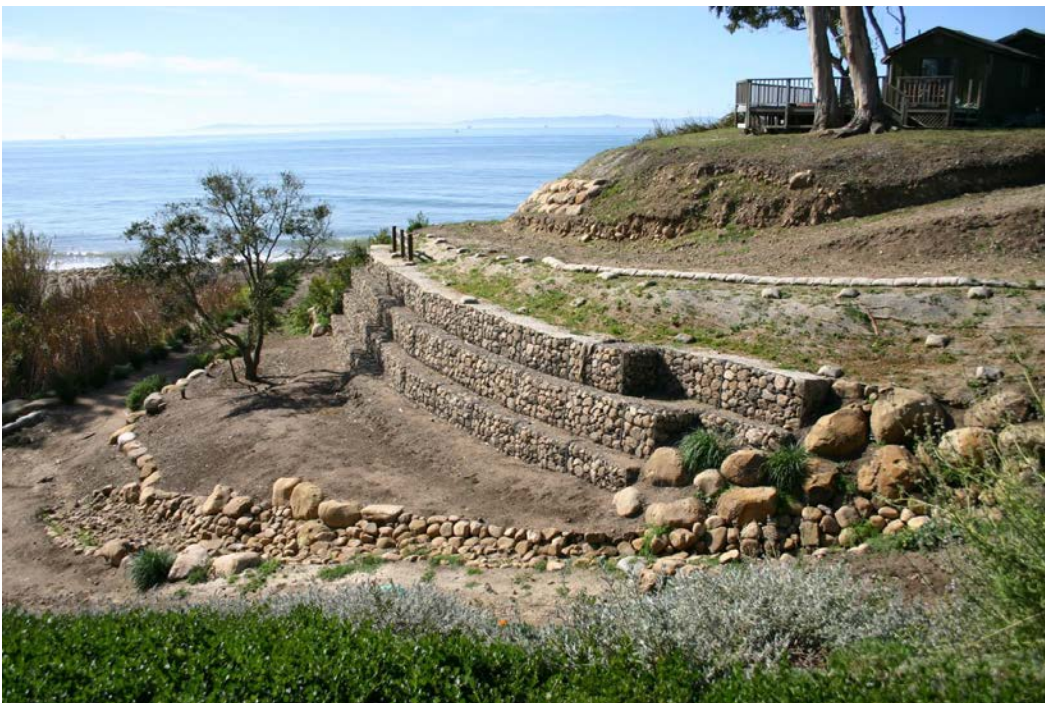
26. Same view, 20 February 2012.
