August 28, 2023

**BIOLOGICAL REPORT
AS-BUILT WALL REPAIR PROJECT
1690 San Leandro Lane (APN: 007-280-012)
Montecito, California**

BIOLOGICAL ASSESSMENT
AS-BUILT WALL REPAIR PROJECT
1690 San Leandro Lane (APN: 007-280-012)
Montecito, California

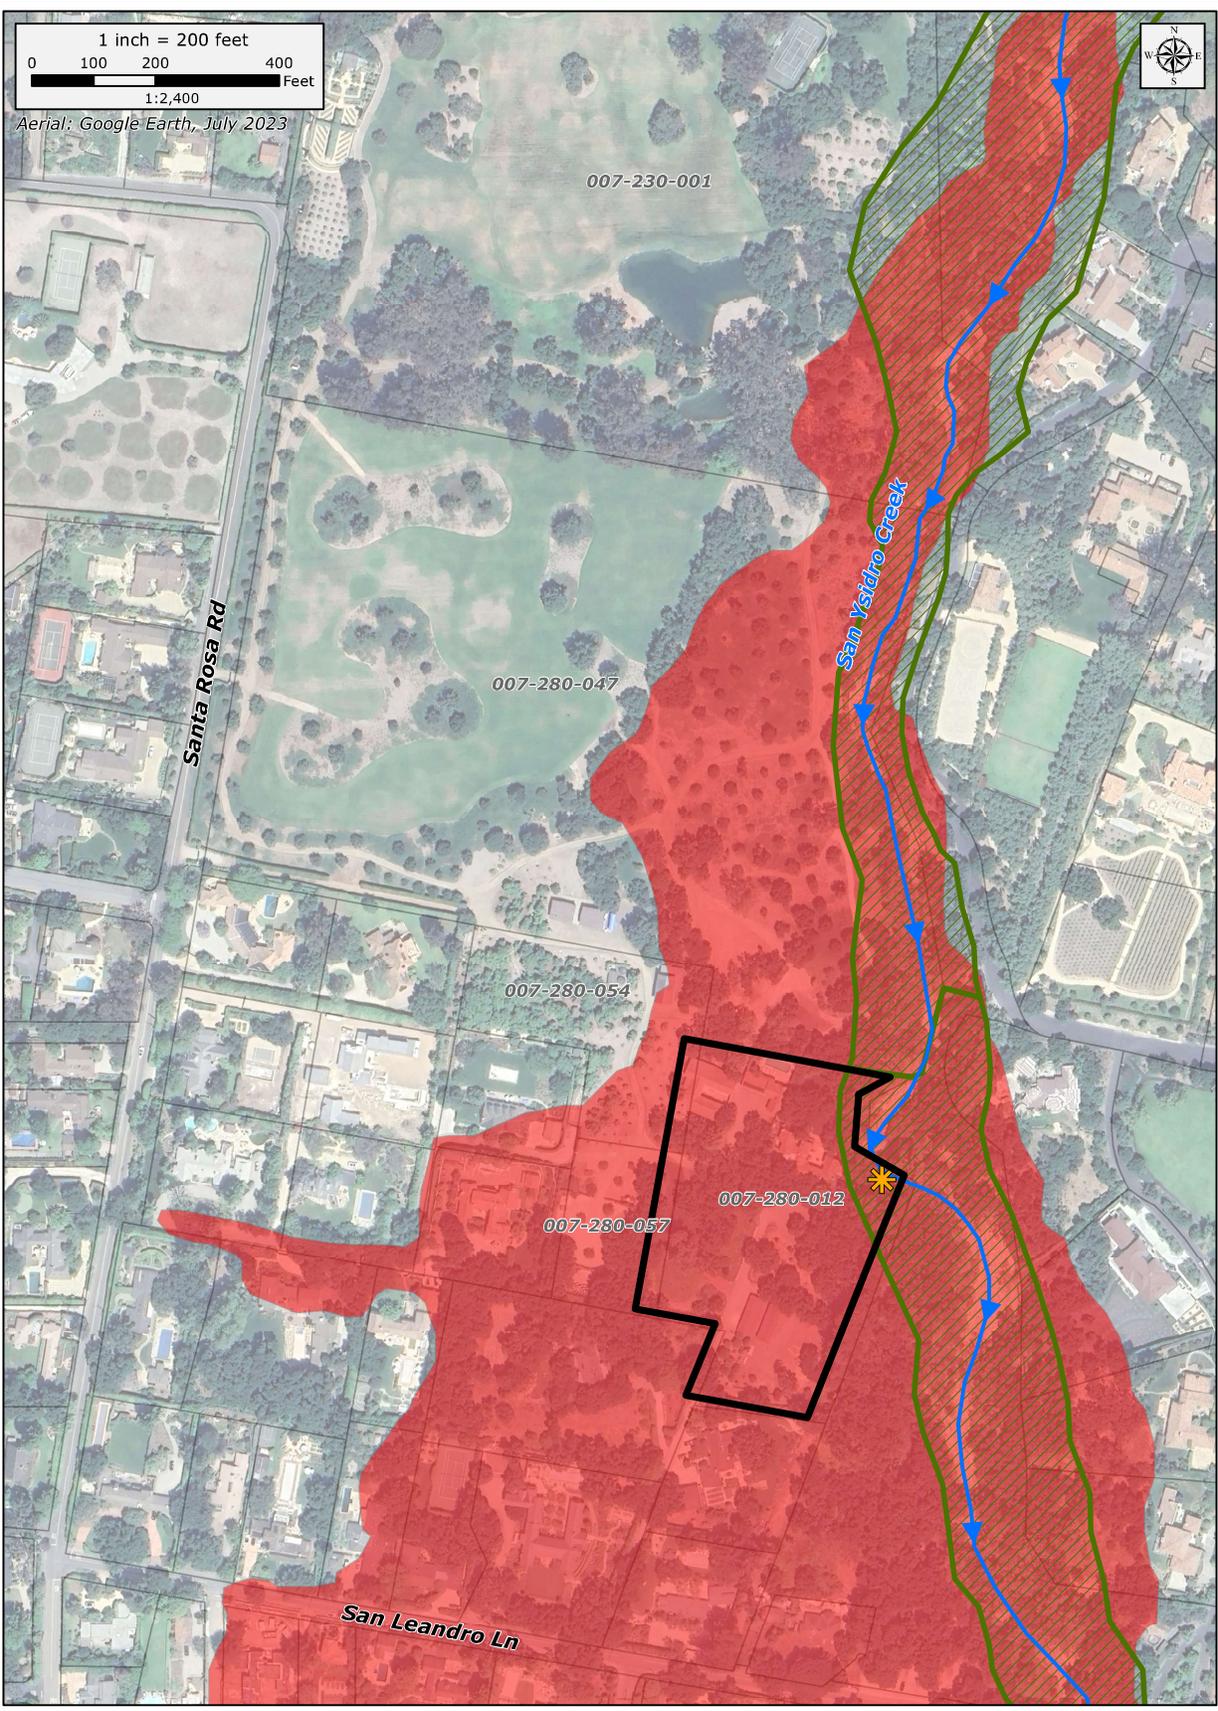
Figure 5. Area Damaged in the Project Vicinity by January 9, 2018 Montecito Mud/Debris Flow

Repairs to the grouted sandstone boulder wall were performed in February and March of 2018 at a time when debris removal efforts from the January 9, 2018 Montecito mud/debris flow were actively in progress. Figure 5 depicts the extent of the mud/debris flow on the 1690 San Leandro Lane property and the adjacent 380 Santa Rosa Lane property. The mud/debris flow destroyed almost all of the herbaceous and shrub vegetation and badly damaged and destroyed many of the mature trees within the mud/debris flow area.

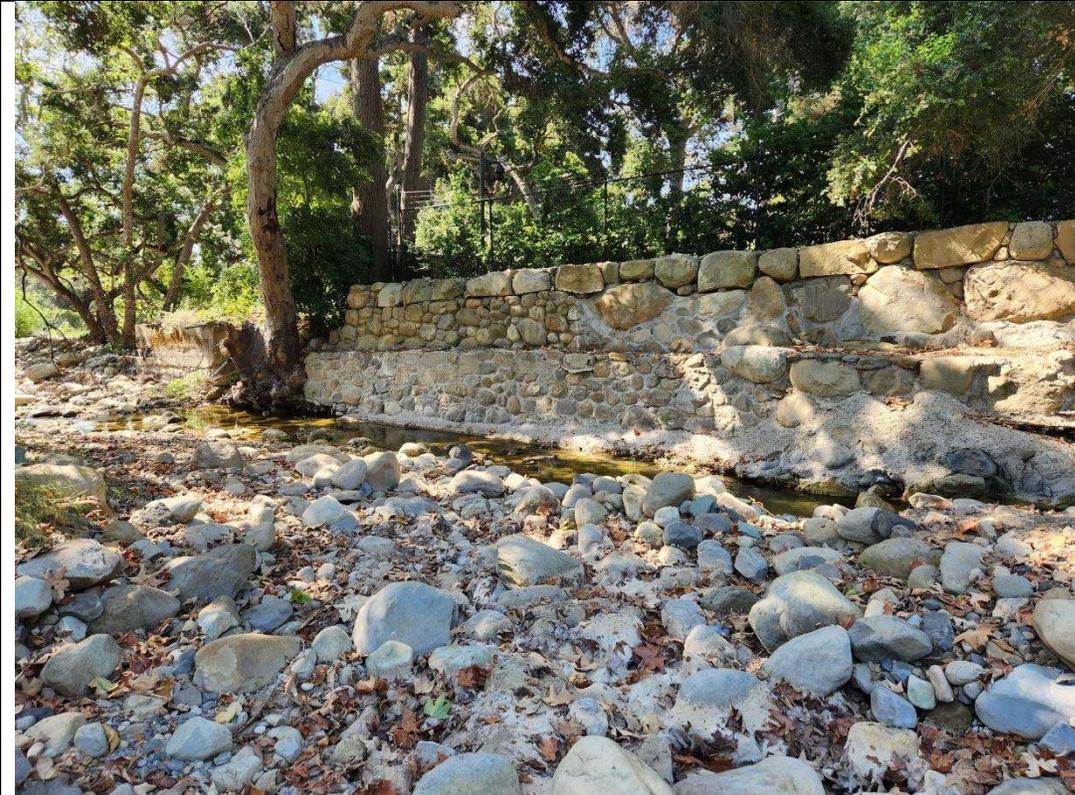
Photo 1. Repaired grouted sandstone boulder wall located on the western bank of San Ysidro Creek in the northeast corner of 1690 San Leandro Lane property. Abandoned concrete bridge abutment is to the left of the tree and sandstone boulder wall (view looking south taken 7/28/2023)

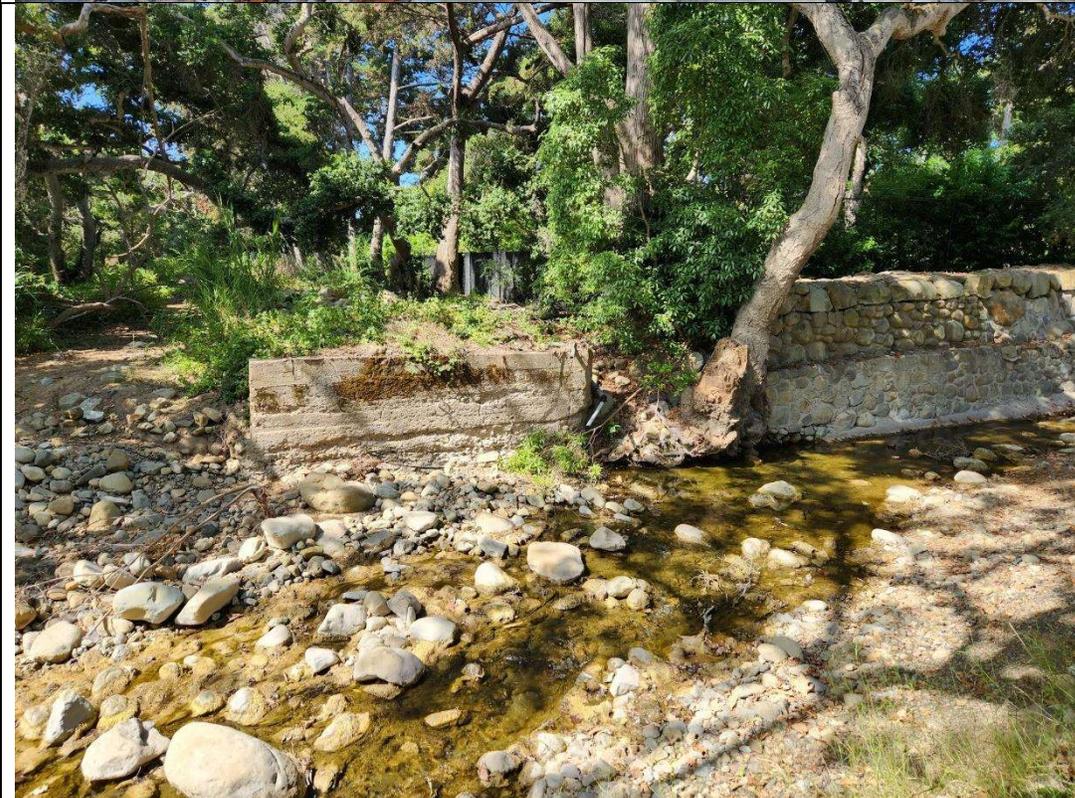
Photo 2. Abandoned concrete bridge abutment adjacent (southeast) of repaired grouted sandstone boulder wall (view looking southwest taken 7/28/2023)

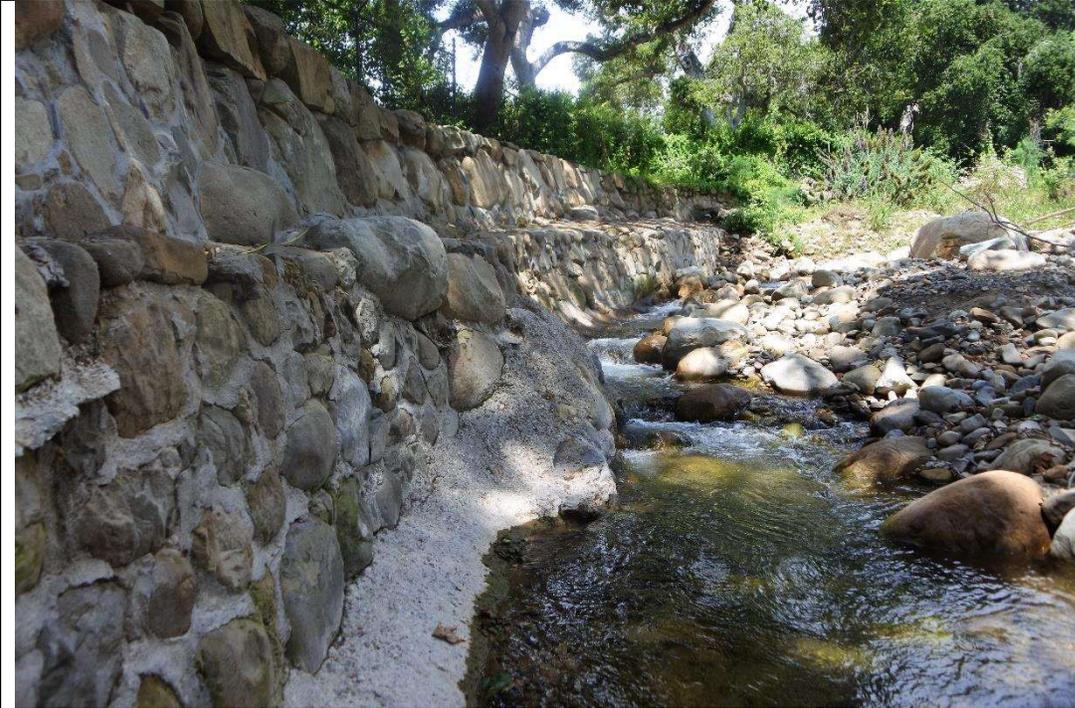
Photo 3. Repaired grouted sandstone boulder wall on western bank of San Ysidro Creek. (view looking west taken 5/8/2023)

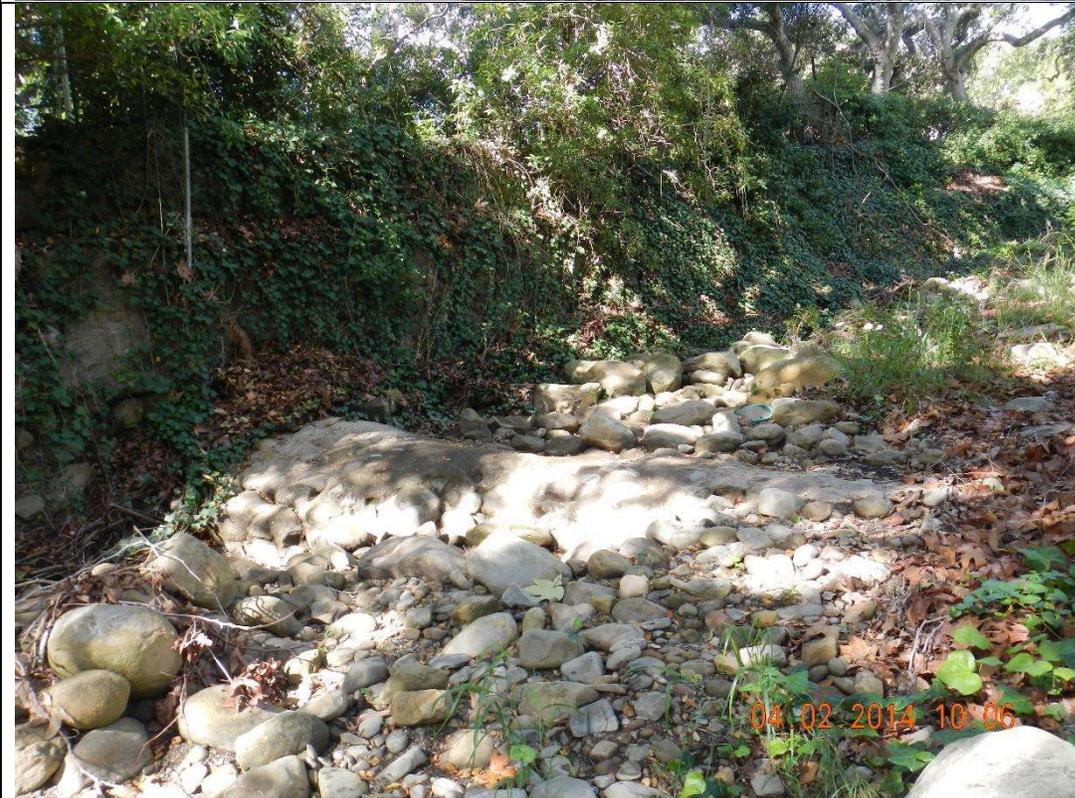
Watershed Environmental was unable to determine the precise date when the wall was built, but we were able to obtain a photograph of the wall taken by the Santa Barbara County flood control department on April 2, 2014. The wall was covered in English ivy in 2014, but the trees in the background of the wall are still present today and are what Watershed Environmental Inc. personnel used to confirm that the 2014 photo is the same wall that was repaired in 2018.

Photo 4. Historic photo of grouted sandstone boulder covered in English ivy taken on 4/2/2014 by SBCO Flood Control Dept. Note: oak tree branch in upper right corner of photo is the same branch in the upper right corner of Photo 3 (view looking west taken 4/2/2014)

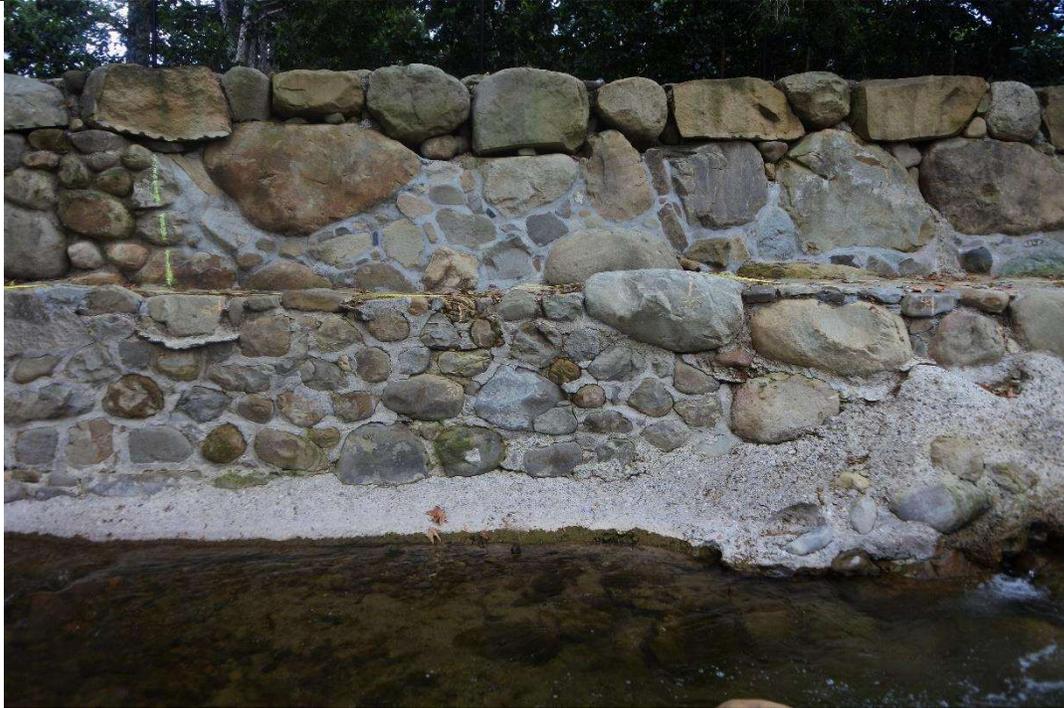
Photo 5. Close up of a portion of the grouted sandstone boulder wall that was repaired. The cement grout in the repaired section is light gray. The color of the concrete grout in wall sections that were not repaired is white. (view looking south taken 5/8/2023)

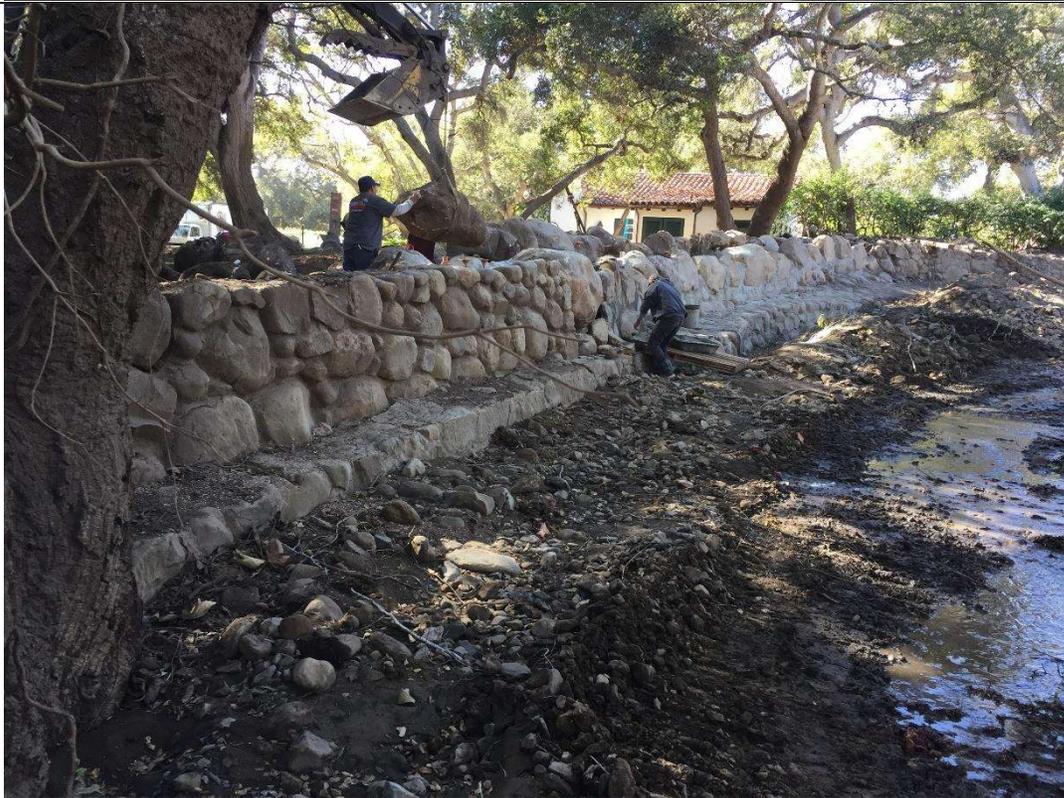
Photo 6. Historic photo of grouted sandstone boulder being repaired taken on 2/20/2018 by SBCO Flood Control Dept. The excavator is staged behind (south) the wall and is lowering boulders into place. The workman in the center of the photo is grouting the joints between the boulders. (view looking west taken 2/20/2018)

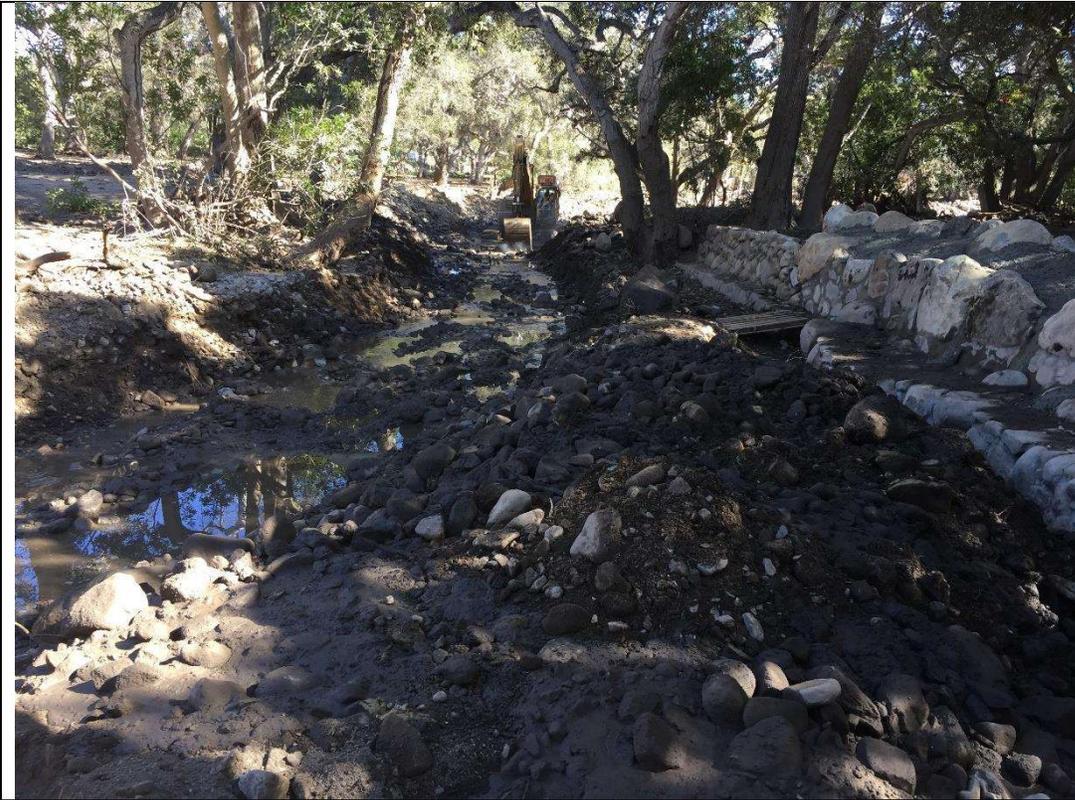
used 5-gallon buckets of cement to grout the sandstone boulders in place. The wall was repaired while the County Flood Control Department and ACOE were operating heavy equipment in the creek bed to clear debris deposited by the January 2018 mud/debris flow.

Photo 7. Historic photo of SBCO Flood Control Department and ACOE using heavy equipment on 2/20/2018 to clear debris from the bed of San Ysidro Creek near the 1690 San Leandro Lane grouted sandstone boulder wall (taken on 2/20/2018 by SBCO Flood Control Dept. view looking southeast)
