**RESTORATION “AS-BUILT” REPORT AND ADDENDUM  
TO  
CONCEPTUAL HABITAT RESTORATION AND  
REVEGETATION PLAN,  
2825 PADARO LANE, SUMMERLAND,  
SANTA BARBARA COUNTY, CALIFORNIA**

**25 May 2012**

**Hunt & Associates Biological  
Consulting Services  
5290 Overpass Road, Ste. 108  
Santa Barbara, CA 93111**

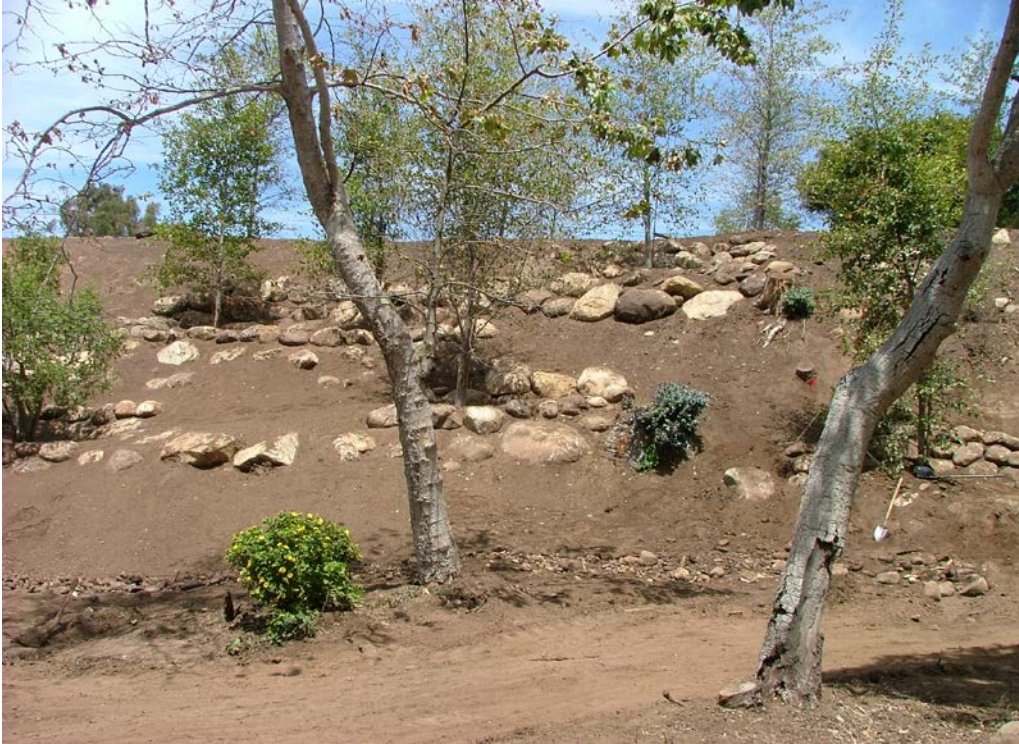
**1. Southern terrace slope looking southwest. Non-native vegetation has been removed and boulders were placed on slope to stabilize soil for planting sites. Coast live oaks and white alder have been planted on slopes. 12 September 2009.**

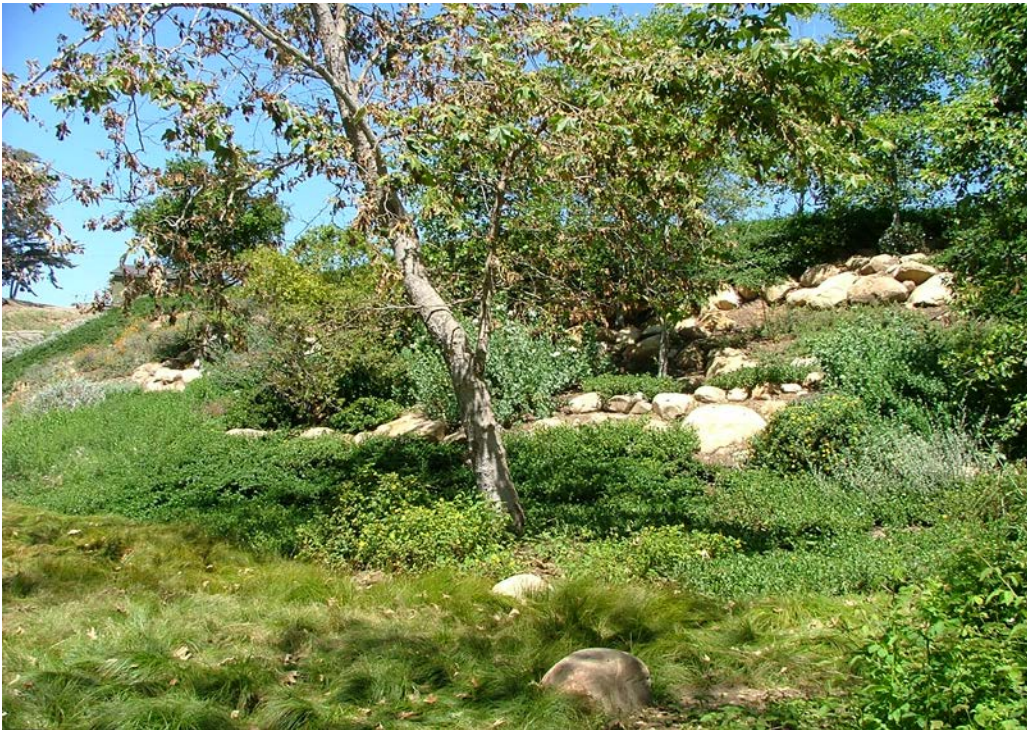
**2. Same site as above after revegetation with native species. Dune sedge (left) and wood mint (right) on terrace floor grades into canyon sunflower, seacliff buckwheat, ceanothus, gum plant, common aster, elderberry, and other species on slope. 22 May 2012.**

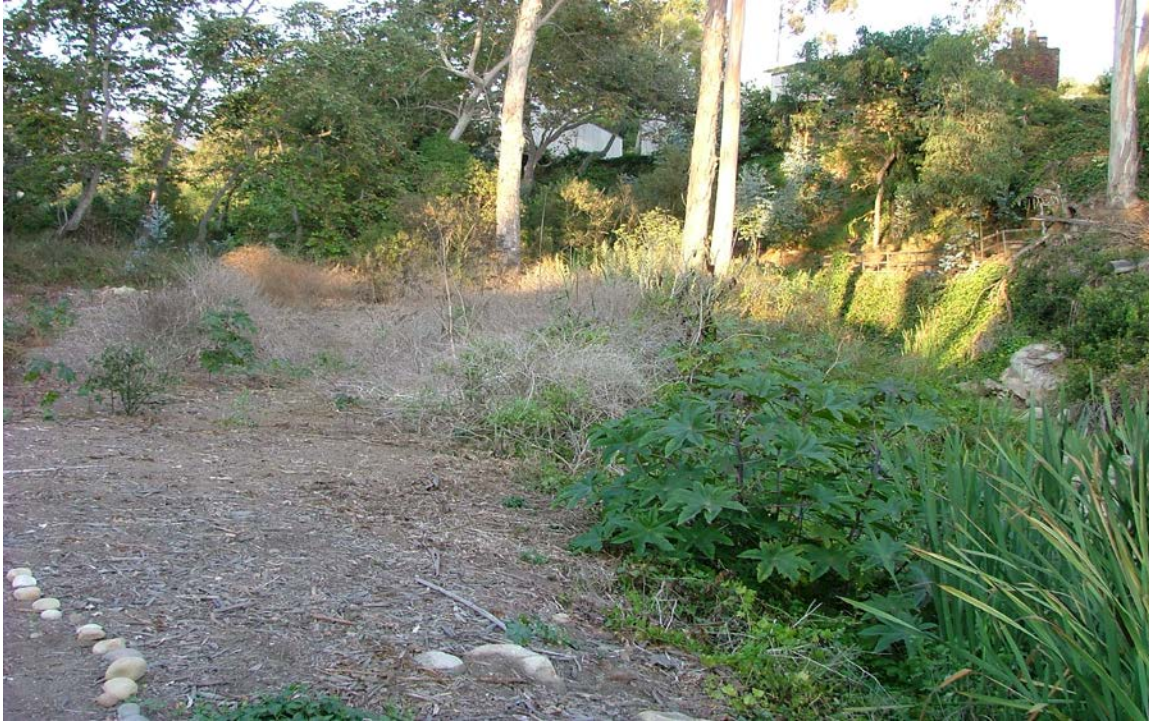
**3. Southern stream terrace and western bank of Toro Canyon Creek, looking northeast, prior to restoration. Terrace was highly disturbed, with bare soil and large patches of invasive, non-native vegetation (mustard, castor bean, periwinkle, etc.). 12 September 2009.**

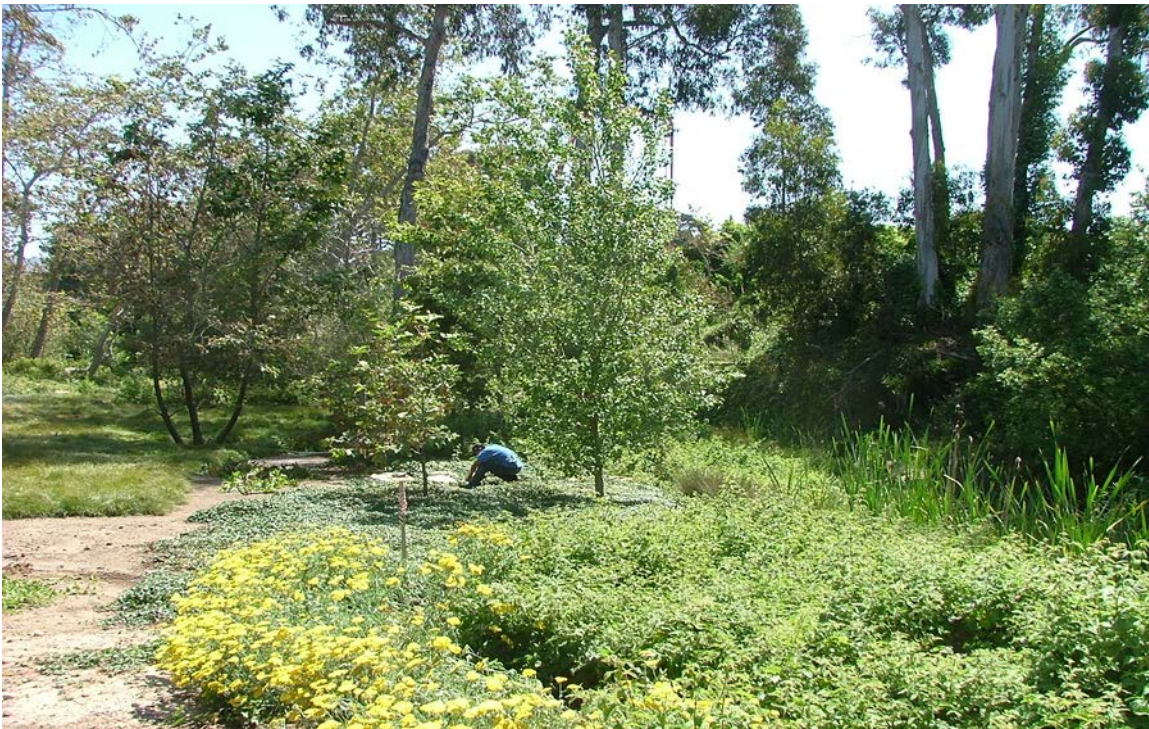
**4. Same site as above, after restoration. Non-native vegetation has been replaced with California blackberry, yarrow, beach strawberry. Planted trees include black cottonwood and western sycamore. Western bank of creek supports common horsetail, cattails, and yellow nut-grass. Eastern bank is covered with cape ivy and other non-native species (see next photo). 22 May 2012.**

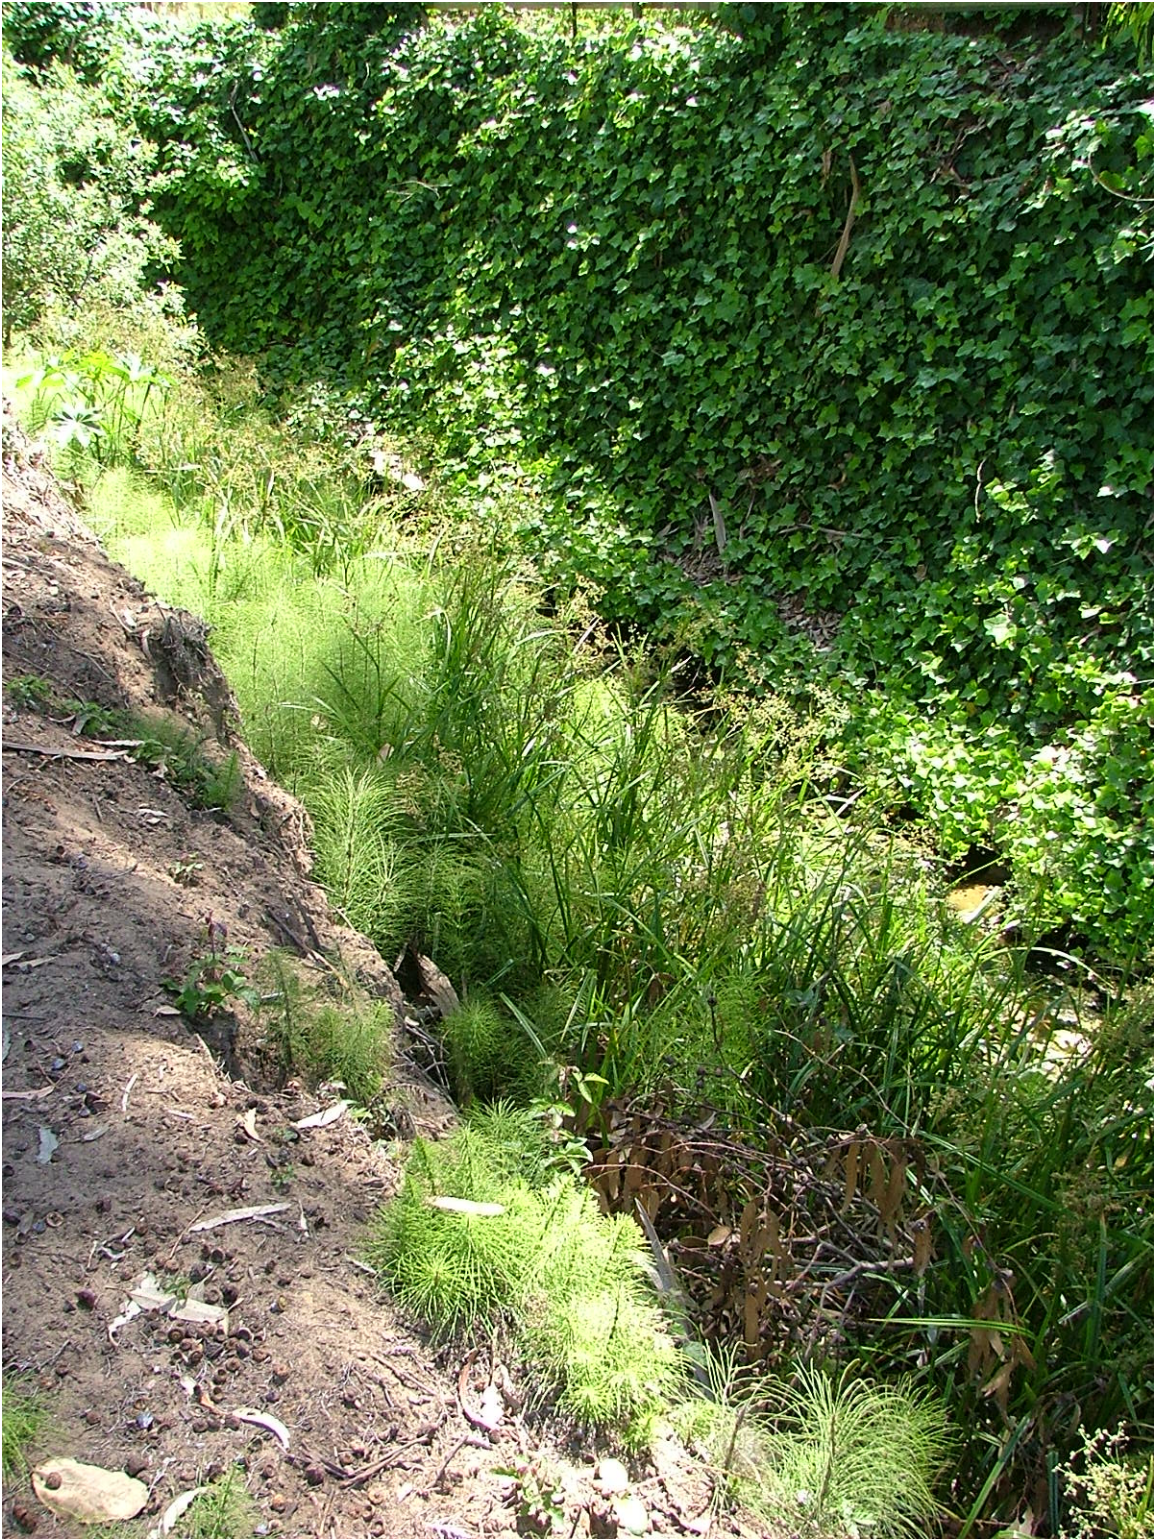
**5. Banks of Toro Canyon Creek adjacent to southern stream terrace showing effects of restoration. Before restoration, the western bank (foreground) used to be covered with same non-native species that still cover the eastern bank (neighboring property). Natives here include scouring rush, cattails, and yellow nut-grass. Eastern bank is a mixture of Algerian ivy and cape ivy. 22 May 2012.**

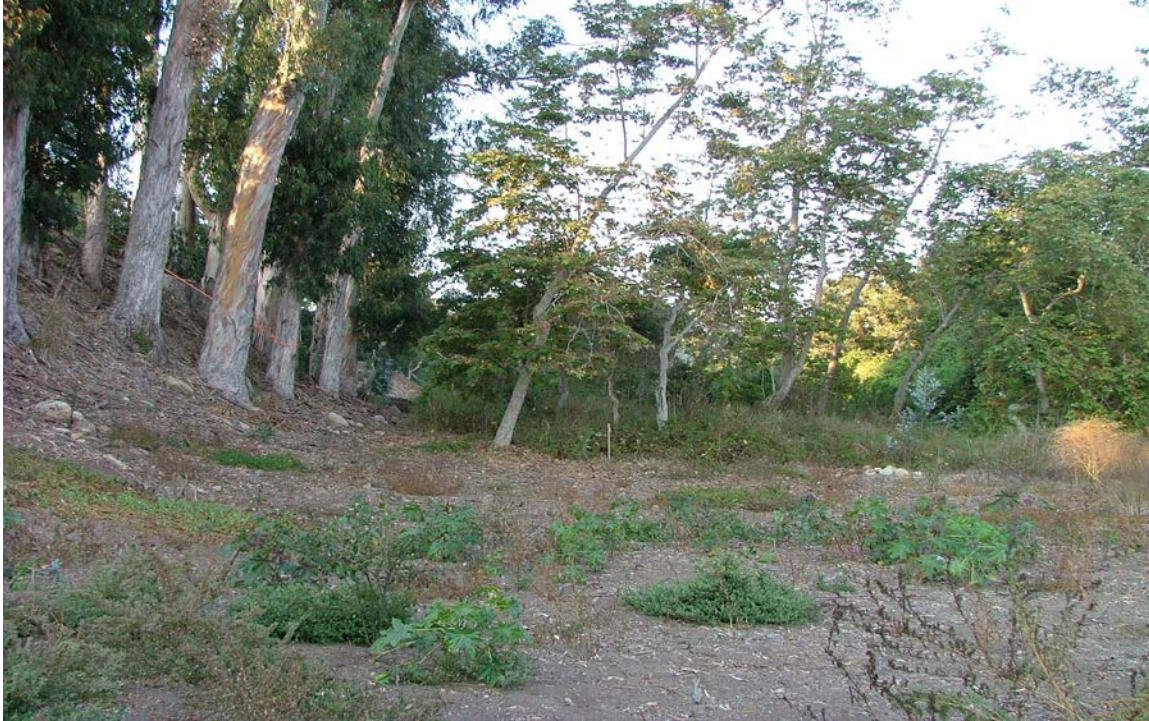
**6. Southern stream terrace, looking north, prior to restoration. Slopes at right were covered with mostly dead or dying blue gum eucalyptus. Floor of terrace was either bare soil or weeds (castor bean, bull mallow, ice plant, etc.), with a few scattered western sycamores and blue gum saplings. 12 September 2009.**

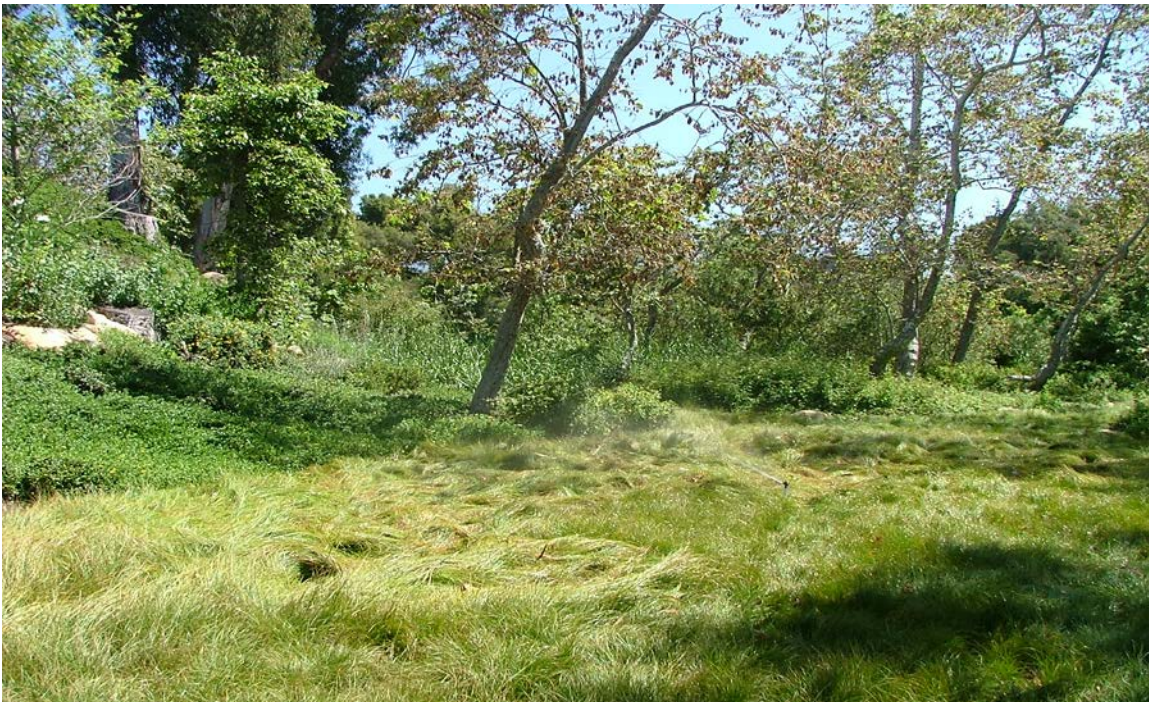
**7. Same view as above, after restoration. Healthy eucalyptus trees have been retained (upper left). Portions of terrace floor have been planted with dune sedge, which grades into patches of giant rye, California rose, wood mint, and canyon sunflower. Western sycamore, black cottonwood, box elder, and arroyo willow have been planted along edges of terrace and on creek banks. Ceanothus, elderberry, mugwort, and other species have been planted on the slope at right. 22 May 2012.**

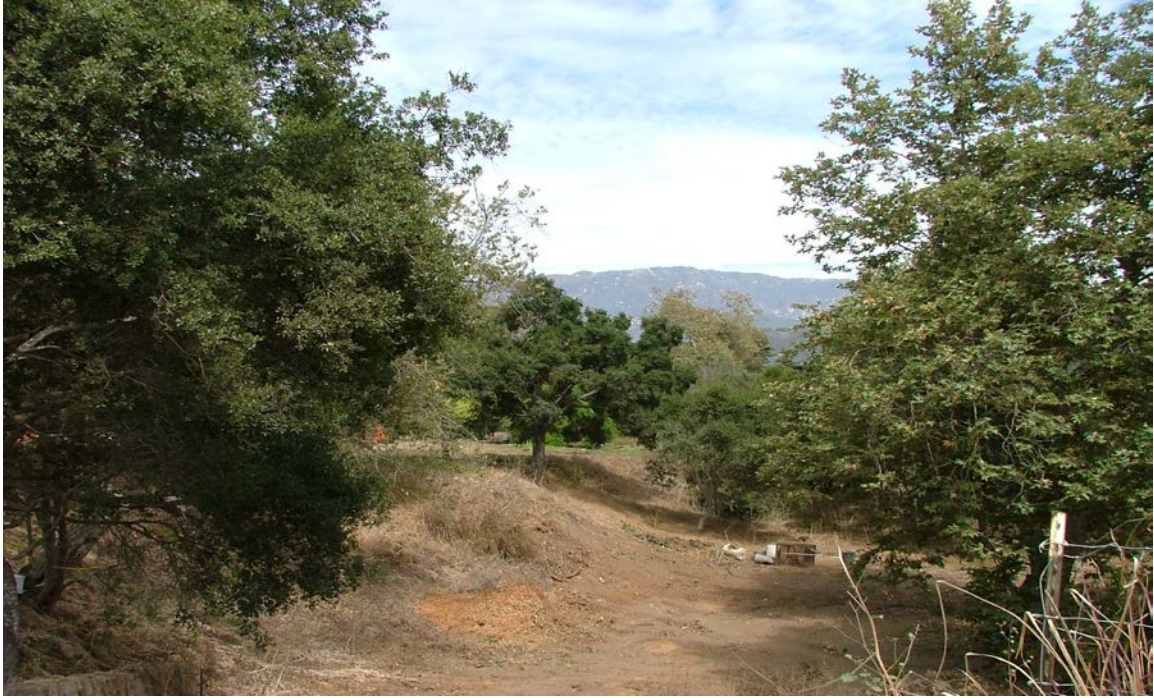
**8. Northern terrace, looking north, prior to restoration. Well is visible in center of terrace. Horse corrals have been removed. Note condition of terrace floor and adjacent slopes. 12 September 2009.**

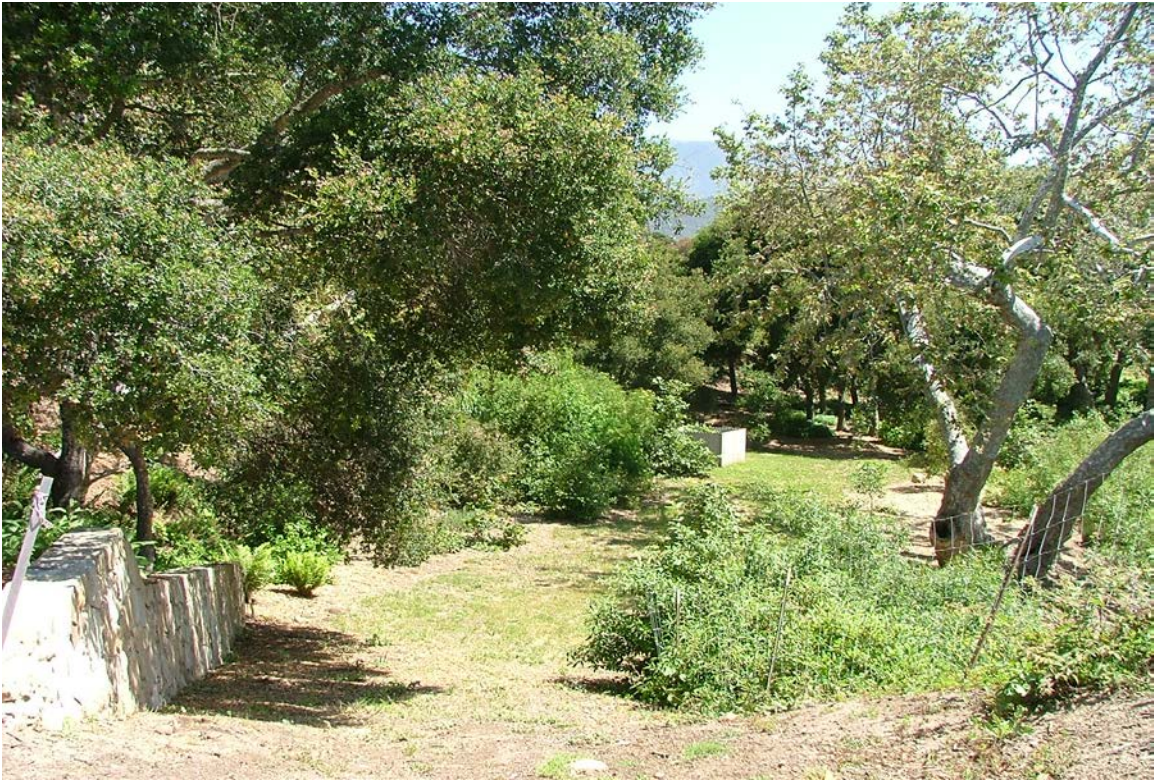
**9. Same view as above. Terrace floor has been planted with western sycamore, holly-leaved cherry, arroyo willow, coast live oak, elderberry, coffeeberry, box elder, and western spice bush. Slope at right retains natural coast live oaks. Giant chain fern, western sword fern, alum root, hummingbird sage, canyon sunflower, California grape, blue-eyed grass, seacliff buckwheat, and other species. 22 May 2012.**

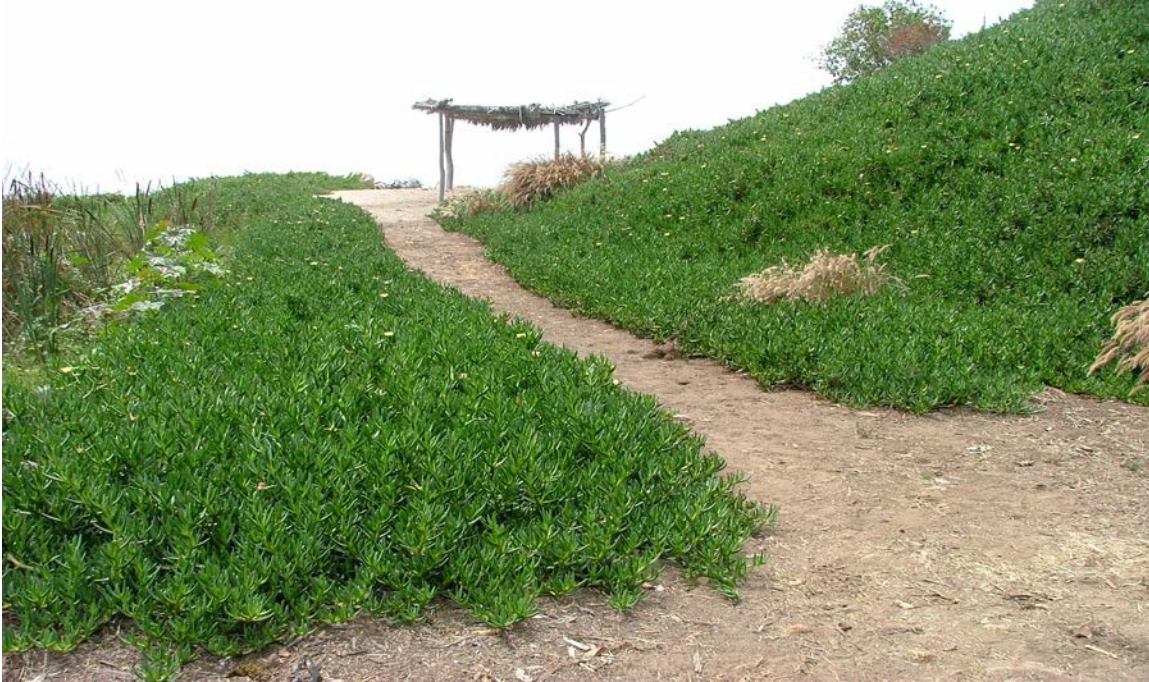
**10. Lower terrace, looking south from edge of creek toward beach. Southern stream terrace and adjacent slope, prior to restoration. Slope and creek banks are covered with ice plant and other non-native vegetation. When this vegetation was removed, slope soils were too unstable to plant. 12 September 2009.**

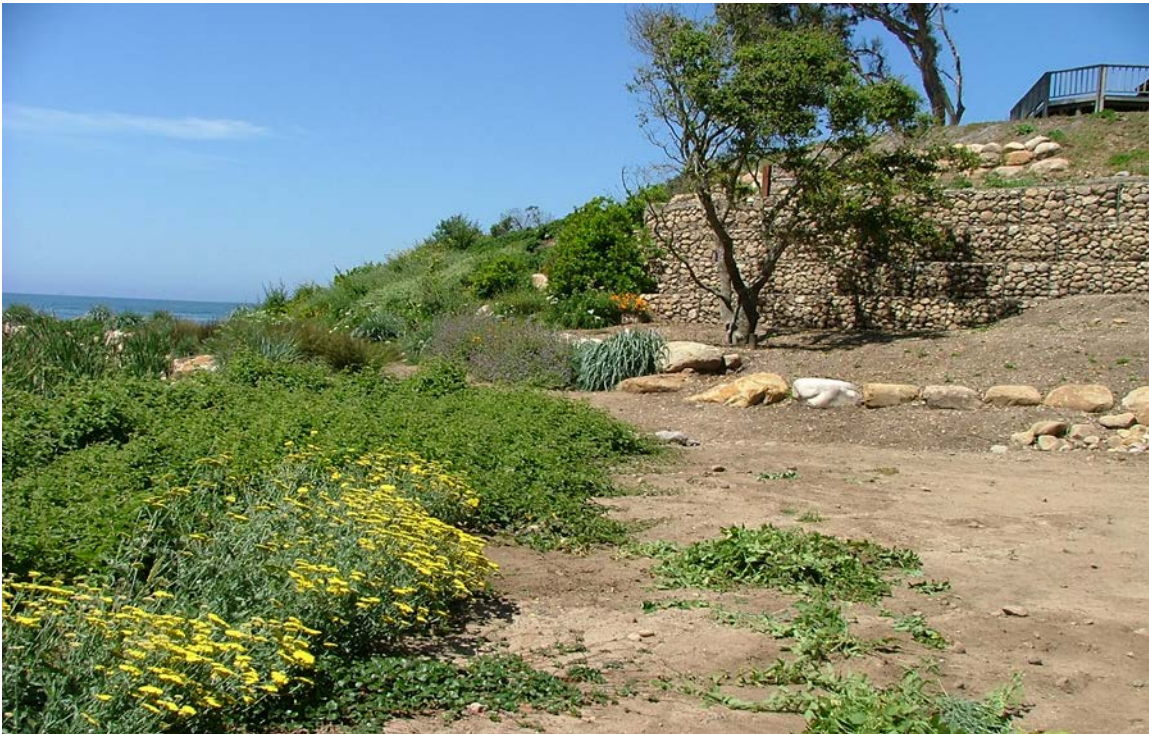
**11. Same view as above. Cage gabion wall was installed to stabilize a portion of the slope for planting. Note proliferation of planted native vegetation along top of bank of creek at left. Ground cover includes yarrow, California blackberry, beach strawberry, giant rye, seaside daisy, and Indian rush. Slopes in background have been planted with coastal bluff scrub shrubs and ground cover. Cage gabion wall will get similar treatment. 22 May 2012.**

*Terrace Slope Erosion – Installation of Cage Gabion Wall.* Not part of the Approved Plan, an approximately 80-foot long segment of the steepest portion of the slope along the southwestern edge of the southern stream terrace was stabilized with cage gabions filled with large cobble and installed in a stair-step arrangement nearly up to the geological top-of-bank (Photos 25-26 in Appendix 1). This structure was installed in late 2010 by the owner in order to: a) control on-going soil erosion that was impacting lower Toro Canyon Creek and the terminal lagoon; b) prevent future slope failure that would have inundated these wetlands; c) provide a stable substrate on which to plant native vegetation, and; d) protect an important Native American cultural site from future erosion.

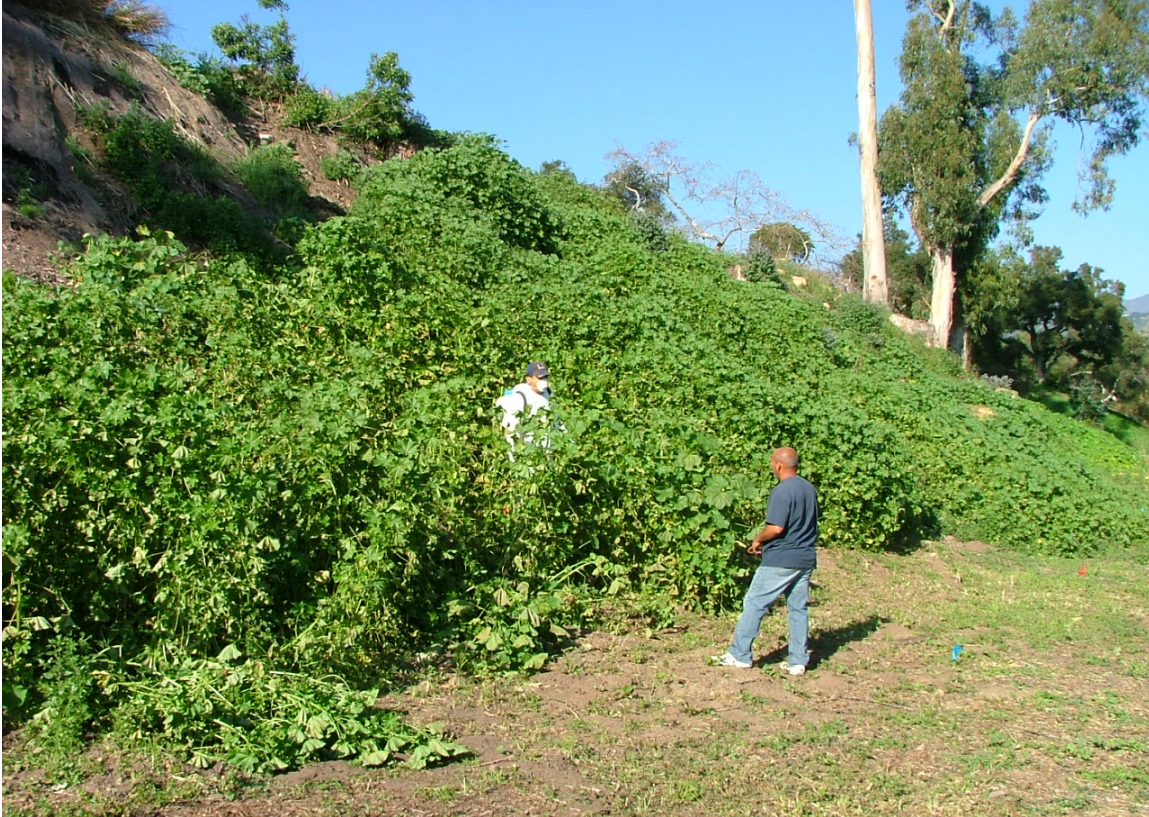
**12. Slopes of southern stream terrace, prior to restoration, covered with bull mallow. 3 Feb 2010.**

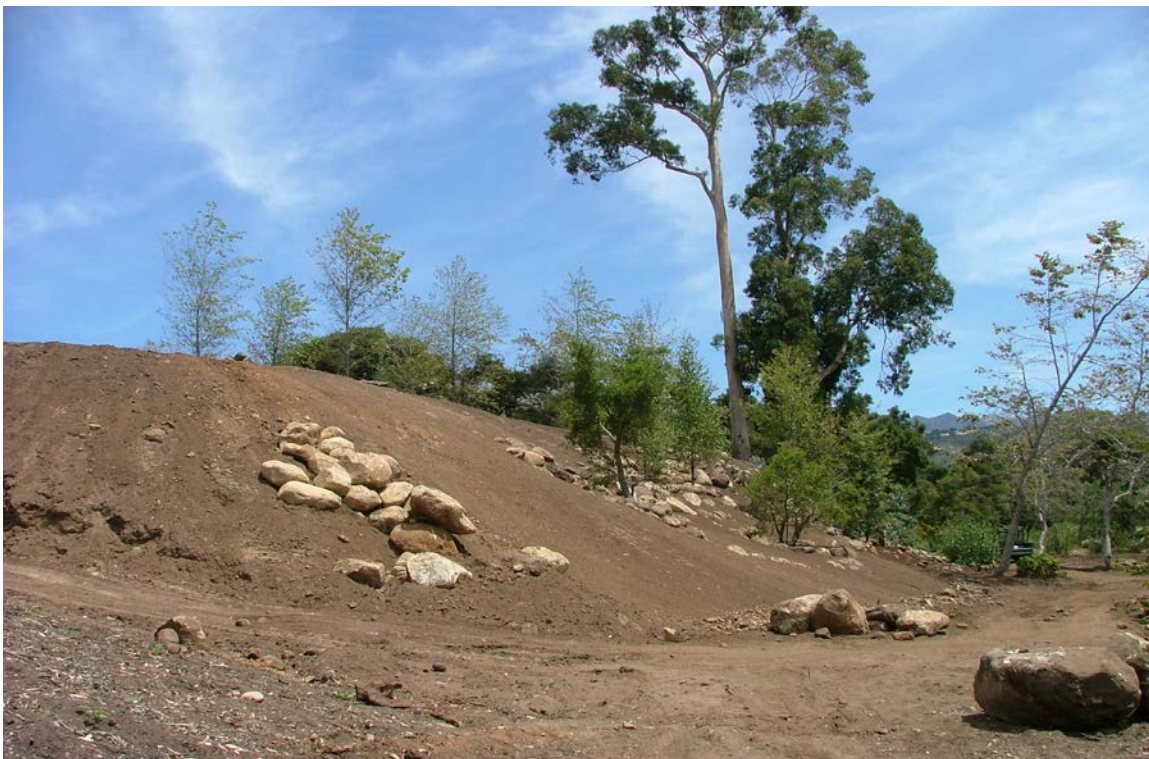
**13. Same view, after non-native vegetation has been removed. 28 May 2010.**

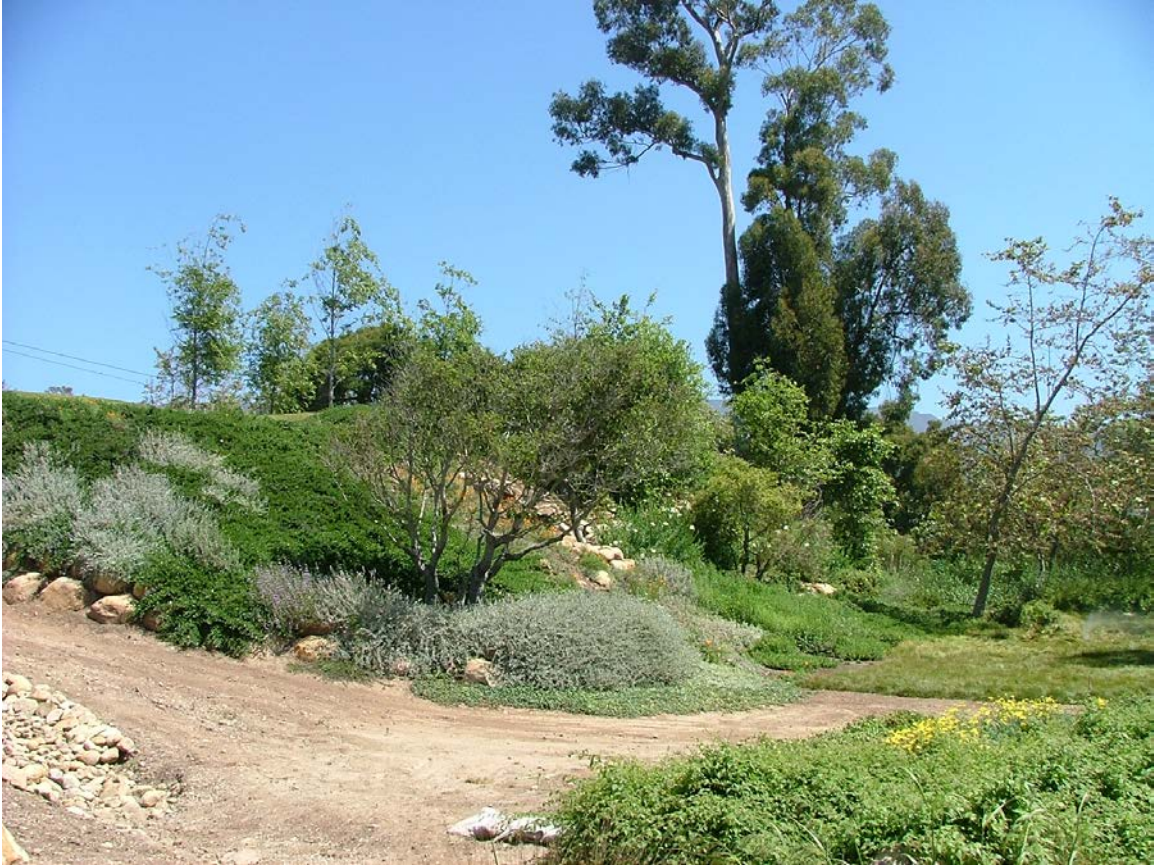
**14. Same view after restoration. Slopes shrubs include purple sage, ceanothus, and other native shrubs. Trees planted here include coast live oak, western sycamore, and white alder. Terrace floor has been planted with dune sedge, beach strawberry, CA blackberry, wood mint, canyon sunflower, and other species. Former erosion channel at left has been lined with cobbles and will be planted with native freshwater marsh species. Bare soil will be planted with similar shrub and ground cover species as in adjacent areas. 22 May 2012.**

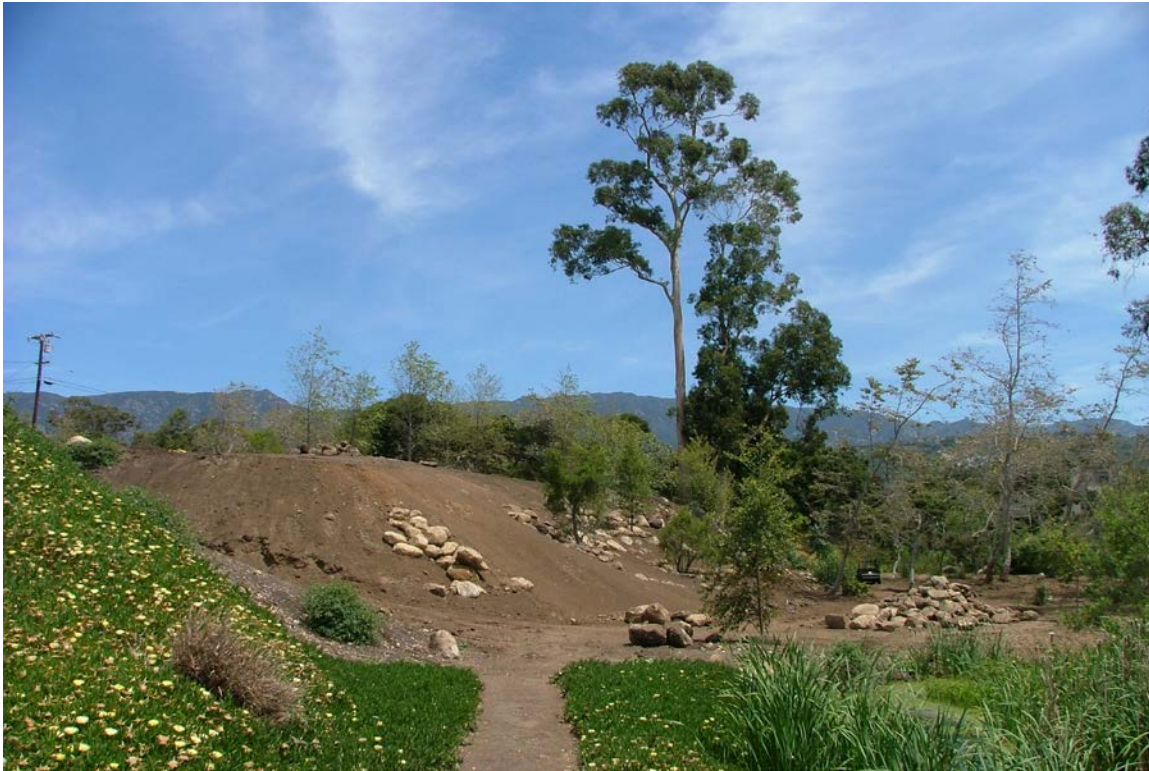
15. Southern terrace and slopes looking north from beach, prior to restoration. Path to beach runs through cut in slope at left and down center of photo. Note ice plant on adjacent slopes. 28 May 2010.

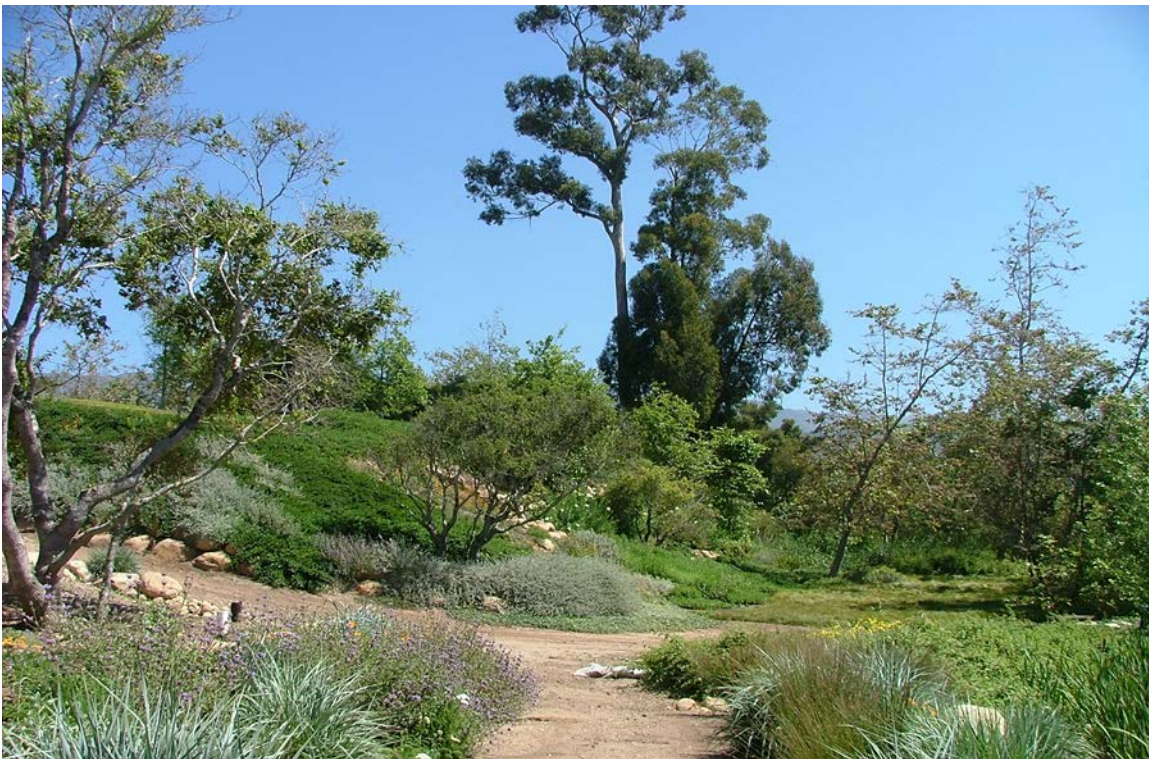
16. Same view after restoration. Non-native vegetation and bare soil has been replaced with coastal bluff scrub, riparian scrub, and oak-sycamore riparian woodland species. 22 May 2012.

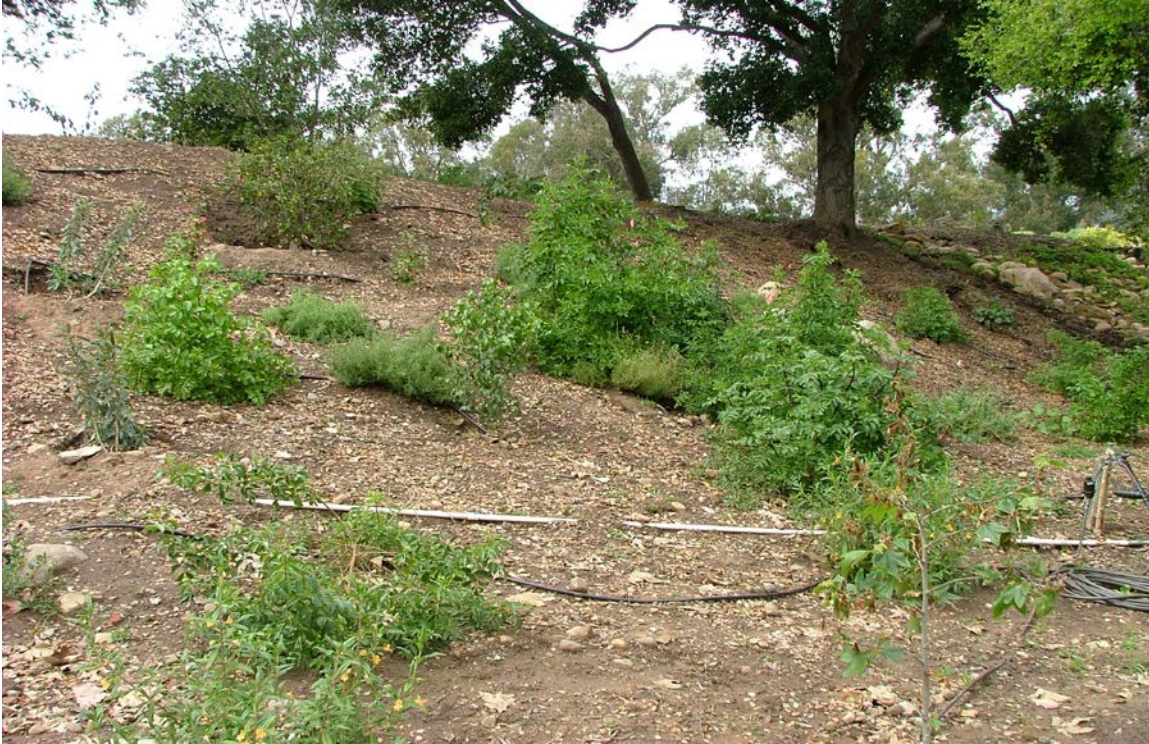
**17. Northern stream terrace slopes at start of plant installation. Slopes were formerly covered with garden nasturtium (*Tropaeolum majus*) and fumitory (*Fumaria officinalis*). Species planted here include coast live oak, giant chain fern, western sword fern, alum root, elderberry, southern bush monkeyflower, and a variety of other oak woodland and oak-sycamore riparian woodland species. 14 December 2010.**

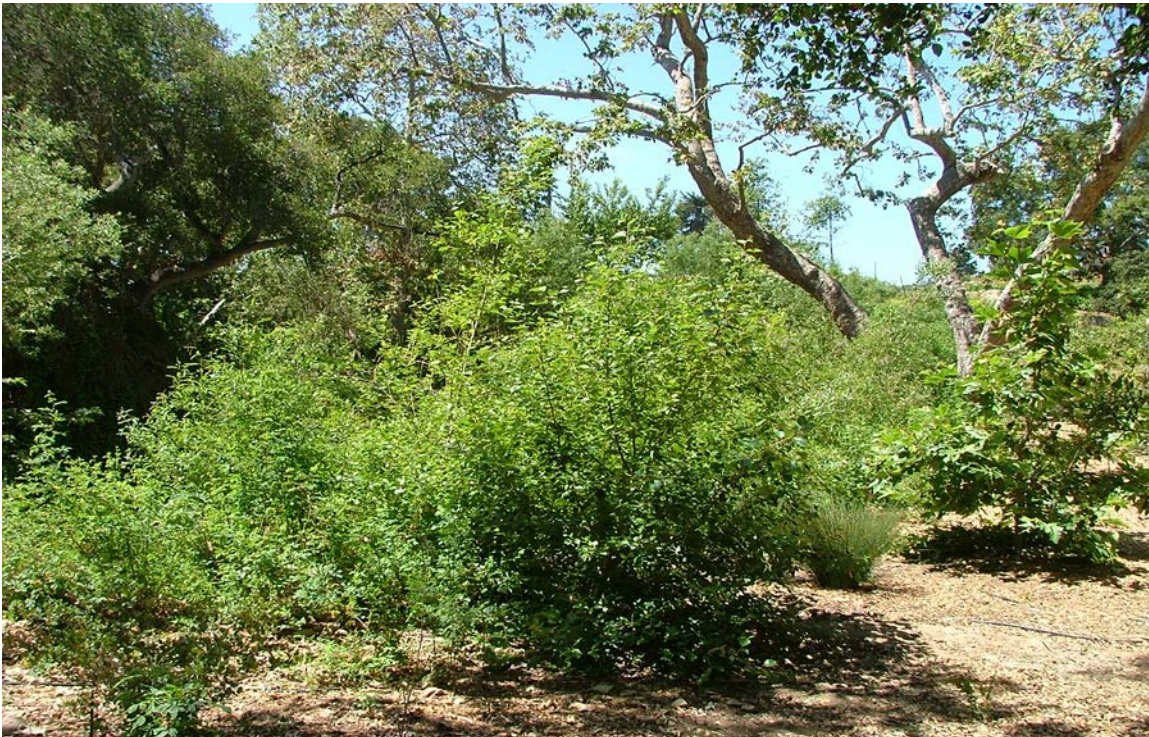
**18a. Same area on 22 May 2012. Oak woodland on slopes at left grades into riparian scrub and oak-sycamore riparian woodland on floor of stream terrace. Toro Canyon Creek is right of large sycamore.**

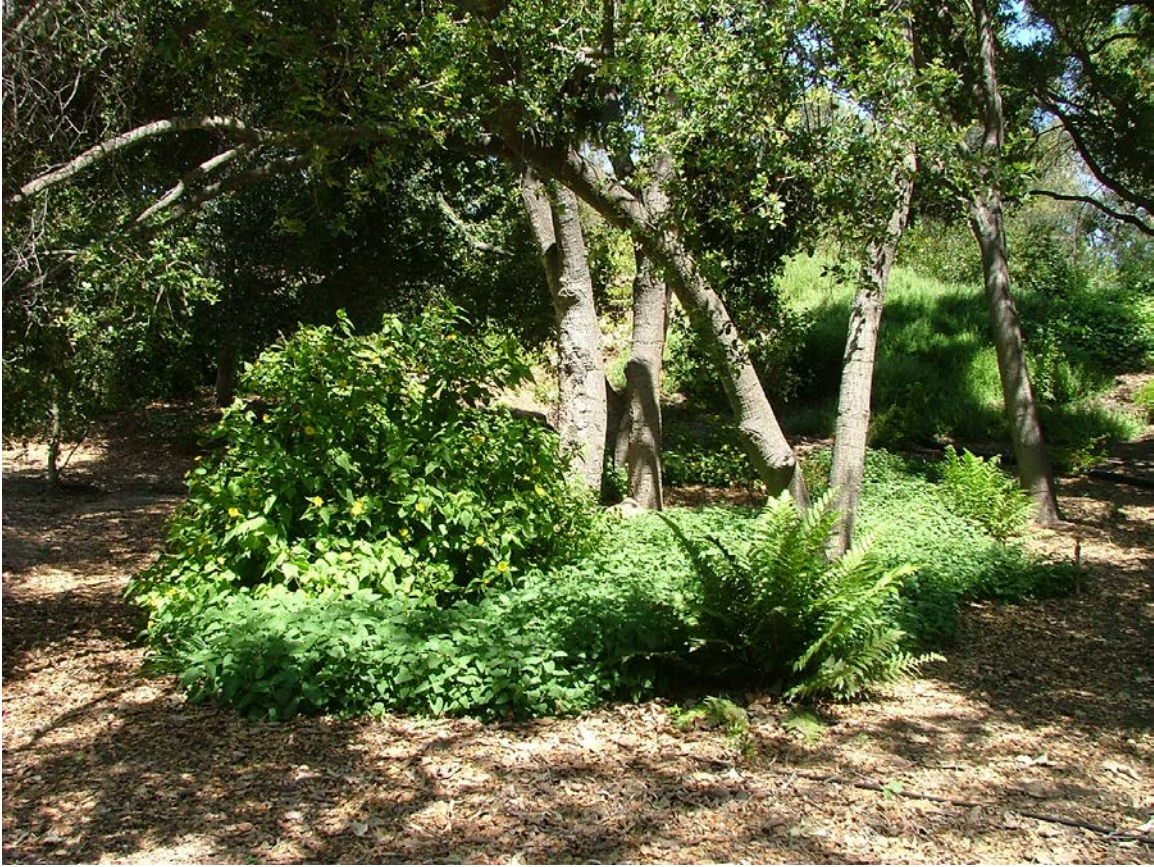
**18b. Oak woodland and oak-sycamore riparian woodland restoration on north stream terrace. Understory plantings include canyon sunflower, wood mint, giant chain fern, western sword fern, elderberry, California grape, and other species. Terrace slope in background has been planted with seacliff buckwheat, which grades into other coastal bluff scrub shrubs in upland areas. 22 May 2012.**

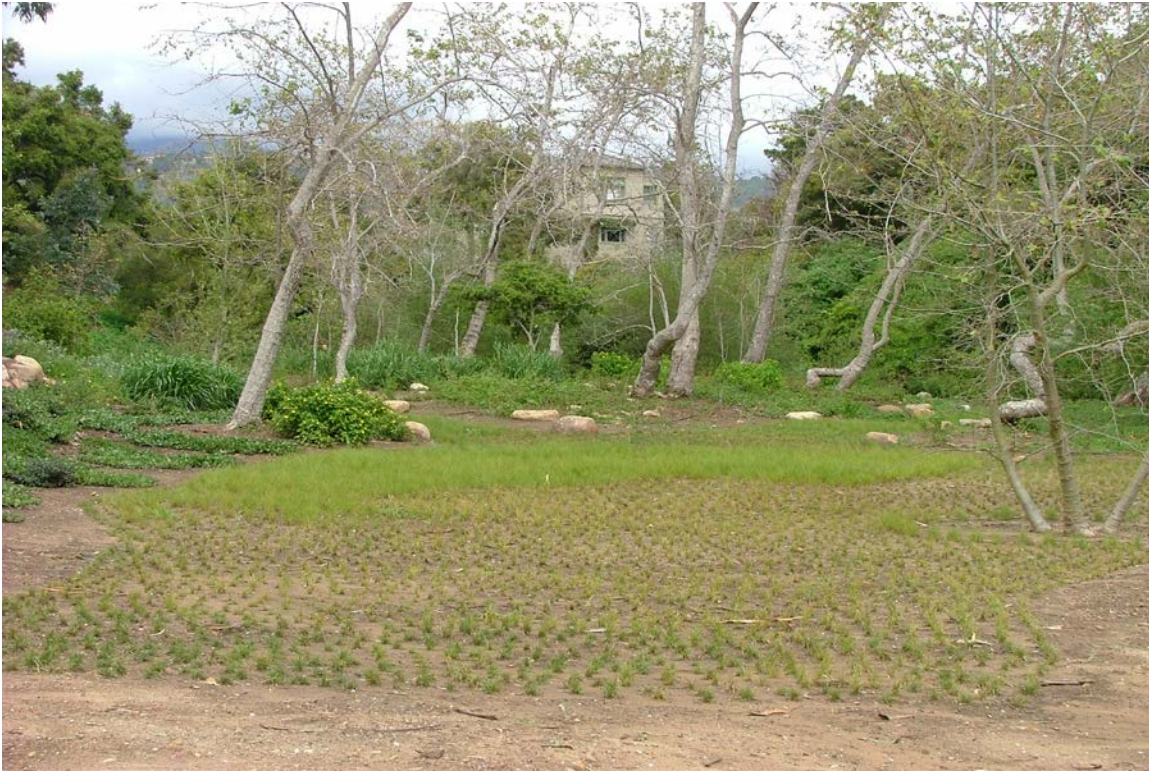
**19. Floor of southern stream terrace just after planting dune sedge plugs. 22 March 2011.**

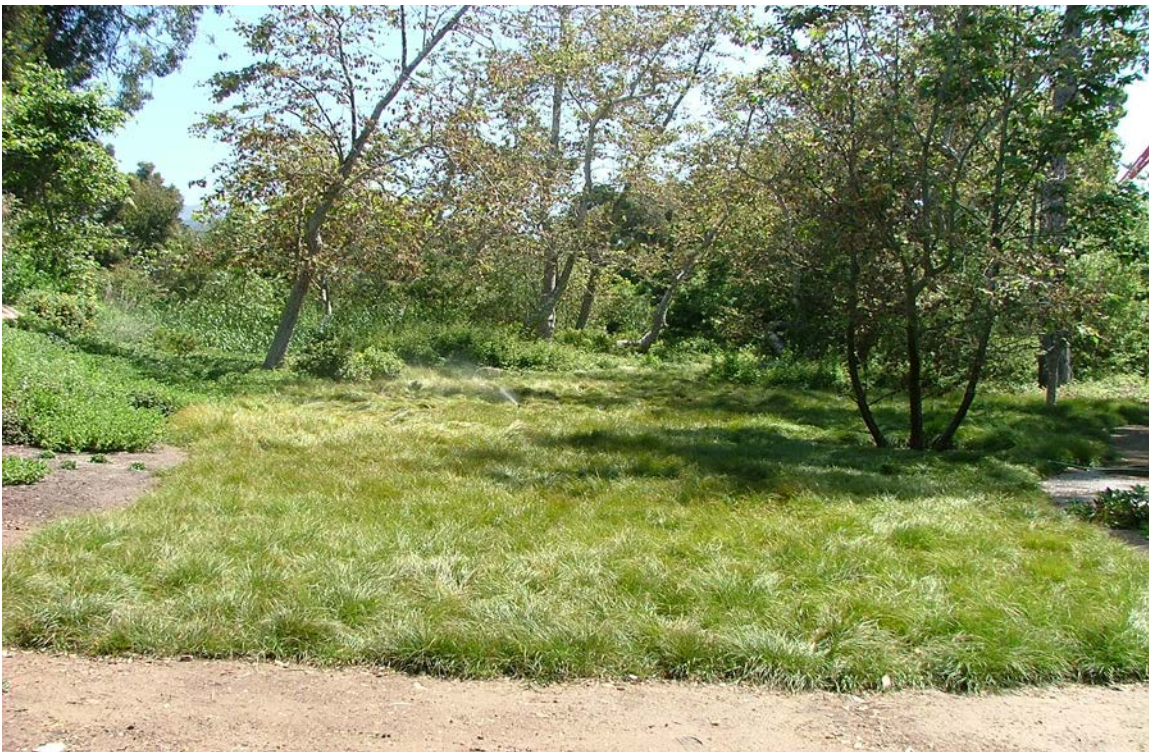
**20. Same view on 22 May 2012. Toro Canyon Creek runs left to right behind trees in background then off right side of photo to ocean. Bare soil in foreground is portion of terrace floor that will be restored with restoration of cage gabion wall.**

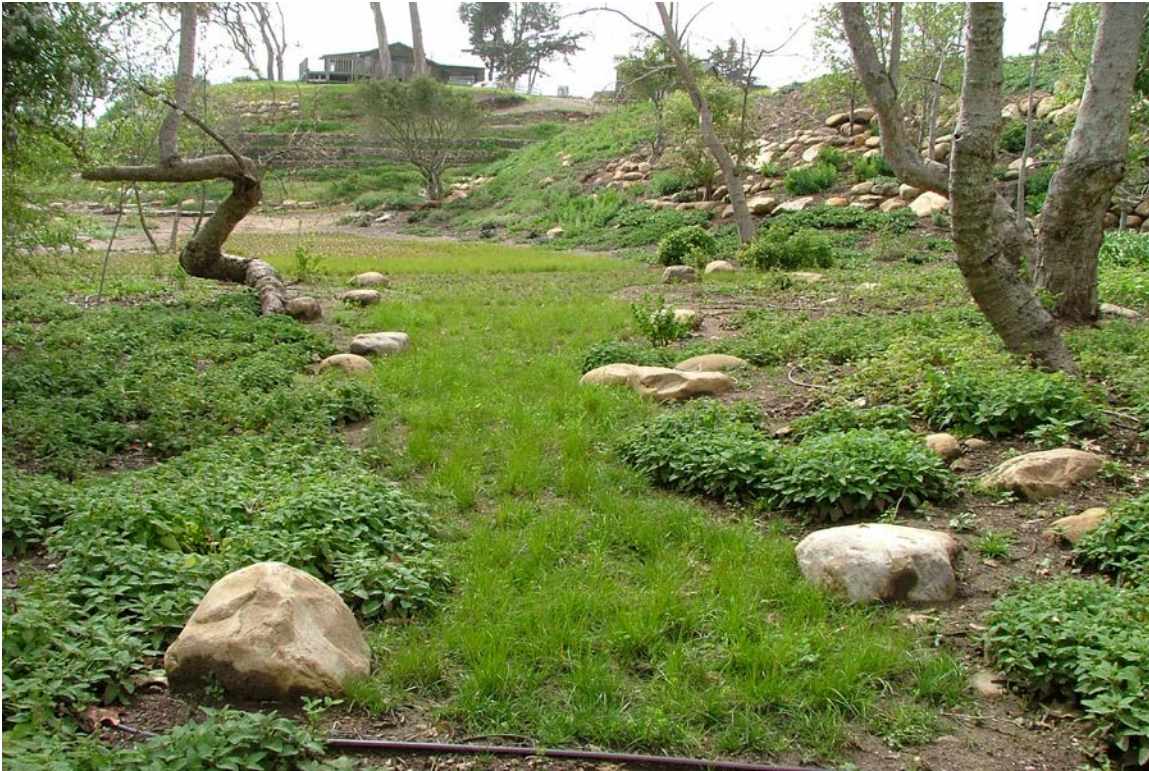
21. Southern terrace floor looking southwest, a few months after planting. Dune sedge covers footpath. Ground cover to left and right of path is wood mint, California rose, canyon sunflower, and California blackberry. 22 March 2011.

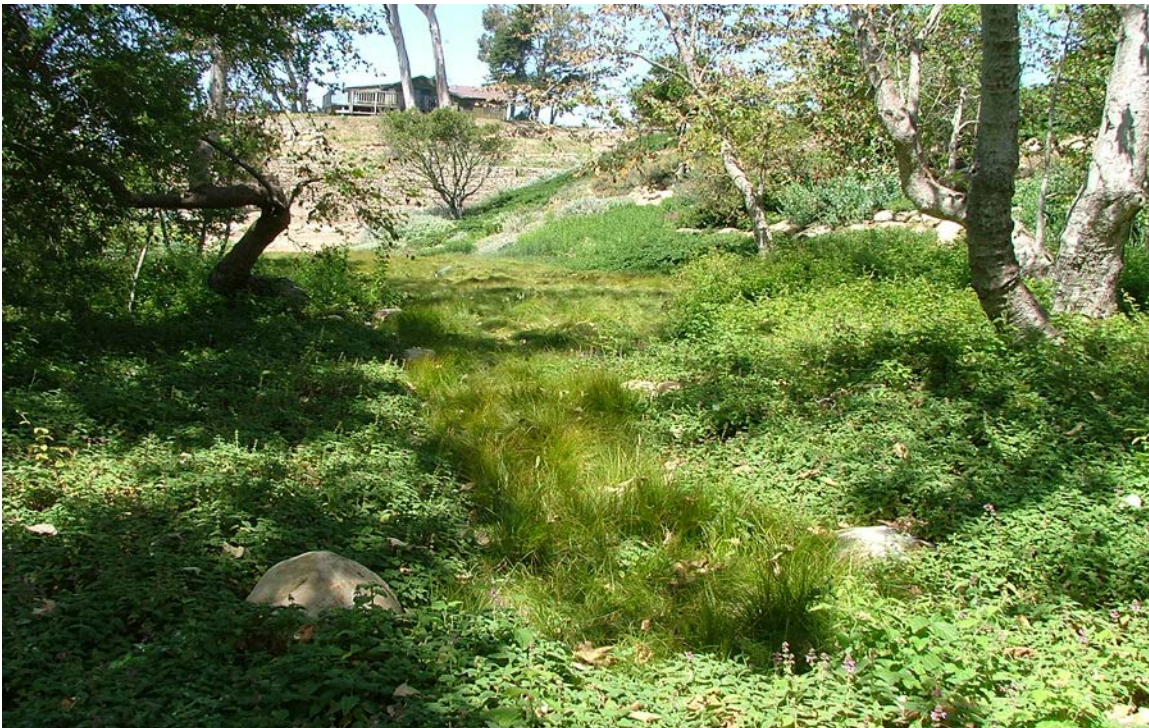
22. Same view as in previous photo. Successful restoration of oak-sycamore riparian woodland and riparian scrub. Weedy slope in background will be restored pending permitting of the cage gabion wall. 22 May 2012.
