**RESTORATION “AS-BUILT” REPORT AND ADDENDUM  
TO  
CONCEPTUAL HABITAT RESTORATION AND  
REVEGETATION PLAN,  
2825 PADARO LANE, SUMMERLAND,  
SANTA BARBARA COUNTY, CALIFORNIA**

**25 May 2012**

**Hunt & Associates Biological  
Consulting Services  
5290 Overpass Road, Ste. 108  
Santa Barbara, CA 93111**

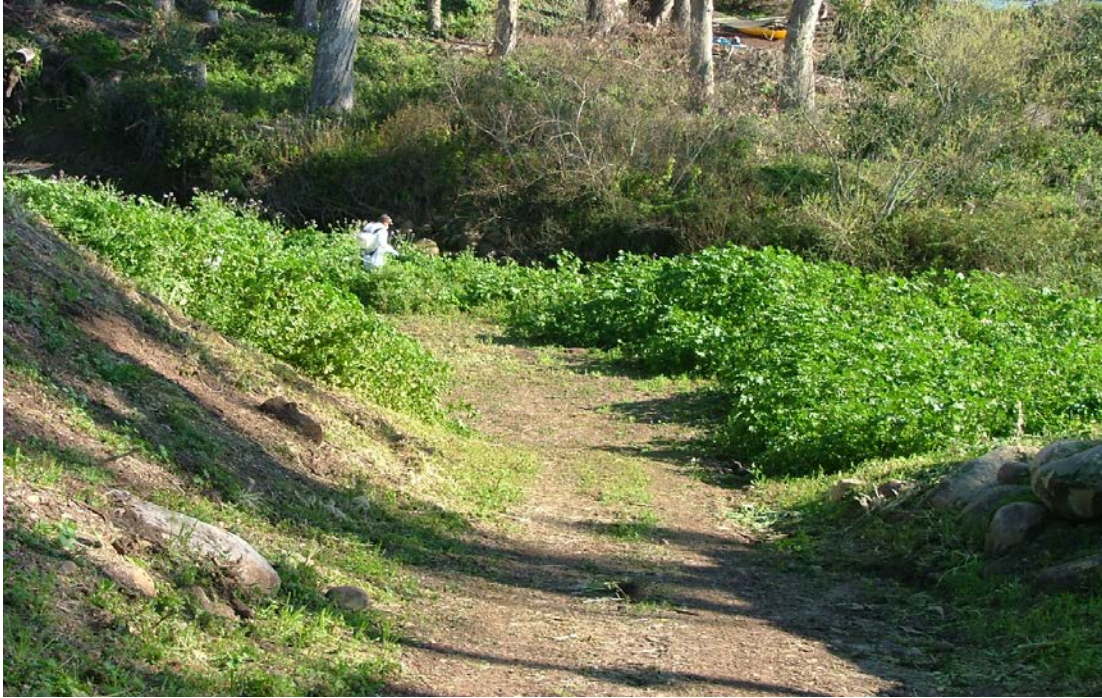
23. Path to southern stream terrace and beach before restoration. Worker is spraying bull mallow with a systemic herbicide (Rodeo). Toro Canyon Creek is behind worker. Note weedy, disturbed condition of terrace slopes. Note erosion channel running downslope along toe of slope at right. 3 February 2010.

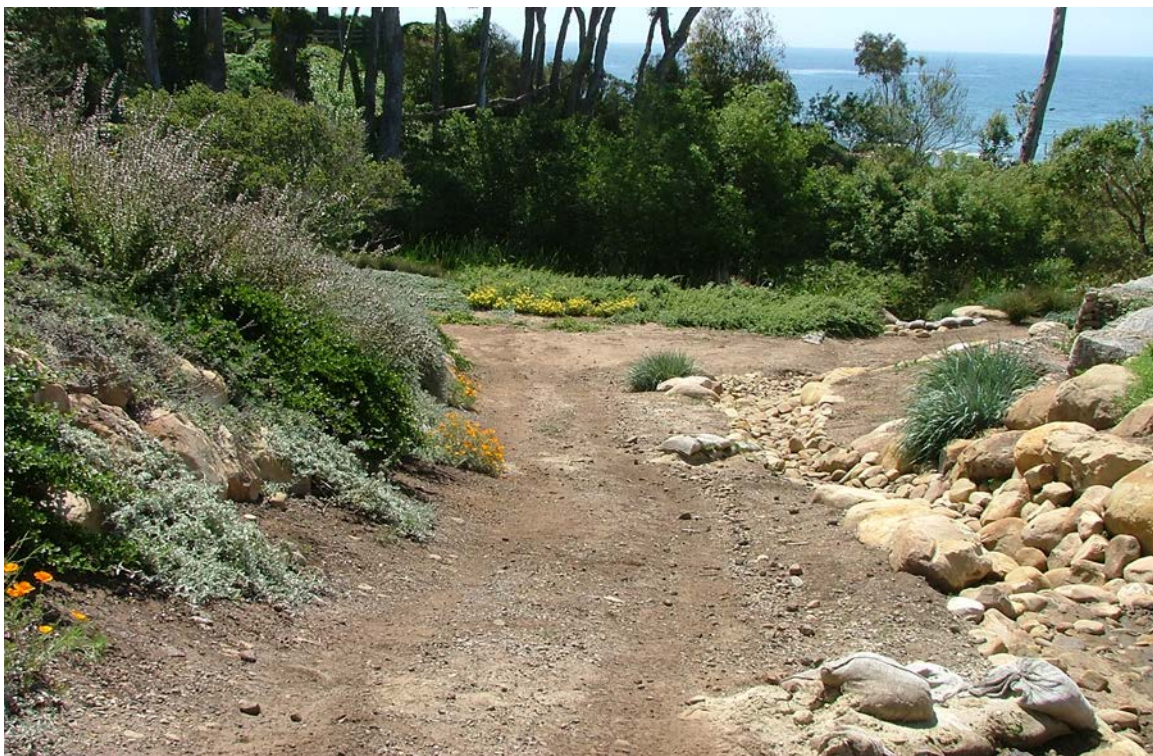
24. Same view. Terrace slope at left has been planted with purple sage, ceanothus, and other coastal bluff scrub shrubs. Slope at right has not yet been restored. Erosion channel has been lined with cobbles and will be restored with freshwater marsh species. Vegetation on terrace floor and bank of Toro Canyon Creek includes beach strawberry, CA blackberry, yarrow, Indian rush, yellow nut-grass, and other species. 22 May 2012.

As requested by California Coastal Commission staff during their site visit on 27 September 2011, these erosion features will be stabilized and revegetated using a “soft-touch” approach including use of small rocks covered with soil and planted with native wetland plants to decrease water velocity, allow runoff to percolate into the stream terraces, and de-silt the water before it enters Toro Canyon Creek. See Item 3 for additional information. Photos 14, 23-24, and 27 in Appendix 1 show current conditions of these features.

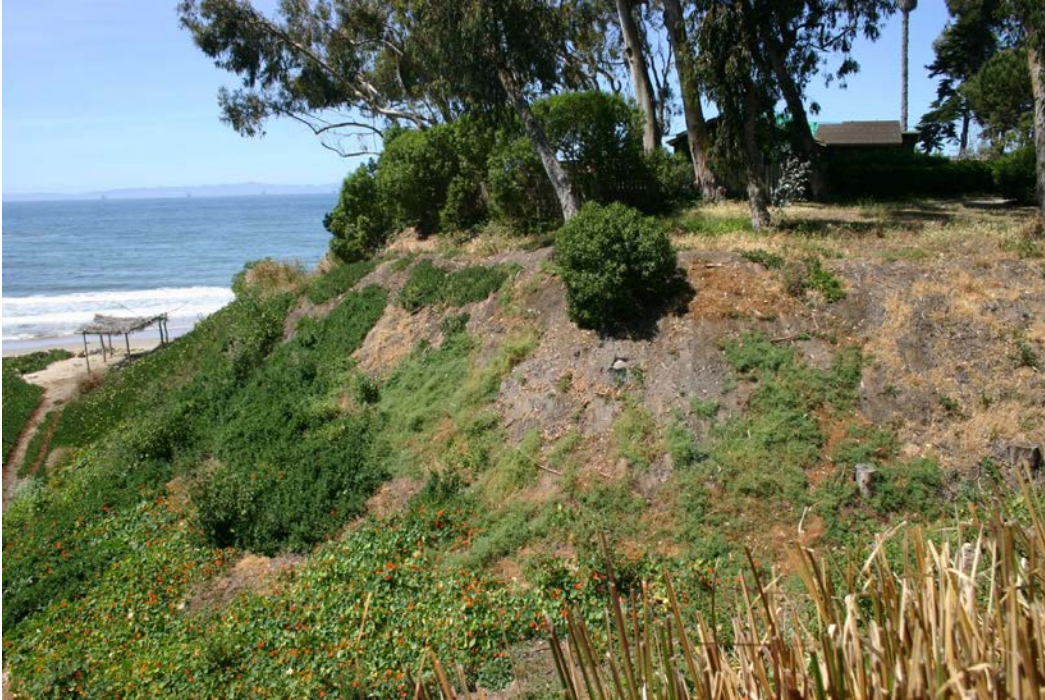
25. Cage gabion slope looking south. 5 May 2009 (photo courtesy of M. Mooney).

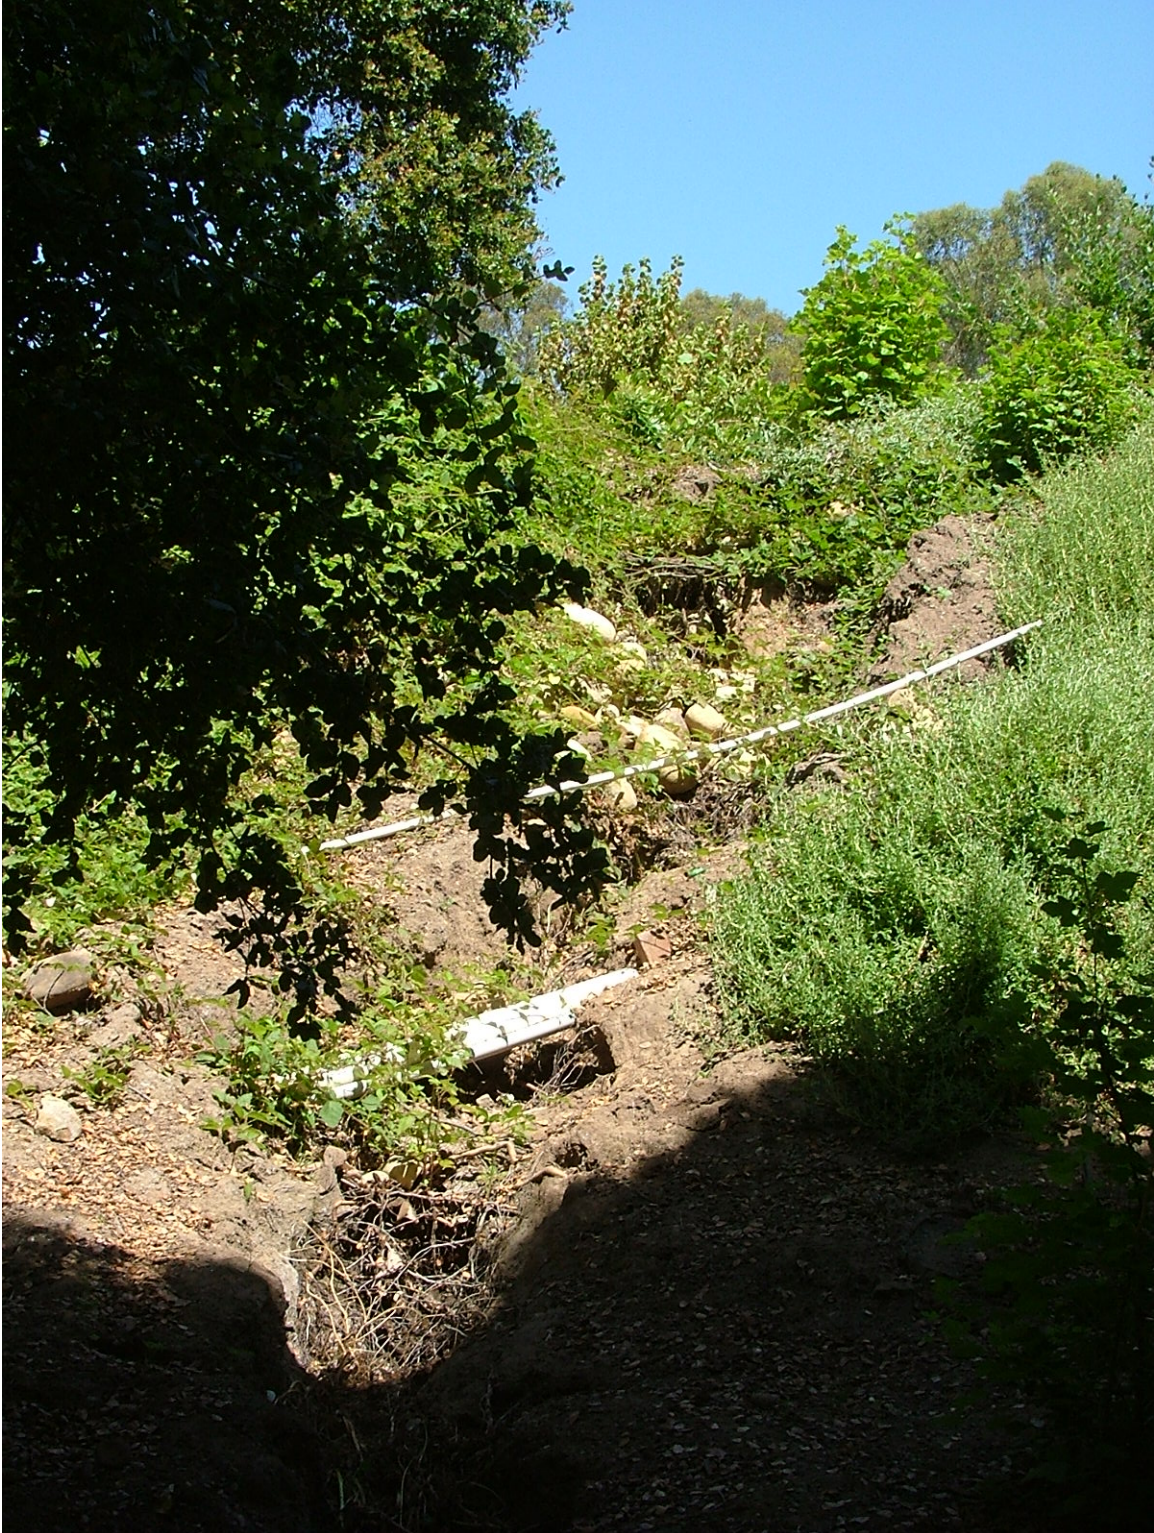
**27. Erosion feature on slope of north terrace that will be restored as the north bioswale. Surface flows from the northern half of the property are severely eroding this slope and creating significant sediment inputs to Toro Canyon Creek during storm events. 22 May 2012.**
