PHASE 2 CULTURAL RESOURCES STUDY
HISTORIC RESOURCES
461 SAN YSIDRO ROAD
MONTECITO, CALIFORNIA
APN 009-060-049

Prepared for
AB Design Studio
27 East Cota Street
Santa Barbara, CA 93101

Prepared by
Alexandra C. Cole
Preservation Planning Associates
519 Fig Avenue
Santa Barbara, CA 93101

May 2010

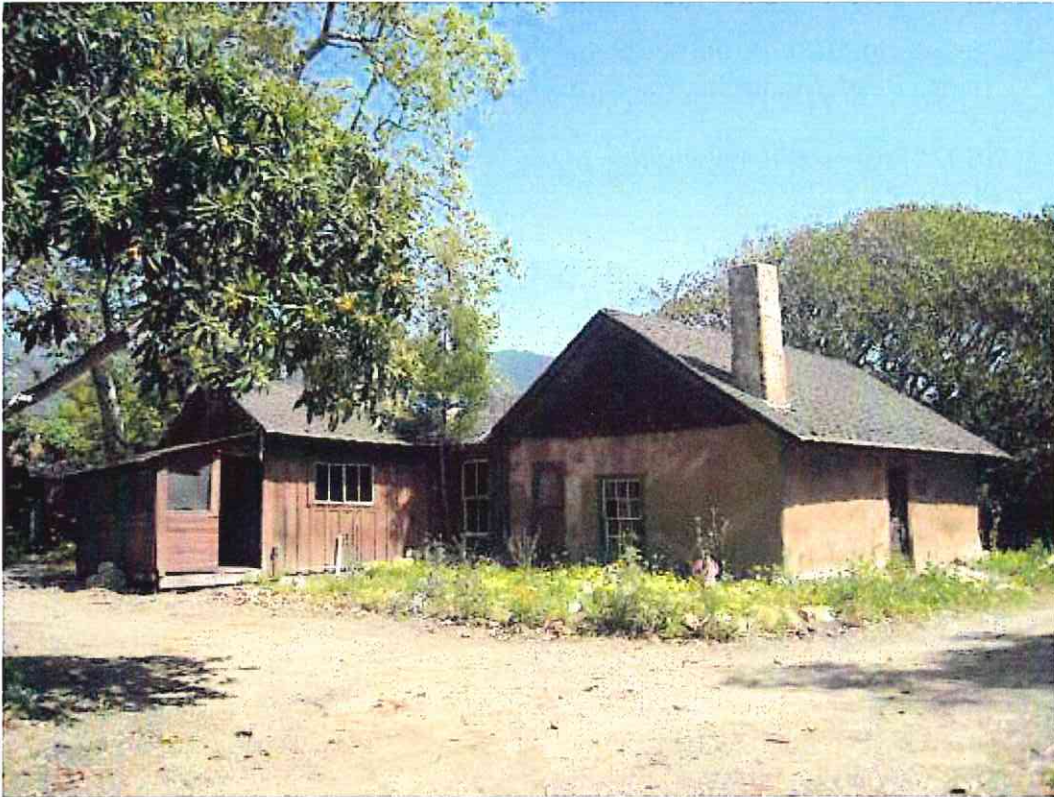
Plate 1. Adobe with kitchen wing at left to be altered. Facing northeast. April 2010. A. C. Cole

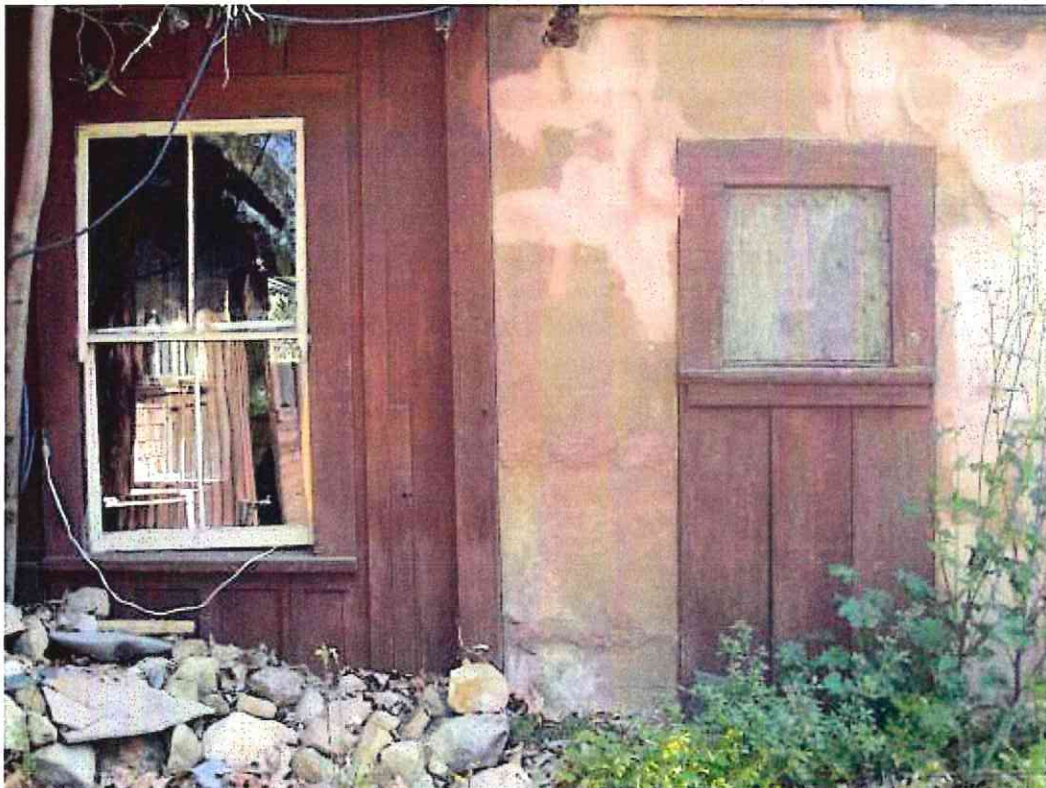
Plate 2. Detail of window at left to be removed and re-used and the opening enlarged for the new front entry. Facing east. April 2010. . A. C. Cole

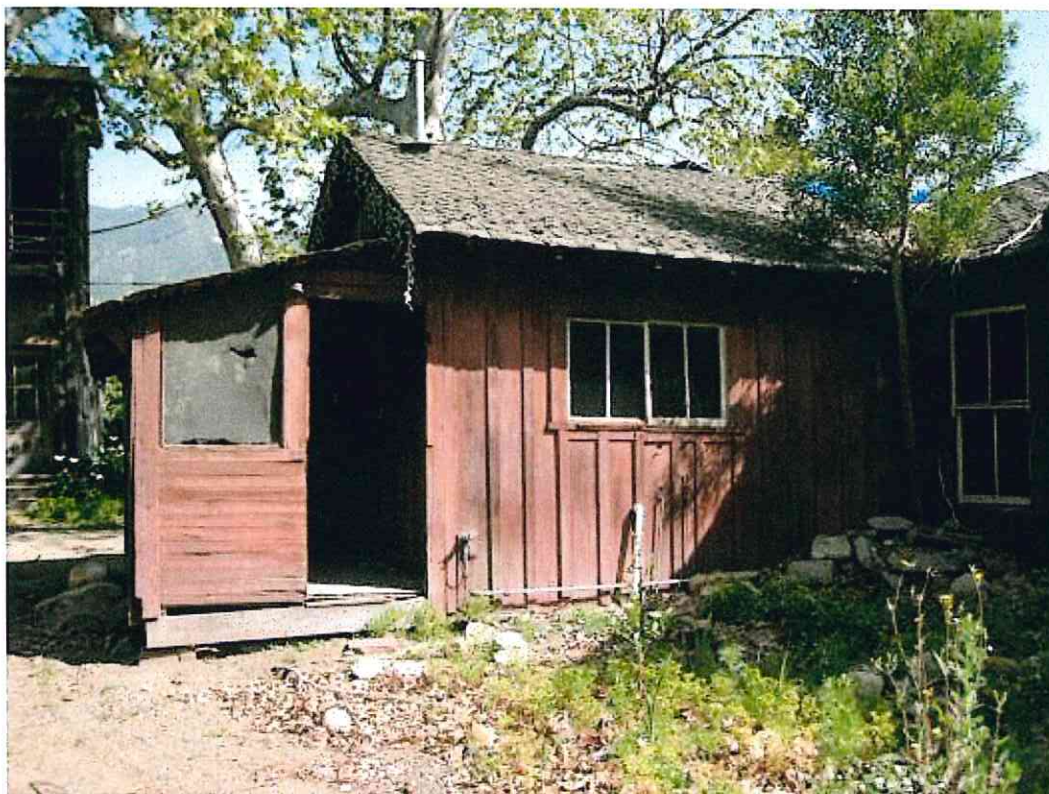
Plate 3. South side of kitchen wing. Lean-to at left to be replaced with a gabled extension and paired 2/2 pane windows to be added. Facing north. April 2010. A. C. Cole

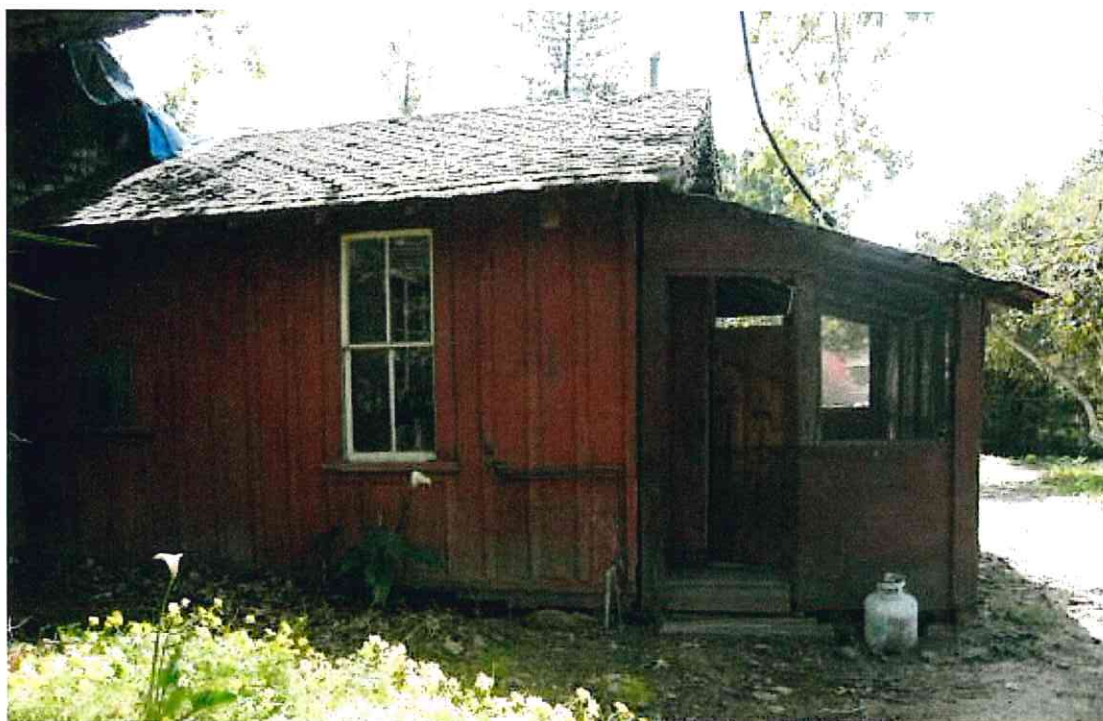
Plate 4. North side of kitchen wing. Lean-to at right to be replaced with a gabled extension and paired 2/2 pane windows to be added. Facing south. April 2010. A. C. Cole A. C. Cole

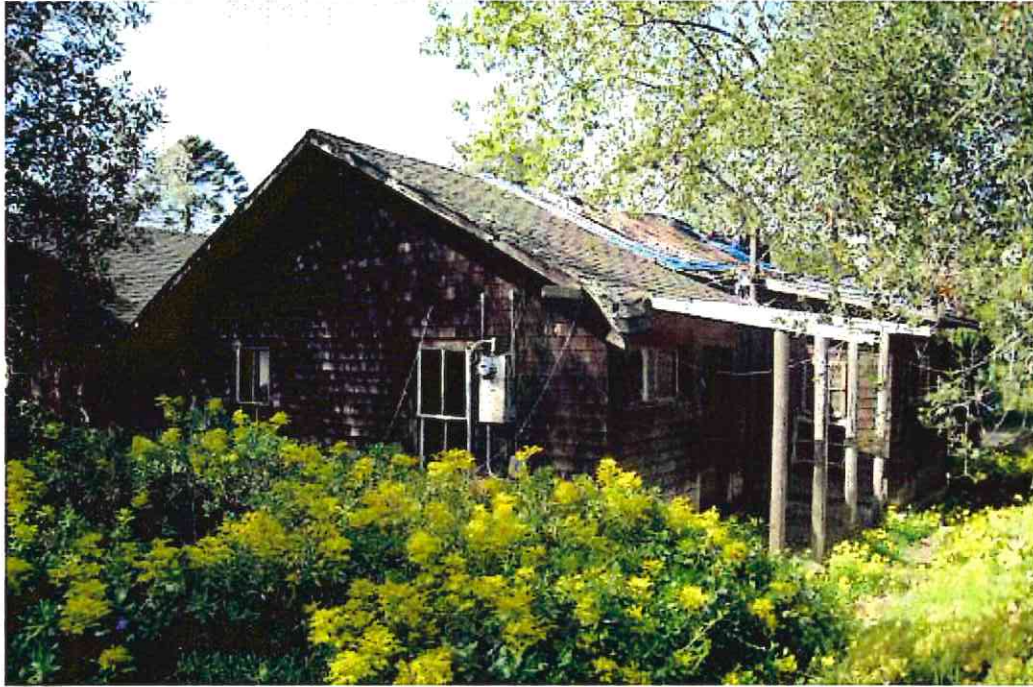
Plate 5. Detail of east and north elevations of 1870s shingled addition. Wall will be extended east and a third 2/2 pane window added on east elevation. Facing southwest. April 2010. A. C. Cole

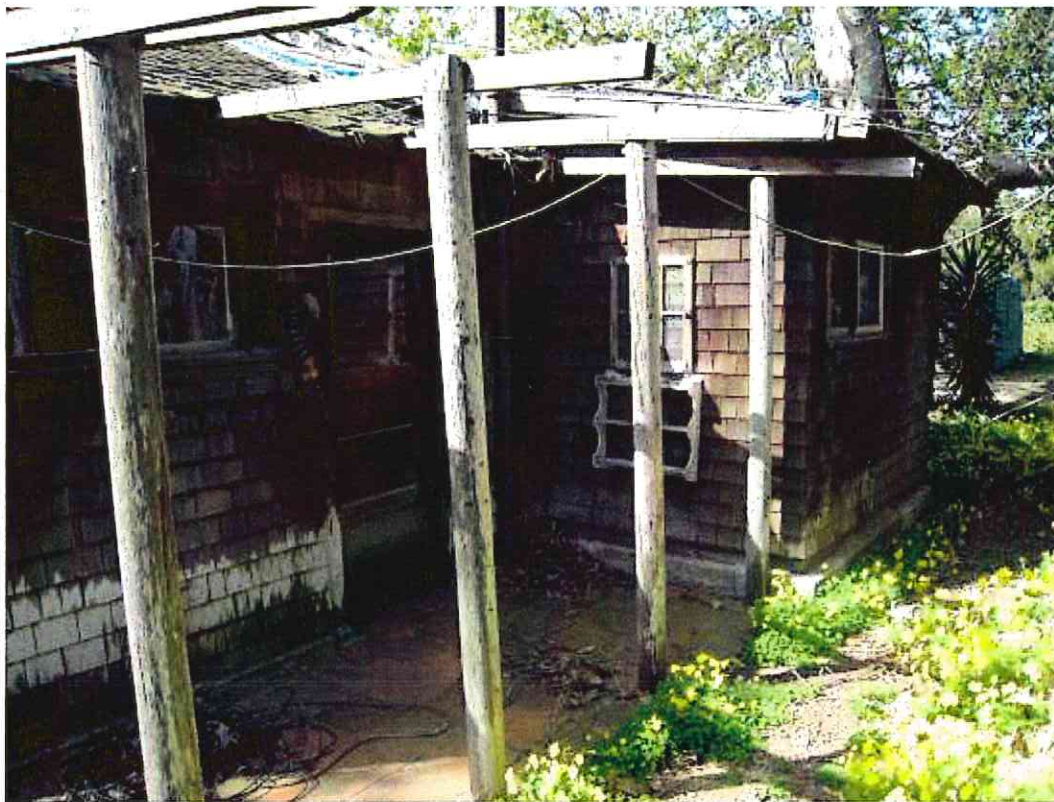
Plate 6. Detail of north elevation, showing roofline of wing at right to be extended eastward. Facing southwest. April 2010. A. C. Cole

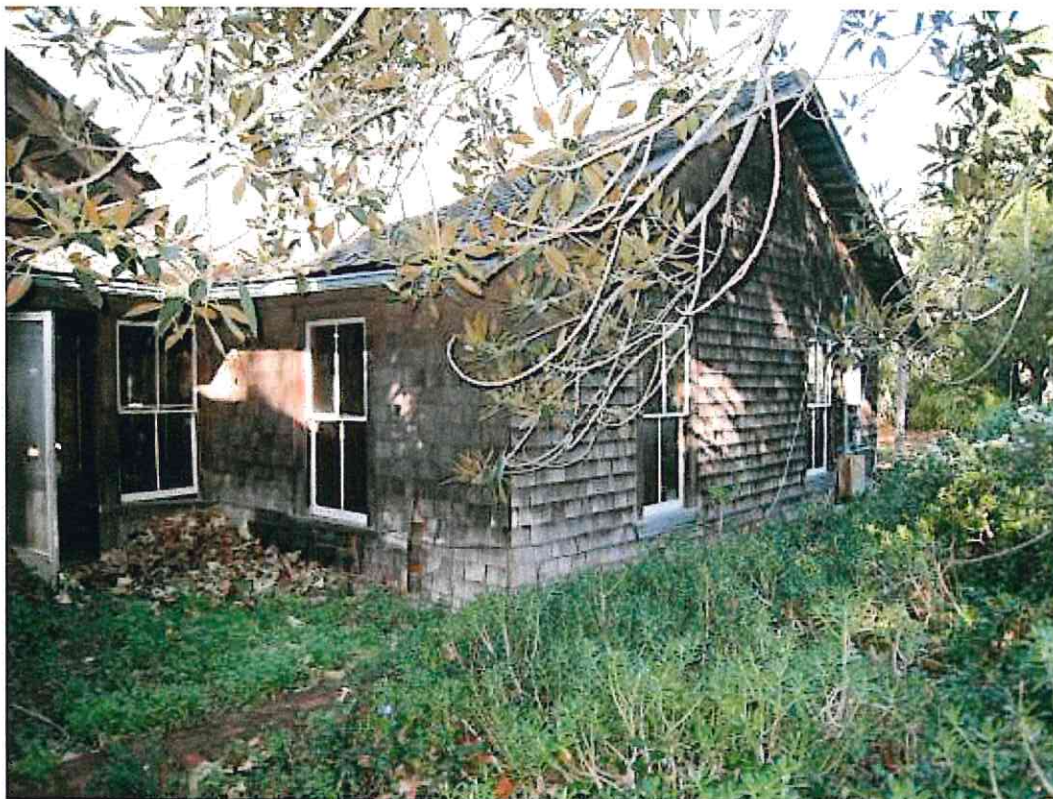
Plate 7. Detail of east and south elevations of 1870s shingled addition. Wall will be extended east and a third 2/2 pane window added on east elevation. Facing northwest. April 2010. A. C. Cole

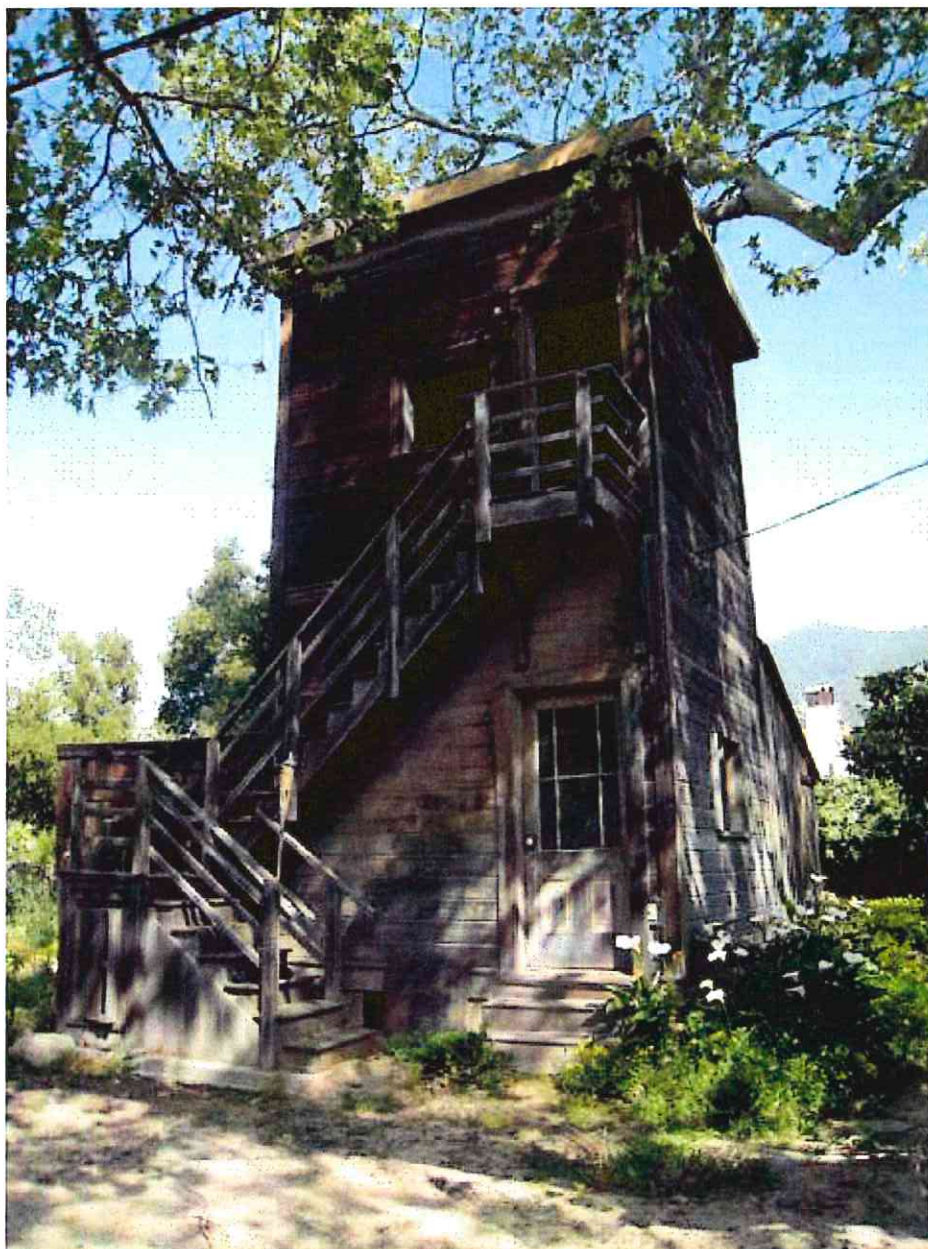
Plate 8. South and east elevations of water tower. Facing northwest. April 2010. A. C. Cole

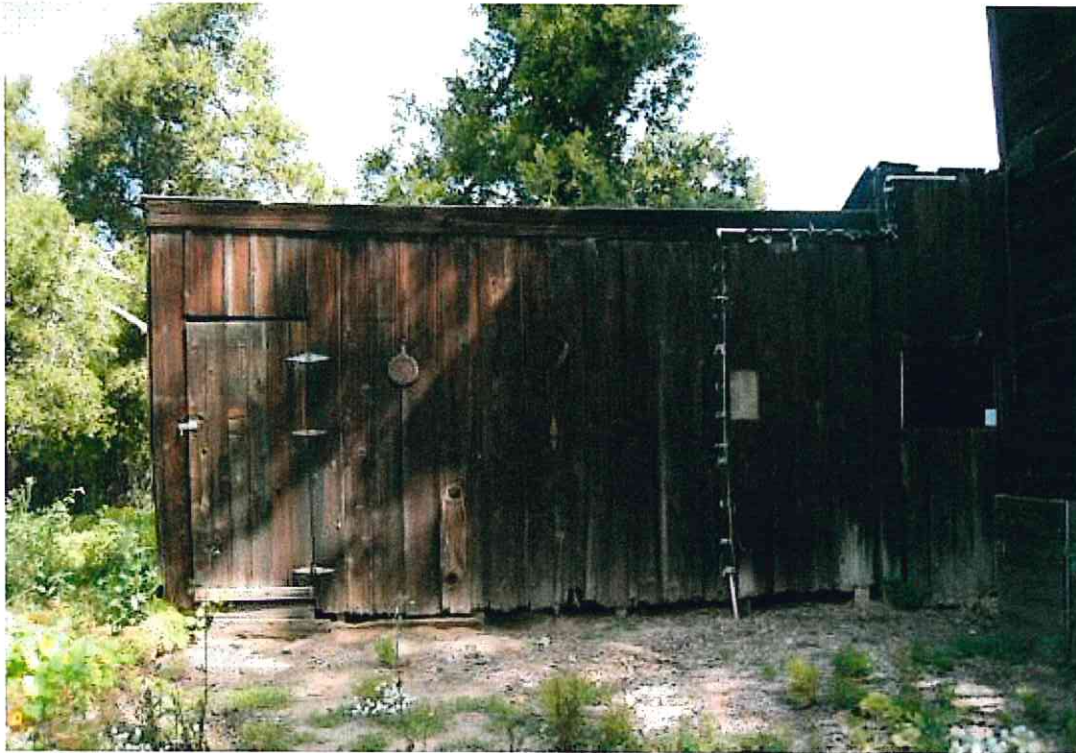
Plate 9. Detail of south elevation of west shed-roof wing on water tower, to be expanded south and 2/2 pane windows added. Facing north. April 2010. A. C. Cole

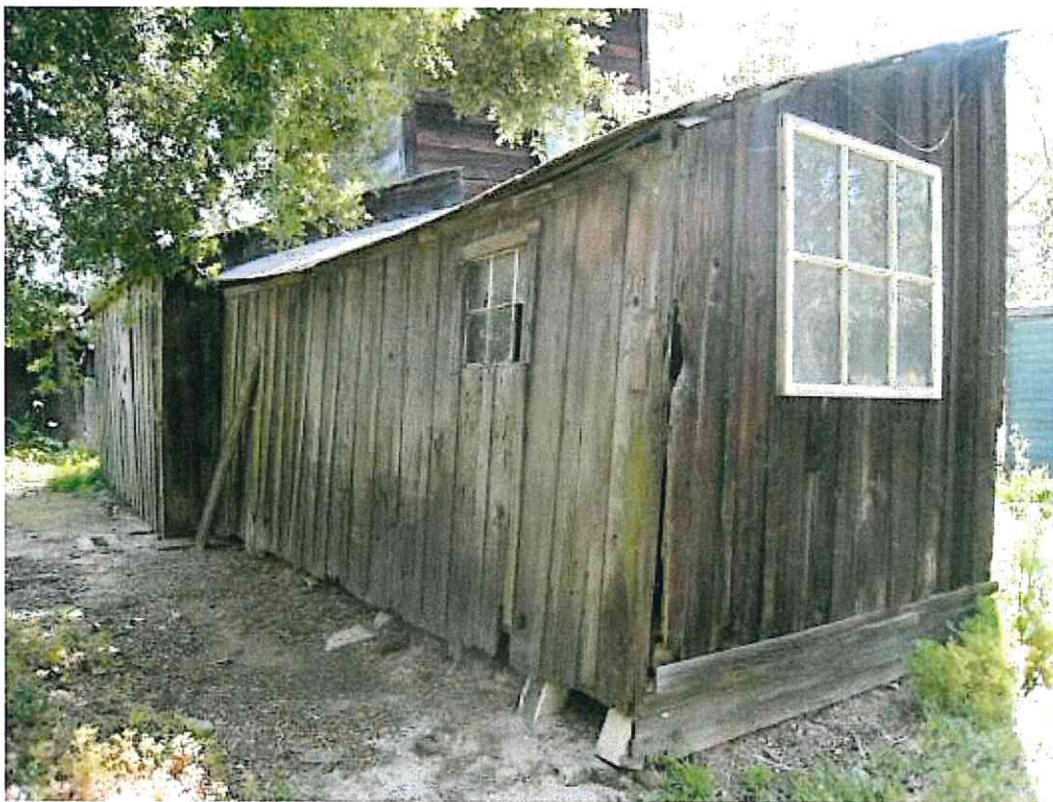
Plate 10. Detail of north and west elevations of north and west shed-roof lean to wings to water tower to have 2/2 pane windows added. Facing southeast. April 2010. A. C. Cole

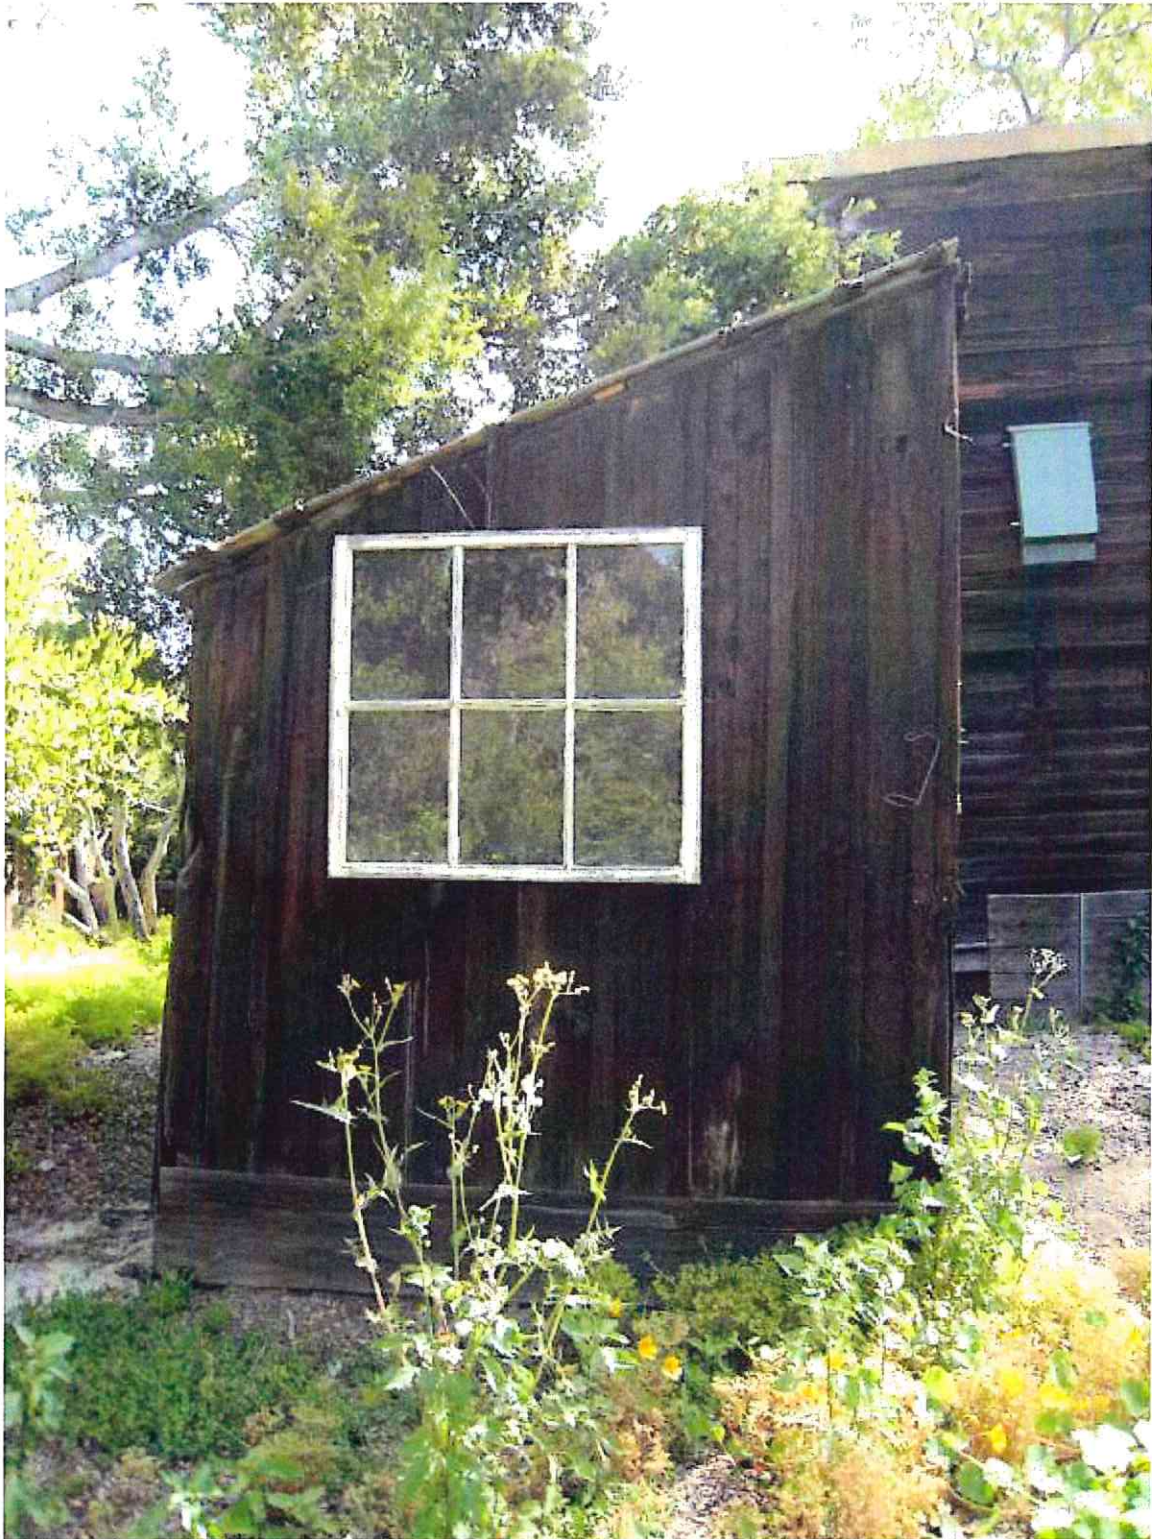
Plate 11. Detail of west elevation of west shed-roof lean-to showing relationship to water tower at rear. Facing east. April 2010. A. C. Cole

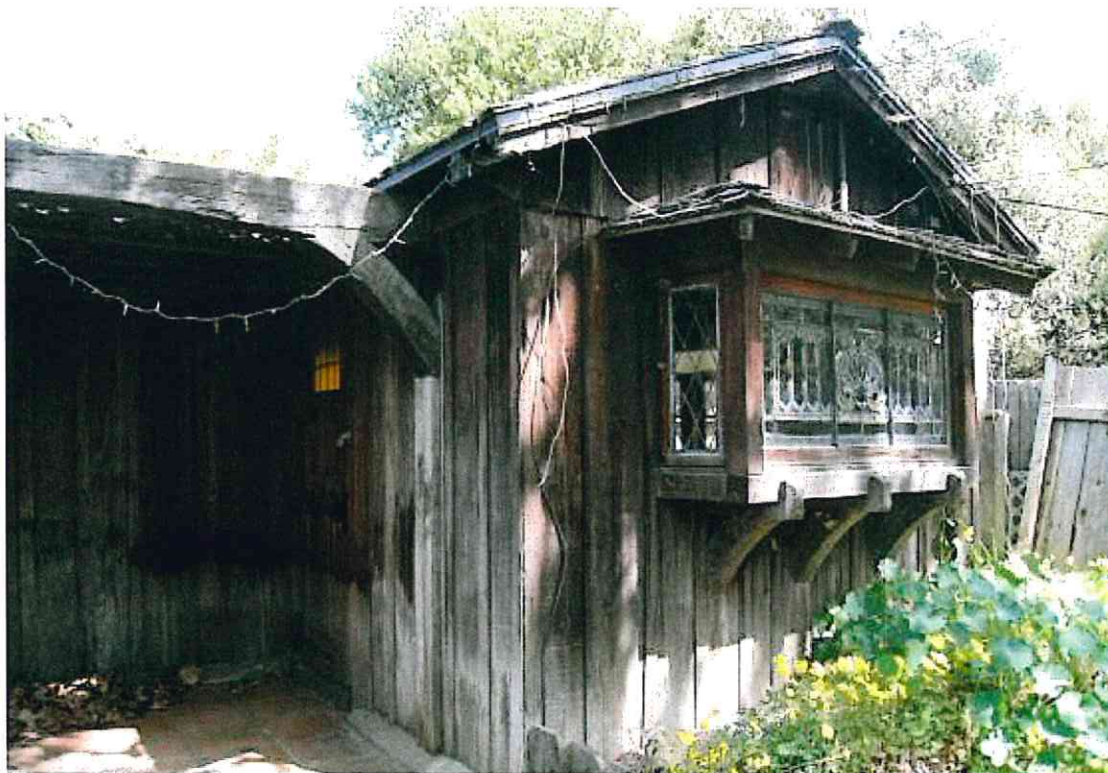
Plate 12 Cottage. South elevation showing recessed porch area to be replaced with storage addition. Facing north. April 2010. A. C. Cole

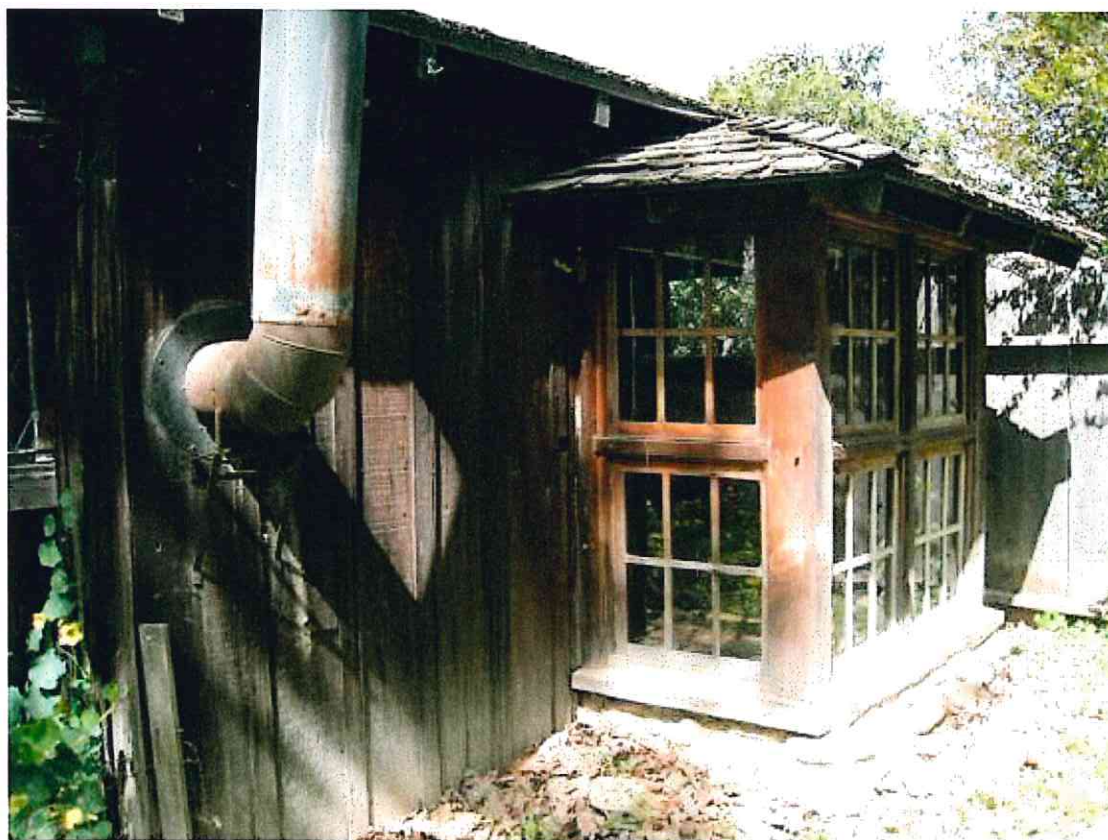
Plate 13 Cottage. East elevation. Facing northwest. April 2010. A. C. Cole

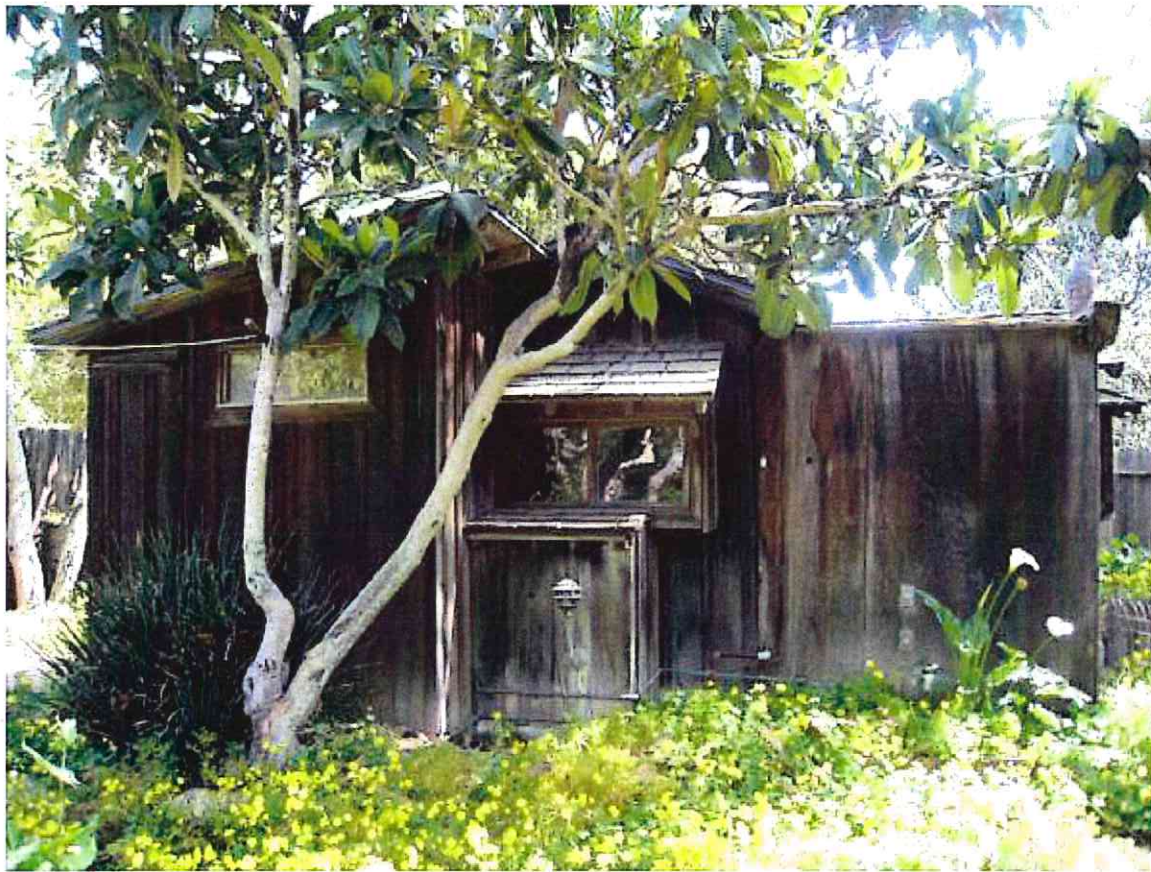
Plate 14. Cottage. North elevation. Facing south. April 2010. A. C. Cole
