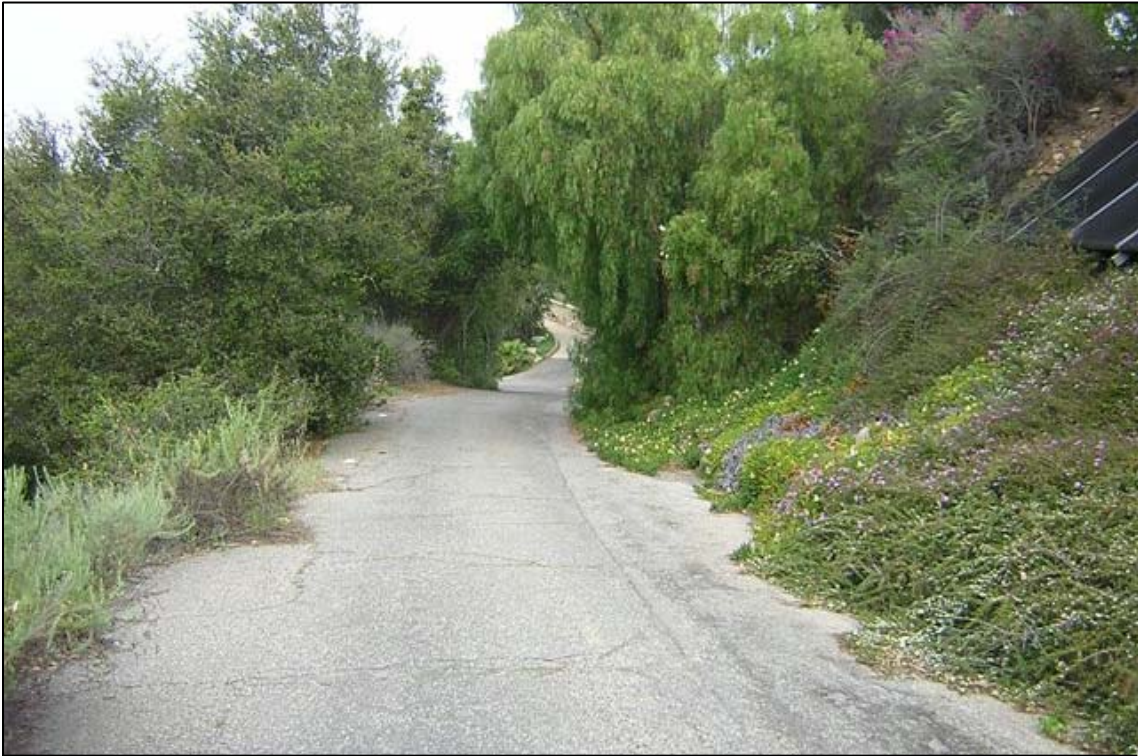
Lower portion of San Antonio Creek Road looking down the road east of Fee Residence. The road narrows to approximately 13 feet in width in this section. Roadside vegetation is encroaching into the travel lanes.

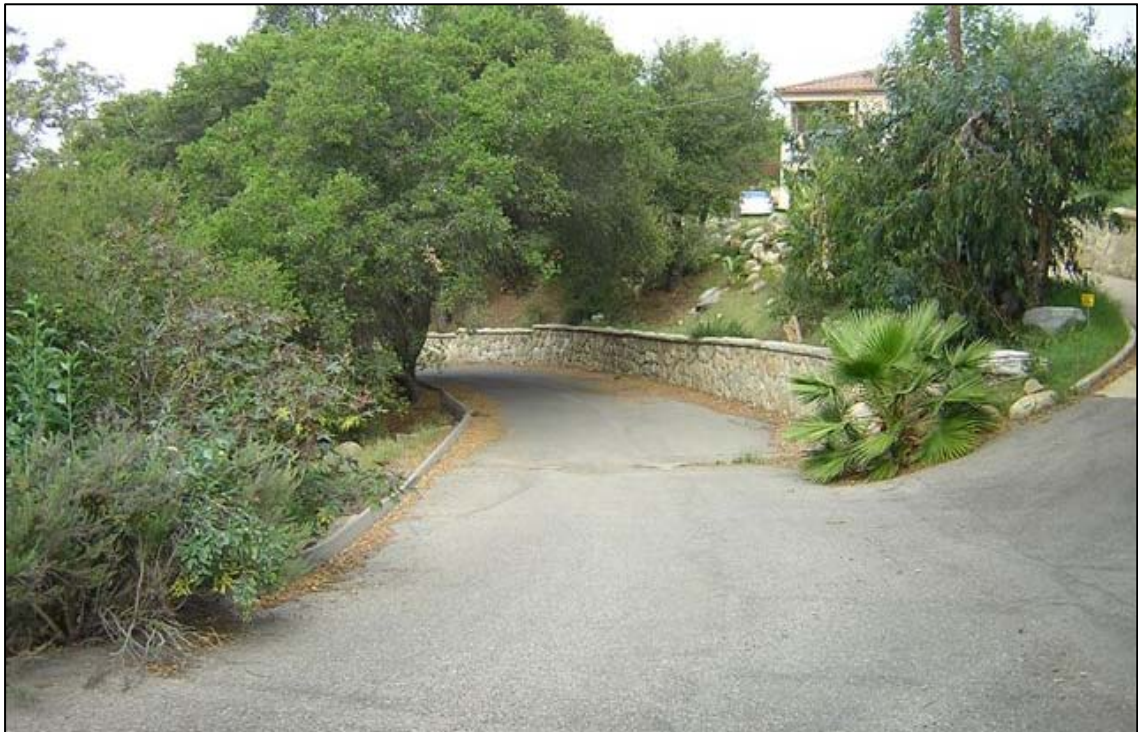
Lower portion of San Antonio Creek Road adjacent to eastern driveway of Fee Residence. The road is a minimum of 20 feet wide in this section. Roadside vegetation could be trimmed to maintain adequate clearance for emergency access.

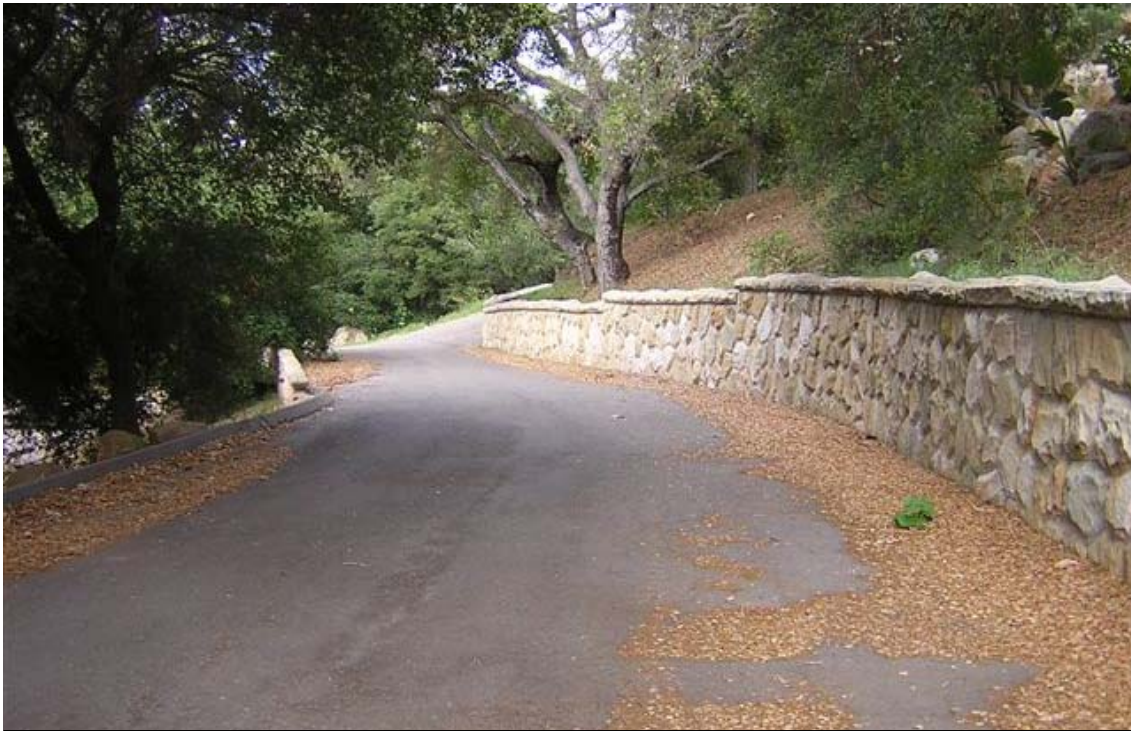
Lower portion of San Antonio Creek Road adjacent to Fee Residence. The road is approximately 22 to 24 feet in width in this section. The retaining wall was constructed in 2007 to restore adequate road width.

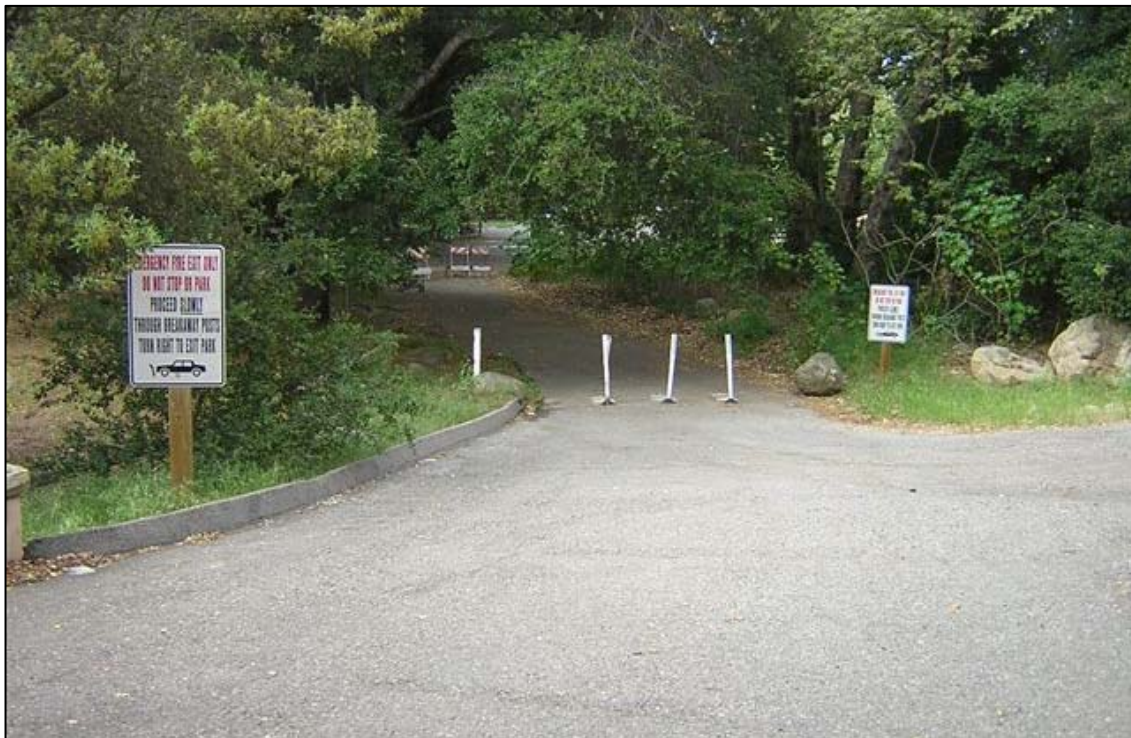
End of San Antonio Creek Road looking towards Tucker's Grove Park. This access is controlled with flexible plastic bollards that can be driven over and signage indicating use of this access for emergency purposes.
