## Goleta Beach Emergency Repair / Protection Photographic Timeline

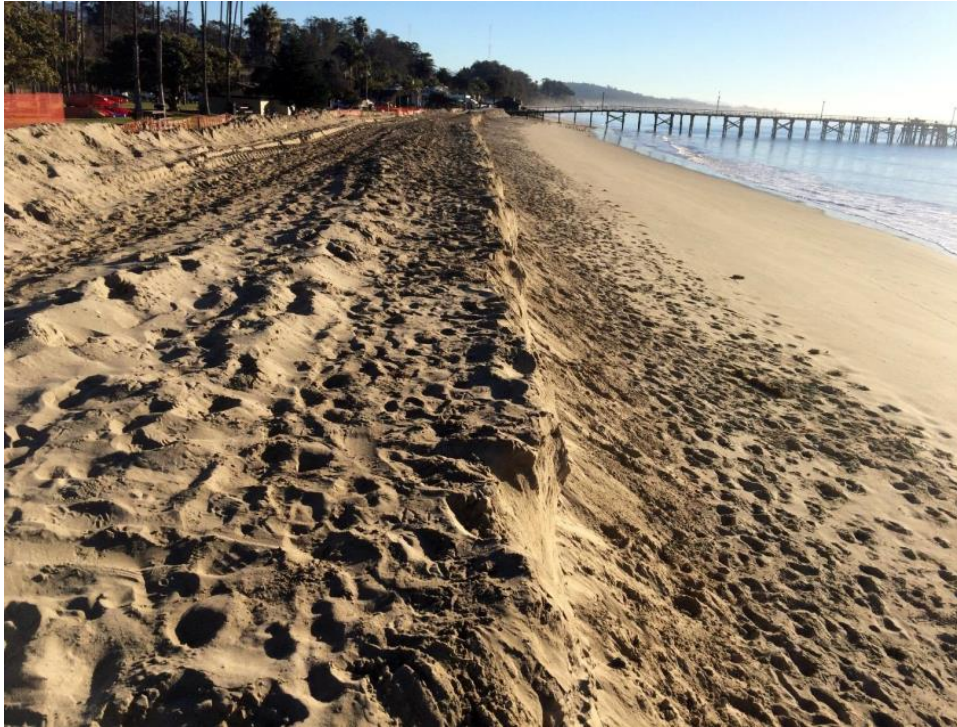
- Nov 2015: In preparation for anticipated El Nino storm season, the California Coastal Commission (CCC) issued an Emergency Coastal Development Permit (ECDP) to install and maintain a 2,400 foot sand berm through Memorial Day weekend 2016

*Berm at central beach area (Dec 18)*

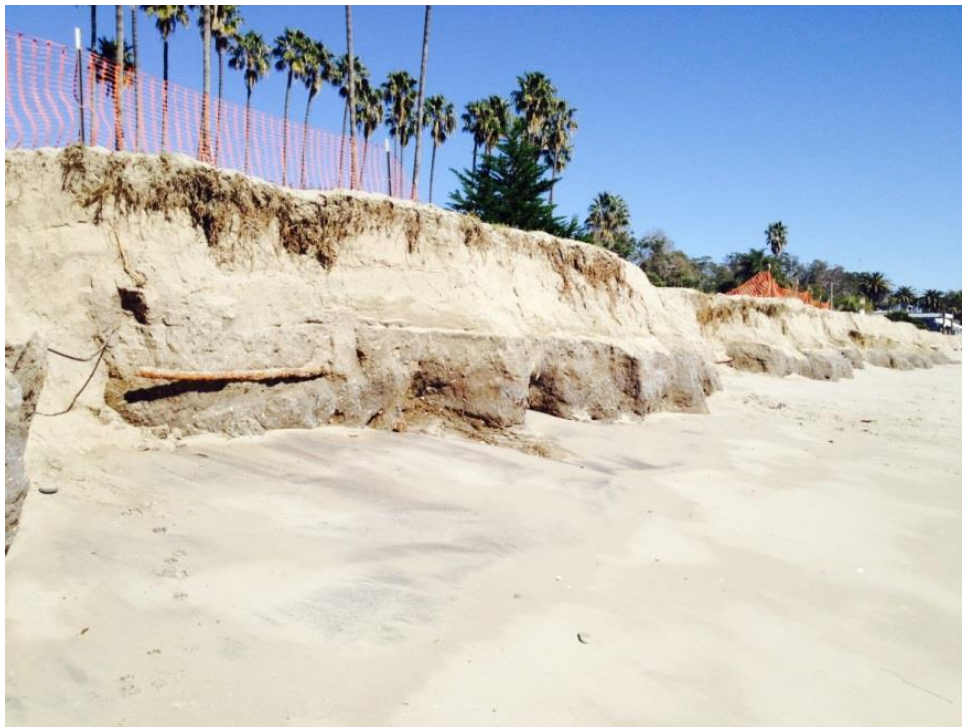
- Jan through Feb: Central parkland had been eroded five to ten feet from the original lawn edge due to high tides and strong surf even though sand berm had been continually maintained. By Feb 19<sup>th</sup> Sand available for berm maintenance noted to be at extremely low levels due to high tides and strong surf.

*Central beach area (Feb 16)*

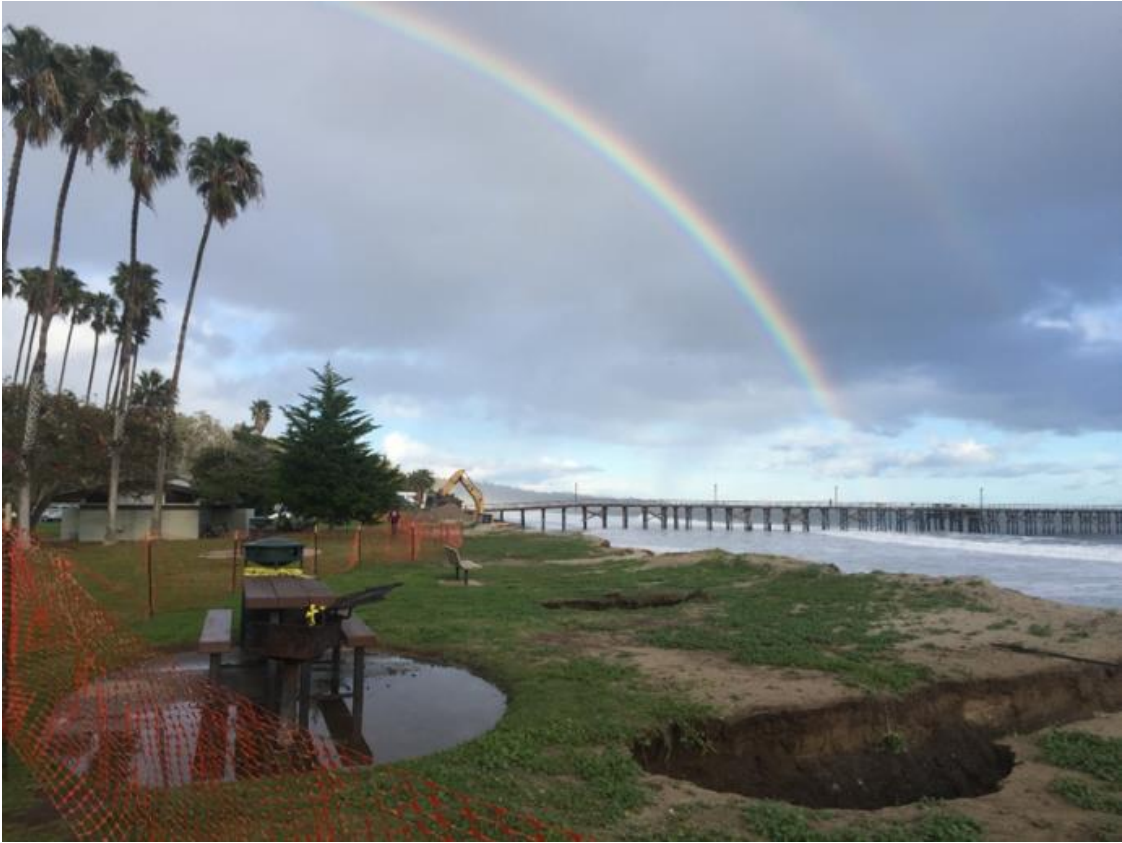
- First Week of Mar: Erosive gaps and sinkholes started to appear in the central park area due to high tides and strong surf

*Sinkholes and erosion aspect east (Mar 7)*

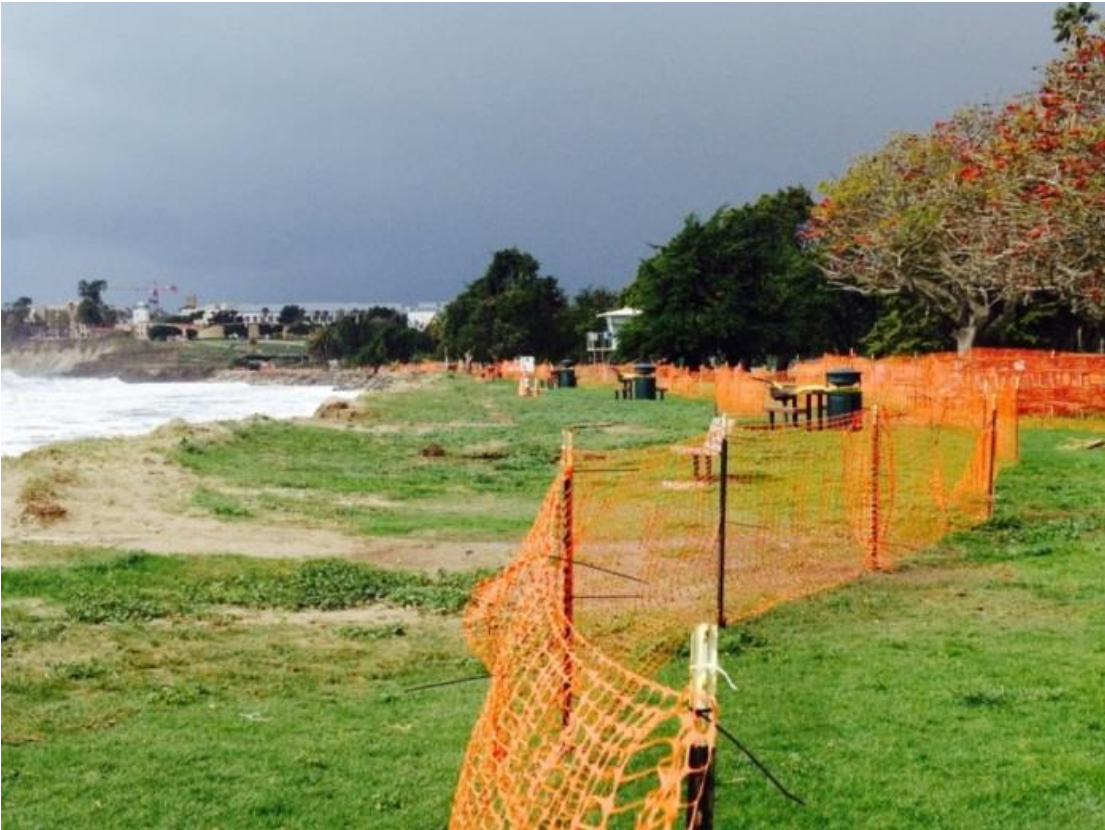
*Sinkholes and erosion aspect west (Mar 7)*

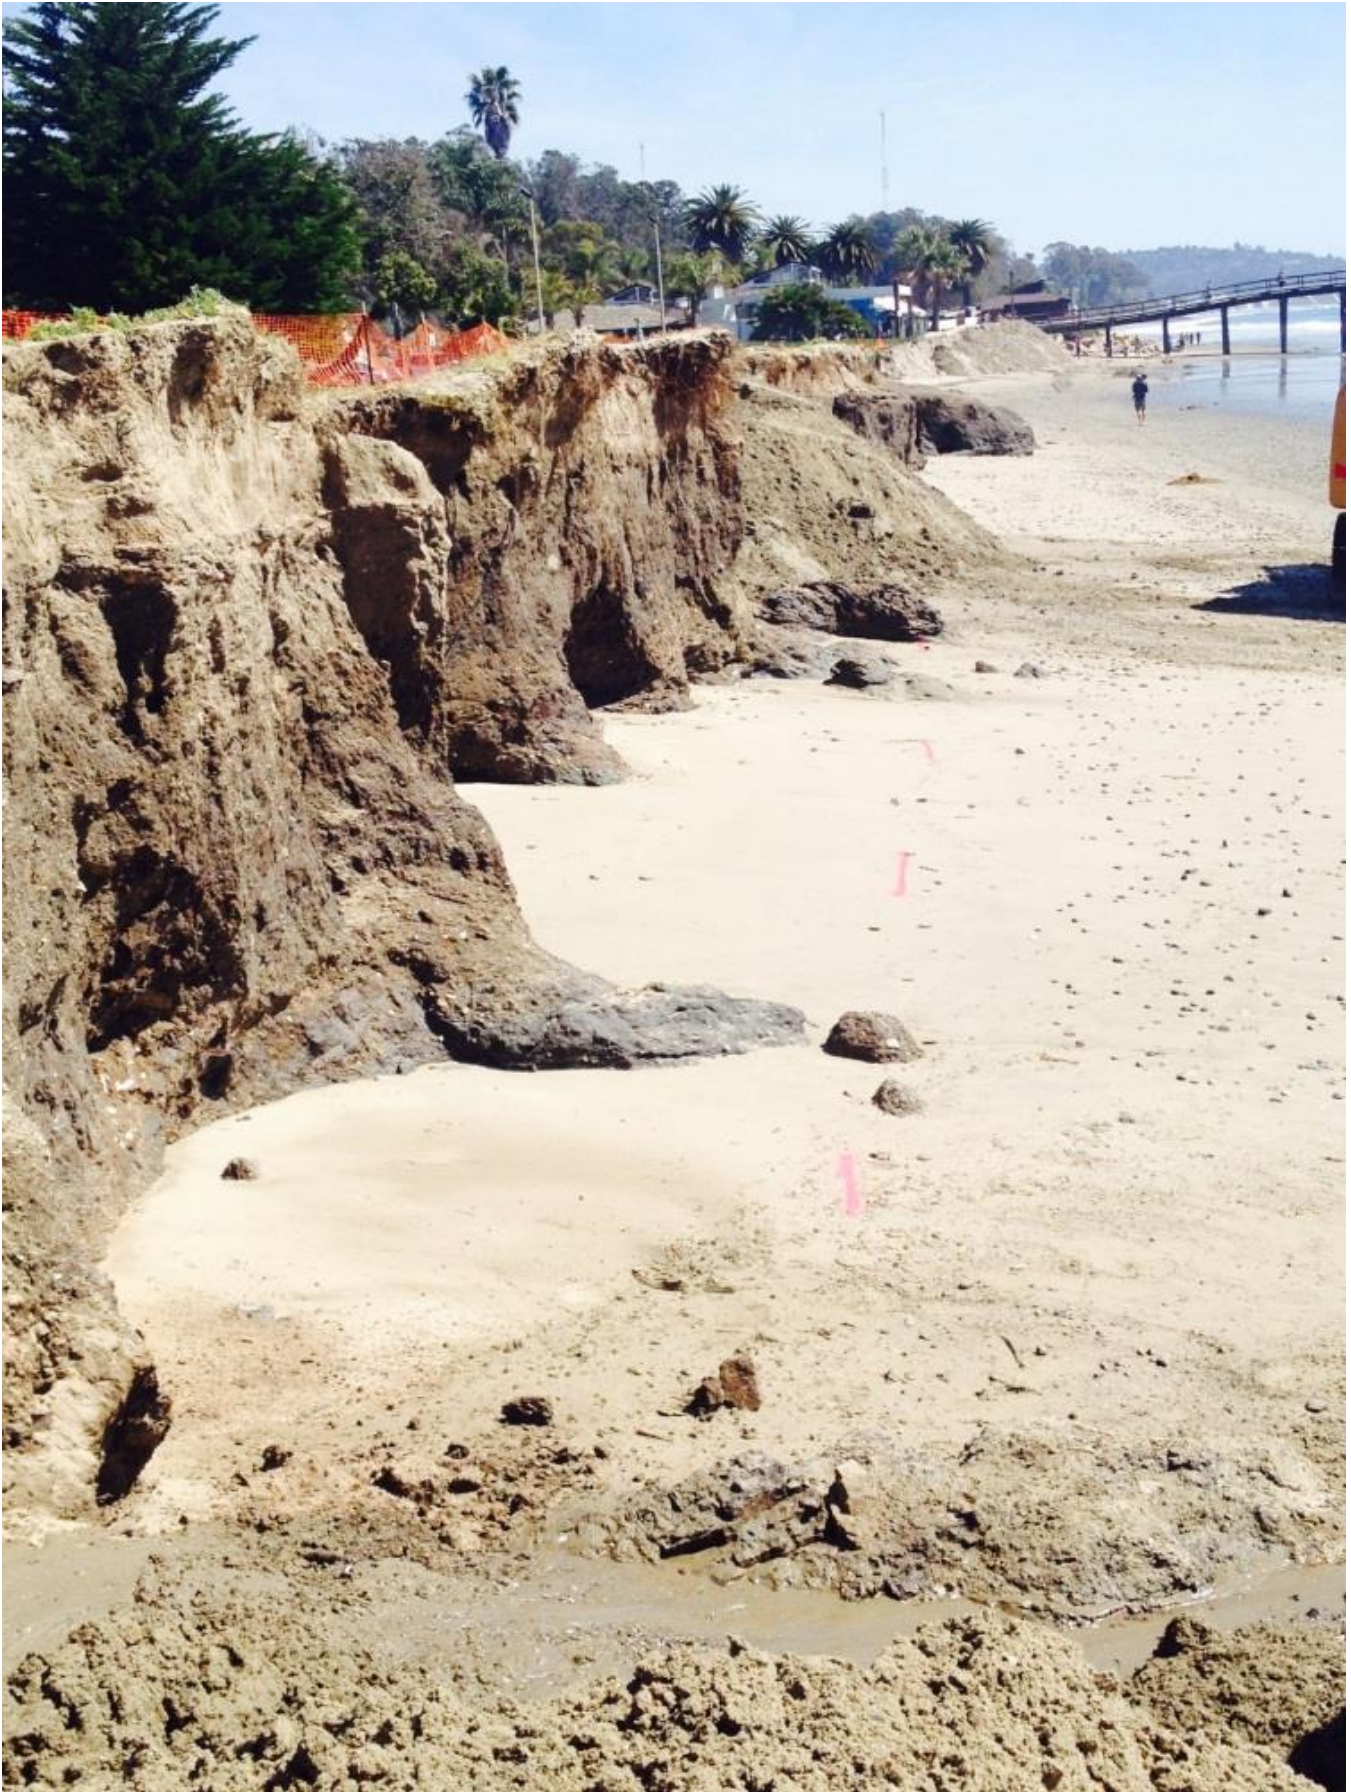
*Soil fill line (still 5 to 10 feet landward of land edge prior to Dec 2015)*

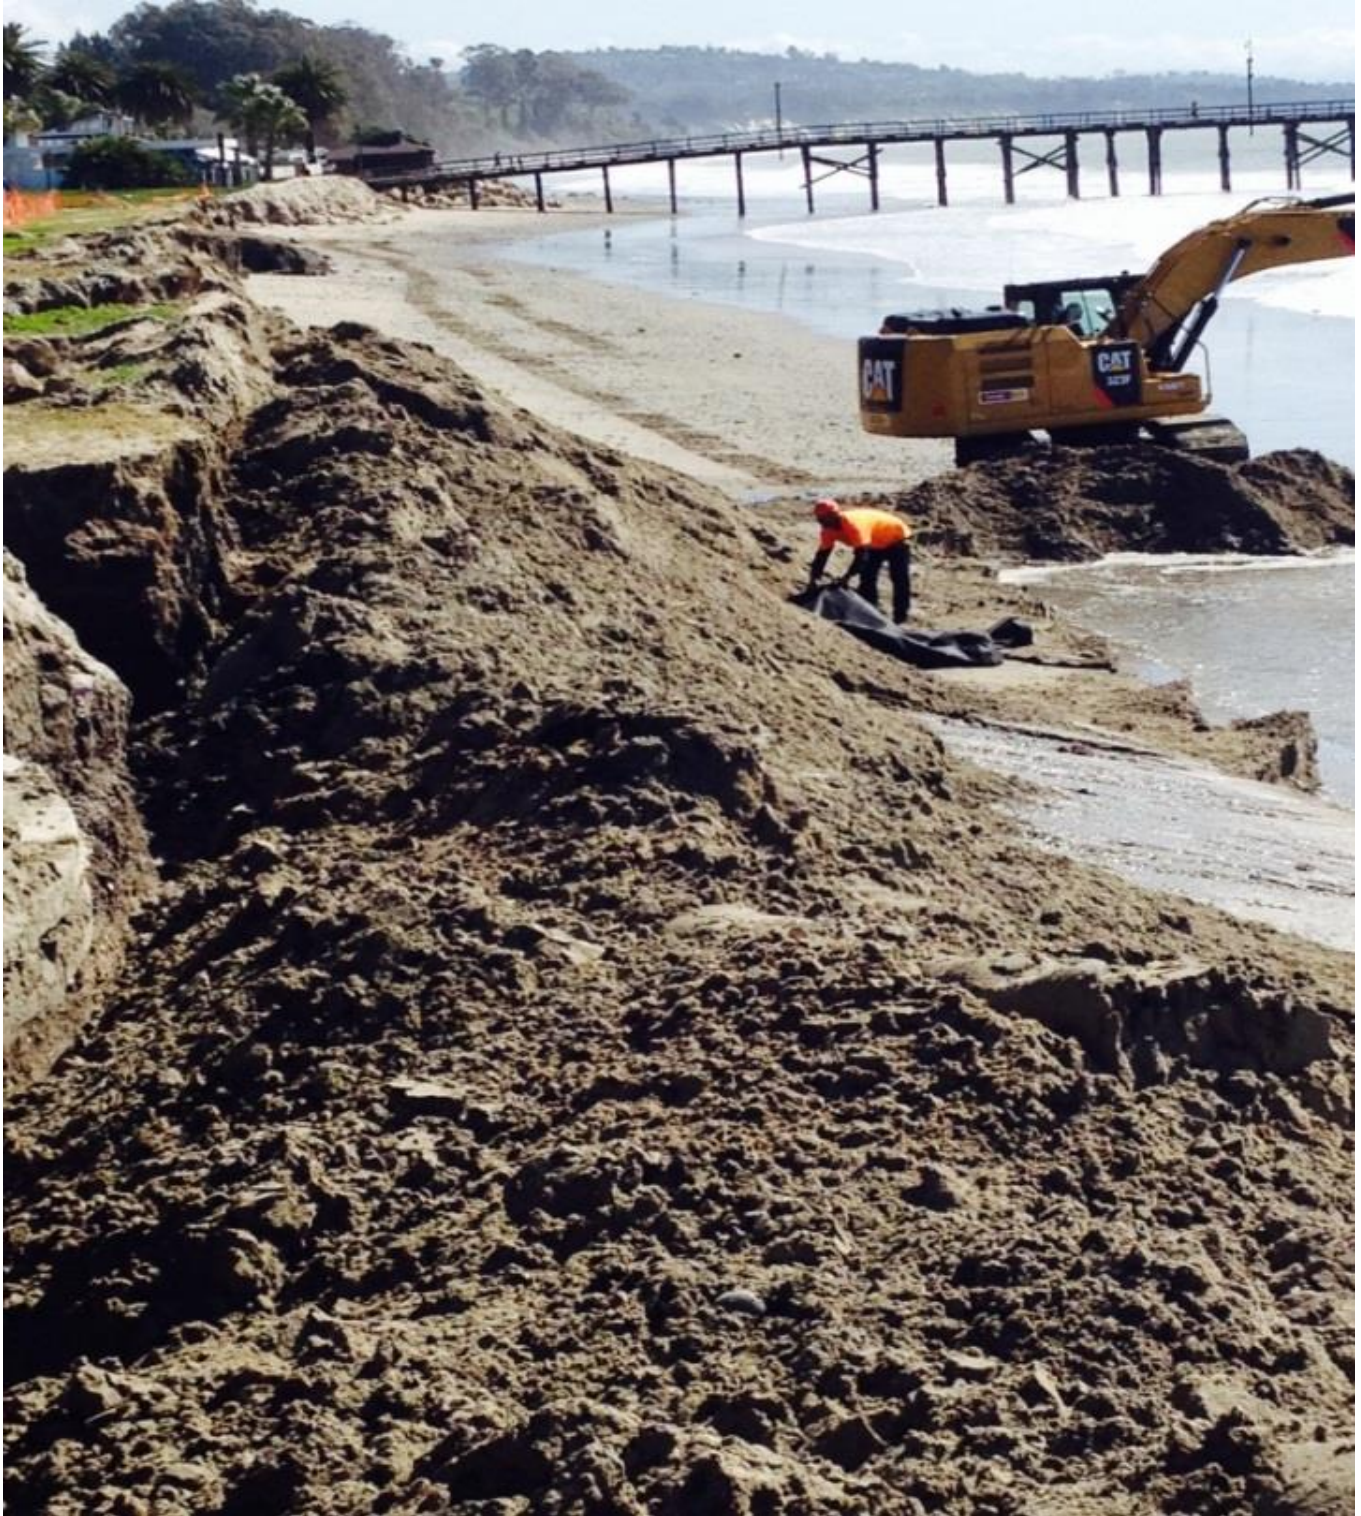
*Soil backfill and vertical fabric filter layer install (Mar 14)*

- Mar 9: California Coastal Commission (CCC) issued an emergency permit to repair sinkholes and erosive gaps and install temporary protections
- Mar 14: Contractor commenced repairs to erosive park area

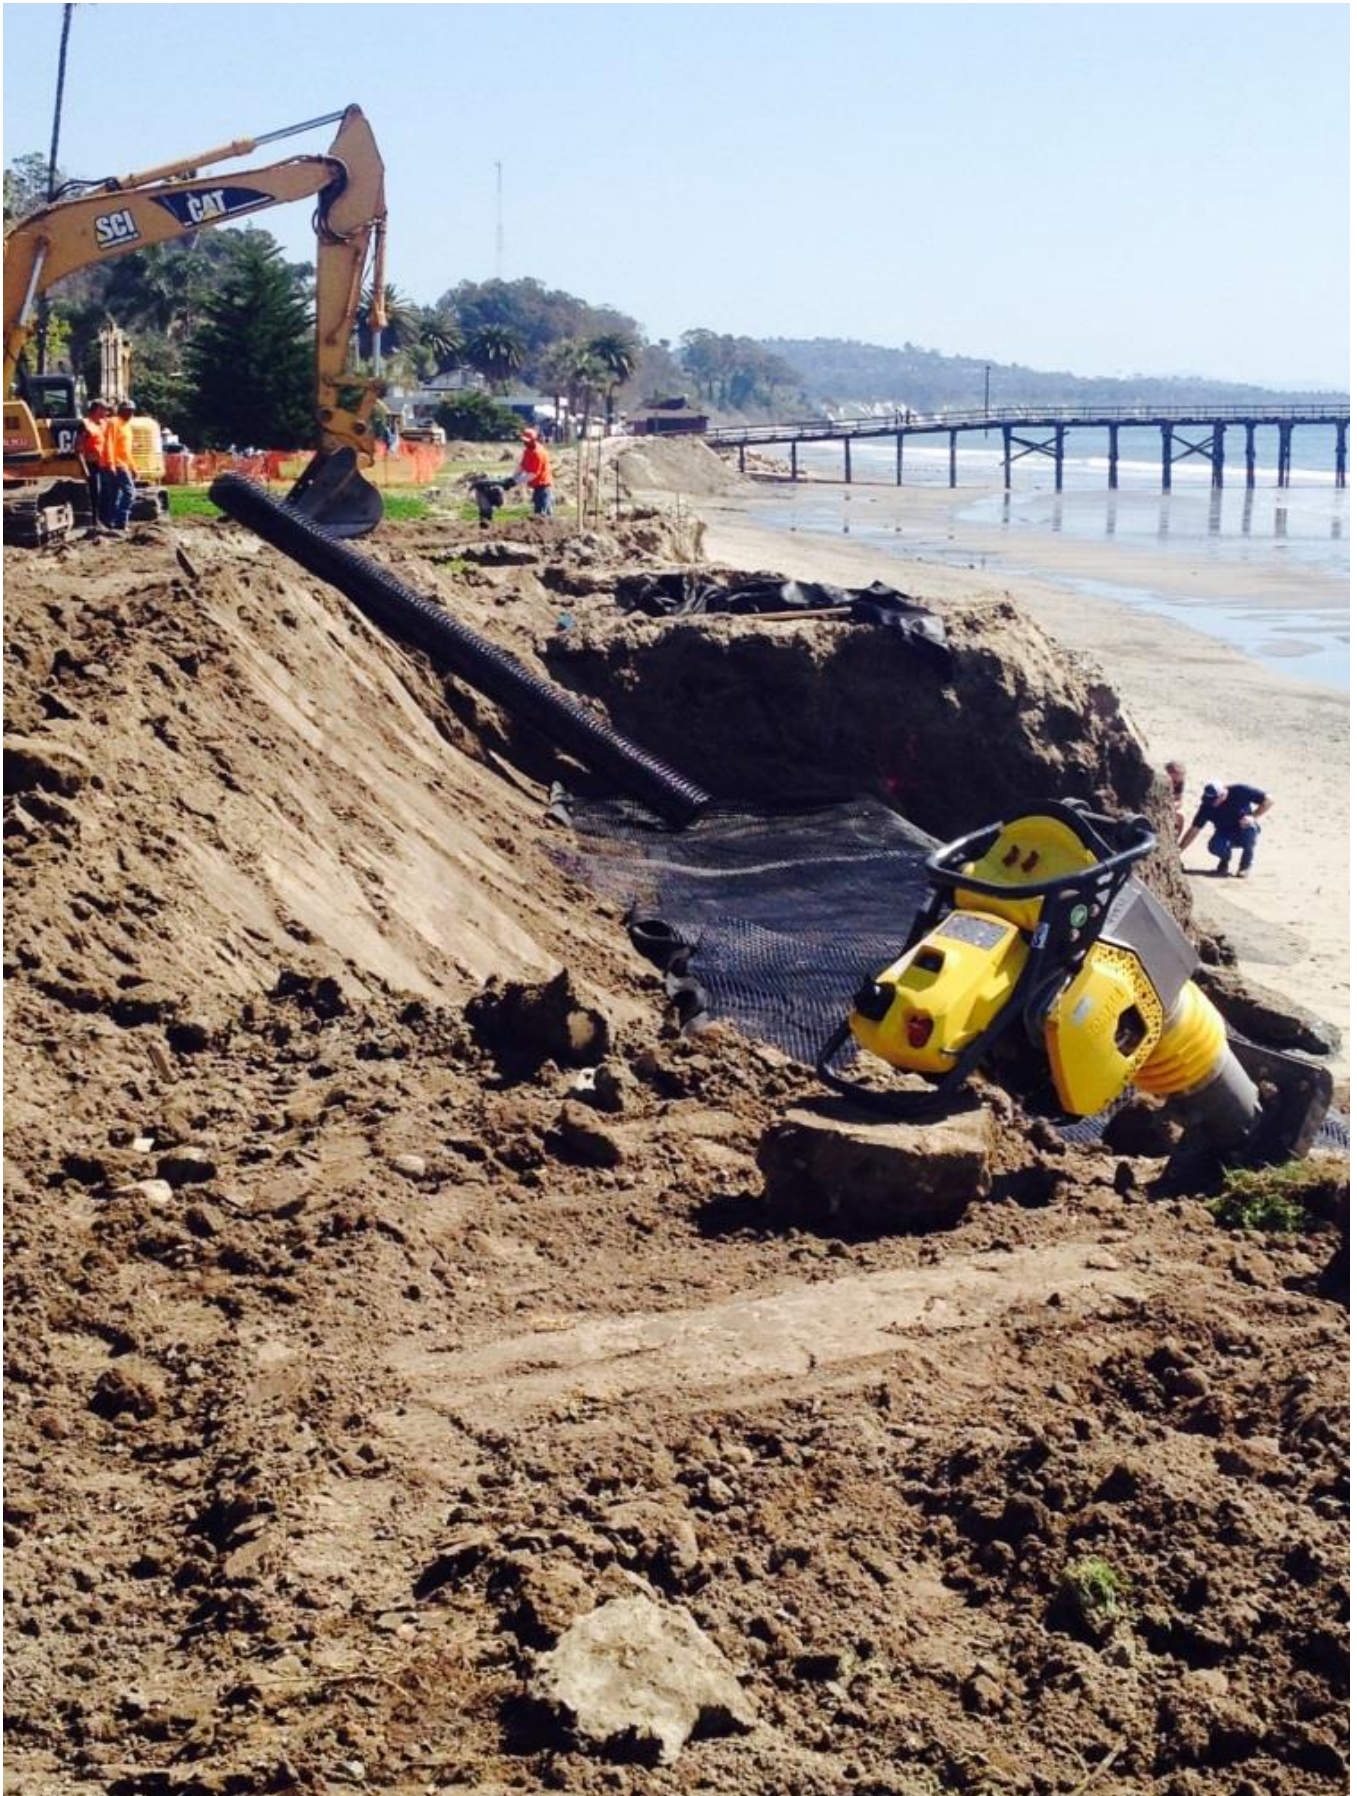
*Layer of filter fabric laid open (Mar 17)*

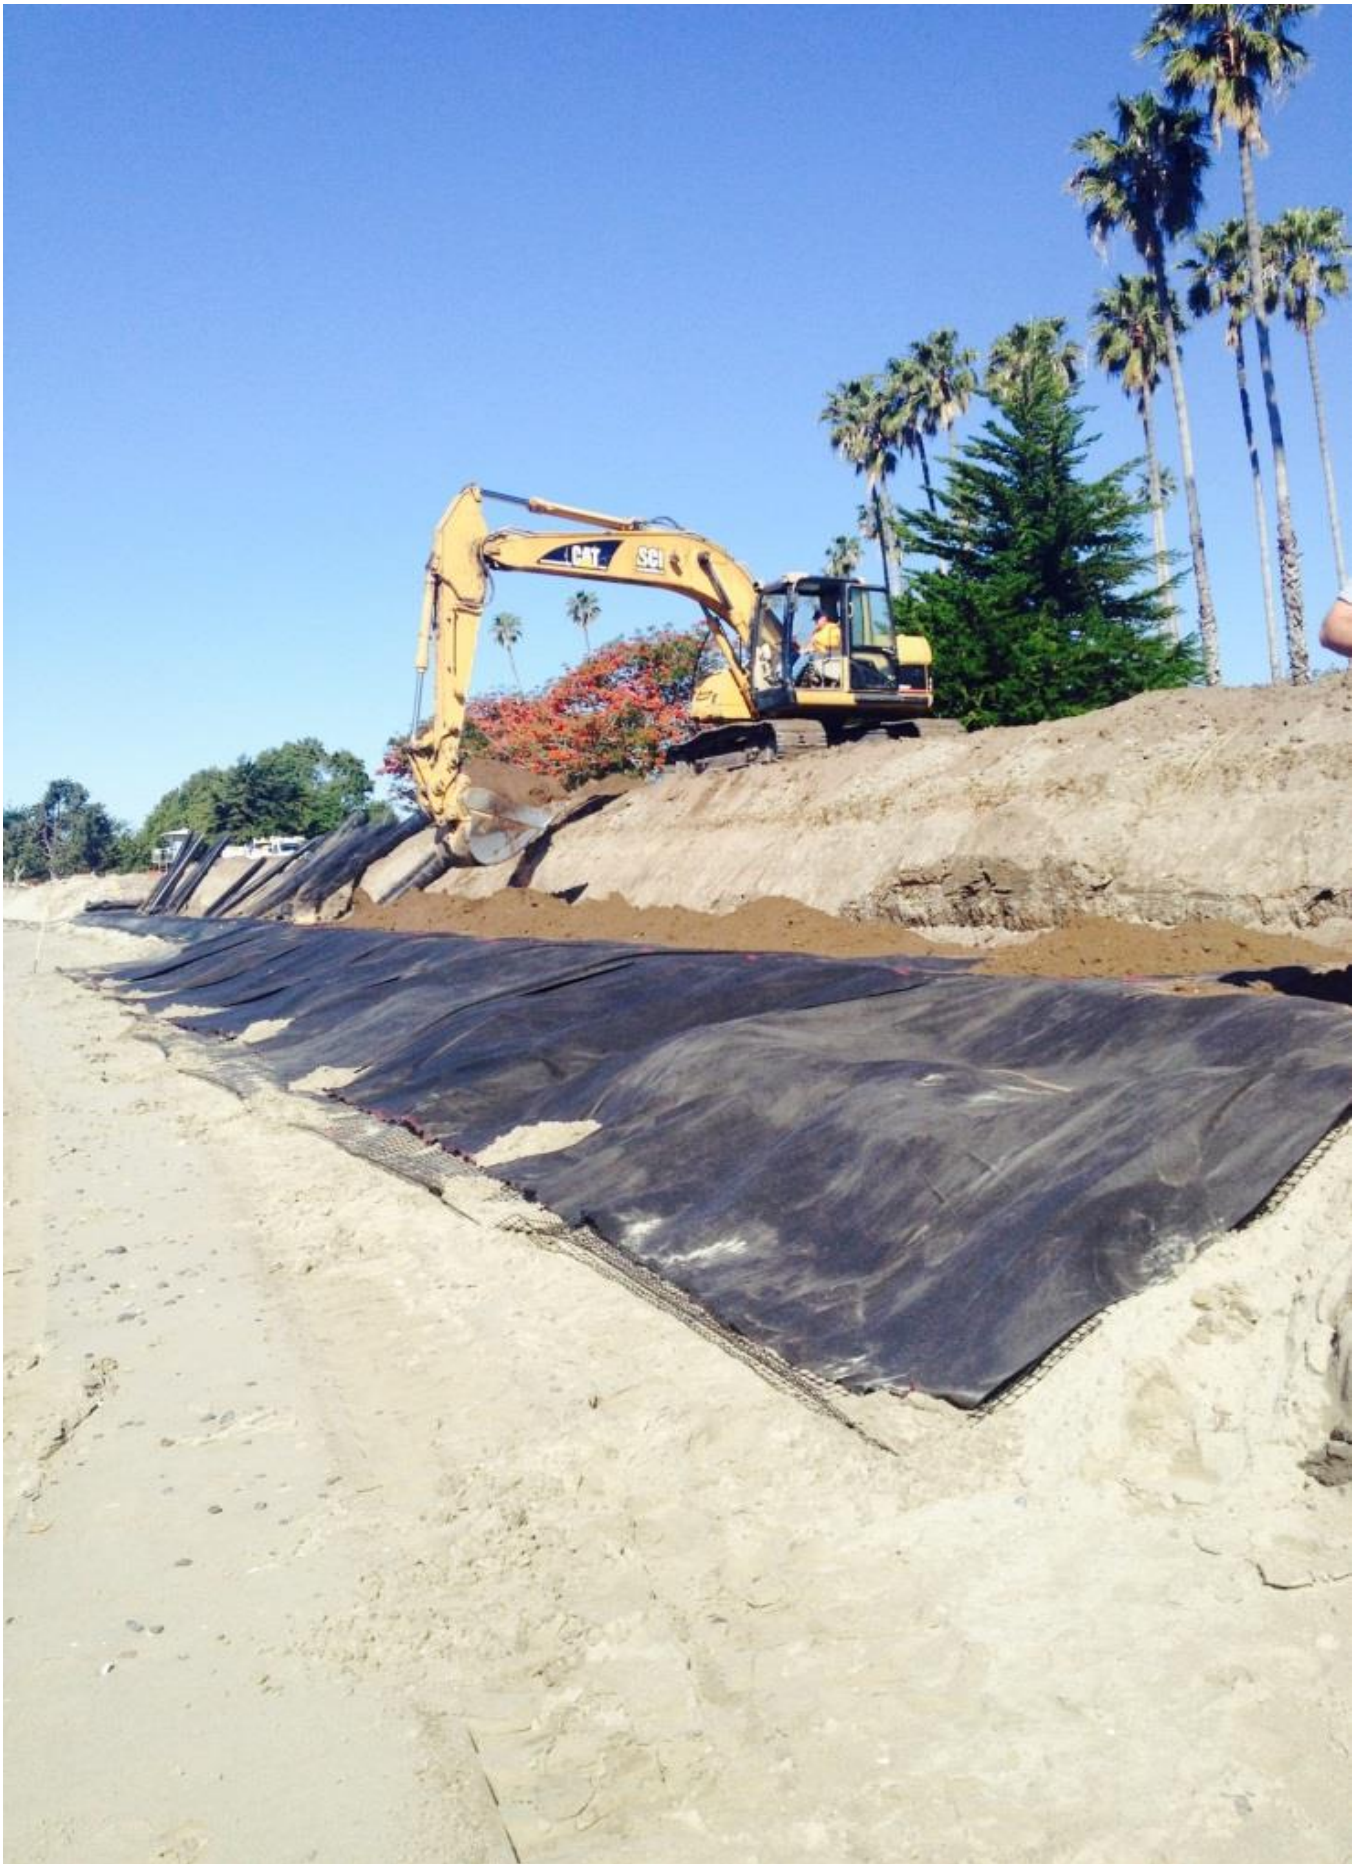
*Layer of filter fabric being filled with earth (Mar 31)*

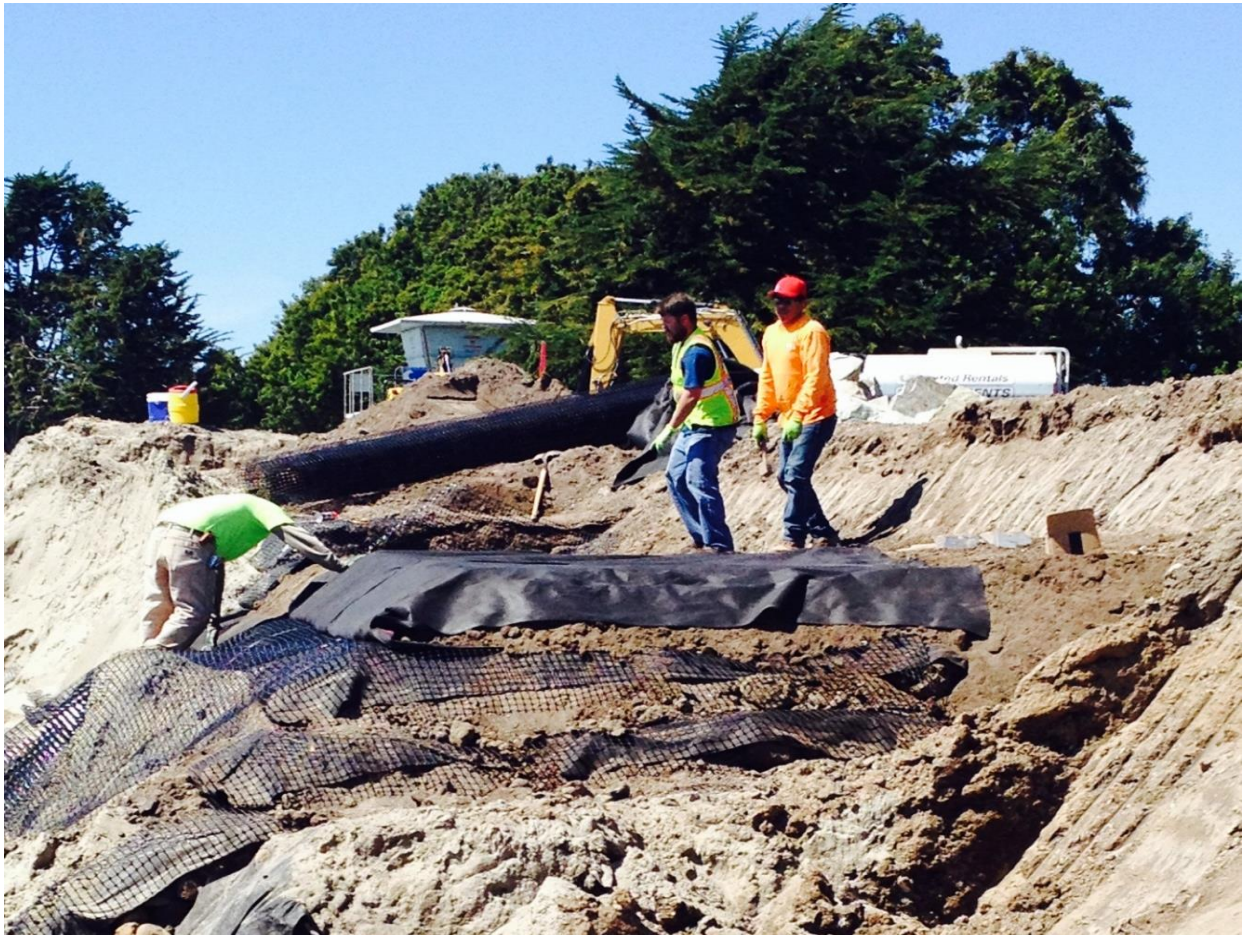
*Layered and filled filter fabric cells (Mar 23)*

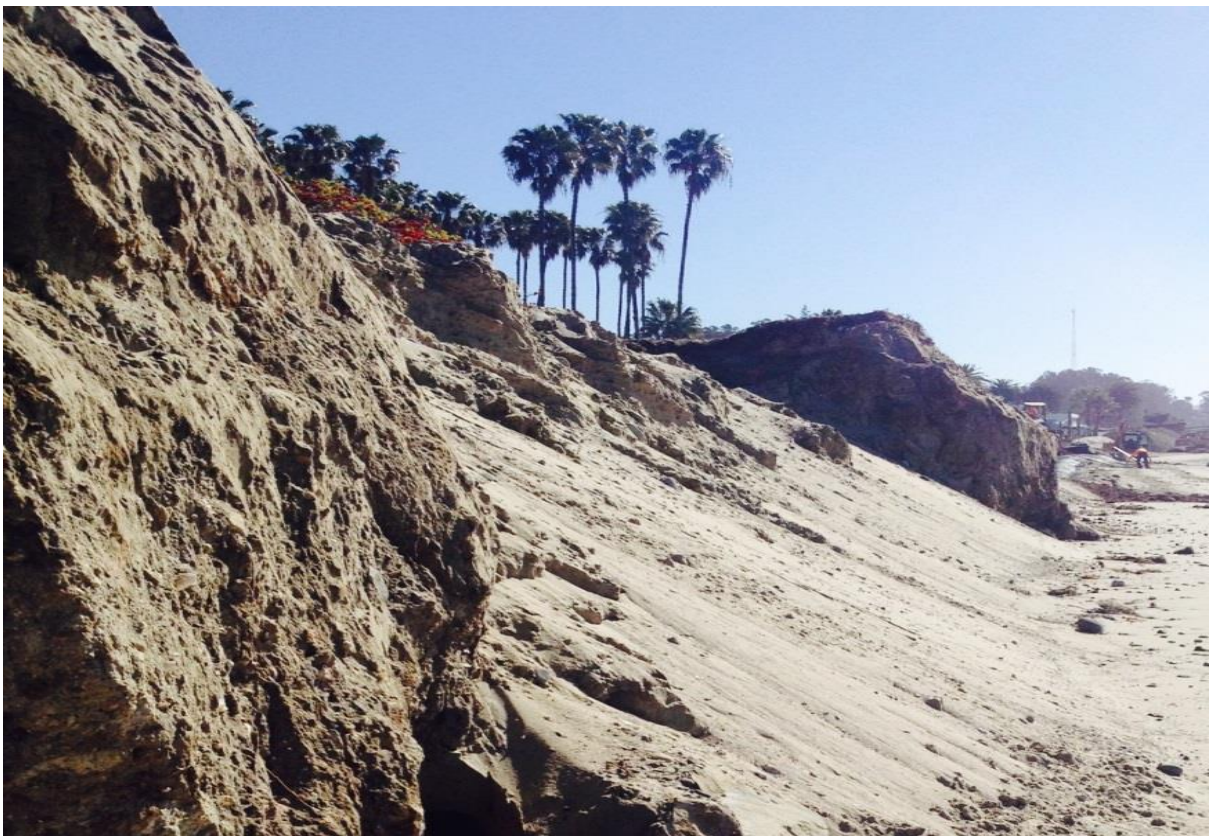
*Repaired area facing east (Mar 31)*

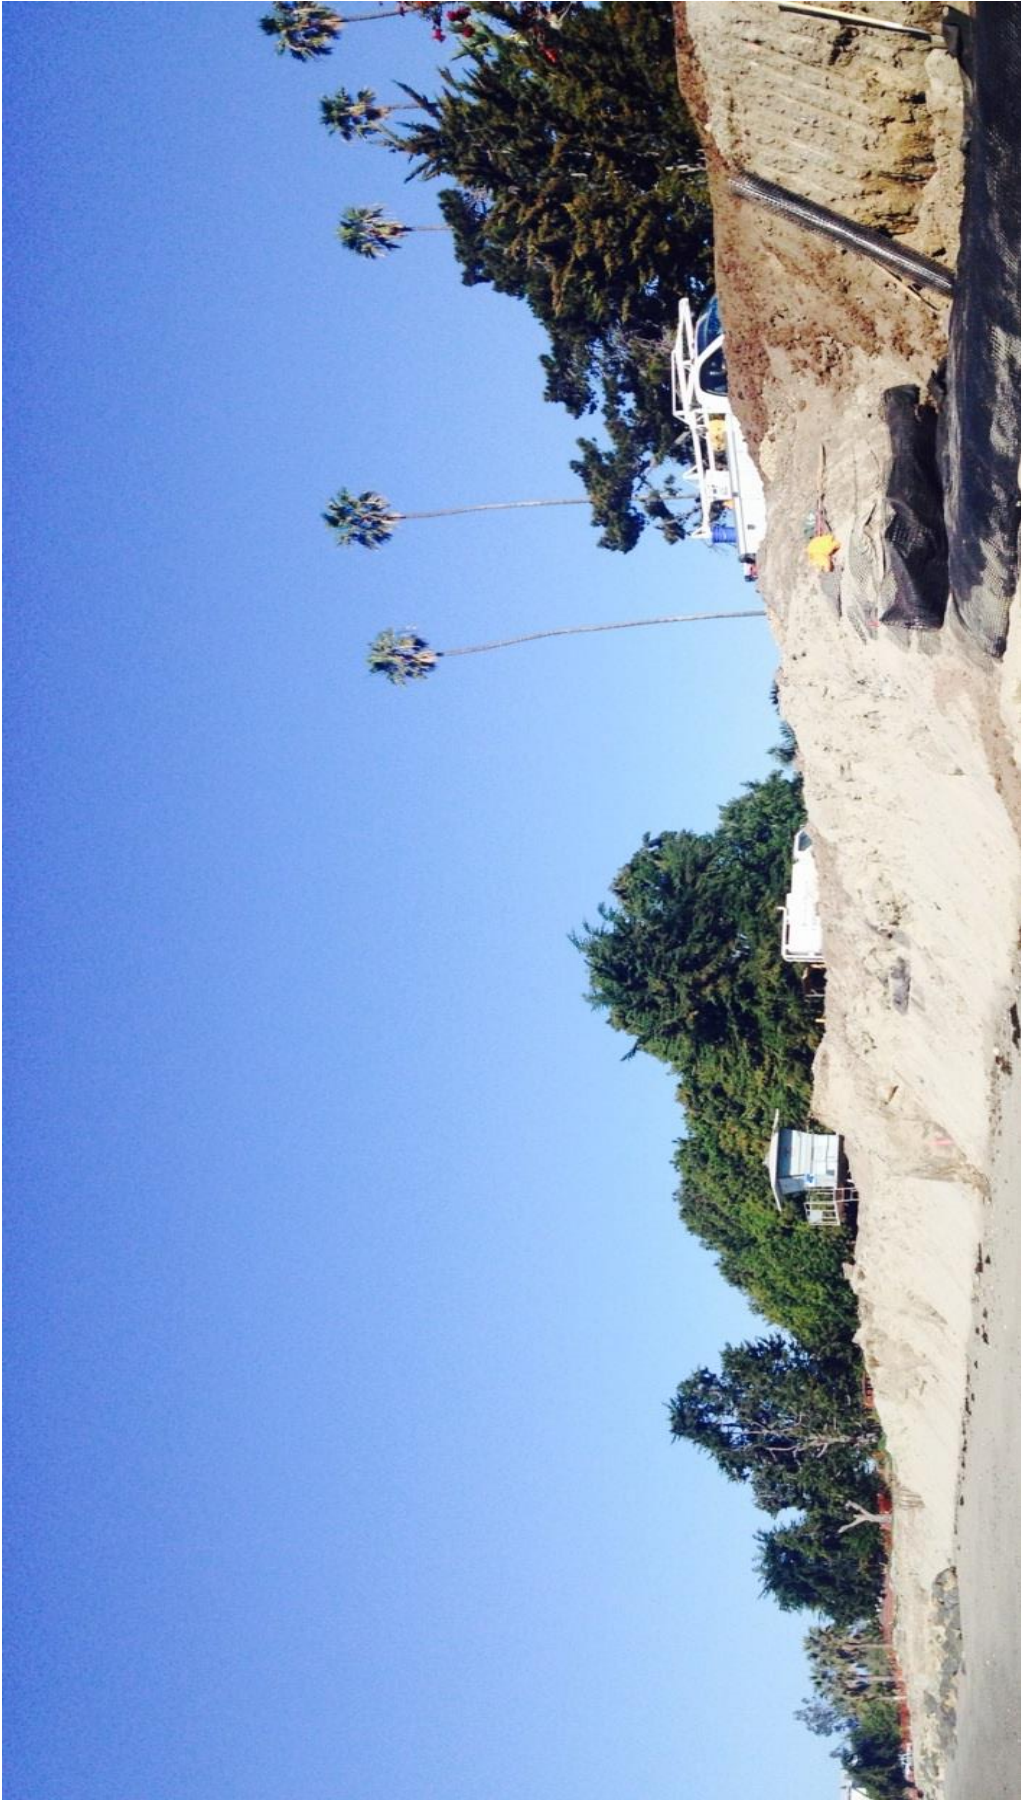
*Repaired area facing northwest (Mar 31)*

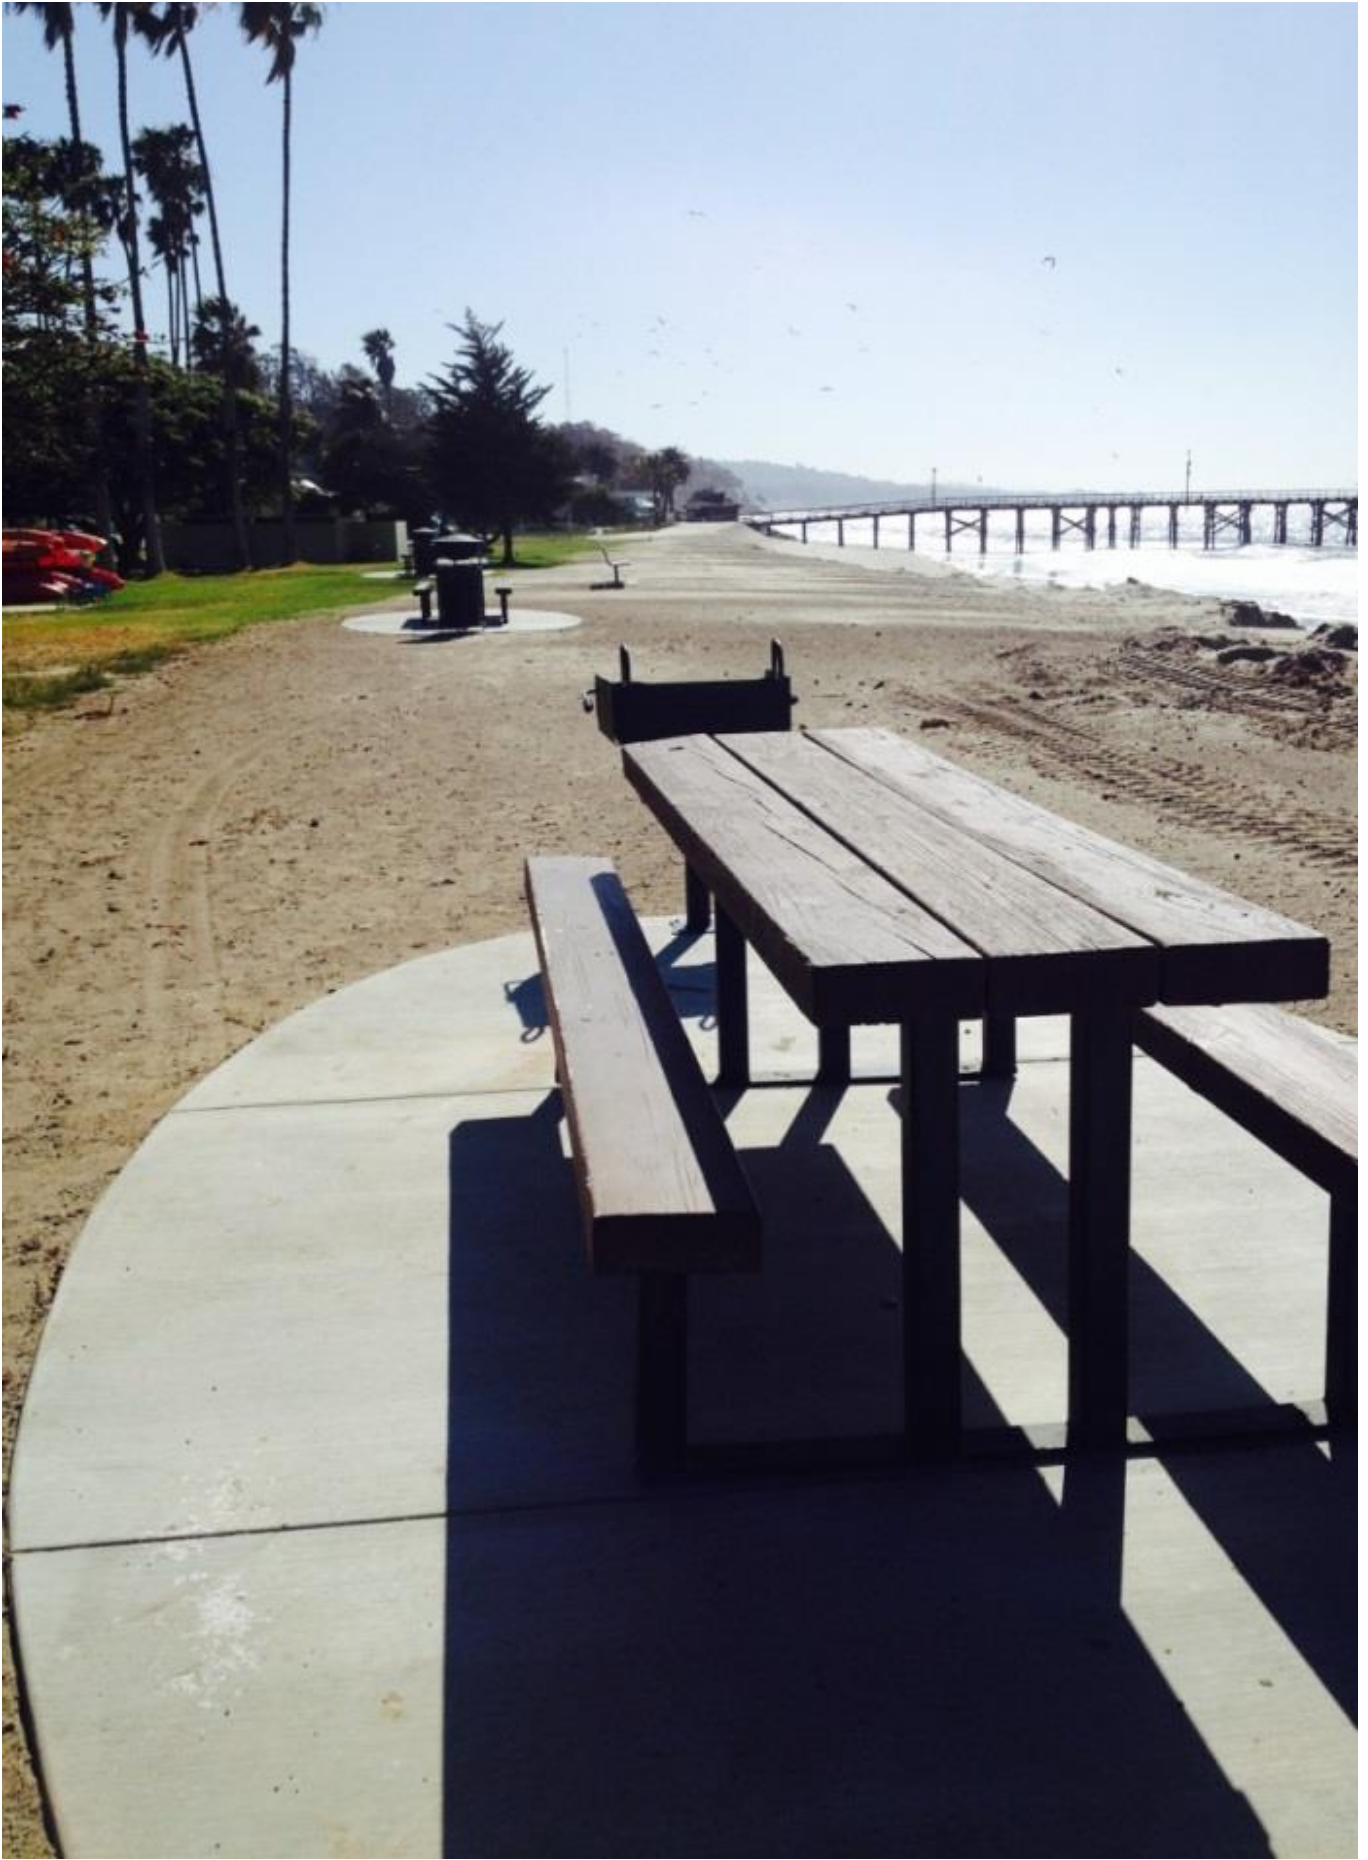
*Repaired lawn area facing east (Apr 25)*

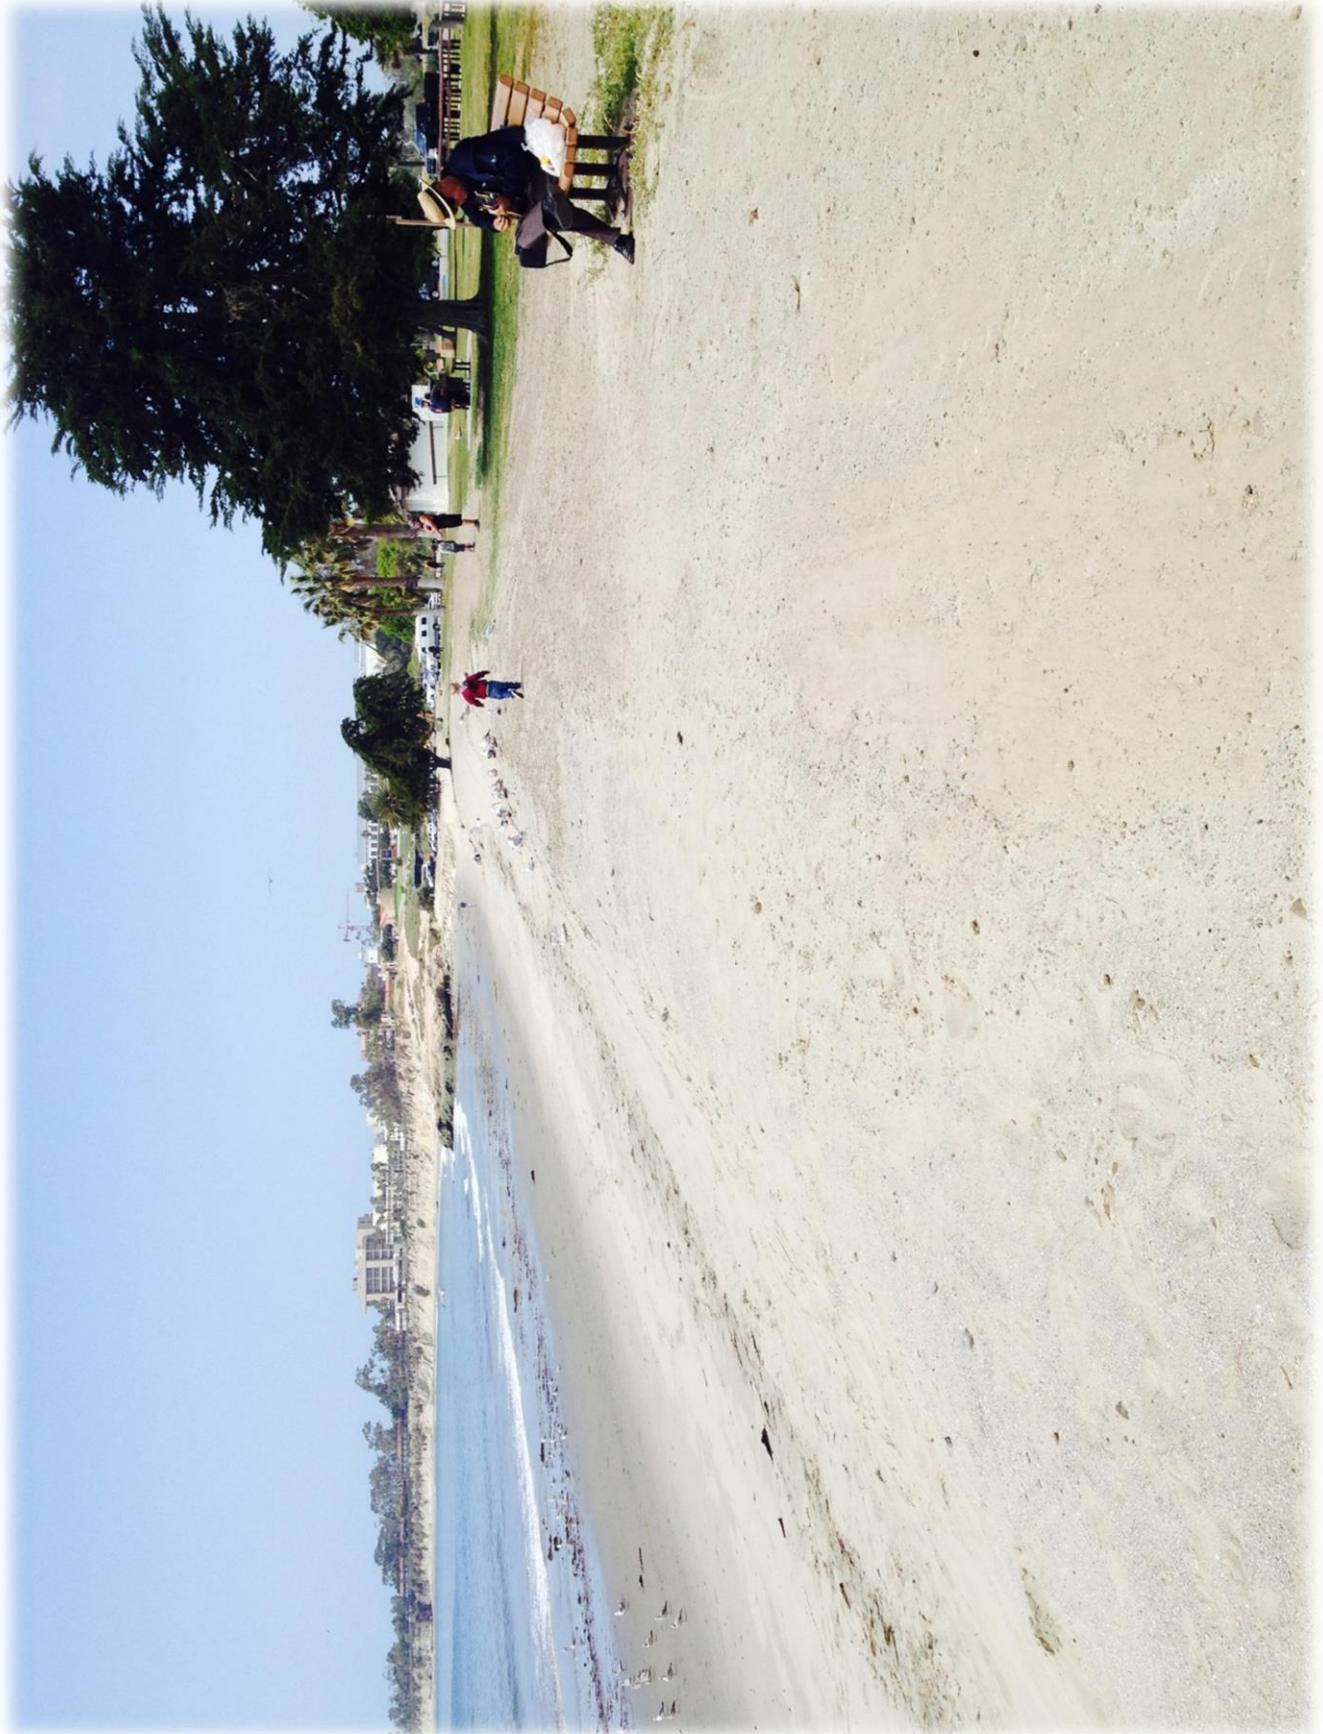
Repair area facing east from east end point of existing permitted revetment (under CDP 4-14-0687)
