## Goleta Beach Emergency Repair / Protection Photographic Timeline

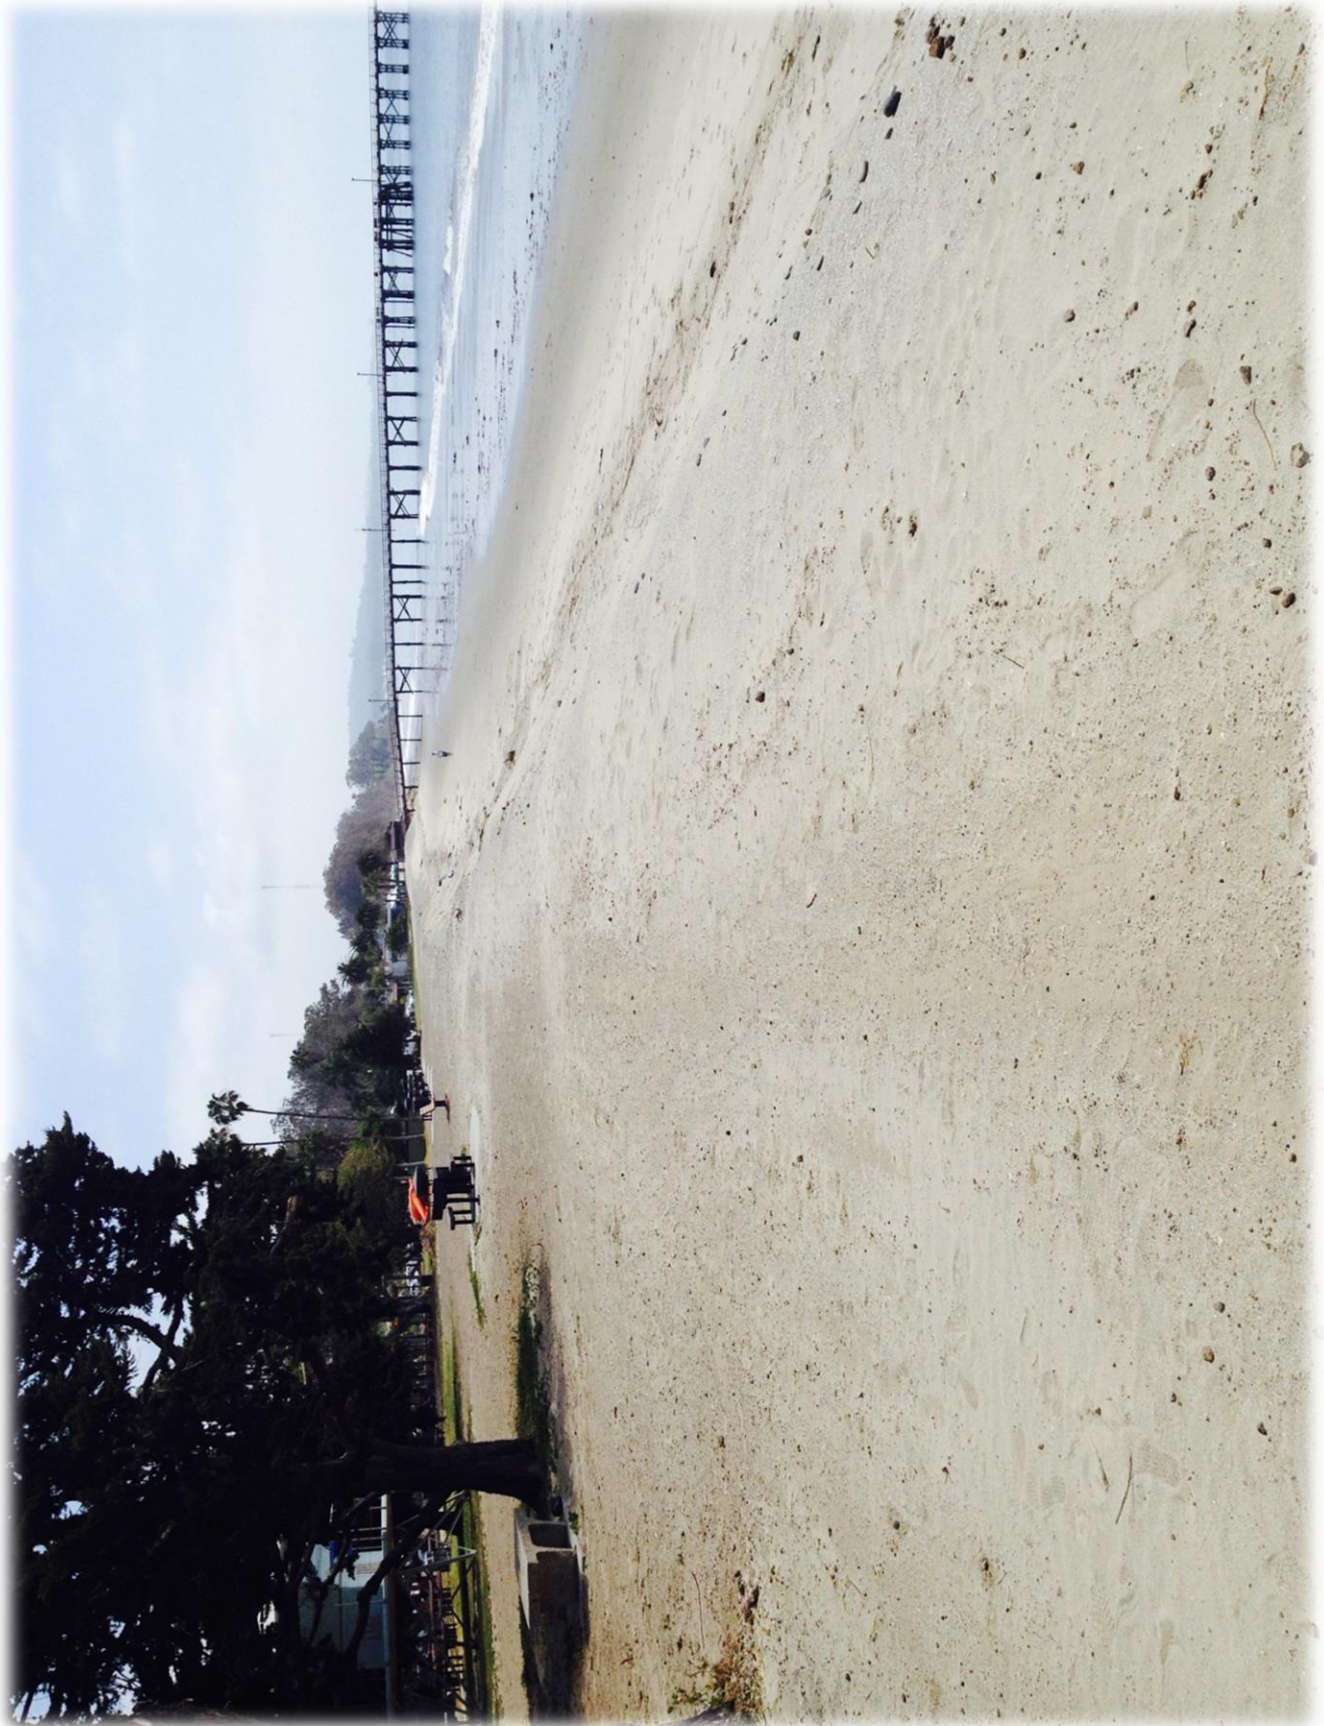
Repair area facing east from east end point of existing permitted revetment (under CDP 4-14-0687)
