Date: February 20, 2014
To: County of Santa Barbara Planning & Development Department
From: Michelle McCovey-Good, PE
Taylor & Syfan Consulting Engineers
Project: Historical Rehabilitation Project
461 San Ysidro Road, Santa Barbara, California
T&S Job No.: 13371

Subject: Report of Existing Structural Conditions

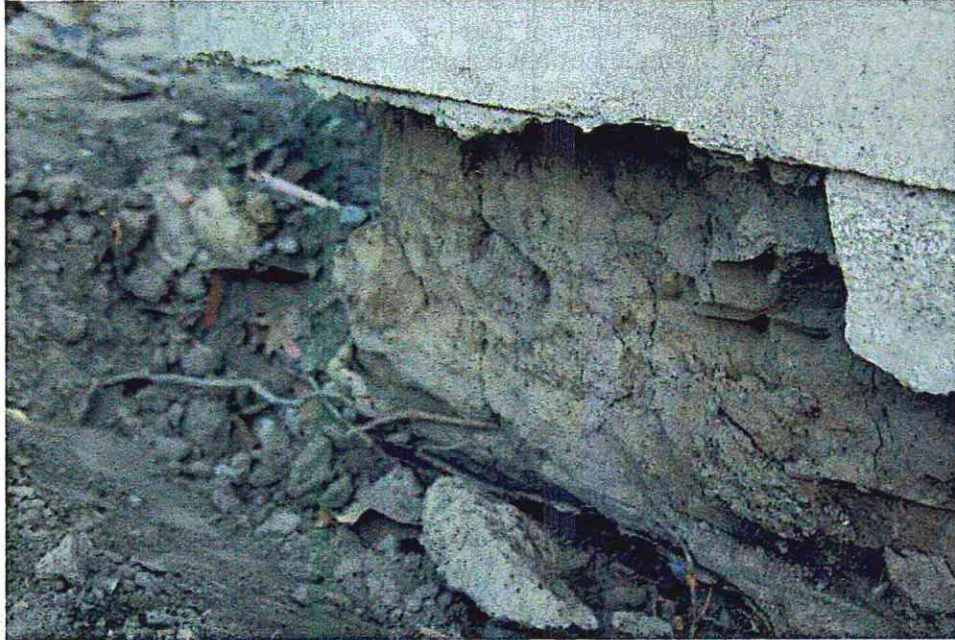
Photo 1 : Adobe sitting on Soil vs Stone Foundation

Extensive cracking of the existing adobe walls is currently present due to excessive differential settlement of this building. The adobe structure sits directly on grade with no existing foundation system (see image 1). This has led to years and years of wicking of water from the soil into the adobe walls. This in combination with the structure being sealed with incompatible Portland cement plaster (versus adobe or lime plaster, which would have allowed for the adobe to breathe) has caused the adobe bricks to erode to a point where they are indiscernible from the mortar that was placed between them (see image 2). This makes re-keying of new adobe bricks into the existing walls impossible to perform. This is exacerbated by the fact that this deterioration occurs predominantly at the base of the wall where grading at the site allowed for water to pond against the exterior wall line of the adobe. Any attempts to repoint or replace adobe at the base of these walls would result in the further settlement and/or collapse of these walls. Poor weatherproofing of the roof has caused significant erosion in the adobe bricks at the top of the adobe walls as well (see image 3). This in combination with pest infestation (see image 4) has caused the tops of the walls to disintegrate upon the use of hand tools.

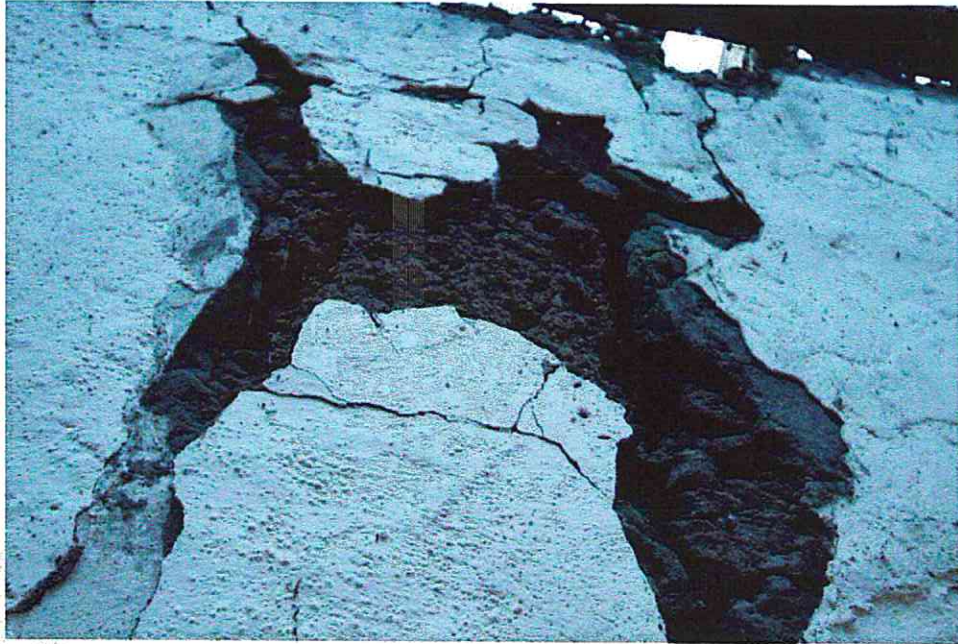
Photo 3 : Deep Erosion at top perimeter of wall line due to water intrusion

When attempting to remove the existing, incompatible plaster, the brittleness the water intrusion has created causes the adobe to disintegrate, even with the delicate use of hand tools. Therefore, shoring up of the existing structure to provide underpinning has not been a plausible solution for the placement of a foundation system. Currently, any attempt made to perform any of the detailed repairs outlined in the Rehabilitation Plan is causing the adobe walls to slough off into piles of dirt.

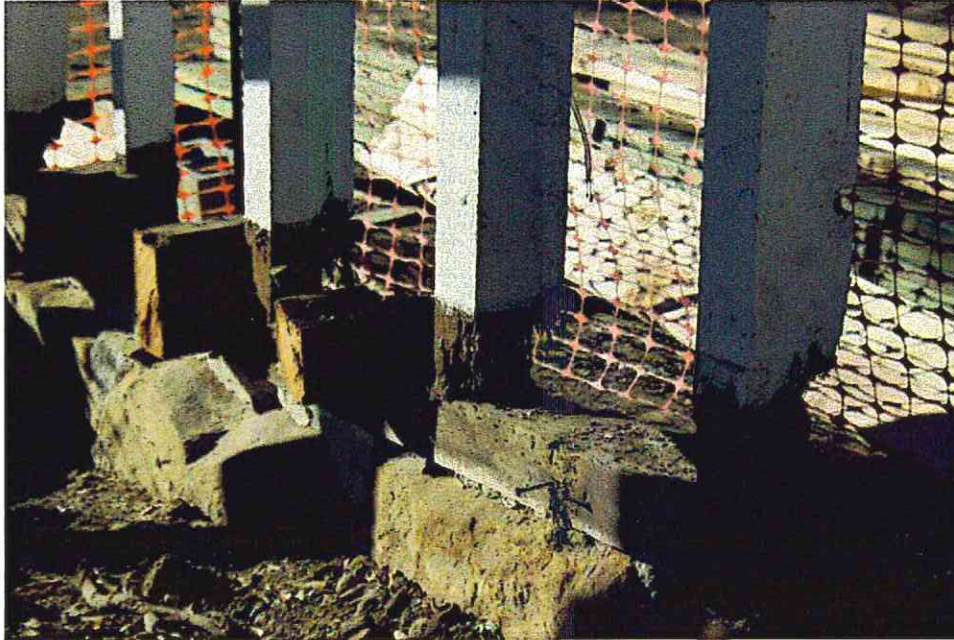
Photo 5 : Vertical support posts completely rotted at sill plate

The interior framing, wood siding, and floor and roof joists of the water tower structure have suffered extensive dry rot and damage from moisture intrusion and pest infestation. The most extensive damage occurs at key connection locations (see image 5 to 7). As indicated in the images, there are sections of posts that should be bearing on sill plates that have completely deteriorated leaving a void. Due to the extensive number of voids present throughout the structure's framing, the possibility of providing any kind of patch repair to the existing wood members is not feasible. The tower's main structural members have lost all structural integrity, as their cross sections have been reduced significantly from this damage (see image 8).

construction crew on-site, it should be carefully dismantled as soon as possible as indicated in our previous reports and reconstructed using any salvageable timber on site, in addition to replacement wood framing.

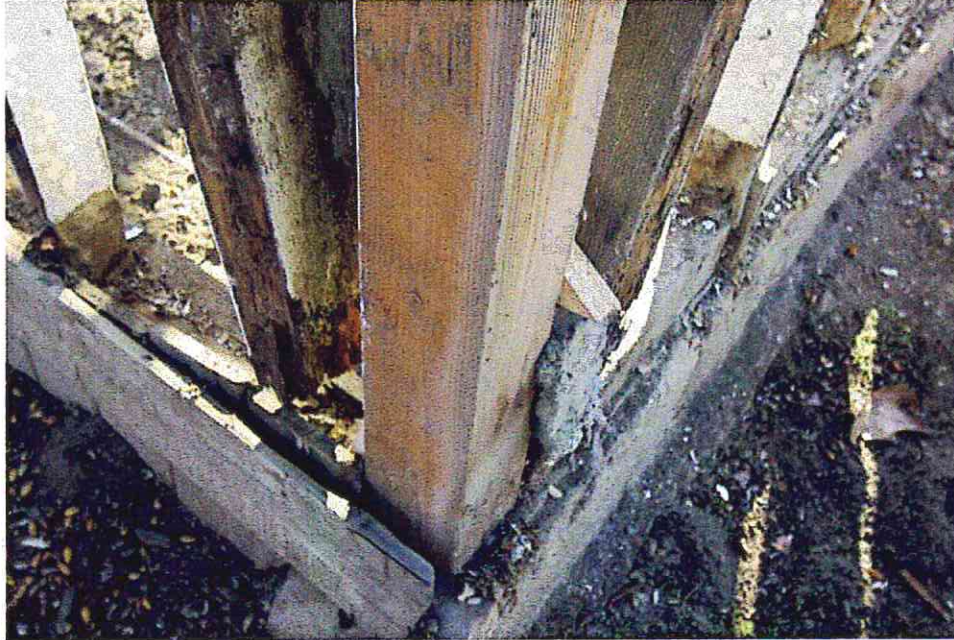
Photo 9: Stone Foundation at Tower on right, earth to wood contact on left

The tower sits on a stone foundation that occurs only on two sides of the structures footprint (see image 9). We anticipate maintaining the existing stone base on the two sides of the structure and placing a new foundation inboard, non-visible to the naked eye, that would provide the structural support needed for this tower element. However, that cannot be done effectively if the framing members supporting the structure are not of a capacity that can deliver the necessary loading to the foundation.

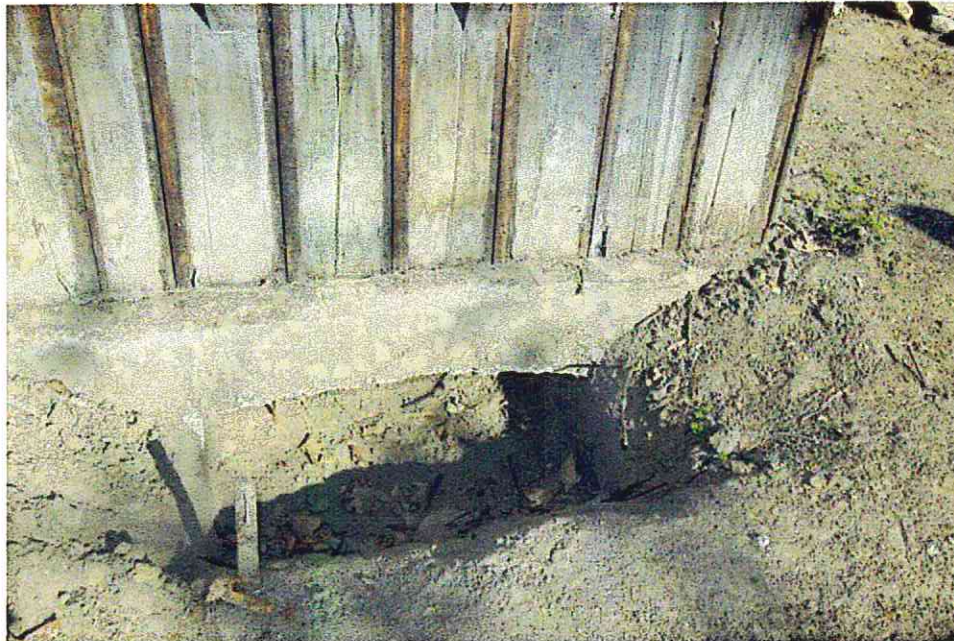
Photo 10: Excavation at perimeter of slab at Cottage showing the absence of a footing

The cottage is not historic in nature based on the report from the Historian, however it is part of the landmark for the Hosmer-Juarez property. As part of the Rehabilitation Plan, a structural design was provided to rehabilitate this structure as well. It has been determined that the cottage sits on a slab that does not have adequate embedment into the competent bearing material (see image 10). Additionally, the walls of the cottage are fabricated with flat 2x studs (see image 11). This is a convention that does not meet current code standards and is structurally unstable to adequately support the roof framing or provide lateral resistance during a seismic event. A vast majority of the wood framing of the cottage also suffers from significant rot and damage due to moisture exposure, parasite infestation, and lack of maintenance (see image 12). This building should be reconstructed to create a life safety factor that allows for the future use of the structure.
