ATTACHMENT B:

TREATMENT "PEOPLE OF LOMPOC: ETHNIC DIVERSITY" MURAL

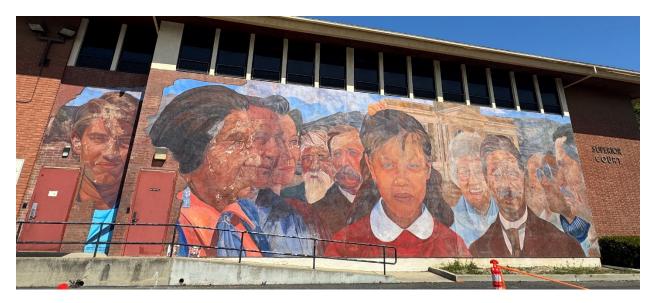
Photograph of the current state of the "People of Lompoc" mural by Richard Wyatt, Jr., on the Superior Court Building wall in Lompoc, Ca. The image has deteriorated and has flaking, paint loss, fading and blanching.

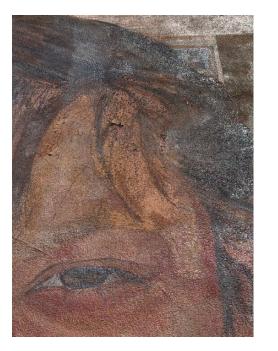
Detail of mural erosion on subject faces.
