JN 1151-01  
County of Santa Barbara Parks Division  
Goleta Beach Shoreline Management Assessment

To: Jill Van Wie  
From: Jon Moore  
Date: August 16, 2017  
RE: Assessment of Emergency Revetment and Shoreline Management Plans  
Cc: Dan Gira

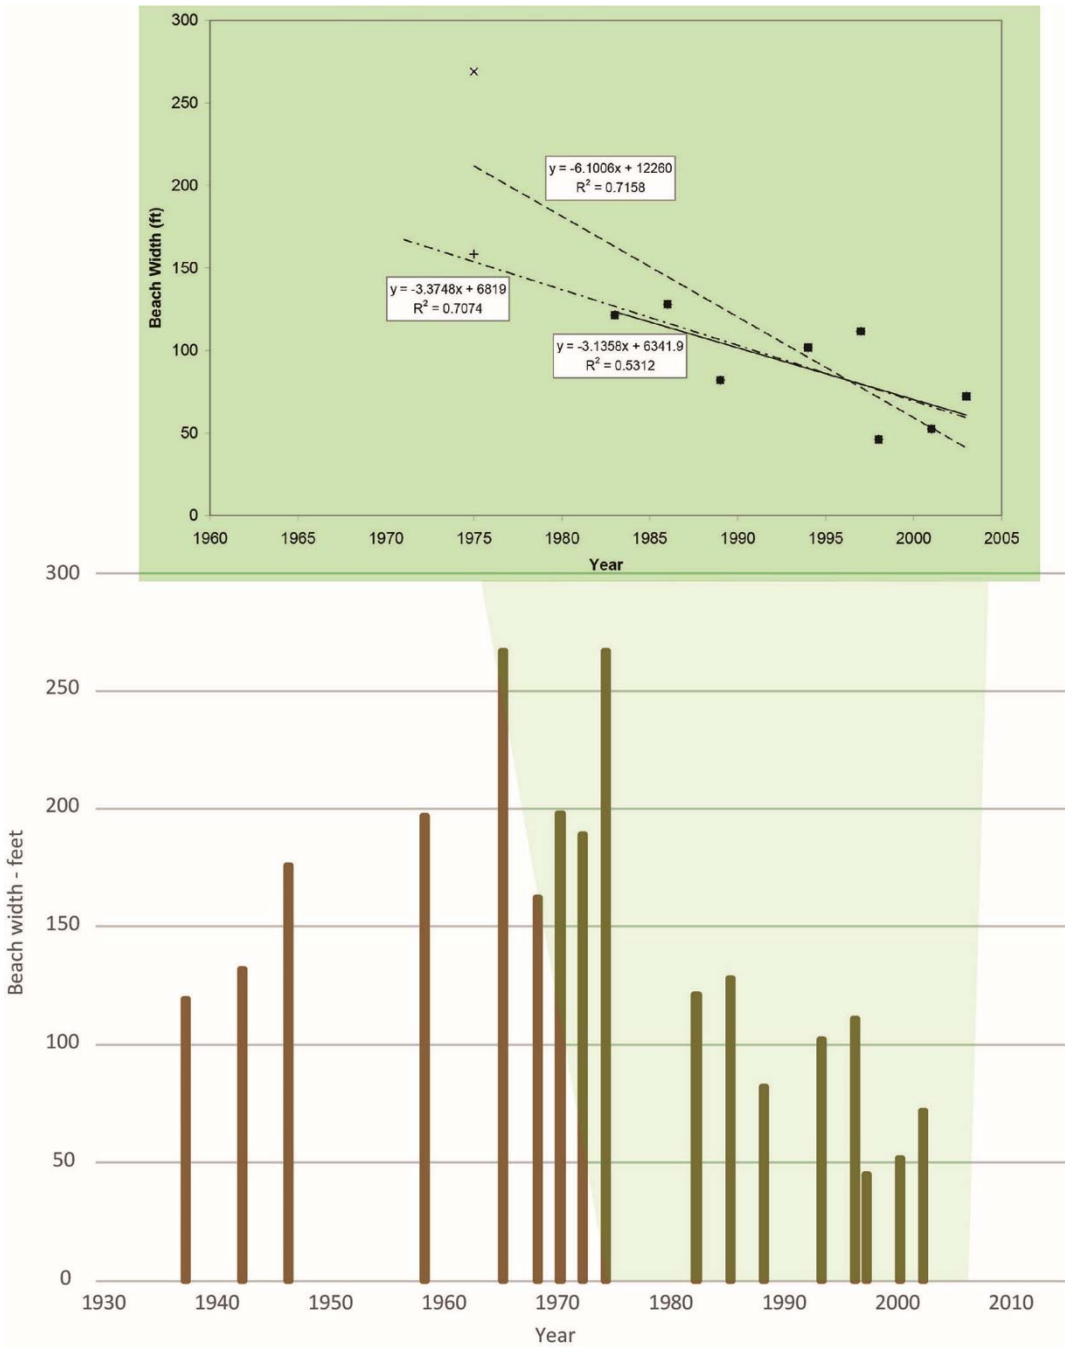
**Figure 5. Goleta Beach widths 1938 to 2003.** The figure shows historical beach widths measured from aerial photographs flown between 1938 and 2003 (Revell, 2007). The inset box is reproduced from Moffatt and Nichol (2007) and illustrates their interpretation of the erosion trend after the record 1982/83 El Niño winter when significant losses occurred. The regression lines represent recession trends of 3 to 6 feet per year depending on whether the 1982/83 losses are included in the analysis.

Before placement of fill behind the beach in 1945, Goleta Beach was considered to be a shifting sand spit regularly breached by the Goleta Slough. Significant changes have been noted since that time. Historical aerial photographs flown between 1938 and 2003 were analyzed (Revell and Griggs, 2006; Revell, 2007) to review changes that were visible over that time period. A summary of the beach measurements is shown in the bar chart of **Figure 5**. The data indicates that the beach accreted between 1938 and 1966, eroded during the 1968/69 and 1972/73 El Niño storm seasons, and accreted again to its maximum recorded width by 1975. The effects of the record 1982/83 El Niño severe storm winter season are shown by the abrupt loss when the beach permanently receded by over 100 feet from its maximum recorded historic width. Thereafter, the beach has been steadily eroding at a rate that varies from about 3 to 6 feet per year as shown in the green inset box of **Figure 5** (Moffatt and Nichol, 2007; Everts Coastal, 2006).

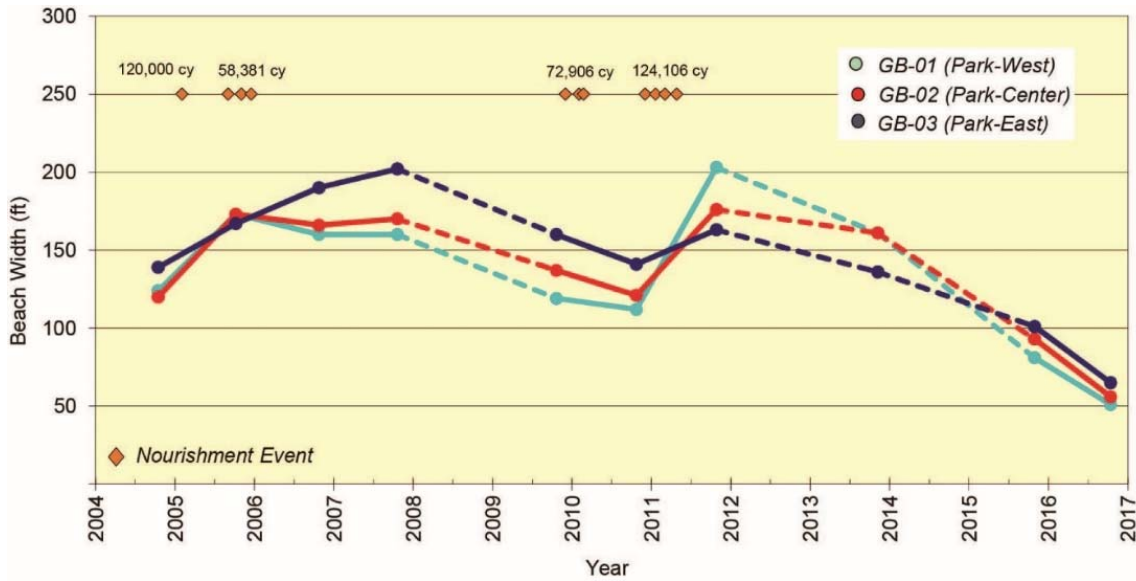
**Figure 6. Goleta Beach widths 2004 to 2016 (Fall Only).**

Comprehensive shoreline monitoring of Goleta Beach has been performed by Coastal Frontiers Corporation since 2004. The program consists of precision beach profiles surveys conducted every Spring and Fall to observe seasonal and longer term trends. Three profiles are located within the park's shoreline, one is roughly central to the sand spit near the Goleta Slough mouth, and two end transects on the east and west ends are intended to note conditions upcoast and downcoast of the park limits. The results of their measurements to date are reproduced in **Figure 6**. The data indicates a strong correlation with the County's beach nourishment cycles and episodes of beach accretion.

The benefits of the Goleta Beach nourishment program are clearly evident from the **Figure 6** beach monitoring data. The volume of sediment that was placed on the beach between 2010 and 2011 restored beach widths to their 2008 wide condition as shown in **Figure 8**. The 150 to 200-foot wide beach at that time enhanced the recreation opportunities and significantly increased the beach's storm protection buffer distance.

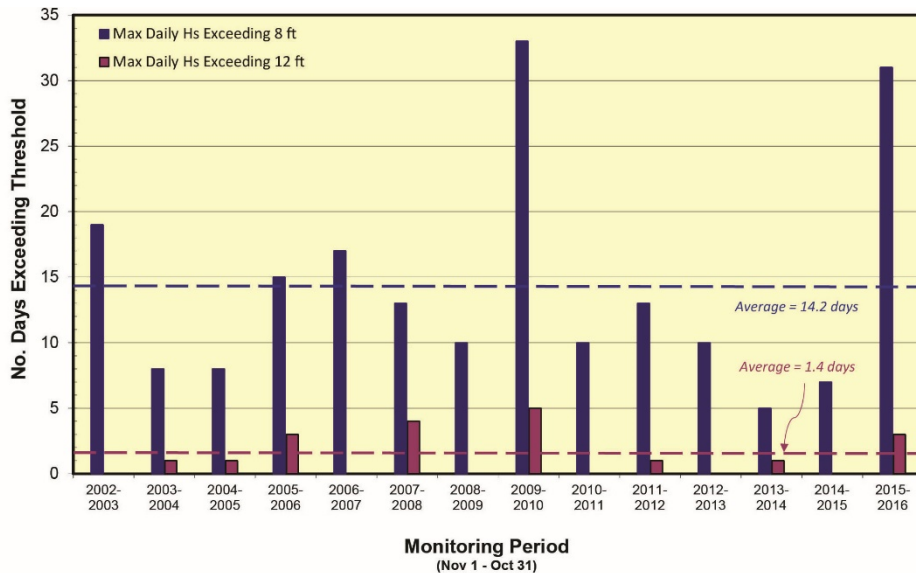
**Figure 7. Wave data summary from CDIP Goleta Point Buoy**

A summary of wave conditions that effected Goleta Beach are shown in **Figure 7**. The figure illustrates the number of days that wave height exceeded either 8 or 12 feet and provides a general indication of wave climate over the beach monitoring period. The 2009/2010 and 2015/2016 measurement years reflect the increased duration of higher wave conditions associated with the more severe El Niño winter seasons that occurred.

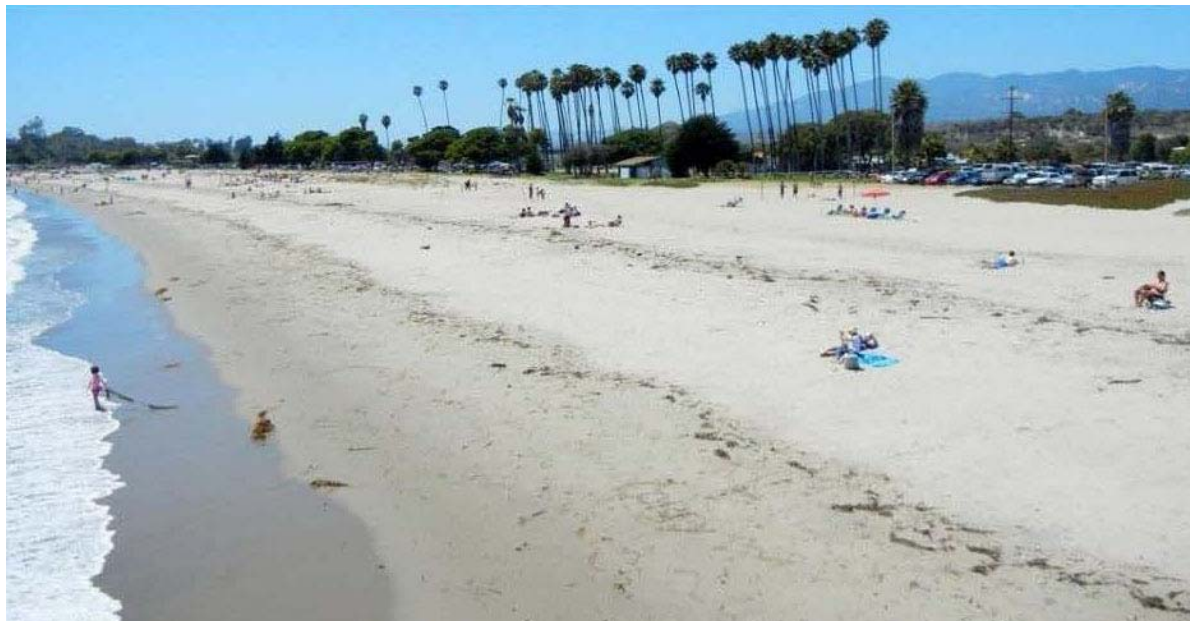
**Figure 8. Goleta Beach in June 2012.** The photograph shows beach conditions following the 2010-2011 beach nourishment cycle. Beach width is about 150 to 200 feet wide.

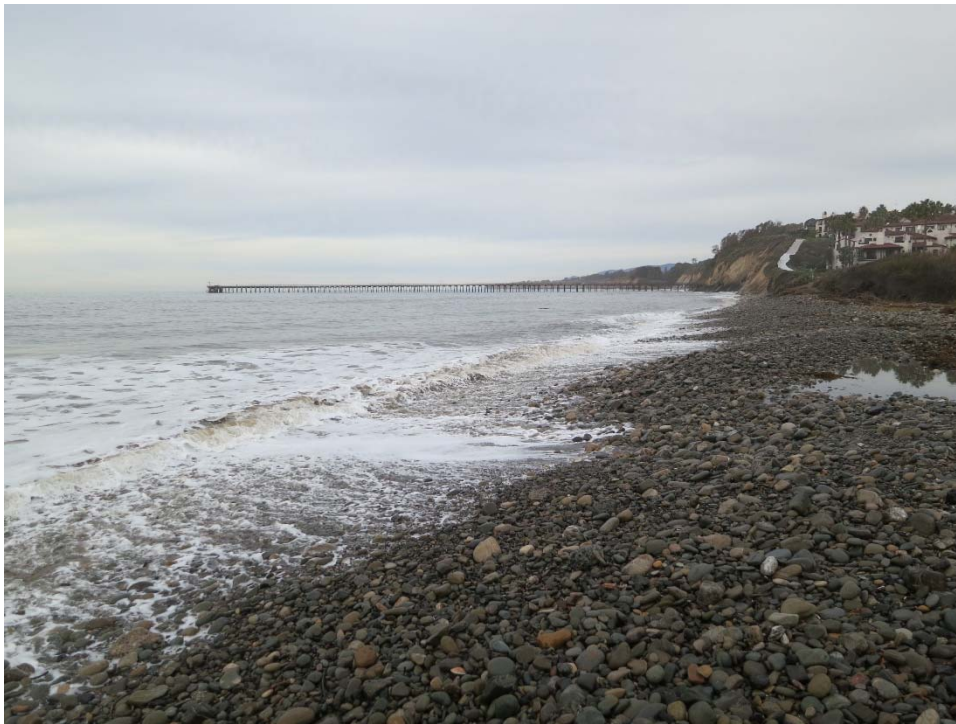
**Figure 13. Haskell's Beach January 11, 2015. The photograph taken during a tide level of approximately +6' MLLW shows the massive natural basement layer deposits of gravel, boulders, and cobble that were exposed when all of the beach sand was stripped away by severe storm surf and high tides.**

**Figure 13** shows Haskell’s Beach in January 2015, shows when a vast basement layer of gravel, boulders, and cobble material was uncovered at that time. If a cobble deposit is to be enhanced at Goleta Beach, significantly greater volumes of material than anticipated may be required.

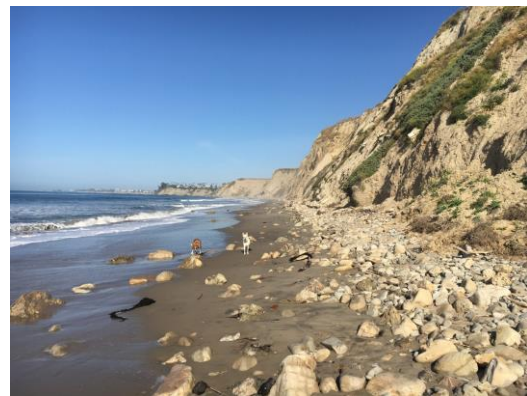
*Formerly wide South Coast beaches such as More Mesa were severely eroded by the 2015-2016 El Niño and remained narrow in 2017, exposing small natural cobble berms. This berm, 2.5 miles downcoast from Goleta Beach is approximately 15-20 feet wide and 2-3 feet high.*

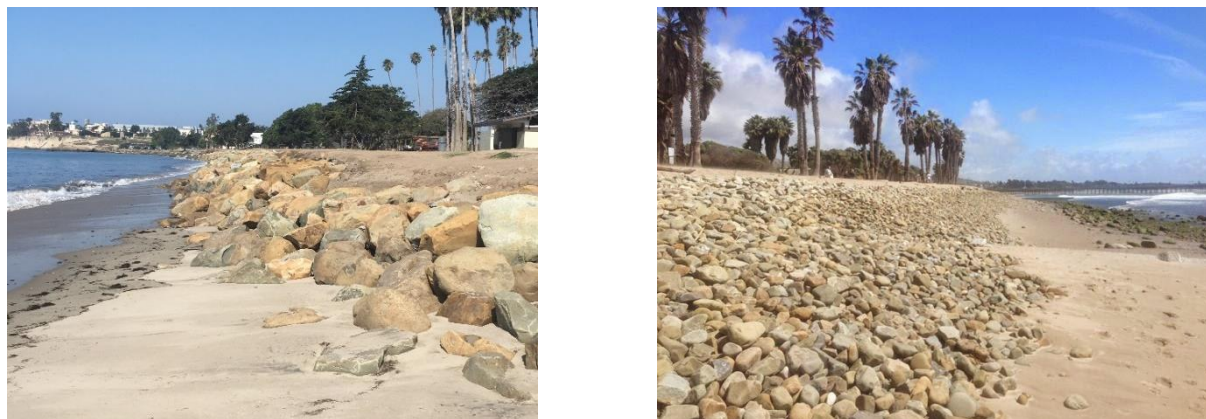
Figure 1. Goleta Beach revetment (left) and Surfers' Point C-Street expansion cobble berm (right)  
Surfers' Point Photo source: <https://toolkit.climate.gov/case-studies/restoring-surfers-point-partnerships-persistence-pays>

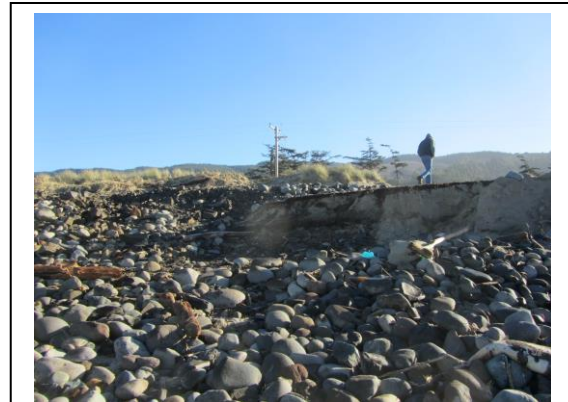
*Cape Lookout State Park in Oregon suffered erosion damage in fall and winter of 2016 along the cobble and dune beach, destroying a segment of park access road. Note cobbles and eroded dunes in background. Oregon Shores Conservation Coalition, October 2016*

The Cape Lookout State Park cobble berm project was originally constructed in 1999. High tides and storm surges associated with the December 2007 to January 2008 El Niño event caused partial dispersal of the cobble berm, erosion of the constructed foredunes resulting in exposure and damage to Park infrastructure including a septic drain field. The emergency permit response included placement of an additional 4,000 cubic yards of rock material raising the level of the remaining cobble berm by 9.8 feet. While detailed information was not located as to how this reconstructed cobble berm and dune system performed between major storm events (Komar & Allan 2010), major erosive damage was documented at this location as a result of the 2015-2016 El Niño event.

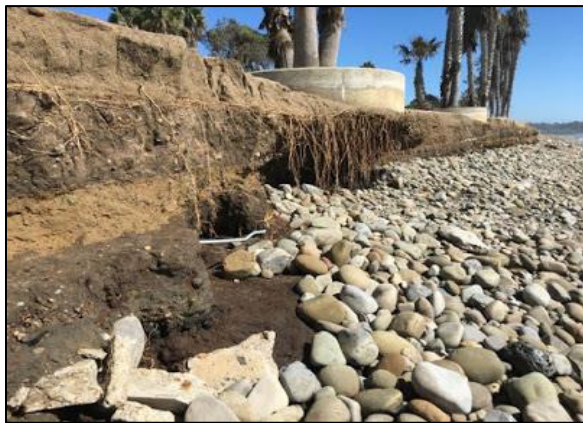
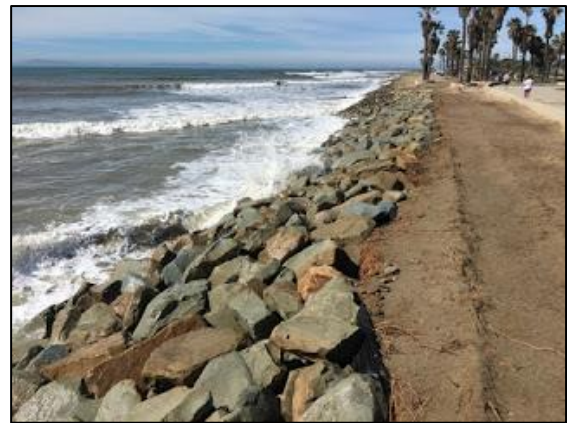
*Figure 2.* The 2015-2016 El Nino overwhelmed cobble berm protection at Surfers' Point, exposing park facilities to damage (left); in response, the City expended \$430,000 to install a 260-foot long 13.5 feet tall emergency rock revetment and cobble replenishment. The project is not yet completed.

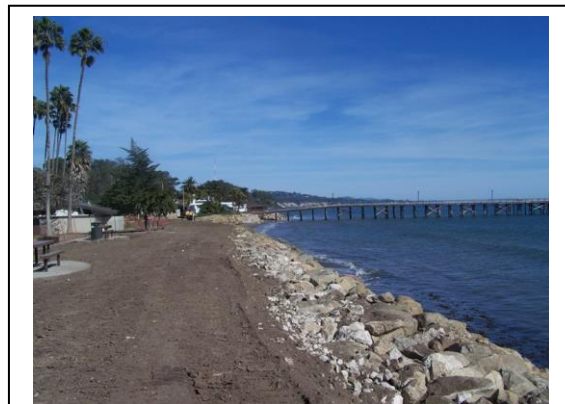
*In halting landward erosion of Goleta Beach Park, under current severe beach erosion and historically low sand conditions, new and existing revetments have contributed to Goleta Beach becoming intertidal. The duration of this condition will depend substantially on renewed sediment input into the system*

The western 1,200 feet of revetments were buried for all or most of the ten year period from 2004 to 2014, with the majority of these revetments in daily contact with the surf for approximately 1.5 years since the 2015-2016 El Niño. During this period, detailed beach surveys performed by Coastal Frontiers Corporation did not document any differential erosion between the beach fronting the revetments and unprotected areas of the Park indicating a lack of active erosion. The new 870 feet of revetment installed in 2017 has been in near daily contact with the surf. Those concerned about potential for active erosion impacts may conclude that the beach is narrow at least in part due to active erosion. However, during the short duration of this revetment's existence, others would argue against any substantial contribution to active beach erosion.

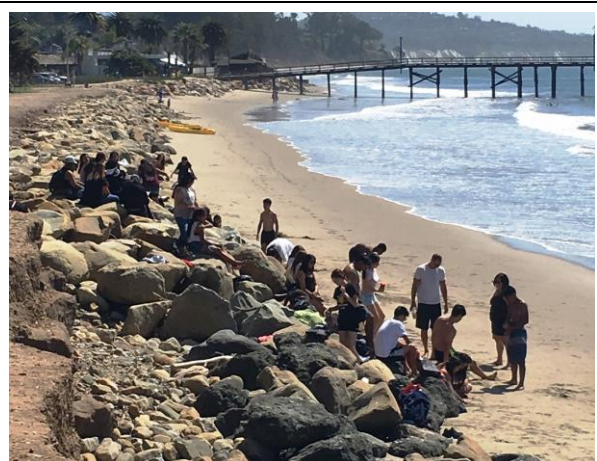
*Although concerns exist that revetments inhibit coastal access, able bodied beachgoers regularly cross, sunbathe or rest on revetments at Goleta Beach and other South Coast Beaches.*

Vertical Coastal Access: Concerns have been expressed that rock revetments inhibit vertical coastal access. At Goleta Beach, when fully exposed to up to 11 feet in height, the revetments can increase difficulty of shoreline access. Field observations of exposed rock revetments at Goleta Beach and 11 other South Coast beaches show regular public access across exposed rock revetments with limited impediments to access by the able bodied. Revetments are relatively stable and typically offer level surfaces for foot and handholds. While not necessarily desirable, revetments appear to create only a modest barrier to vertical access to the able bodied, while presenting a barrier to the elderly or disabled.
