**COUNTY OF SANTA BARBARA
PLANNING AND DEVELOPMENT**

RE: 10APL-00000-00016 Bagdasarian Appeal of P&D Denial of
09LUP-00000-00256

TECHNICAL MEMORANDUM

Subject: Hot Springs Creek Hydraulic Analysis

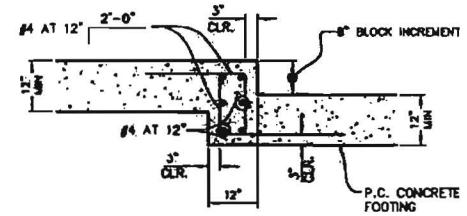
NOTE: REINFORCEMENT SHOWN IS IN ADDITION TO THAT SHOWN IN THE WALL DETAIL(S).
TYPICAL SPREAD FOOTING STEP DETAIL
SCALE: N.T.S.

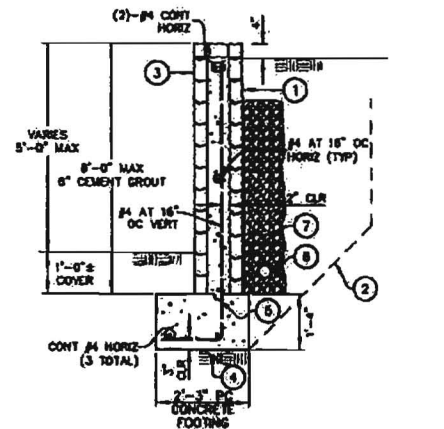
TYPICAL RETAINING WALL SECTION
SCALE: 1" = 2'

1. CONSTRUCT WATERPROOFING AT BACK OF WALL.
2. CONSTRUCT GRANULAR NON-EXPANSIVE BACKFILL COMPACTED TO A MINIMUM 90% RELATIVE COMPACTION (UNLESS NOTED OTHERWISE) AT A 1:1 SLOPE FROM BOTTOM OF FOOTING TO A HORIZONTAL DISTANCE NO LESS THAN 60% OF RETAINED SOIL HEIGHT.
3. CONSTRUCT 4" WIDE SANTA BARBARA SANDSTONE VENEER WITH IRREGULAR PATTERN PER DETAILS "B" AND "D", THIS SHEET.
4. UNDISTURBED ORIGINAL GROUND OR SUBGRADE COMPACTED TO 90% RELATIVE COMPACTION.
5. CONSTRUCT 2x KEYWAY AT CONCRETE CONSTRUCTION JOINTS.
6. CONSTRUCT CONTINUOUS 4-INCH PERFORATED PIPE AT TOP OF FOOTING AND DRAIN TO DAYLIGHT.
7. CONSTRUCT MINIMUM 12" WIDE FILTER FABRIC WRAPPED GRAVEL COLUMN AT BACK OF WALL TO WITHIN 12" OF FINISH SURFACE BEHIND WALL.

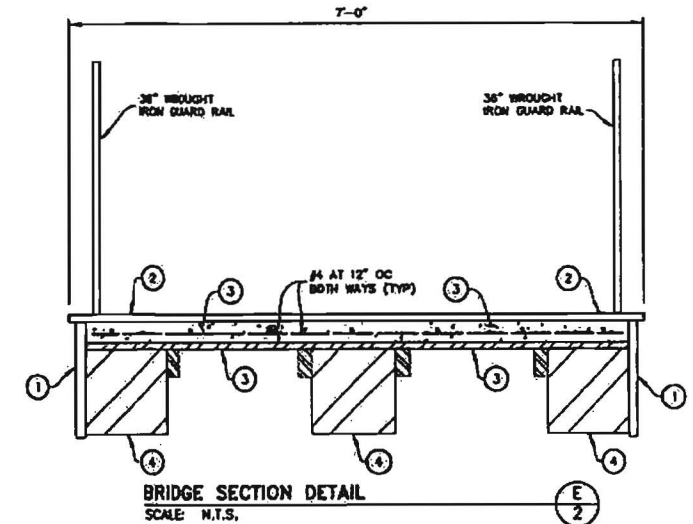
BRIDGE SECTION DETAIL
SCALE: N.T.S.

1. CONSTRUCT 2" WIDE SANTA BARBARA SANDSTONE VENEER WITH SAME IRREGULAR PATTERN PER DETAIL "B", THIS SHEET.
2. CONSTRUCT 1" THICK FLAGSTONE WITH SAME IRREGULAR PATTERN PER DETAIL "B", THIS SHEET.
3. CONSTRUCT 3" THICK CEMENT GROUT ABOVE 1" THICK PLYWOOD.
4. CONSTRUCT 12"x12" WOOD BEAMS. EMBED 36" INTO BRIDGE ABUTMENTS.
5. BRIDGE ABUTMENTS PER WALL DETAILS THIS SHEET.
