Coastal Armor Destroys Beaches

April 11, 2017

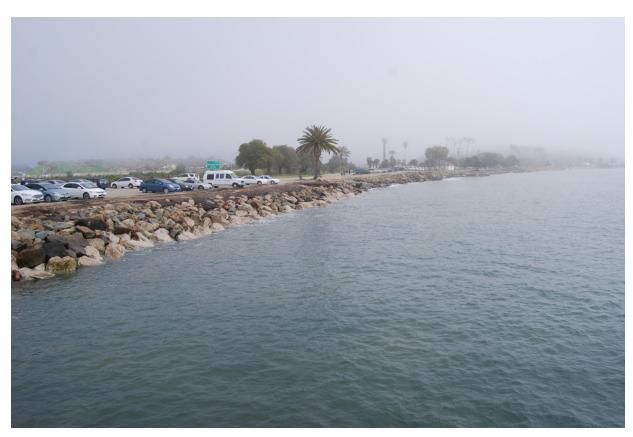
Goleta "Beach" on March 14, 2017 at +4 ft tide. Typical summertime high tide is +6 ft.

AMEC's 2015 EIR predicted that until 2050, "the emergency revetment would remain buried except temporarily following heavy storm event[s]"

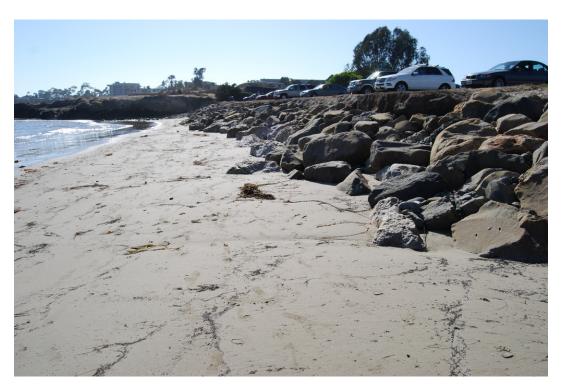
Goleta Beach west end revetment, September 15, 2016.

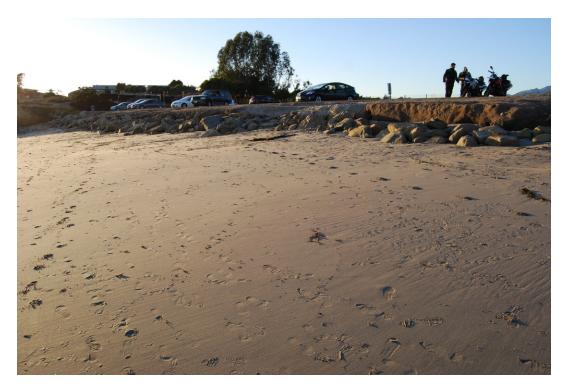
Goleta Beach west end revetment, December 28, 2016. There has been literally (littorally?) tons of "sediment input" at Goleta Beach over the last two years...

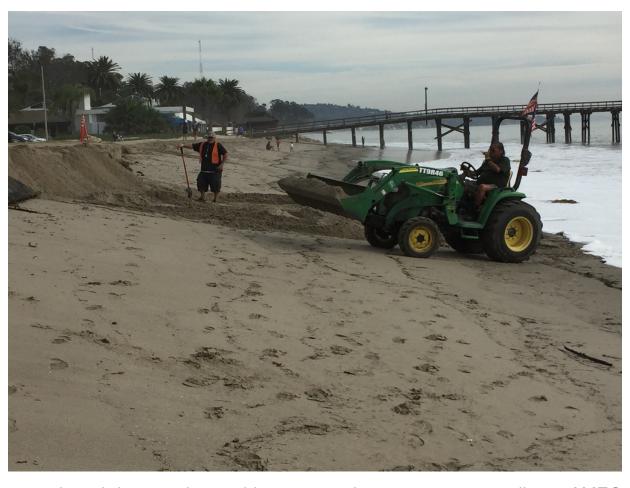
... and yet it has not been able to cover the revetment naturally as AMEC predicted and County staff asserted.

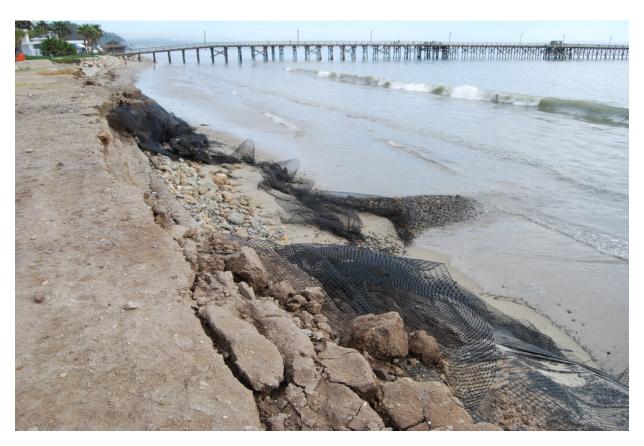
Moffatt & Nichol: "The Tensar geogrid material (used for wrapping all cells) is especially durable and rugged, i.e. it is not expected to tear or deteriorate under the conditions at the Park site."

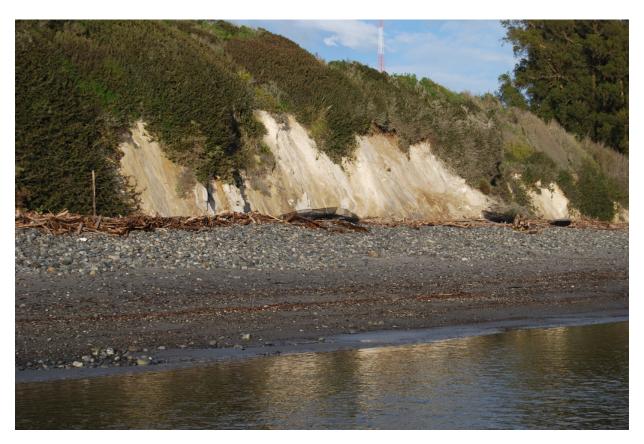
Moffatt & Nichol: "In general, it is expected that there will be no impacts to the Goleta Beach coastal processes or marine resources if the geotextile cells are damaged or become ineffective over the long term."

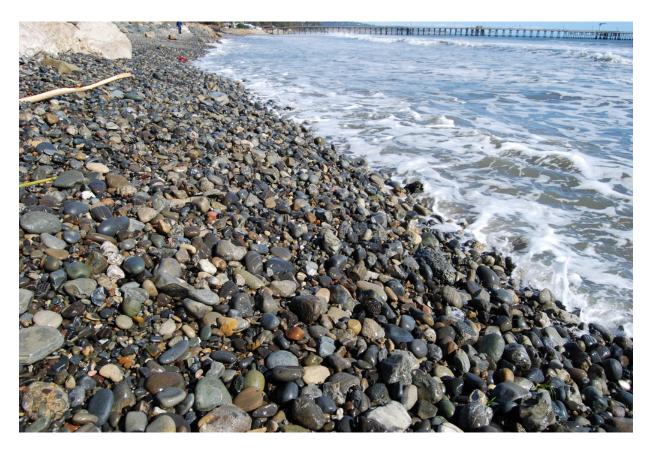
Goleta Beach on February 22, 2017.

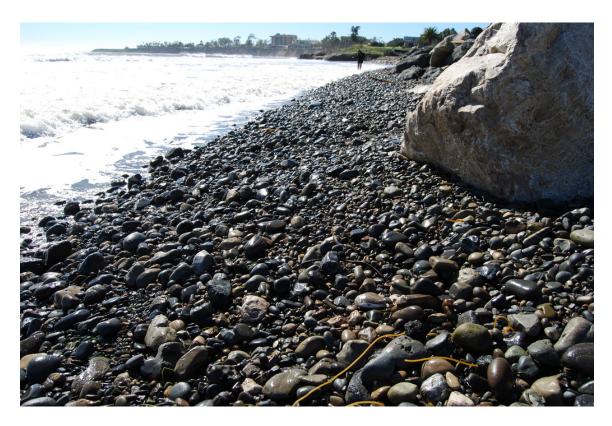
Goleta Beach on February 22, 2017.

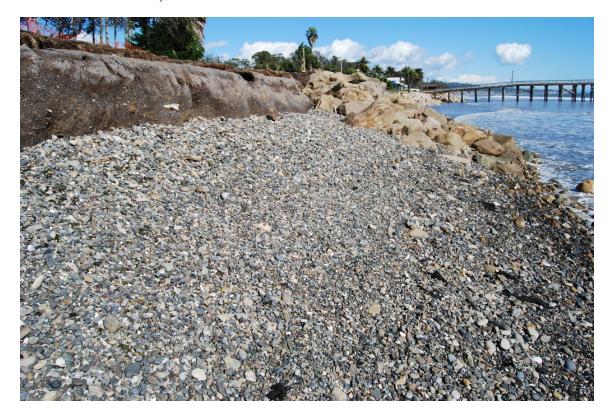
Goleta Beach on February 22, 2017.

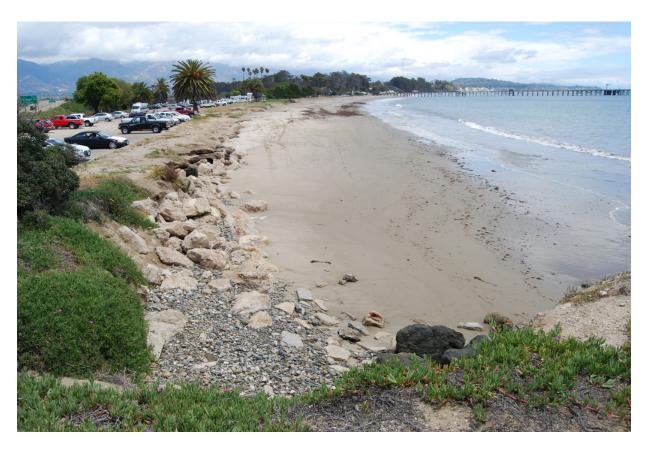
Goleta Beach on May 15, 2015.

Natural cobble at the west end has prevented significant erosion of the access trail over the last two years.

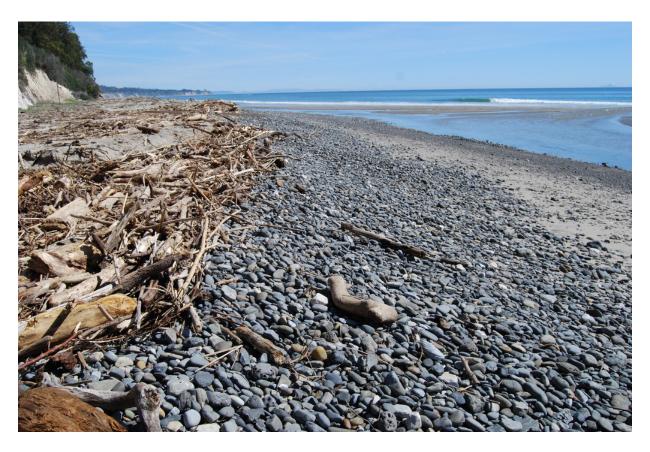
Natural cobble berm east of Goleta pier on March 8, 2017.

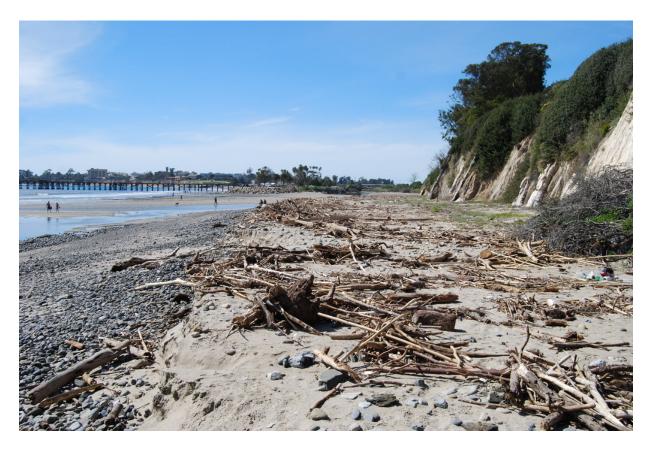
Natural cobble berm east of Goleta pier supports a wide sandy beach and stable vegetation at the base of the cliff. March 8, 2017.
