August 18, 2017

Re: Goleta Beach Revetment

**I. The County Must Undertake a Complete Review of the Revetment and Project Alternatives.**

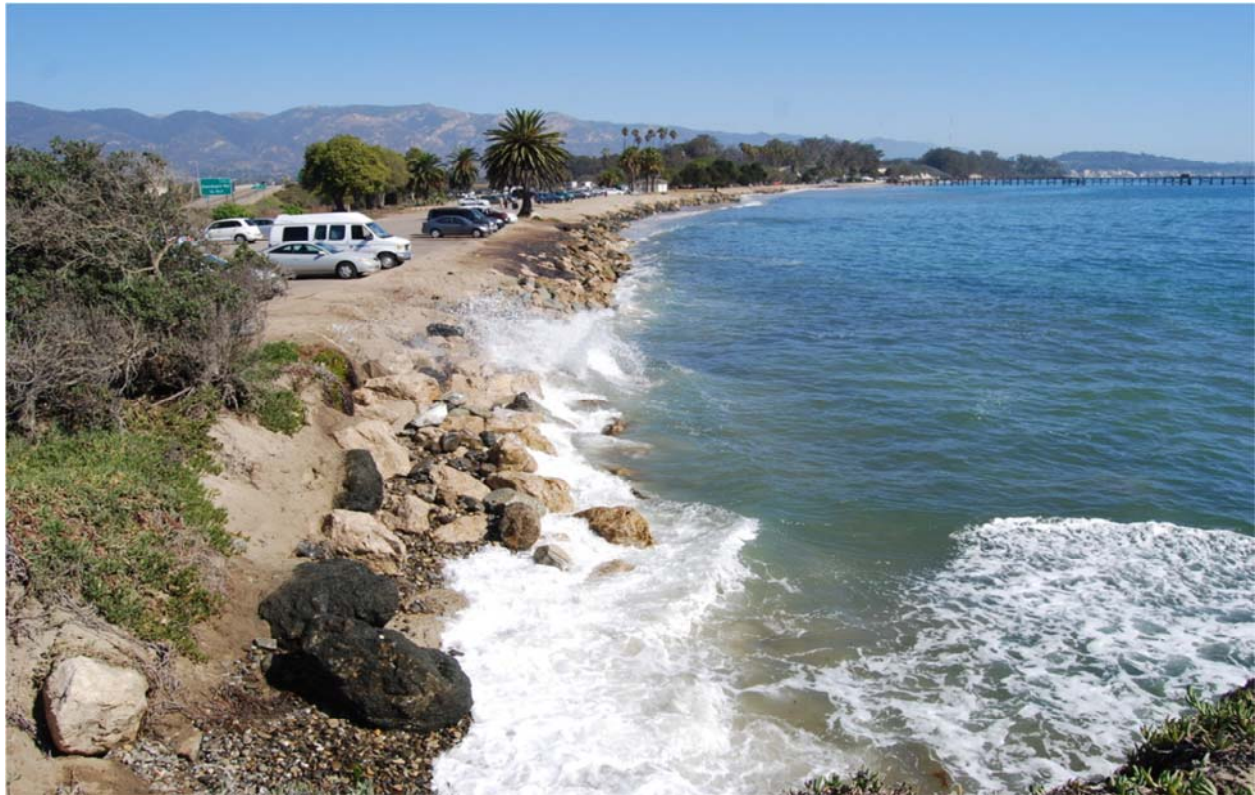
*Exposed revetment at Goleta Beach on October 18, 2016, courtesy Surfrider Foundation.*

The revetment has spectacularly failed. Surfrider has documented near-continuous revetment exposure greater than 200 linear feet every month since the CDP was approved by the Commission in December 2015. The County's 2016 Report confirms this exposure. See Santa Barbara Cty. Parks, *Goleta Beach Revetment Annual Monitoring Report 2016*, at D2-D3. Beyond strongly indicating that the revetment is performing remarkably worse than expected and must therefore be reevaluated under the Emergency Permits, such continuous exposure will itself trigger mandatory reapplication to the Coastal Commission for a new permit in December 2017, two years after the date of the CDP's issuance.<sup>1</sup>

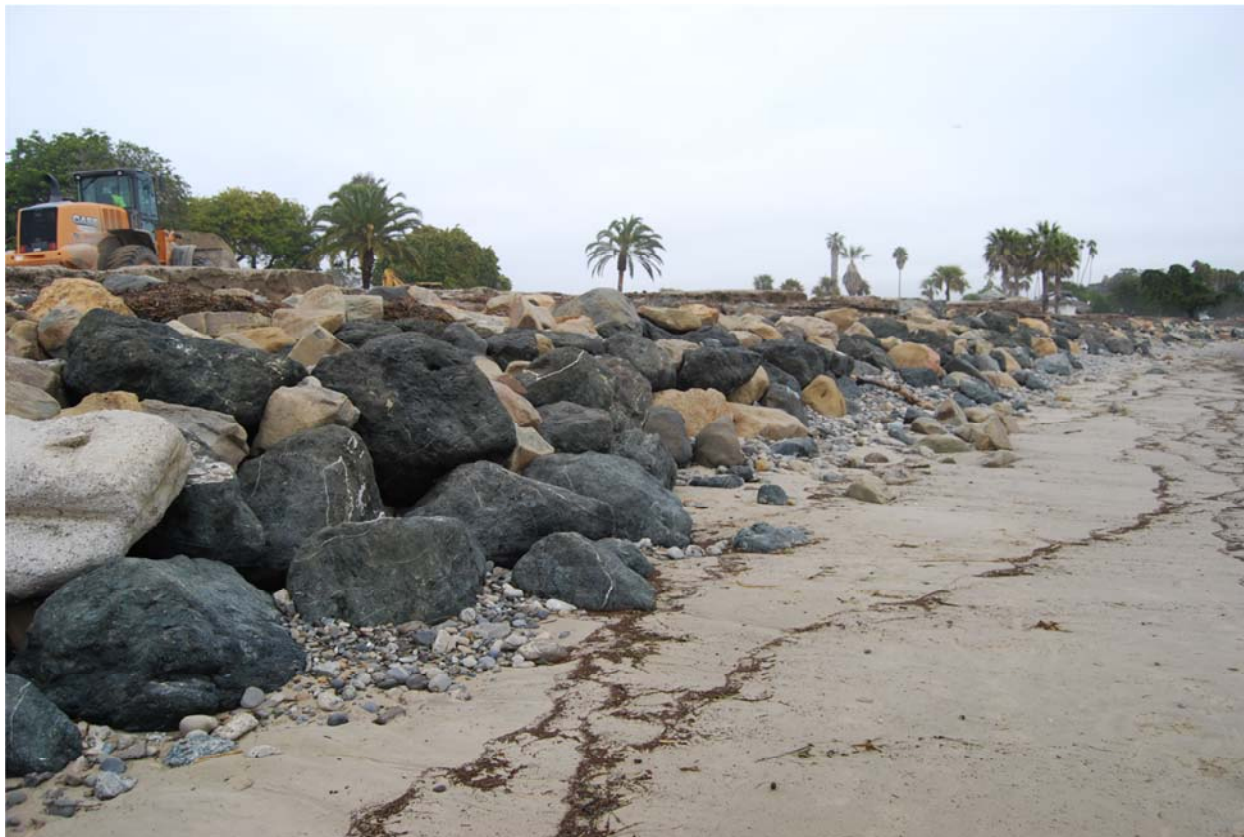
*Exposed revetment at Goleta Beach in February 2017, courtesy Surfrider Foundation.*

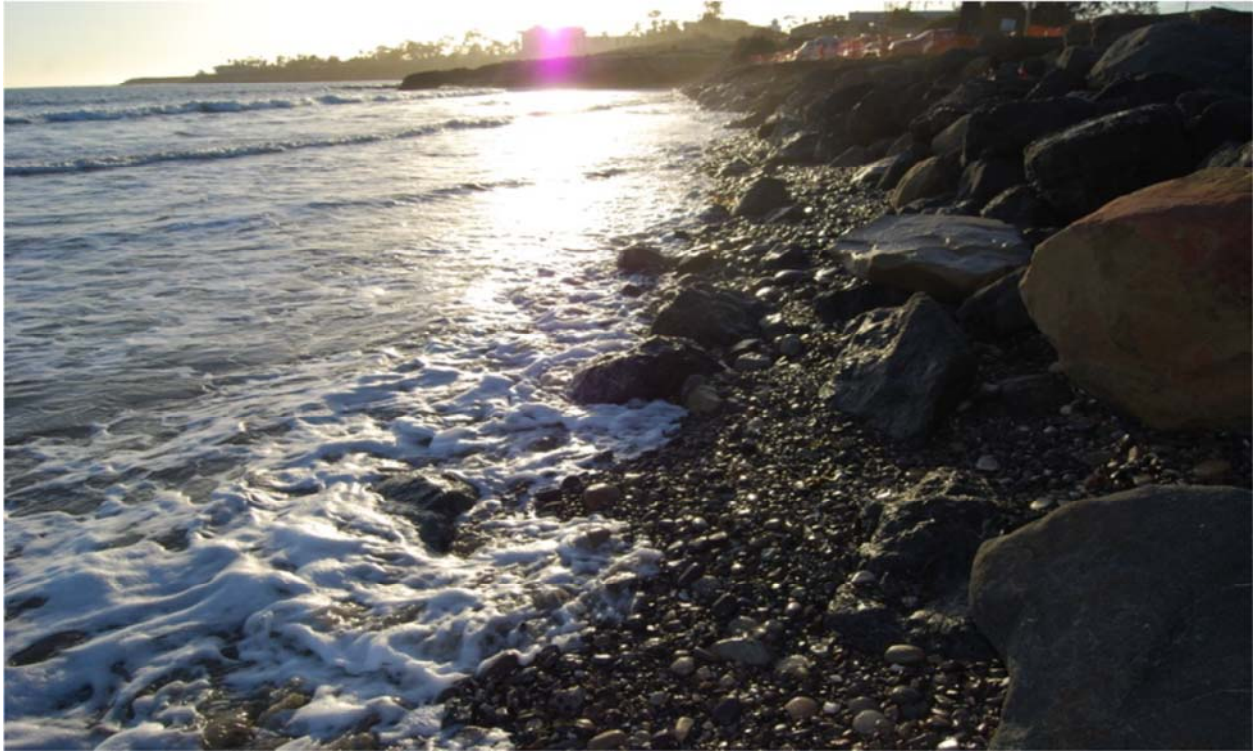
First, a cobble berm could serve as a “soft armoring option for the beach. It would protect the beach from the harshest wave forces associated with storms, while remaining flexible and able to move with the beach’s natural sand cycle, thus avoiding the critical issue of passive erosion. Further, it would protect critical public access to the beach even in times of increased storm-related erosion. Such cobble berms are found at river mouths (for example, Surfers Point, Ventura) and as a “lag” deposit below beaches near bluffs (for example, in the vicinity of Goleta Beach).<sup>5</sup> A rigorous technical analysis by Environmental Science Associates “indicates that a cobble berm can be employed to limit erosion at Goleta Beach.” *See* Letter from Bob Battalio, Vice Pres., Environmental Science Associates to Everett Lipman, Vice Chair, Surfrider Found. Santa Barbara Chapter, at 3 (Aug. 17, 2017) (available upon request). Because naturally occurring cobblestones have been observed frequently at Goleta and other beaches in the area, this alternative should be given particularly serious consideration.

*Cobblestones at Goleta Beach in January 2016, courtesy Surfrider Foundation.*

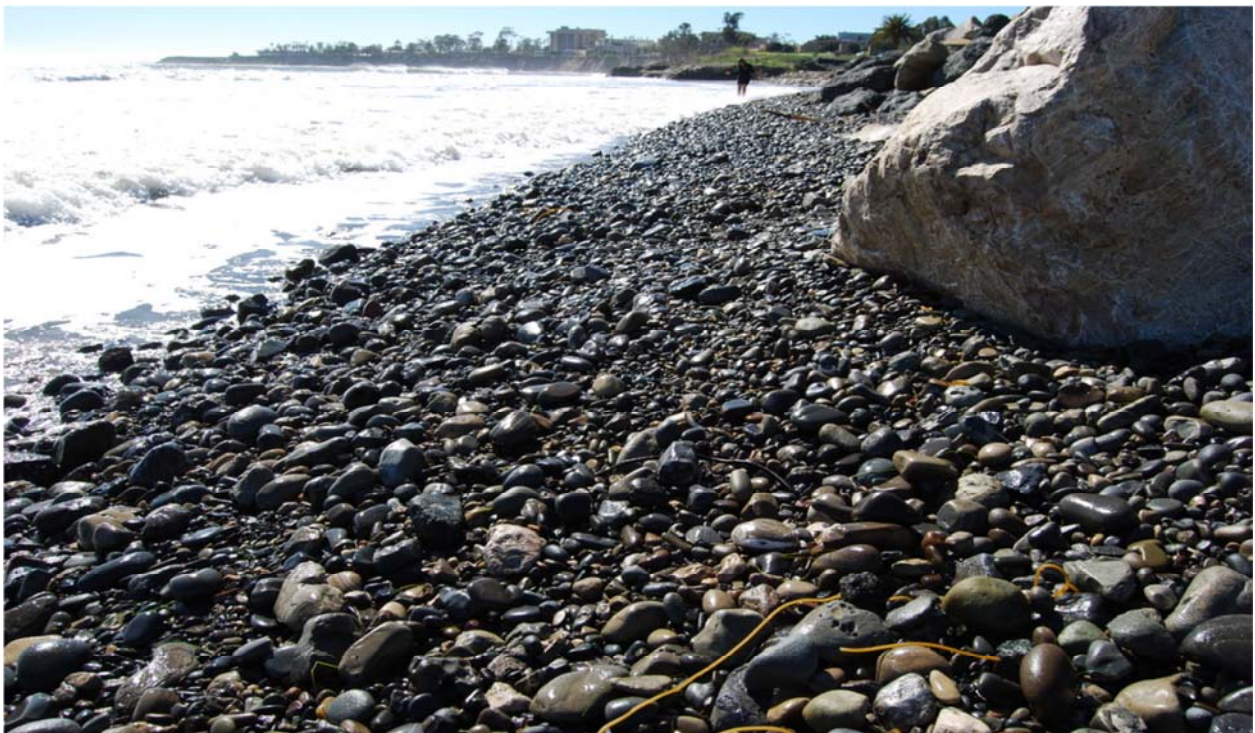
*Cobblestones at Goleta Beach in February 2017, courtesy Surfrider Foundation.*

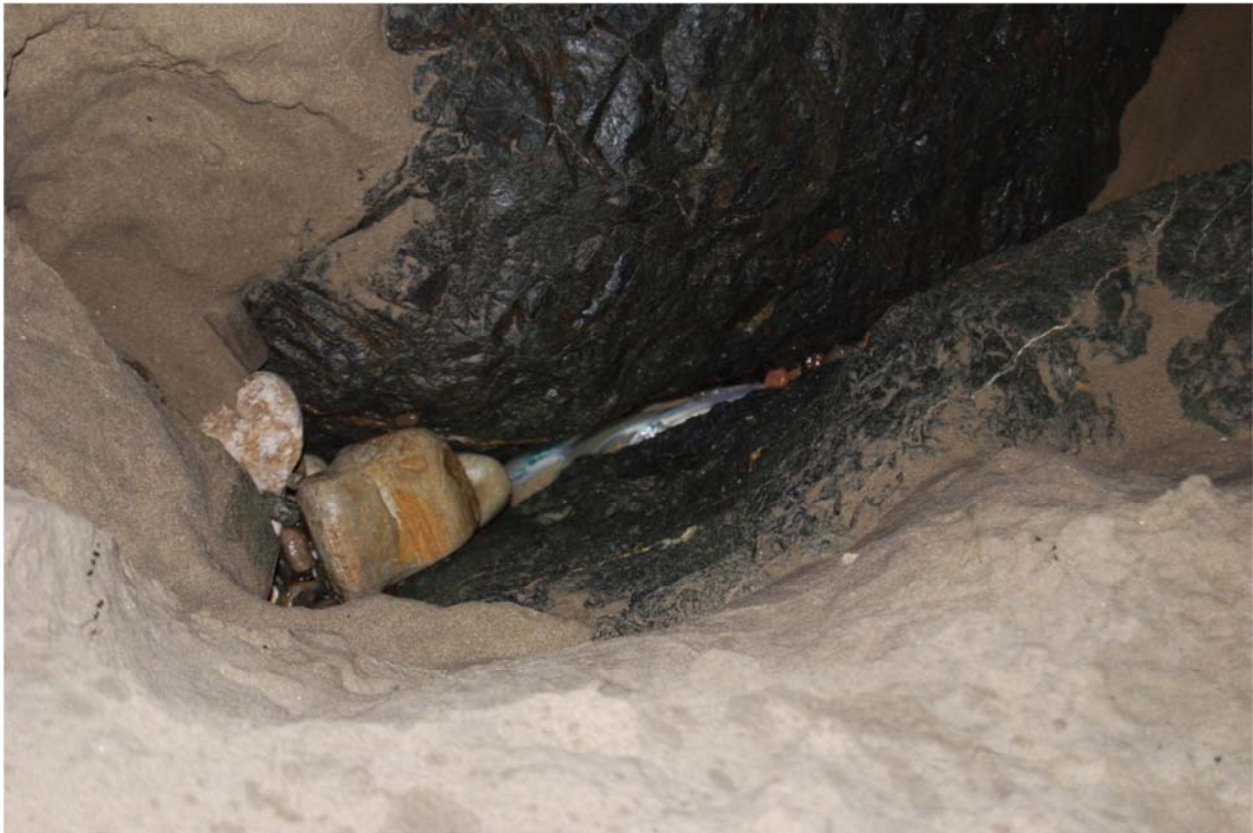
As revetment-related erosion has impaired beach width and sand supply, grunion spawning “runs” have become increasingly threatened. In some instances, grunion attempting to spawn at the beach had little or no sand to spawn in and were instead washed into the revetments (and to their deaths) by the tide. The County acknowledged in its 2016 status report that “the location of the revetment behind the beach [] limit[ed] grunion spawning habitat” during the 2016 season. *See Santa Barbara Cty. Parks, Goleta Beach Revetment Annual Monitoring Report 2016*, at A6.

*Grunion trapped in the revetment in May 2016, courtesy Surfrider Foundation.*
