EMERGENCY PERMIT

11EMP-00000-00006

Case Name: More Mesa Stairway Repair and Slope Repair
Case Number: 11EMP-00000-00006
Site Address: 5235 and 5227 Austin Road
APN: 065-310-016, 065-310-017, 065-310-018
Applicant/Agent Name: Douglas Keep for the More Mesa HOA
Owner Name: More Mesa HOA

**Geologic Review of Beach Access
Stair Area - More Mesa Homeowners Association
Santa Barbara, California
February 2011**

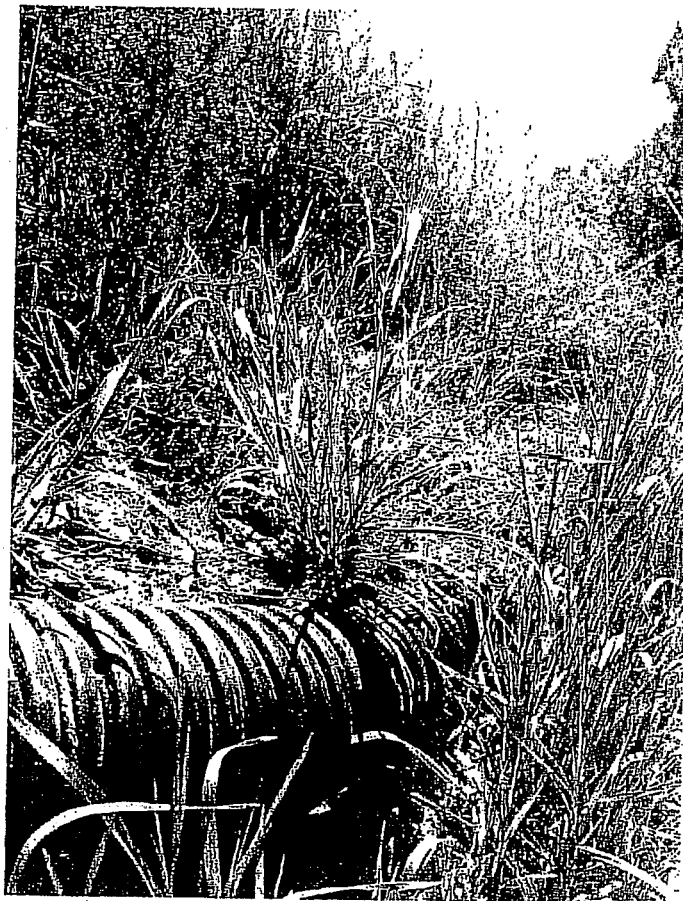
1. Ineffective collection of runoff particularly during heavy rainfall winters causes saturation of the soils which contributes to destabilization of the steep bluffs in the area of the stairway. This, in turn, causes damage to the drainage system which causes more saturation resulting in erosion and further destabilization.
2. Most of the storm runoff for the stairway system originates from an existing drain line which discharges concentrated drainage from properties and the street above. This flow is partially collected by a catch basin at the top landing.
3. The existing storm drainage system below the top landing contains broken and deteriorated drainage pipes some of which daylight just below the upper landing and contribute to erosion under the stairway and at the concrete steps where the stairway terminates.

Example of Needed Drainage System Repair

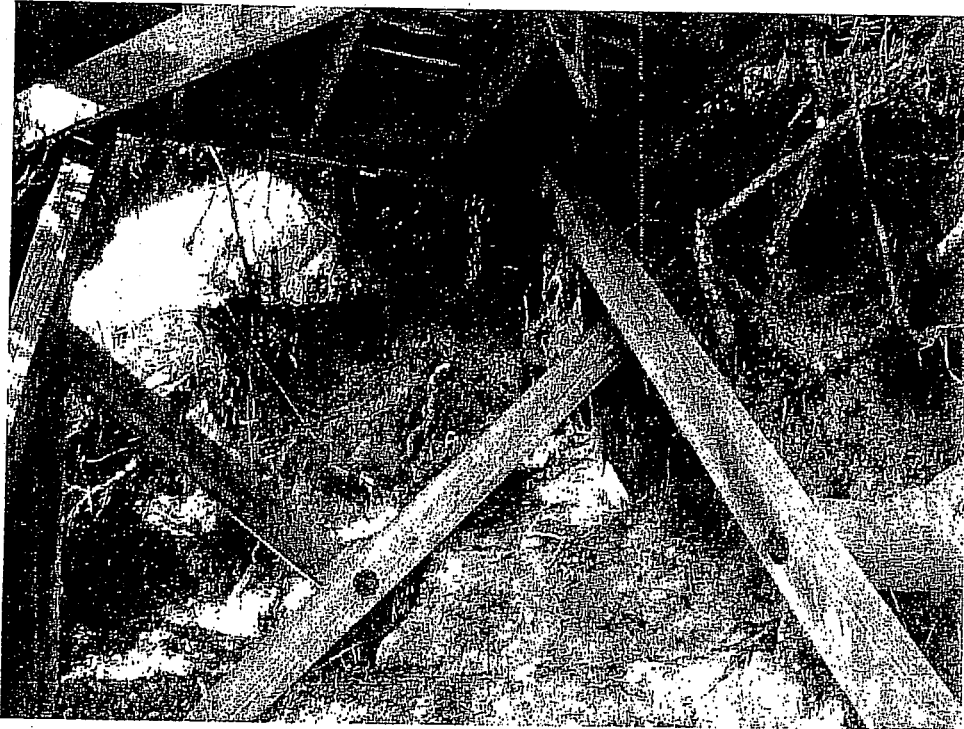
The lower portion of the bluff face, between the beach and a point approximately 30 feet up the slope, west of the stairs, contains a recently active area of soil creep and shallow sloughing that has deflected some of the wooden pier supports under the steps. The shallow nature of the slope failure would appear to allow the piers to be straightened and rebraced as one repair option. The depth to competent bedrock is unknown, but is expected to be found at a shallow enough depth under the loose slope material that new piers can be installed economically if necessary at a future date.

Shallow Slope Sloughing Causing Pier Deflection Under Middle Landing of Staircase

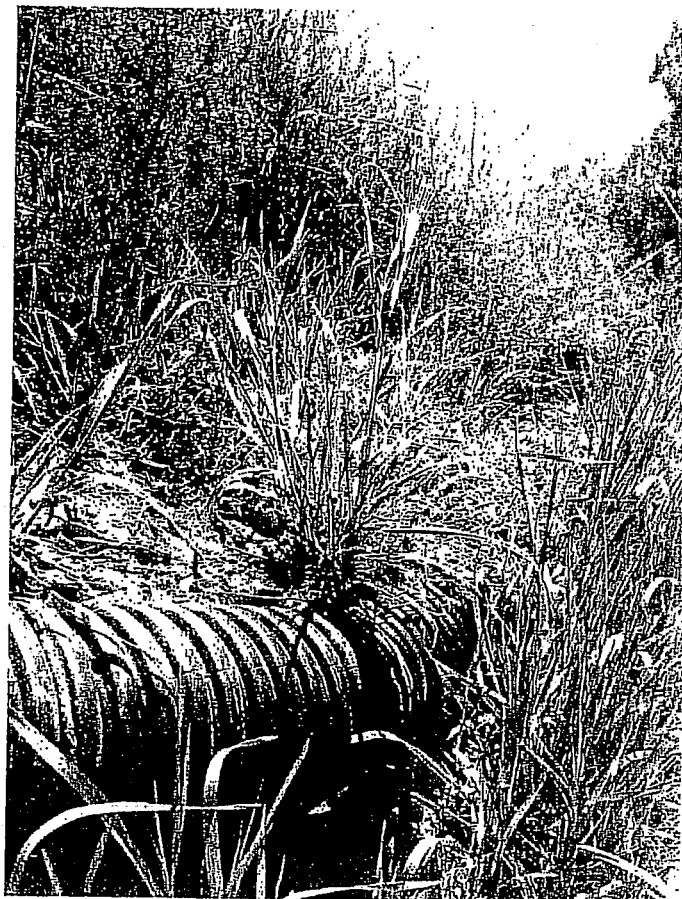
Example of Needed Drainage System Repair
