# County of Santa Barbara Department of Public Works, Transportation Division

**Proposed Final Mitigated Negative Declaration  
Bridge 51C-163 over Toro Creek Scour Repair Project  
15NGD-00000-00013  
State Clearinghouse No. 2016031043  
April 2016**

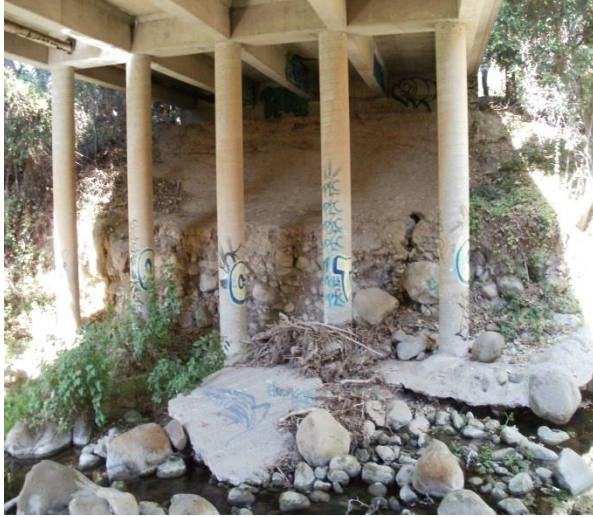
Western side Toro Creek bank

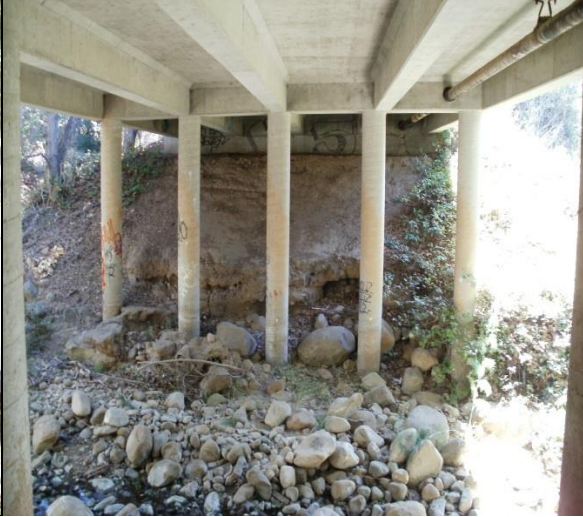
Eastern side creek channel view

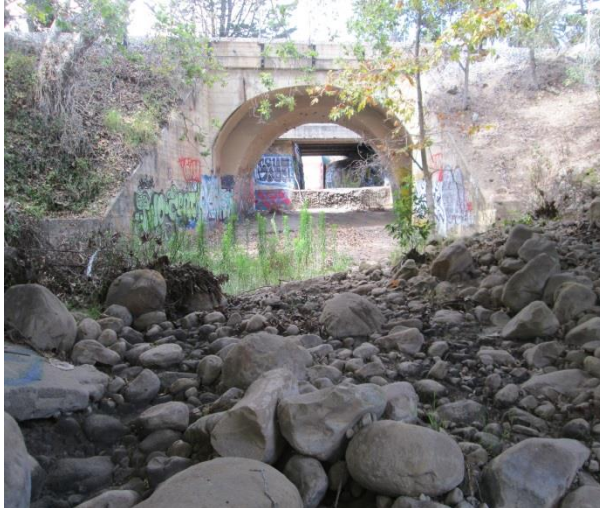
Upstream view under Bridge 51C-163

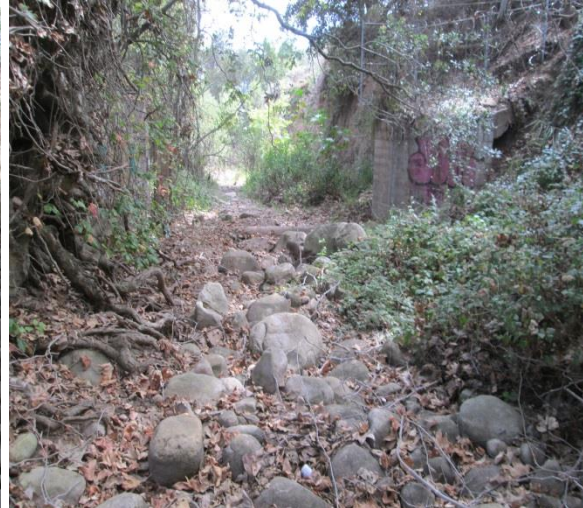
Downstream view under Bridge 51C-163

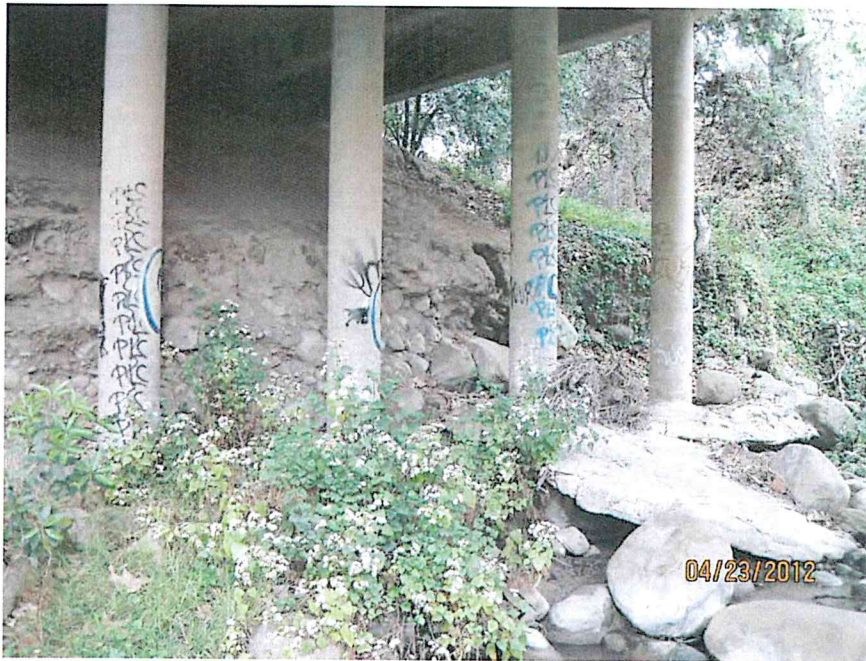
**Photo 3.** View of west abutment and piers of Bridge 51C-063.
