COUNTY OF SANTA BARBARA
PLANNING AND DEVELOPMENT

MEMORANDUM

RE: Summary of December 7, 2008, offshore oil spill from Platform A

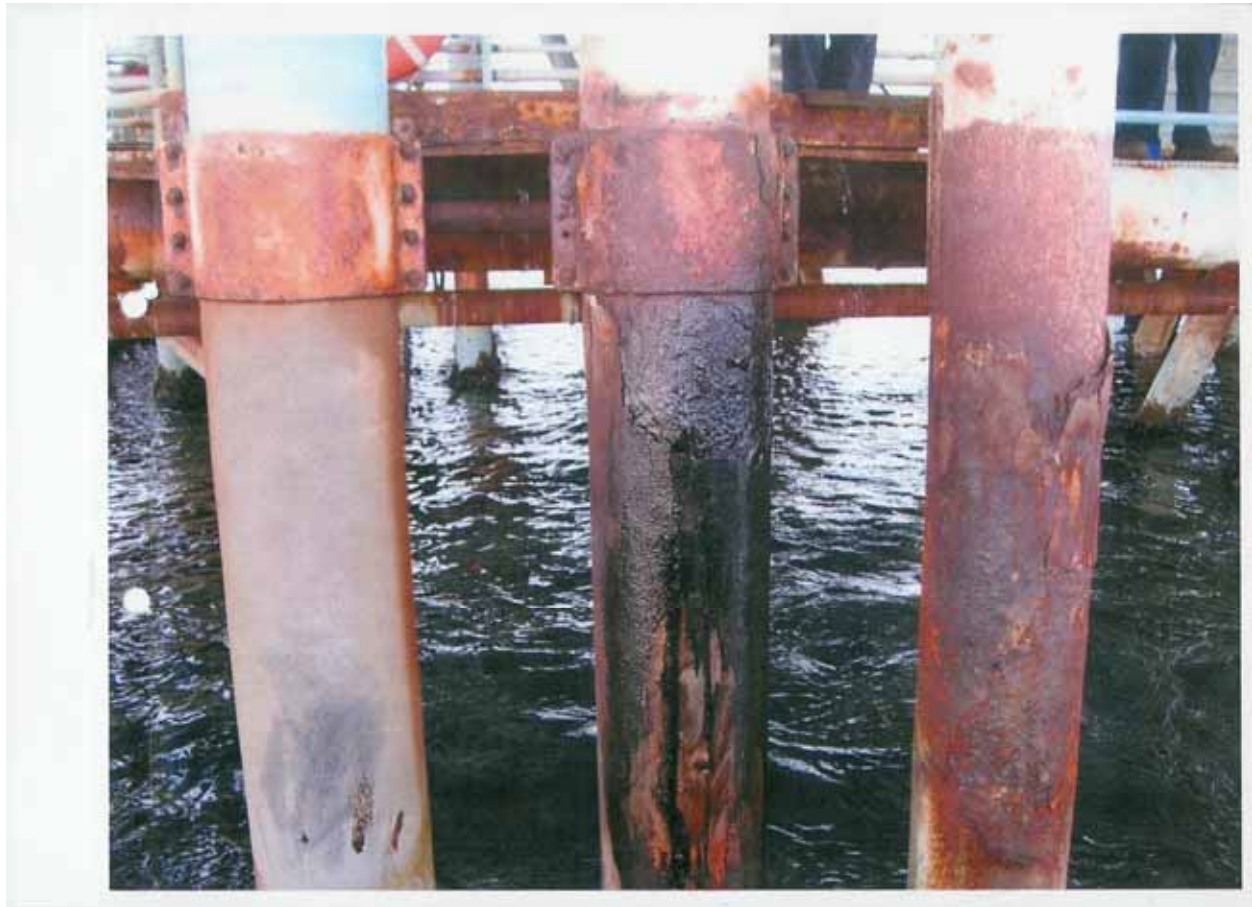
Source and Cause of Spill: The oil emulsion was released from a hole, approximately $\frac{3}{4}$ inch in diameter, in a shipping pump can (pictured below). Initial analysis indicates the can was corroded and the operator's maintenance program failed to detect and replace the can before the corrosion resulted in an oil emulsion spill. This type of platform design, that is one that employs cans such as these shown below, is antiquated, and exists only on five platforms in offshore

Santa Barbara County: Platforms A, B, C, Gilda, and Irene. As shown below, the cans hang over the sides of the platform in a manner that provides no opportunity for containment of spills on the platform.

Figure 2: Some of the Shipping Pump Cans on Platform A, including the One that Spilled Oil on 12-07-08

Spill Detection: According to the Minerals Management Service inspector on scene afterwards, a crew boat in the area contacted the platform operator and reported that it spotted oil in the ocean, coming from Platform A. The platform operators inspected the platform and discovered the hole in No. 4 shipping pump can at 7:01 a.m. on December 7, 2008.

Initial Response to Stop Spill: Upon discovery of the spill, the operator shutdown the platform, plugged the leak, and coated the can's surface with Splash zone. DCOR then took the leaking shipping pump can out of service, flushing and sealing it, and shifting oil to another shipping pump can in better condition. DCOR reportedly notified regulators an hour after discovering the spill.

Follow Up Corrective Measures: The Minerals Management Service (MMS) reports that DCOR inspected and conducted pressure tests on all shipping pump cans. DCOR plans to eventually take all the cans out of service on Platforms A, B, and C very soon, and the MMS has also inquired with PXP about similar action for Platform Irene. MMS did issue two incidents of non-compliance to DCOR as a result of the spill, and expects DCOR to convert to a different system very soon. MMS has also approached PXP to discuss future service of shipping pump cans on Platform Irene.
