**THE PARTNERSHIP**  
FOR RESILIENT COMMUNITIES

**Re: Montecito Emergency Debris Flow Mitigation Project.**

This letter summarizes BGC's site reconnaissance observations, preliminary interpretations, and recommended short-term actions for debris-flow risk management. It also describes the qualifications and experience of BGC's debris-flow risk management team. This letter is intended to be used by TPRC to inform development of risk management plans for the winter 2018/2019 rainy season. This letter was requested in an email from Les Firestein dated July 30, 2018, and prepared under terms of contract between BGC and TPRC dated August 1, 2018.

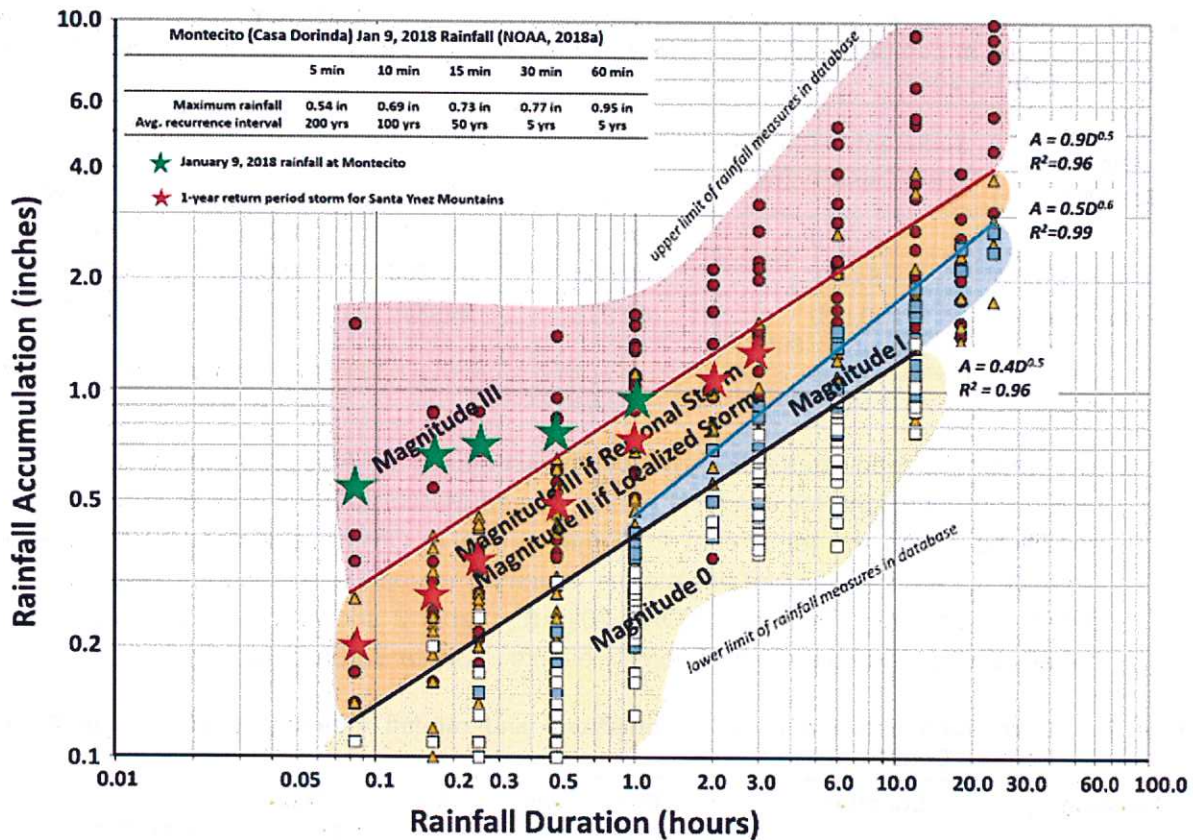
Figure 1. Adapted from Fig. 3 of Cannon et al. 2011. Within-storm rainfall accumulations for storms that triggered debris flows and floods. Open squares are storms with negligible response; blue squares are magnitude I events (small flows, houses damaged, but few large buildings threatened); orange triangles are magnitude II events (moderate flows, damage to houses and infrastructure); red circles are magnitude III events (large flows, buildings and infrastructure may be destroyed); green stars are rainfall reported at Montecito on January 9, 2018 by NOAA (2018a); red stars are rainfall for a 1-year return period in the Santa Ynez Mountains above Montecito (NOAA 2018b)

8. The rainfall measured on January 9, 2018 at Montecito was rare (NOAA 2018a), but was not unprecedented in southern California (Cannon et al. 2011). Rainfall intensity was comparable to others that have triggered post-wildfire debris flows in southern California (Cannon et al. 2011). Furthermore, debris flows from burned areas are commonly initiated from rainfall conditions with recurrence intervals of less than five years (Cannon et al. 2008). Figure 1 compares January 9, 2018 rainfall reported by NOAA (2018a) with rainfall events that triggered debris flows in southern California between 1928 and 2010. It also shows that a 1-year return period storm correlates with Magnitude II or Magnitude III debris-flows, which are capable of damaging or destroying infrastructure.

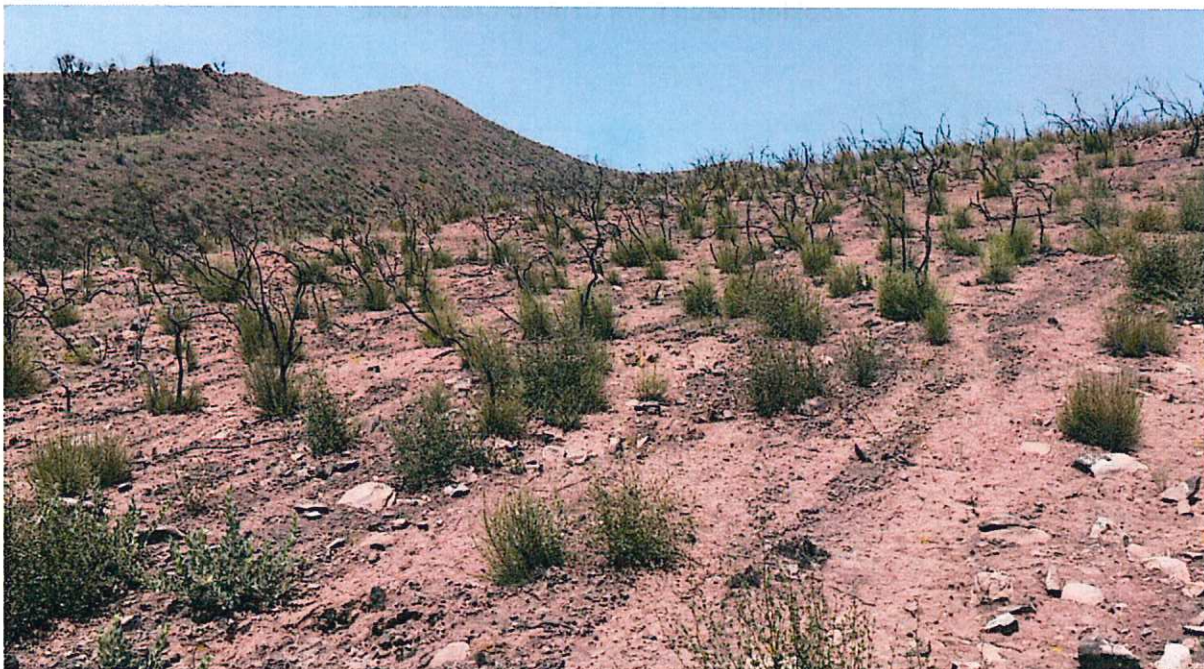
**Figure 3. Typical watershed slope following the Thomas Fire. Note lack of vegetation and lack of organic duff layer, and loose soil directly exposed to rainfall. Pioneer vegetation has developed since the Thomas Fire. BGC photo, July 2018, looking northwest from lower Buena Vista Creek watershed.**

3. The Thomas Fire burned most vegetation in the Montecito Watersheds (Figure 3), although the burn severity appears to be somewhat less in Romero watershed compared to the other Montecito Watersheds (Figure 4, Figure 5). The Montecito fire department (K. Kellogg, pers. comm.) reports that the watersheds burned between December 13 and 16, 2017.

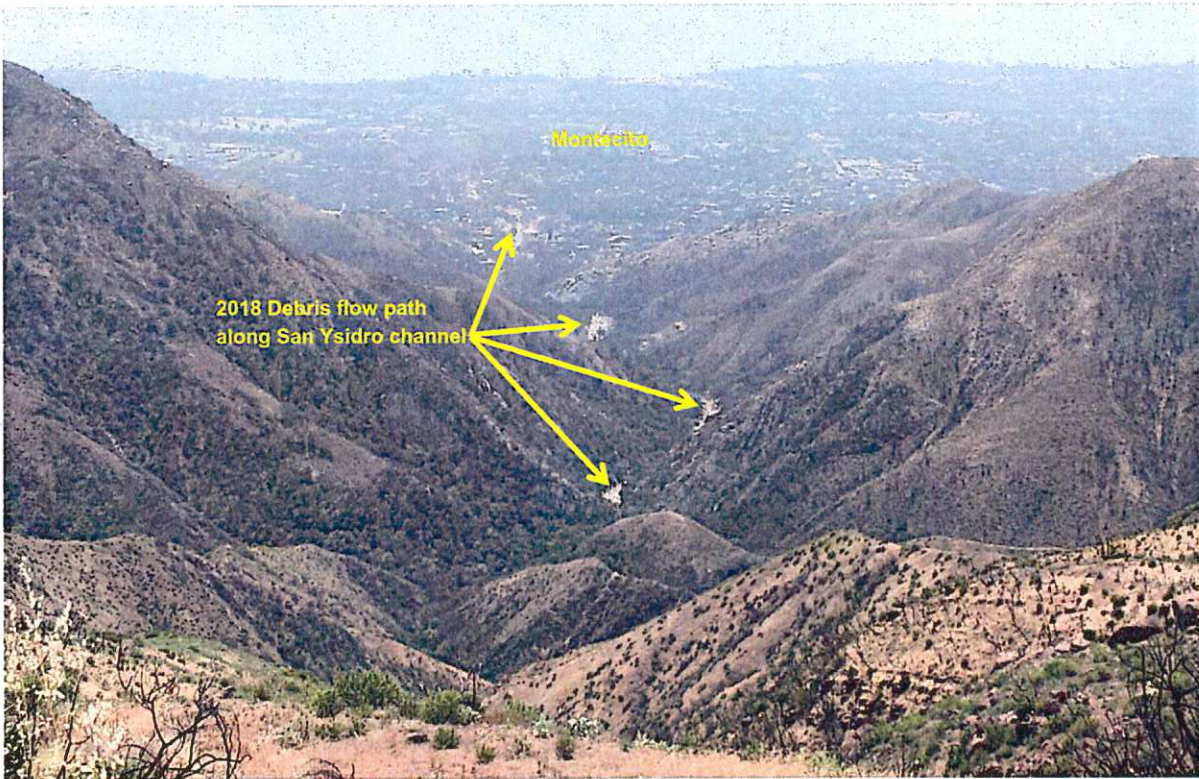
Figure 4. San Ysidro Creek watershed following the Thomas fire. BGC photo, July 2018, looking south from Camino Cielo Road.

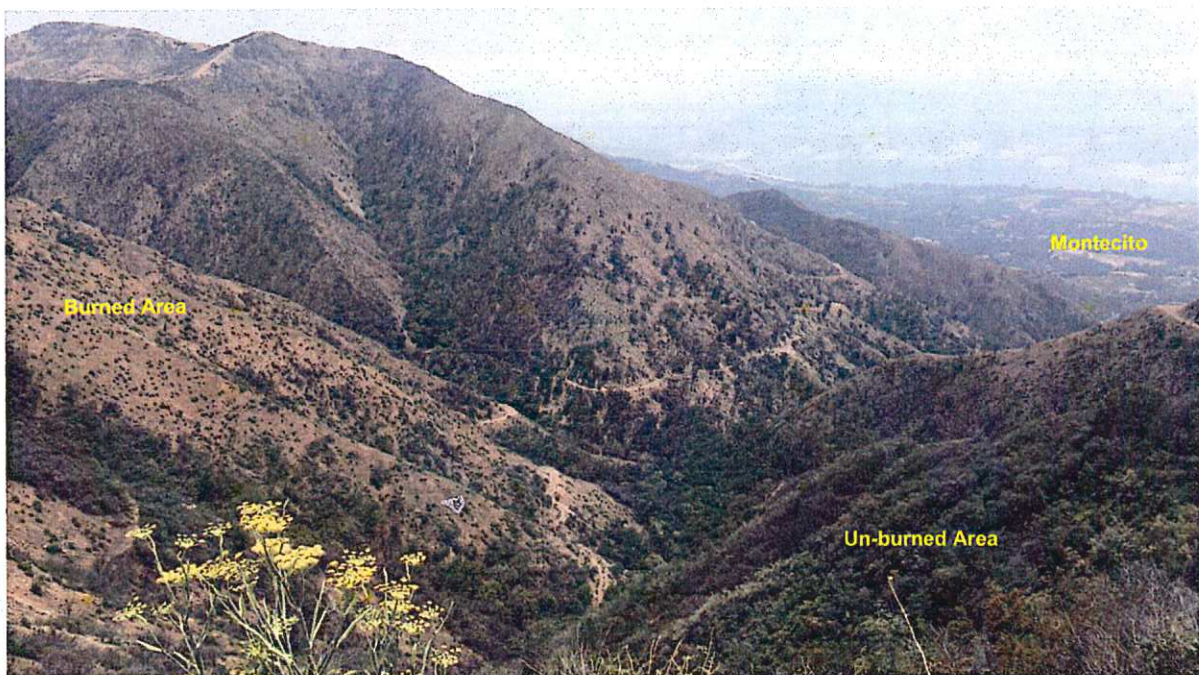
Figure 5. Romero Creek watershed showing a mixture of un-burned and burned areas from the Thomas fire. BGC photo, July 2018, looking south from Camino Cielo Road.

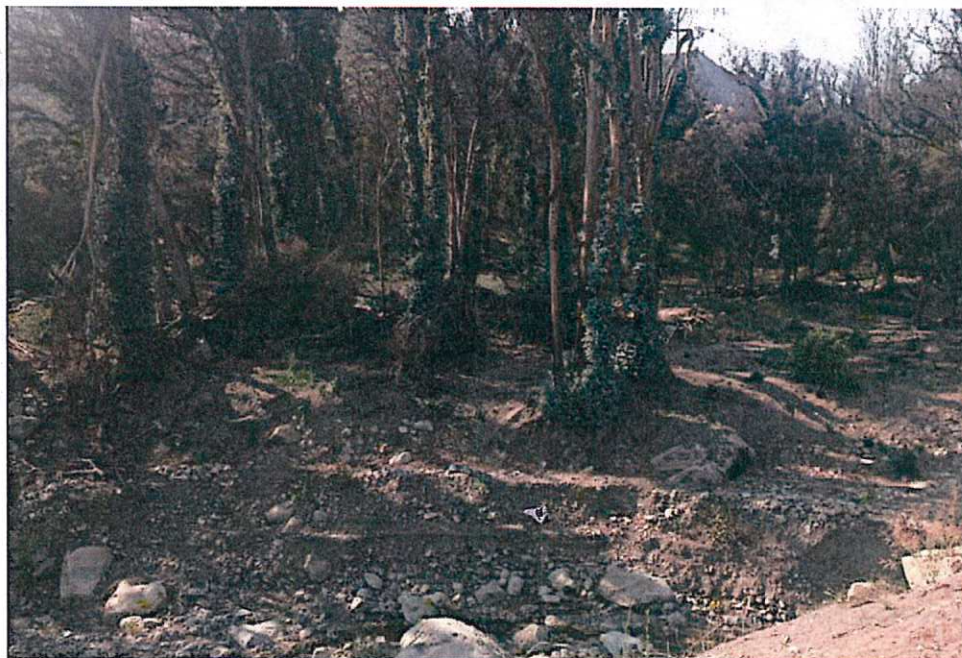
**Figure 7. Woody debris and erodible channel banks in San Ysidro Canyon approximately 200 m upstream from the development interface. BGC photo, July 2018, looking west.**

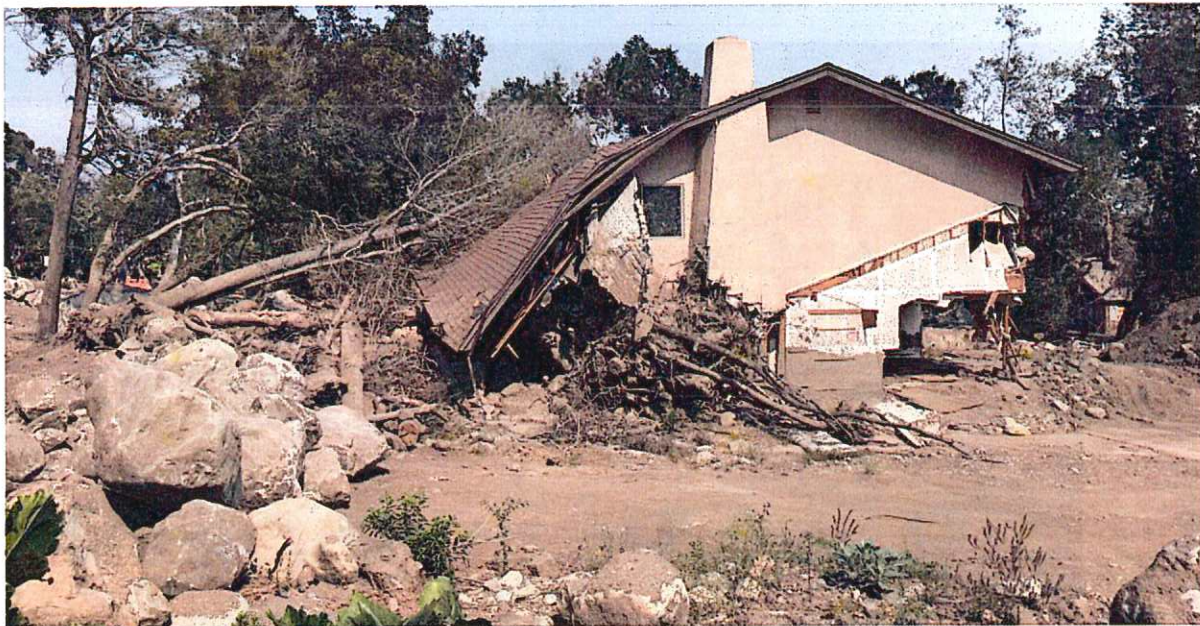
**Figure 9.** Destroyed home on San Ysidro Creek, located approximately 1 km from the fan apex. BGC photo, July 2018, looking east.

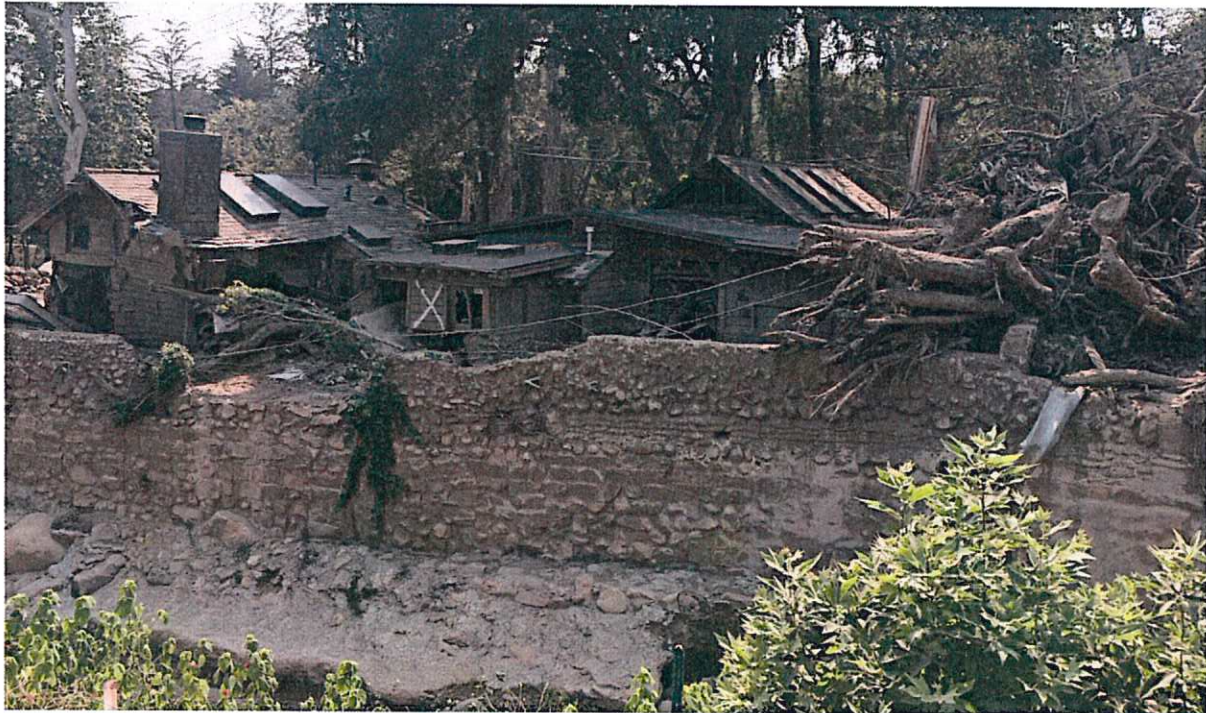
**Figure 10.** Woody debris immediately upstream of a destroyed home on Montecito Creek located approximately 2 km from the fan apex. BGC photo, July 2018, looking west.

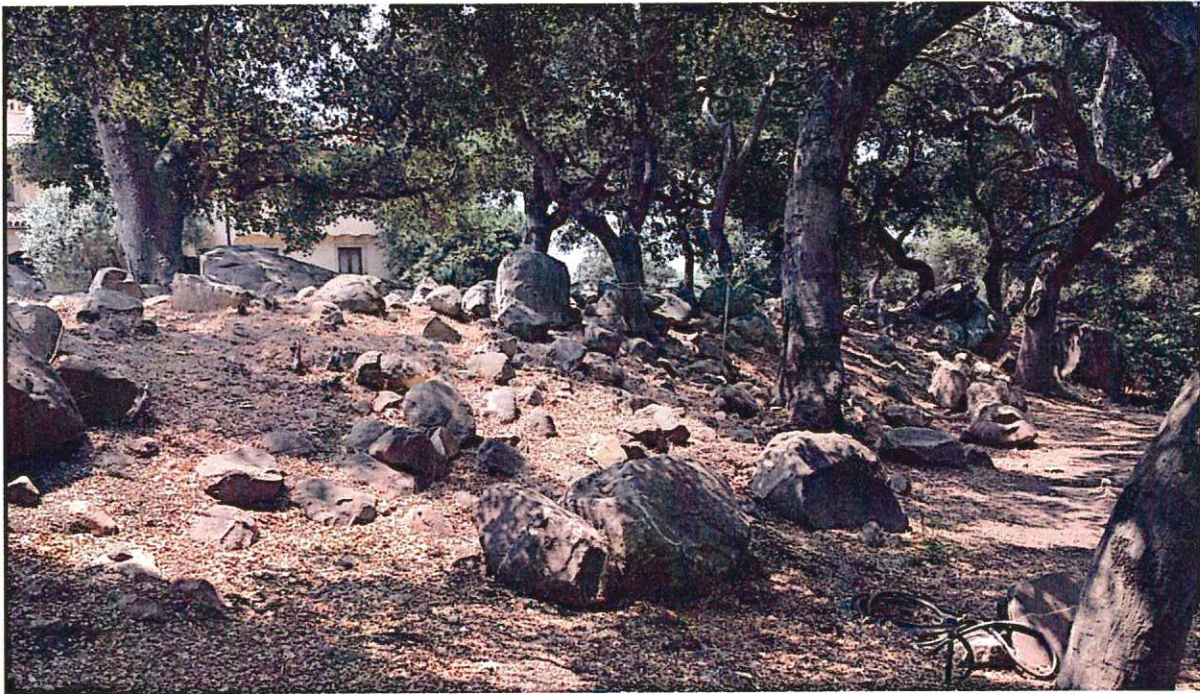
7. Evidence of previous debris flows has been reported and observed, including an anecdote of a swimming pool that filled with mud near San Ysidro creek several times in the previous decades, and landforms on the upper fan area interpreted to be debris flow levees (Figure 12).

**Figure 12. A landform interpreted to be a debris flow levee from an event that pre-dates construction of the home in the background, located 500 m from the Hot Spring Creek fan apex. Boulders up to 1 m diameter in foreground. BGC photo, July 2018, looking south.**
