LAS VARAS RANCH PROJECT

ADMINISTRATIVE RECORD

TECHNICAL REPORTS

VOL. 2 OF 4

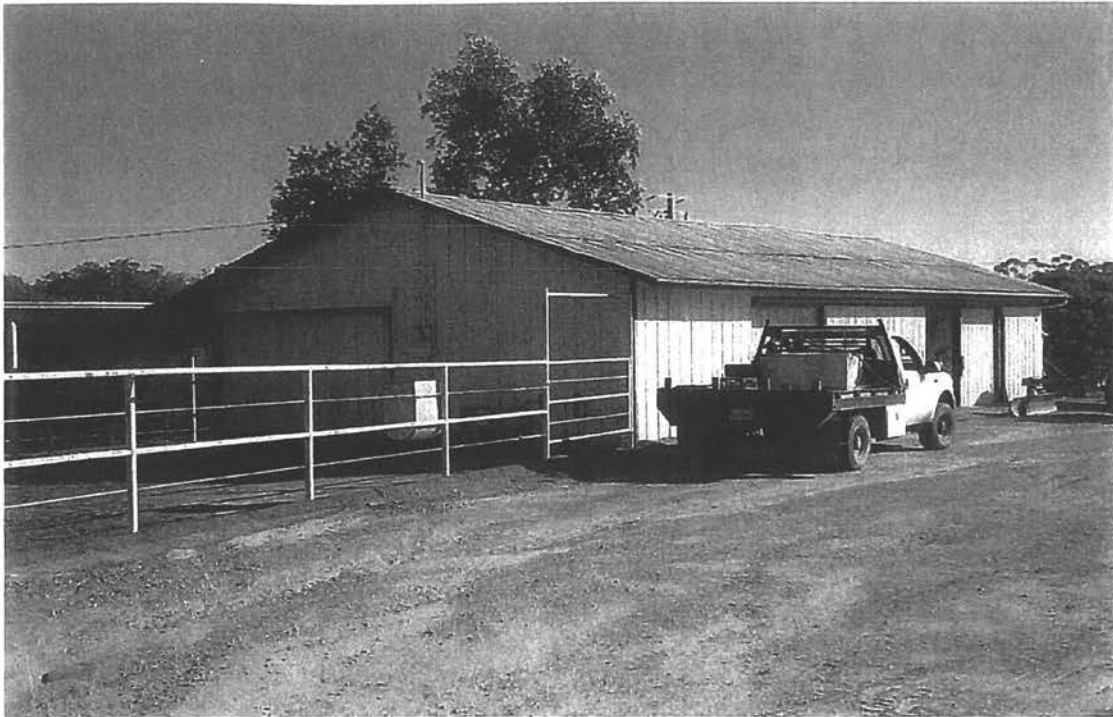
Repair Garage, north and west elevations, looking southeast.

This is a vernacular one-story, rectangular-shaped building built between 1910 and 1920. It is located south of the Foreman's House. Set on a concrete foundation, it has board and batten siding, and a side-gabled roof covered with corrugated metal. There are two double, board and batten sliding doors on the west elevation. The doorway in the center is significantly larger than the one to its right. The north elevation contains a single, double-sized sliding board and batten door. An open shed with a metal roof and posts extends from the east side, and a lean-to is located on the south elevation. Identical windows, containing fixed, 10-pane sashes, have been installed on the east and south elevations. The building is in good condition.

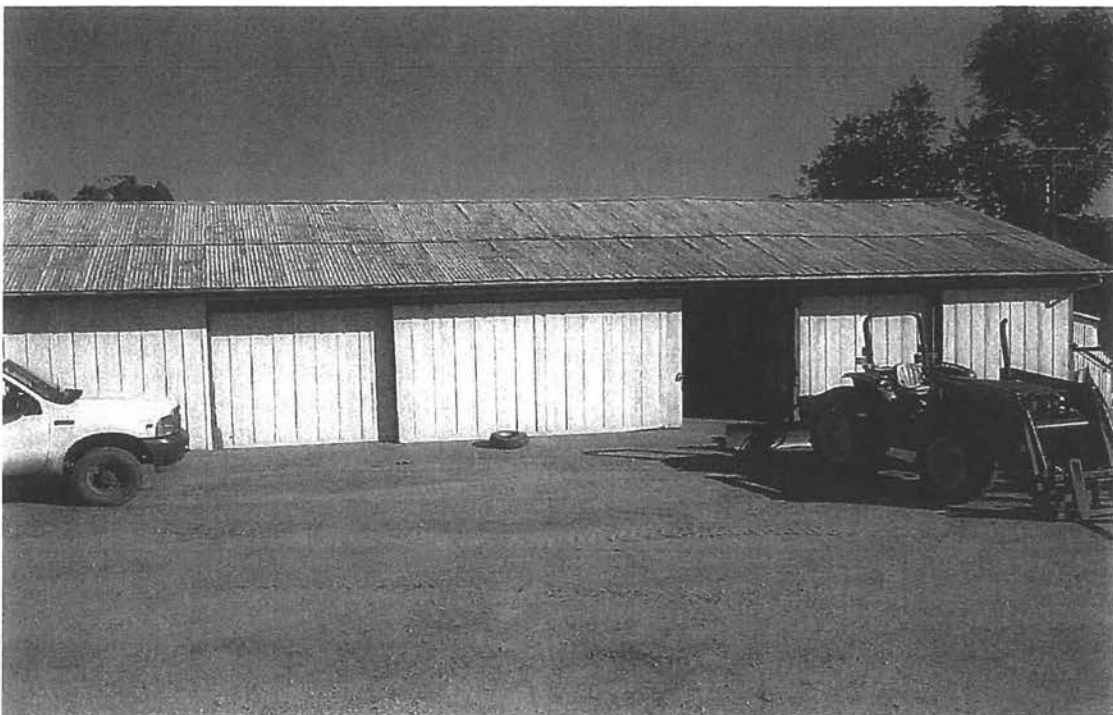
Repair Garage, west elevation, looking east.

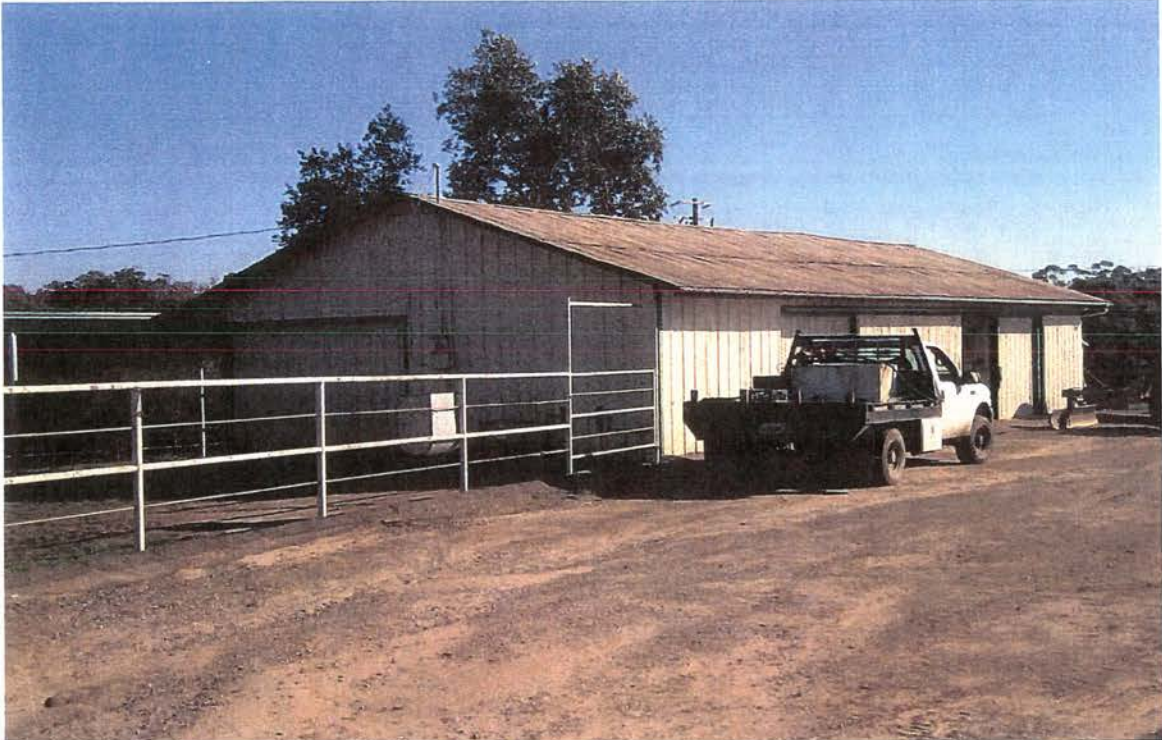
Repair Garage, north and west elevations, looking southeast.

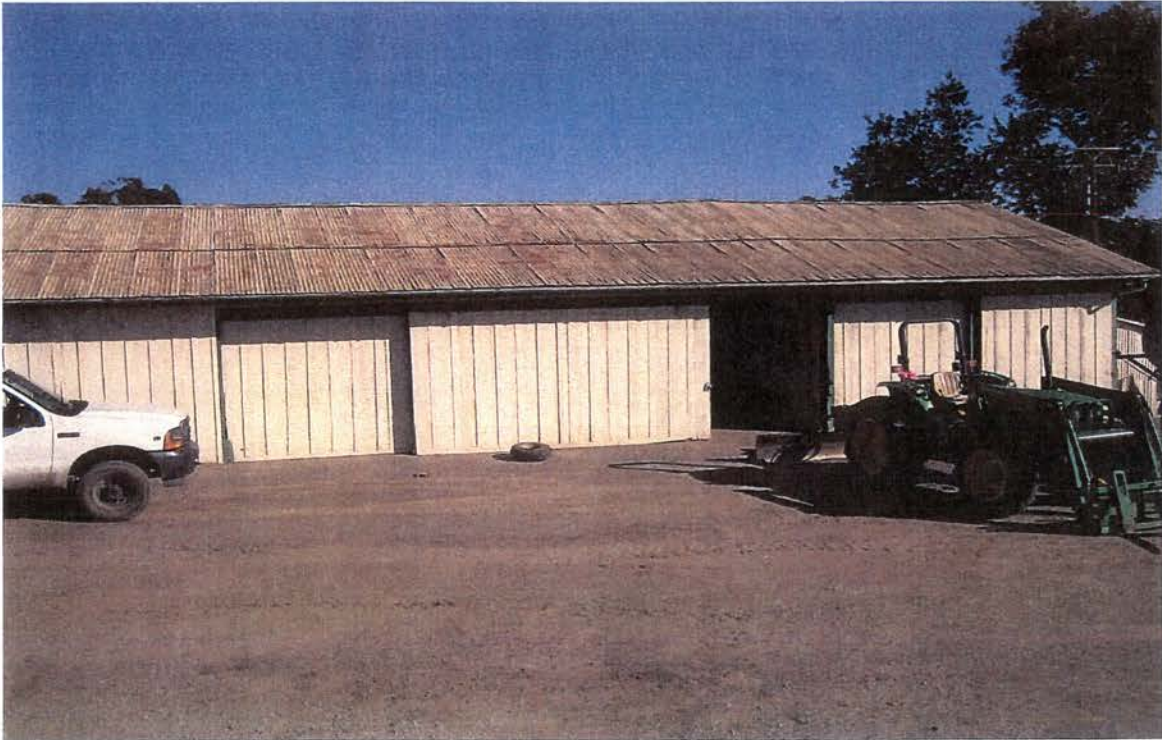
Repair Garage, west elevation, looking east.

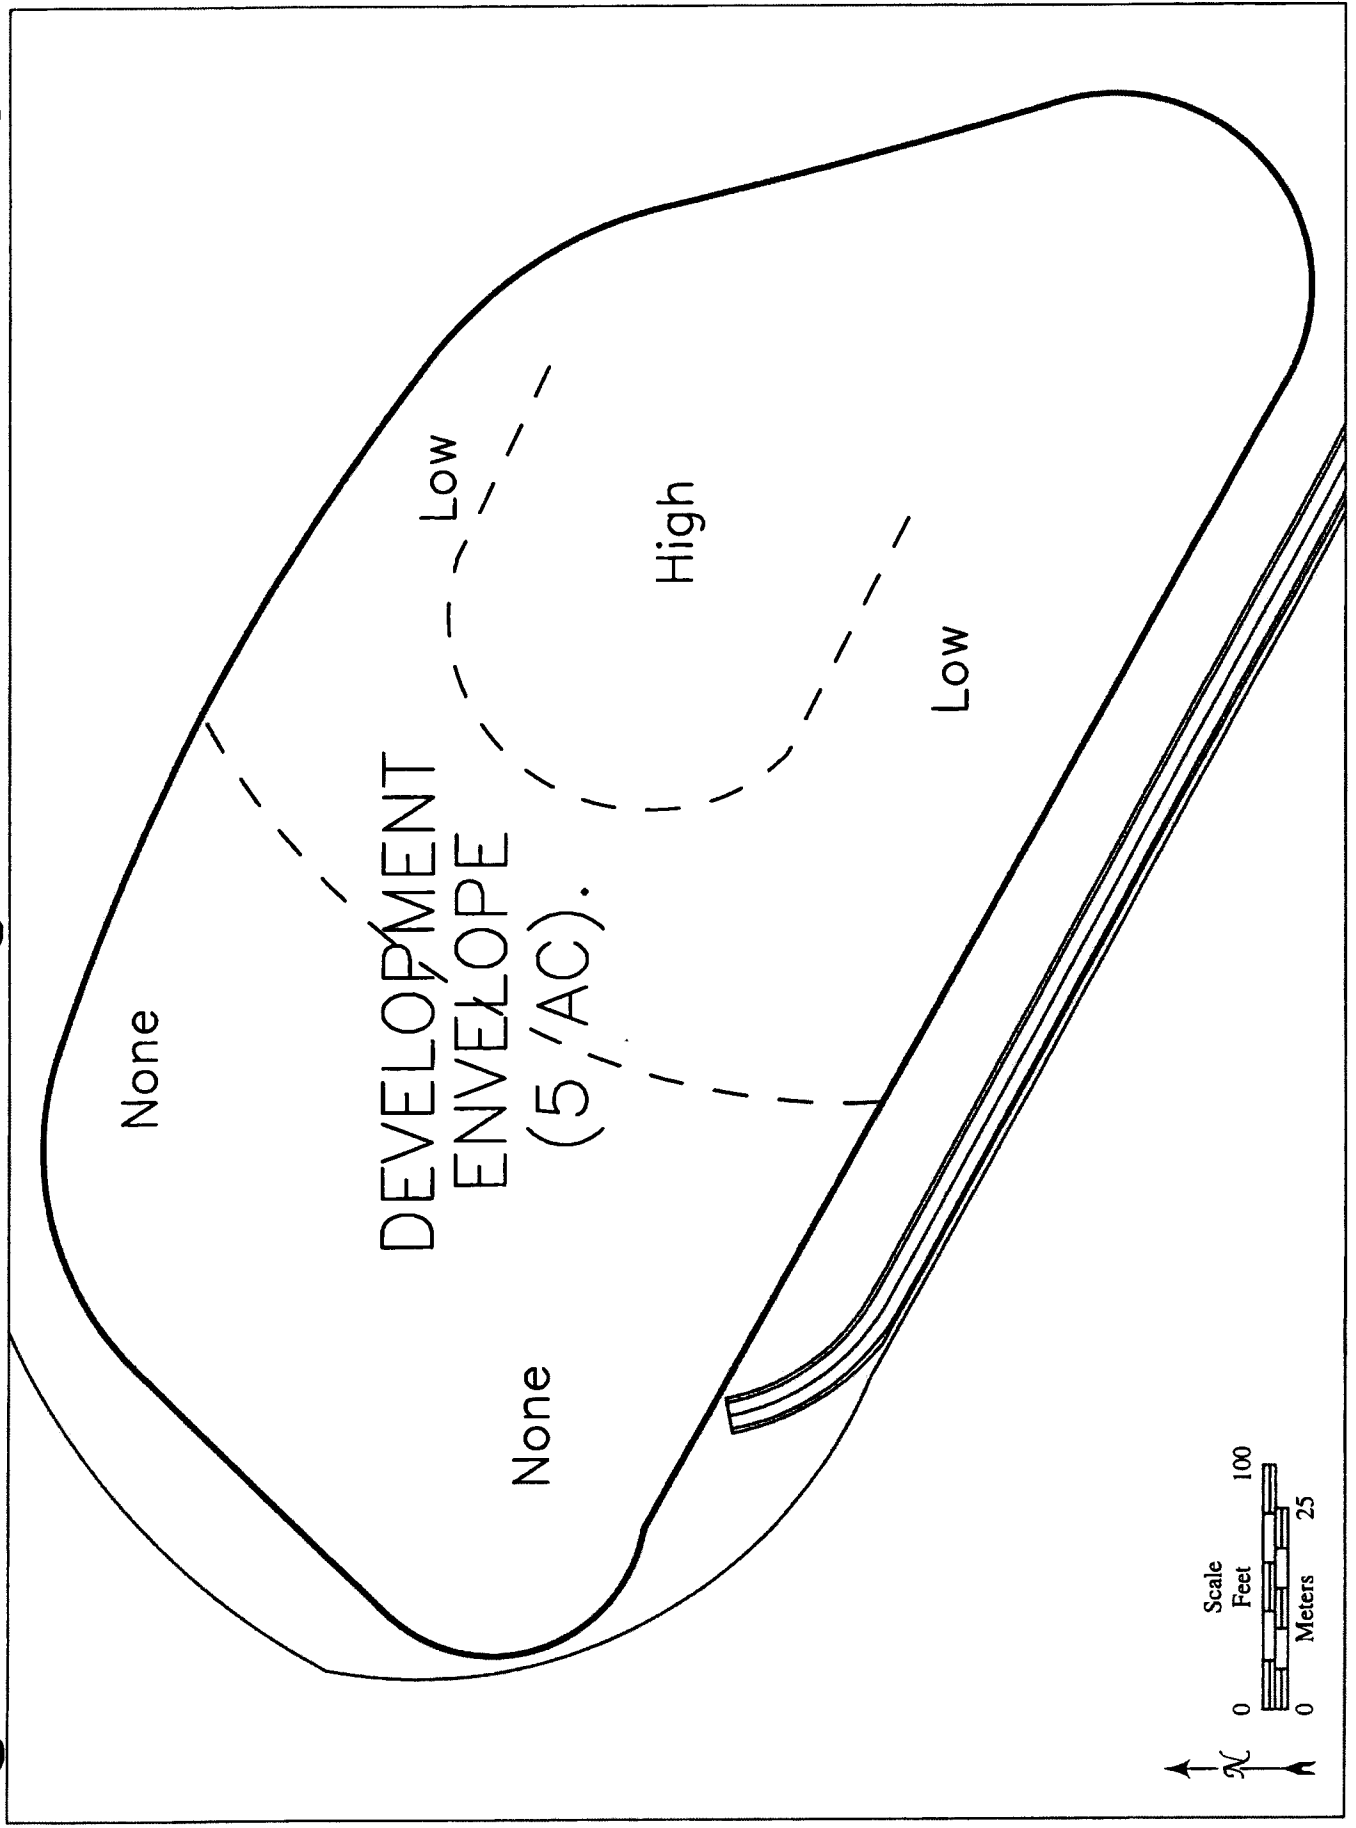
Figure 5. CA-SBA-80/Proposed Parcel 3 Development Envelope Archaeological Sensitivity

Shell density within the high-density area ranges from 60.32 gm/m³ in STP 16 to 22,735.76 gm/m³ in STP 18 while flake density ranges from 39.7 pieces/m³ in STP 18 to 297.1 pieces/m³ in STP 17 and bone density within the high-density area ranges from 1.35 gm/m³ in STP 16 to 105.17 gm/m³ in STP 15.
