ATTACHMENT 9: BIOLOGICAL RESOURCES ASSESSMENT, DATED JANUARY 14, 2021

**REVISED BIOLOGICAL RESOURCES ASSESSMENT
AUTUMN BRANDS, LLC AND OCEAN HILL FARMS, LLC
CANNABIS CULTIVATION PROJECT (19CDH-00000-00001)
3615 FOOTHILL ROAD (APN 005-280-041), CARPINTERIA, CALIFORNIA**

Revised: January 14, 2021

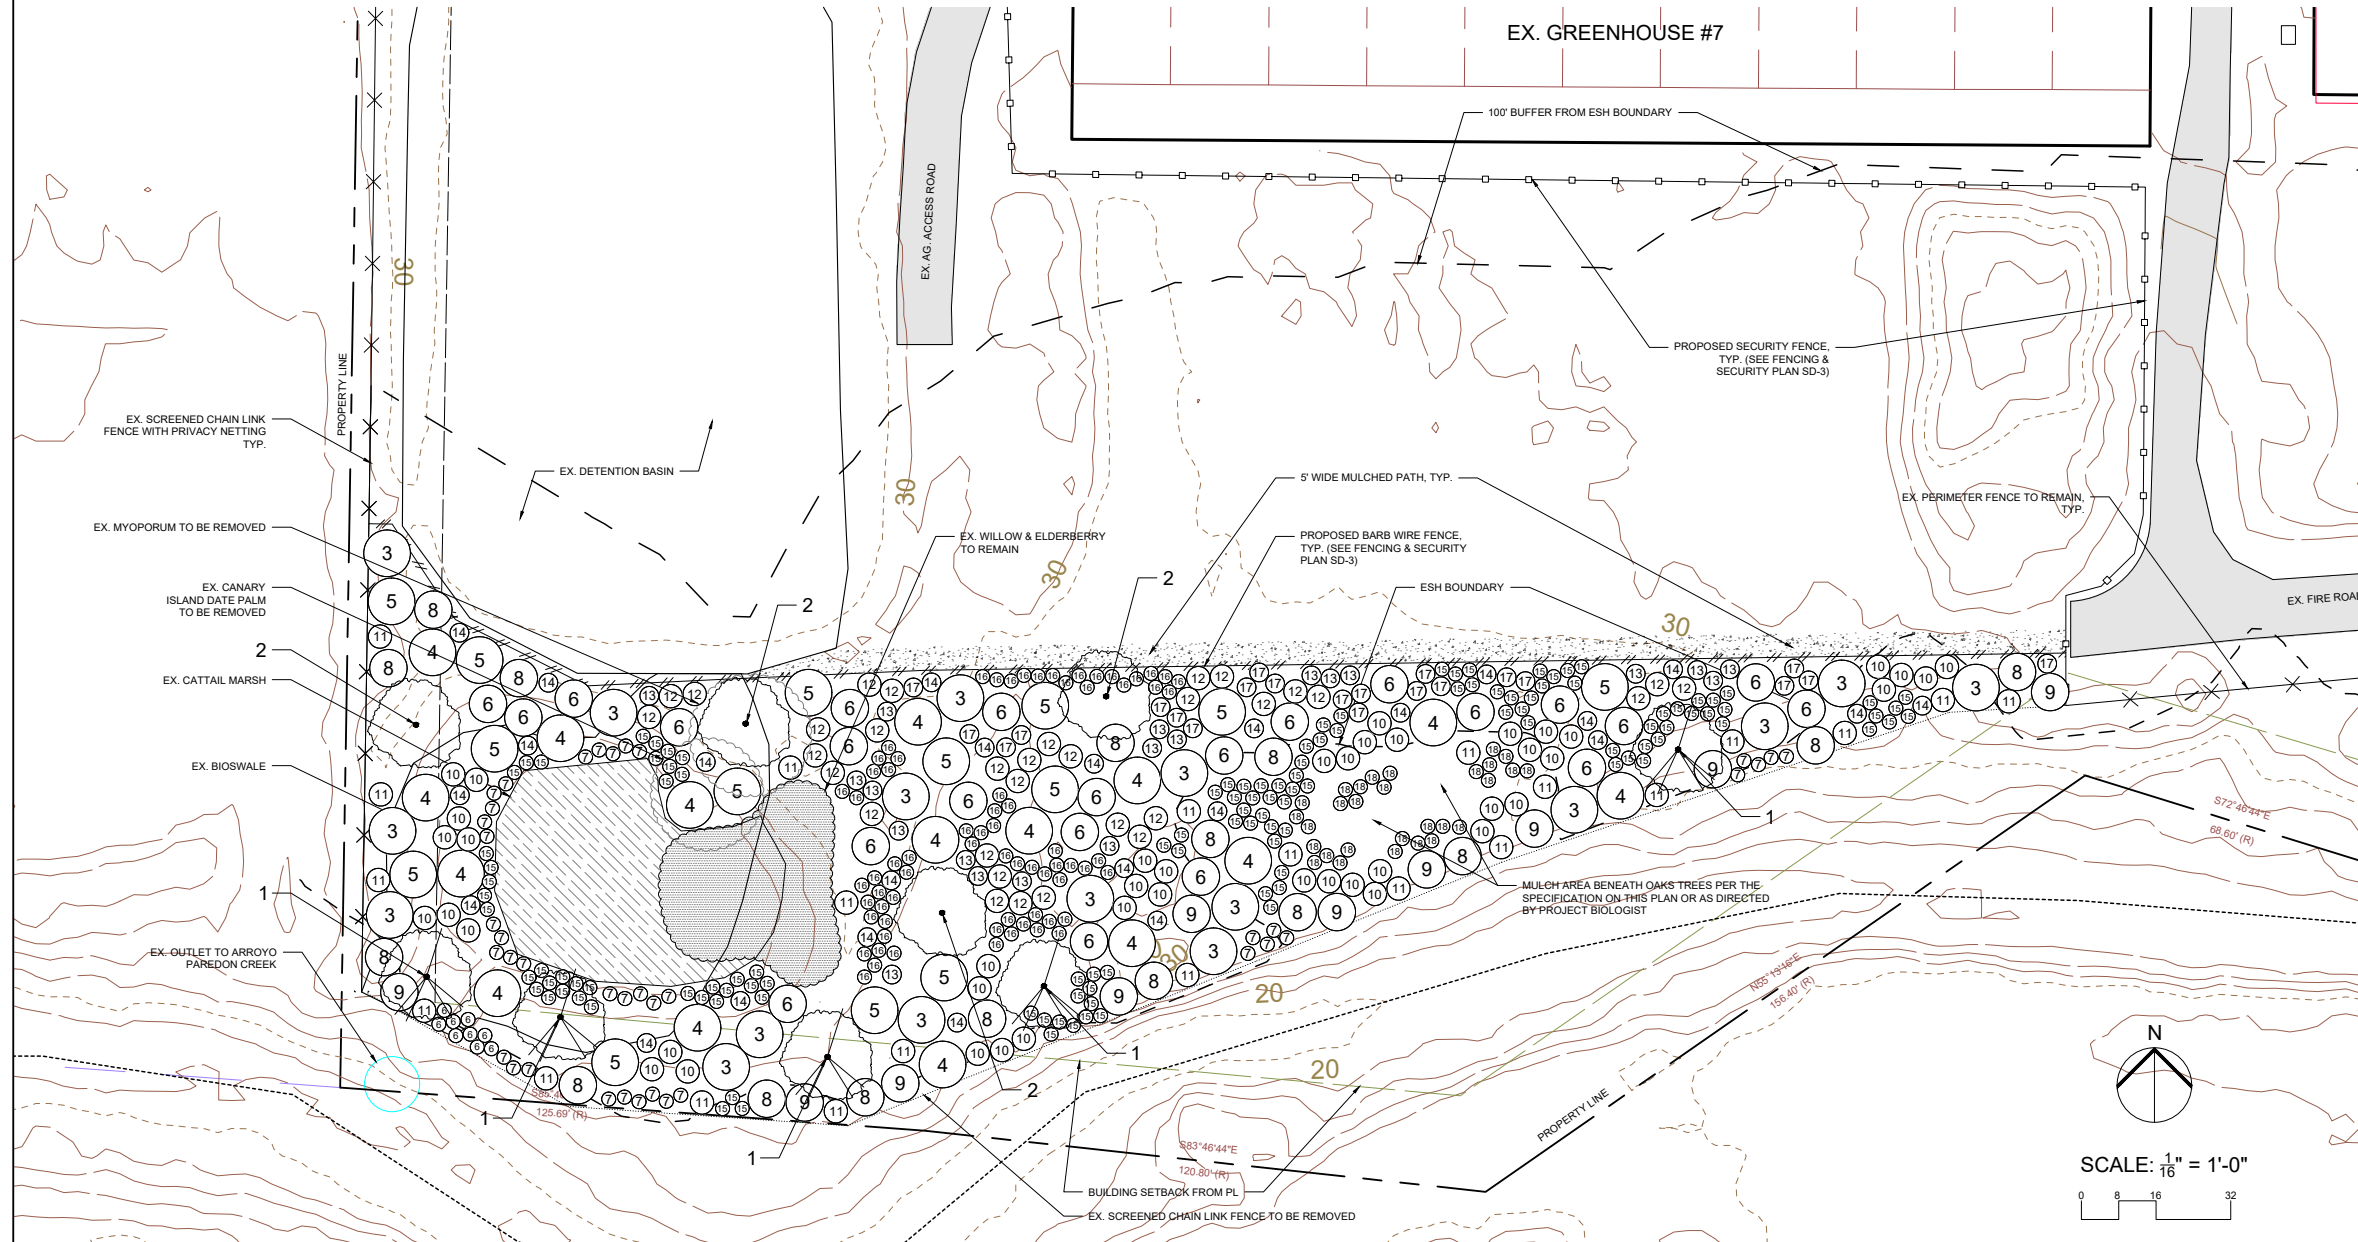
A TEMPORARY DRIP IRRIGATION SYSTEM WILL BE USED DURING THE FIRST AND SECOND YEARS TO ENSURE SUCCESSFUL GERMINATION AND PLANT ESTABLISHMENT. FREQUENCY OF IRRIGATION WILL DEPEND ON WATER AVAILABILITY, CLIMATIC CONDITIONS, AND SOIL MOISTURE, AND MAY BE ADJUSTED AS NEEDED BY THE RESTORATION MANAGER OR LANDSCAPE CONTRACTOR.

MAINTENANCE ACTIVITIES PERFORMED IN THE RESTORATION AREA SHALL EXTEND FOR A PERIOD OF 5 YEARS FROM THE DATE OF THE INSTALLATION COMPLETION AND WILL INCLUDE WEED ERADICATION, IRRIGATION, TRASH REMOVAL, SUPPLEMENTAL PLANTING OR PLANT REPLACEMENT (AS NECESSARY), AND MAINTENANCE OF EROSION CONTROL MATERIALS. CARE SHALL BE TAKEN TO AVOID EXISTING NATIVE PLANTS IN AND ALONG THE BANKS OF ARROYO PAREDON CREEK AND THE BIOSWALE.

Figure 3 – Riparian Restoration Planting Plan

As noted above, the portion of the existing dirt road that is within the County-prescribed setback from Arroyo Paredon Creek will be removed as part of the Project and included in the Riparian Restoration Area. The remainder of the prescribed setback from Arroyo Paredon Creek on the southwestern side of the Project Site (i.e., the area between the Riparian Restoration Area and Existing Greenhouse #7) will be mowed annually to reduce non-native, invasive plant species spread into the Riparian Restoration Area and creek corridor (Figure 3 – Riparian Restoration Planting Plan). No ground disturbance will occur within the prescribed setback as part of mowing; roots will be left in place to maintain soil stability. No other activity is proposed in or adjacent to the prescribed setback from Arroyo Paredon Creek.

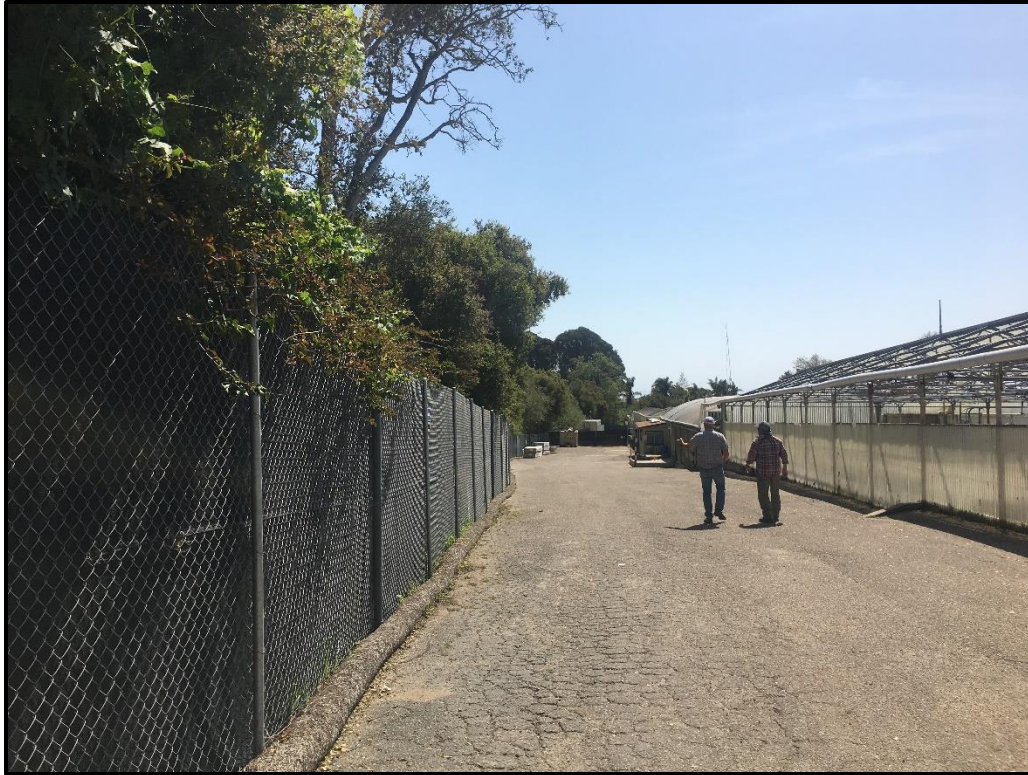
Photo 1: Access road and coast live oak woodland along the ephemeral drainage on the eastern Project Site boundary (Aspect: South). Photo taken: March 25, 2019.

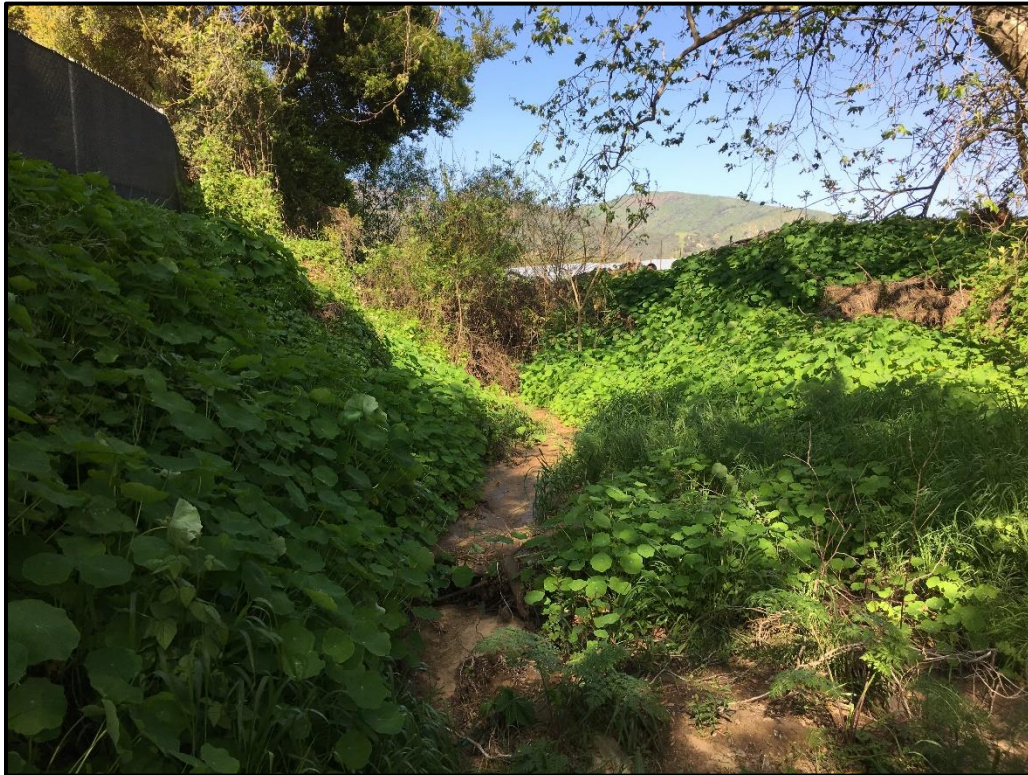
Photo 2: Dense garden nasturtium on banks of the ephemeral drainage (Aspect: North). Photo taken: March 25, 2019.

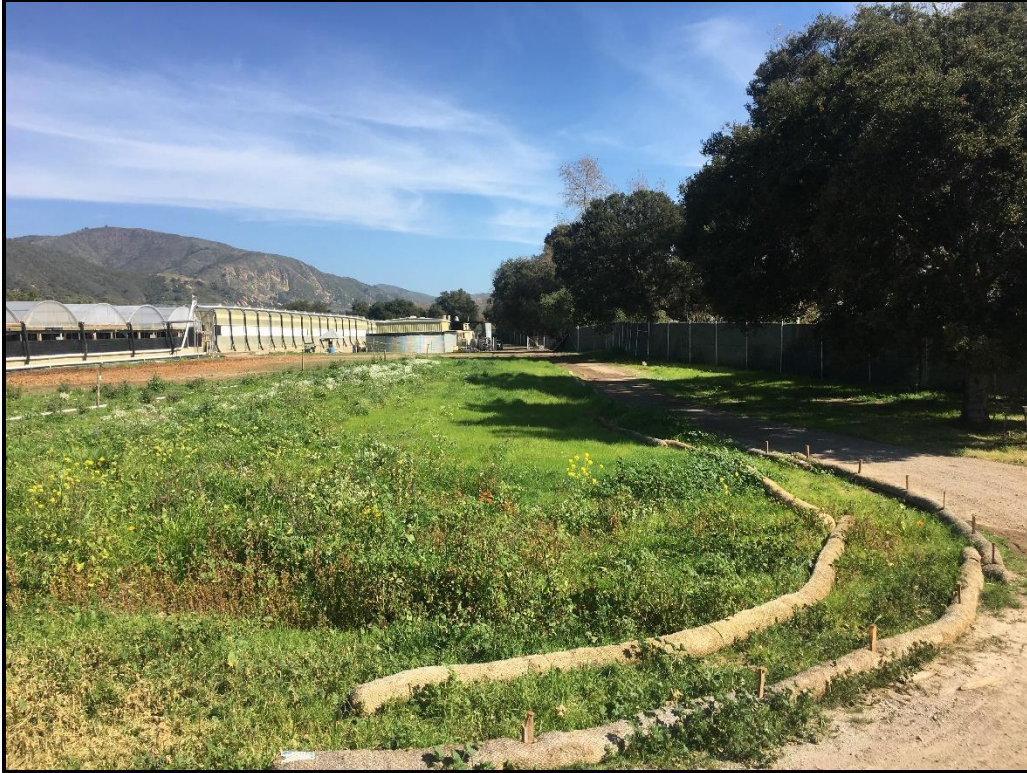
Photo 3: Southern portion of the Project Site and existing access road with Arroyo Paredon Creek corridor on the right (Aspect: East). Photo taken: February 13, 2020.

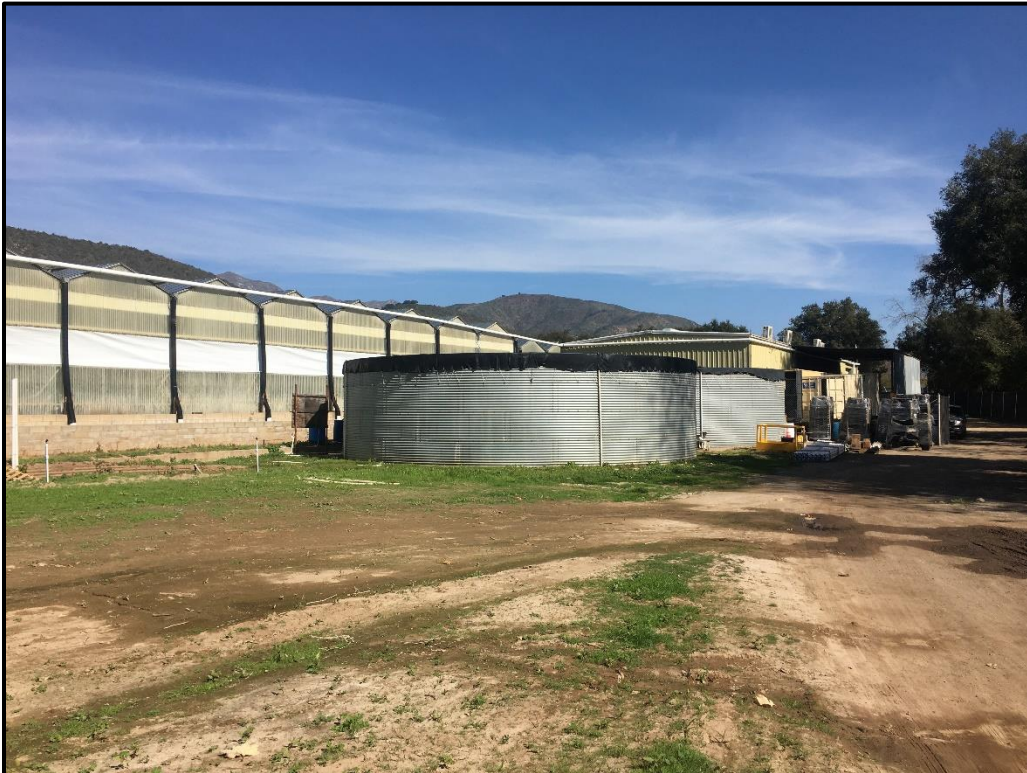
Photo 4: Water tanks proposed for removal along the southern boundary (Aspect: East). Photo taken: February 13, 2020.

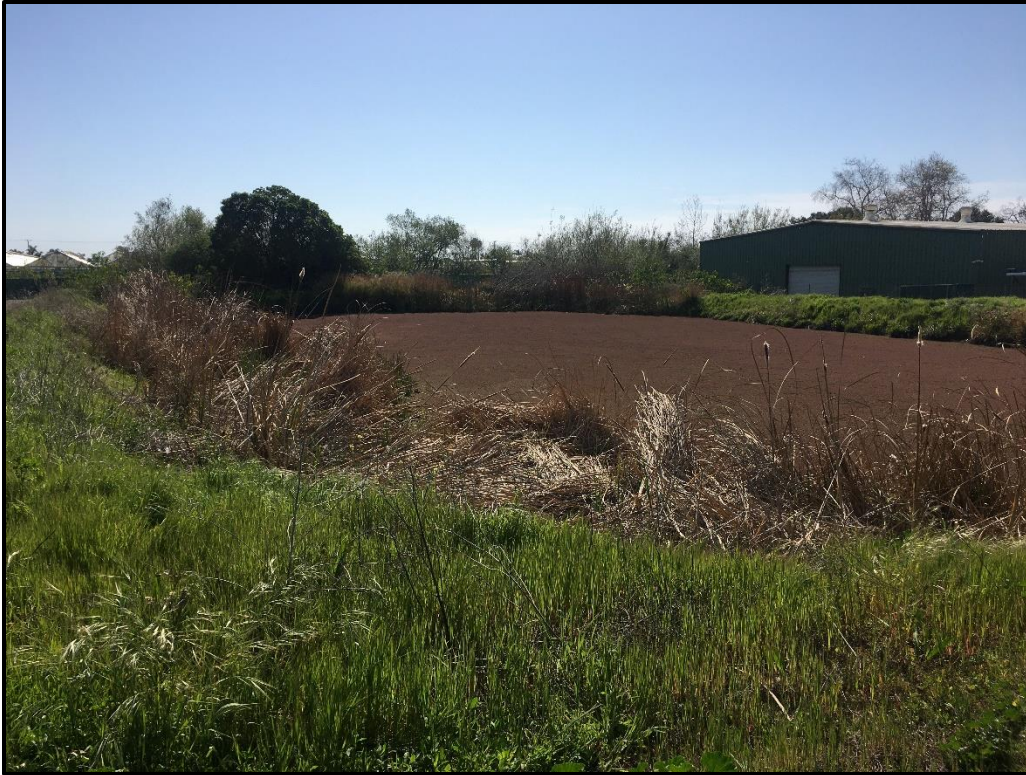
Photo 5: Detention basin in southwest corner of Project Site (Aspect: South). Photo taken: February 13, 2020.

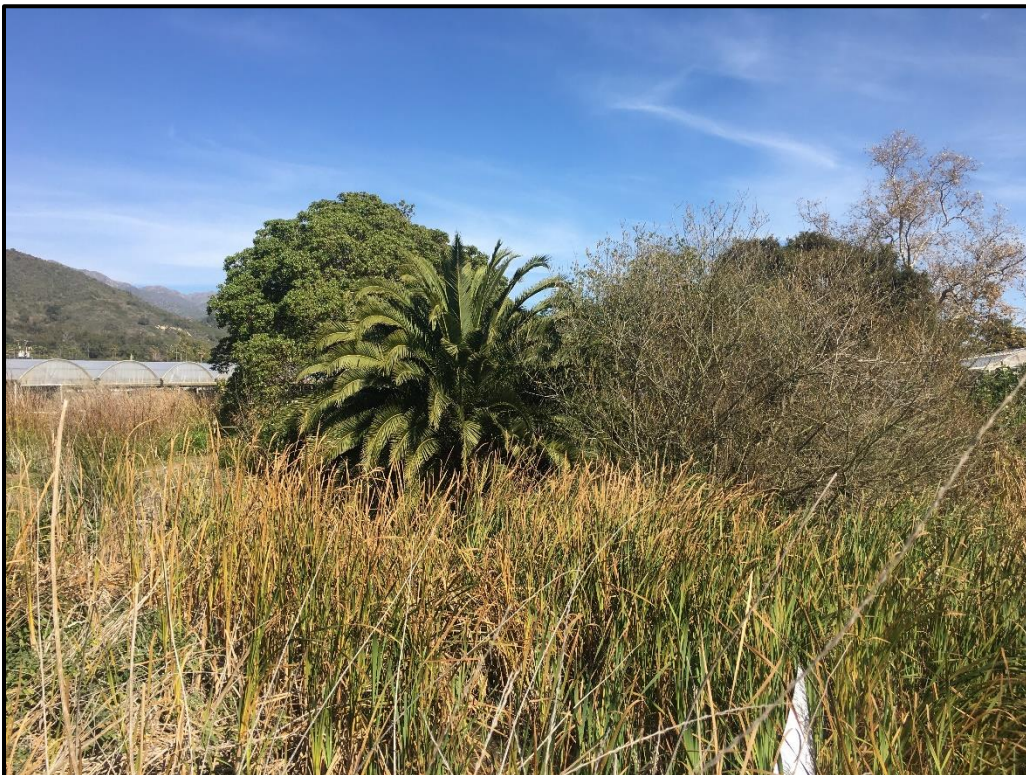
Photo 6: Cattail marsh bioswale adjacent to Arroyo Paredon Creek (Aspect: Northeast). Palm and Myoporum trees will be removed as part of restoration. Photo taken: February 13, 2020.

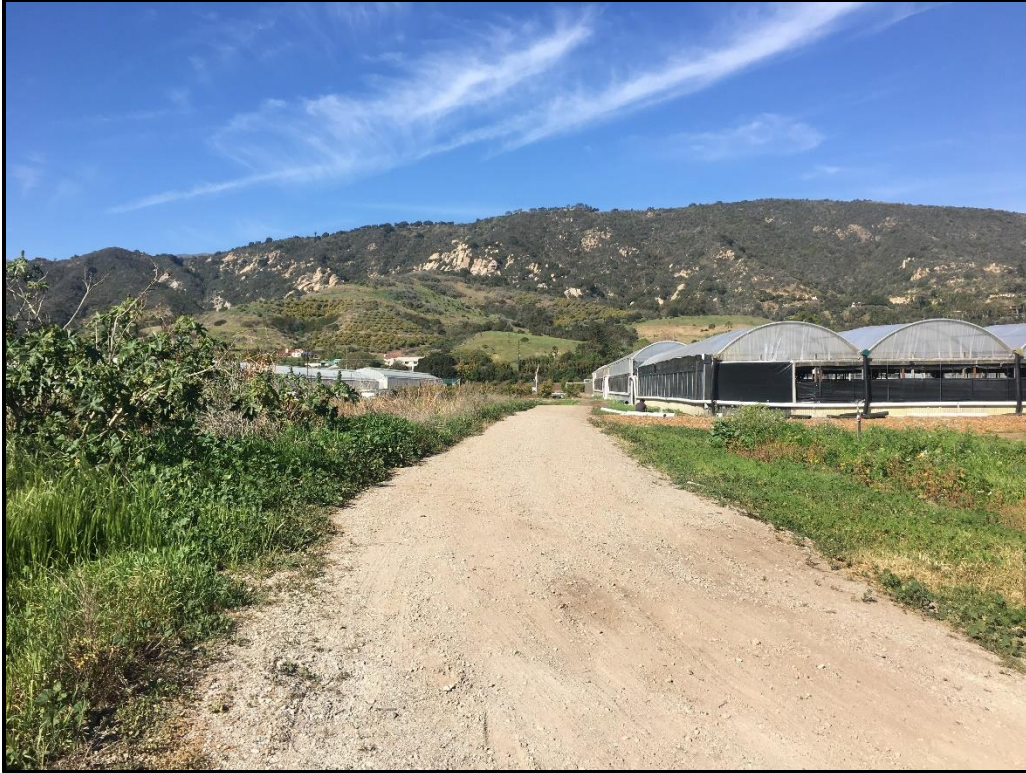
Photo 7: Existing dirt access road adjacent to the Riparian Restoration Area and detention basin (Aspect: North). Photo taken: February 13, 2020.

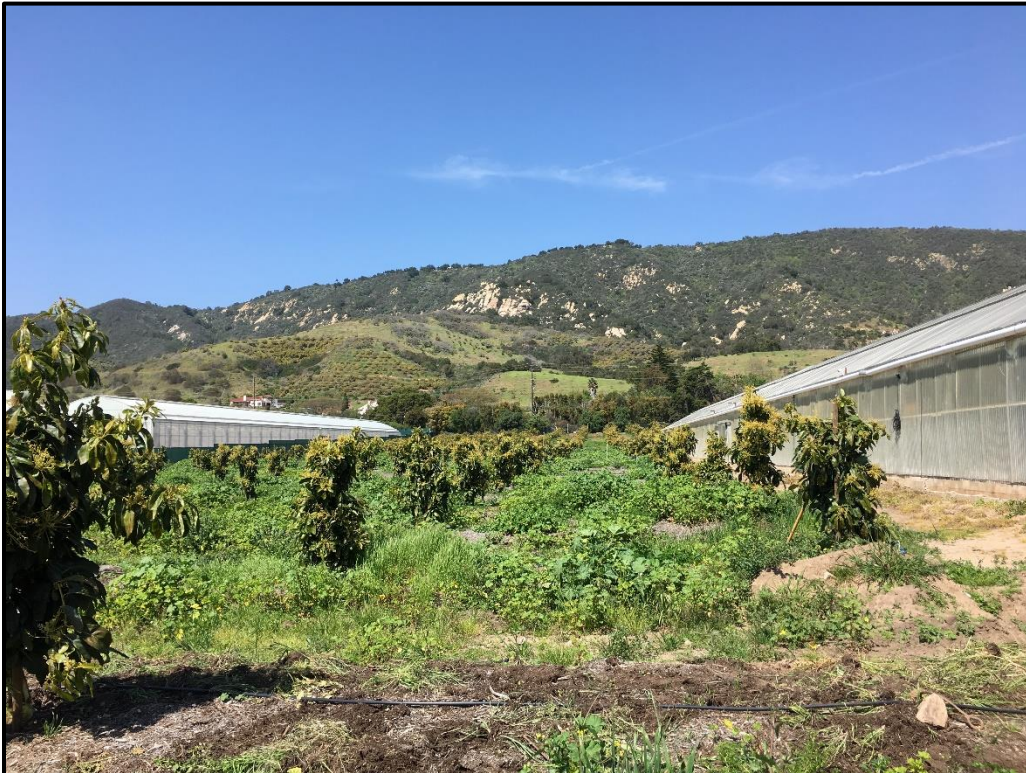
Photo 8: Avocado orchard on the western side of the Project Site (Aspect: North). Photo taken: March 25, 2019.

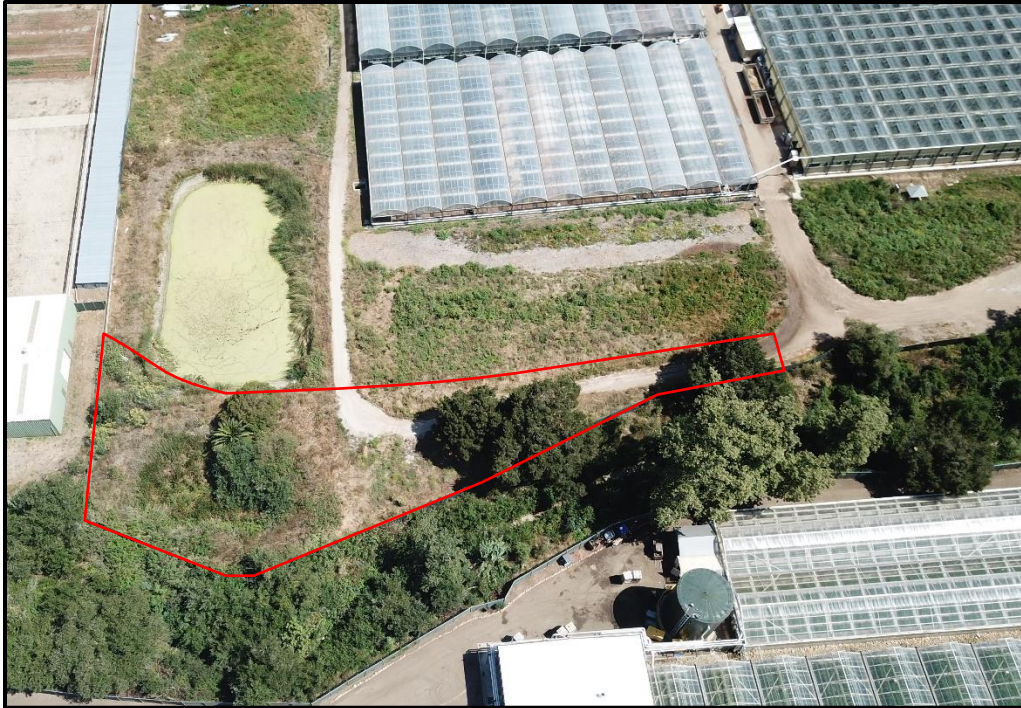
Photo 9: Drone photograph of the southwest corner of Project Site, bioswale, detention basin, and approximate Riparian Restoration Area (red outline). Photo taken July 7, 2020.

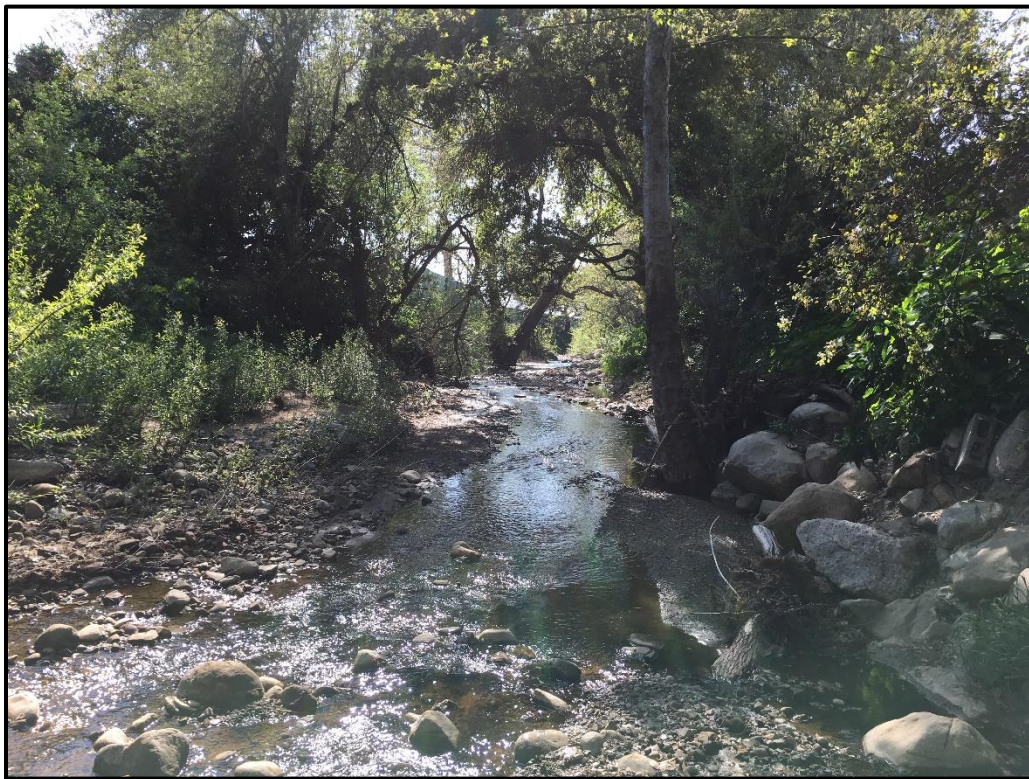
Photo 10: Arroyo Paredon Creek corridor at Via Real (Aspect: East). Photo taken: March 25, 2019

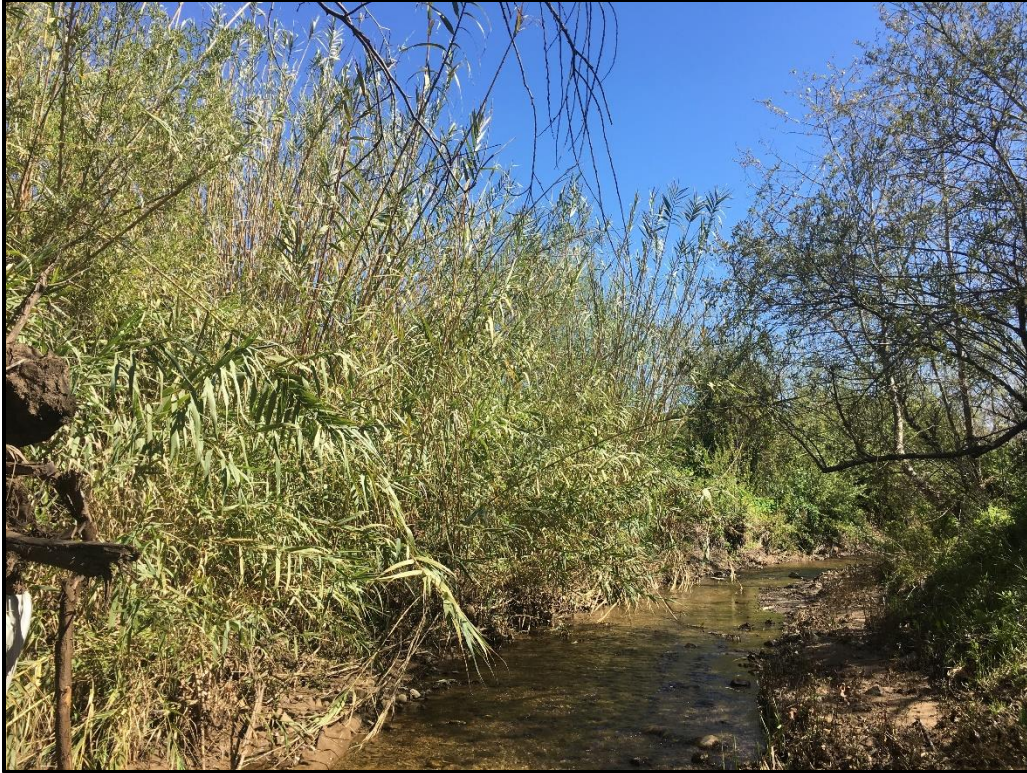
Photo 11: Giant reed infestation along Arroyo Paredon Creek adjacent to the Project Site (Aspect: East). Photo taken March 13, 2020.

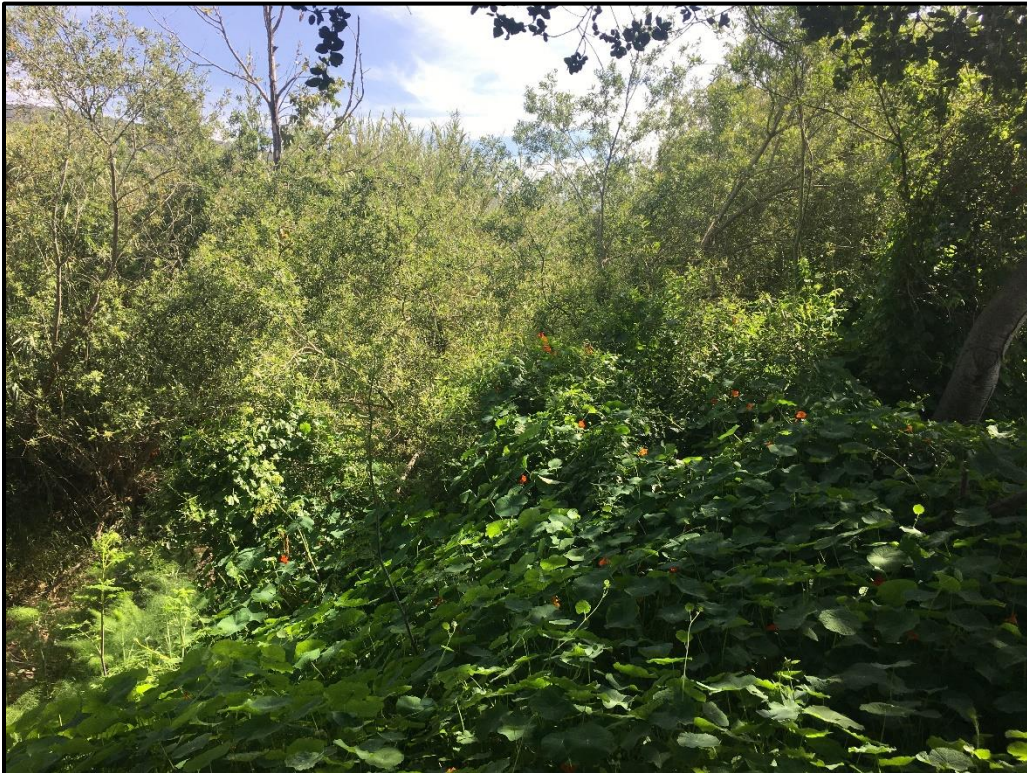
Photo 12: Dense understory vegetation, comprised of non-native species, along the banks of Arroyo Paredon Creek (Aspect: South). Photo taken May 7, 2020.
