**REVISED BIOLOGICAL RESOURCES ASSESSMENT  
FOR THE  
CREEKSIDE BLOOMS NURSERY, LLC MIXED-LIGHT CANNABIS  
CULTIVATION PROJECT (19CDP-00000-00027, 19DVP-00000-00020)  
3508 VIA REAL (APN 005-280-025), CARPINTERIA, CALIFORNIA**

**Revised:** November 23, 2021

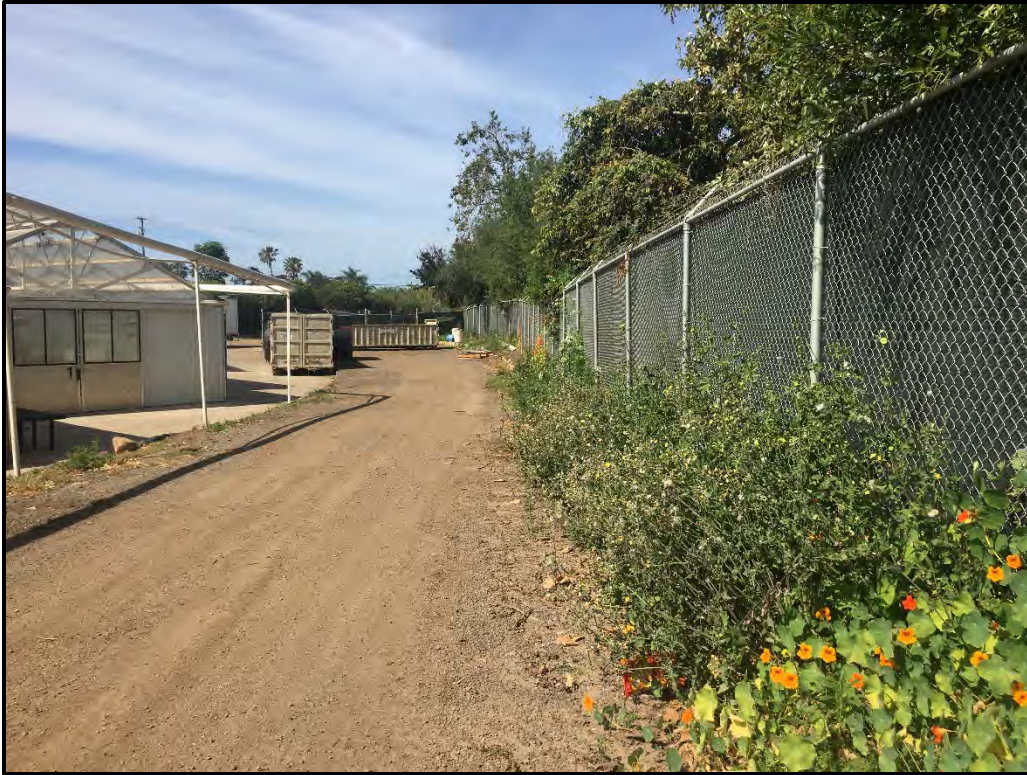
Photo 1: Project Site entrance, ruderal habitat along existing fence to be landscaped with natives, and riparian corridor of Arroyo Paredon Creek (Aspect: West). Photo taken 5/7/2020.

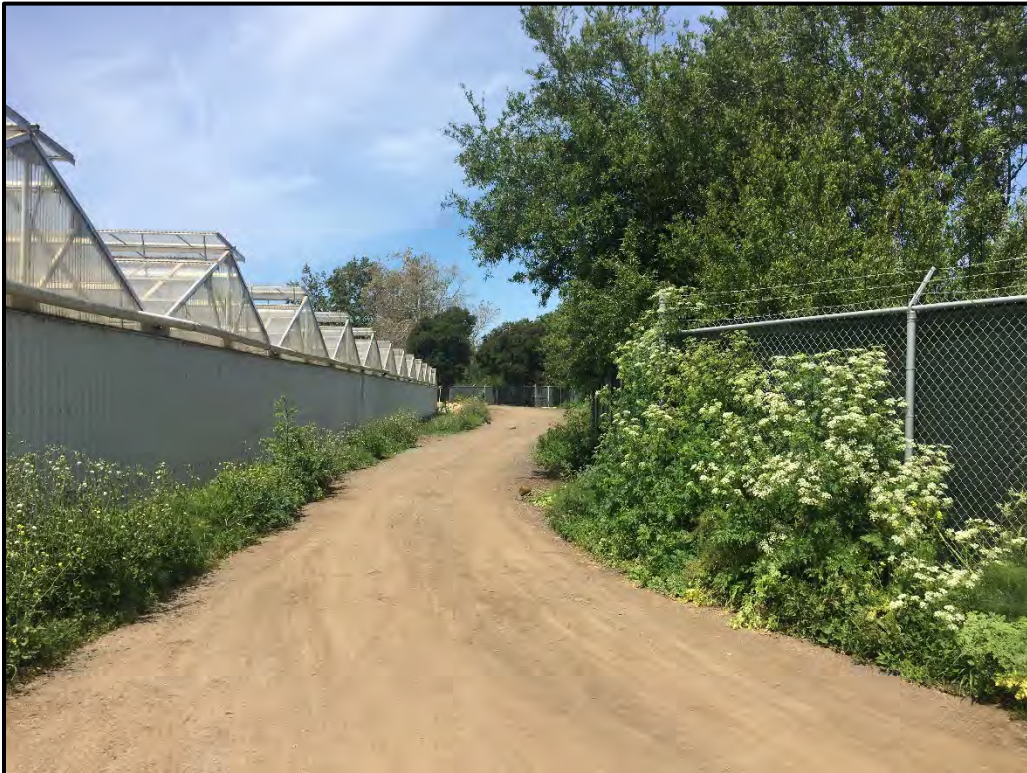
Photo 1: Edges of greenhouses to be demolished, ruderal habitat to be landscaped with natives, and riparian corridor of Arroyo Paredon Creek (Aspect: East). Photo taken 5/7/2020.

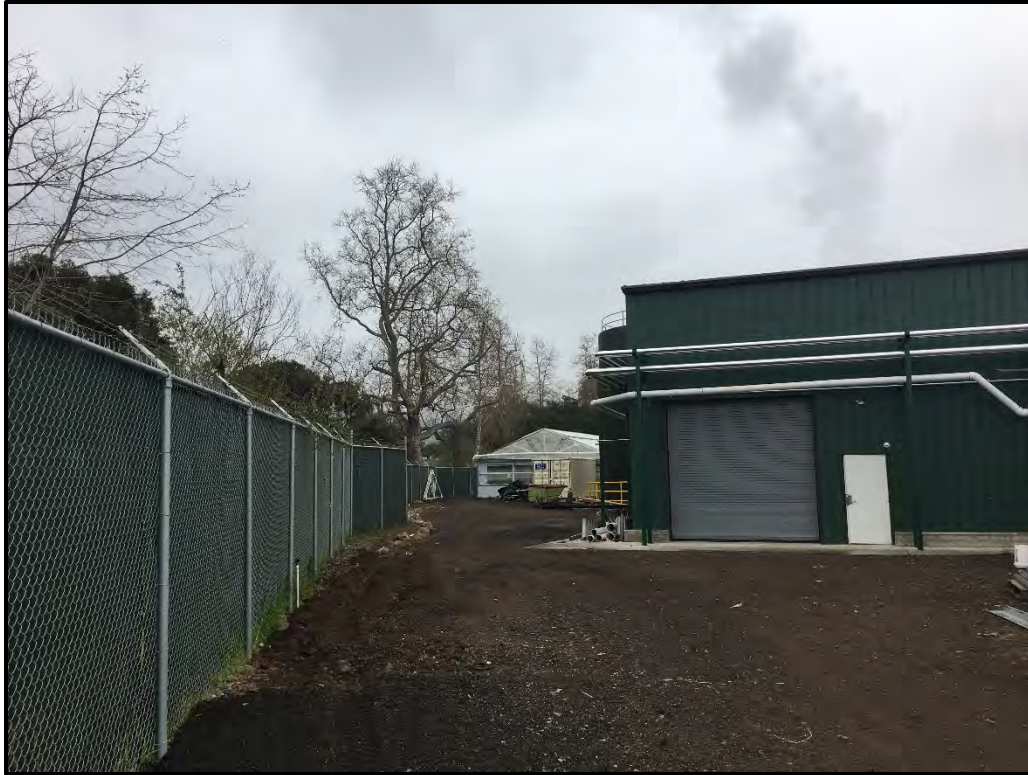
Photo 1: Greenhouse and broiler to be demolished in ESH Buffer (Aspect: East). Photo taken 2/27/2019.

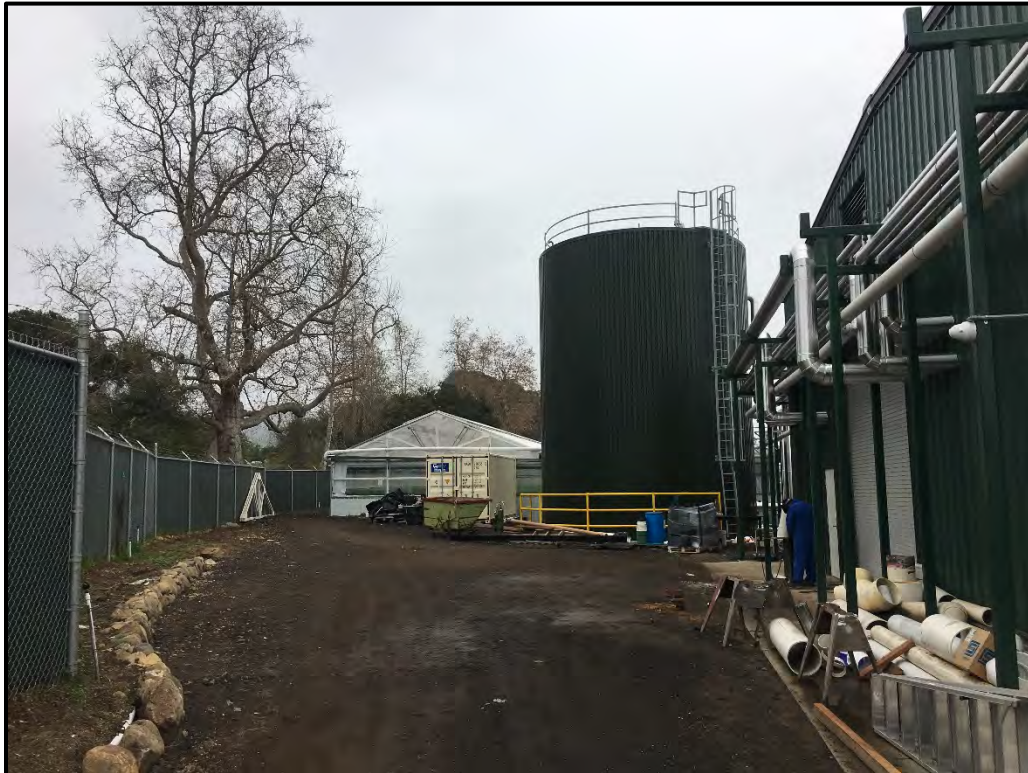
Photo 2: Water tank and greenhouse to be demolished in ESH Buffer (Aspect: East). Photo taken 2/27/2019.

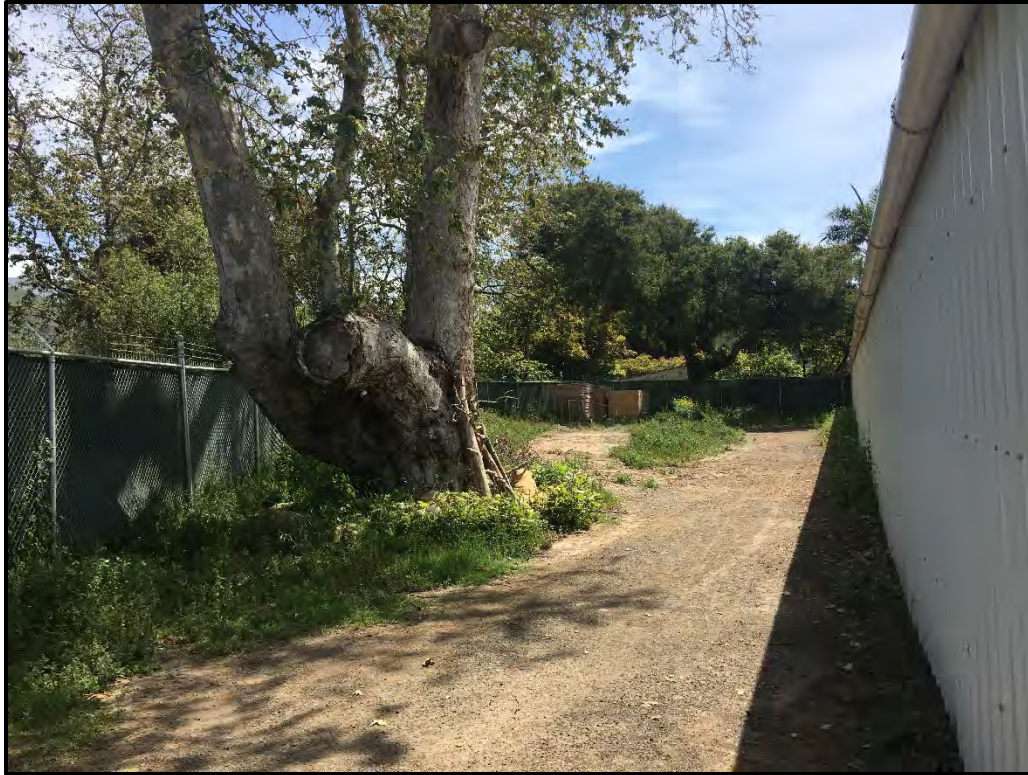
Photo 3. Western sycamore, coast live oak, and Native Habitat Enhancement Area in northeast corner of Project Site (Aspect: West). Greenhouse will be demolished. Photo taken 5/7/2020.

No native trees will be removed as part of the proposed Project. The coast live oak and western sycamore trees in the Project Site will be incorporated in the Native Habitat Enhancement Area. Protective fencing will be installed around these trees prior to demolition and will remain until demolition is complete. With implementation of the recommended avoidance and minimization measures outlined below, no impacts to native trees are expected.

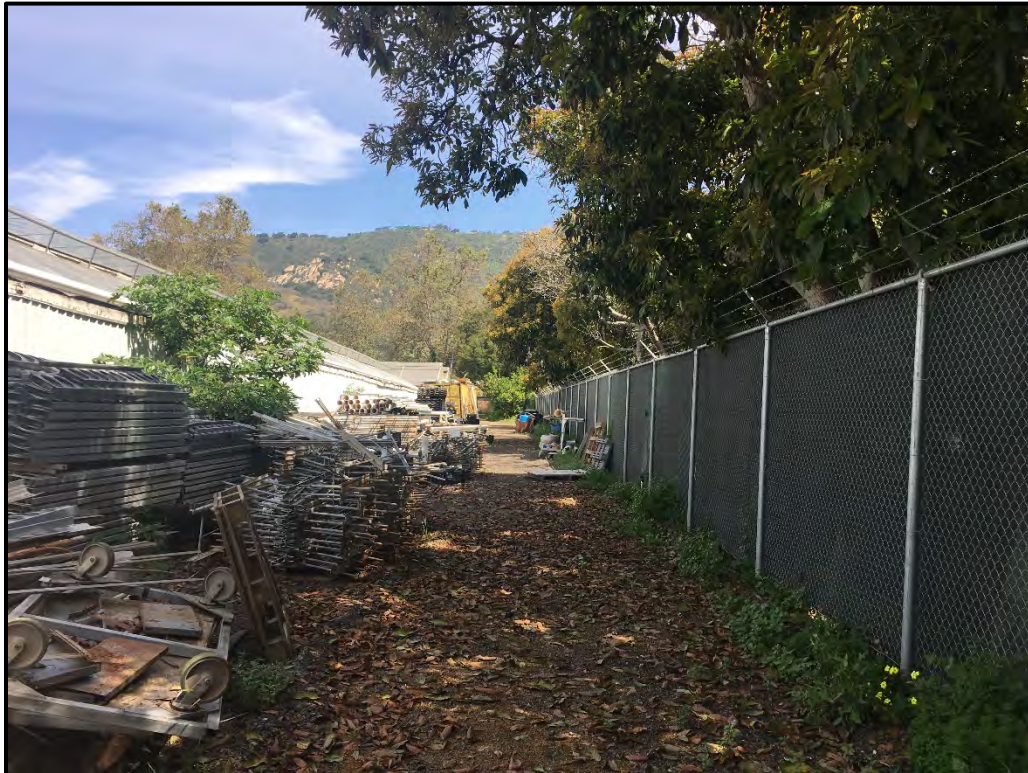
Photo 4: East side of Project Site where underground stormwater detention basin will be located, outside of the ESH buffer (Aspect: North). Photo taken 5/7/2020.

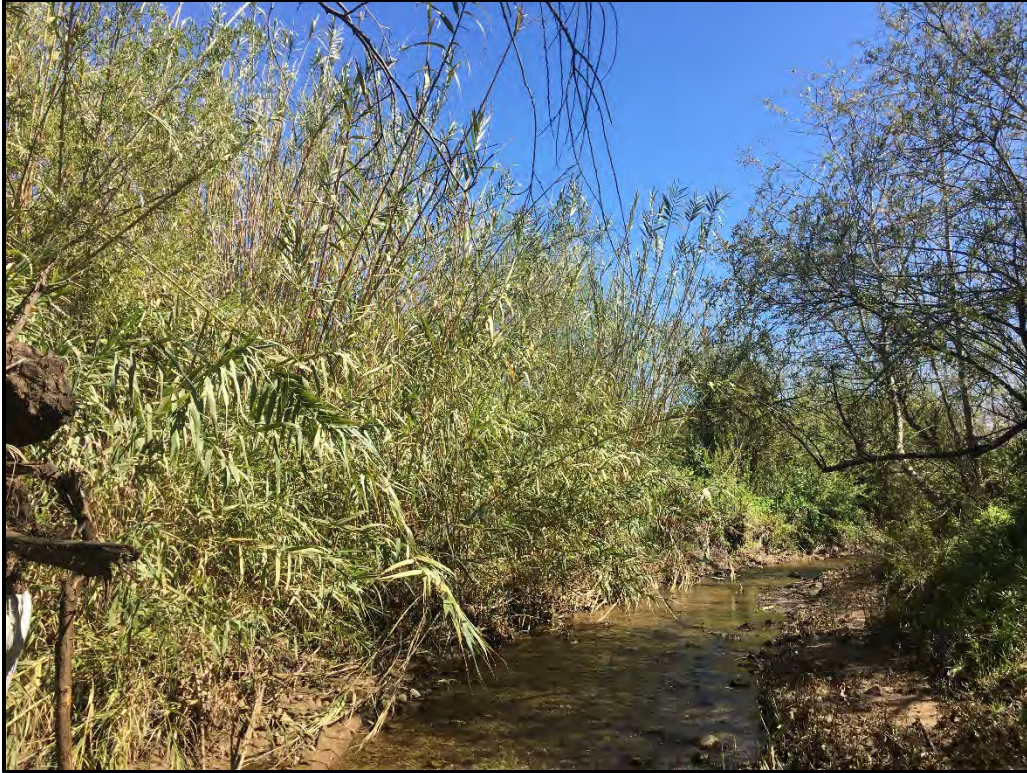
Photo 5: Giant reed infestation along Arroyo Paredon Creek adjacent to the Project Site (Aspect: East). Photo taken 3/13/2020.

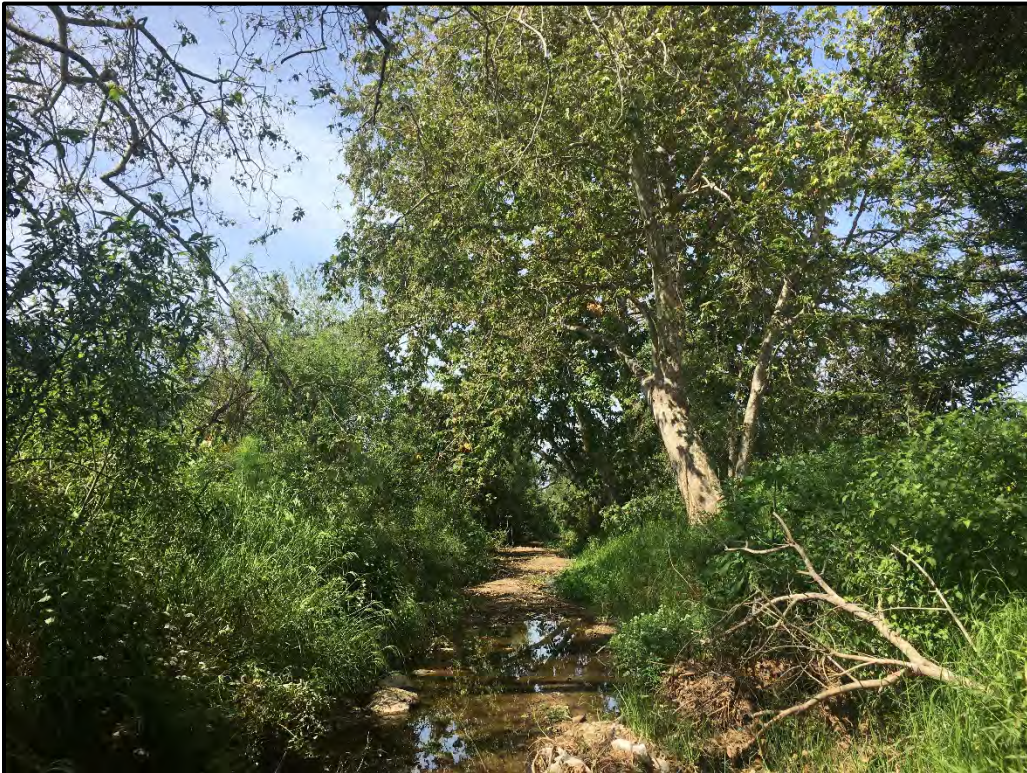
Photo 6. Arroyo Paredon Creek along northern boundary of Project Site (Aspect: West). Photo taken 5/7/2020.

The surface flow in Arroyo Paredon Creek varied from 2 to 12 inches deep and 5 to 20 feet wide, with limited small pools or vegetative cover that would support breeding habitat for CRLF. Due to the lack of pools and short duration of the hydroperiod in the creek, CRLF breeding in the vicinity of the Project Site is considered unlikely. Upland CRLF dispersal and migration occur under wet conditions during fall and winter. If CRLF utilize the habitat near the Project Site, it would likely be on a transient basis only and they would be expected to remain largely within the riparian habitat along Arroyo Paredon Creek.

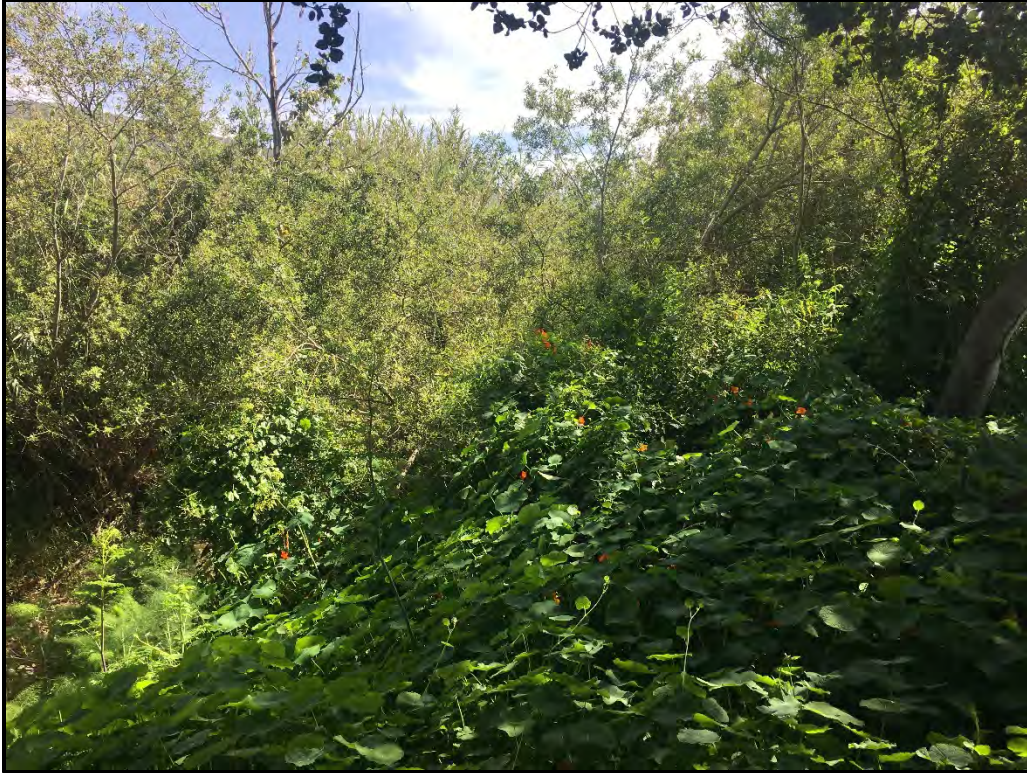
Photo 7: Dense understory vegetation, comprised of non-native species, along the banks of Arroyo Paredon Creek (Aspect: South). Photo taken 5/7/2020.

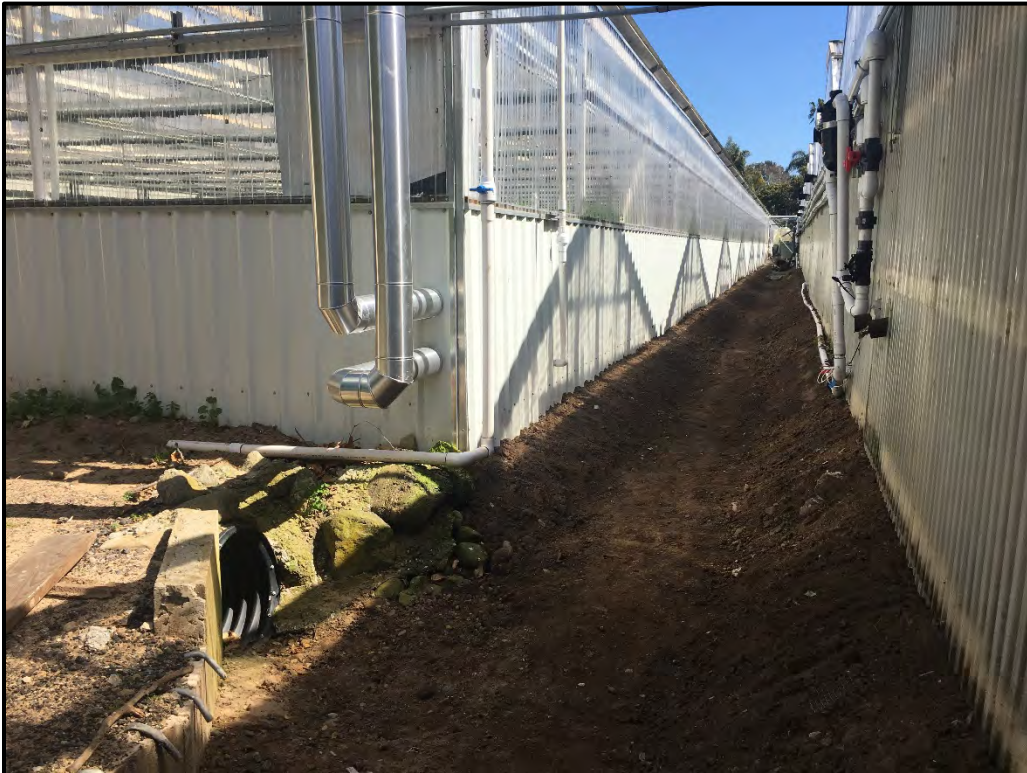
Photo 8: Culvert behind the water tank that discharges stormwater into Arroyo Paredon Creek (Aspect: East).
