**COUNTY OF SANTA BARBARA
PLANNING AND DEVELOPMENT**

RE: Case Nos. 16DET-00000-00004 & 10RVP-00000-00048
Lompoc Stone Mining Area Expansion Vesting Determination and Reclamation
Plan Revision Project
Assessor Parcel Numbers 083-060-015, -009, 083-070-018, & -010

Subject: Geologic and Aerial Photo Review – Lompoc Stone Quarry
3135 Santa Rosa Road
APNs 83-060-015 and -009
Lompoc, California

**Site Observations – Disturbance Areas Visible in August 12, 1958 Aerial Photo and
at February 13, 2018 Site Reconnaissance**

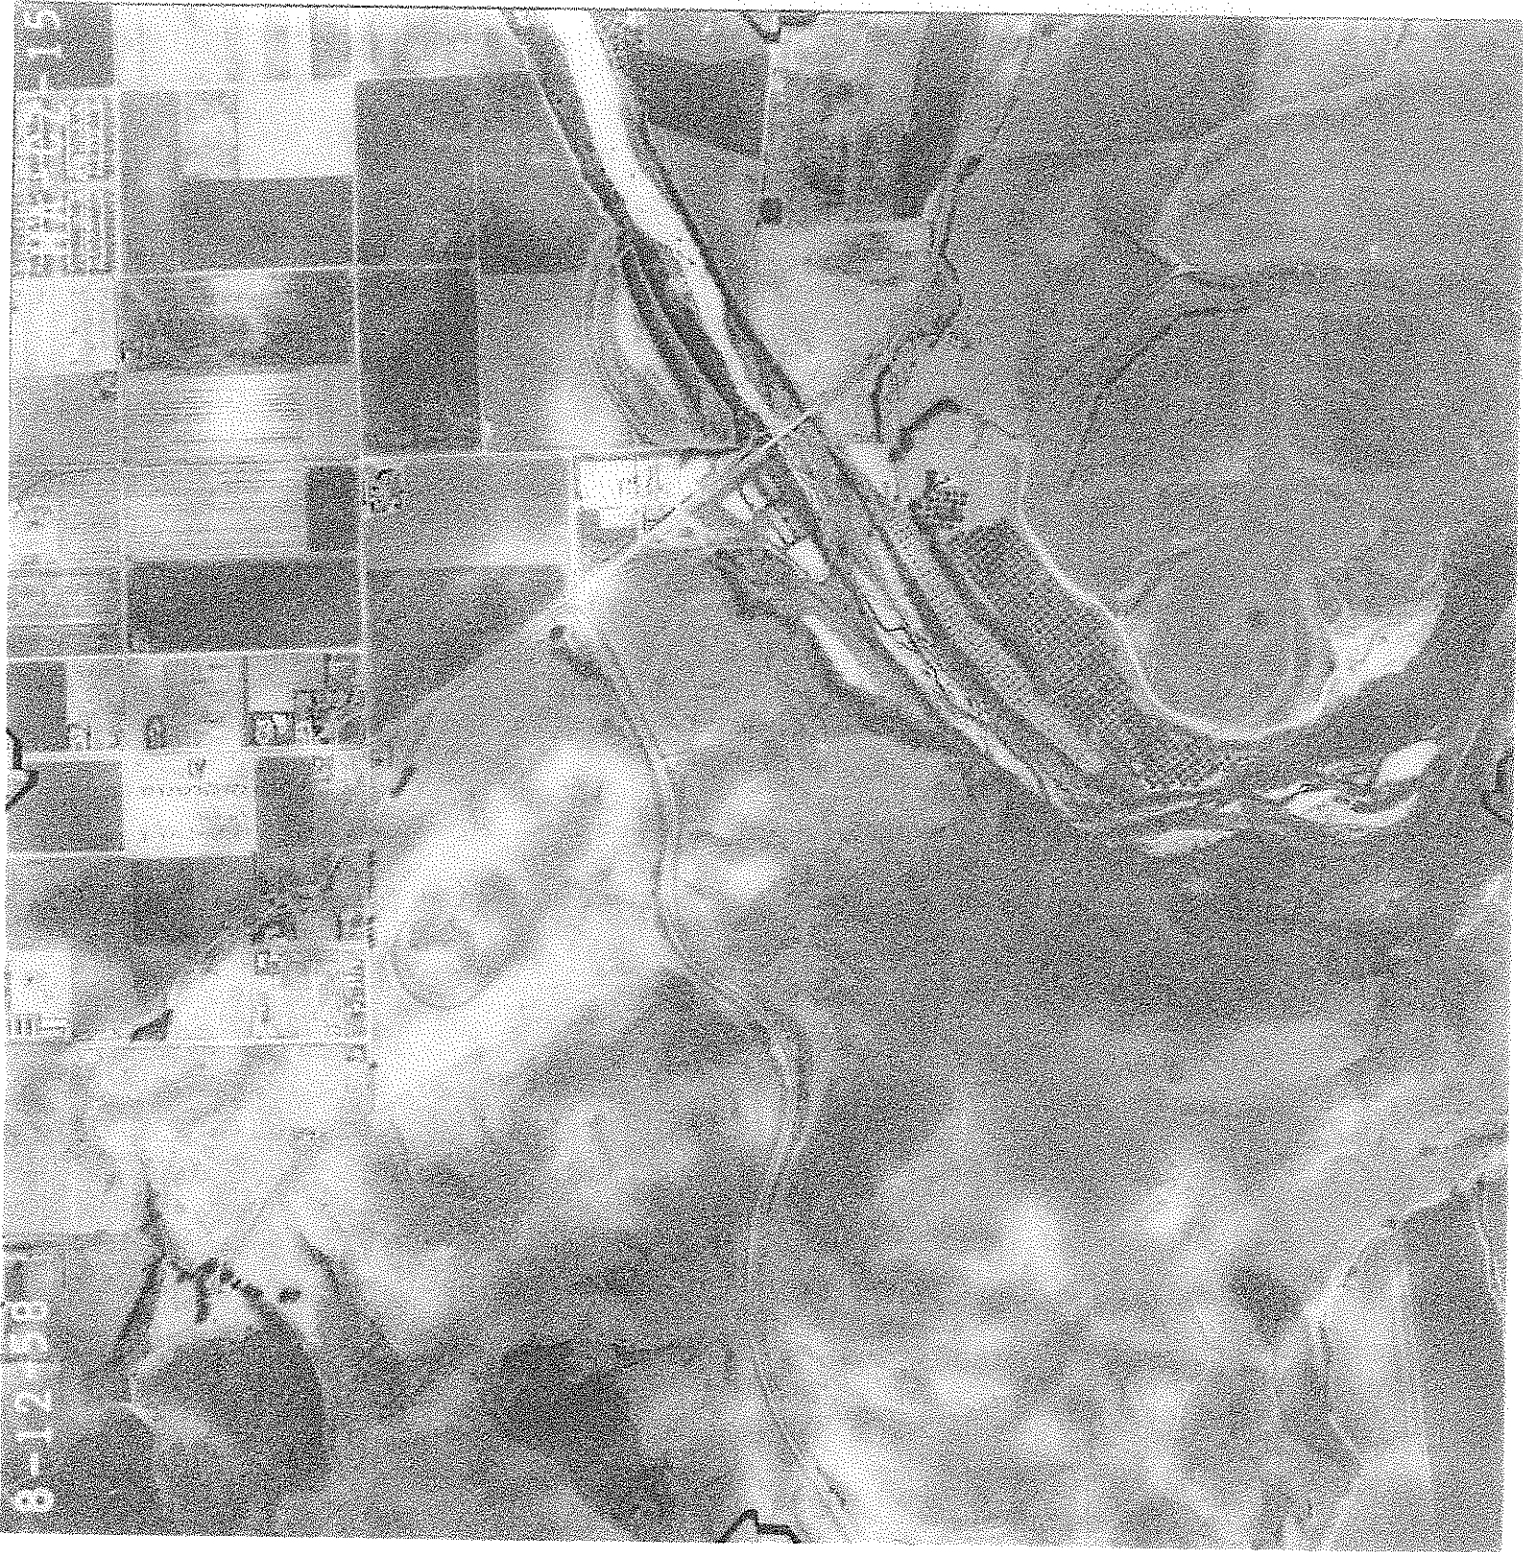
AF 74-9
609 D.1
1974

DATED 1-5-68
USC AIR PHOTOS
HB-44-32
D-490

See attached. Again, the progression of mining shown on aerial photos from the 1950's to current, documents the past and current mine operators' knowledge that suitable resources existed and their intent to follow that resource within this portion of the ranch. Steve Campbell is also able to provide his insight and opinion regarding evidence he recently observed onsite in relation to aspects of the 1958 air photos.

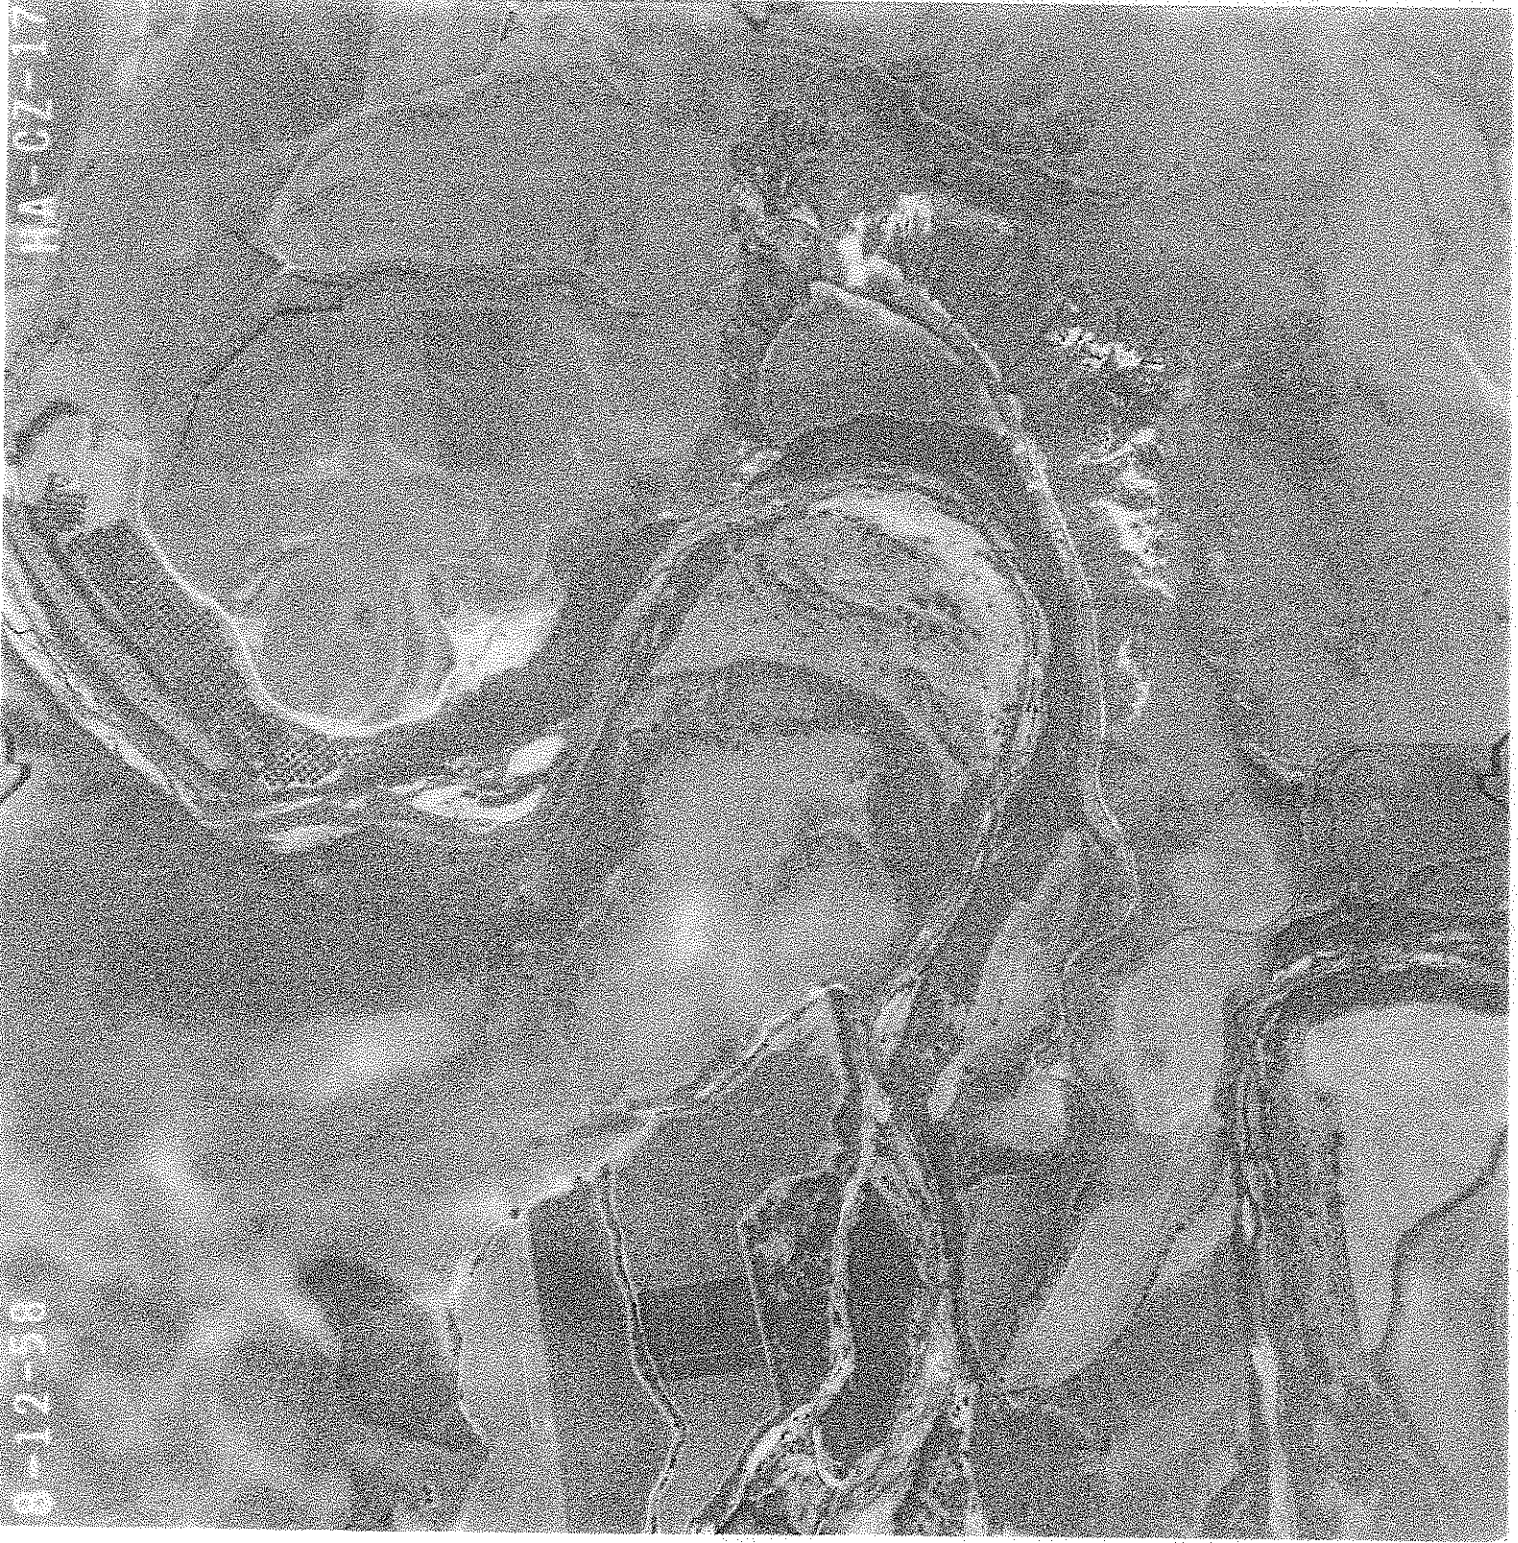
HA-02-17

8-12-58

In the August 1958 aerial photos viewed stereoscopically show the same features described above for the 1956 photo. In addition there is a disturbed area with little or no vegetation some relief that has the appearance of a rock ridge or possibly a picked over area. This feature is coincident with the "quarry" symbol mapped on the 1959 USGS topographic quadrangle for Lompoc. We noted that what appeared on the site photos as areas of moderate site disturbance (partially revegetated, rounded surface features) were evident by ground truth evaluations to be areas of past grading or other site disturbance. The partially revegetated and rounded features in the photos from the 1950's suggest site activity may have started decades earlier.

We collected site photographs during a February 13, 2018 site reconnaissance. Those photos have been collected at features that show ground disturbance in both the 1958 aerial photograph and in the 2018 ground based photographs, which are numbered 1 through 8 and illustrated on the attached sheets. The location and orientation of each of the eight (8) photographs is noted on an attached enlarged print of the 1958 aerial photograph. These photos demonstrate that various levels of site clearing and grading were conducted at least as early as August 1958 and are still visible today. The ground examination clearly confirms these features (roads, hummocky topography) that were visible in the 1958 aerial photo are still evident and are associated with the rock quarry operation.

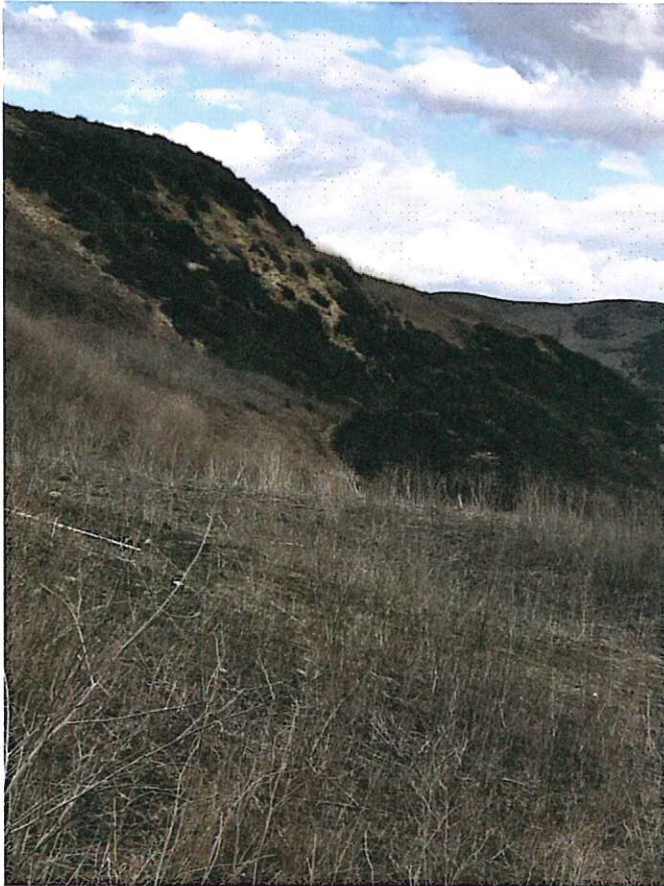
In the 1956 aerial photos, disturbed areas with hummocky, obviously unnatural topography are visible on the east facing slope of APN 083-060-009. This area correlates exactly to the area examined in February 2018 by photos #1 and #2 (described below). In

Photo #1 – View to East;
Previously Graded Area Visible
on August 12, 1958 aerial
photograph

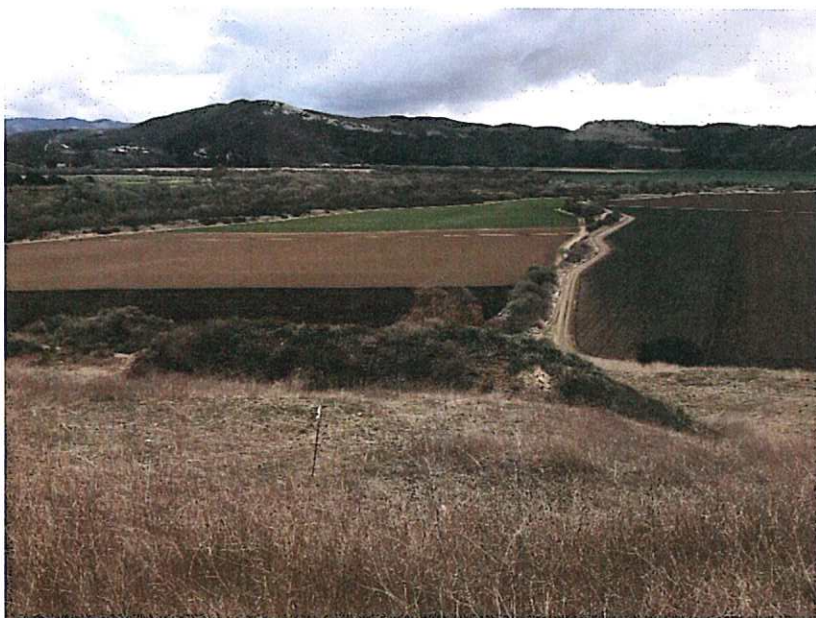
Photo # 2 – View to South; Same
Previously Graded Area as
Above Visible on August 12,
1958 aerial photograph

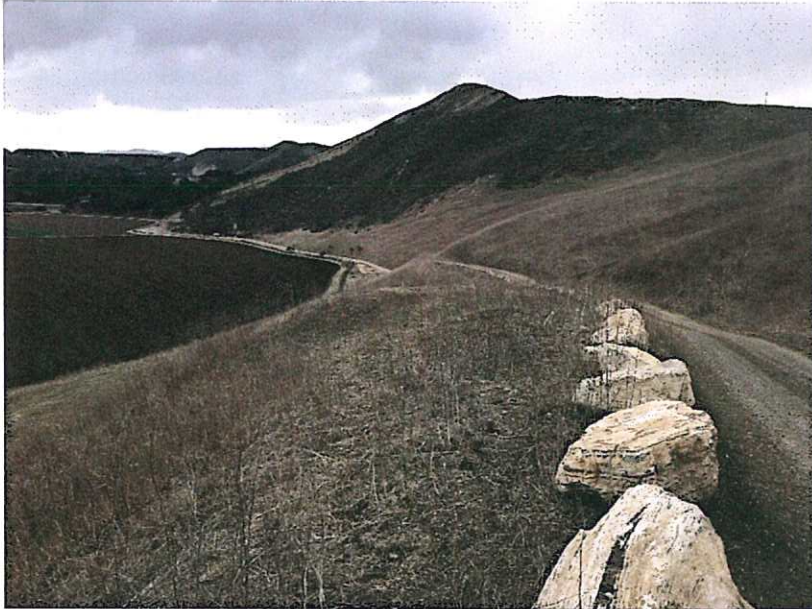
Photo # 3 – View to Southwest;
Access Road to Quarry Visible
on August 12, 1958 aerial
photograph

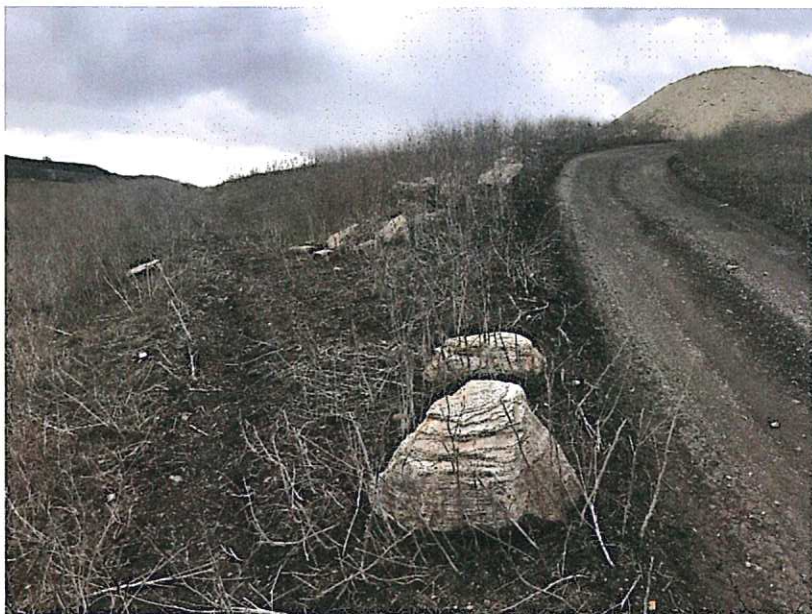
addition the road described in 2018 photo #4 and the fence line in 2018 photo #6 are also visible.

Photo # 4 – View to West; Older
Access Road on Left (visible in
August 12, 1958) Adjacent to
Current Access Road on Right

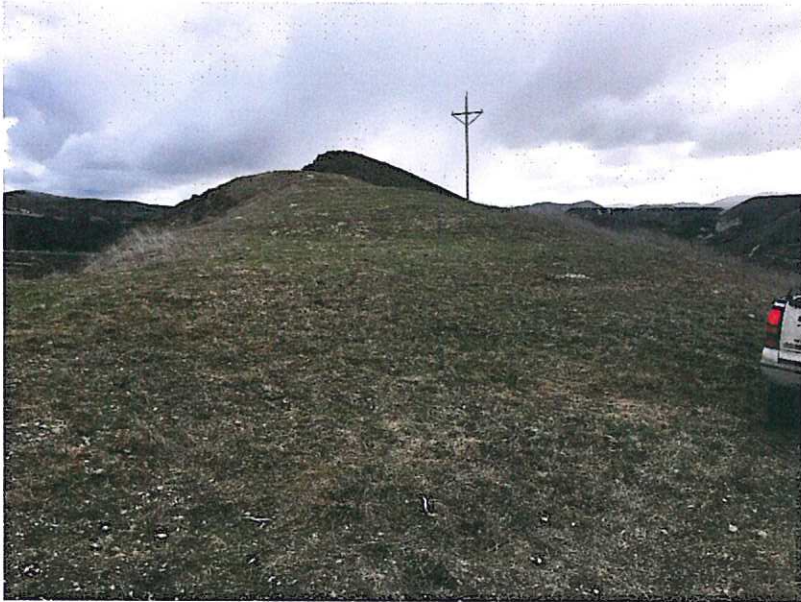
Photo # 5 – View to South; Older Graded Area Visible as Light Area (unvegetated) on August 12, 1958 aerial photograph

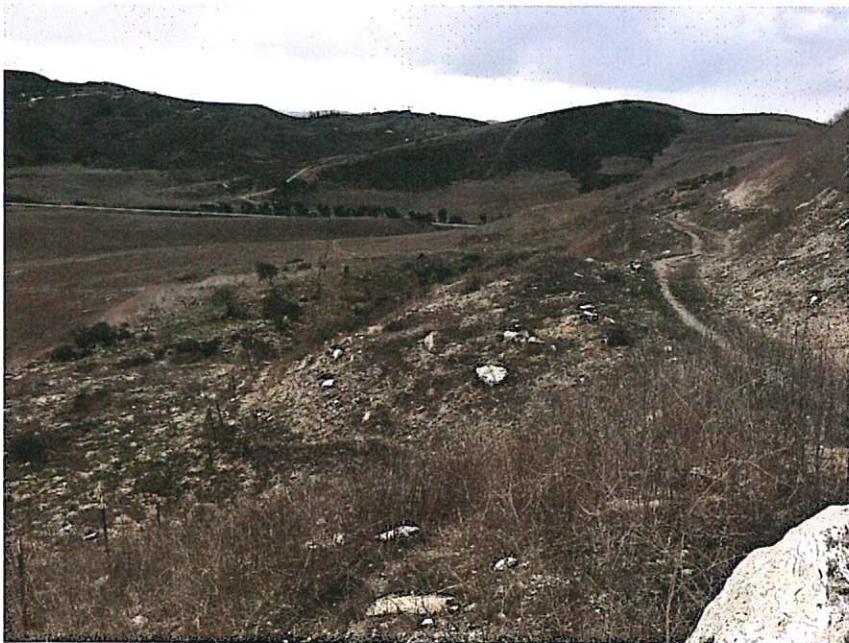
Photo # 6 – View to West of Old Wire Fence Traversing Spoils Piles and other Quarry Disturbances; Fence and Some Disturbances Visible on August 12, 1958 aerial photograph

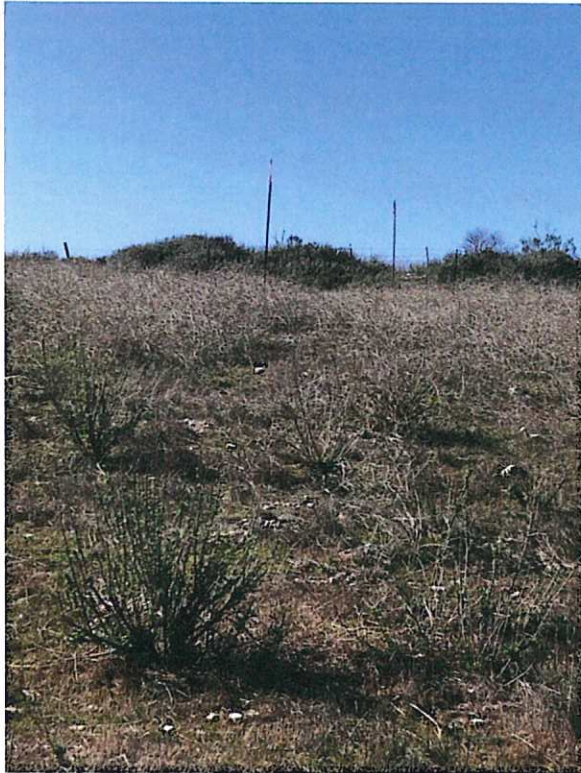
Photo #7 – View to Northwest;
Disturbed area on APN 083-060-009
also visible in August 12, 1958 aerial
photo

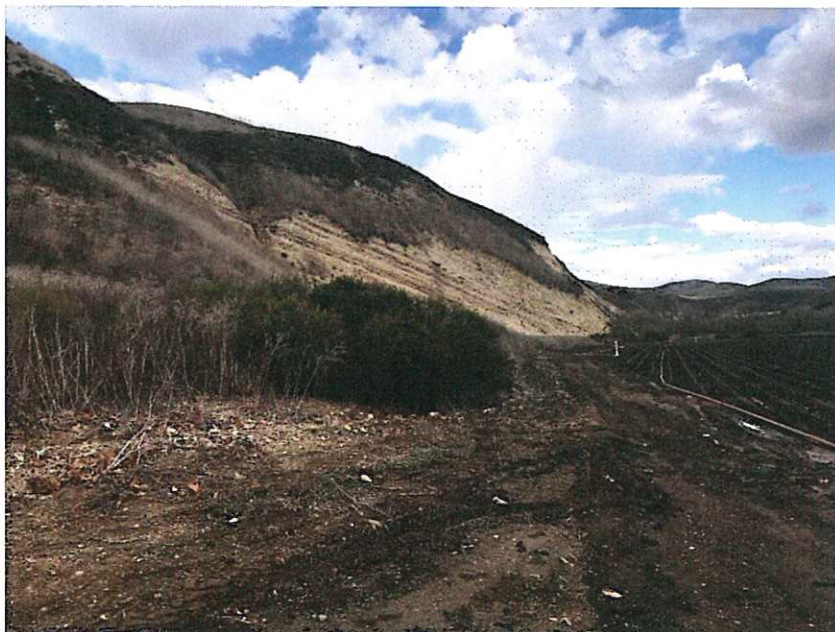
Photo #8 – View to Northeast;
Monterey Formation on APN
083-060-009

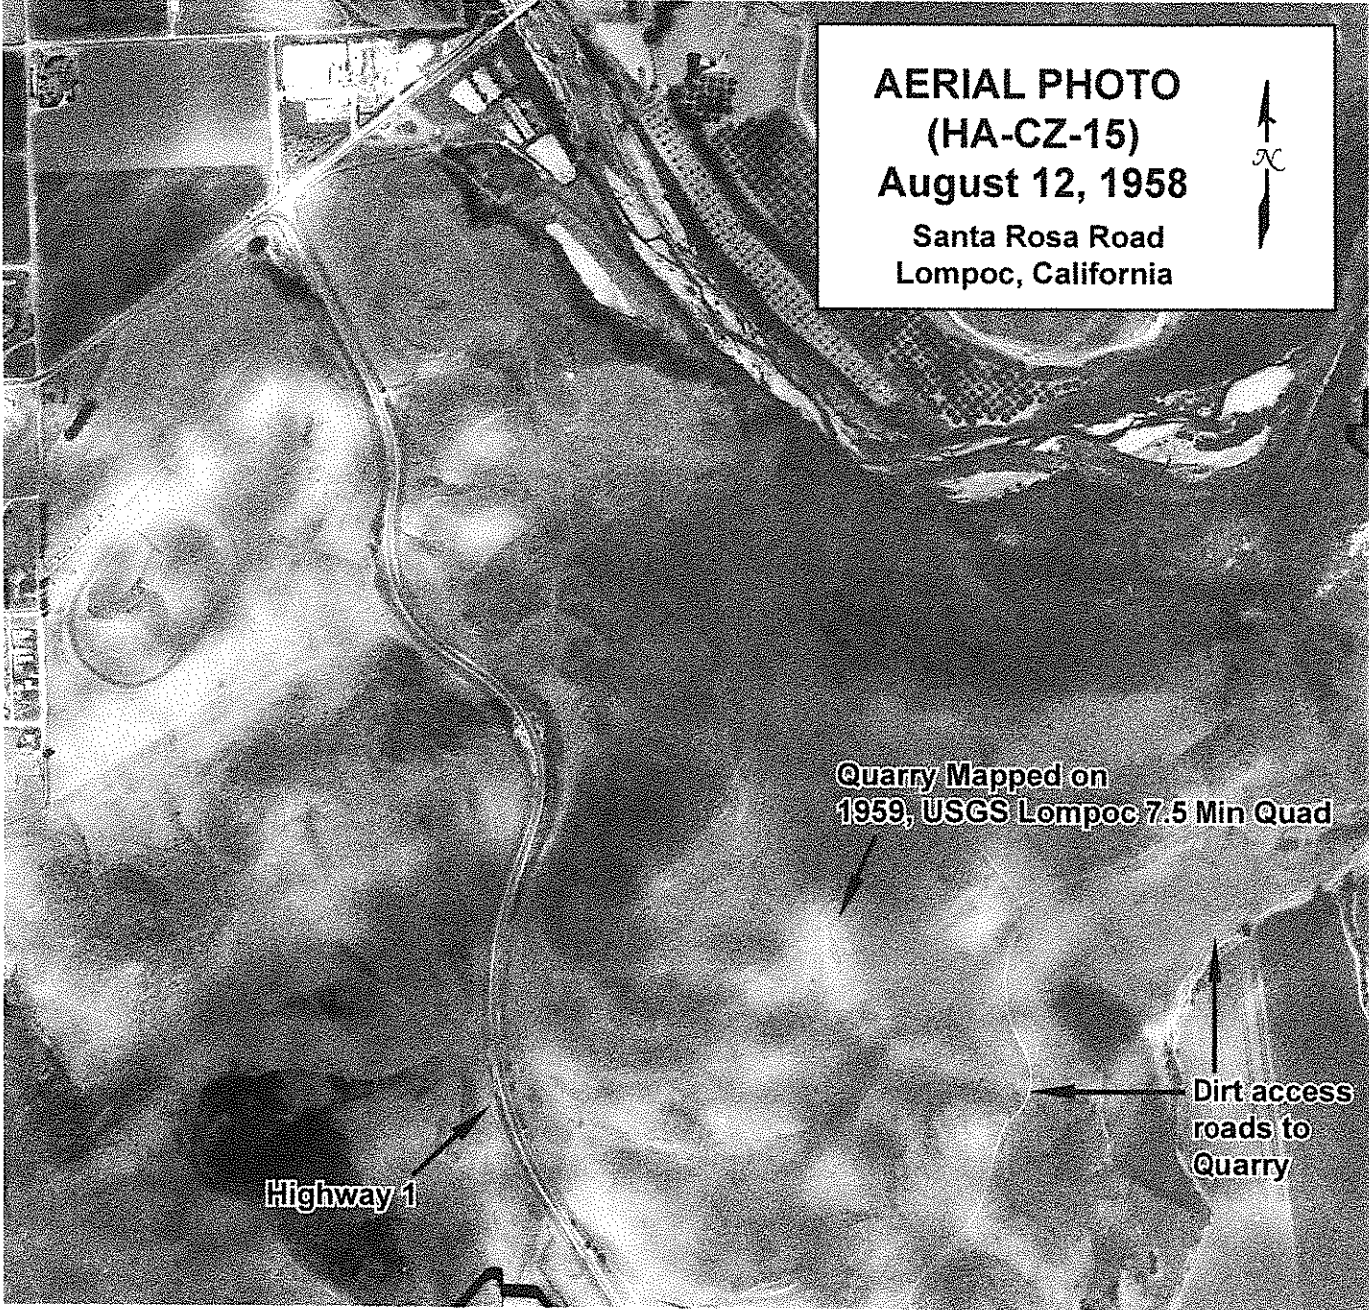
AERIAL PHOTO
(HA-CZ-15)
August 12, 1958
Santa Rosa Road
Lompoc, California

Quarry Mapped on
1959, USGS Lompoc 7.5 Min Quad

Dirt access
roads to
Quarry
