JESUSITA FIRE
Emergency Watershed Response Plan

Santa Barbara County Operational Area
Operations Section

Santa Barbara County Public Works Department
Santa Barbara County Flood Control District

June 2009

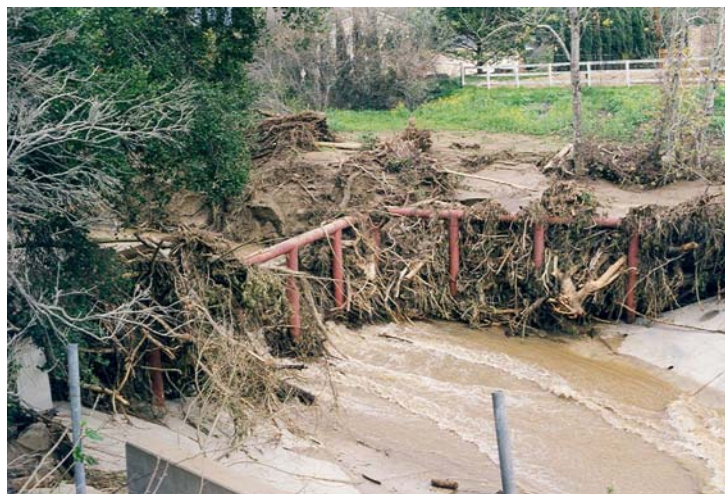
Figure 2 – Existing Debris Rack on Tecolote Creek during the 1998 Floods

An example of an existing rack currently exists on Tecolote Creek below Rancho Embarcadero; a photo of this facility is shown below in Figure 2.

Prior to winter, four large woody debris racks, also called “Grizzlies,” are planned like those installed following the Gap Fire.

Throughout the winter, especially after individual storms, the debris racks will be inspected and cleaned of debris as necessary. The racks are cleaned using a small hydro-crane or cable winch truck. Captured vegetation will be temporarily stockpiled until it can be moved to a disposal site. Any rack constructed by the City would be maintained by the City.

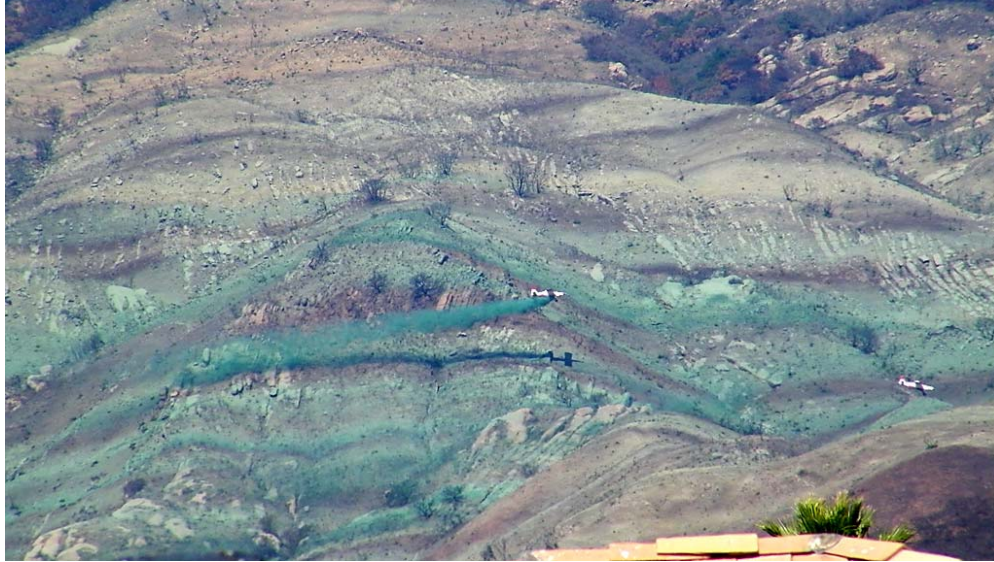
Figure 4 – Aerial Hydromulching (Gap Fire 2008)

One fire mitigation measure proposed by the USFS is hydromulching of federal lands within the burn area where slopes have a gradient of between 25% and 60%. This work was done after the Gap Fire in 2008. Hydromulching is a treatment of organic mulch with the addition of a tackifier to help bind the mulch in place. The hydromulch would be applied by air.

Because the USFS is precluded from carrying out treatments off of federal lands, the responsibility for any such treatments falls to the Natural Resources Conservation Service (NRCS) in cooperation with a local sponsor. Approximately 75% - 80% of the burn area is located on non-federal lands. Treatment of the non-federal lands offers benefits to downstream areas by slowing runoff and sedimentation yield. County Public Works will take the lead as the local sponsor and has requested the costs assistance with the NRCS if a feasible project can be developed considering slope restrictions, setback from structures and improvements, and rock outcropping. Land Owner permission is also required as all of the potential area is private property. A final determination of this project is due in the coming weeks. Figure 4 is a photo of the application of aerial hydromulch following the Gap Fire in 2008.

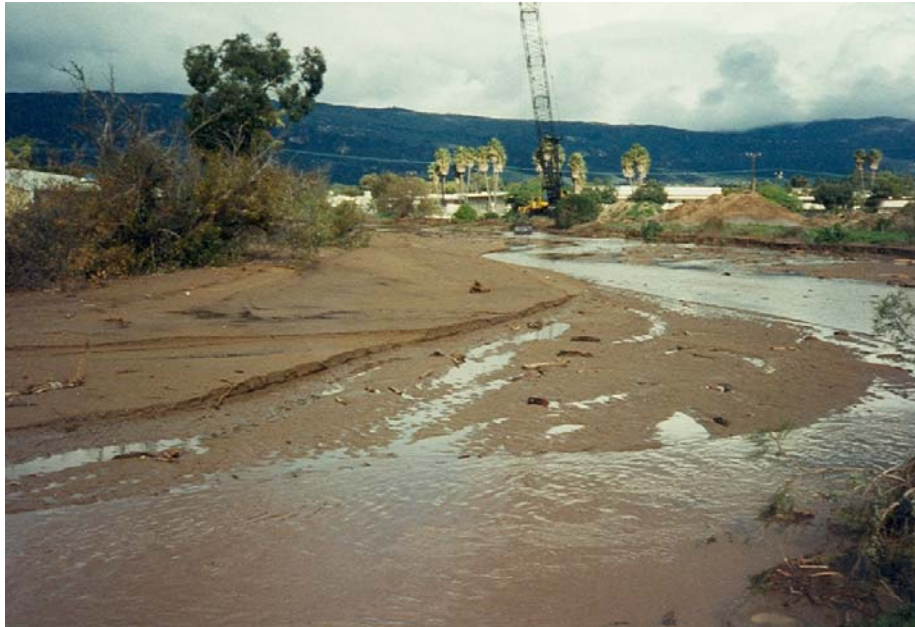
Figure 5 – Carneros Creek Sediment Basin, 1995

Excavation of the basins is accomplished by large heavy cranes and possibly assisted by larger long-reach excavators. Sediment is temporarily stockpiled and then removed to make room for more material as the operation continues.

Figure 5 below shows desilting of the Carneros Sediment Basin in 1995.

On-going dredging of the airport sediment basins will be a necessary and essential element of this winter's response efforts. Without active dredging, the channels will clog with sediment, resulting in reduced capacities. It is possible that the basins could be overwhelmed in a single rain event, in which case immediate emergency desilting will be required.
