Appeal to the Board of Supervisors or Planning Commission (County or Montecito)

APPEAL TO THE BOARD OF SUPERVISORS OR PLANNING COMMISSION (APL) on the issuance, revocation, or modification of :

1192 East Mountain Drive
 Montecito California
 June 15, 2009

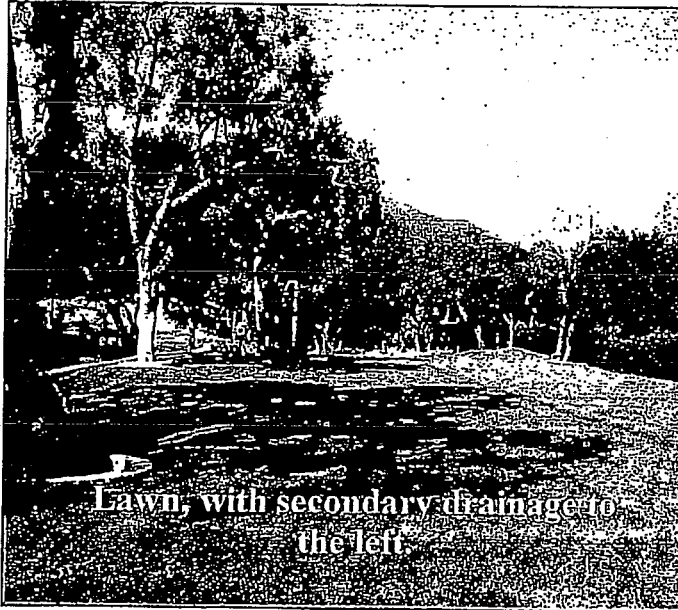
Coast Live Oak, Individual Trees

Coast live oak (*Quercus agrifolia*) trees are studded along the edge of the installed lawn as well as on the mid- to top of bank of the secondary drainage. These trees are pruned, healthy and well balanced. Tree wells (for surrounding grade increases) or retaining walls (for surrounding grade reductions) were recently installed around a number of the mature oaks. Little natural understory is present. Several oaks along the main branch of Hot Spring Creek extend into the lawn.

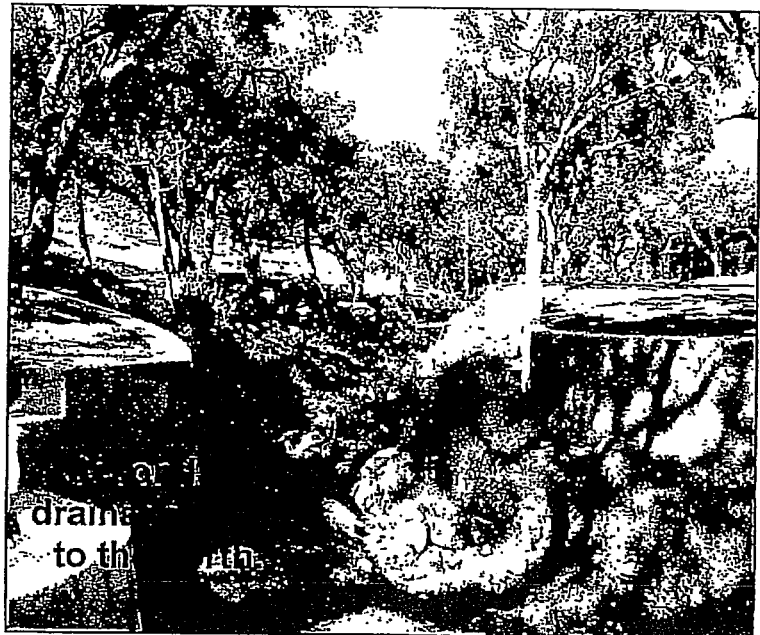
Vegetation Map 2009

The general appearance of this feature is a half landscaped, weedy dry creek bed. This grouping does not lend itself to any classification alliance. Non-permitted improvements to the upper bank include a vertical rock wall on sections of both side of the drainage and two pedestrian bridges.

Vegetation within the secondary drainage is a mixture of planted ornamental, woody groundcover, invasive groundcover and common weeds often seen on

Plant communities or vegetation types found on the site in 2001 and currently are classified under two systems, which are listed in Table 1 and mapped on Figure 2. The division between

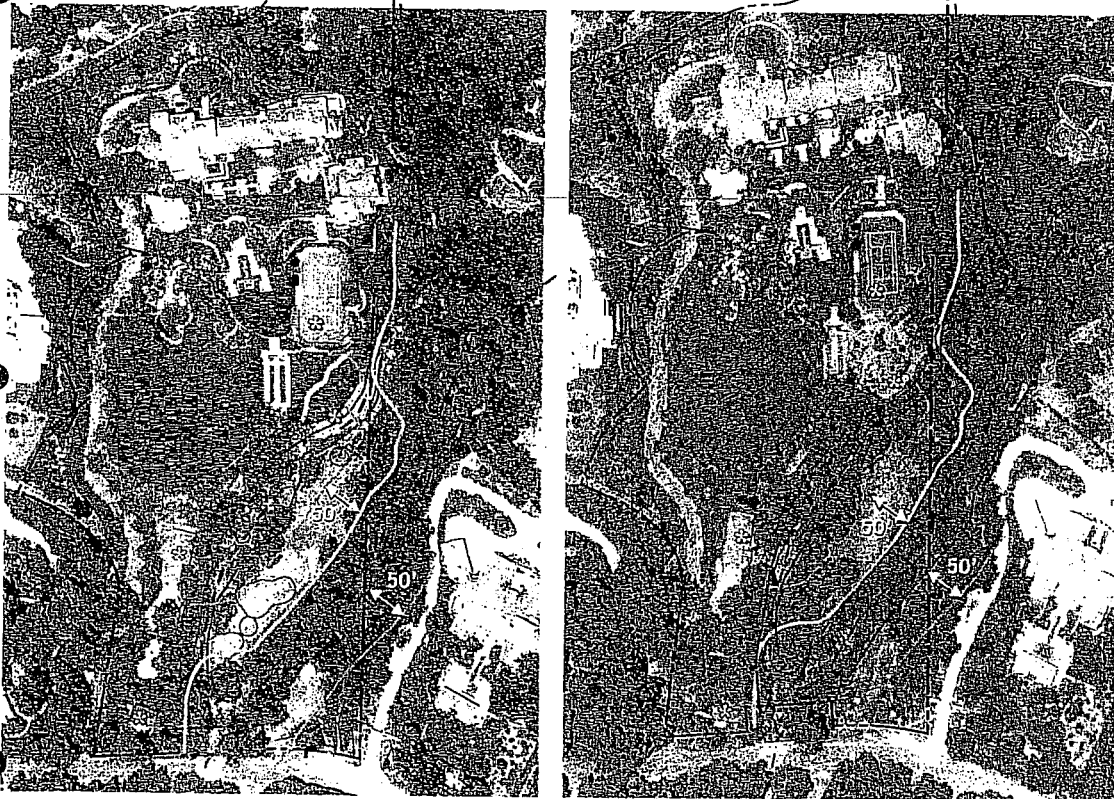
- Location of ESH
- Location of 50' Buffer (Buffer not extended into area developed prior to Montecito Community Plan)
- Flow Line
- Top of Bank
- Property Line
- Trees Removed Between 2001 and 2009
- Structures west of secondary drainage developed prior to Montecito Community Plan Update (1992)

Vegetation Maps A comparison of the 2008 aerial and current conditions (individual trees and ground cover) was made in the field. Each tree along the top of bank of Hot Springs Creek (and thus the actual border of the current riparian canopy) was compared with the 2008 aerial. All trees along the secondary drainage were likewise marked on the 2008 aerial. All differences were noted on a topographic map. After this assessment, a vegetation map of the current condition could be made using the 2008 aerial. Vegetation was likewise map from the 2001 aerial.

Changes in Vegetation To determine if any changes occurred within the general area of non-permitted work between 2008 and the present, the canopy cover noted in the 2008 aerial photograph was compared to vegetation in the 2001 aerial.¹ A clear plastic overlay of the 2008 trees and plant community distribution was then placed over the 2001 aerial. A light table was used to help identify any trees or other vegetation "textures" that were missing or altered in any of the later aerial photographs. Changes in vegetation were highlighted on the aerials and shown on the vegetation maps.

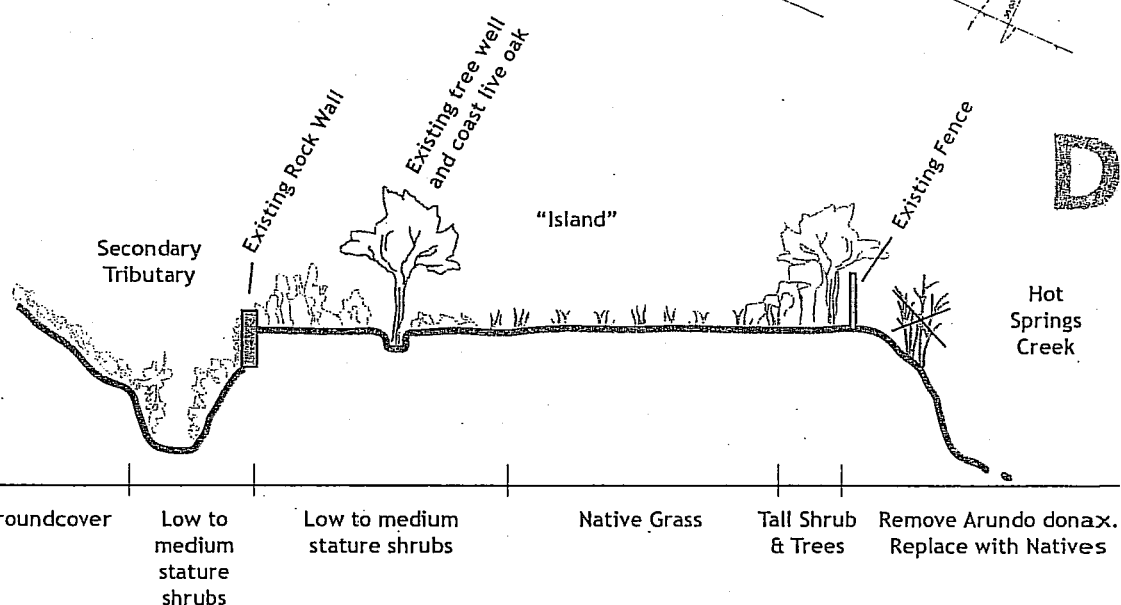
Current Condition

This is the primary disturbance site. The area is now open and park-like, from the secondary drainage east to the top of bank of Hot Springs Creek. Coast live oak (*Quercus agrifolia*) trees are studded along the edge of the installed lawn as well as on the mid to top of bank of the secondary drainage. These trees are heavily pruned and healthy. Wells (for surrounding grade increases) or retaining walls (for surrounding grade reductions) protect a number of these oaks. Understory planting is absent.
