SANTA BARBARA MONTECITO PLANNING COMMISSION
Staff Report for the Bagdasarian-Karman Appeal of
the P&D Director's Denial of 09LUP-00000-00256

Hearing Date: October 27, 2010
Staff Report Date: October 8, 2010
Case No.: 10APL-00000-00016

This site is identified as Assessor Parcel Number 011-020-034 and 011-020-042, located north of East Mountain Drive and along Hot Springs Creek and tributary, known as 1192 and 1194 East Mountain Drive, Montecito, First Supervisorial District.

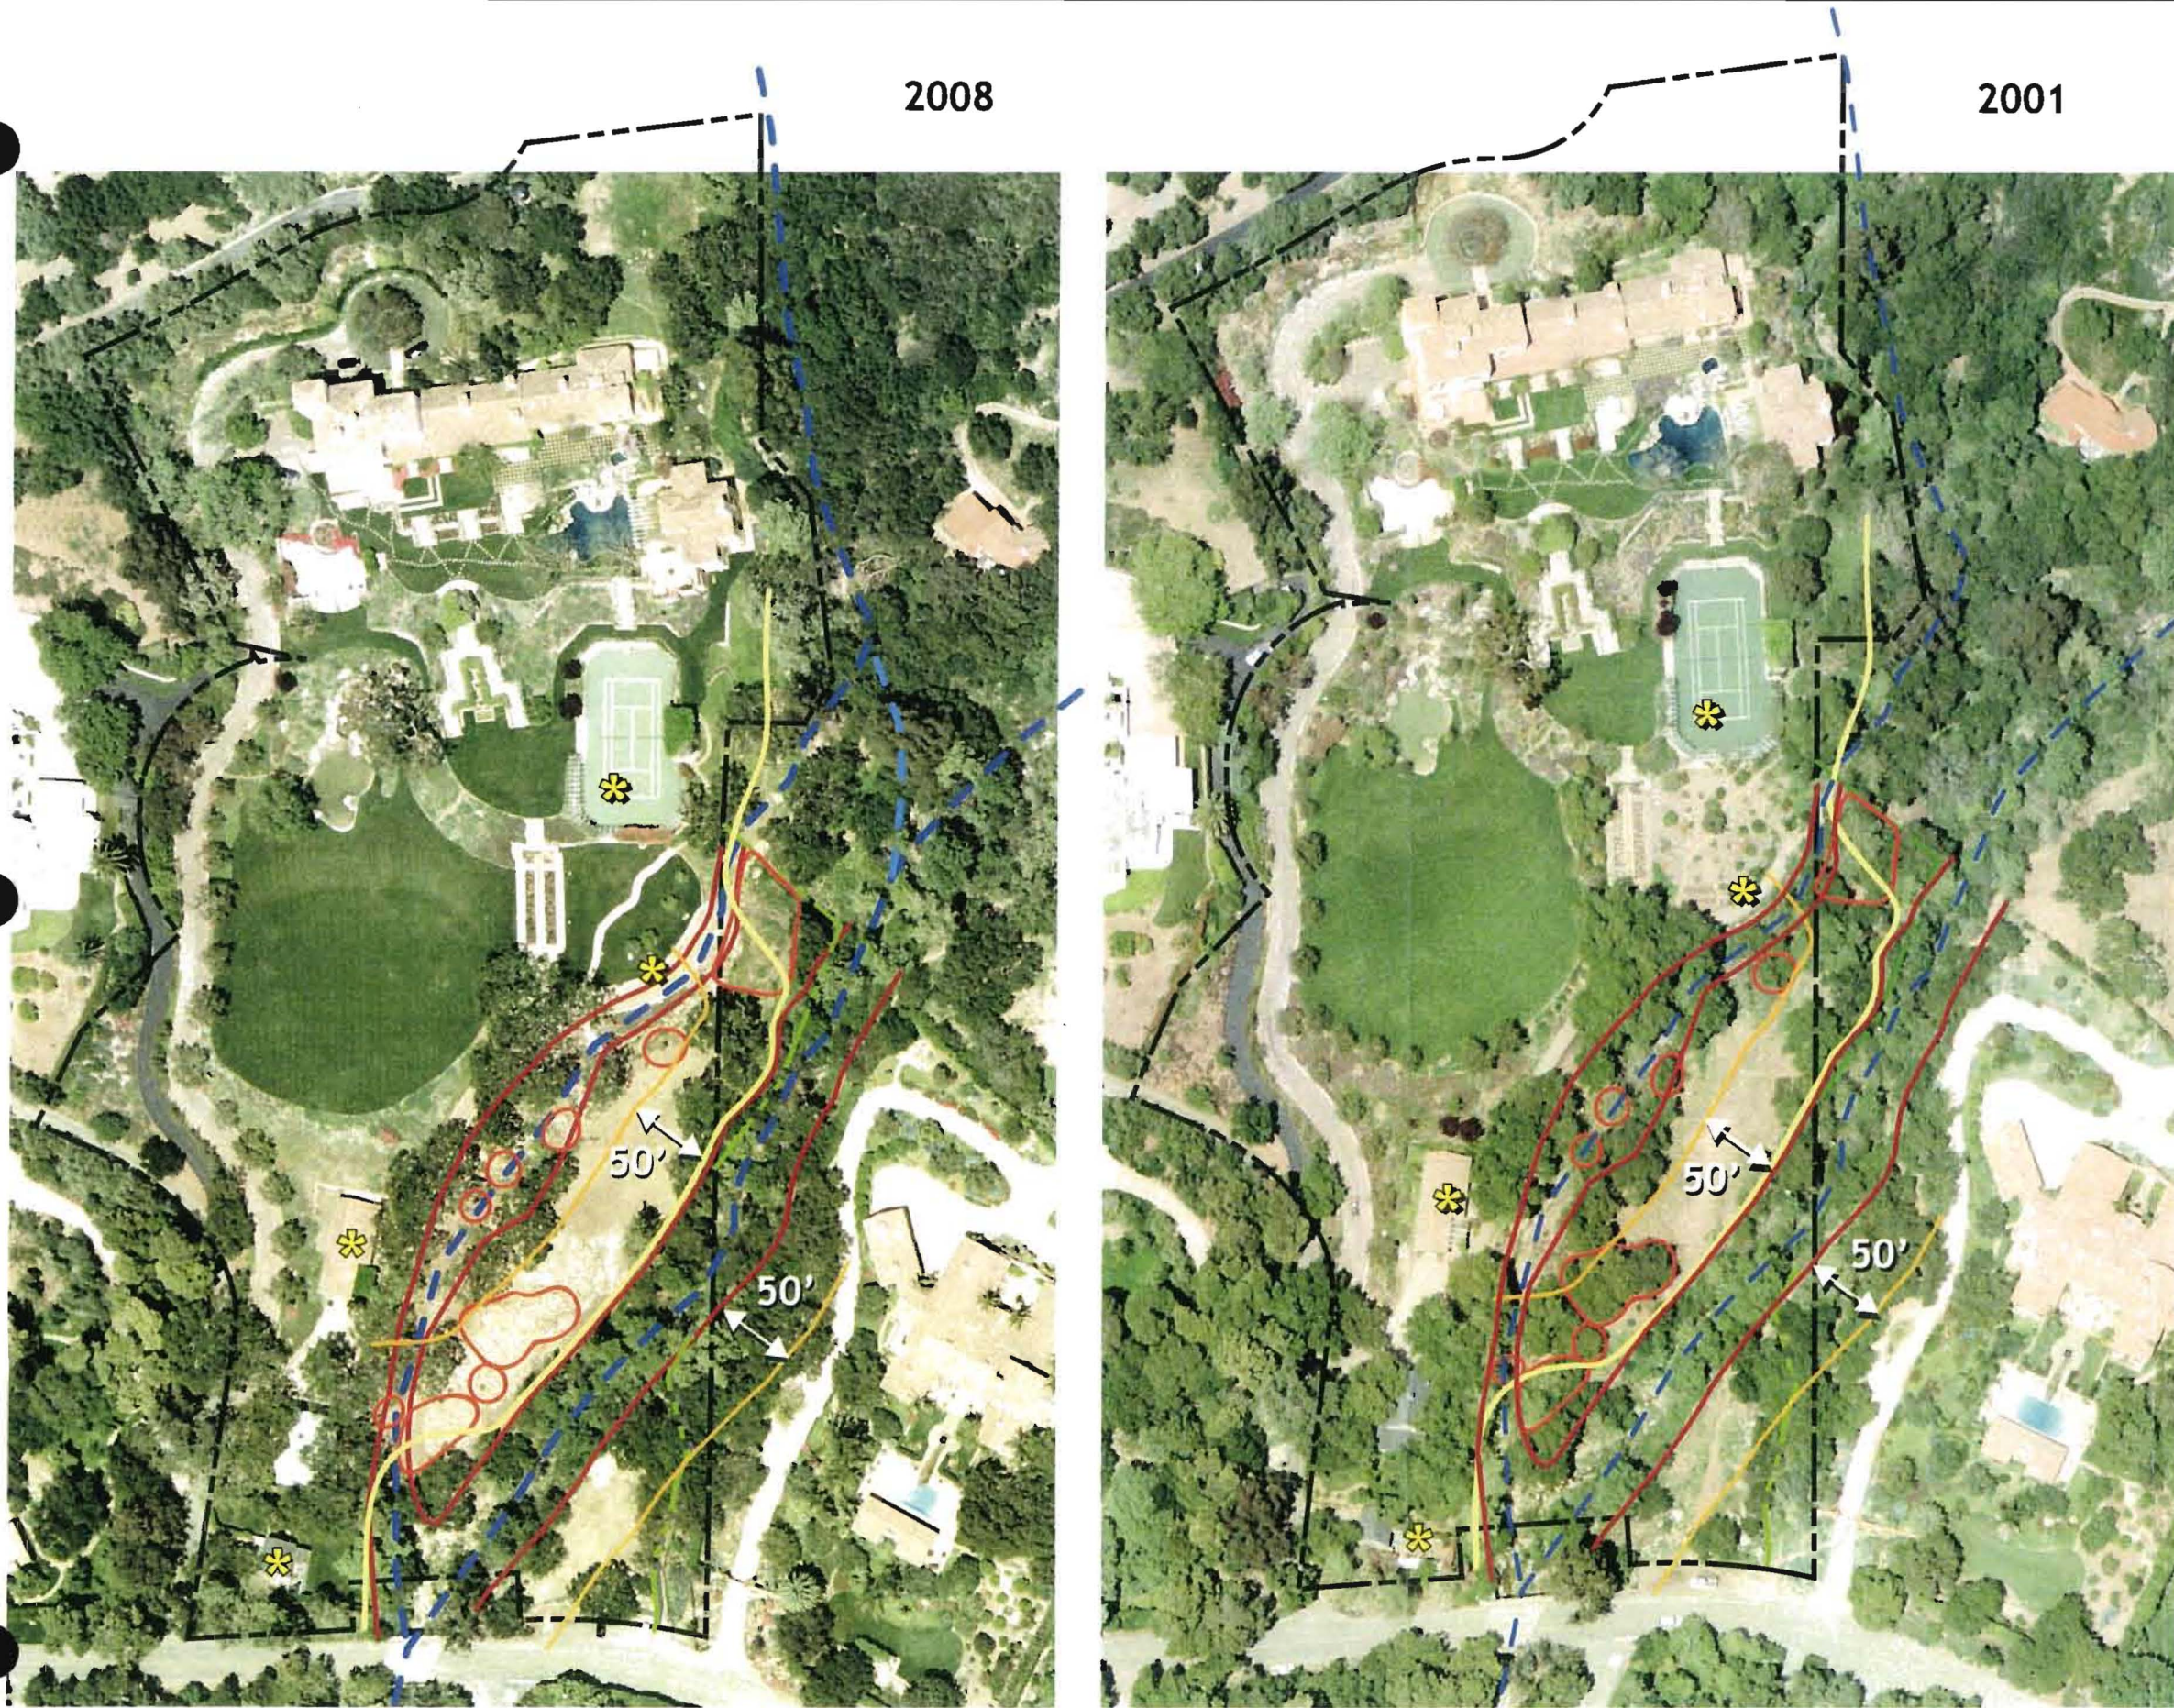
To determine if any changes (losses) to vegetation occurred within the general area of non-permitted work, the presence of canopy cover noted in the 2008 aerial photograph was compared to individual trees and other vegetation the field. Each tree along the top of bank of Hot Springs Creek (and thus the actual border of the current riparian canopy) was compared with the 2008 aerial. All trees along the secondary drainage were likewise marked on the 2008 aerial. A clear plastic overlay of the existing trees was then made and compared to the 2001 aerial. A light table was used to help identify any trees or other vegetation "textures" that were missing or altered in the latter aerial photographs.

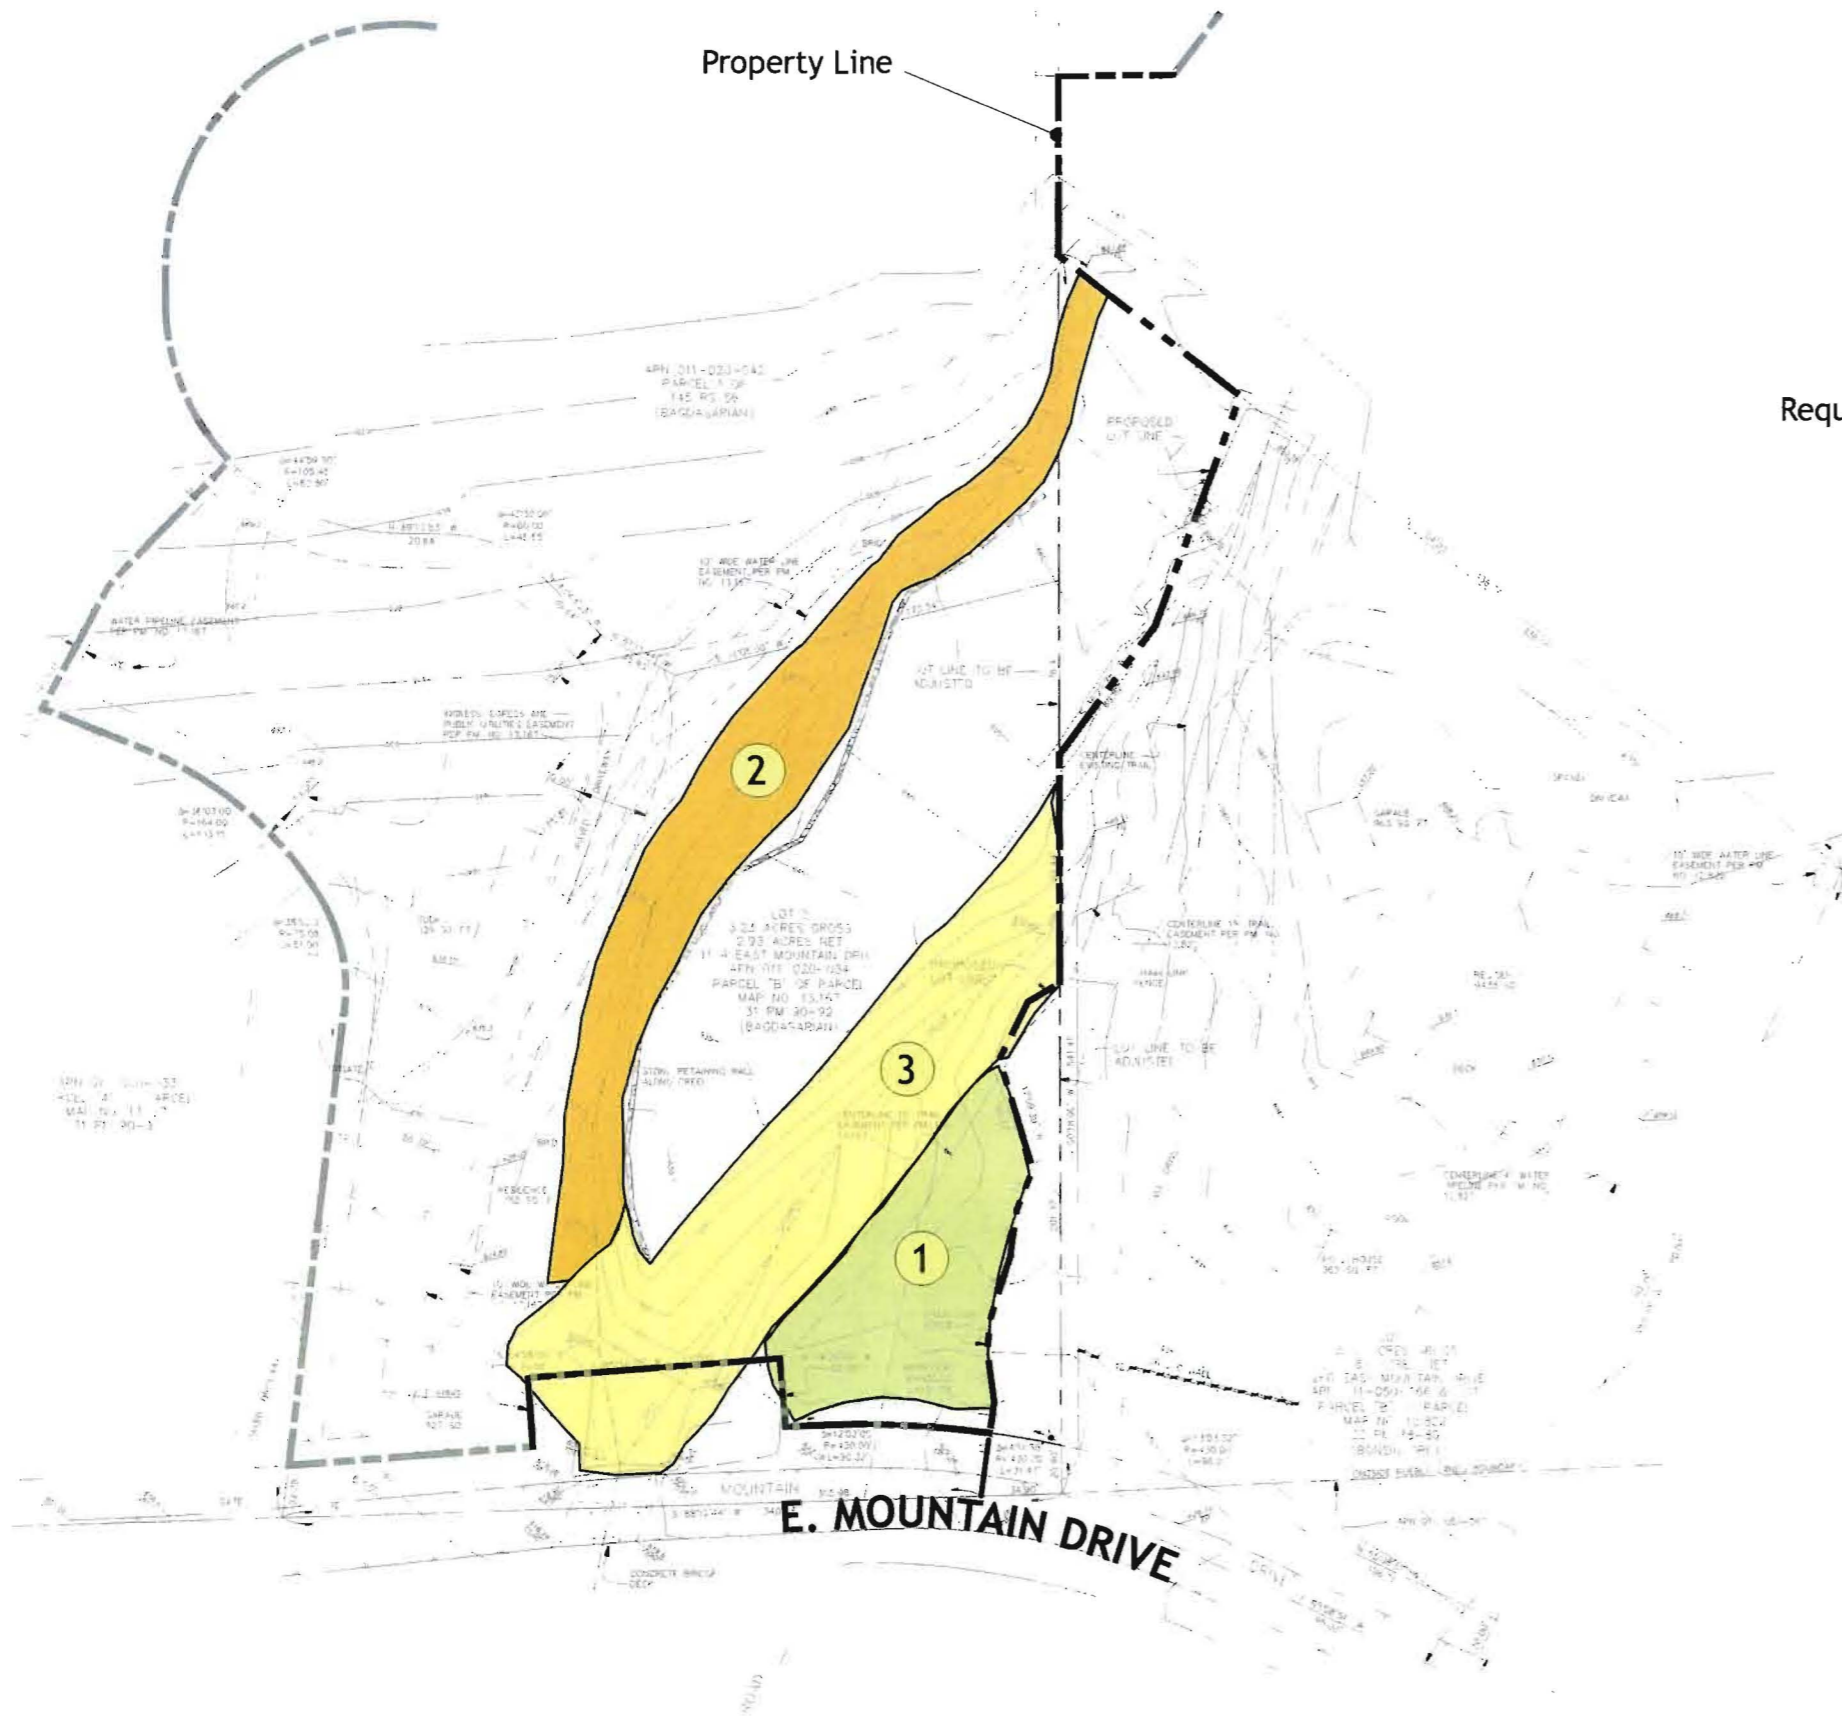
Figure 4: Restoration Areas

Available For On-Site Restoration -0.87 acres

Required Off Site Mitigation Area or "In-Lieu Fee" 0.81 acres

See response to item 3 above. Additionally, the area of irrigated lawn to be removed is not reported or defined on project plans. Based on the proposed restoration data (see Figure 4 of Ms. Tierney's report dated May 25, 2010), only approximately 0.25 acres of the ESH that was actually disturbed by the unpermitted activities are proposed to be restored (i.e., planting of native plant species). The remainder of onsite restoration is proposed for the rock stockpile area (0.22 acres not included in the documented 1.1 acres of lost or disturbed ESH), where the majority of replacement oaks and sycamores is proposed, and the main branch and confluence of Hot Springs Creek where no disturbance occurred (removal of the weed, *Arundo donax*, which has invaded an undetermined portion but not the entire 0.40-acre area proposed for weed removal).

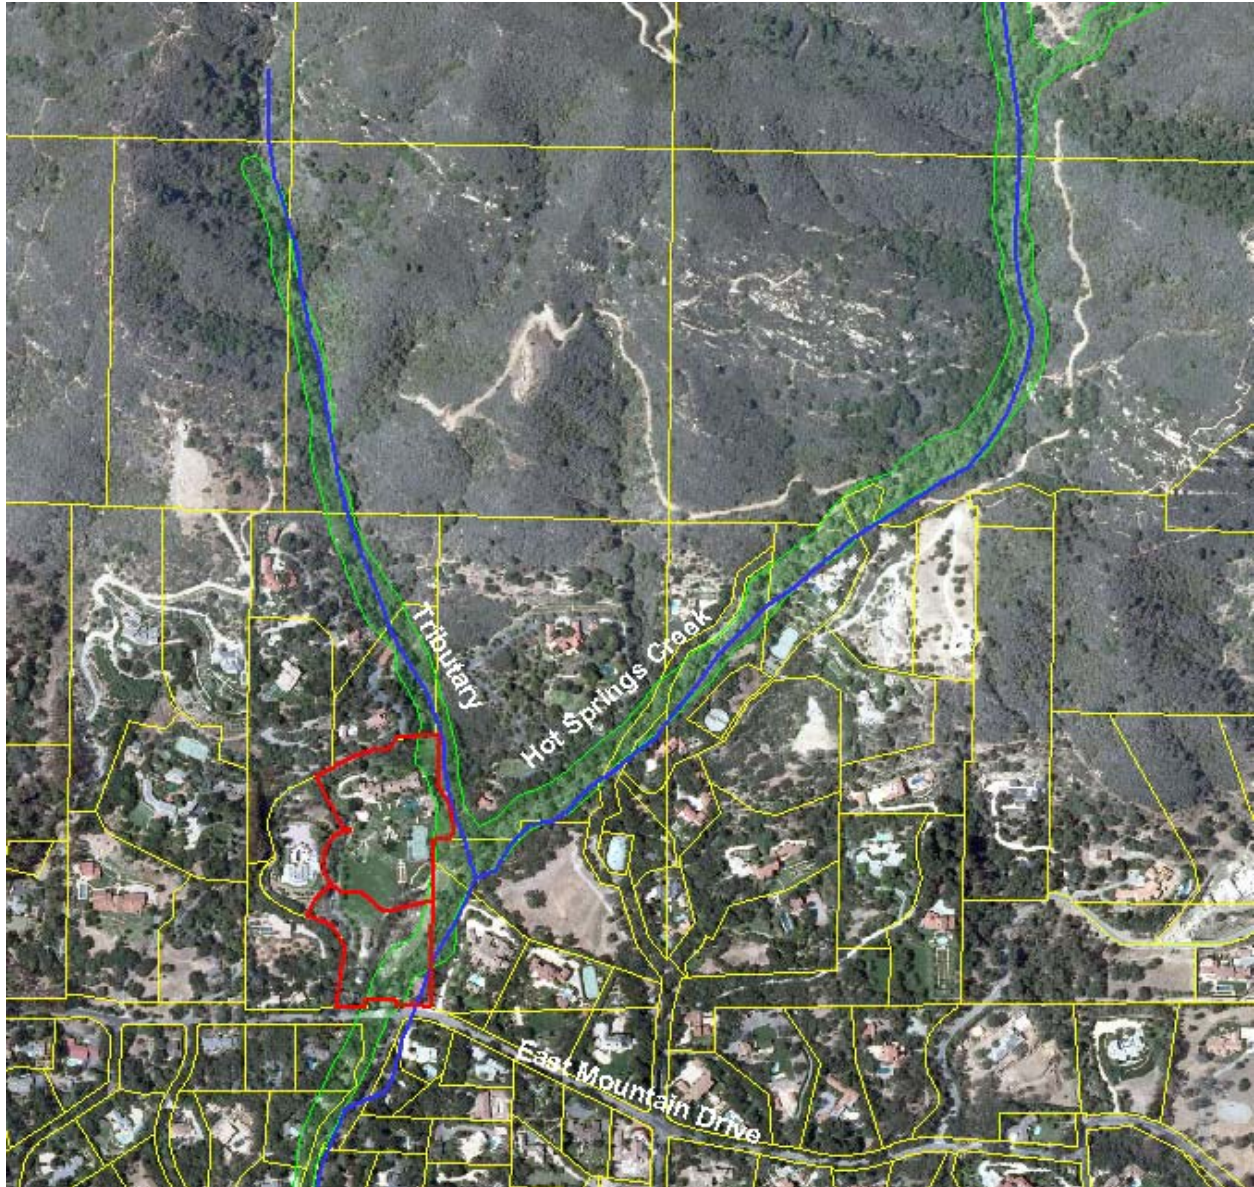
2008 Aerial Photo of Bagdasarian Property and Creek System Overview – The source for the blue line representing Hot Springs Creek and its tributary is the USGS 7.5 minute quadrangle topographic maps. The green shading represents the County's mapped ESH. The site is outlined in red. Note that the tributary in question is a significant tributary to Hot Springs Creek and that ESH mapping in 1992 encompassed the entire tributary.

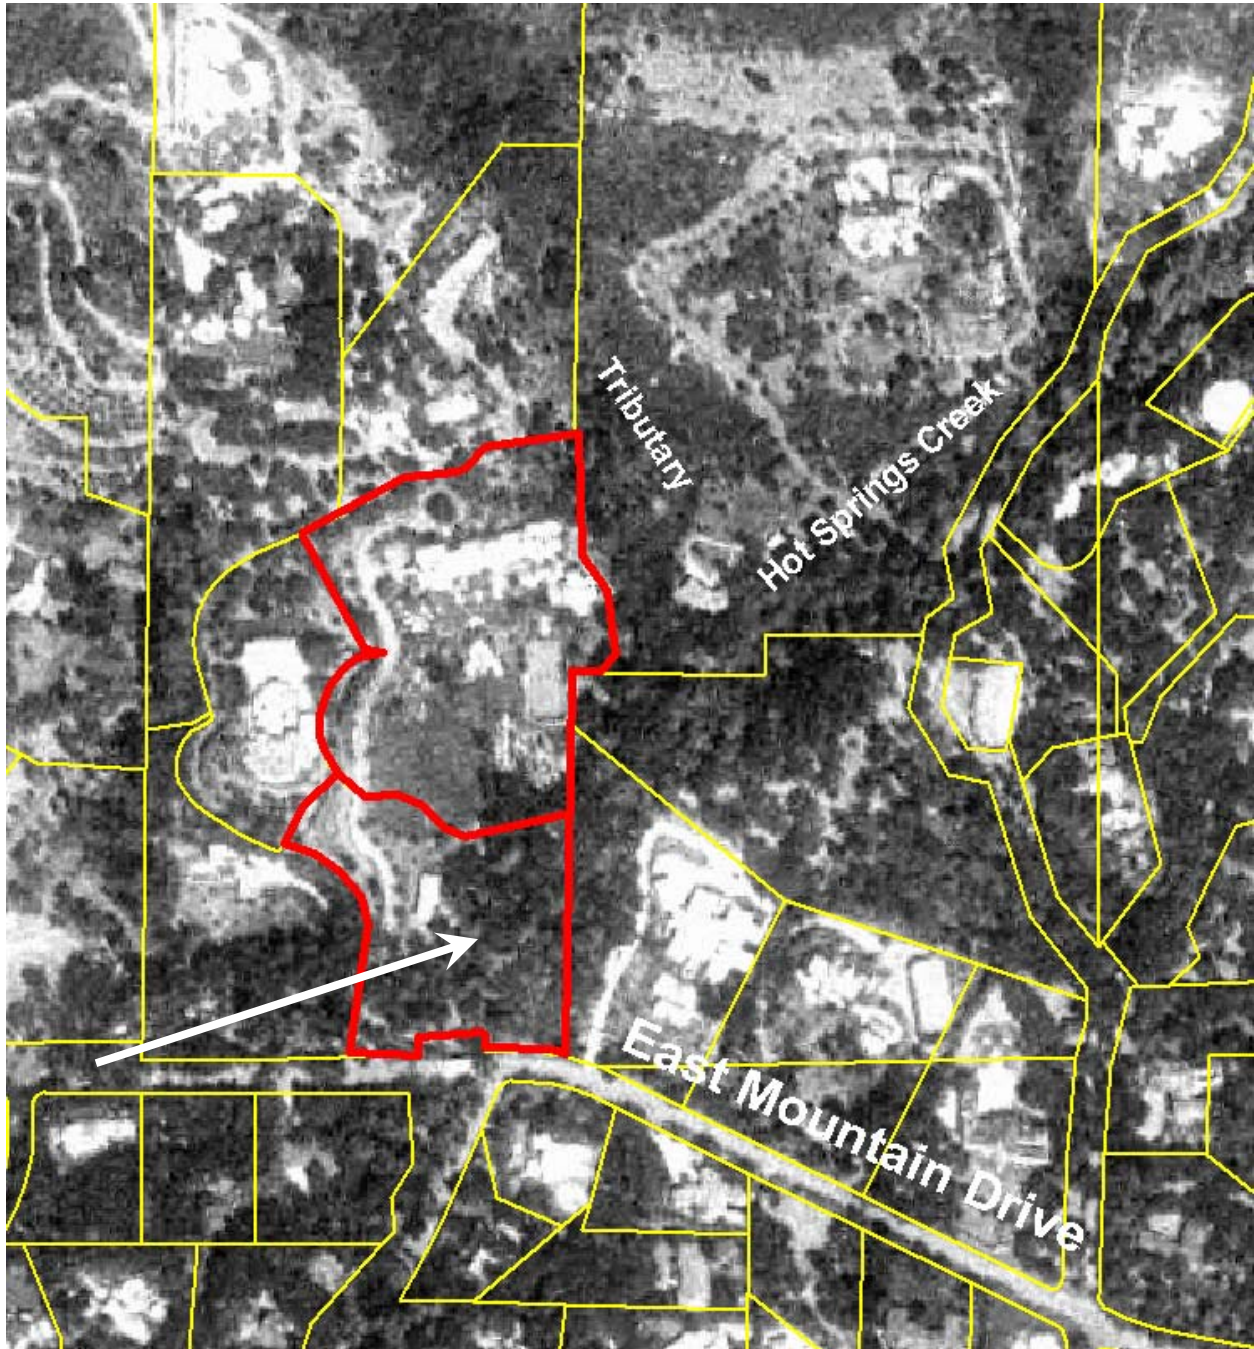
1994 Aerial Photo of Bagdasarian Property – Note the solid vegetation canopy covering both the main branch of Hot Springs Creek and the tributary especially in the area in which the construction of the retaining walls, bridges and tree wells, and lawn installation occurred.

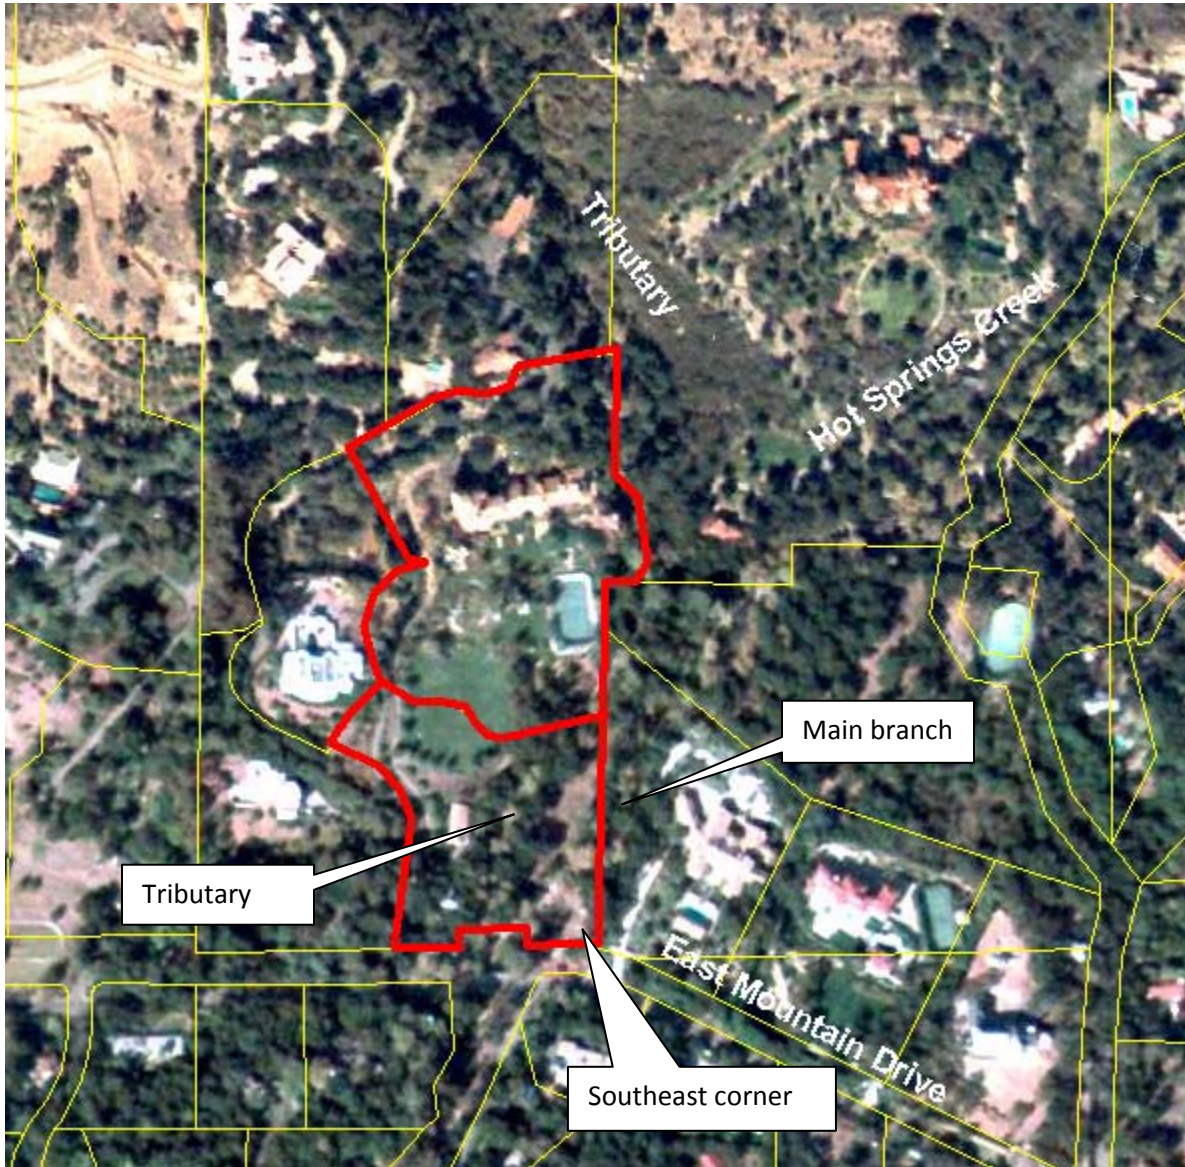
1998 Aerial Photo of Bagdasarian Property – Note the apparent change in vegetation cover on the peninsula between the tributary and the main branch of Hot Springs Creek, as well as in the southeast corner. The southeast corner is the area that has been used as a stockpile area. The southeast corner and the small cleared area in the peninsula remain relatively clear of tree canopy from this time forward. The tree canopy over the tributary remains intact.

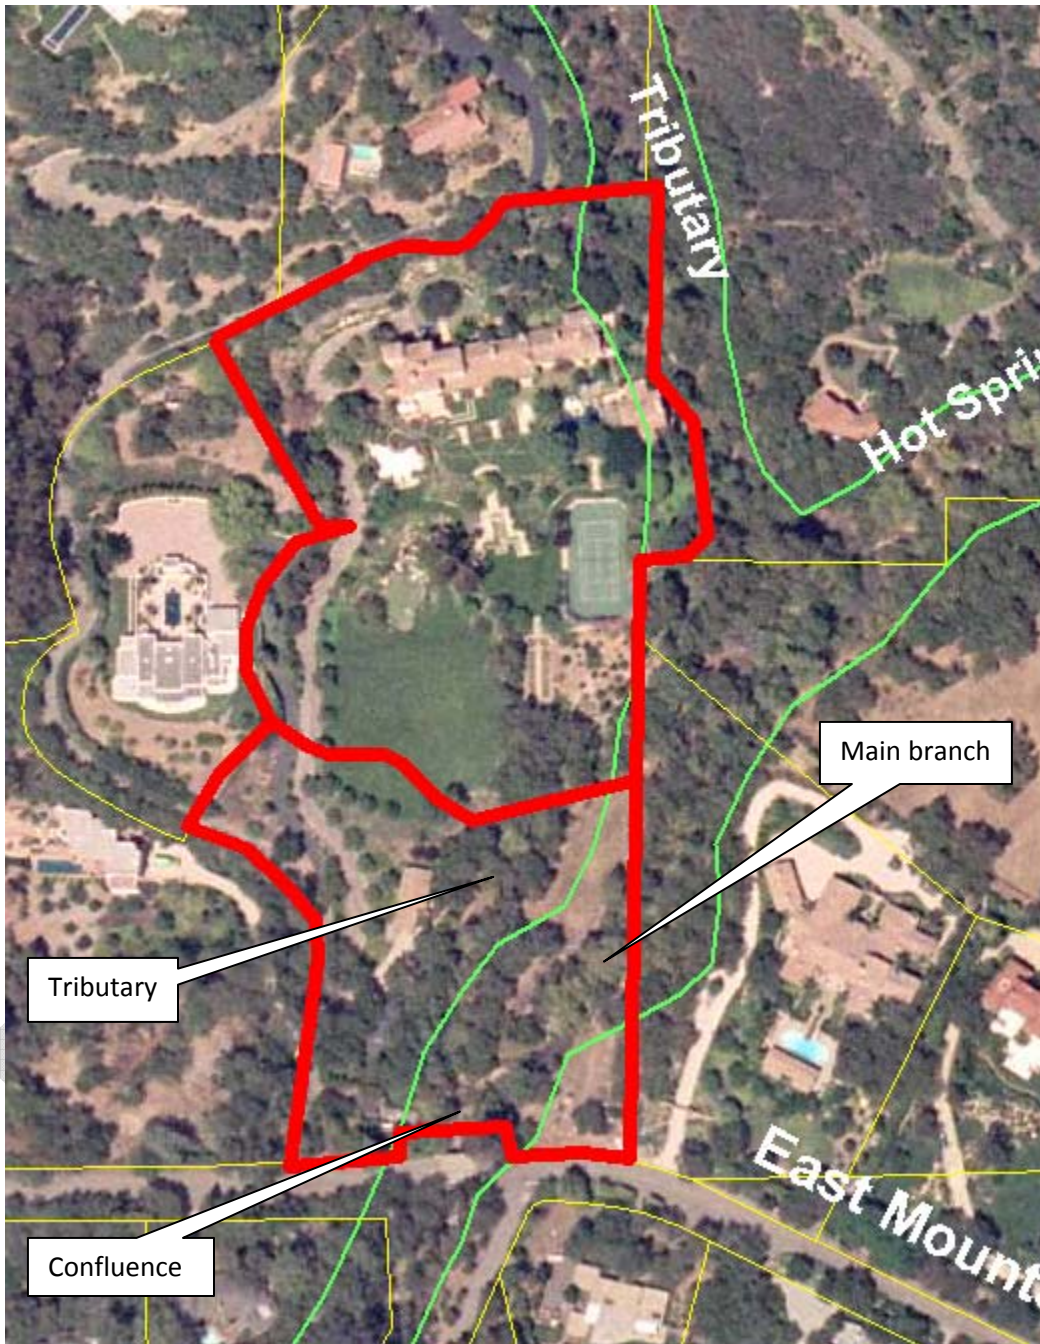
2002 Aerial Photo of Bagdasarian Property with ESH Overlay – Riparian tree canopy coverage over the main branch, tributary and confluence is similar to 1998. This is the first aerial photo for which the mapped ESH Overlay is available, shown by green lines. Note the full tree canopy cover on the adjacent properties to the east.

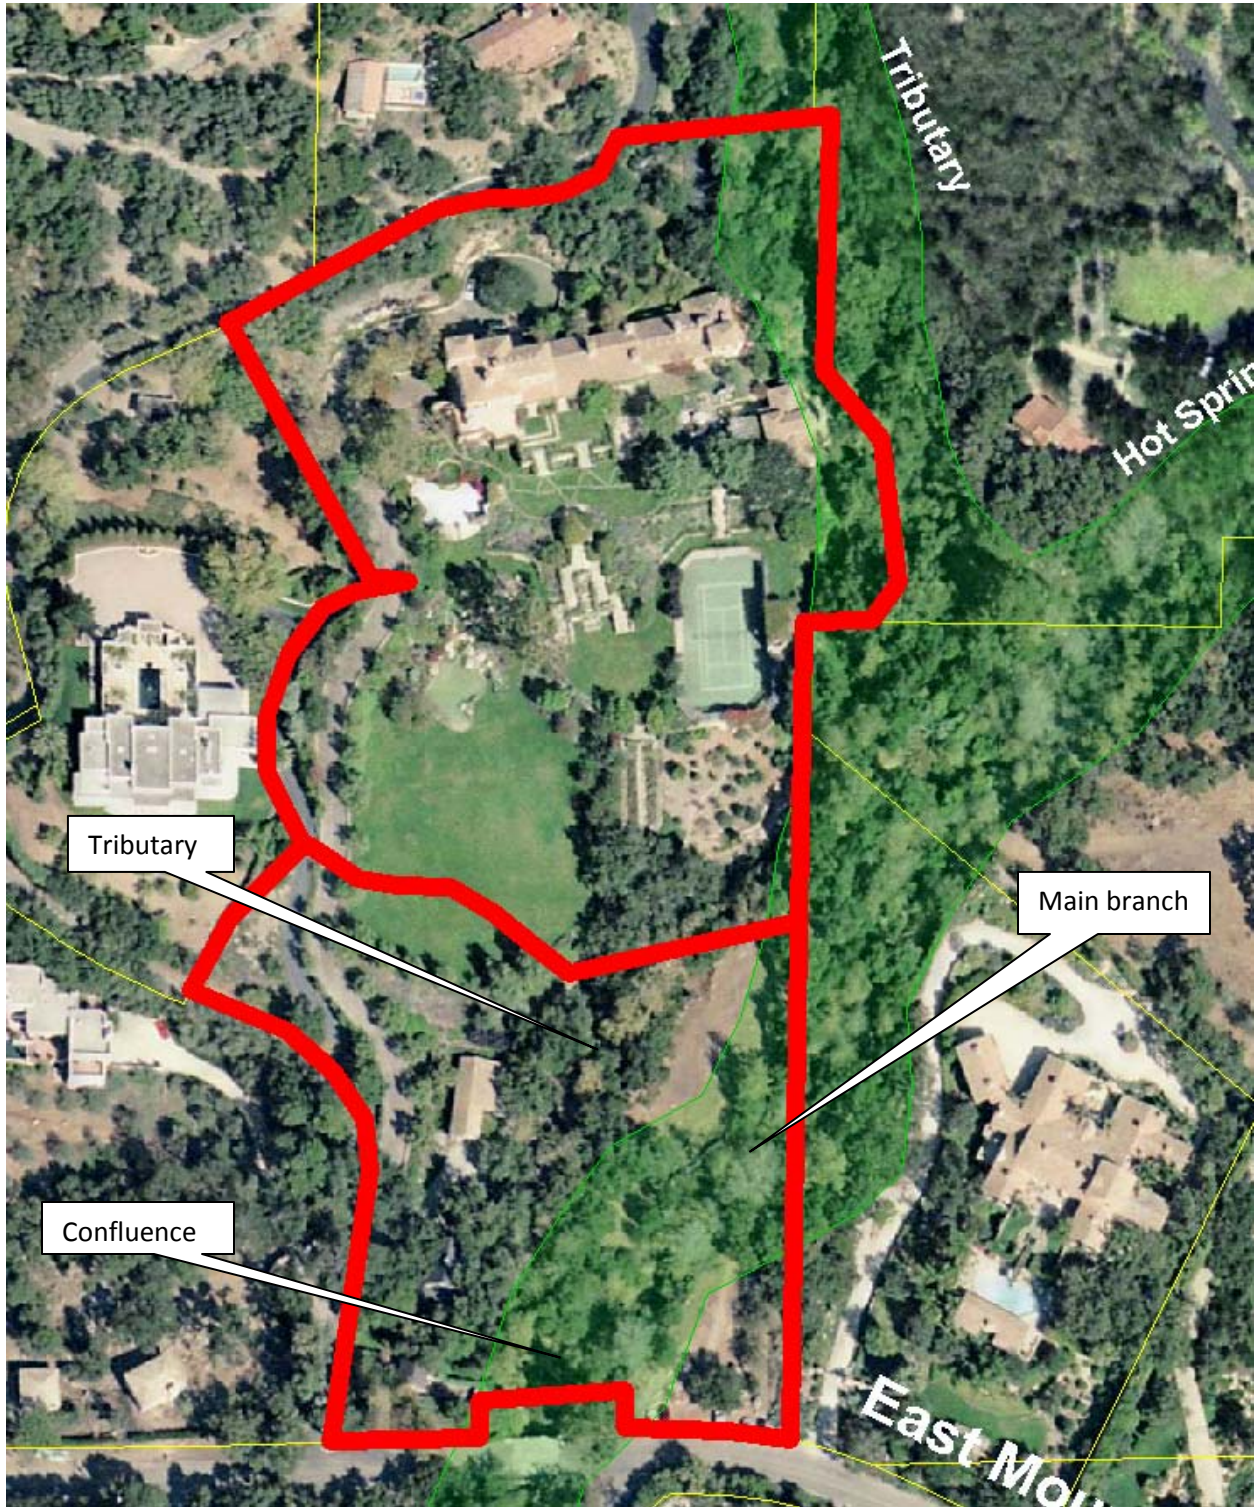
2004 Aerial Photo of Bagdasarian Property with ESH Overlay – Again, note little to no change to the riparian tree canopy.

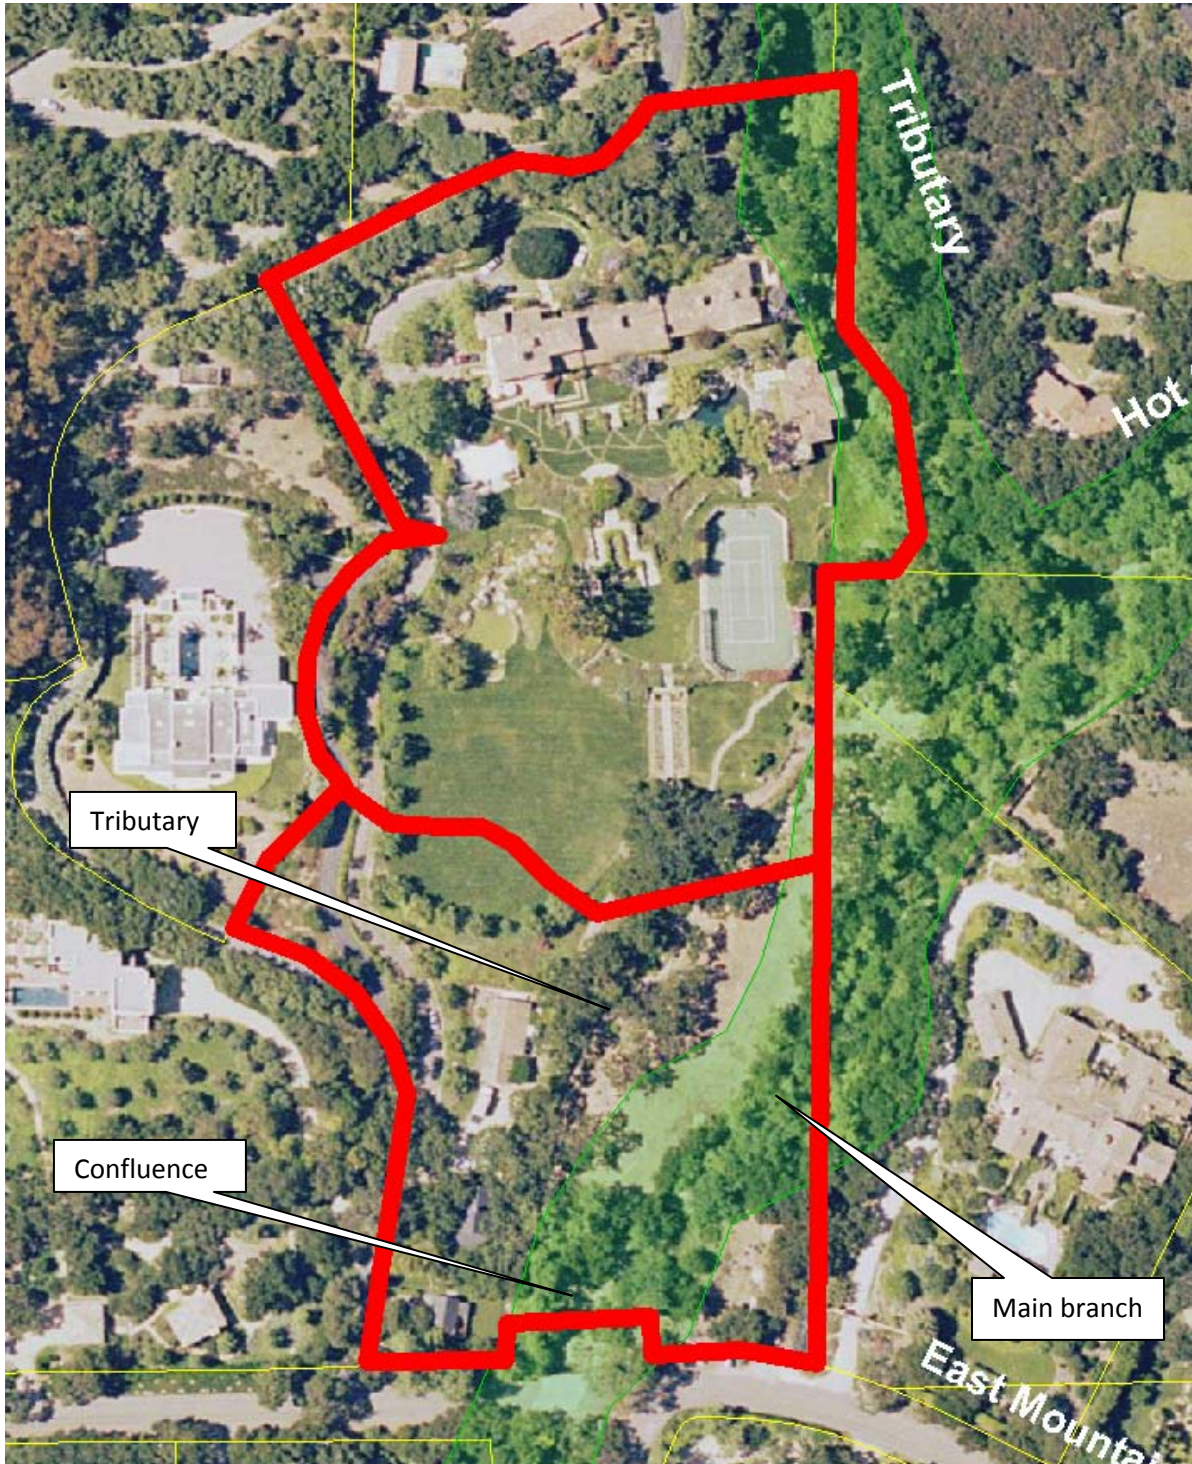
2006 Aerial Photo of Bagdasarian Property with ESH Overlay – Note vegetation along the tributary is thinner than in previous years and the shape of the cleared area on the peninsula appears larger.

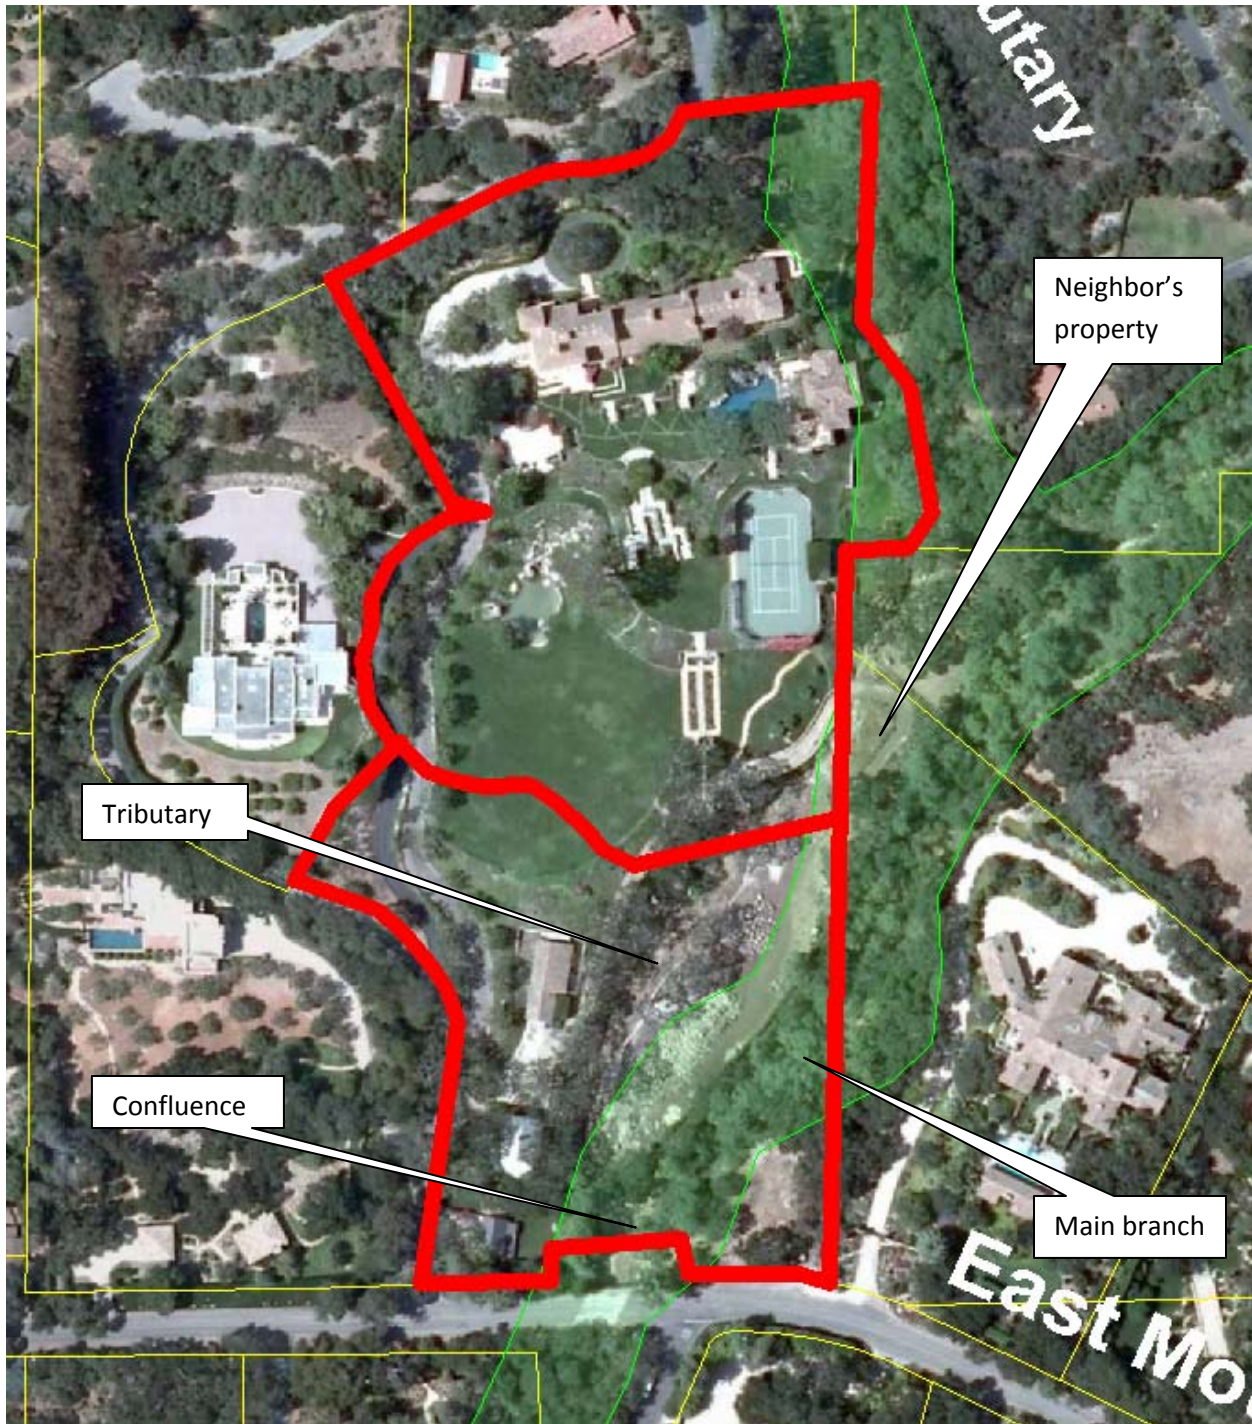
2008 Aerial Photo of Bagdasarian Property – Work is apparently underway on the peninsula between the creek channels. Construction and stockpiles of rock are visible. Notice construction on the neighbors' property to the east and apparent tree removal. Refer to Attachment I for more recent photos from the ground.

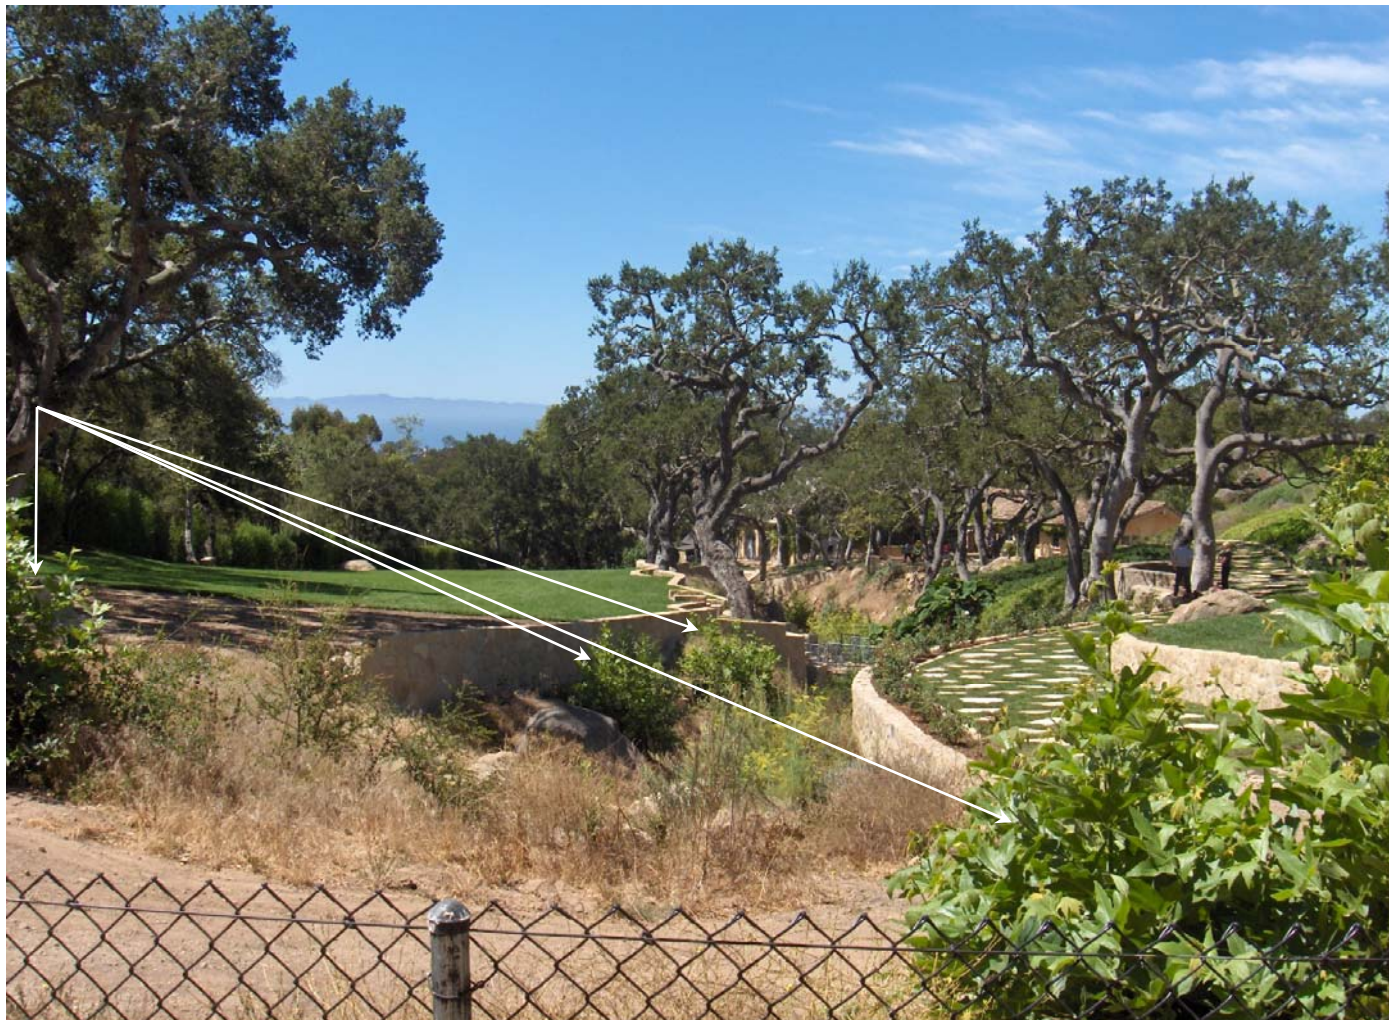
August 5, 2009 – Looking south at the tributary and the unpermitted development (walls, bridges) and lawn. Note re-sprouting sycamores, north bridge down in the creek channel and existing permitted buildings on the south lot in the background. Note dirt roadway built across the tributary channel in foreground.

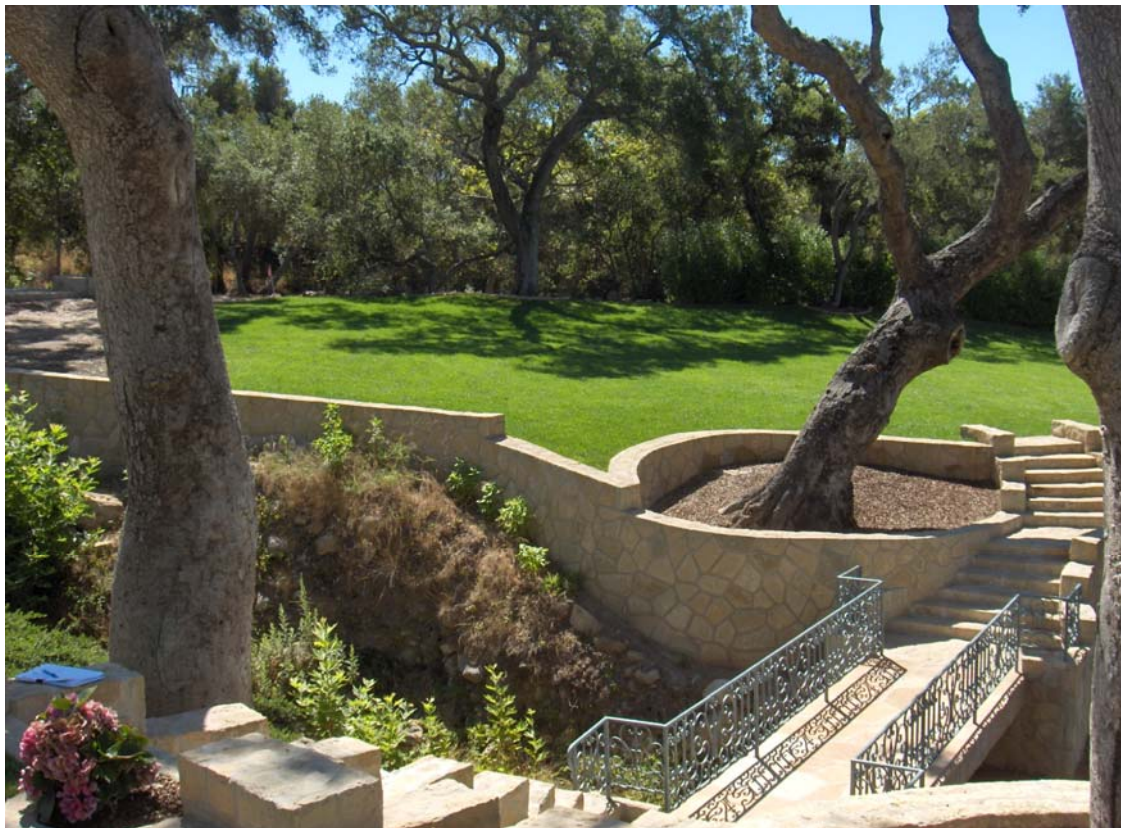
August 5, 2009 – North bridge over tributary, retaining wall, tree well around oak.
Note the sycamores re-sprouting in creek.

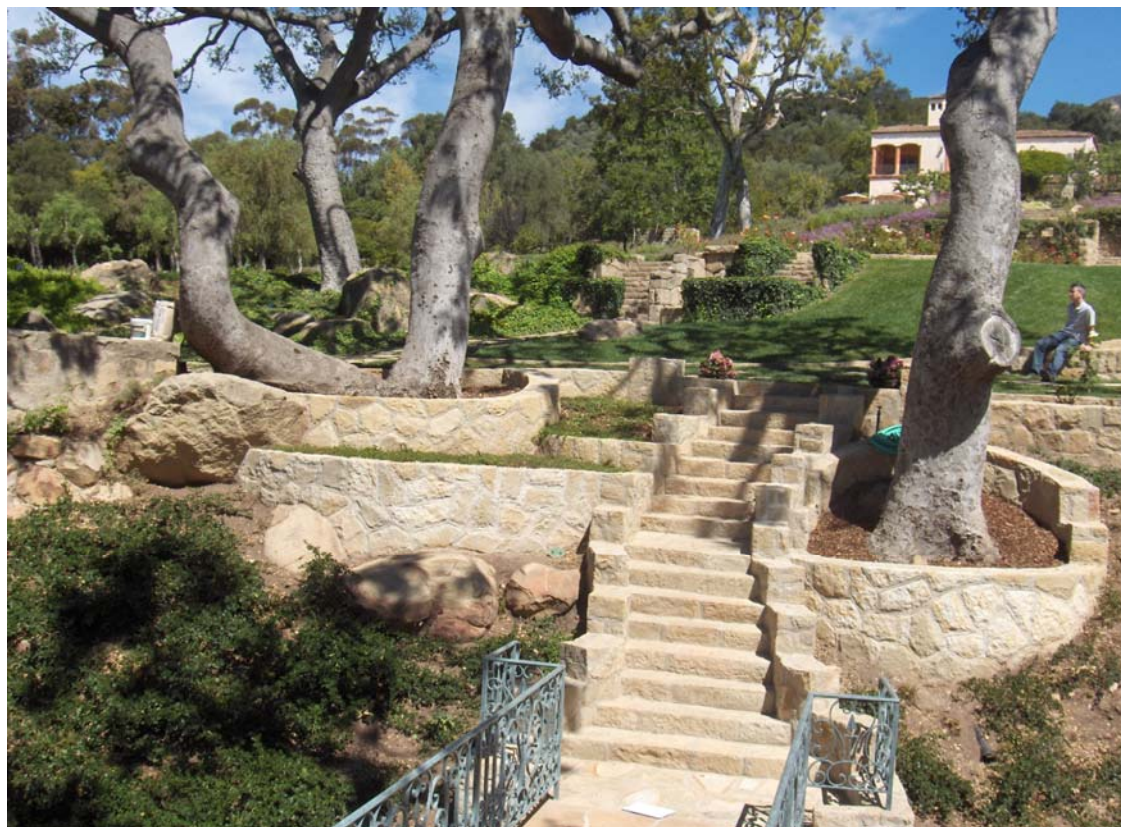
August 5, 2009 – At north bridge, new retaining walls, tree wells around oaks.
