SANTA BARBARA MONTECITO PLANNING COMMISSION
Staff Report for the Bagdasarian-Karman Appeal of
the P&D Director's Denial of 09LUP-00000-00256

Hearing Date: October 27, 2010
Staff Report Date: October 8, 2010
Case No.: 10APL-00000-00016

This site is identified as Assessor Parcel Number 011-020-034 and 011-020-042, located north of East Mountain Drive and along Hot Springs Creek and tributary, known as 1192 and 1194 East Mountain Drive, Montecito, First Supervisorial District.

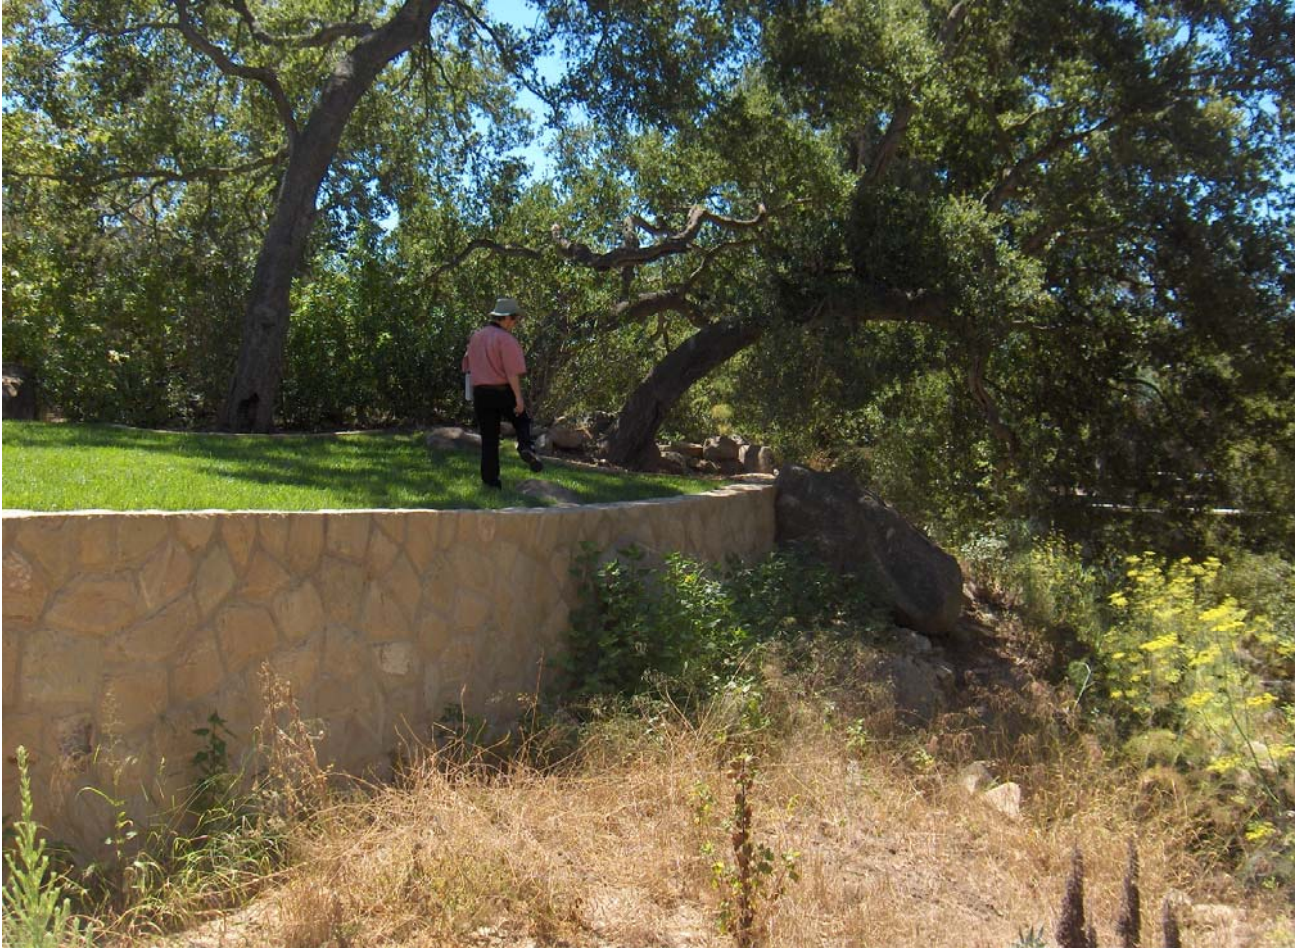
August 5, 2009 – South end of lawn and retaining wall on tributary, just north of confluence.
