# **MYERS' ROAD AND BRIDGE APPEAL**

**POWERPOINT PRESENTATION**

# 949 TORO CANYON ROAD

## A case for a 2nd means of egress/access

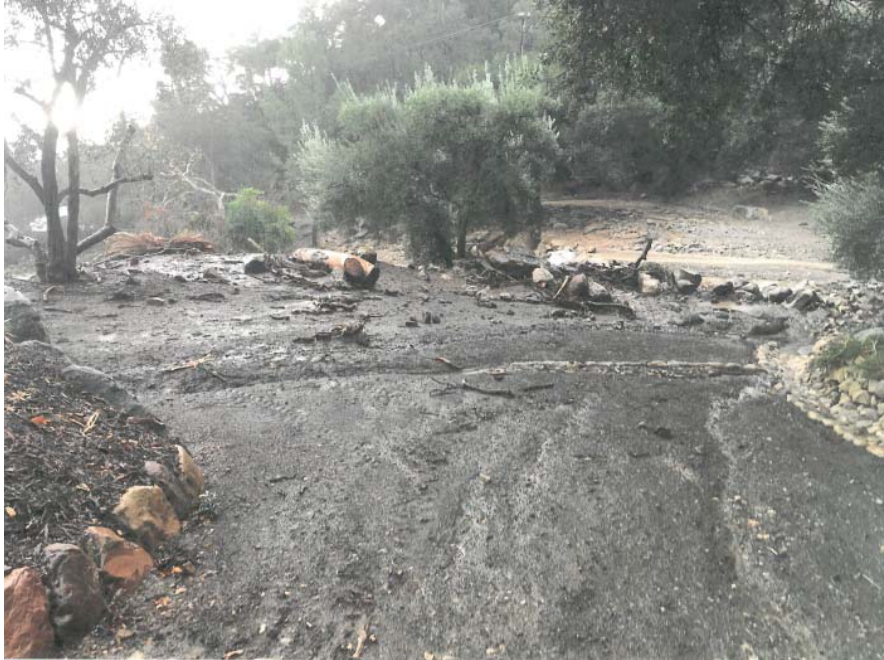
Debris Flow blocking 930/949 Toro Canyon easement and blocking culvert 1/9/18. Supports the need for a second means of egress.

DEBRIS FLOW ON 1/9/18 RENDERED ROAD INACCESSIBLE

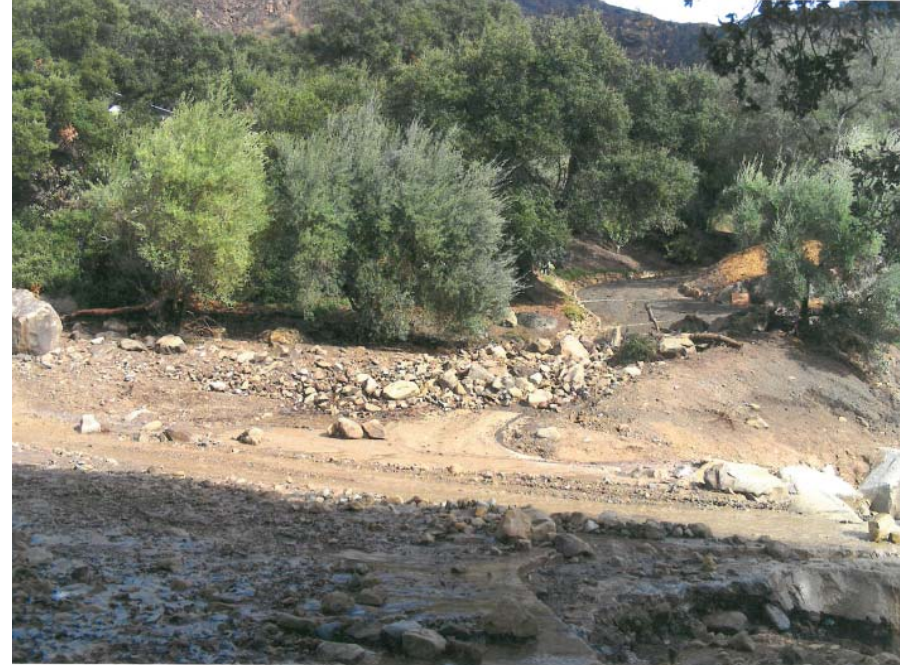
Easement road blockage view east. 1/9/18.

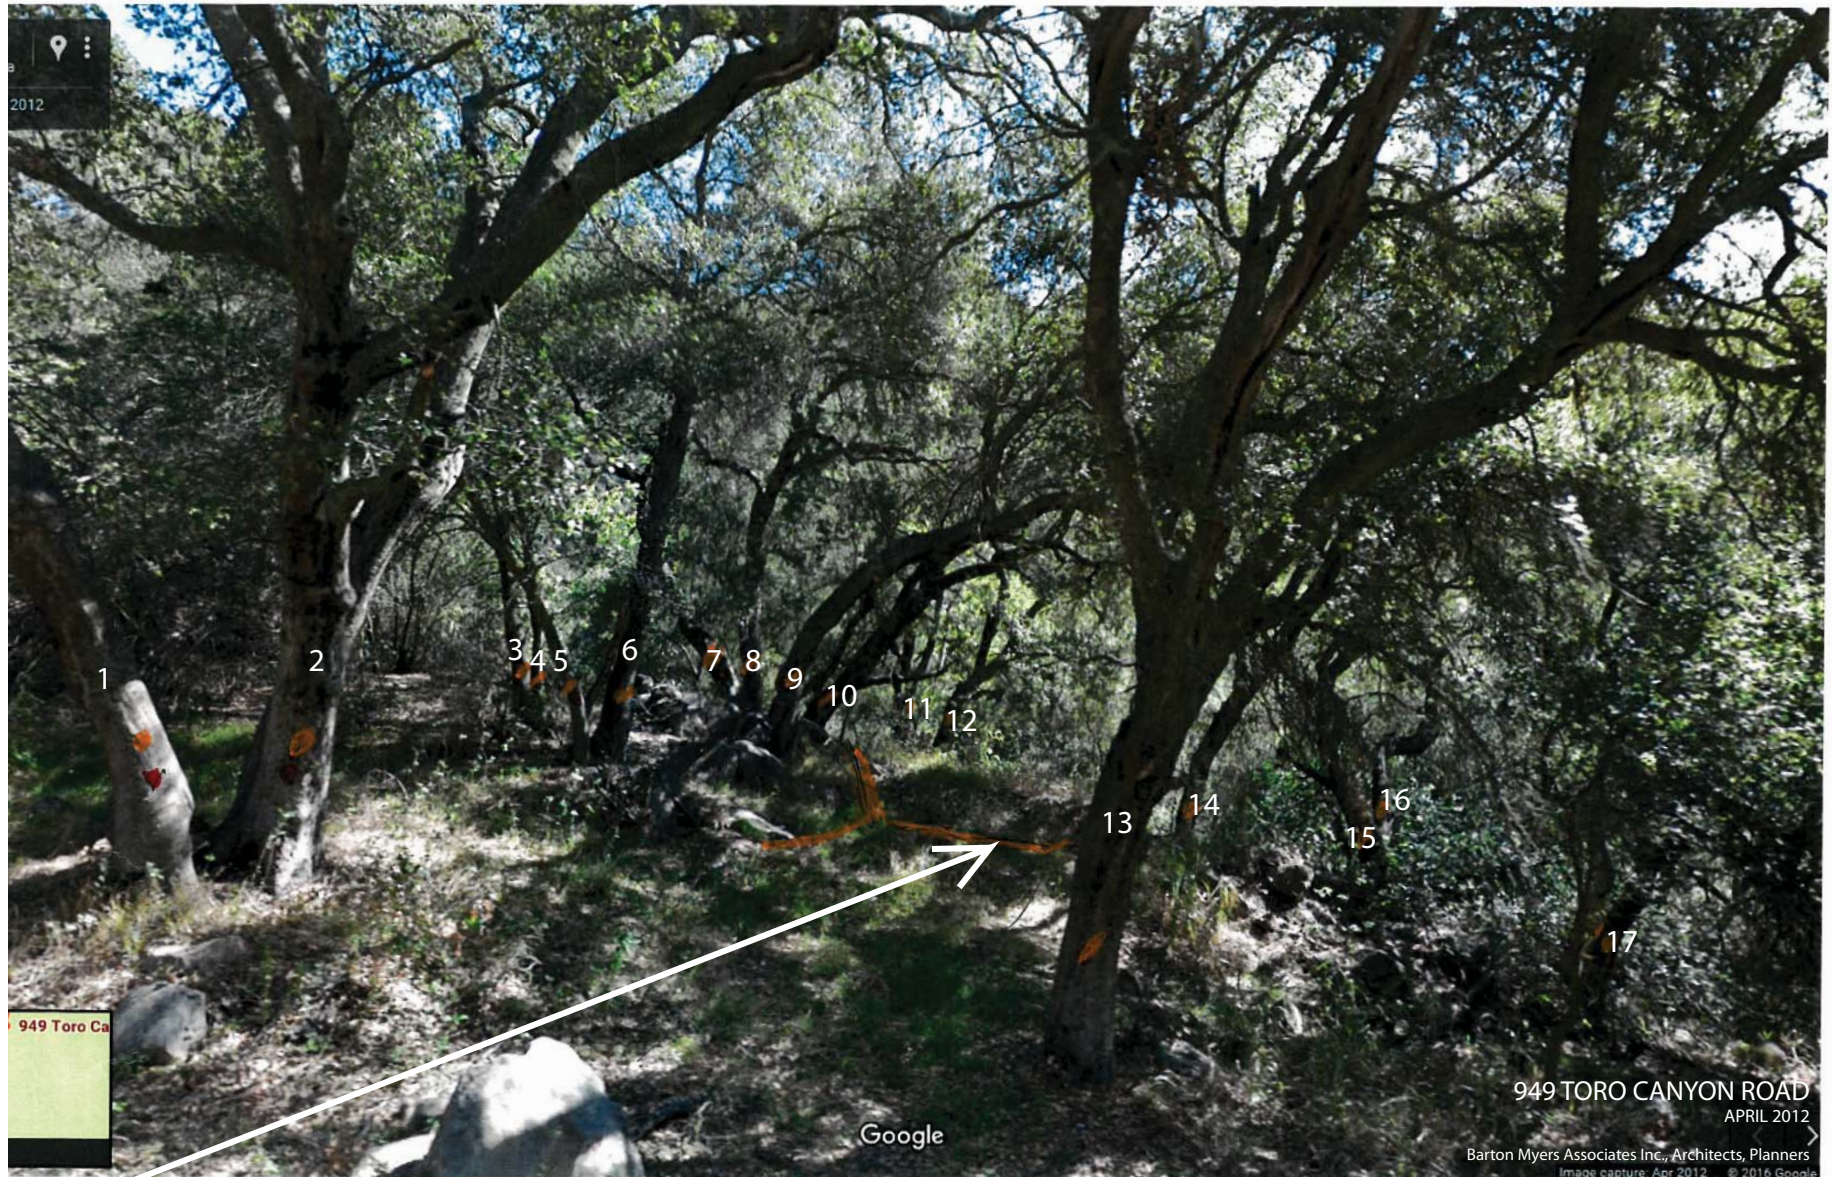
**949 Toro Canyon Road Entrance - April 2012**

**NOTE: Marked Trees**

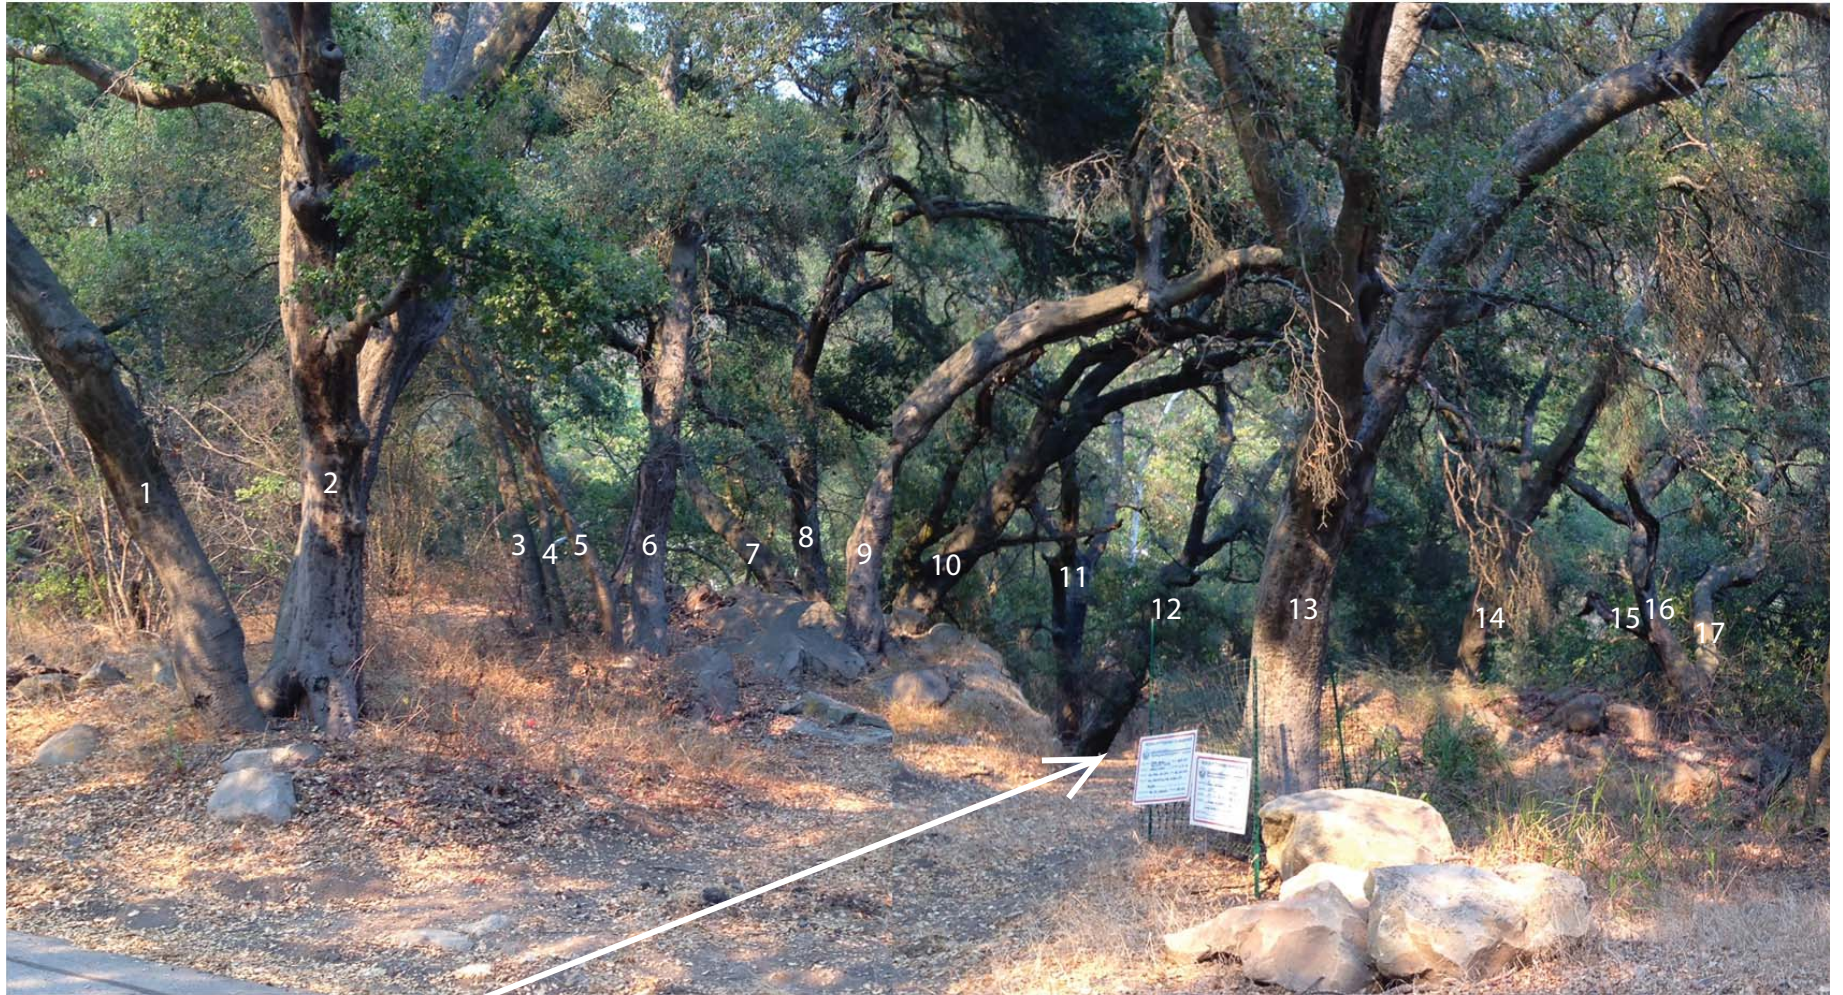
**949 Toro Canyon Road Entrance - August 2016**  
**NOTE: Marked Trees are still there**

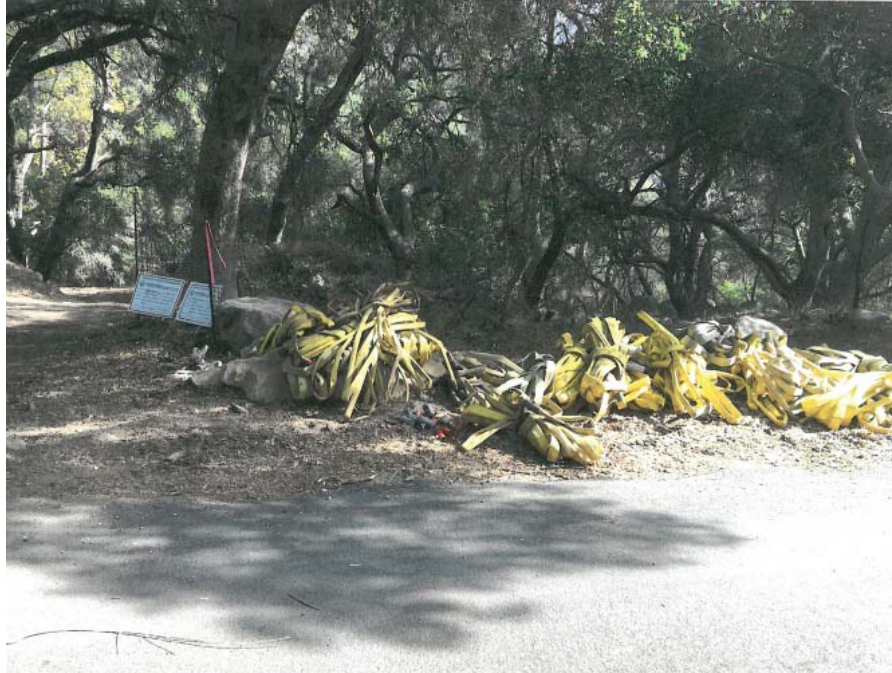
949 Toro Canyon Road 12/17/17

Collection of fire hoses for pickup. A vindication of our arguments and those of 2 fire marshals and 1 distinguished fire captain, that the second means of access/egress would provide life/health/public safety in one of the most dangerous fire areas in Santa Barbara County.

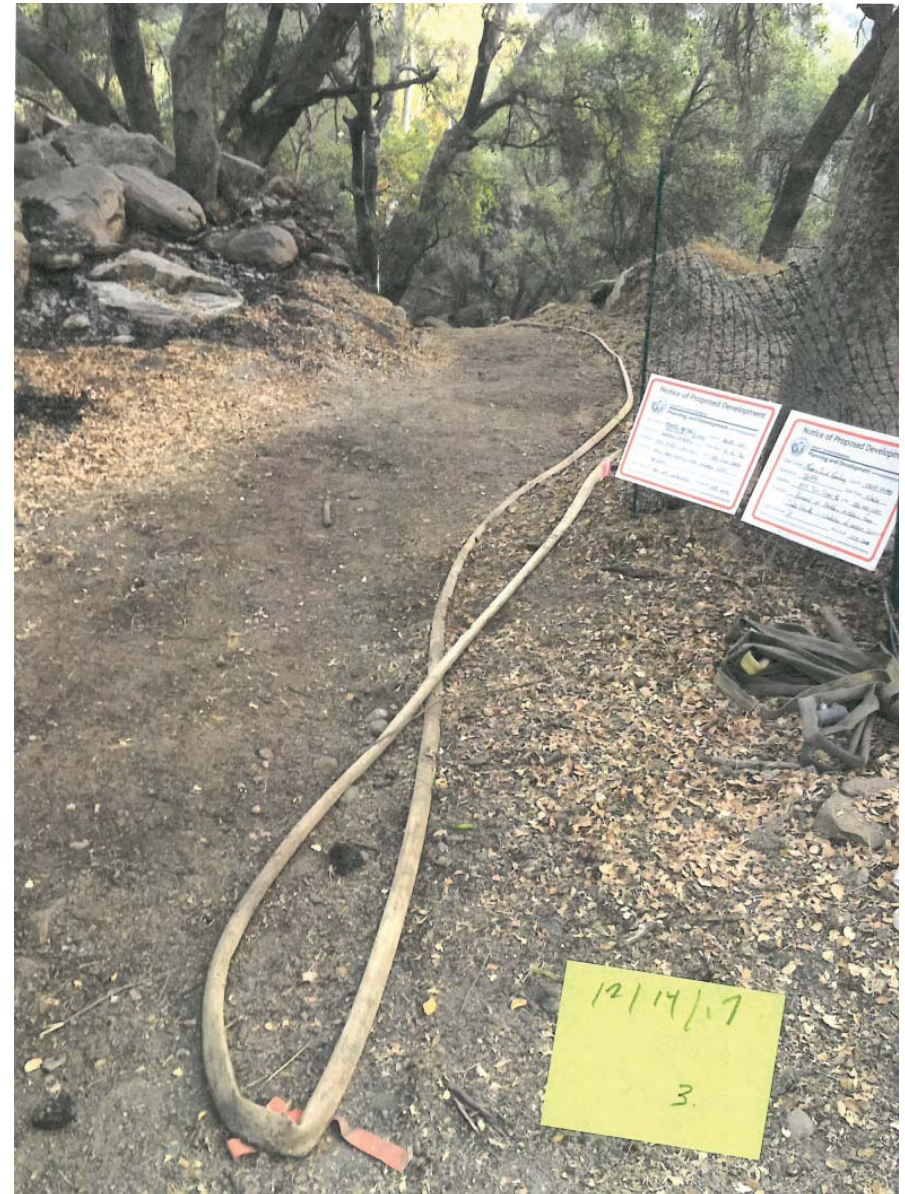
949 Toro Canyon access road 12/14/17 showing Cal Fire fire hoses.

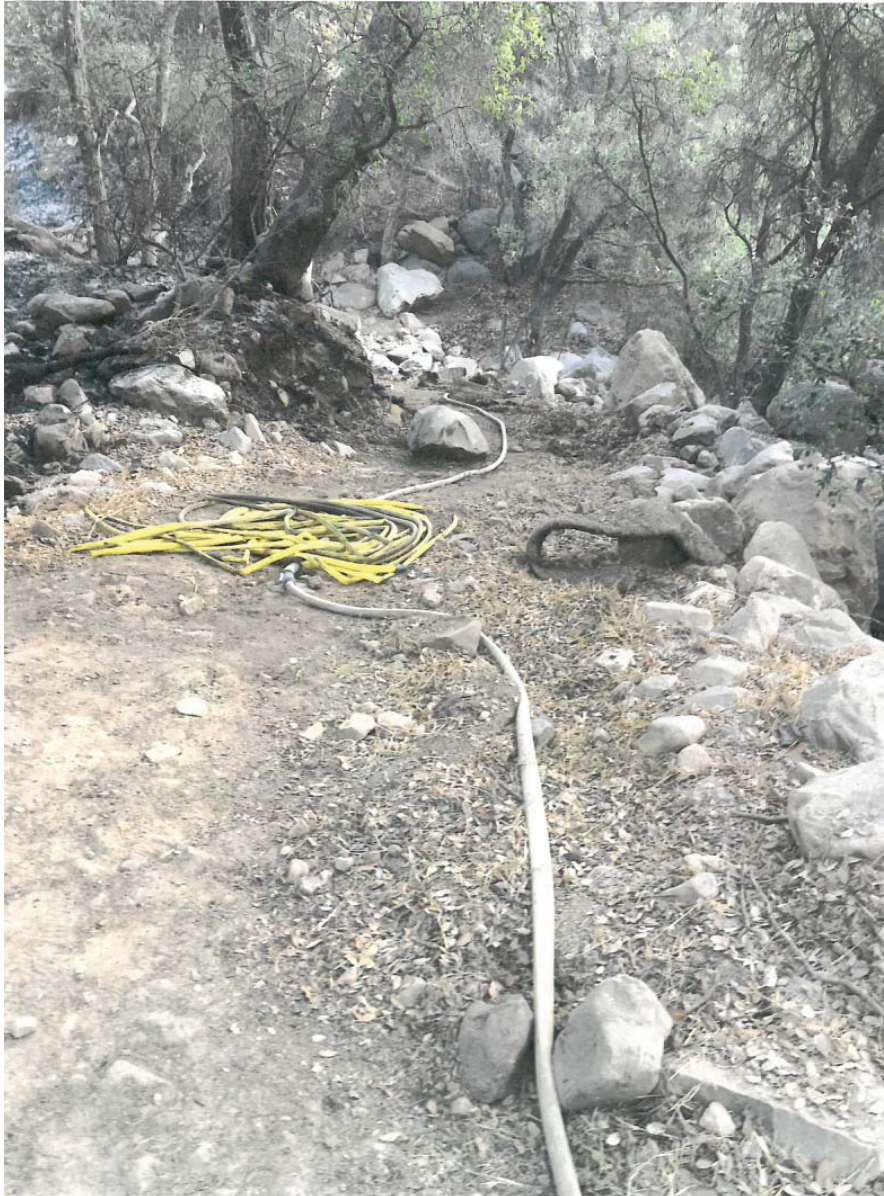
949 Toro Canyon access road 12/14/17. View east of the creek with fire hoses. Notice creek to the north showing burned areas.

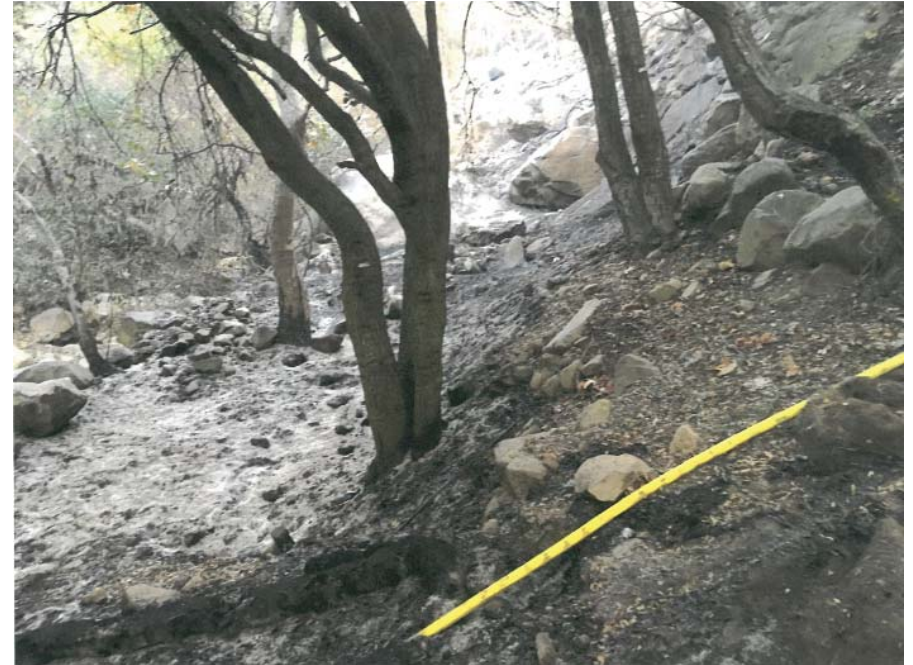
949 Toro Canyon access road 12/14/17 showing fire hoses west of the creek. Fire burned south to access road.

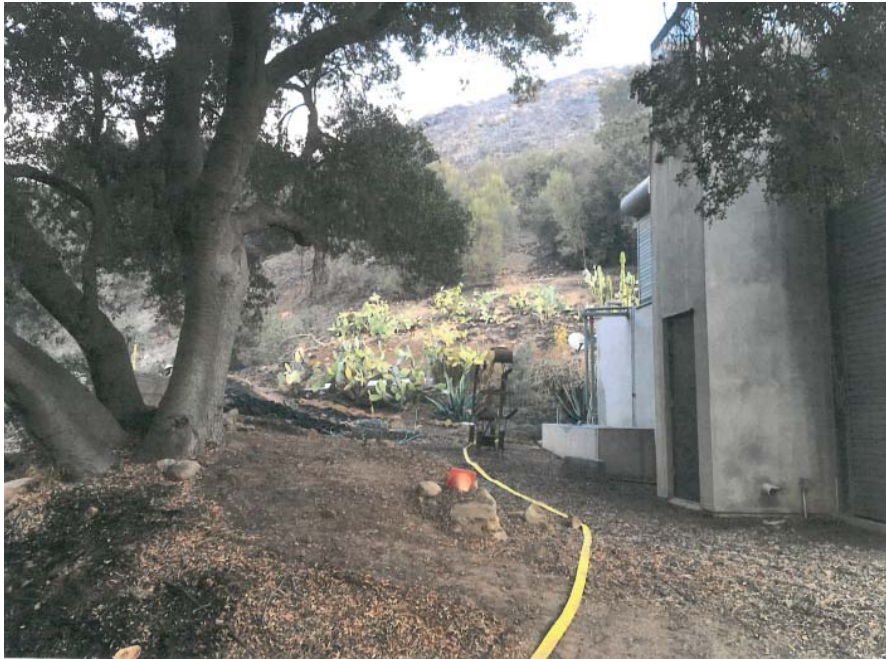
View of fire hose west of accessory building.  
Fire burned within 10 feet of the building.

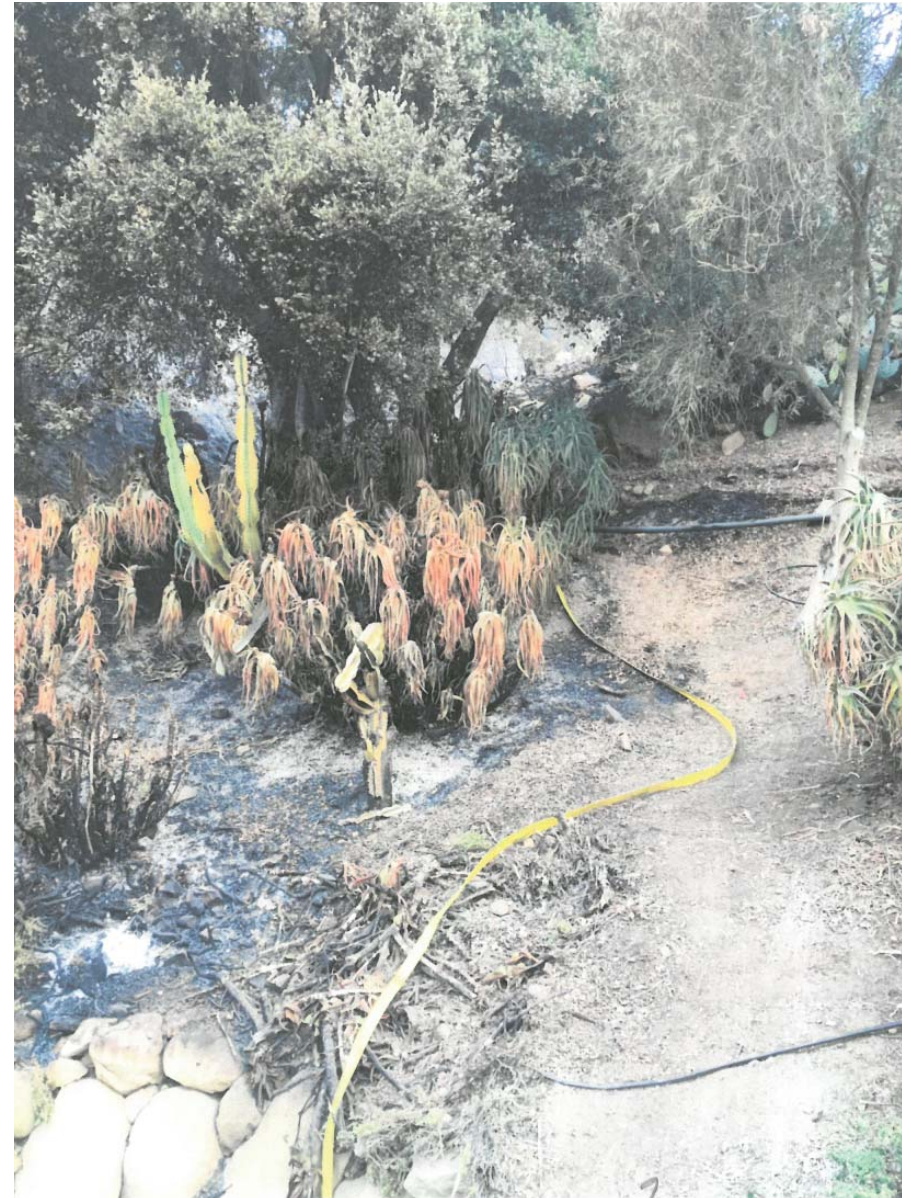
View of fire hose east of accessory building. Fire burned within 10 feet of the building.

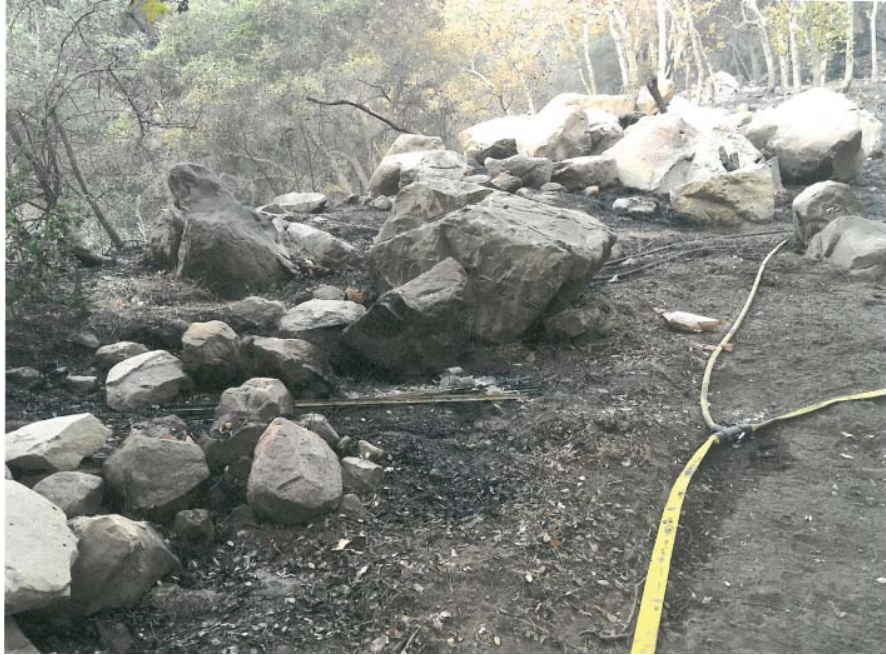
949 Toro Canyon access road 12/14/17. East embankment above creek, hoses and burned area.

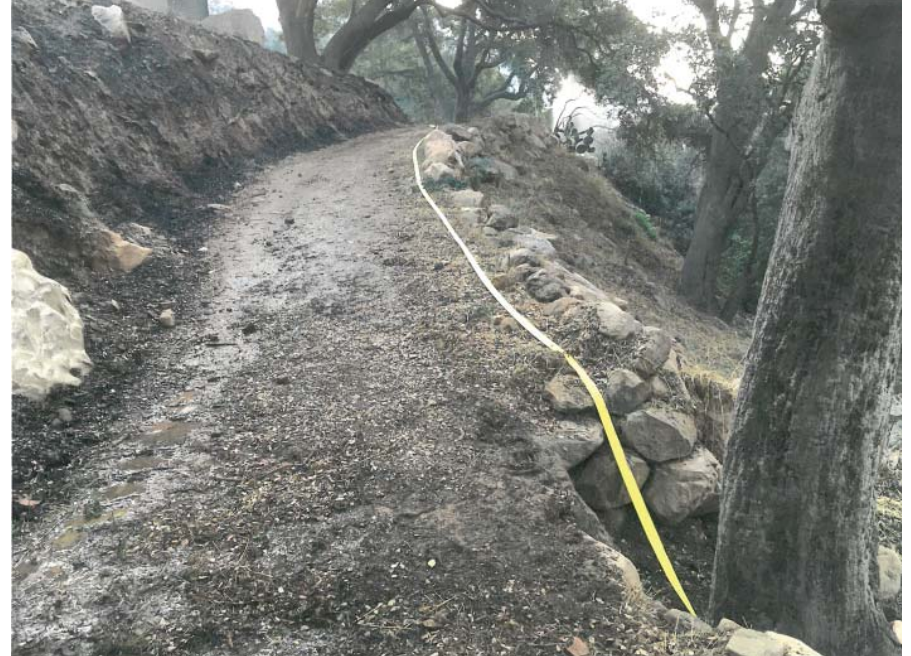
949 Toro Canyon access road 12/14/17. View is south, location is west of accessory building, trail of fire hoses/

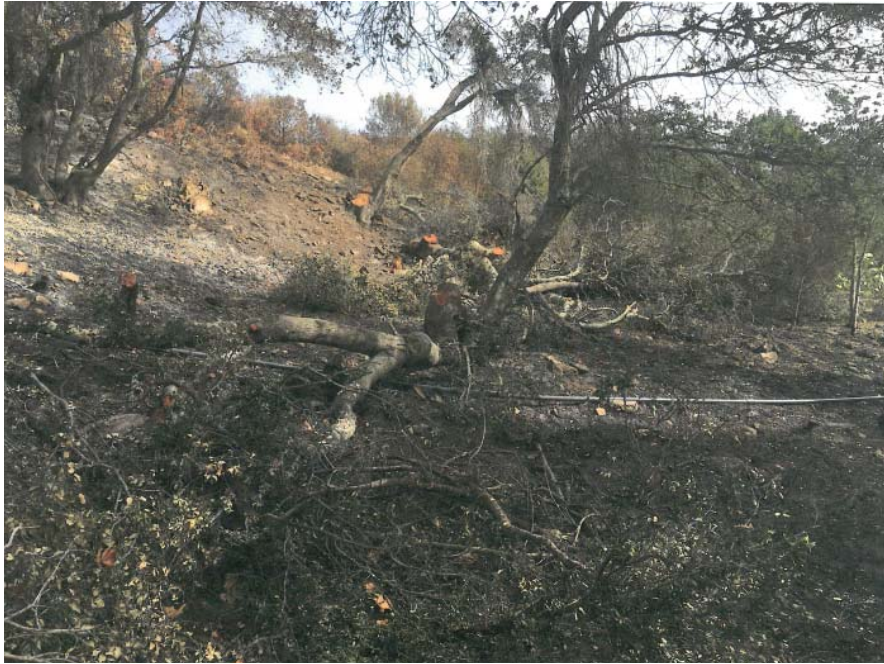
View of the fire break cut by Cal Fire through oaks north of accessory building 1/6/18.

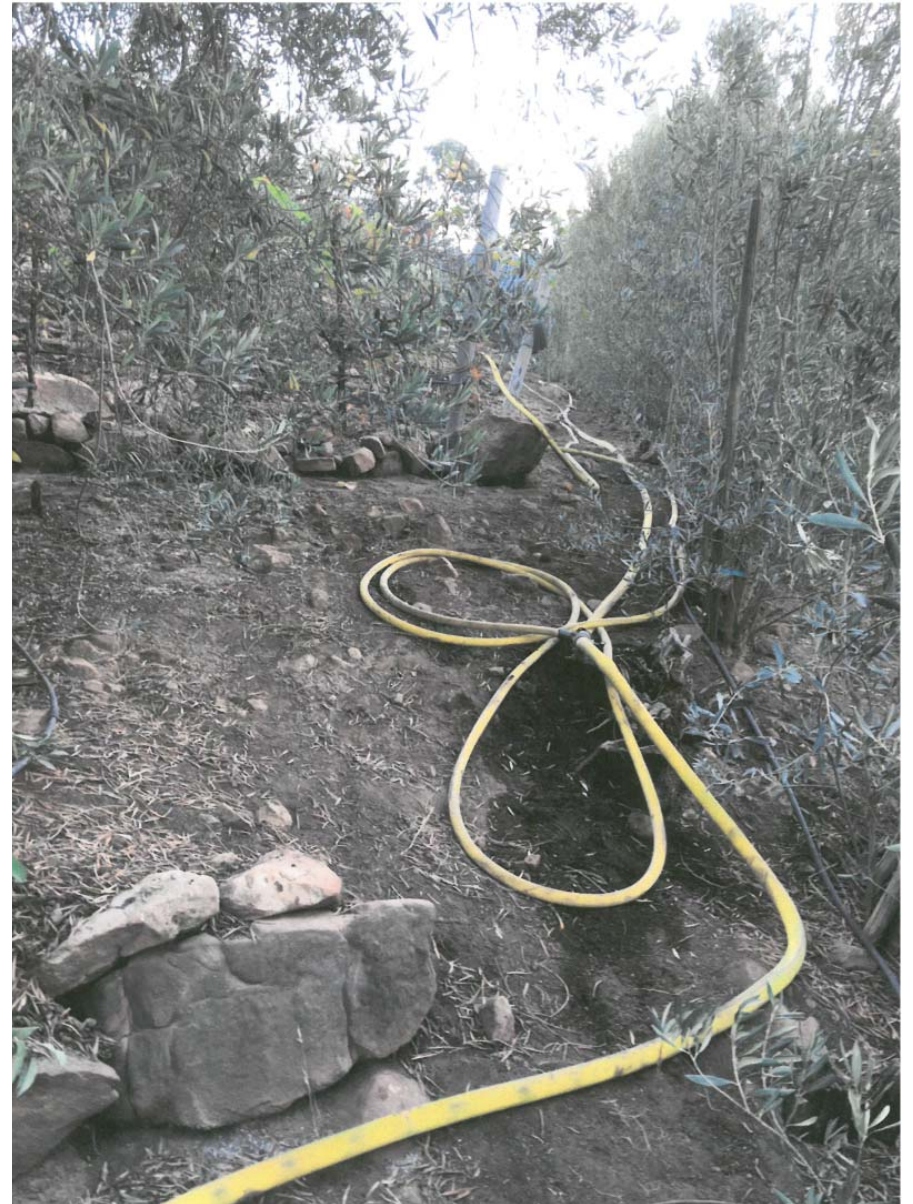
Fire hoses on south property line running east up hillside.  
12/14/17.

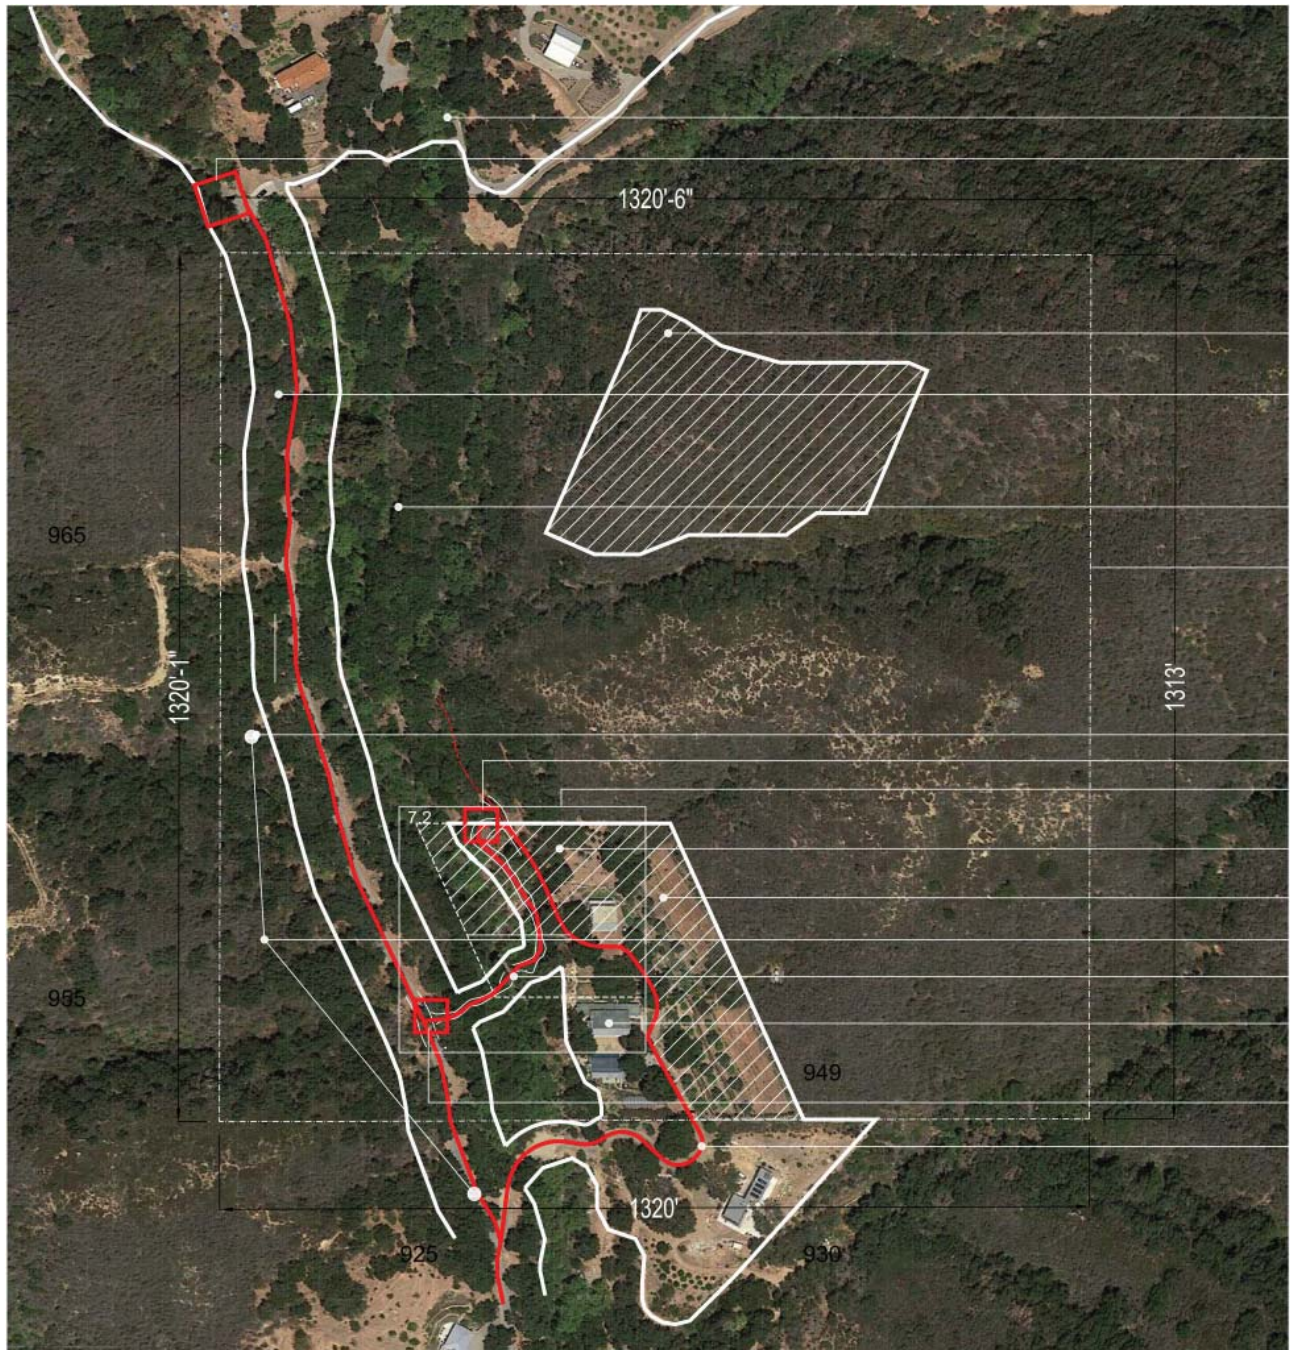
**949 Toro Canyon Road  
FIRE PROTECTION PLAN**

- AG Fire Break
- Fire Department Hydrant #89/Hammerhead
- Future AG Fire Break
- Fuel Management for Toro Canyon Road
- Toro Canyon Creek
- Property Line
- Existing Well #3 / #4 Hammerhead Fire Refuge
- Existing Service Road
- Existing AG
- Existing Fire Hydrant
- Location of Proposed Bridg
- Existing Residence (4 Buildings @ 6,000SF) Fire Resistant Shelter
- Hammerhead
- Existing Driveway
