# **Habitat Mitigation Monitoring Plan for the Foothill Road Low Water Crossing Removal and Construction of Bridge 51C-031 on the Cuyama River**

Prepared by: **Morgan M. Jones**

**Santa Barbara County Public Works Dept.**

**Table of Contents, Foothill Road Habitat Restoration Plan for County Bridge 51C-381  
August 1, 2020**

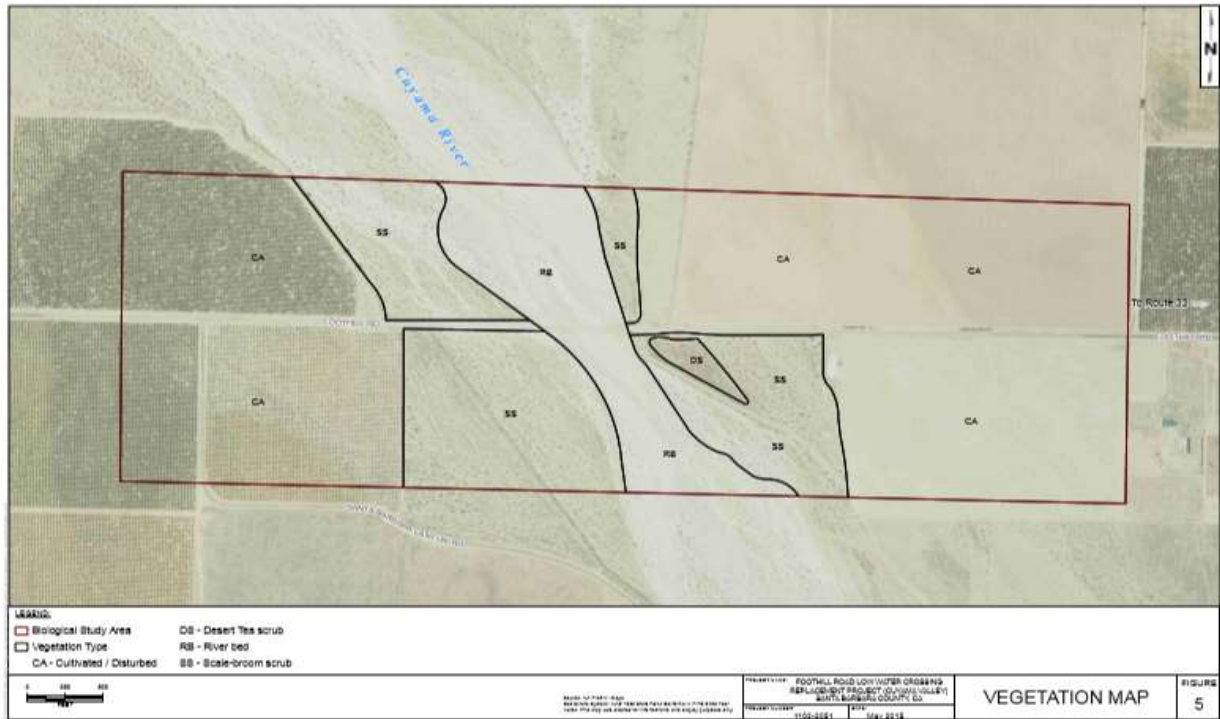
**3.3.1 Figure Three:** vegetative communities and land cover types

The following vegetative communities and land cover types were identified in association with the main channel and adjacent terraces of the Cuyama River.

The following vegetative communities and land cover types were identified within the biological study area which covers approximately 88.5 acres:

Vegetation/Habitat	Area within BSA	Area within PIA	
		Construction-related Disturbance	Displacement by Structures and RSP
Scale-broom scrub	78.0	4.8	0.28
California desert tea scrub	2.5	0.3	0.00
Riverbed	36.5	2.6	0.01
Cultivated/disturbed areas	208.2	11.6	0.01
<b>Total</b>	<b>325</b>	<b>19.3</b>	<b>0.30</b>

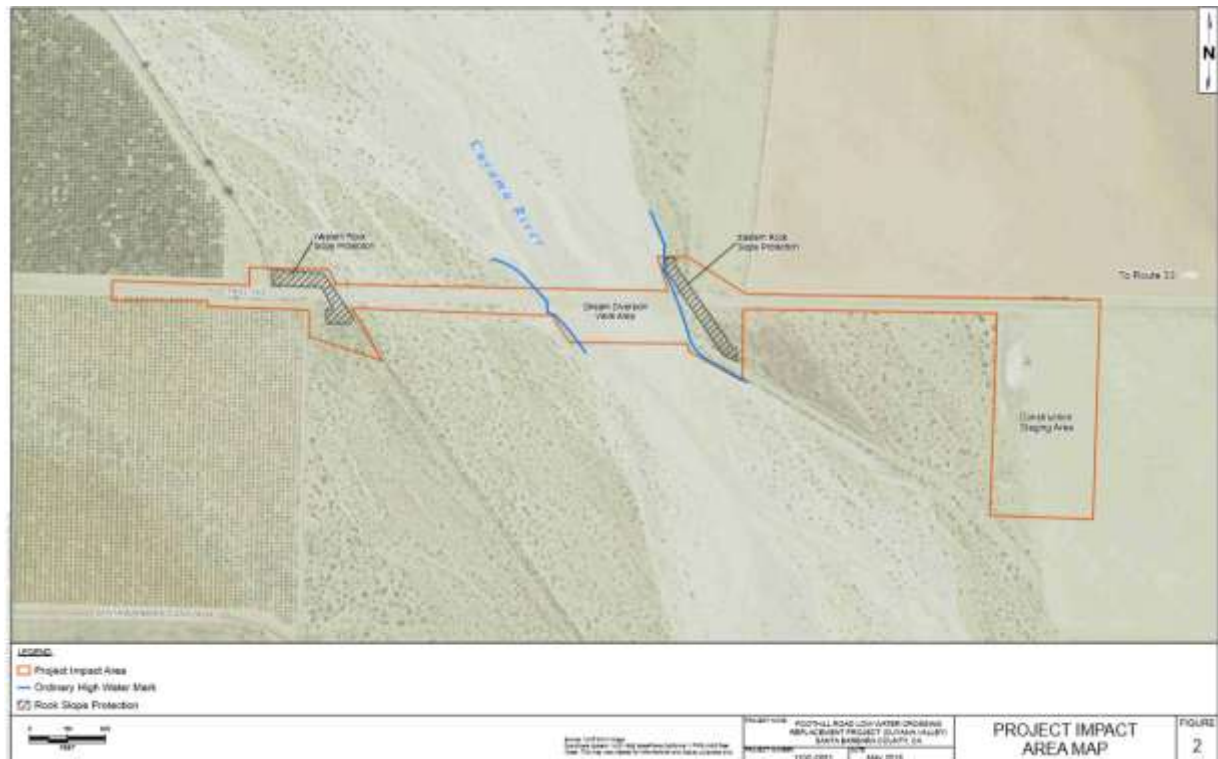
**3.4.1 Figure Four:** Project Impact Area Map

Disturbance to CDFW/RWQCB jurisdiction is approximately 4.2 acres and disturbance to USACE jurisdiction is approximately 2.4 acres within the 325 acres biological study area.

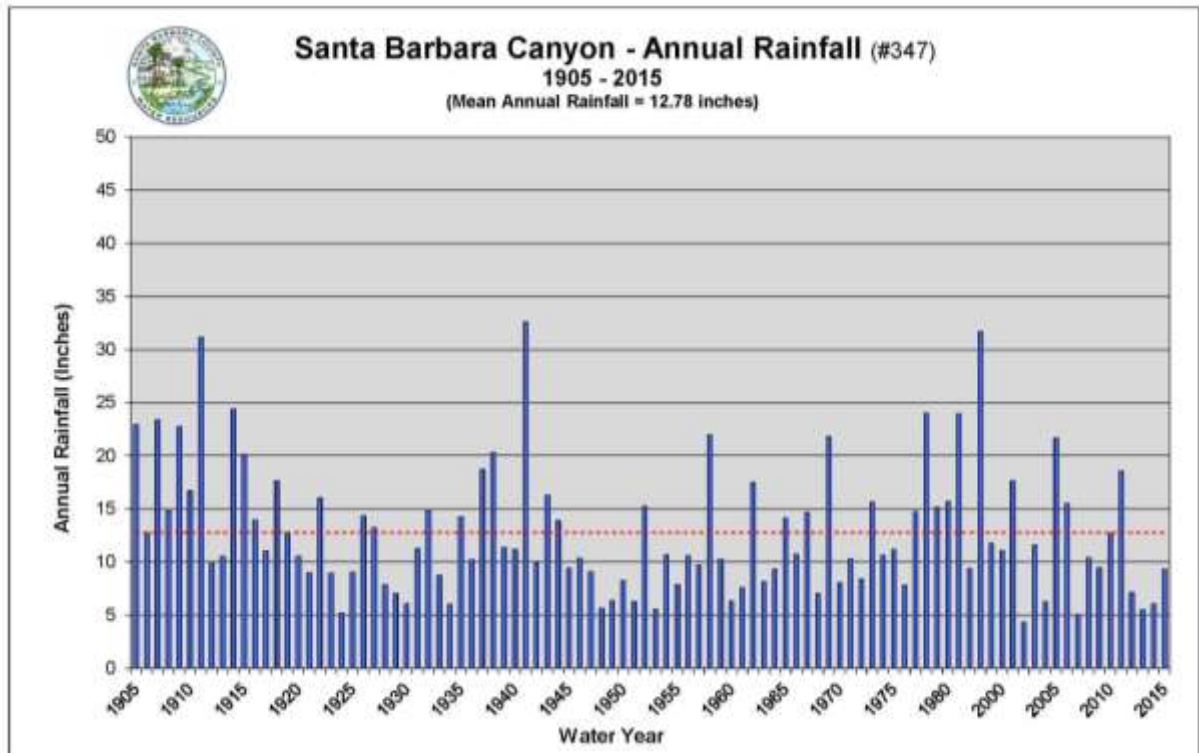
**Figure Five:** Rainfall data for the Cuyama Valley area from 1905-2015, taken from the Flood Control District of Santa Barbara County Public Works.

The closest location with many years of temperature and precipitation data is in Santa Barbara Canyon, California. This data is shown below.

### 1905 – 2015 Annual Rainfall Chart

Based on data collected at the U. S. Geological Survey gauging station near Ventucopa (about 18 miles upstream of the project site, the upper Cuyama River is typically dry from June through September (mean monthly discharge of 1.5 cfs or less). Climate data collected at Fire Station #41 at New Cuyama indicates the average annual rainfall within the biological study area is 7.70 inches (1954-2014 data). However, rainfall recorded at Fire Station #41 during the 2010-2011 rainy season was 40 percent above normal (10.73 inches). Subsequent rainfall has been below normal; 5.09 inches in 2011-2012, 2.32 inches in 2012-2013, 1.74 inches in 2013-2014 and 5.29 inches in 2014-2015.

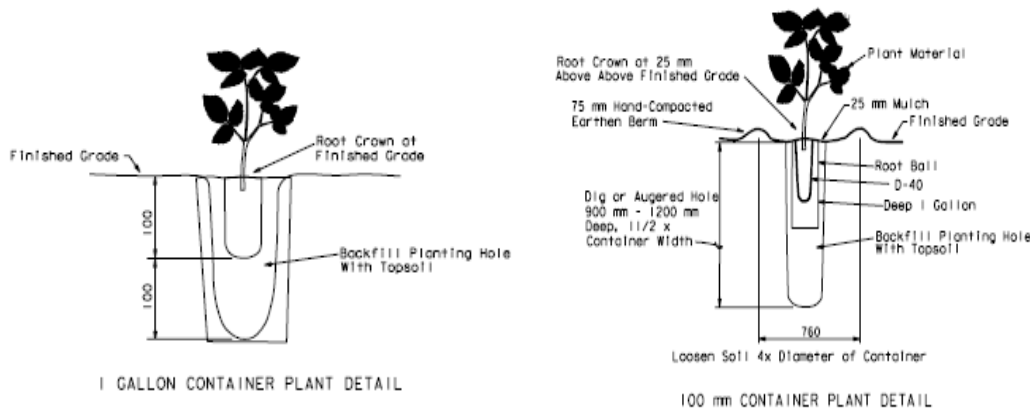
#### 4.5.3 Figure Five: Diagram for planting container plants.

Planting holes will be dug by hand with a posthole digger or by mechanical methods such as an auger at least twice as deep and wide as the container size. While the plant is still in the container, the root ball will be thoroughly wetted. The plant will then be removed from the container. If the taproot has begun to encircle the container, the roots will be cut back to a single taproot. For most native revegetation projects, soil amendment is not recommended. The soil should be soft and friable. Large rocks and clods should be removed from planting hole backfill soil. If the supervising biologist calls for soil amendment, a mix of approximately one-third composted or nitrolized forest humus to two-third native soil should be blended and used as backfill. Prior to placement of the plant into the planting hole, fill the hole with water, which will be allowed to percolate into the subsoil. Some of the backfill material will then be spilled in the planting hole, moistened, and tamped to form a mound in the bottom of the planting hole. With water flowing slowly from the hose into the hole, more backfill material will be placed into the hole, up to about two-thirds of the height of the root ball. The backfill material

will be moistened, tamped, and set all around. The position of the plant, relative to finished grade, will be rechecked to be sure that the collar is still above grade. The remaining portion of the planting hole surrounding the root ball will be filled with backfill material. An irrigation basin berm 2 to 3 feet outside the dimension of the trunk will be created using the remaining backfill and soil. Coarse, organic, weed-and disease-free mulch will be applied at least one-inch deep. The exposed collar and inside the entire basin area will be top-dressed. Once planting is complete, the plant will be irrigated from the top, filling the irrigation basin and sprinkling the surrounding area to settle backfill, mulch, and berm. Plants will be deep-watered once per week through the first 3 to 5 months following planting, unless frequent rainfall makes deep-watering unnecessary. Weeding will be conducted as needed to reduce competition with non-native species.
