Proposed Amendment to the Goleta Beach County Park Coastal Development Permit (CDP No. 4-14-0687)

GOLETA BEACH
 EMERGENCY PROTECTION
 APRIL 2016

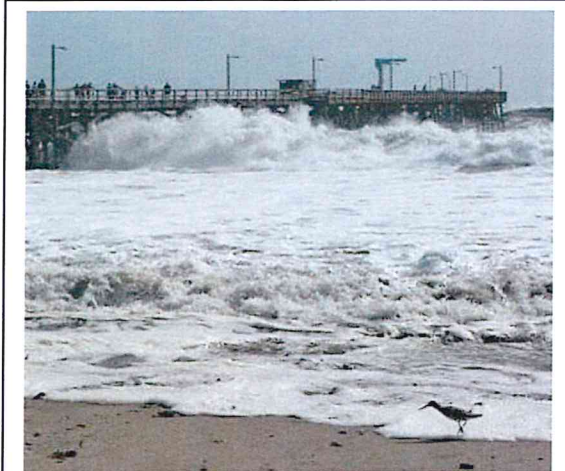
Although Goleta Beach is generally sheltered from big surf, it can experience extreme surf conditions, particularly during El Niño storm events or when waves arrive with a west swell.

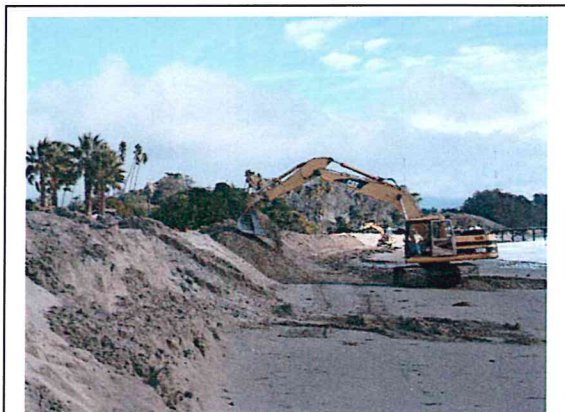
Following completion of the sand berm in December, frequent maintenance involved use of excavators to rebuild the eroding sand berm.

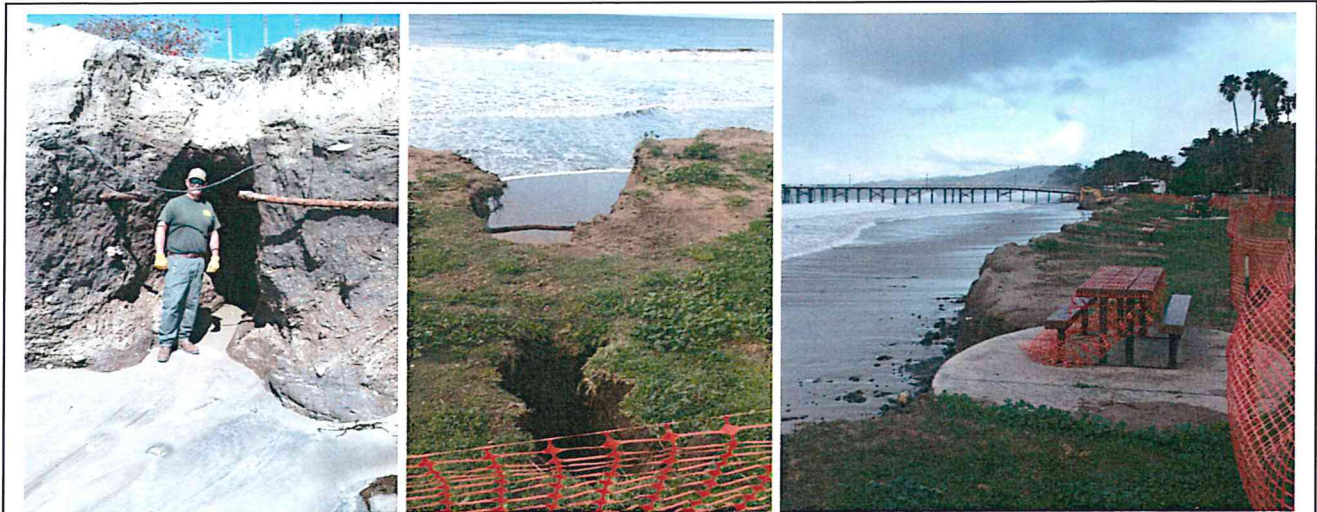
Sink holes that developed in March 2016 exceeded more than 10 feet in depth in some locations (left), with crevasses extended 15-20 feet deep into the lawn resulting in imminent substantial impacts to public safety at the park. The County took permitted emergency action to cordon off and fill these areas and to initiate repairs.

On March 9, 2016, the CCC approved emergency work under CDP G-4-16-0027, including backfilling of the sinkholes with imported earth and cobbles (see Figure 1).¹ However, these measures proved ineffective and erosion and damage to park facilities accelerated along with release of compacted earth and cobbles into the surf zone due to high tides and strong wave action.

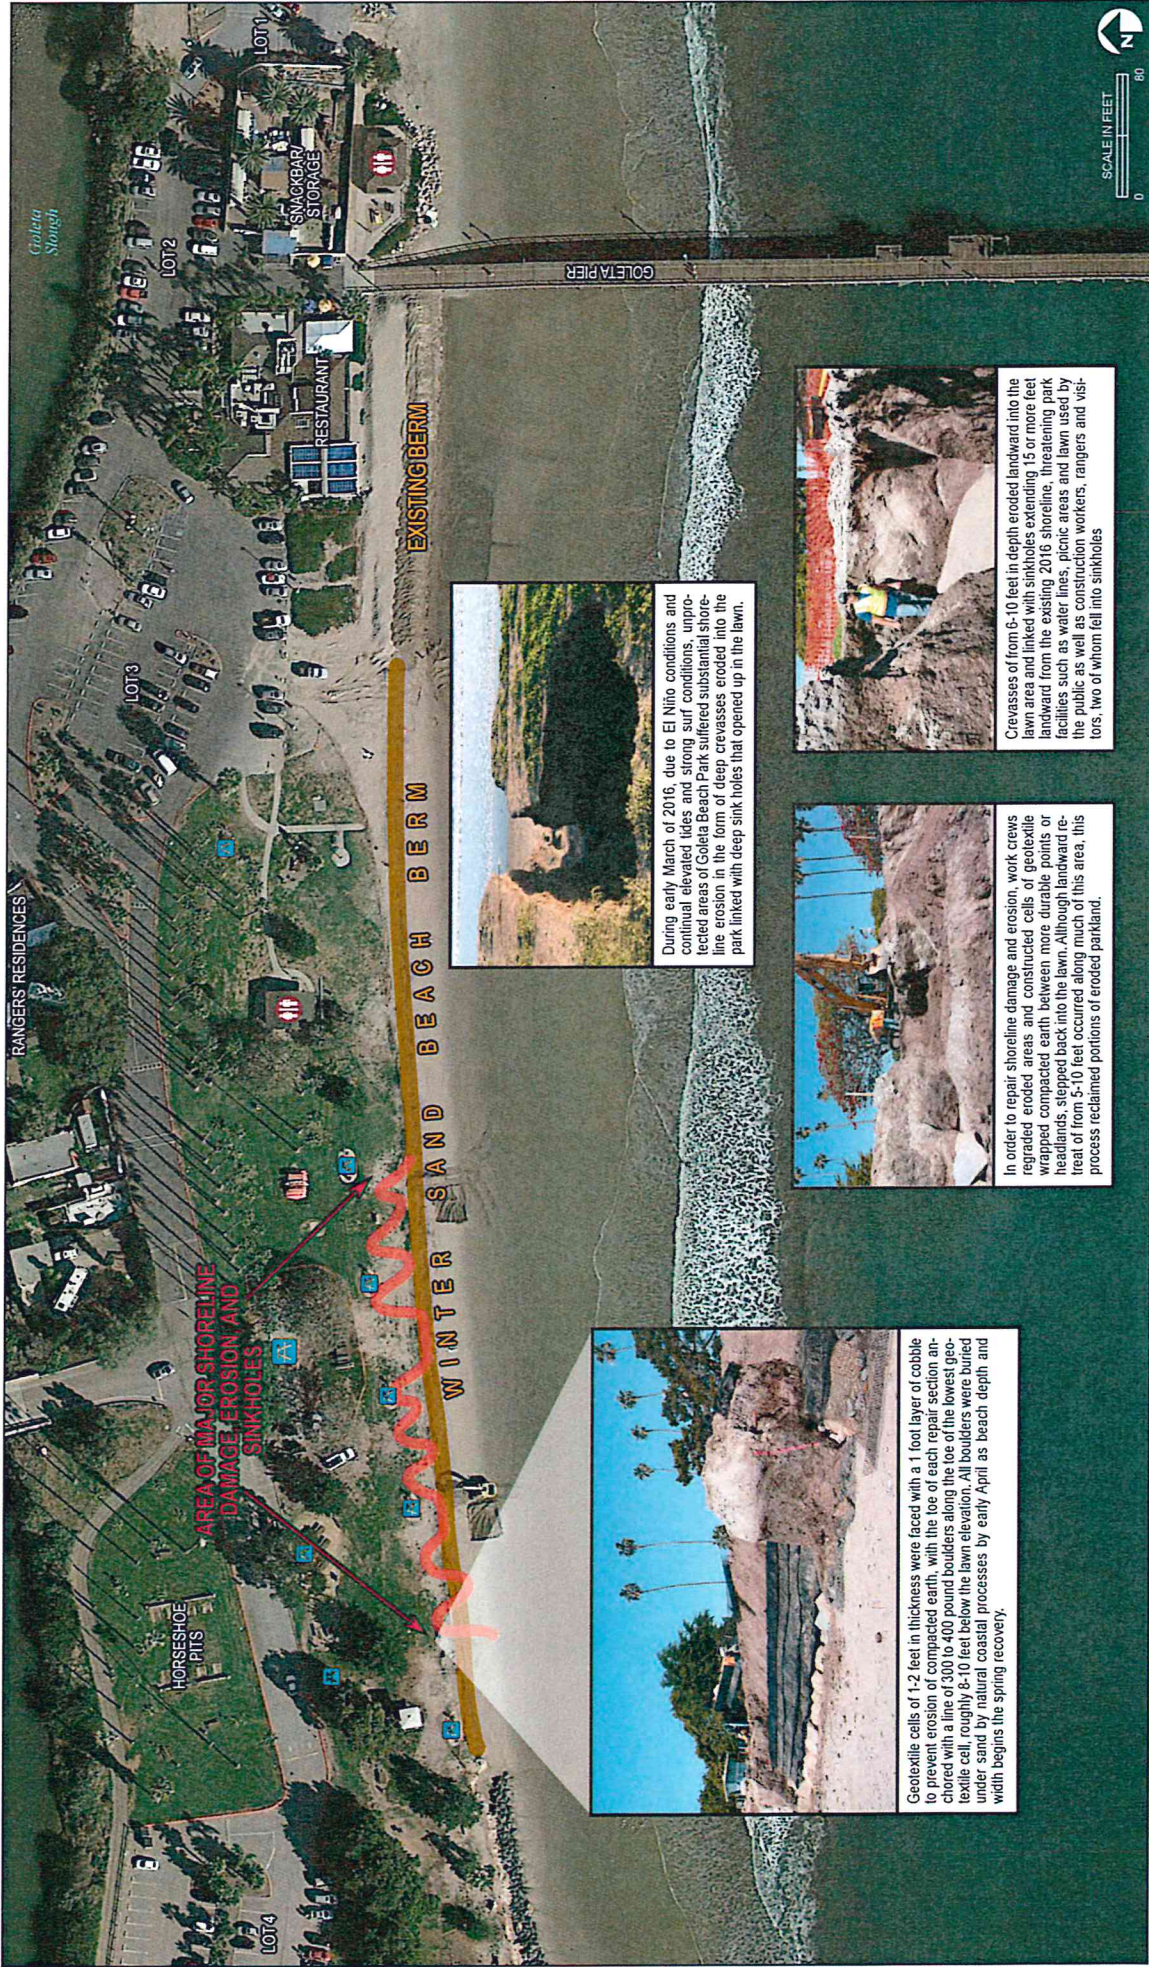
Figure 1. Goleta Beach Repairs

During early March of 2016, due to El Niño conditions and continual elevated tides and strong surf conditions, unprotected areas of Goleta Beach Park suffered substantial shoreline erosion in the form of deep crevasses eroded into the park linked with deep sink holes that opened up in the lawn.

Crevasses of from 6-10 feet in depth eroded landward into the lawn area and linked with sinkholes extending 15 or more feet landward from the existing 2016 shoreline, threatening park facilities such as water lines, picnic areas and lawn used by the public as well as construction workers, rangers and visitors, two of whom fell into sinkholes

In order to repair shoreline damage and erosion, work crews regrated eroded areas and constructed cells of geotextile wrapped compacted earth between more durable points or headlands, stepped back into the lawn. Although landward retreat of from 5-10 feet occurred along much of this area, this process reclaimed portions of eroded parkland.

Geotextile cells of 1-2 feet in thickness were faced with a 1 foot layer of cobble to prevent erosion of compacted earth, with the toe of each repair section anchored with a line of 300 to 400 pound boulders along the toe of the lowest geotextile cell, roughly 8-10 feet below the lawn elevation. All boulders were buried under sand by natural coastal processes by early April as beach depth and width begins the spring recovery.

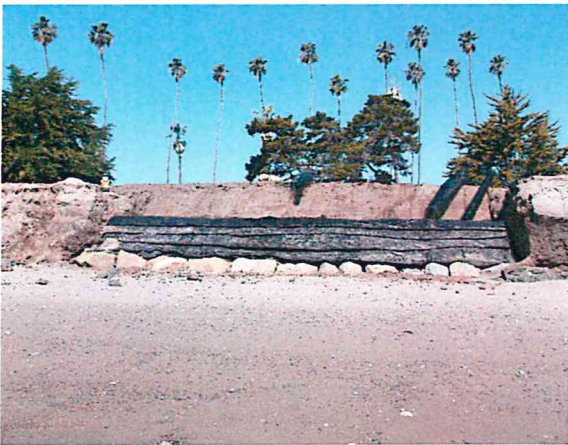
In response to damaging erosion, work crews installed geotextile fabric earth filled cells to protect park facilities in areas that were not already protected by the existing revetment (boulders were temporary and have been removed).

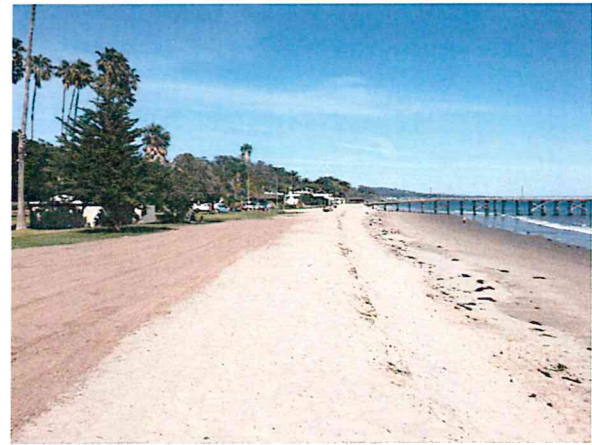
Areas subject to emergency repairs have now been covered with sand by both natural spring time accretion and heavy equipment.

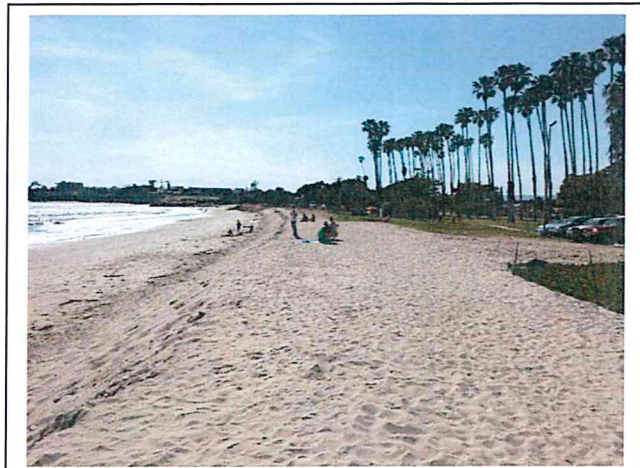
Repairs at Goleta Beach Park have been completed and lie buried beneath the sand (April 2016).

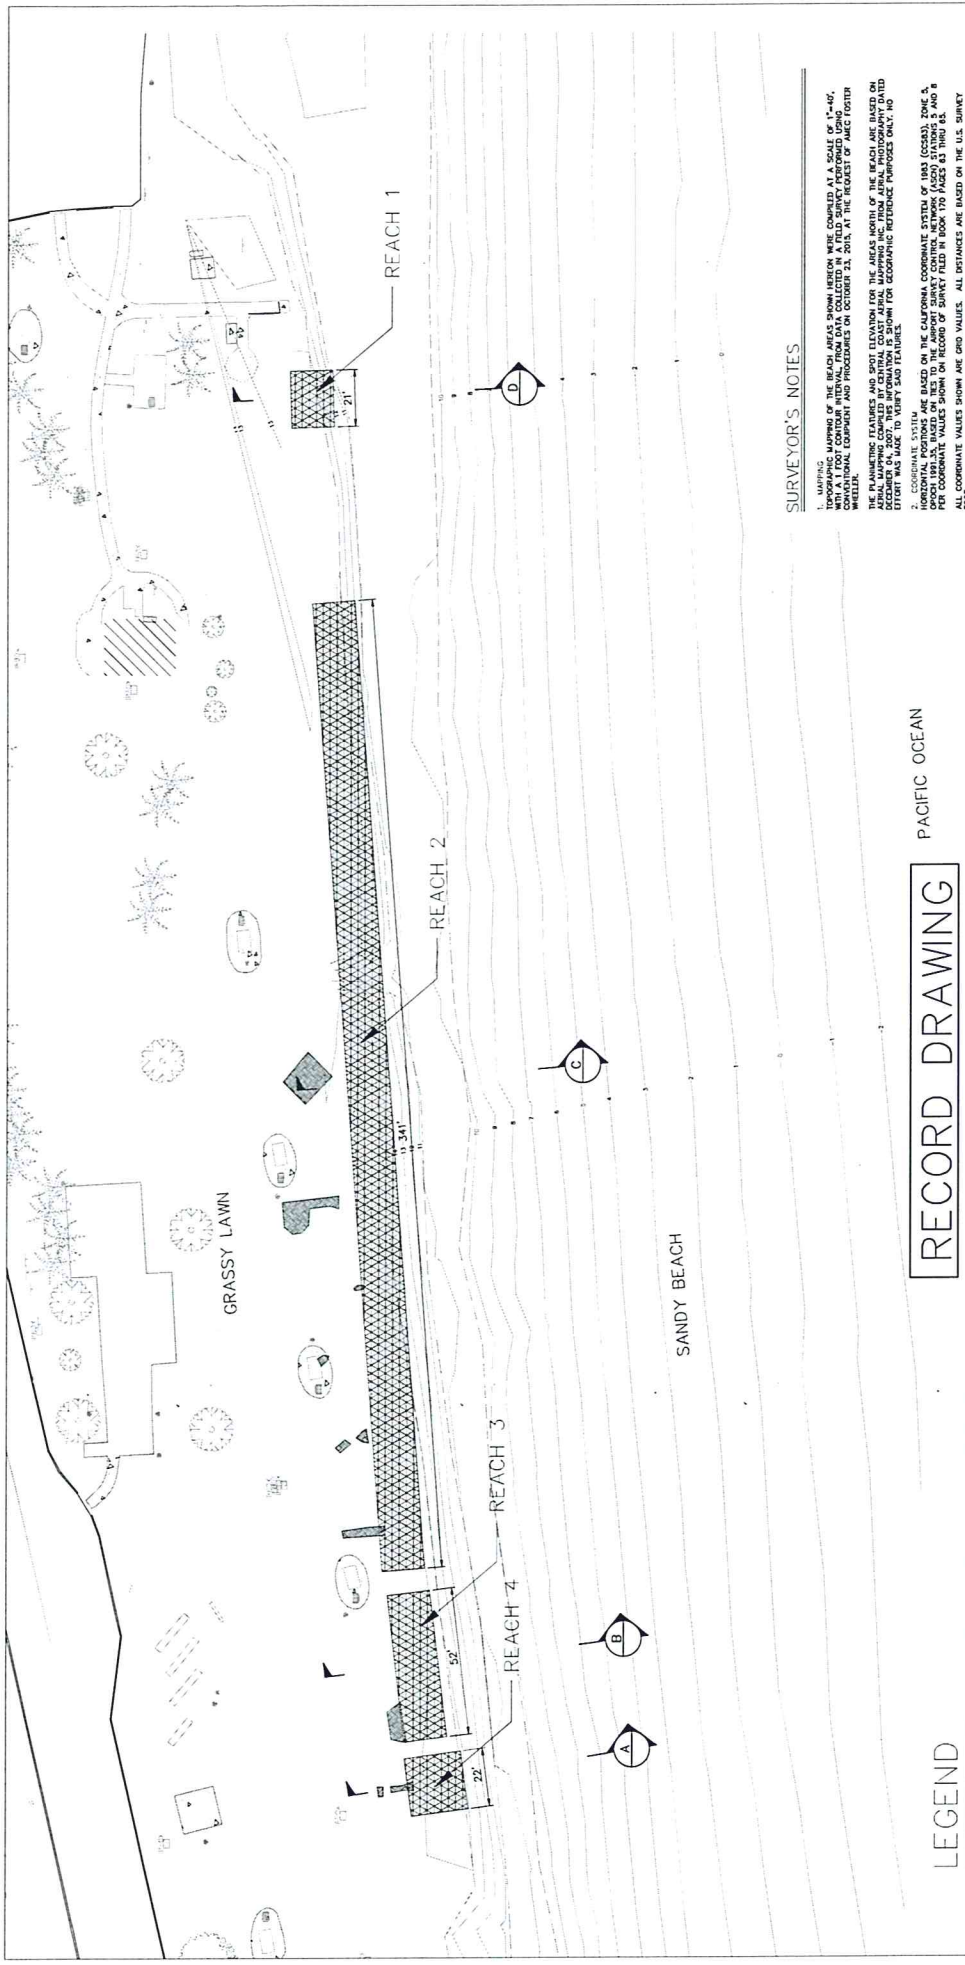
1. BOTTOM OF SINKHOLE FILLED WITH ~24" LAYER OF COBBLE, REMAINING VOID FILLED WITH COMPACTED COMPATIBLE EARTHEN FILL AND FINISHED TO MATCH EXISTING GRADE OF GRASSY LAWN.
2. SINKHOLES COMPATIBLE EARTHEN FILL FROM GOLETA SLOUGH COUNTY DEBRIS BASIN. TOTAL QUANTITY OF SOIL FOR SINKHOLE FILL: ~150 CY
3. SINKHOLES COBBLE FILL 6"-12"Ø. TOTAL QUANTITY OF COBBLE FOR SINKHOLE FILL: ~90 TONS

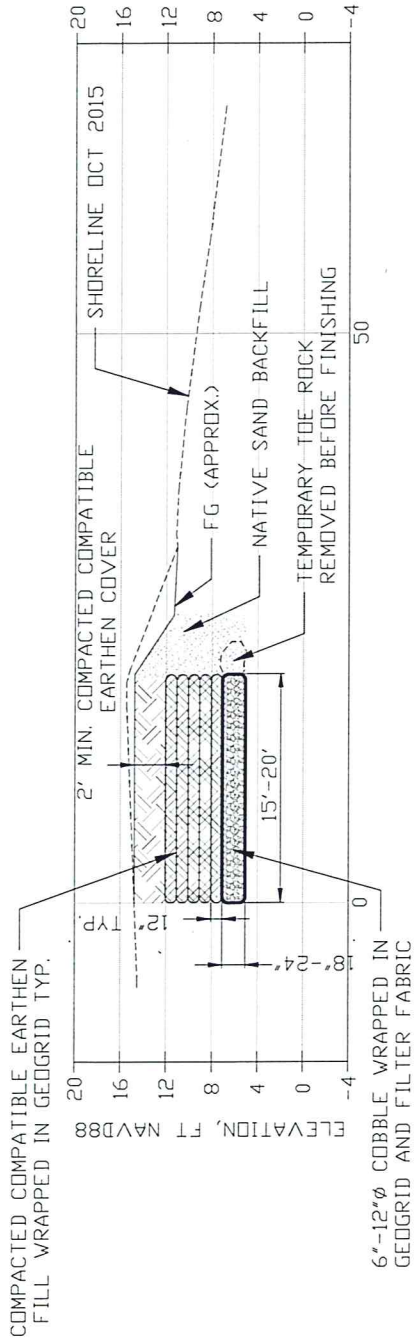
SECTION A - REACH 4

1. GEOGRID INSTALLED: TENSAR BX1200.
2. FILTER FABRIC INSTALLED: MIRIFI NC140.
3. COMPATIBLE EARTHEN FILL FROM GOLETA SLOUGH COUNTY DEBRIS BASIN. TOTAL QUANTITY OF SOIL FOR BANK REPAIR: ~1,000 CY
4. TOTAL QUANTITY OF COBBLE FILL FOR BANK REPAIR: ~510 TONS
5. TEMPORARY TOE ROCK REMOVED BEFORE FINISHING AND STOCKPILED IN COUNTY YARD.

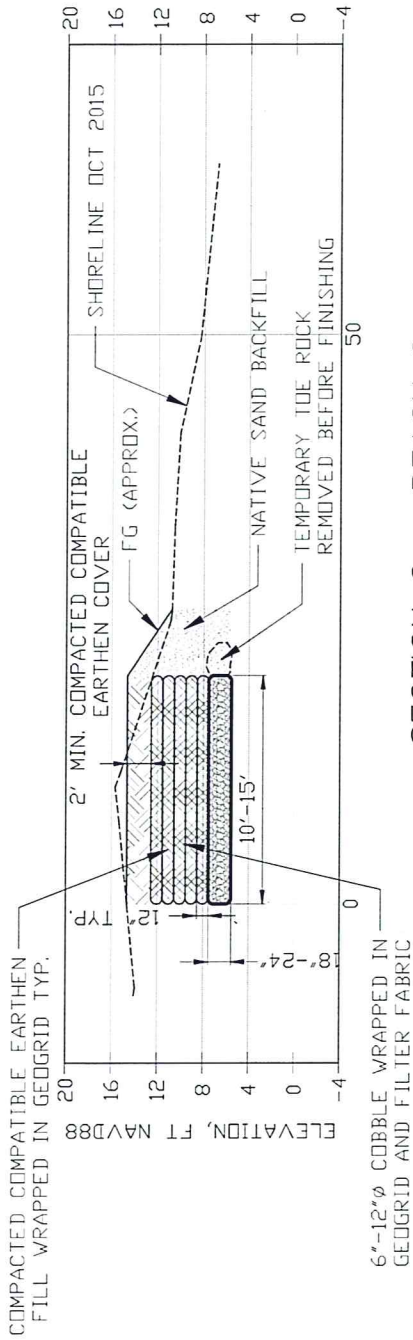
SECTION C - REACH 2

1. GEOGRID INSTALLED: TENSAR BX1200.
2. FILTER FABRIC INSTALLED: MIRIFI NC140.
3. COMPATIBLE EARTHEN FILL FROM GOLETA SLOUGH COUNTY DEBRIS BASIN. TOTAL QUANTITY OF SOIL FOR BANK REPAIR ~1,000 CY
4. TOTAL QUANTITY OF COBBLE FILL FOR BANK REPAIR: ~510 TONS
5. TEMPORARY TOE ROCK REMOVED BEFORE FINISHING AND STOCKPILED IN COUNTY YARD.
6. NO COBBLE, GEOGRID, OR FILTER FABRIC WAS USED IN REACH 1 SHOWN BY SECTION D.
